Minnesota Airport System Pavement Evaluation 2011 Update

Richard B. Helgeson Airport (TWM)

Two Harbors, Minnesota

January 2012

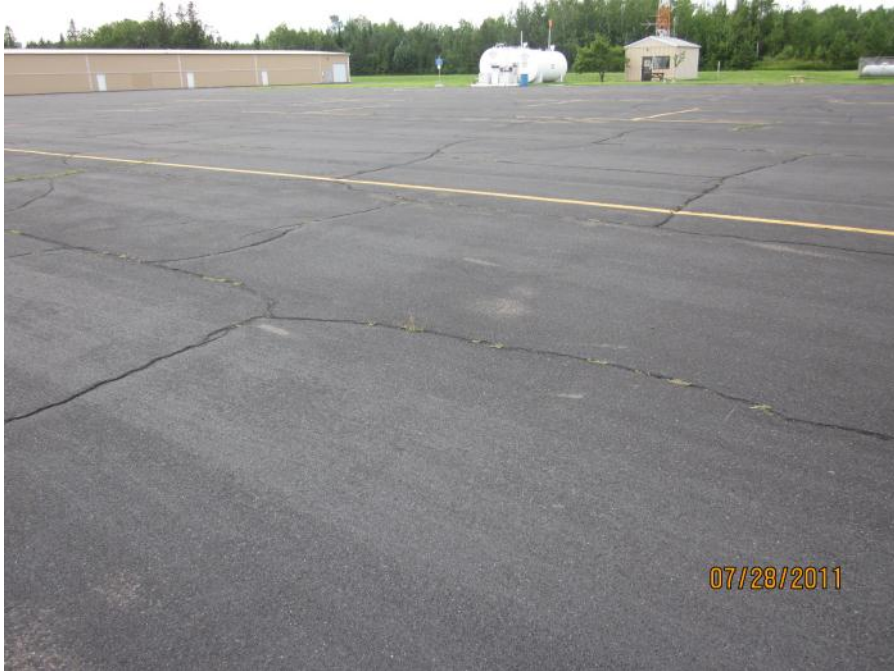
TWM APA 001 (PCI = 42)

Conditions: PCI : 42

43 BLOCK CRACKING M 5,000.00 SqFt Comments:

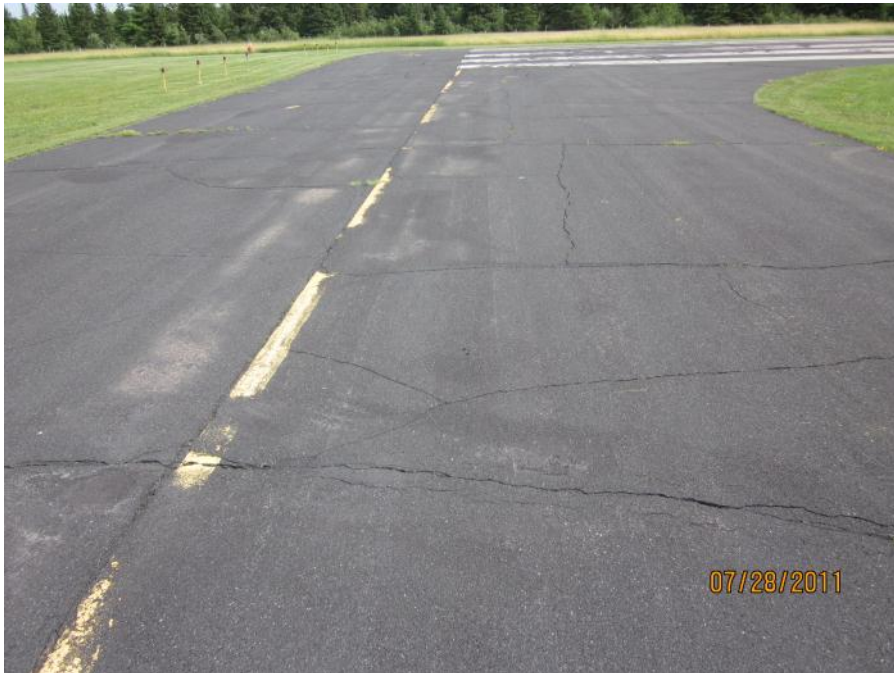
TWM CTA 001 (PCI = 59)

Conditions: PCI: 59

43 BLOCK CRACKING L 4,735.00 SqFt Comments:

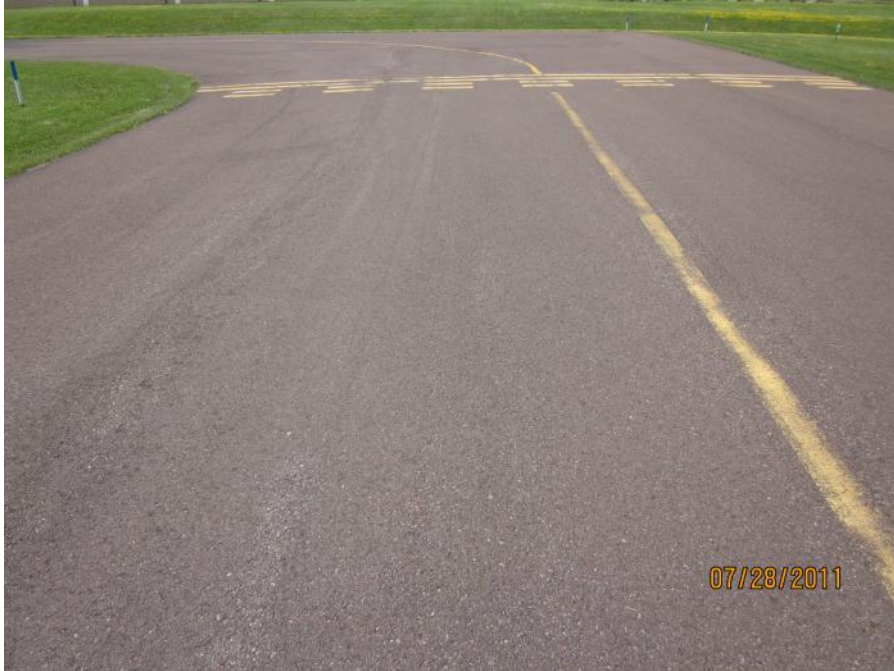
TWM CTA 002 (PCI = 83)

Conditions: PCI : 83

48	LONGITUDINAL/TRANSVERSE CRACKING	L	100.00 Ft	Comments:
48	LONGITUDINAL/TRANSVERSE CRACKING	M	16.00 Ft	Comments:
52	RAVELING	M	6.00 SqFt	Comments:

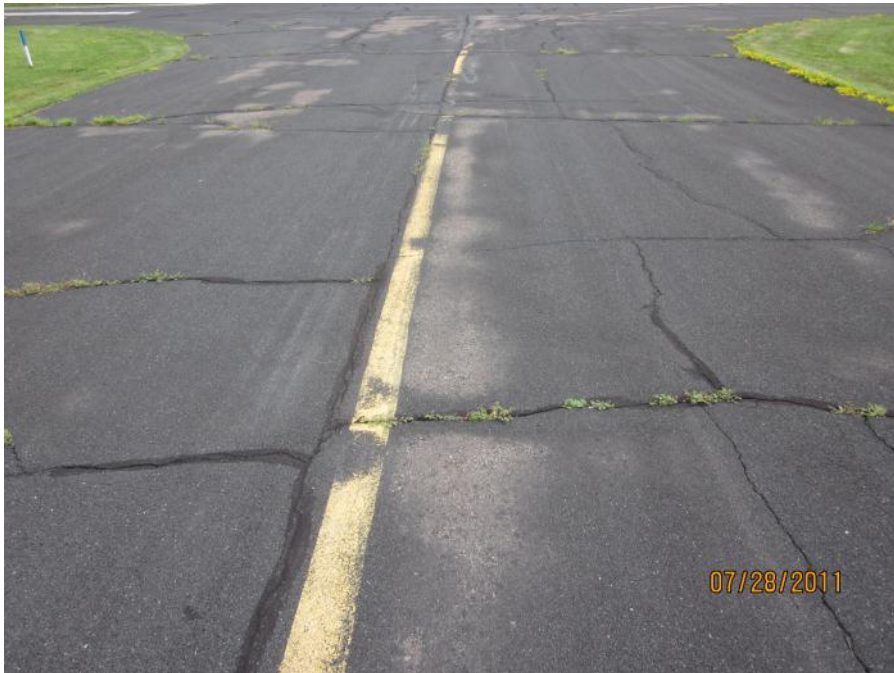
TWM CTB 001 (PCI = 62)

Conditions: PCI : 62

43 BLOCK CRACKING	L	2,000.00 SqFt	Comments:
48 LONGITUDINAL/TRANSVERSE CRACKING	L	162.00 Ft	Comments:
48 LONGITUDINAL/TRANSVERSE CRACKING	M	8.00 Ft	Comments:

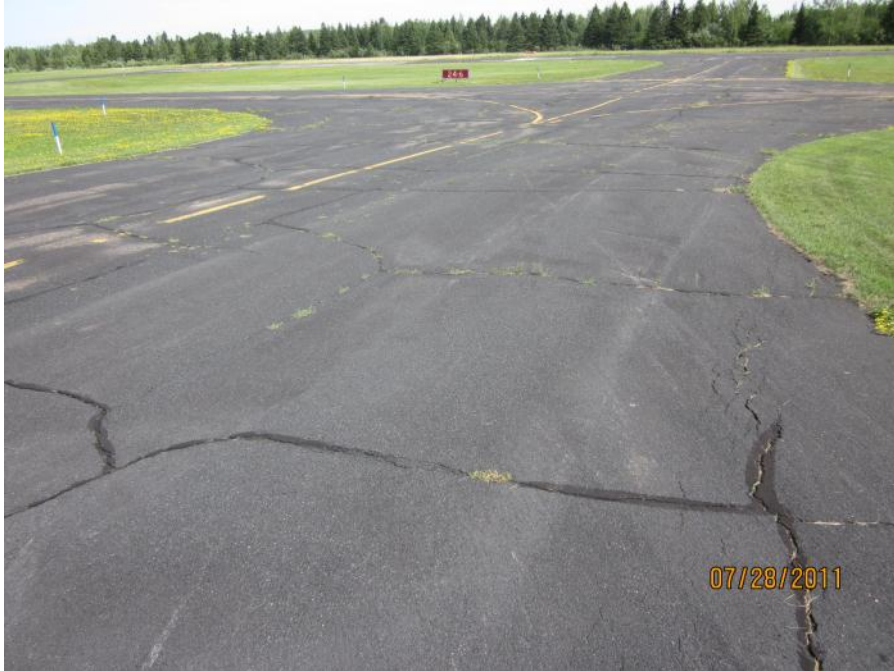
TWM CTBX 001 (PCI = 38)

Conditions: PCI : 38

43	BLOCK CRACKING	L	5,010.00	SqFt	Comments:
41	ALLIGATOR CRACKING	M	50.00	SqFt	Comments:
41	ALLIGATOR CRACKING	L	10.00	SqFt	Comments:
53	RUTTING	H	15.00	SqFt	Comments:
52	RAVELING	M	5.00	SqFt	Comments:

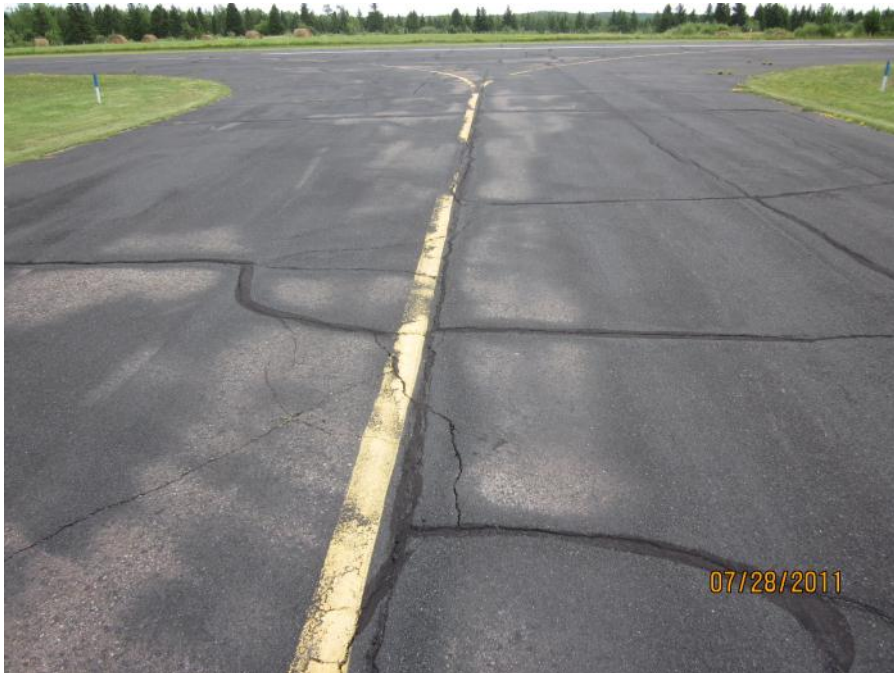
TWM CTC 001 (PCI = 64)

Conditions: PCI: 64

43 BLOCK CRACKING L 4,670.00 SqFt Comments:

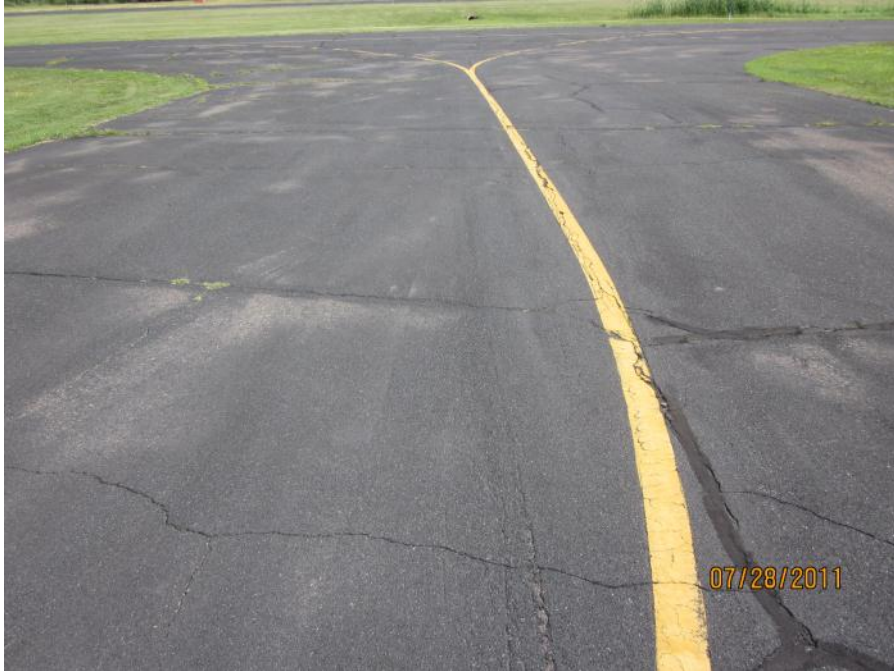
TWM CTD 001 (PCI = 45)

Conditions: PCI : 45

41 ALLIGATOR CRACKING M 70.00 SqFt Comments:

41 ALLIGATOR CRACKING L 40.00 SqFt Comments:

43 BLOCK CRACKING L 5,010.00 SqFt Comments:

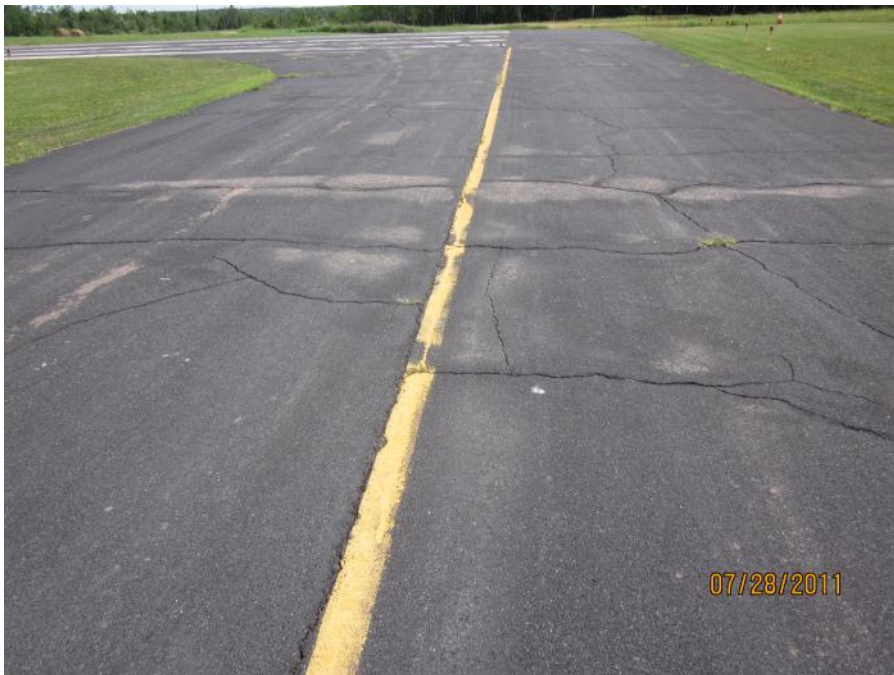
TWM CTF 001 (PCI = 59)

Conditions: PCI : 59

43 BLOCK CRACKING	L	4,615.00 SqFt	Comments:
56 SWELLING	L	240.00 SqFt	Comments:

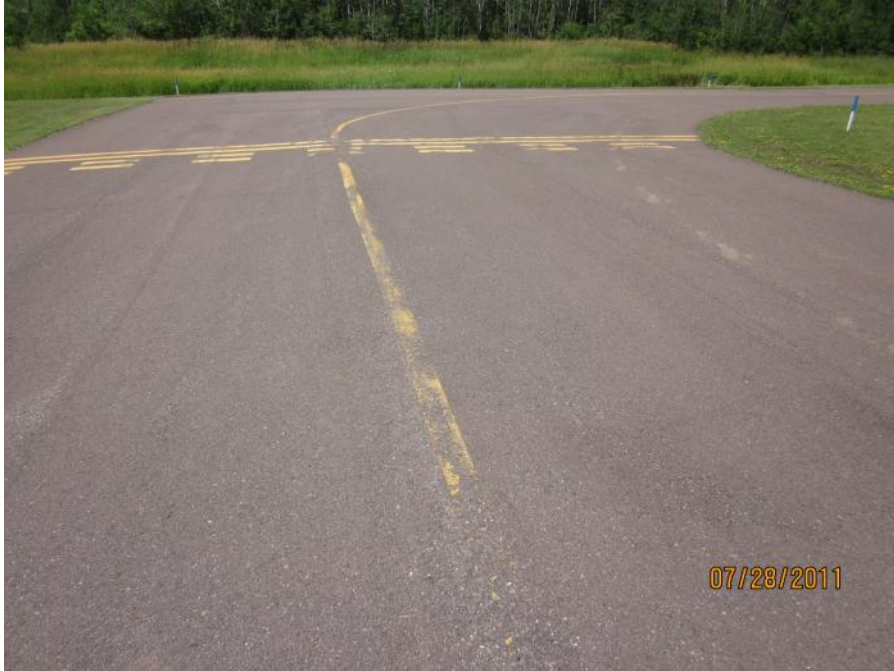
TWM CTF 002 (PCI = 92)

Conditions: PCI: 92

48 LONGITUDINAL/TRANSVERSE CRACKING L 85.00 Ft Comments:

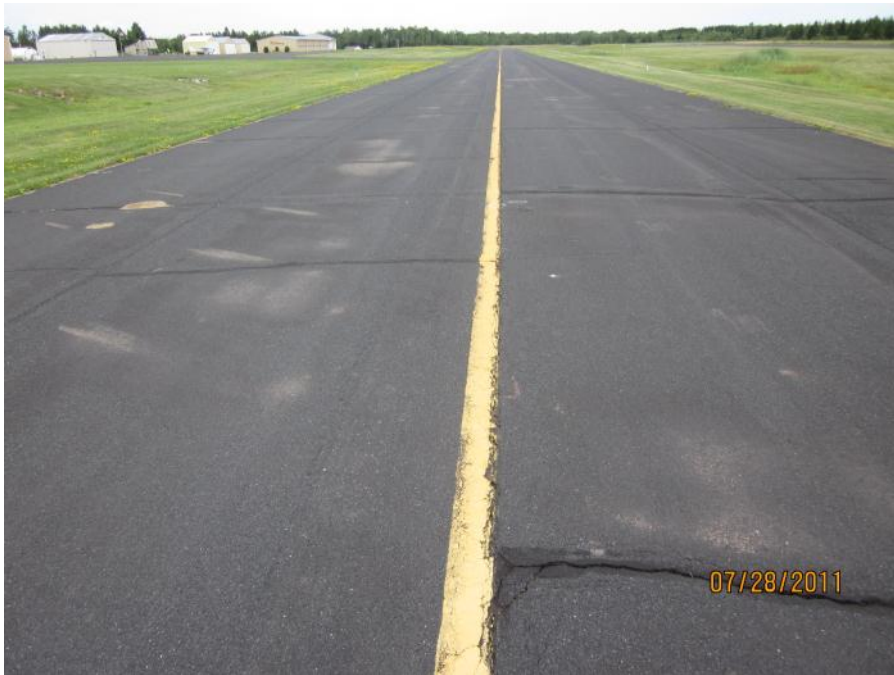
TWM PTA 001 (PCI = 64)

Conditions: PCI : 64

Sample Number: 104 Type: R Area: 4,000.00SqFt PCI = 64
Sample Comments:
43 BLOCK CRACKING L 4,000.00 SqFt Comments:

Sample Number: 111 Type: R Area: 4,000.00SqFt PCI = 64
Sample Comments:
43 BLOCK CRACKING L 4,000.00 SqFt Comments:

Sample Number: 118 Type: R Area: 4,000.00SqFt PCI = 64
Sample Comments:
43 BLOCK CRACKING L 4,000.00 SqFt Comments:

Sample Number: 125 Type: R Area: 4,000.00SqFt PCI = 62
Sample Comments:
43 BLOCK CRACKING L 2,000.00 SqFt Comments:
48 LONGITUDINAL/TRANSVERSE CRACKING L 210.00 Ft Comments:
48 LONGITUDINAL/TRANSVERSE CRACKING M 112.00 Ft Comments:

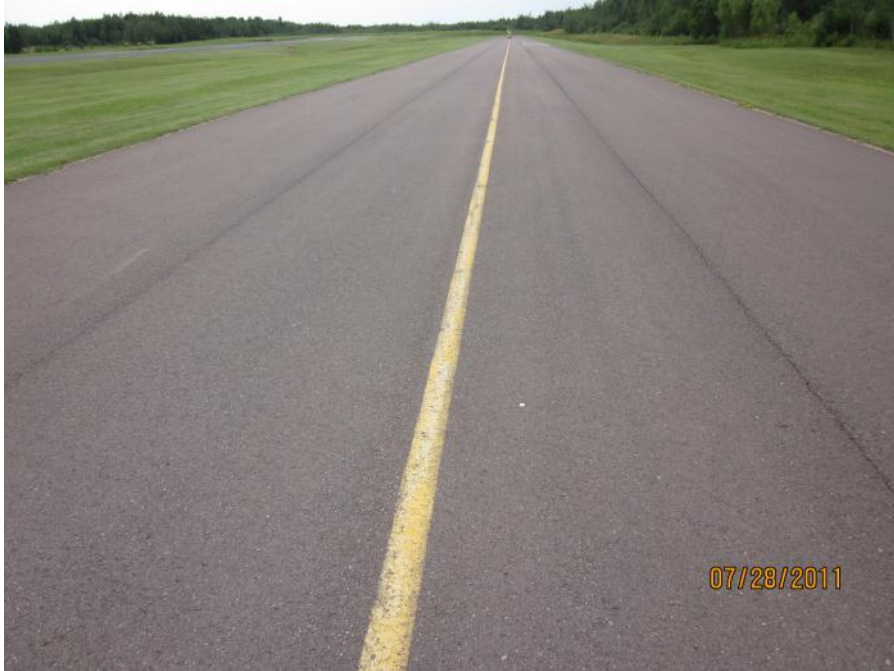
TWM PTA 002 (PCI = 91)

Conditions: PCI : 91

48 LONGITUDINAL/TRANSVERSE CRACKING L 7.00 Ft Comments:
57 WEATHERING M 29.00 SqFt Comments:

48 LONGITUDINAL/TRANSVERSE CRACKING L 26.00 Ft Comments:
57 WEATHERING M 25.00 SqFt Comments:

48 LONGITUDINAL/TRANSVERSE CRACKING L 92.00 Ft Comments:
48 LONGITUDINAL/TRANSVERSE CRACKING M 21.00 Ft Comments:
50 PATCHING L 84.00 SqFt Comments:

48 LONGITUDINAL/TRANSVERSE CRACKING L 52.00 Ft Comments:

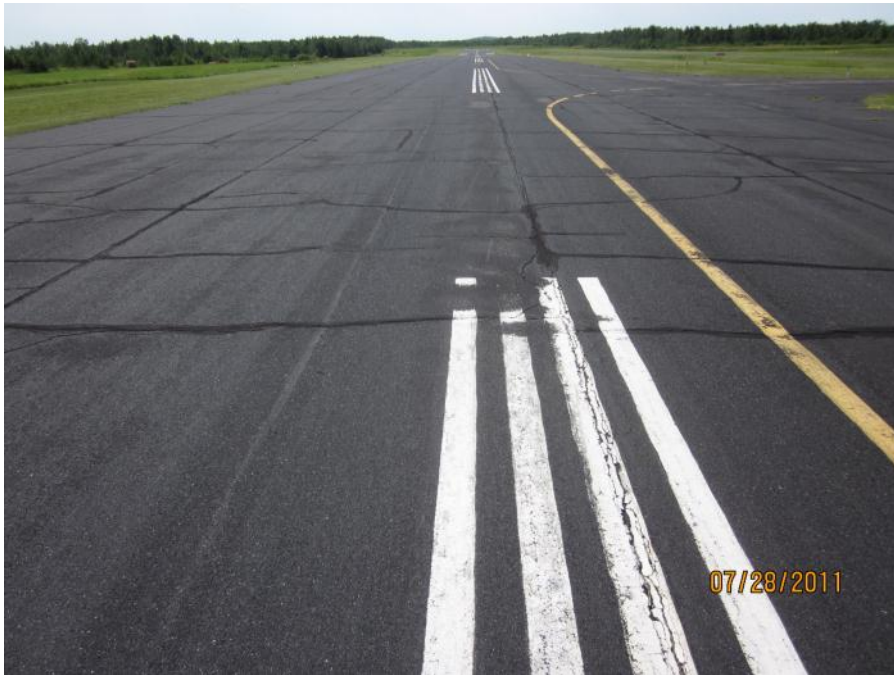
TWM RY624 001 (PCI = 64)

Conditions: PCI : 64

Sample Number: 108 Type: R Area: 3,750.00SqFt PCI = 64
 Sample Comments:
 43 BLOCK CRACKING L 3,750.00 SqFt Comments:

Sample Number: 117 Type: R Area: 3,750.00SqFt PCI = 64
 Sample Comments:
 43 BLOCK CRACKING L 3,750.00 SqFt Comments:

Sample Number: 126 Type: R Area: 3,750.00SqFt PCI = 64
 Sample Comments:
 43 BLOCK CRACKING L 3,750.00 SqFt Comments:

Sample Number: 135 Type: R Area: 3,750.00SqFt PCI = 64
 Sample Comments:
 43 BLOCK CRACKING L 3,750.00 SqFt Comments:

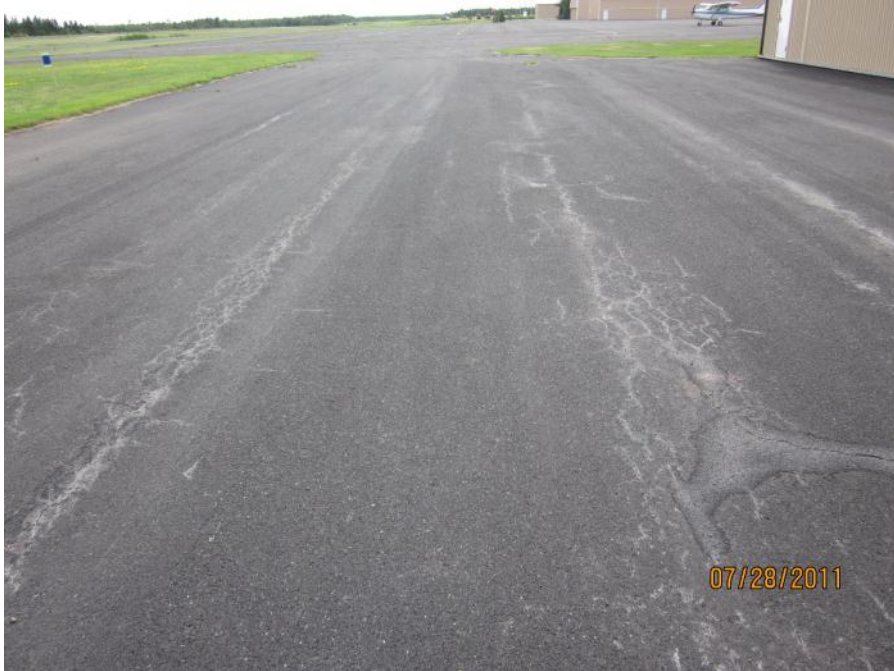
TWM TLA 001 (PCI = 33)

TLA	1	AC	30,300	1901	47	33	0.6	92	8	Alligator cracking, L&T cracking, Rutting
TLB	1	AC	28,090	1991	61	42	2.9	34	66	Alligator cracking, Block cracking
TLB	2	AC	31,275	1991	74	71	1.5	0	100	L&T cracking
TLC	1	AC	8,170	2005	64	73	4.5	0	41	L&T cracking, Patching, Swelling, Weathering
TLC	2	AC	44,000	2009	100	85	7.5	62	35	L&T cracking, Patching, Rutting, Swelling
