# Minnesota Airport System Pavement Evaluation 2011 Update

Elbow Lake Municipal Airport (Y63)

Elbow Lake, Minnesota

January 2012

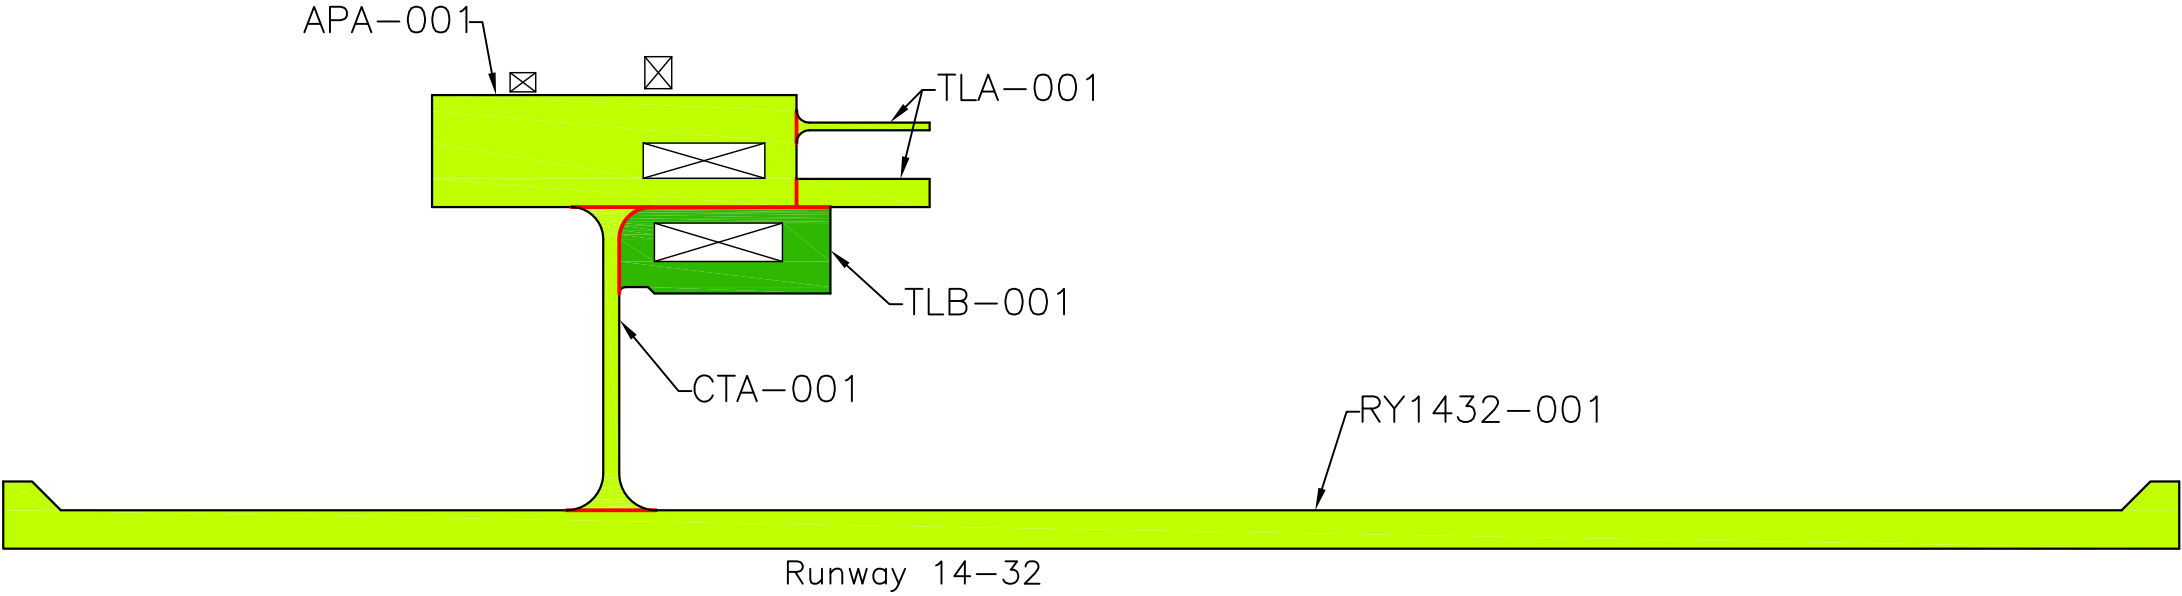
Figure 4. 2011 Pavement Condition Index Rating at Elbow Lake Municipal Airport (Y63).

Figures 5 and 6 present the overall PCI for Y63 by area distribution and pavement use, respectively. Table 3 presents the PCI summary for each section at Y63, including the drop in PCI per year. Generally, pavement sections will deteriorate between 1 and 3 PCI points per year. Sections deteriorating at higher rates may need maintenance above the normal application rates and should be closely monitored in case major repairs become necessary.

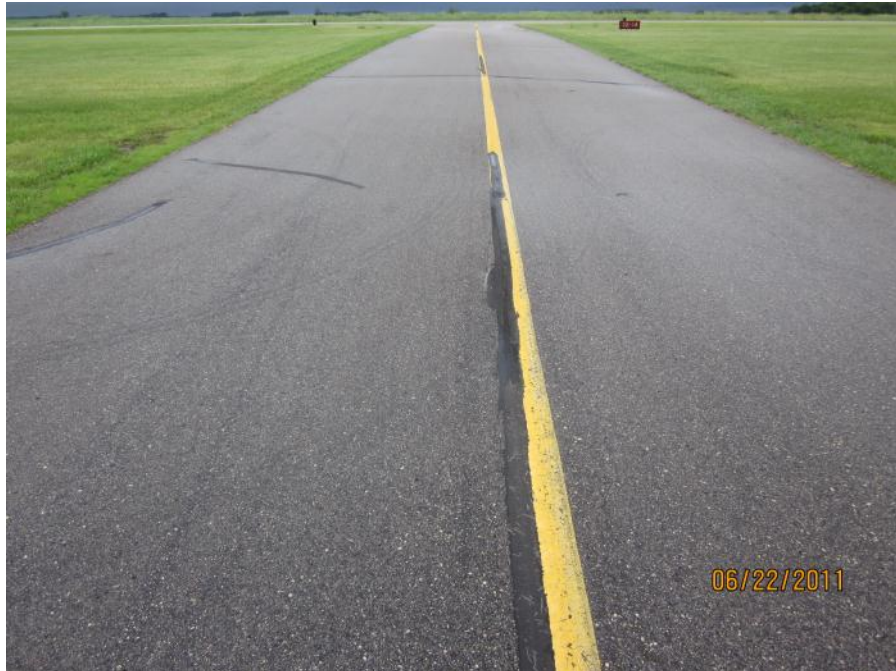
Y63 CTA 001 (PCI = 82)

| Branch ID | Section ID | Surface type <sup>1</sup> | Section area (SF) | LCD <sup>2</sup> | 2008 PCI | 2011 PCI | Drop in PCI/Yr <sup>3</sup> | % Deduct due to | | Distress types |
|---|---|---|---|---|---|---|---|---|---|---|
| CTA | 1 | AC | 13,050 | 2006 | 100 | 82 | 3.6 | 0 | 93 | L&T cracking, Swelling |

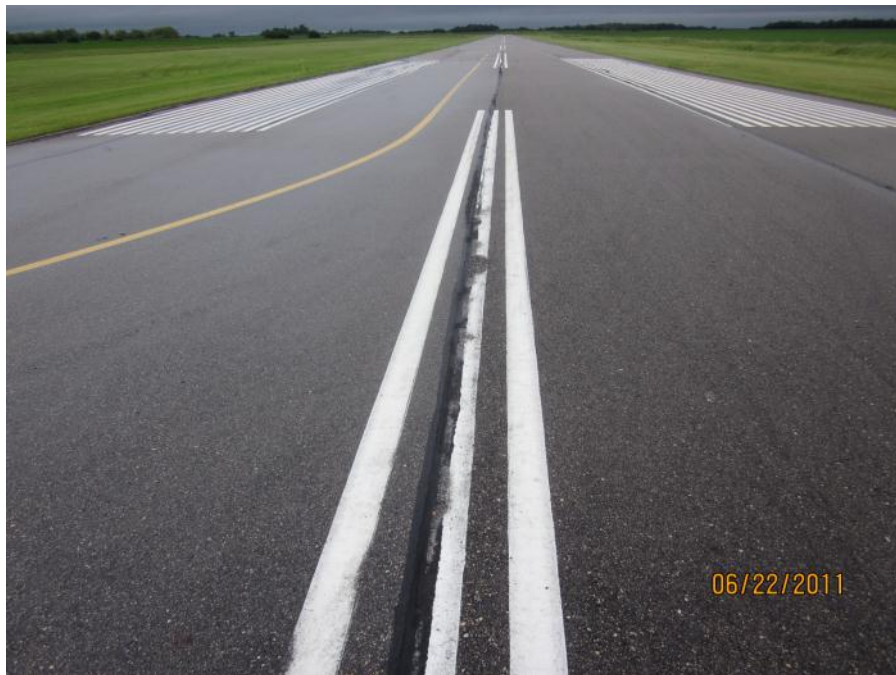
Y63 RY1432 001 (PCI = 77)

| Branch ID | Section ID | Surface type <sup>1</sup> | Section area (SF) | LCD <sup>2</sup> | 2008 PCI | 2011 PCI | Drop in PCI/Yr <sup>3</sup> | % Deduct due to | | Distress types |
|---|---|---|---|---|---|---|---|---|---|---|
| RY1432 | 1 | AAC | 210,075 | 2006 | 98 | 77 | 4.6 | 19 | 78 | Alligator cracking, L&T cracking, Swelling |

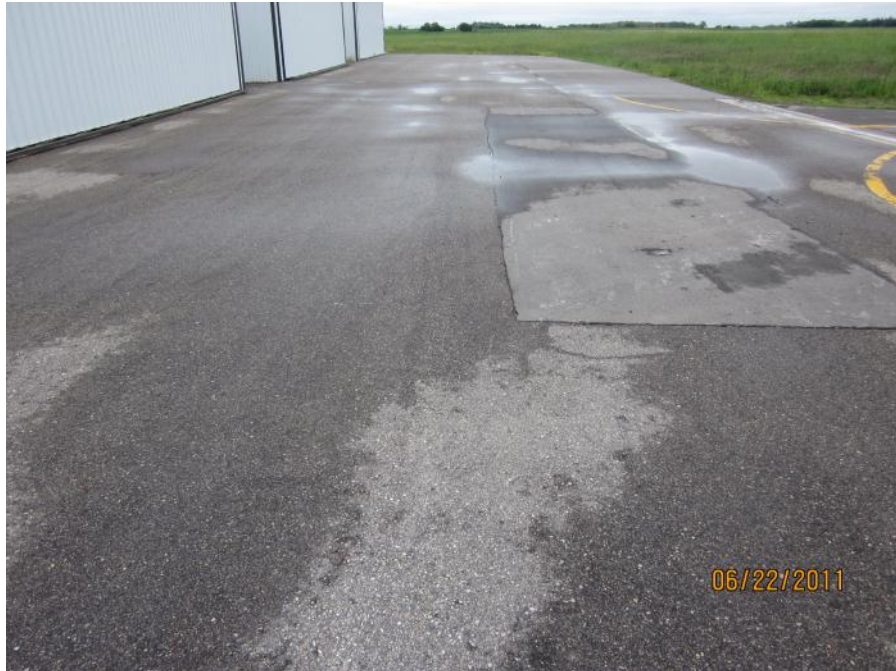
Y63 TLA 001 (PCI = 82)

| Branch ID | Section ID | Surface type <sup>1</sup> | Section area (SF) | LCD <sup>2</sup> | 2008 PCI | 2011 PCI | Drop in PCI/Yr <sup>3</sup> | % Deduct due to | | Distress types |
|---|---|---|---|---|---|---|---|---|---|---|
| TLA | 1 | AAC | 13,000 | 2006 | 70 | 82 | 3.6 | 0 | 96 | Depression, L&T cracking, Patching |

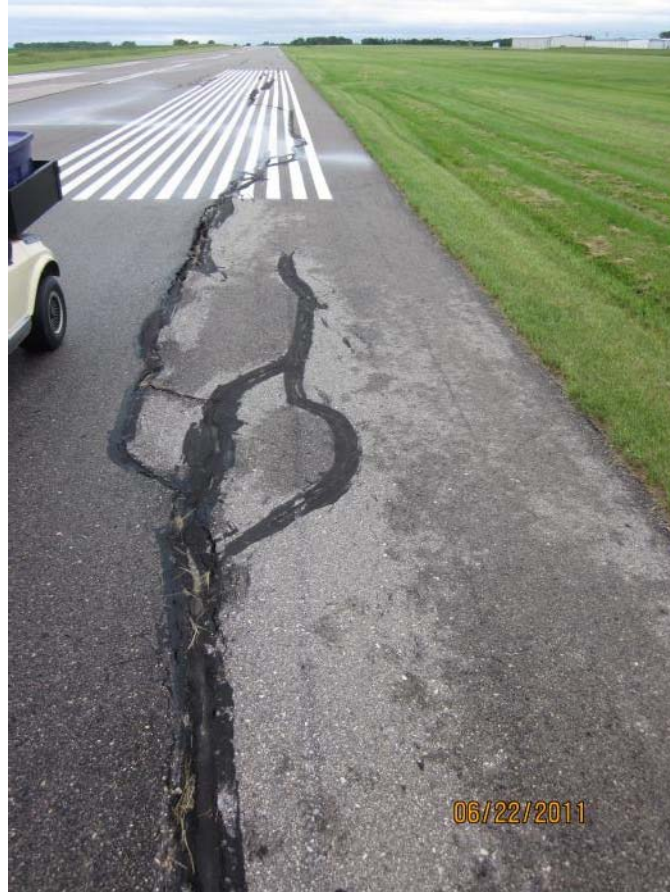
Y63 RY1432 major crack near edge of runway.
