Minnesota Airport System Pavement Evaluation 2012 Update

ADA-Twin Valley Airport (D00)

ADA, Minnesota

Final Report

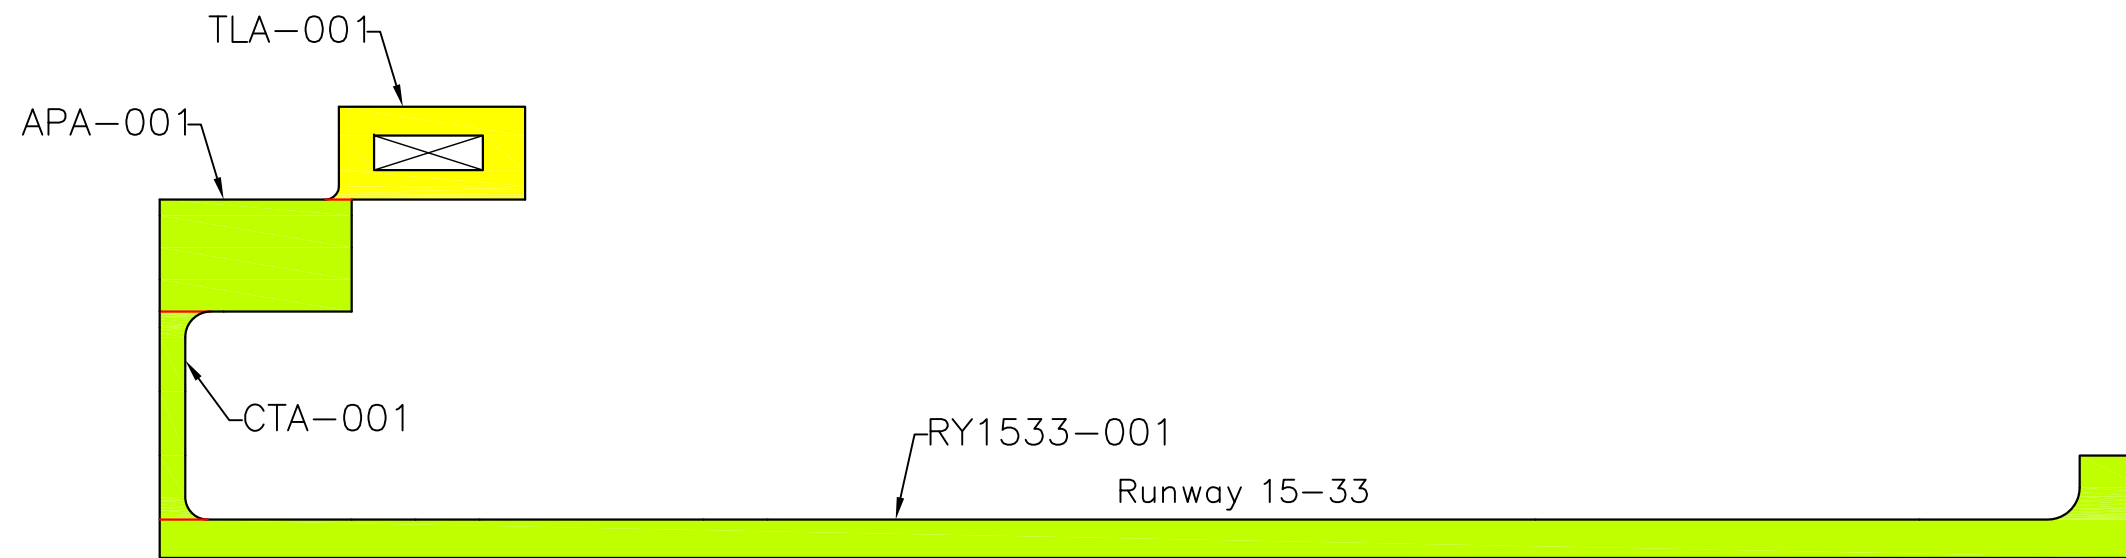
Figure 4. 2012 Pavement Condition Index Rating at Ada-Twin Valley Airport (D00).

Figures 5 and 6 present the overall PCI for D00 by area distribution and pavement use, respectively. Table 3 presents the PCI summary for each section at D00, including the drop in PCI per year. Generally, pavement sections will deteriorate between 1 and 3 PCI points per year. Sections deteriorating at higher rates may need maintenance above the normal application rates and should be closely monitored in case major repairs become necessary.

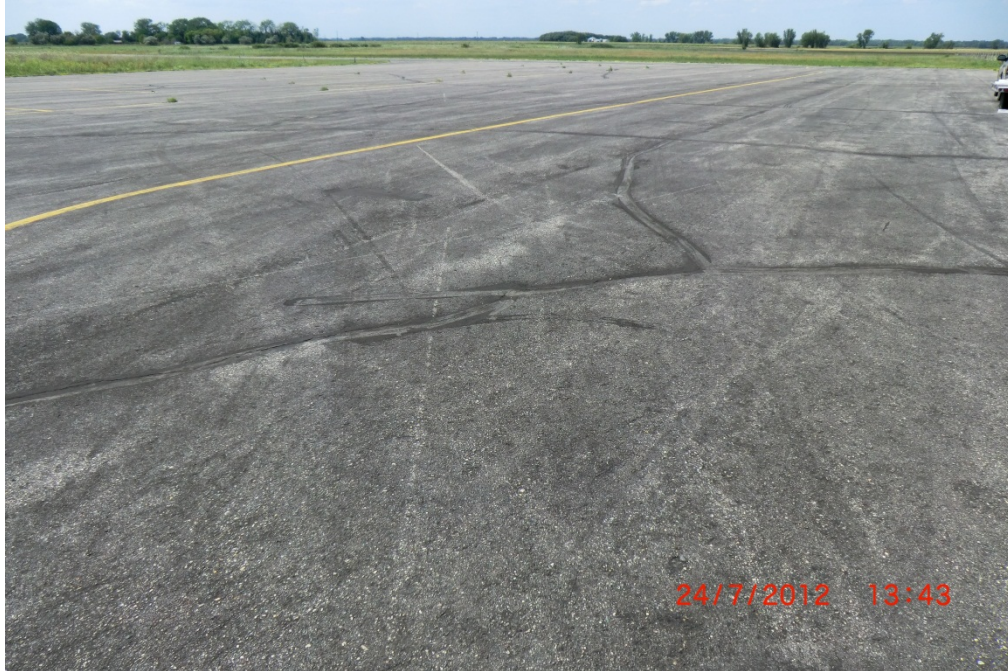
D00 APA 001 (PCI = 79)

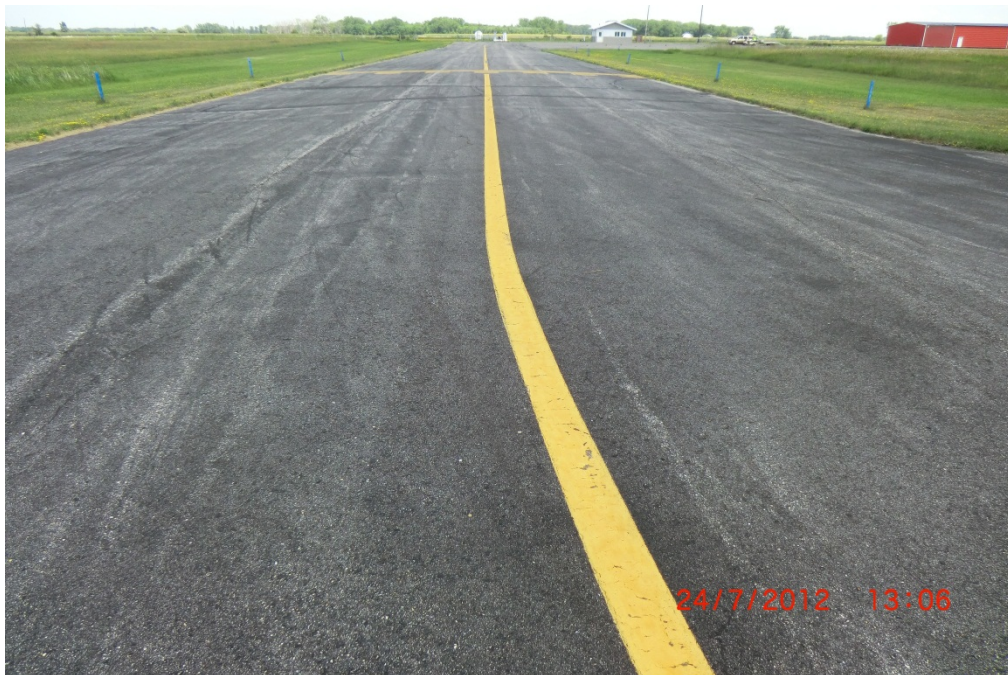
D00 CTA 001 (PCI = 84)

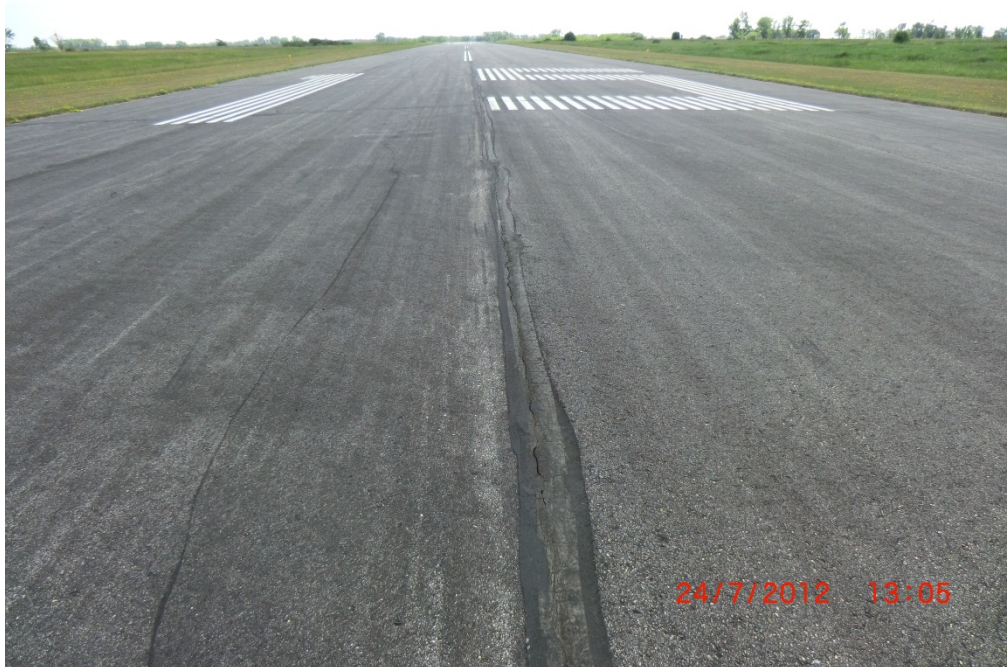
D00 RY1533 001 (PCI = 80)

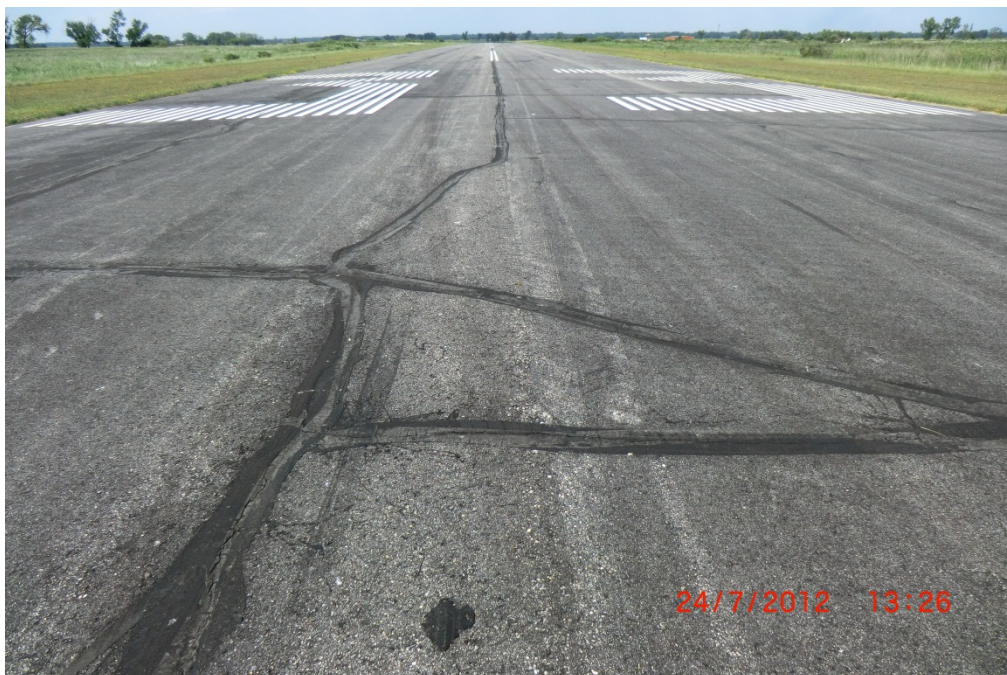
D00 RY1533 001 (PCI = 80)

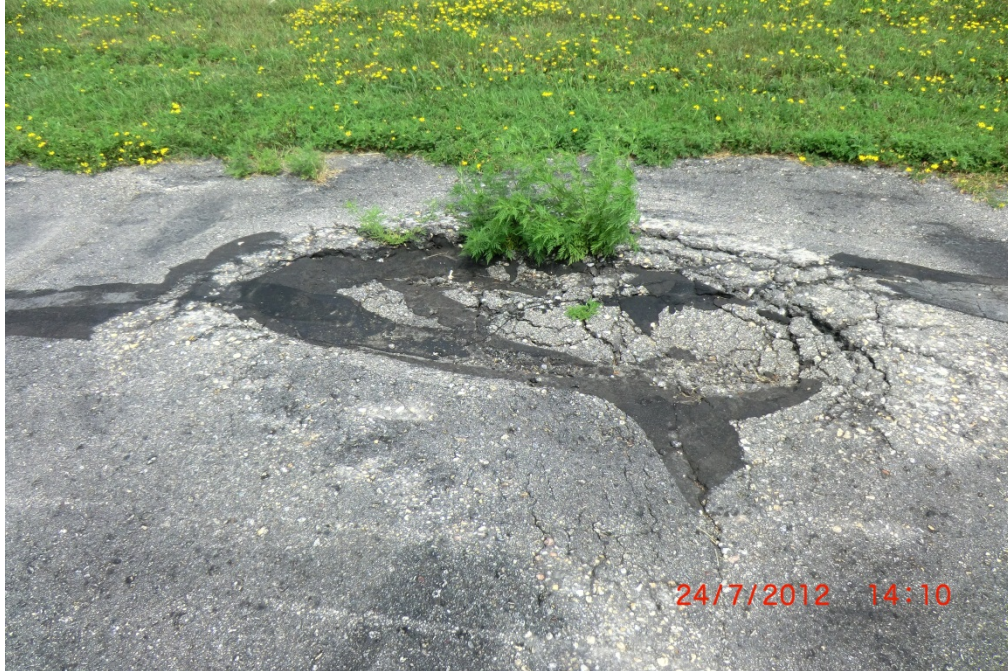
D00 TLA 001 swell & alligator cracking (PCI = 59)

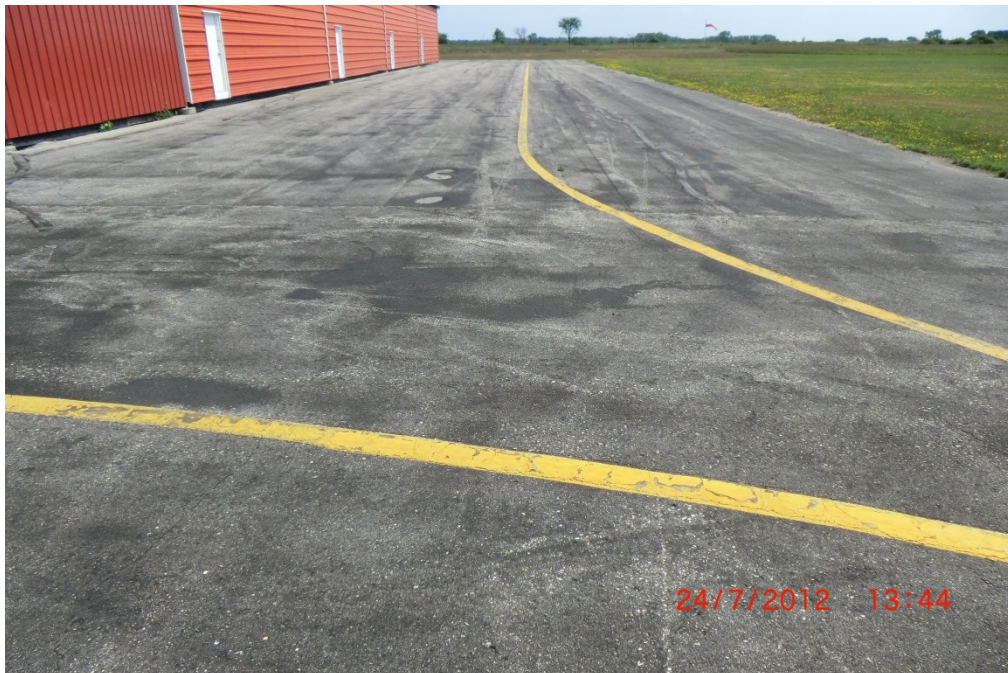
D00 TLA 001 (PCI = 59)

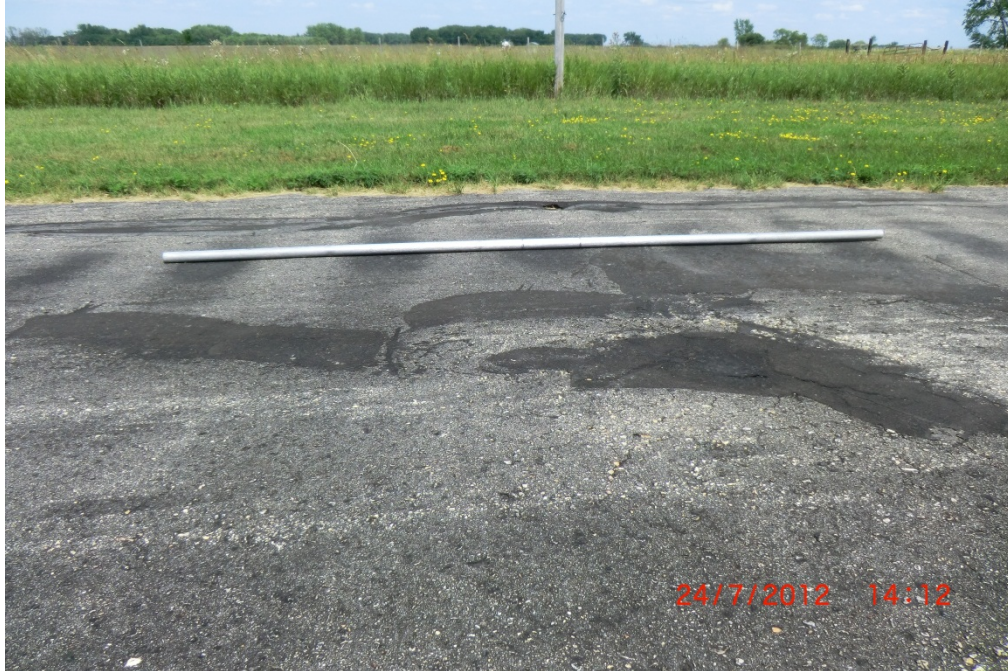
D00 TLA 011 corrugation (PCI = 59)
