# Minnesota Airport System Pavement Evaluation 2012 Update

Appleton Municipal Airport (AQP)

Appleton, Minnesota

January 2013

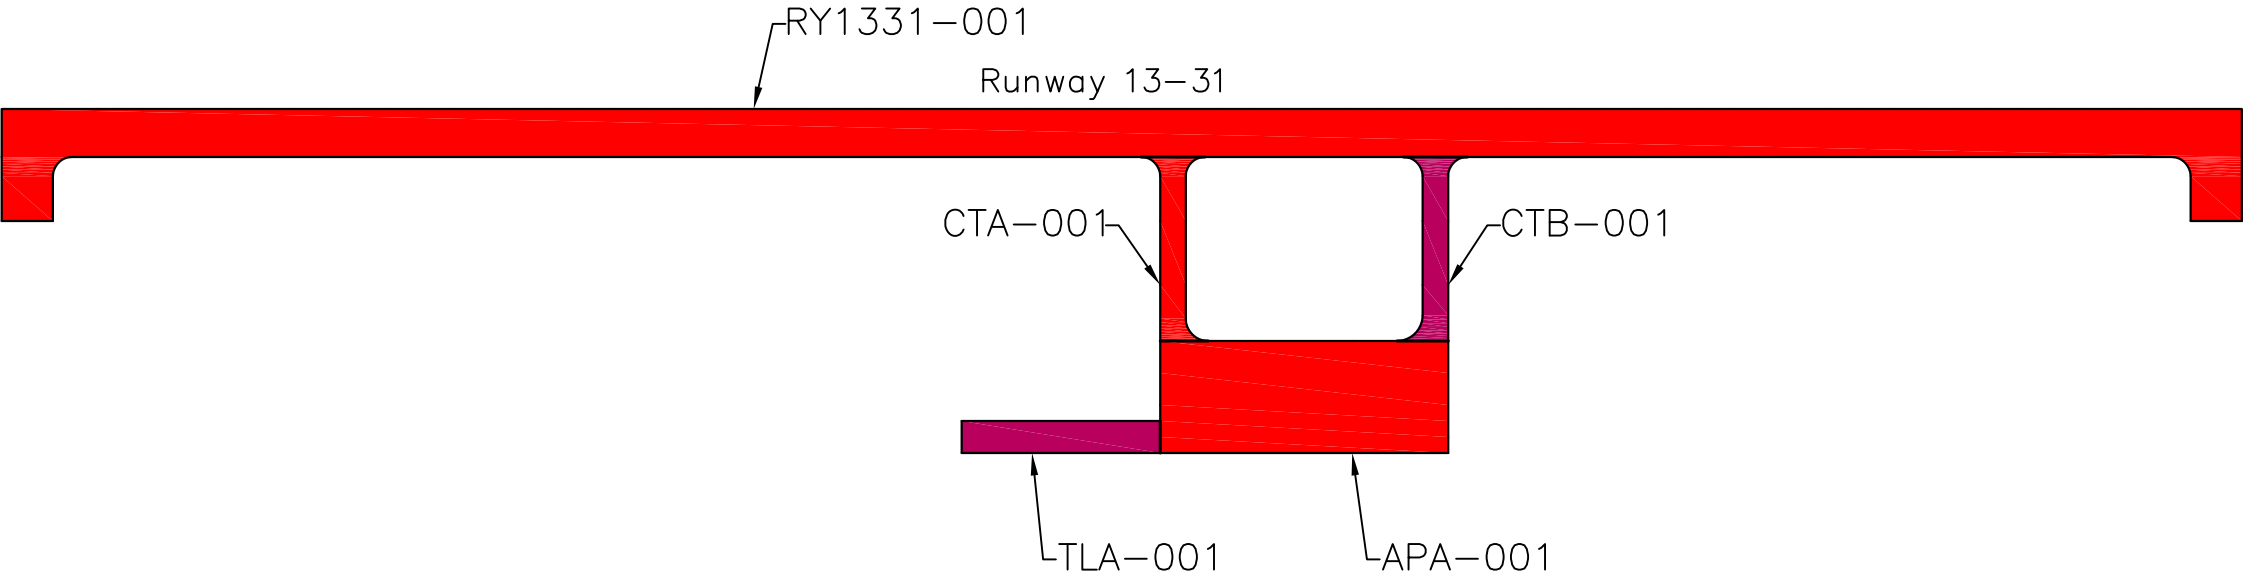
Figure 4. 2012 Pavement Condition Index Rating at Appleton Municipal Airport (AQP).

Branch ID	Section ID	Surface type <sup>1</sup>	Section area (SF)	LCD <sup>2</sup>	2009 PCI	2012 PCI	Drop in PCI/Yr <sup>3</sup>	% Deduct due to		Distress types
								Load <sup>4</sup>	Climate <sup>5</sup>	
APA	1	AAC	78,750	1991	33	31	3.3	0	100	Longitudinal & transverse (L&T) cracking, raveling
CTA	1	AAC	12,235	1991	33	33	3.2	0	100	L&T cracking, raveling
CTB	1	AAC	12,315	1991	33	18	3.9	10	90	Alligator cracking, L&T cracking, raveling
RY1331	1	AAC	278,900	1991	33	27	3.5	5	95	Alligator cracking, L&T cracking, raveling
TLA	1	AC	15,500	1991	38	23	3.7	0	100	L&T cracking, raveling

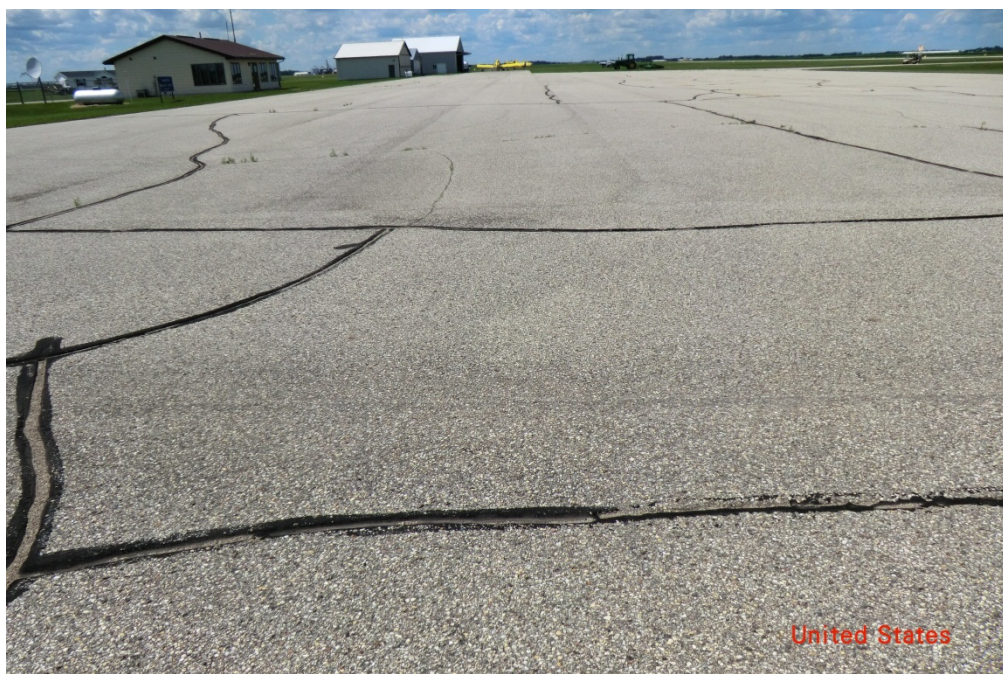
AQP APA 001 (PCI = 31)

Conditions: PCI : 31

48 LONGITUDINAL/TRANSVERSE CRACKING L 180.00 Ft Comments:  
48 LONGITUDINAL/TRANSVERSE CRACKING M 224.00 Ft Comments:  
48 LONGITUDINAL/TRANSVERSE CRACKING H 4.00 Ft Comments:  
52 RAVELING M 5,000.00 SqFt Comments:

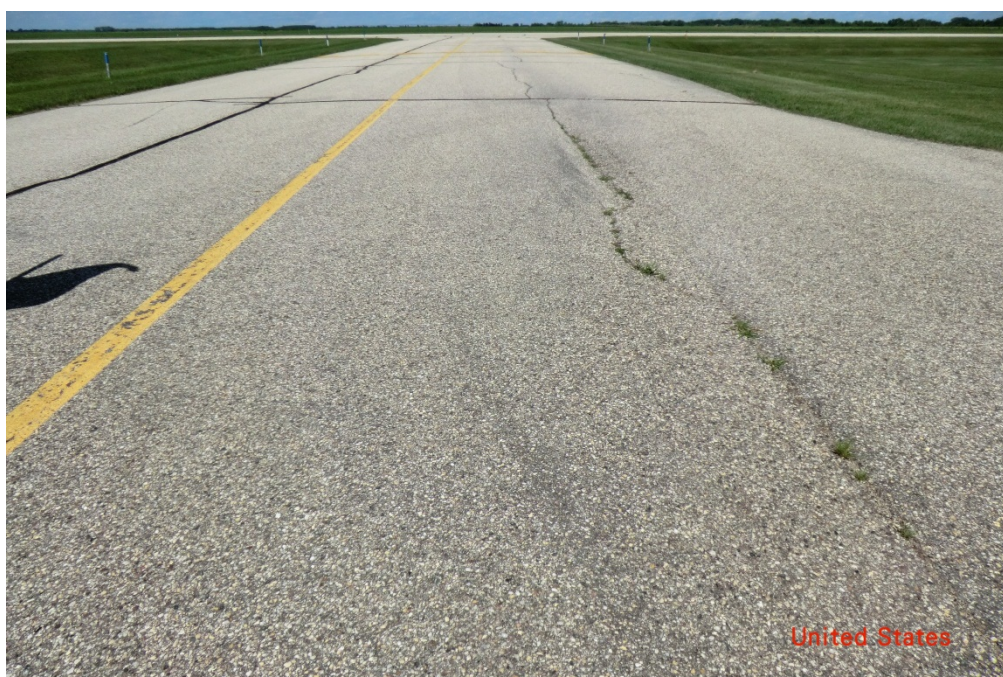
AQP CTA 001 (PCI = 33)

Conditions: PCI : 33

48 LONGITUDINAL/TRANSVERSE CRACKING L 236.00 Ft Comments:

48 LONGITUDINAL/TRANSVERSE CRACKING M 118.00 Ft Comments:

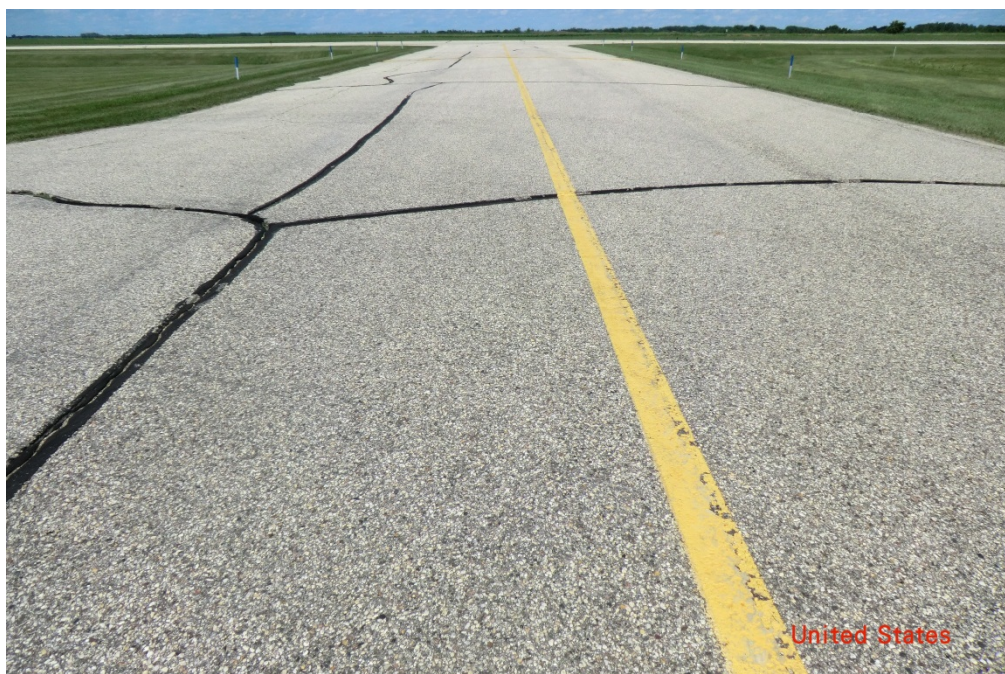
AQP CTB 001 (PCI = 18)

Conditions: PCI : 18

48 LONGITUDINAL/TRANSVERSE CRACKING L 188.00 Ft Comments:

48 LONGITUDINAL/TRANSVERSE CRACKING M 208.00 Ft Comments:

41 ALLIGATOR CRACKING L 24.00 SqFt Comments:

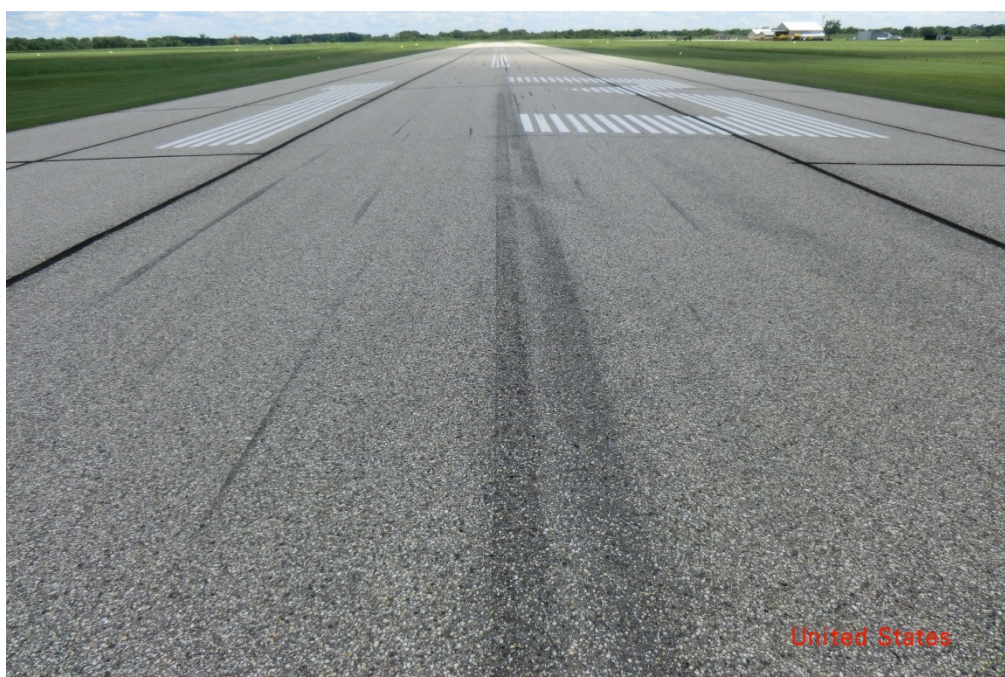
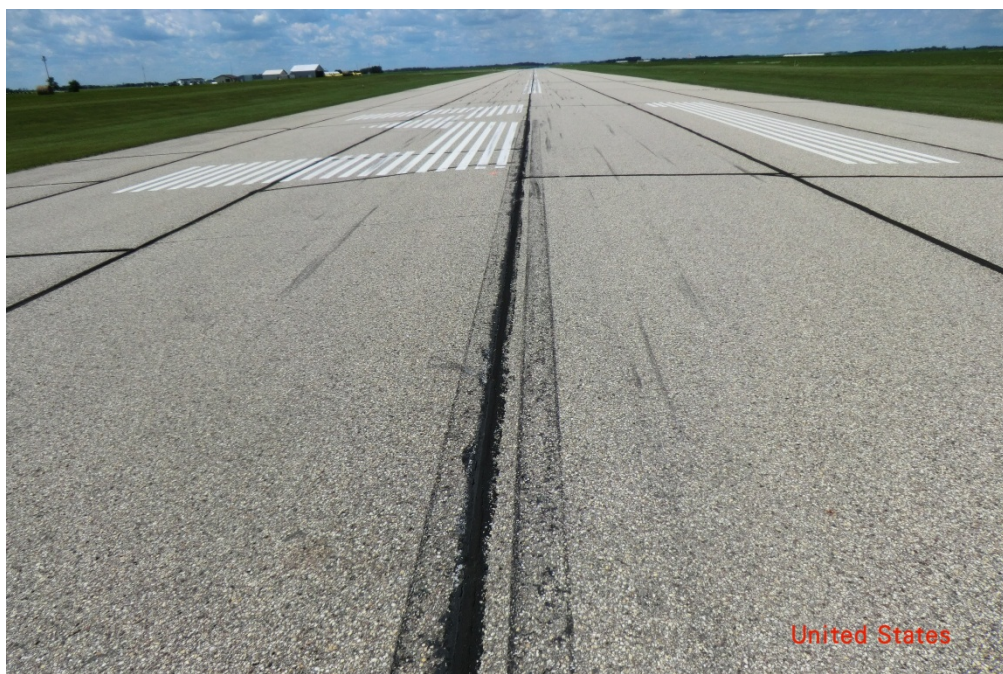
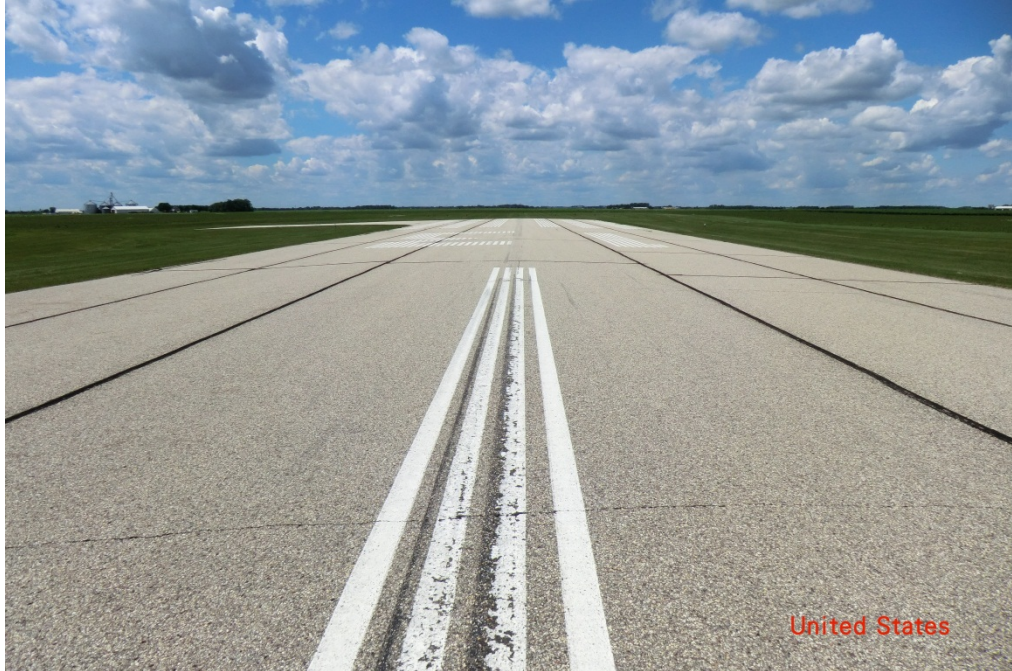
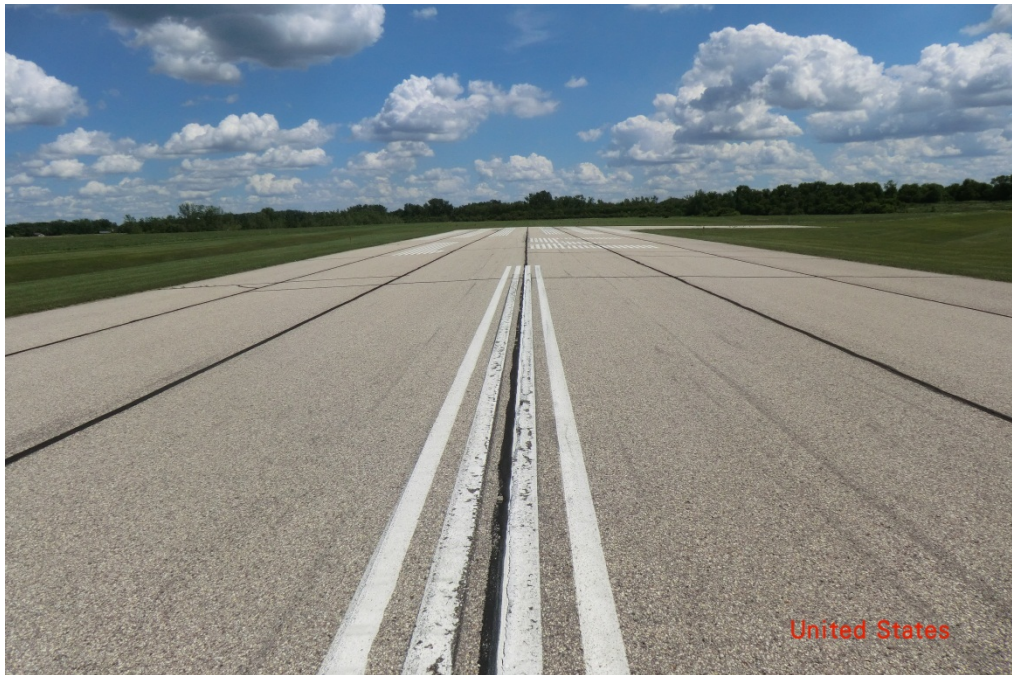
AQP RY1331 001 (PCI = 27)

Conditions: PCI : 27

48 LONGITUDINAL/TRANSVERSE CRACKING L 369.00 Ft Comments:  
48 LONGITUDINAL/TRANSVERSE CRACKING M 49.00 Ft Comments:  
52 RAVELING M 3,750.00 SqFt Comments:  
41 ALLIGATOR CRACKING L 20.00 SqFt Comments:

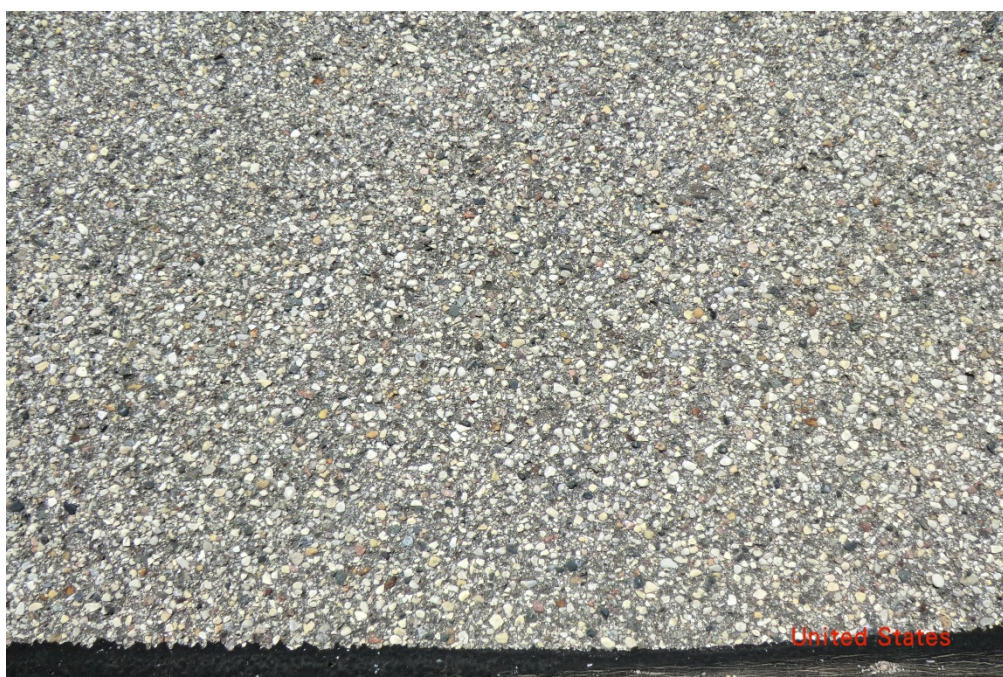
AQP RY1331 001 medium severity raveling (PCI = 27)

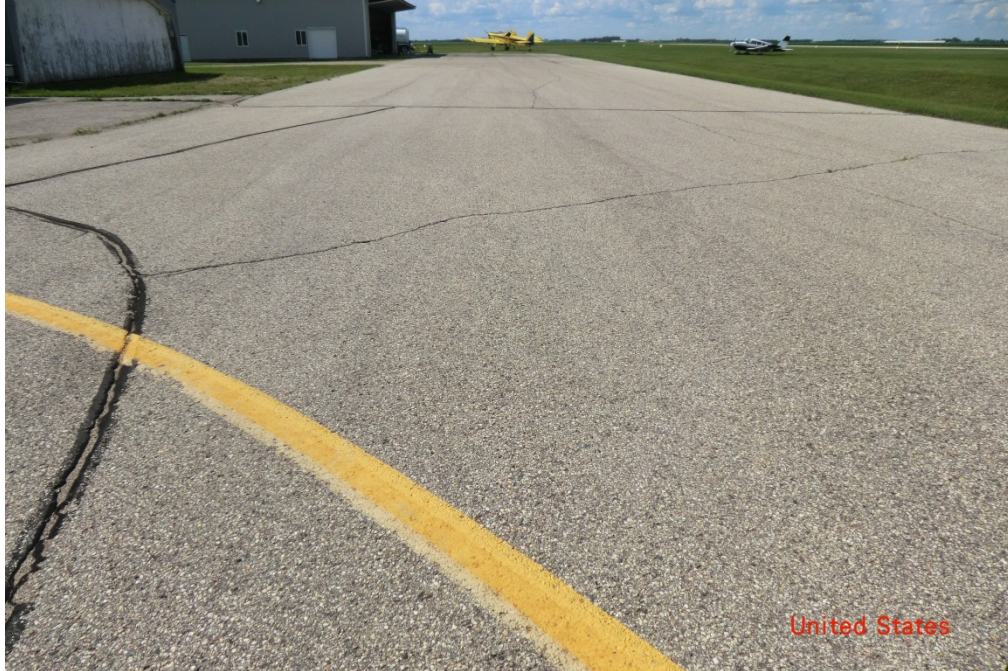
AQP TLA 001 (PCI = 23)

Conditions: PCI : 23

48 LONGITUDINAL/TRANSVERSE CRACKING L 212.00 Ft Comments:

48 LONGITUDINAL/TRANSVERSE CRACKING M 102.00 Ft Comments:
