# Minnesota Airport System Pavement Evaluation 2012 Update

Bemidji Regional Airport (BJI)

Bemidji, Minnesota

January 2013

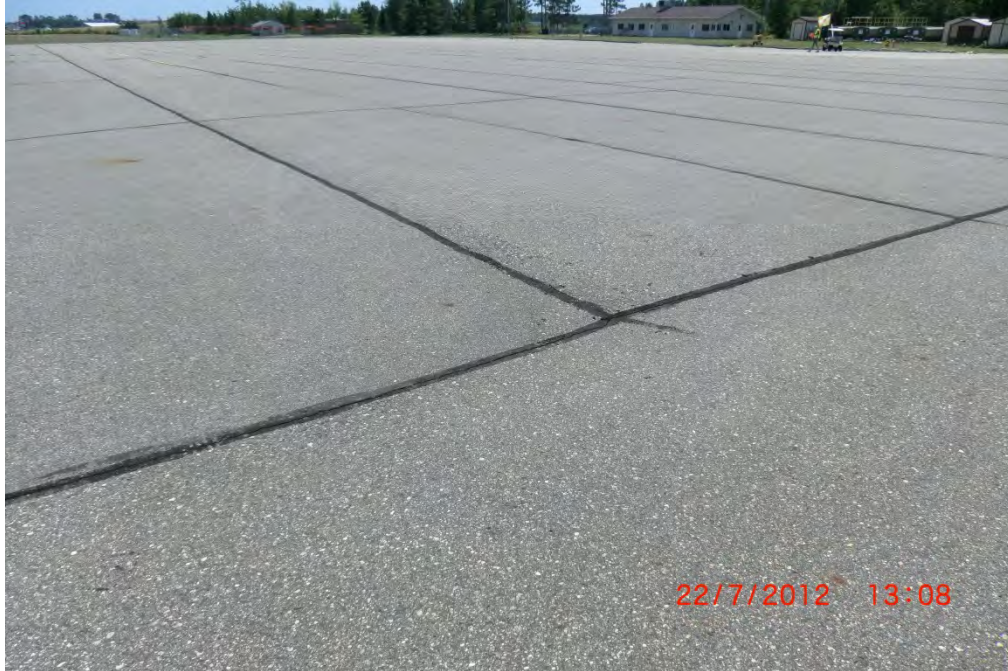
BJI ADNR 001 (PCI = 70)

Conditions: PCI: 70

48 LONGITUDINAL/TRANSVERSE CRACKING L 571.00 Ft Comments:  
48 LONGITUDINAL/TRANSVERSE CRACKING M 23.00 Ft Comments:

48 LONGITUDINAL/TRANSVERSE CRACKING L 610.00 Ft Comments:  
48 LONGITUDINAL/TRANSVERSE CRACKING M 8.00 Ft Comments:  
57 WEATHERING L 375.00 SqFt Comments:

Section Comments: maint. R&E (crack seal)

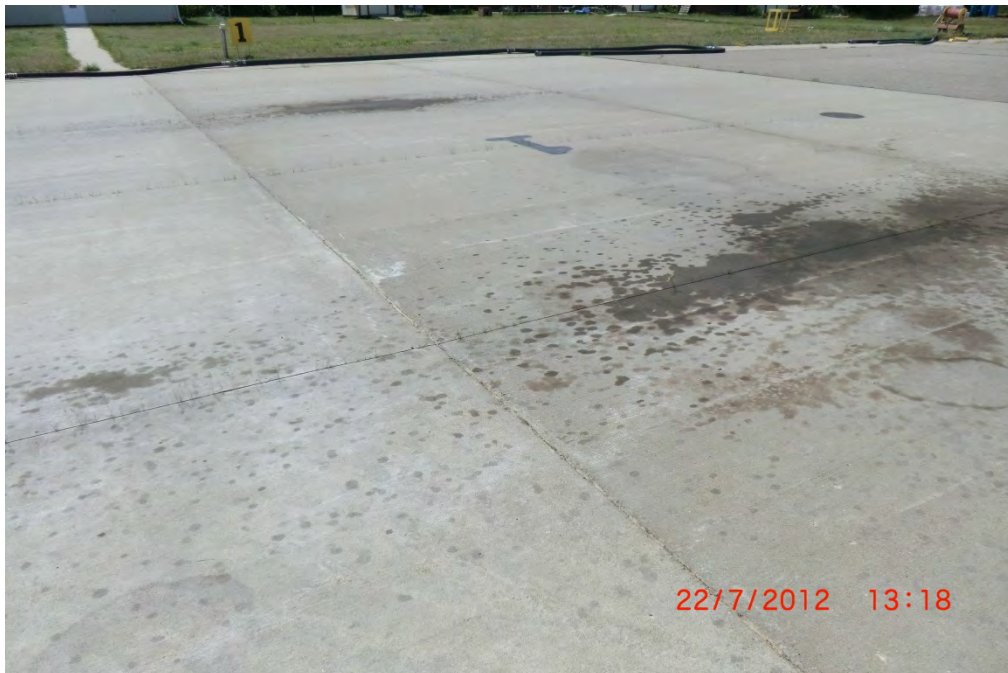
BJI ADNR 002 (PCI = 99)

Conditions: PCI : 99

73 SHRINKAGE CRACKING N 2.00 Slabs Comments:

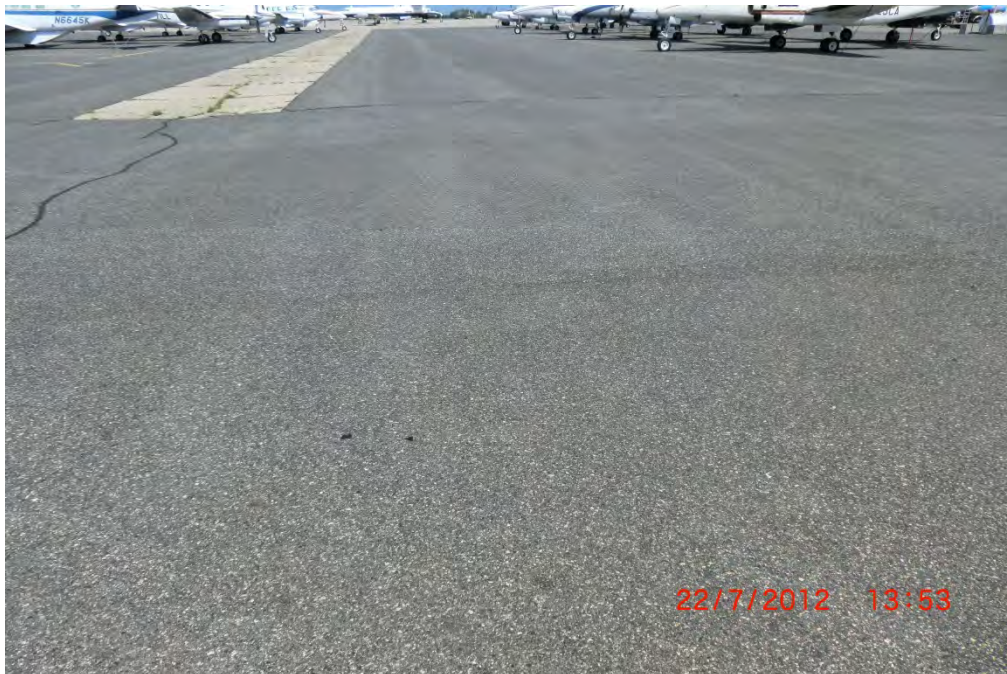
BJI APA 001 (PCI = 90)

Conditions: PCI: 90

48 LONGITUDINAL/TRANSVERSE CRACKING L 87.00 Ft Comments:  
49 OIL SPILLAGE N 20.00 SqFt Comments:

48 LONGITUDINAL/TRANSVERSE CRACKING L 80.00 Ft Comments:

48 LONGITUDINAL/TRANSVERSE CRACKING L 128.00 Ft Comments:  
49 OIL SPILLAGE N 80.00 SqFt Comments:

Section Comments: maint. R&E (crack seal)

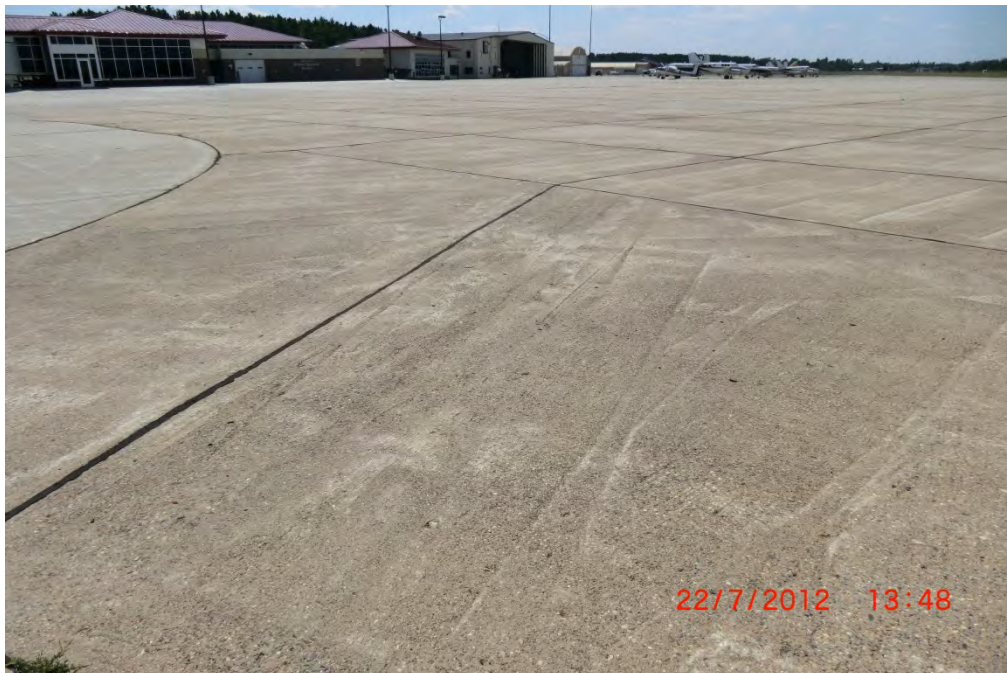
BJI APB 001 (PCI = 90)

Conditions: PCI : 90

74 JOINT SPALLING L 1.00 Slabs Comments:  
65 JOINT SEAL DAMAGE M 16.00 Slabs Comments:

74 JOINT SPALLING L 2.00 Slabs Comments:  
74 JOINT SPALLING M 2.00 Slabs Comments:

74 JOINT SPALLING M 1.00 Slabs Comments:  
65 JOINT SEAL DAMAGE M 16.00 Slabs Comments:

65 JOINT SEAL DAMAGE M 24.00 Slabs Comments:

Section Comments: maint. R&E (replacement slabs)

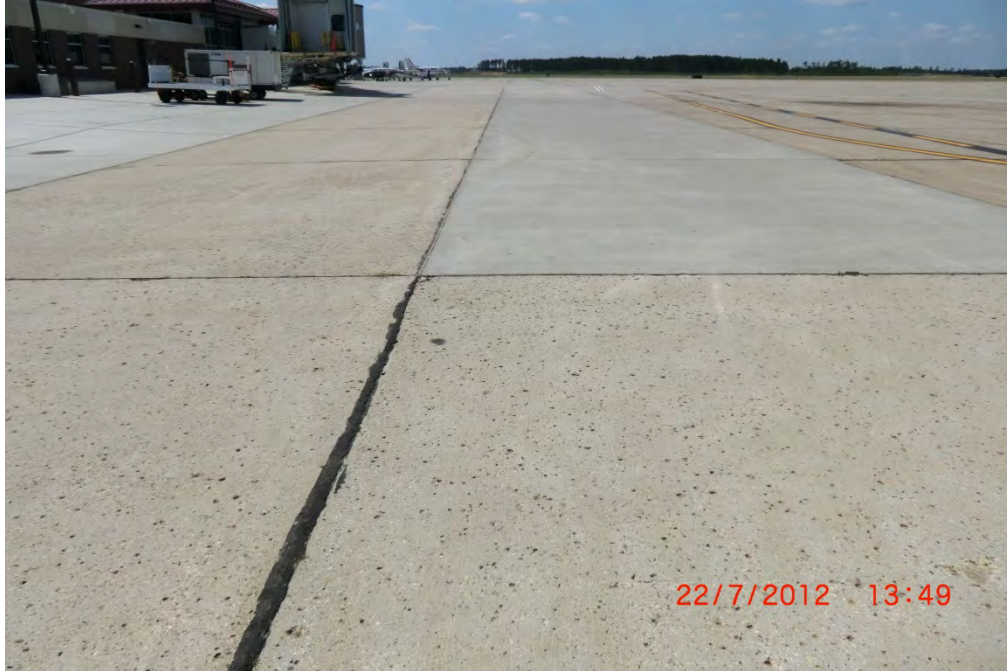
BJI APB 002 (PCI = 83)

Conditions: PCI : 83

Section Comments: maint. R&E (slab replacements)

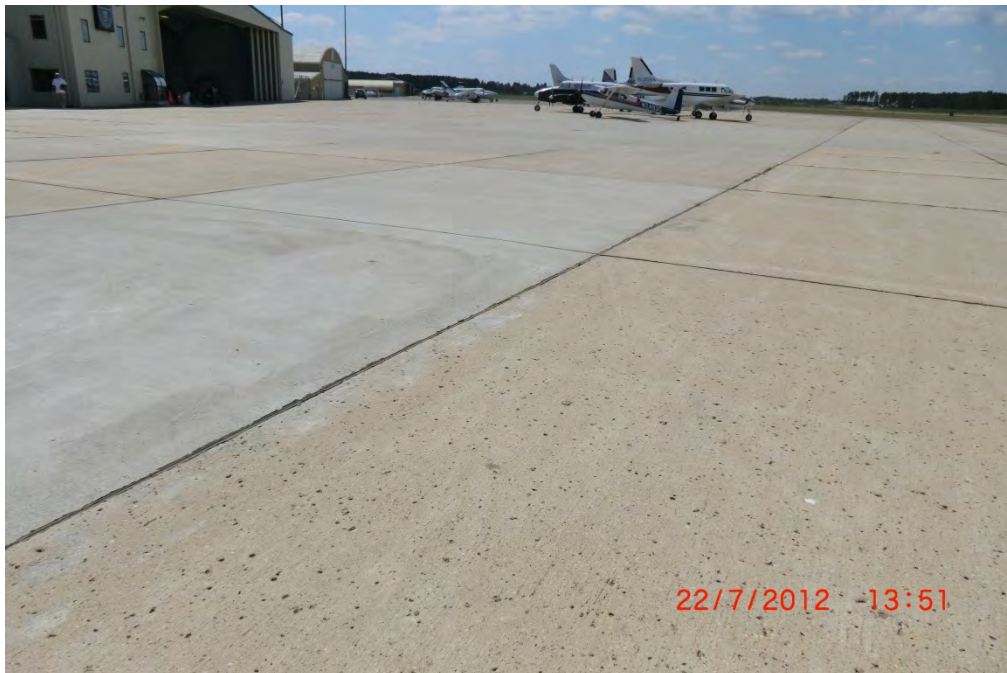
BJI APB 003 (PCI = 61)

Conditions: PCI : 61

Section Comments: maint. R&E (replacement slabs)
