Minnesota Airport System Pavement Evaluation 2012 Update

Benson Municipal Airport (BBB)

Benson, Minnesota

Final Report

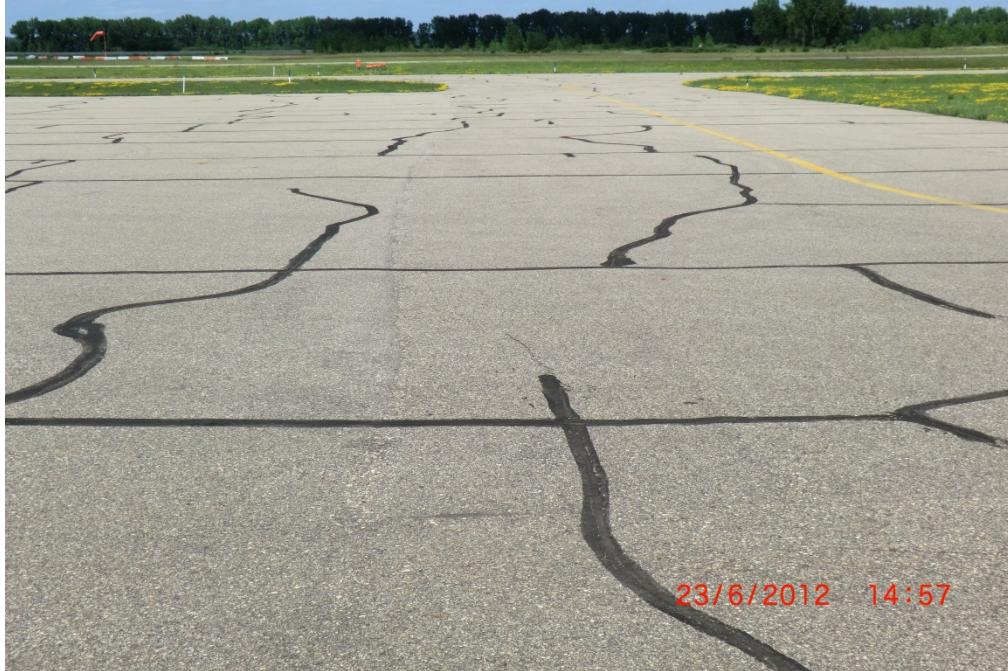
BBB APA 001 (PCI = 65)

Sample Number: 100 Type: R Area: 5,000.00SqFt PCI = 66
Sample Comments:
48 LONGITUDINAL/TRANSVERSE CRACKING L 713.00 Ft Comments:
48 LONGITUDINAL/TRANSVERSE CRACKING M 12.00 Ft Comments:
52 RAVELING L 10.00 SqFt Comments:

Sample Number: 201 Type: R Area: 5,000.00SqFt PCI = 59
Sample Comments:
48 LONGITUDINAL/TRANSVERSE CRACKING L 620.00 Ft Comments:
48 LONGITUDINAL/TRANSVERSE CRACKING M 12.00 Ft Comments:
52 RAVELING H 2.00 SqFt Comments:
52 RAVELING L 120.00 SqFt Comments:

Sample Number: 302 Type: R Area: 5,000.00SqFt PCI = 64
Sample Comments:
48 LONGITUDINAL/TRANSVERSE CRACKING L 682.00 Ft Comments:
48 LONGITUDINAL/TRANSVERSE CRACKING M 4.00 Ft Comments:
52 RAVELING M 2.00 SqFt Comments:

Sample Number: 403 Type: R Area: 5,000.00SqFt PCI = 70
Sample Comments:
48 LONGITUDINAL/TRANSVERSE CRACKING L 696.00 Ft Comments:
52 RAVELING L 25.00 SqFt Comments:

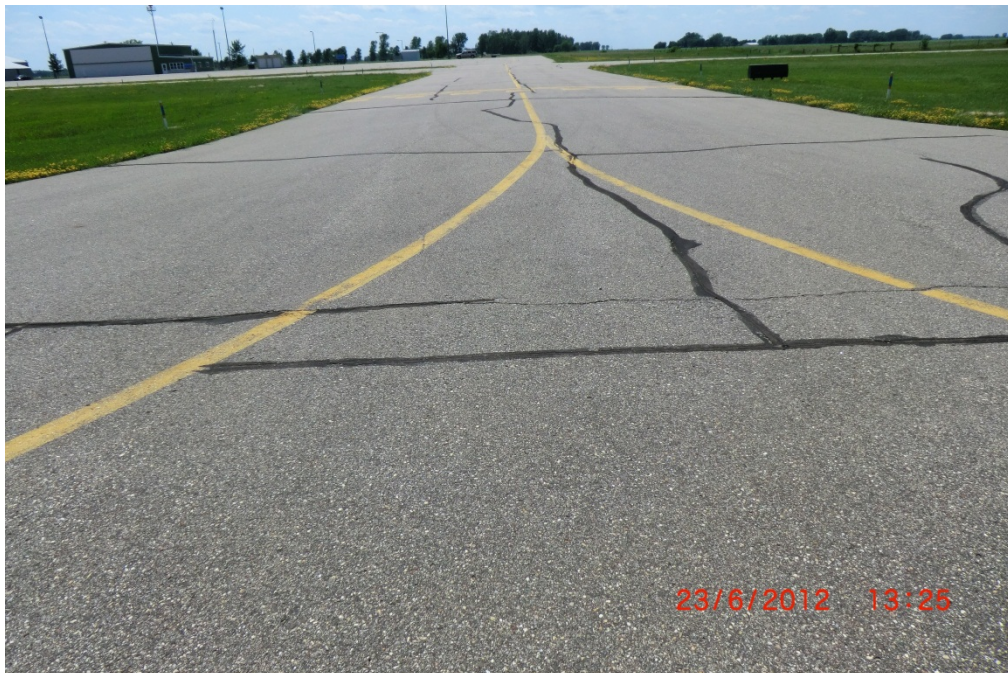
BBB CTA 001 (PCI = 68)

48	LONGITUDINAL/TRANSVERSE CRACKING	L	375.00 Ft	Comments:
48	LONGITUDINAL/TRANSVERSE CRACKING	M	8.00 Ft	Comments:
48	LONGITUDINAL/TRANSVERSE CRACKING	H	5.00 Ft	Comments:

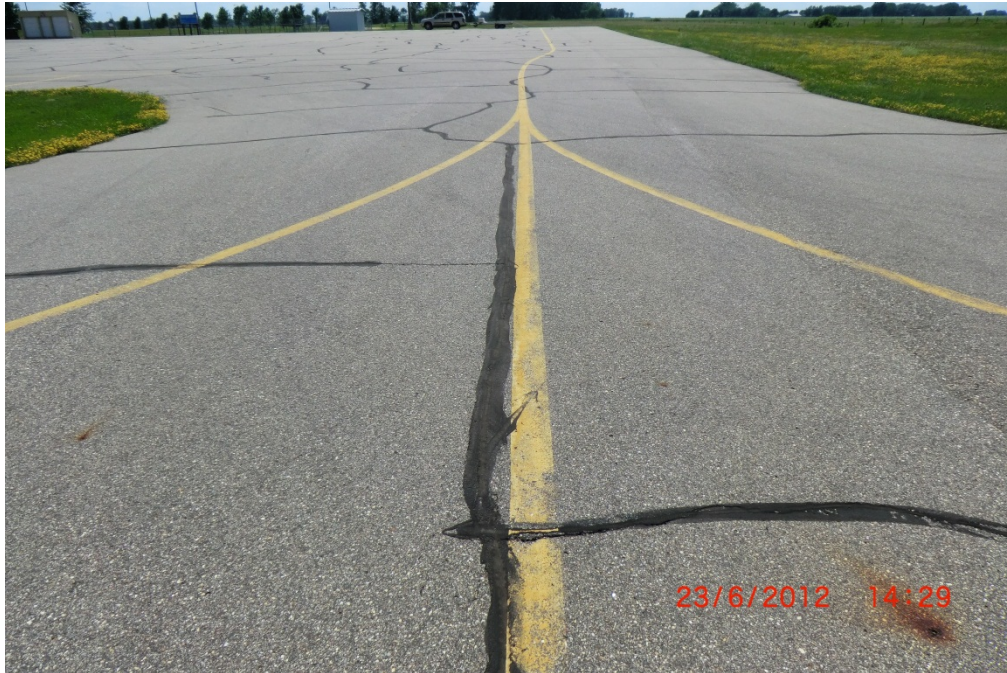
BBB CTAX 001 (PCI = 74)

48 LONGITUDINAL/TRANSVERSE CRACKING L 329.00 Ft Comments:

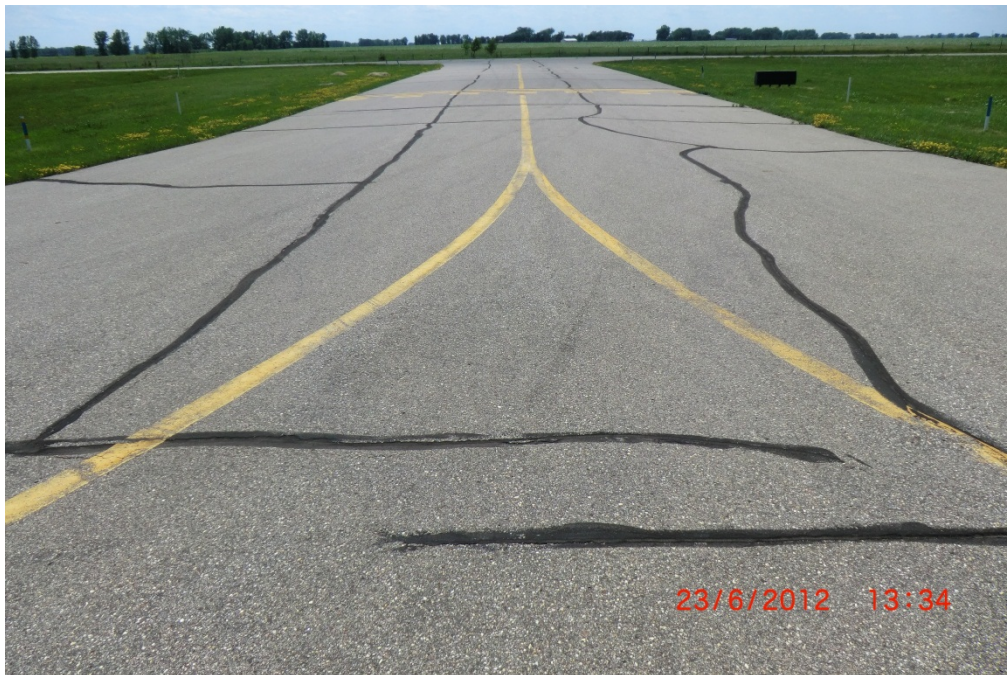
BBB CTB 001 (PCI = 61)

50	PATCHING	L	12.00	SqFt	Comments:
52	RAVELING	L	166.00	SqFt	Comments:
45	DEPRESSION	L	40.00	SqFt	Comments:
48	LONGITUDINAL/TRANSVERSE CRACKING	L	424.00	Ft	Comments:
48	LONGITUDINAL/TRANSVERSE CRACKING	M	20.00	Ft	Comments:

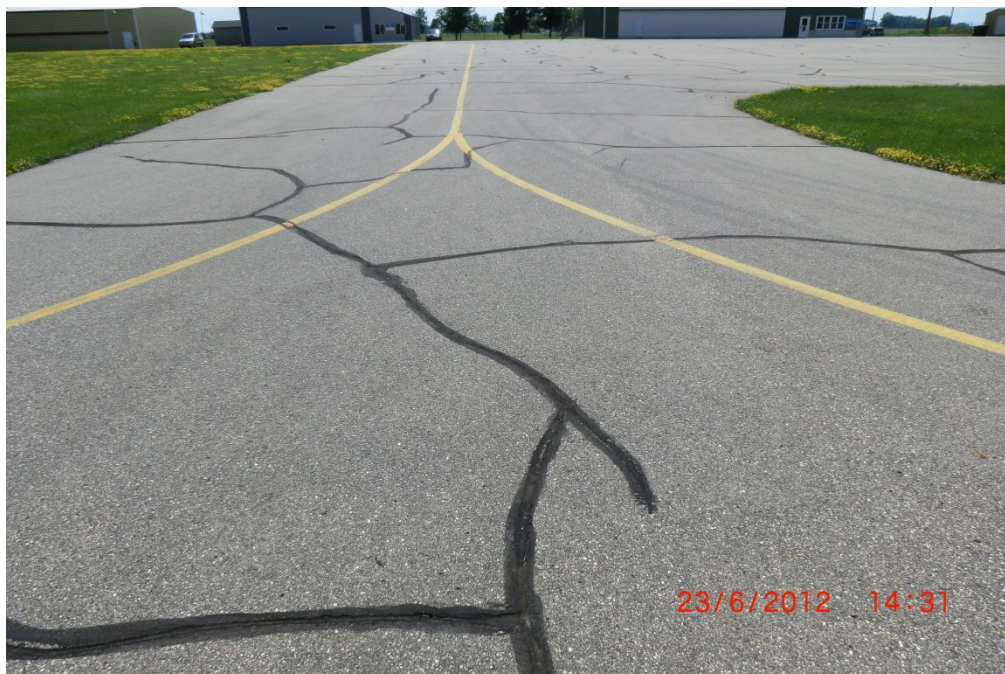
BBB CTC 001 (PCI = 74)

48 LONGITUDINAL/TRANSVERSE CRACKING L 300.00 Ft Comments:

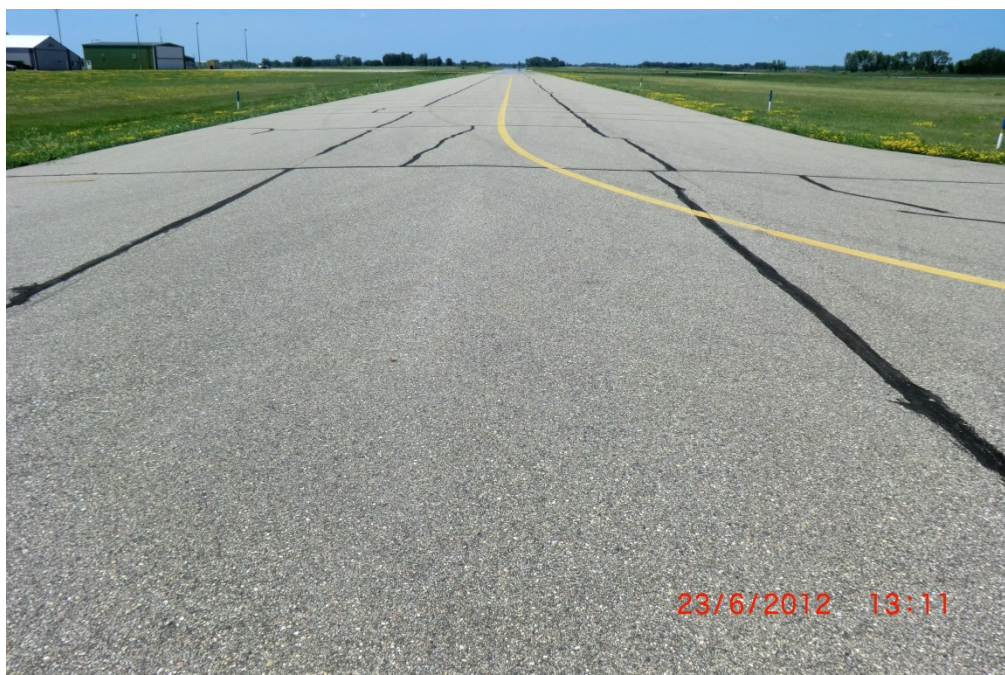
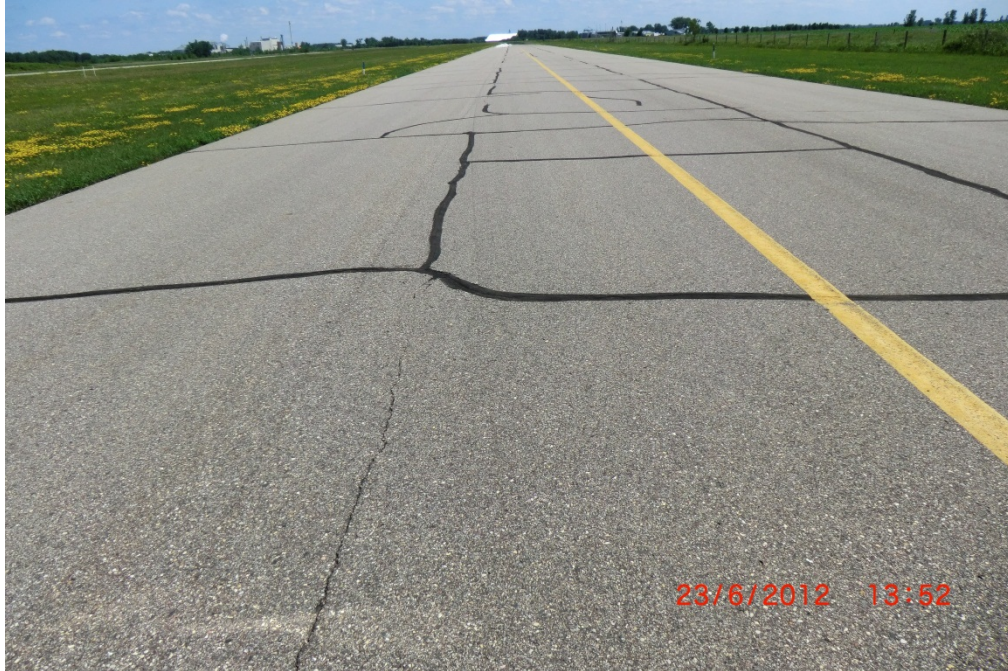
BBB PTA 001 (PCI = 70)

48 LONGITUDINAL/TRANSVERSE CRACKING L 419.00 Ft Comments:
48 LONGITUDINAL/TRANSVERSE CRACKING M 12.00 Ft Comments:

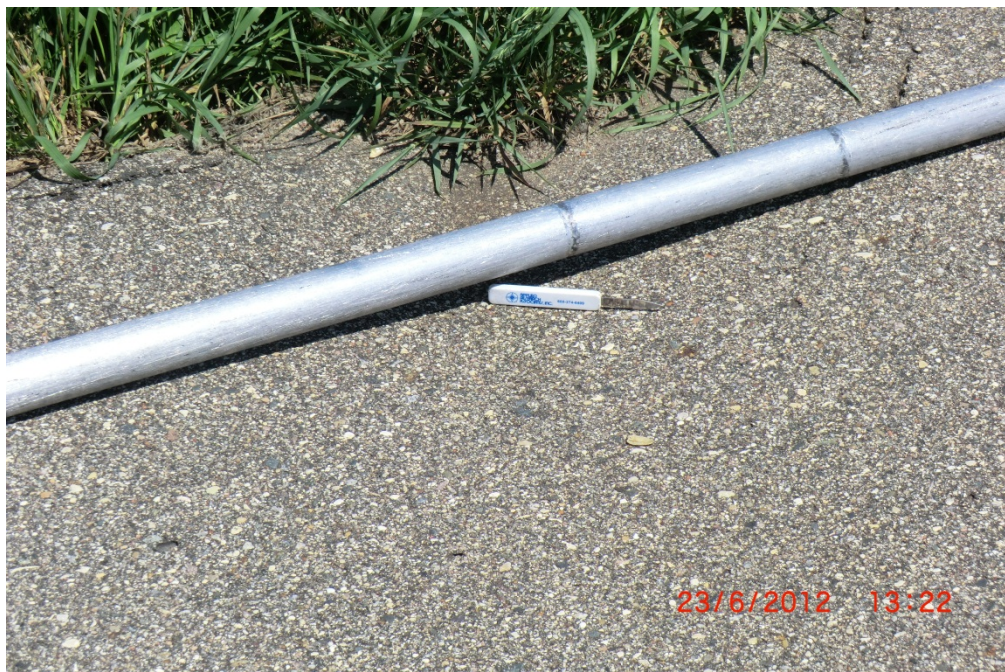
BBB RY1432 001 depression (PCI = 74)

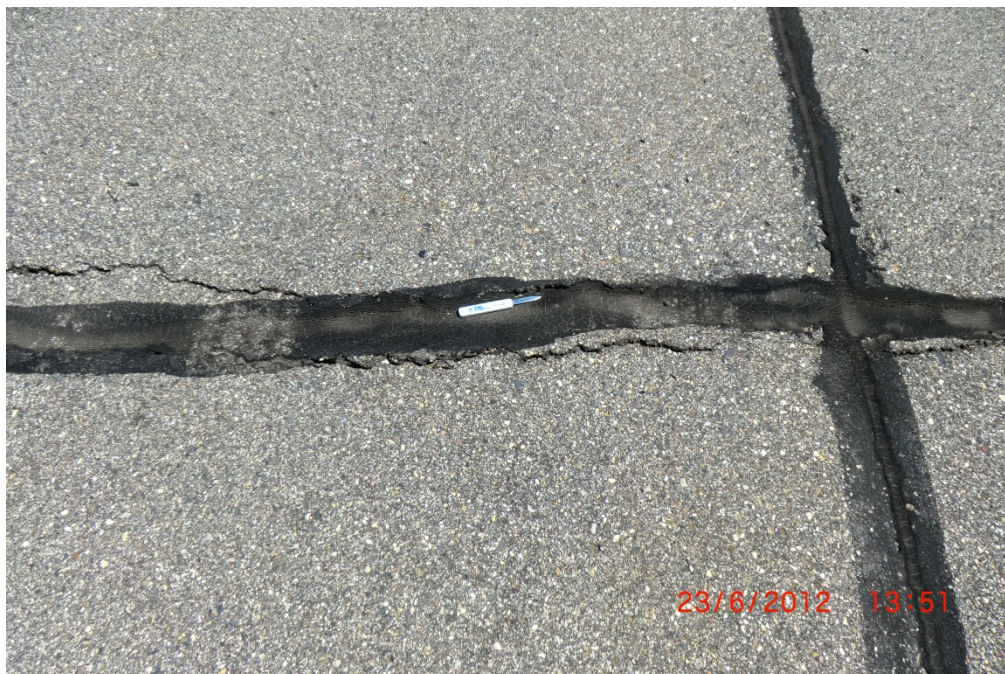
BBB RY1432 003 high severity crack (PCI = 74)
