# Minnesota Airport System Pavement Evaluation 2012 Update

Blue Earth Municipal Airport (SBU)

Blue Earth, Minnesota

January 2013

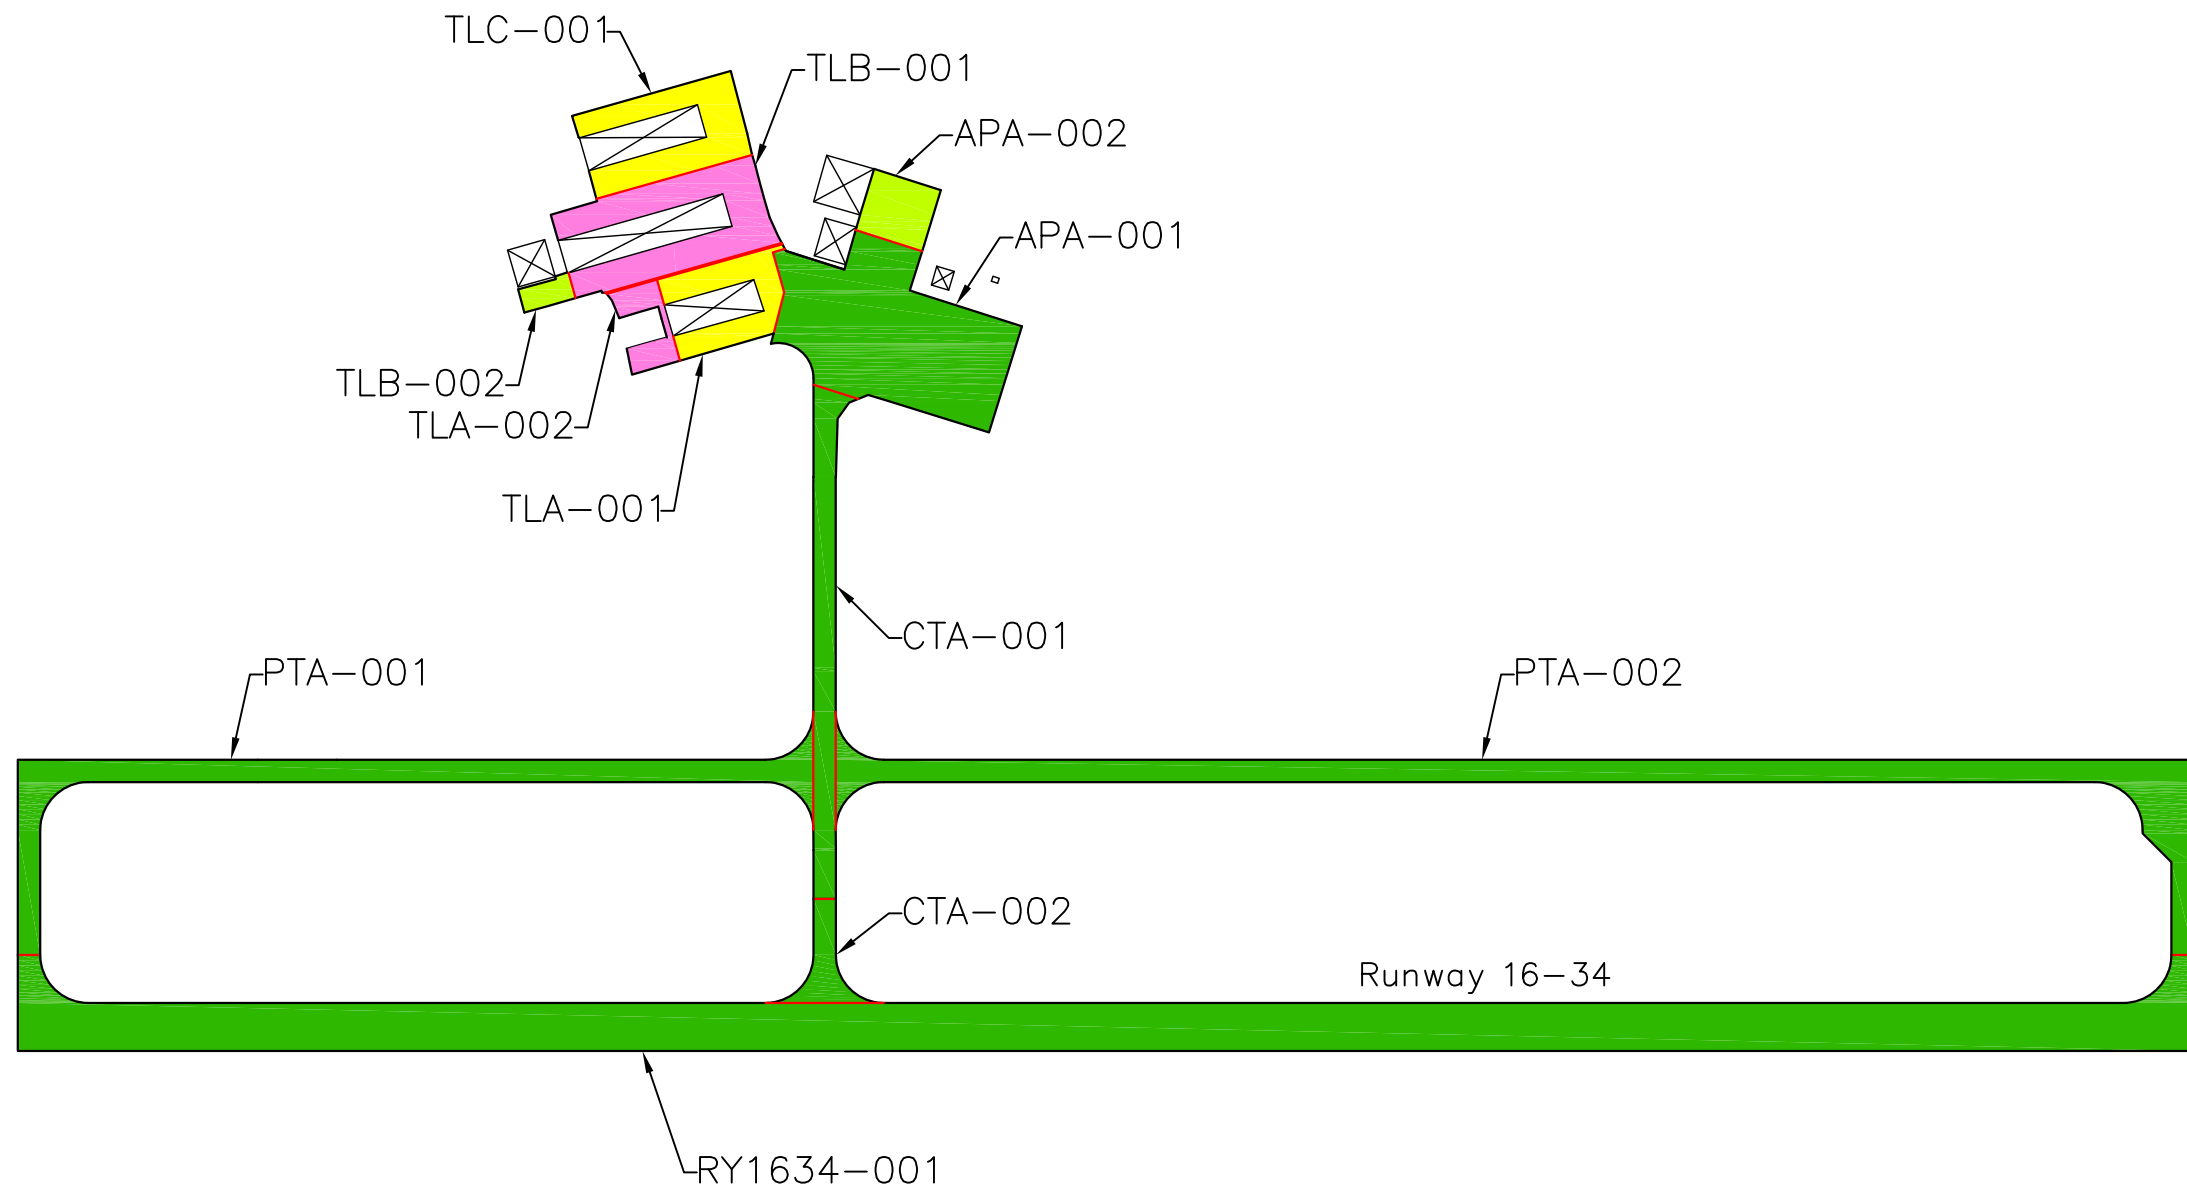
Figure 4. 2012 Pavement Condition Index Rating at Blue Earth Municipal Airport (SBU).

Figures 5 and 6 present the overall PCI for SBU by area distribution and pavement use, respectively. Table 3 presents the PCI summary for each section at SBU, including the drop in PCI per year. Generally, pavement sections will deteriorate between 1 and 3 PCI points per year. Sections deteriorating at higher rates may need maintenance above the normal application rates and should be closely monitored in case major repairs become necessary.

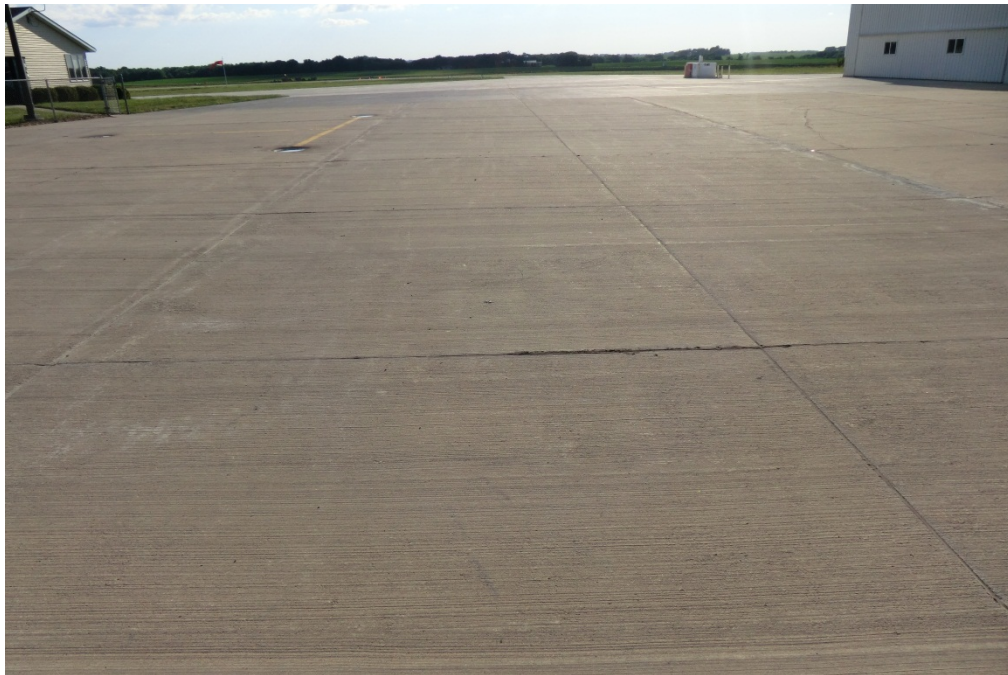
| Branch ID | Section ID | Surface type <sup>1</sup> | Section area (SF) | LCD <sup>2</sup> | 2009 PCI | 2012 PCI | Drop in PCI/Yr <sup>3</sup> | % Deduct due to | | Distress types |
|---|---|---|---|---|---|---|---|---|---|---|
| APA | 2* | PCC | 10,500 | 2002 | 76 | 85 | 1.5 | 81 | 0 | Corner break, linear cracking, small patch, joint spalling |

SBU APA 002 (PCI = 85)

| 63 LINEAR CRACKING | L | 2.00 Slabs | Comments: |

| 63 LINEAR CRACKING | L | 3.00 Slabs | Comments: |
| 74 JOINT SPALLING | L | 1.00 Slabs | Comments: |

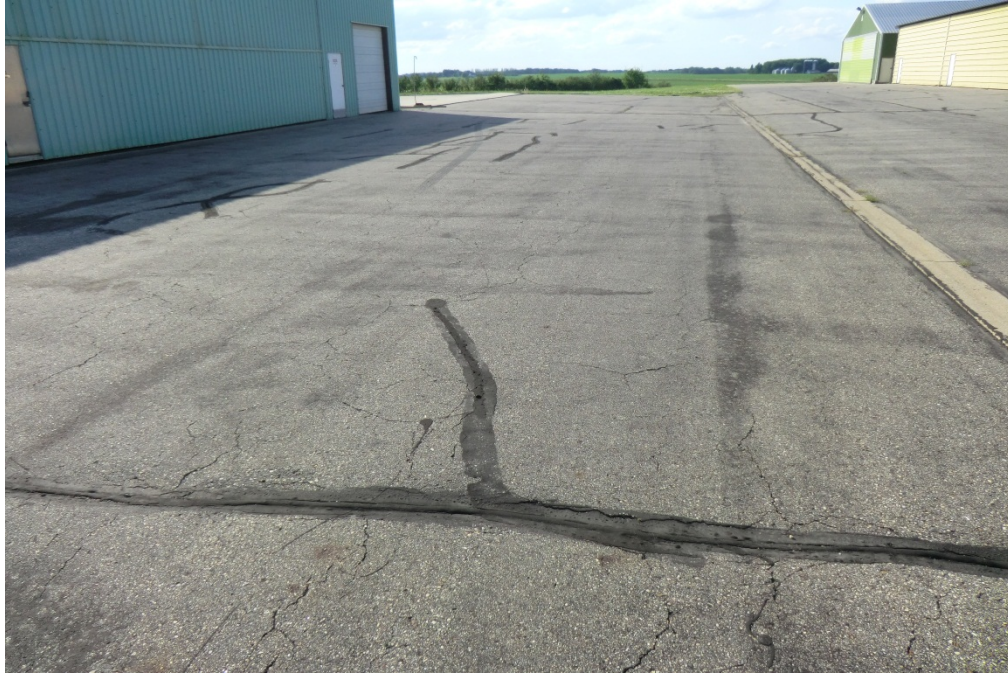
| Branch ID | Section ID | Surface type <sup>1</sup> | Section area (SF) | LCD <sup>2</sup> | 2009 PCI | 2012 PCI | Drop in PCI/Yr <sup>3</sup> | % Deduct due to | | Distress types |
|---|---|---|---|---|---|---|---|---|---|---|
| TLA | 1 | AAC | 17,590 | 1991 | 71 | 61 | 1.9 | 0 | 94 | Bleeding, block cracking, Longitudinal & transverse (L&T) cracking |

SBU TLA 001 (PCI = 61)

| 48 | LONGITUDINAL/TRANSVERSE CRACKING | L | 225.00 Ft | Comments: |
| 48 | LONGITUDINAL/TRANSVERSE CRACKING | M | 24.00 Ft | Comments: |
| 48 | LONGITUDINAL/TRANSVERSE CRACKING | H | 10.00 Ft | Comments: |
| 43 | BLOCK CRACKING | L | 756.00 SqFt | Comments: |

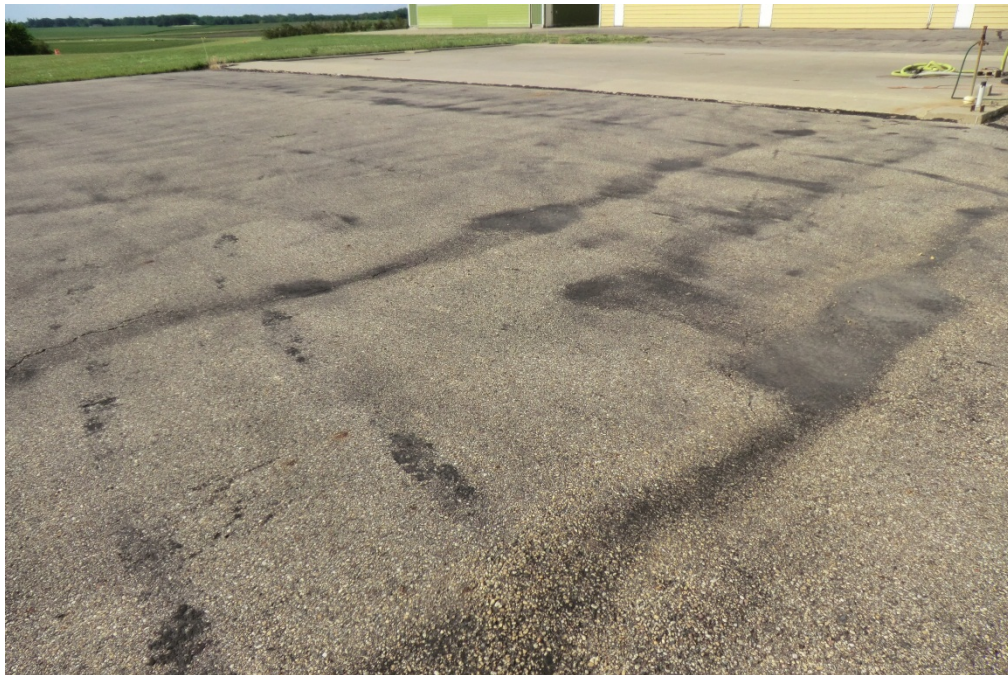
| Branch ID | Section ID | Surface type <sup>1</sup> | Section area (SF) | LCD <sup>2</sup> | 2009 PCI | 2012 PCI | Drop in PCI/Yr <sup>3</sup> | % Deduct due to | | Distress types |
|---|---|---|---|---|---|---|---|---|---|---|
| TLA | 2 | AC | 7,270 | 1992 | 44 | 49 | 2.6 | 0 | 43 | Bleeding, depression, L&T cracking, oil spillage |

SBU TLA 002 (PCI = 49)

48 LONGITUDINAL/TRANSVERSE CRACKING L 130.00 Ft Comments:

48 LONGITUDINAL/TRANSVERSE CRACKING H 41.00 Ft Comments:

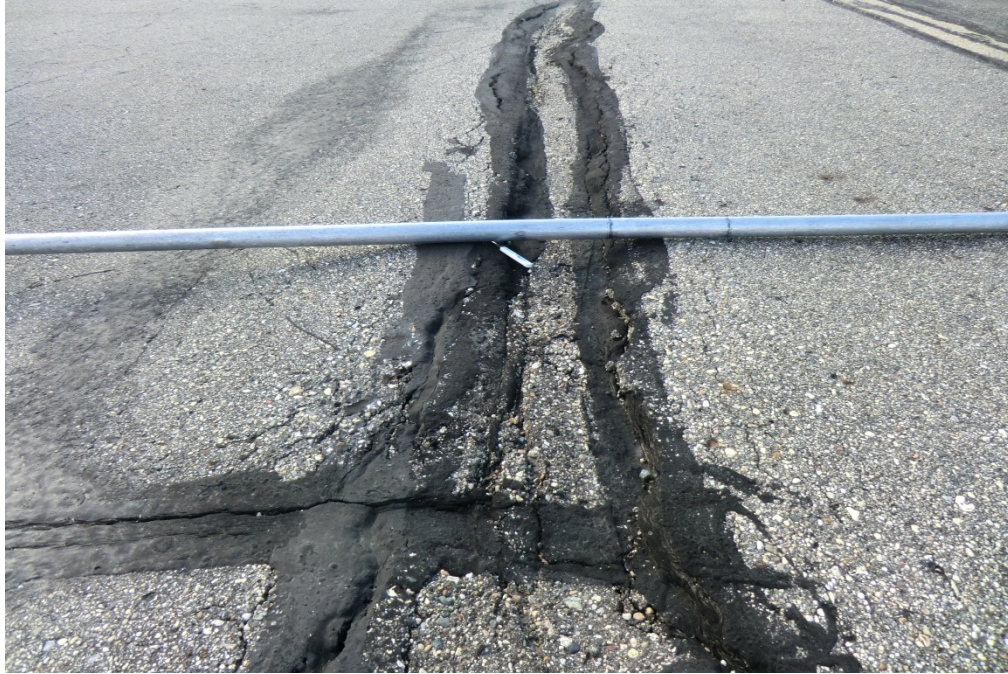
| Branch ID | Section ID | Surface type <sup>1</sup> | Section area (SF) | LCD <sup>2</sup> | 2009 PCI | 2012 PCI | Drop in PCI/Yr <sup>3</sup> | % Deduct due to | | Distress types |
|---|---|---|---|---|---|---|---|---|---|---|
| TLB | 1 | AAC | 31,220 | 1991 | 50 | 53 | 2.2 | 28 | 66 | Alligator cracking, block cracking, L&T cracking, rutting, swelling |

SBU TLB 001 Swell, (PCI = 53)

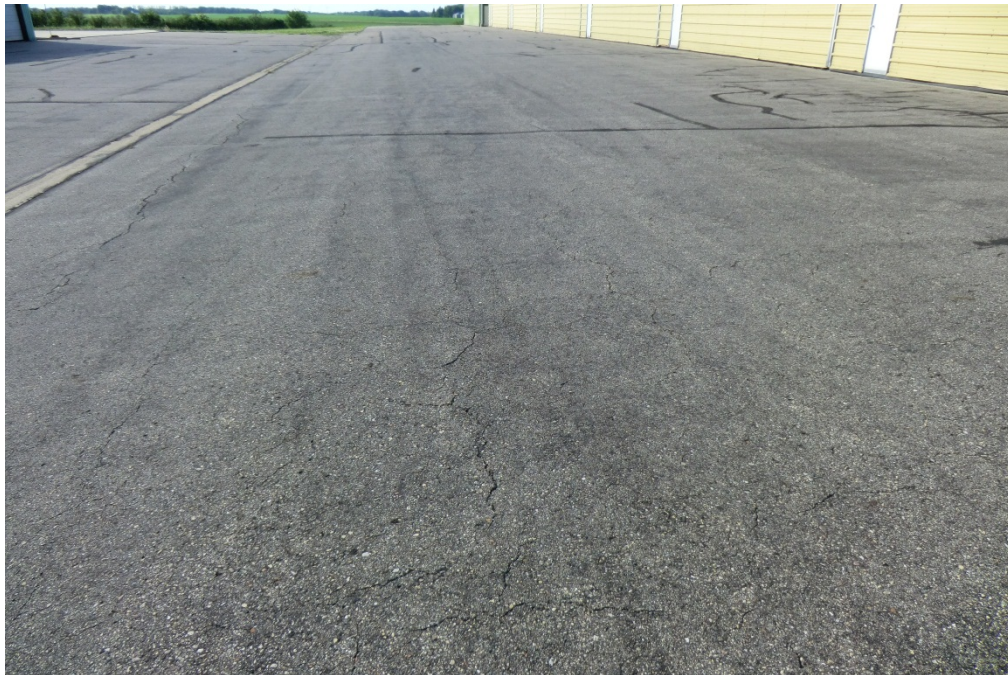
SBU TLB 001 (PCI = 53)

| 41 ALLIGATOR CRACKING | M | 23.00 SqFt | Comments: |
| 43 BLOCK CRACKING | L | 1,350.00 SqFt | Comments: |
| 48 LONGITUDINAL/TRANSVERSE CRACKING | L | 270.00 Ft | Comments: |
| 48 LONGITUDINAL/TRANSVERSE CRACKING | M | 36.00 Ft | Comments: |
| 48 LONGITUDINAL/TRANSVERSE CRACKING | H | 16.00 Ft | Comments: |

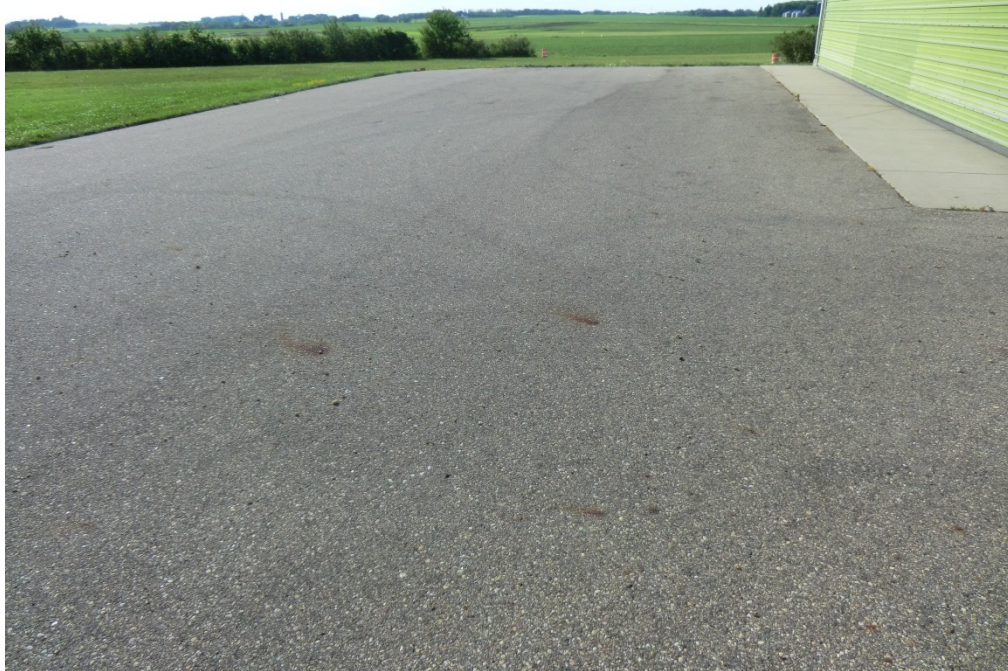
| Branch ID | Section ID | Surface type <sup>1</sup> | Section area (SF) | LCD <sup>2</sup> | 2009 PCI | 2012 PCI | Drop in PCI/Yr <sup>3</sup> | % Deduct due to | | Distress types |
|---|---|---|---|---|---|---|---|---|---|---|
| TLB | 2 | AAC | 2,880 | 1999 | 86 | 74 | 2.0 | 0 | 92 | Depression, L&T cracking |

SBU TLB 002 (PCI = 74)

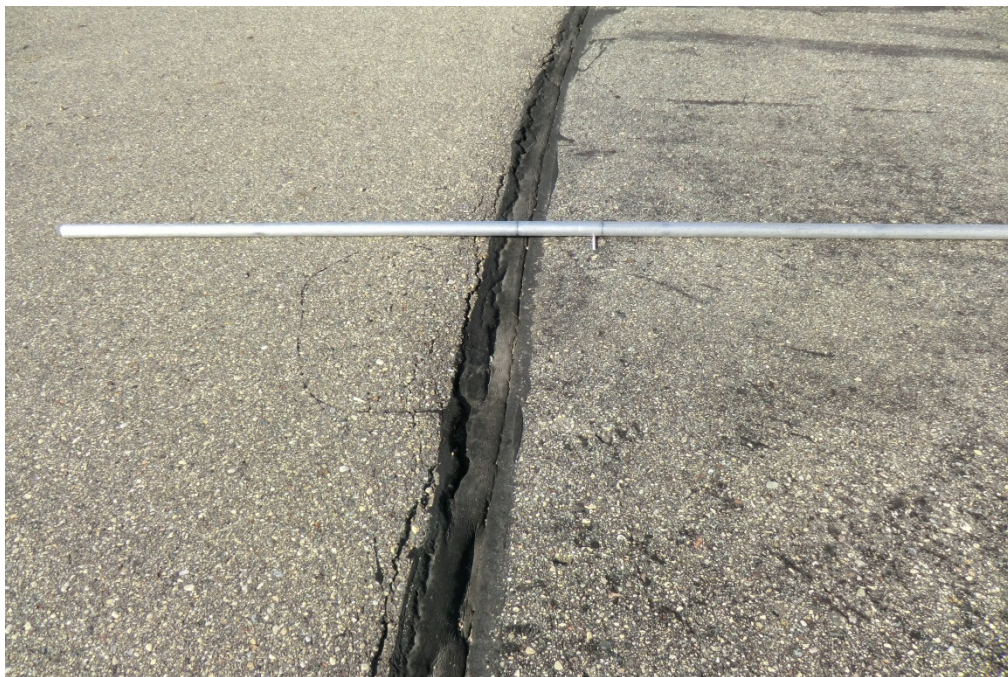
SBU TLB L & T Cracking

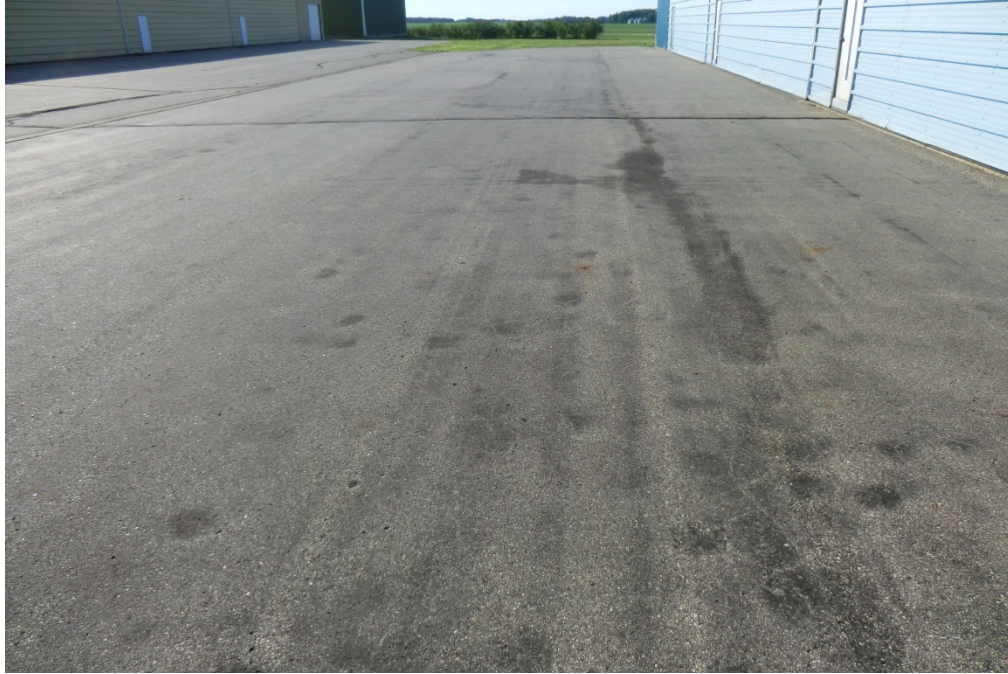
| Branch ID | Section ID | Surface type <sup>1</sup> | Section area (SF) | LCD <sup>2</sup> | 2009 PCI | 2012 PCI | Drop in PCI/Yr <sup>3</sup> | % Deduct due to | | Distress types |
|---|---|---|---|---|---|---|---|---|---|---|
| TLC | 1 | AC | 21,800 | 2000** | 76 | 66 | 2.8 | 0 | 98 | L&T cracking, raveling, swelling |

SBU TLC 001 (PCI = 66)
