Minnesota Airport System Pavement Evaluation 2012 Update

Crookston Municipal Airport (CKN)

Crookston, Minnesota

Final Report

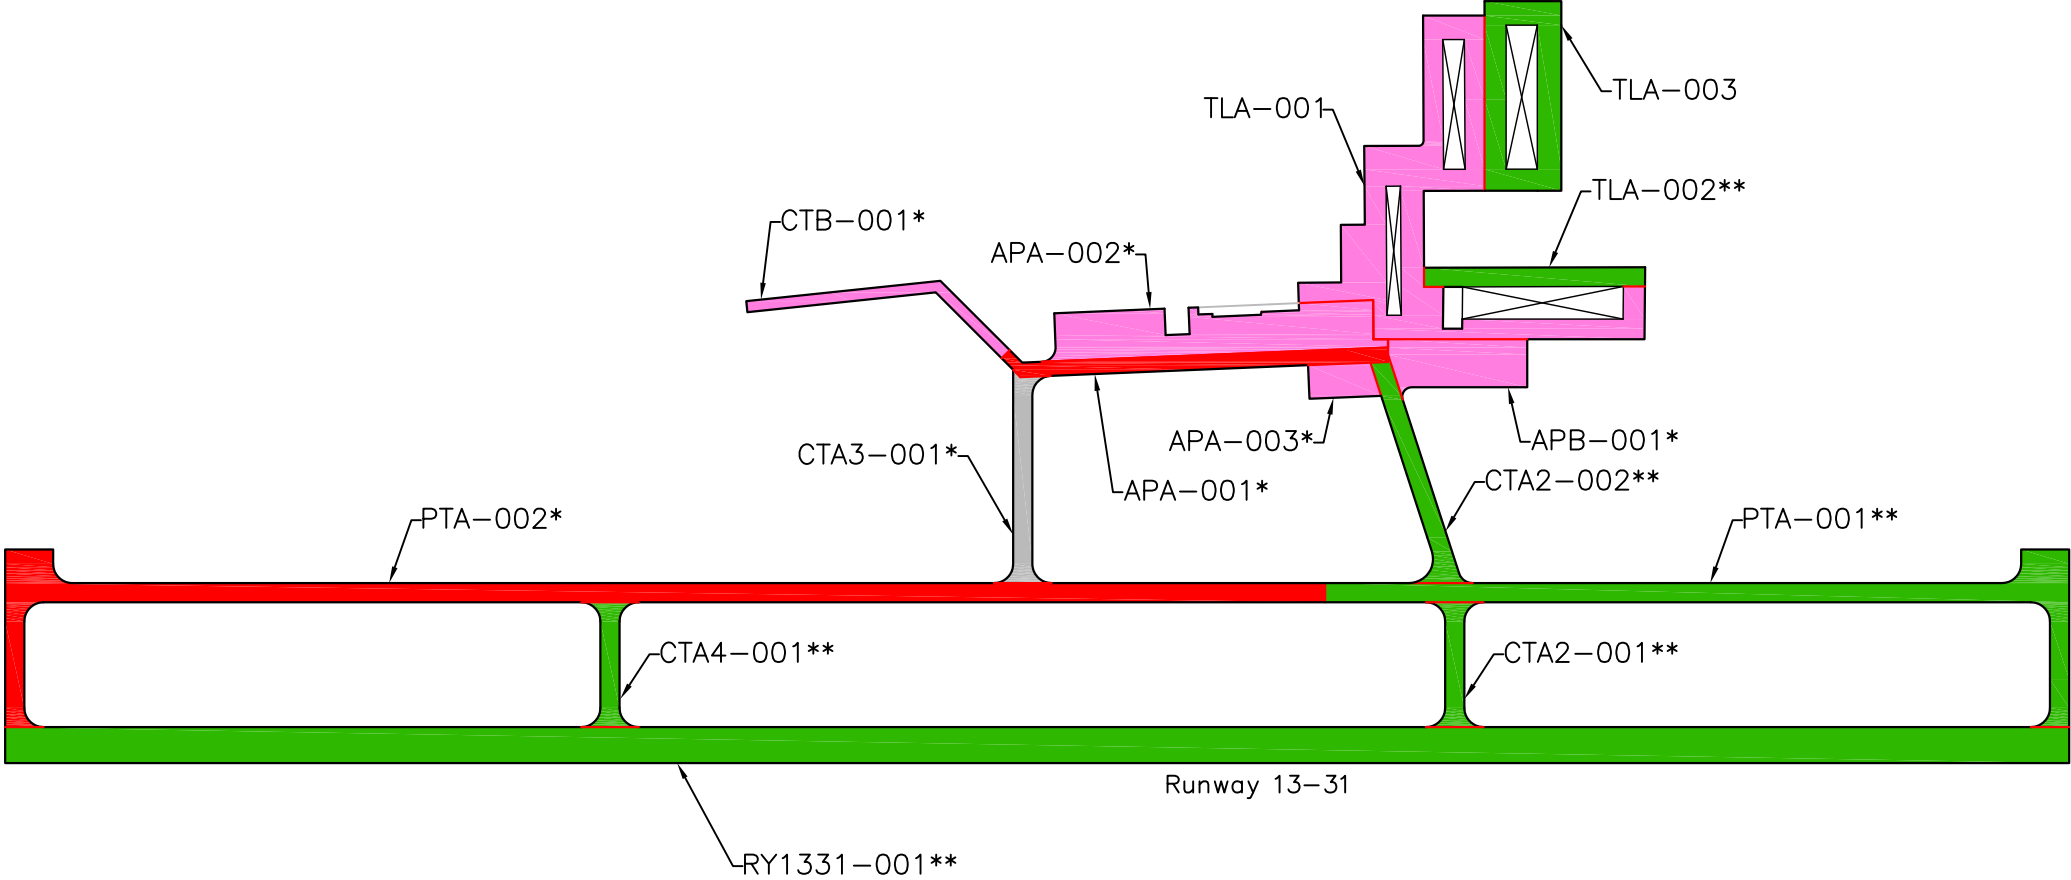
Figure 4. 2012 Pavement Condition Index Rating at Crookston Municipal Airport (CKN).

Figures 5 and 6 present the overall PCI for CKN by area distribution and pavement use, respectively. Table 3 presents the PCI summary for each section at CKN, including the drop in PCI per year. Generally, pavement sections will deteriorate between 1 and 3 PCI points per year. Sections deteriorating at higher rates may need maintenance above the normal application rates and should be closely monitored in case major repairs become necessary.

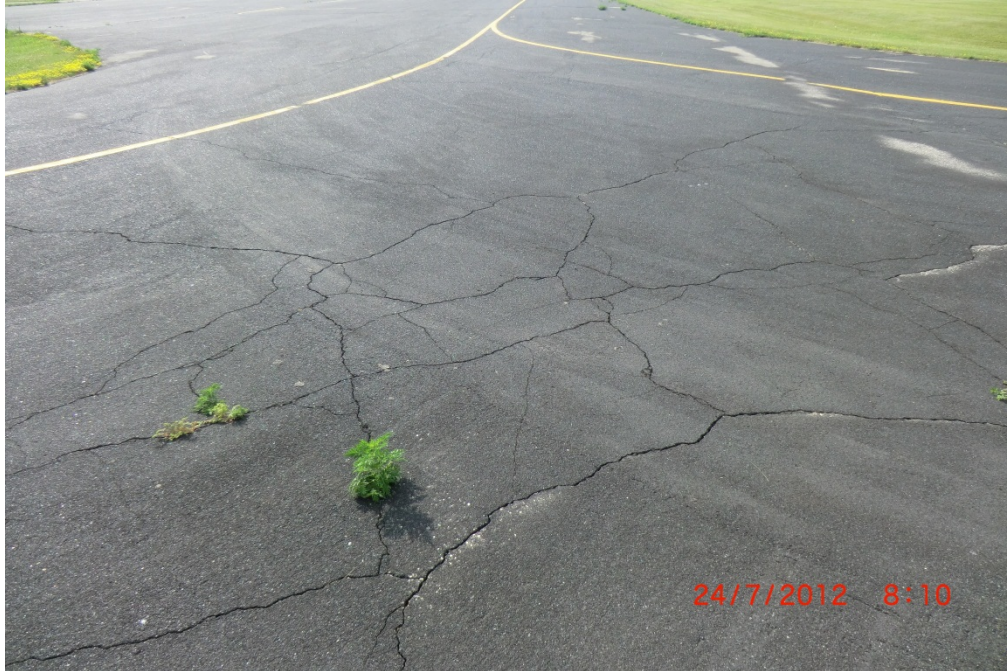
| Branch ID | Section ID | Surface type ¹ | Section area (SF) | LCD ² | 2009 PCI | 2012 PCI | Drop in PCI/Yr ³ | % Deduct due to | | Distress types |
|---|---|---|---|---|---|---|---|---|---|---|
| APA | 1* | AAC | 24,900 | 1996 | 27 | 17 | 5.2 | 53 | 47 | Alligator cracking, block cracking, Longitudinal & transverse (L&T) cracking, rutting |

CKN APA 001 (PCI = 17)

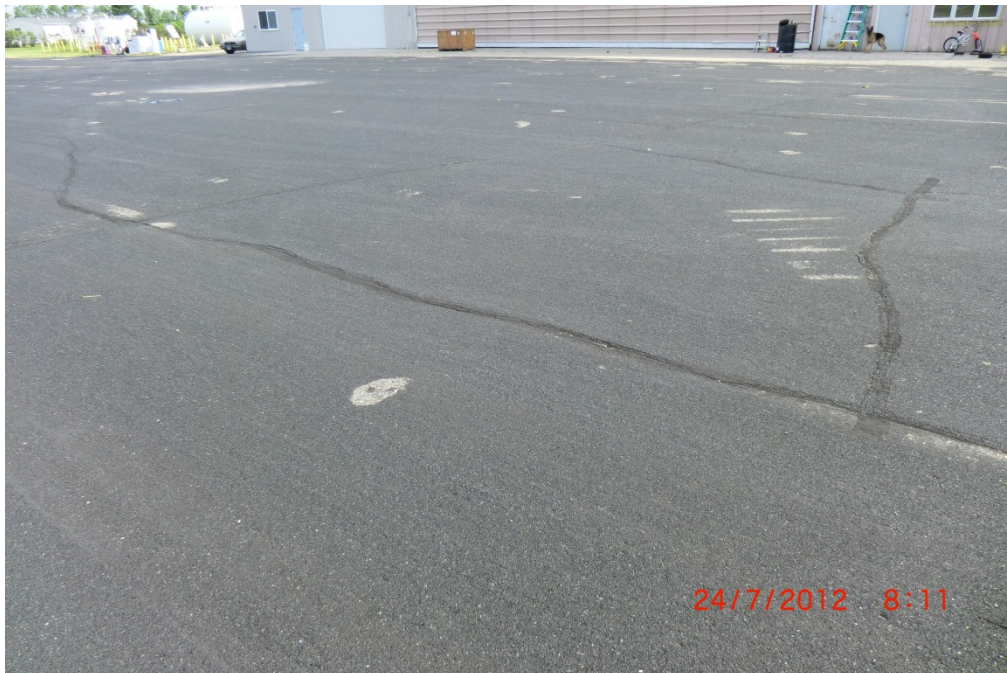
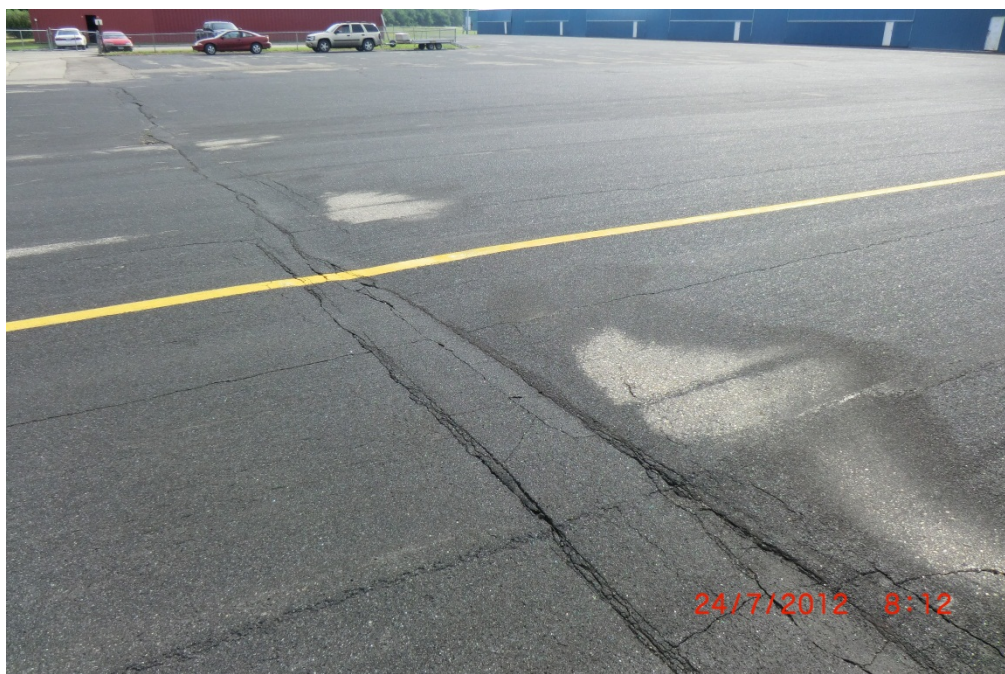
| Branch ID | Section ID | Surface type ¹ | Section area (SF) | LCD ² | 2009 PCI | 2012 PCI | Drop in PCI/Yr ³ | % Deduct due to | | Distress types |
|---|---|---|---|---|---|---|---|---|---|---|
| APA | 2* | AAC | 45,250 | 1996 | 52 | 47 | 3.3 | 62 | 35 | Alligator cracking, L&T cracking, rutting, swelling |

CKN APA 002 (PCI = 47)

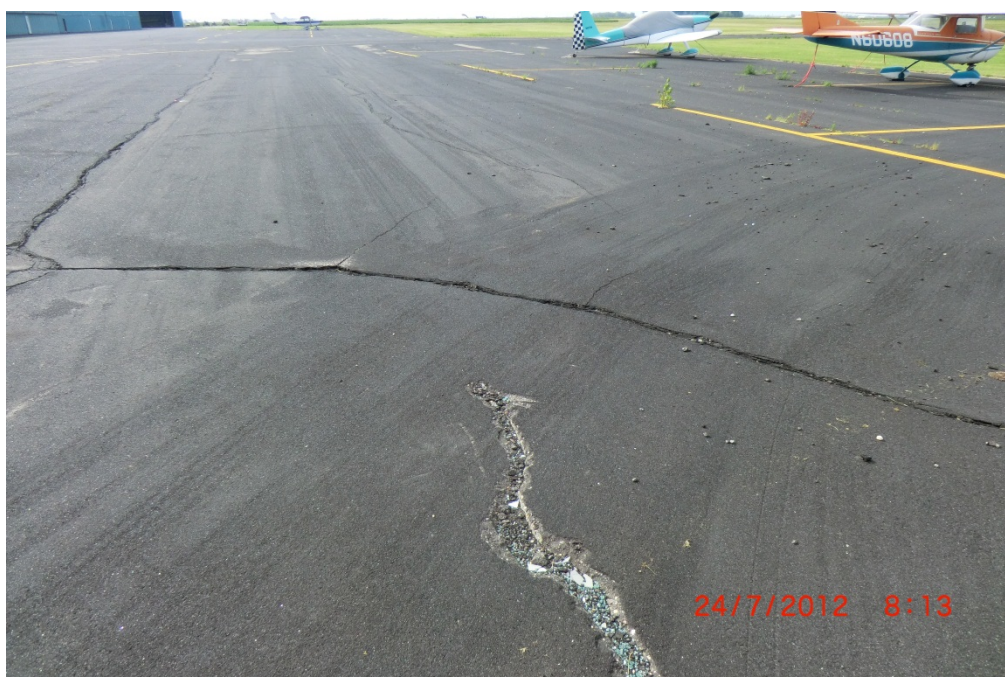
| Branch ID | Section ID | Surface type ¹ | Section area (SF) | LCD ² | 2009 PCI | 2012 PCI | Drop in PCI/Yr ³ | % Deduct due to | | Distress types |
|---|---|---|---|---|---|---|---|---|---|---|
| APA | 3* | AAC | 10,500 | 1996 | 58 | 53 | 2.9 | 0 | 100 | L&T cracking |

CKN APA 003 (PCI = 53)

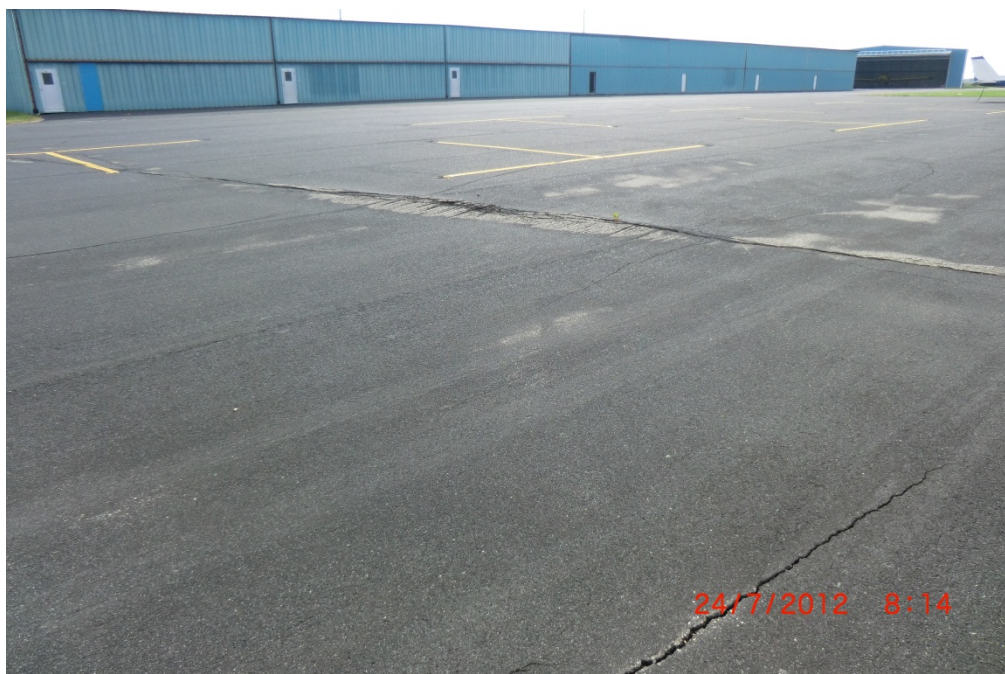
| Branch ID | Section ID | Surface type ¹ | Section area (SF) | LCD ² | 2009 PCI | 2012 PCI | Drop in PCI/Yr ³ | % Deduct due to | | Distress types |
|---|---|---|---|---|---|---|---|---|---|---|
| APB | 1* | AAC | 29,000 | 1996 | 53 | 48 | 3.3 | 44 | 50 | Alligator cracking, L&T cracking, raveling, swelling |

CKN APB 001 (PCI = 48)

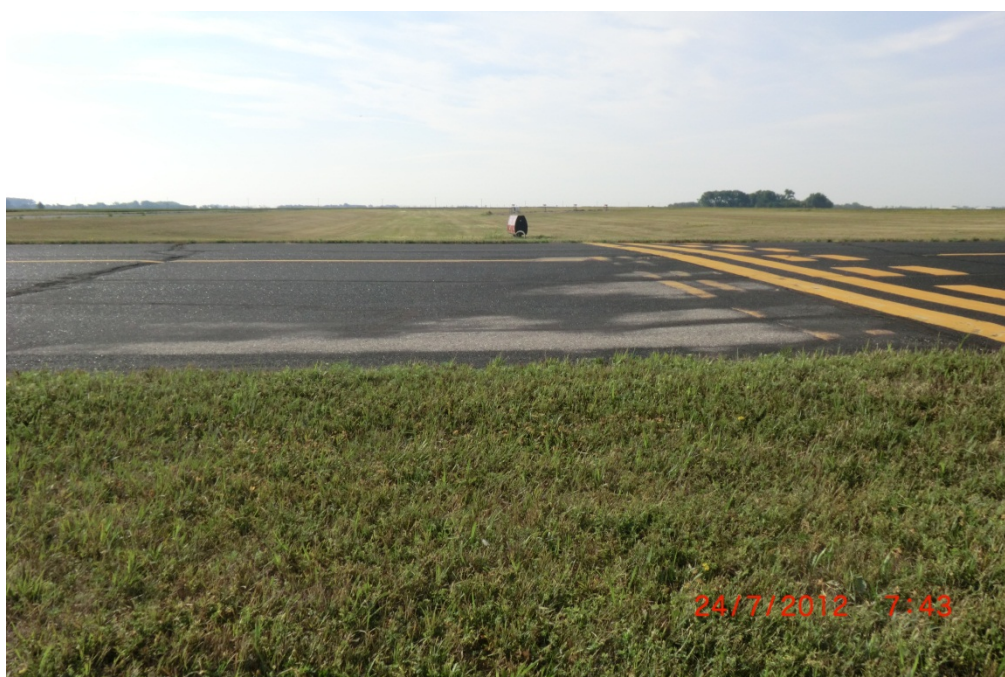
CKN CTA2 001 (prior to 2012 rehabilitation)

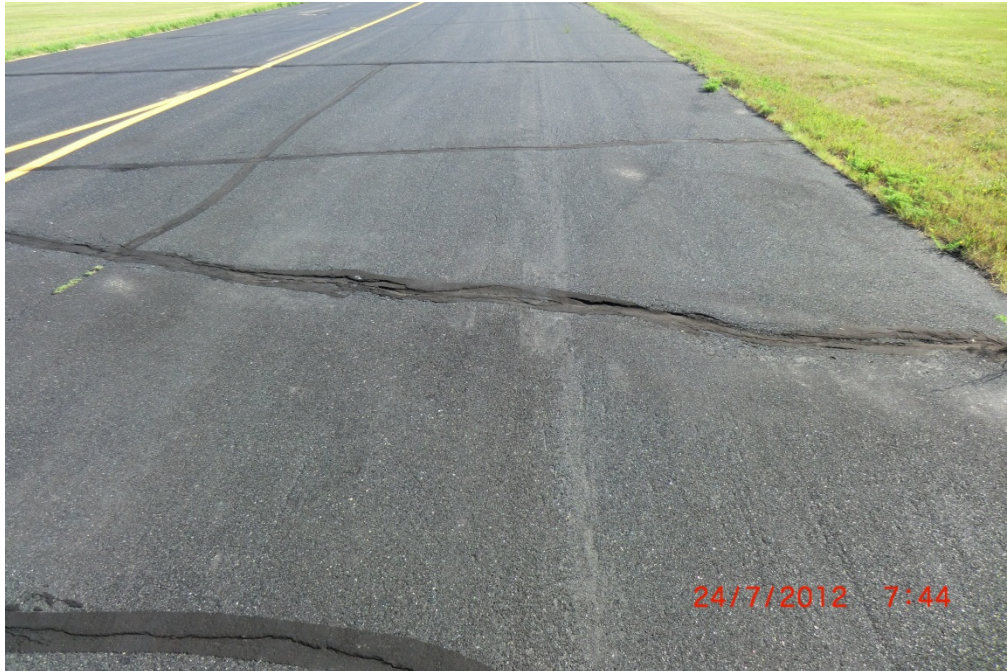
CKN CTA2 002 (prior to 2012 rehabilitation)

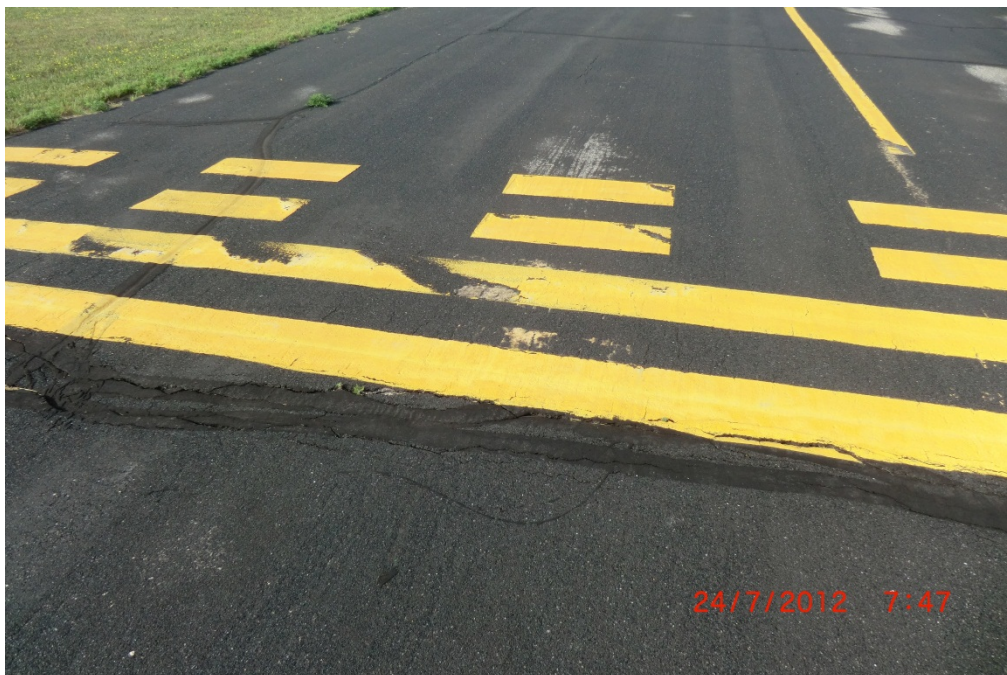
CKN CTA3 001 (prior to 2012 rehabilitation)

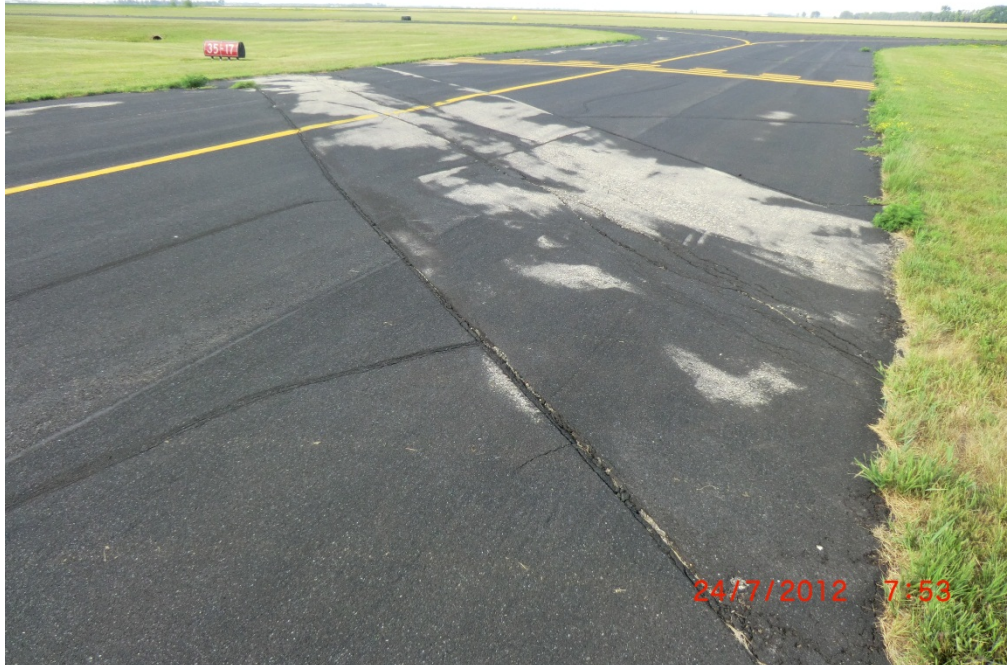
| Branch ID | Section ID | Surface type ¹ | Section area (SF) | LCD ² | 2009 PCI | 2012 PCI | Drop in PCI/Yr ³ | % Deduct due to | | Distress types |
|---|---|---|---|---|---|---|---|---|---|---|
| CTA3 | 1* | AC | 17,808 | 1989 | 27 | 3 | 4.2 | 64 | 36 | Alligator cracking, L&T cracking, rutting |

CKN CTA3 001 (PCI = 3)

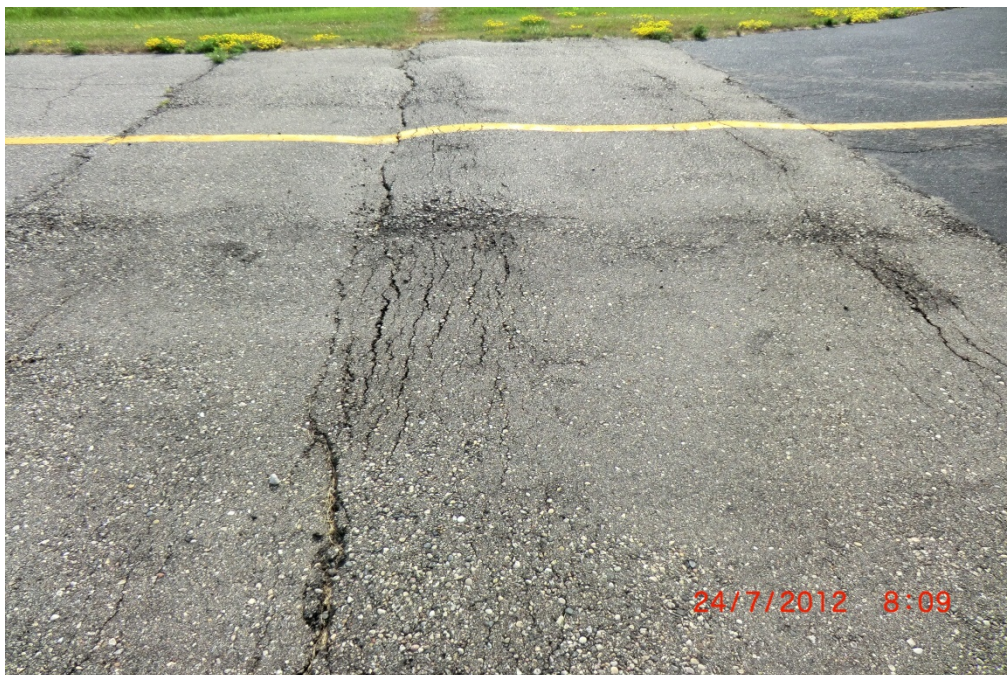
| Branch ID | Section ID | Surface type ¹ | Section area (SF) | LCD ² | 2009 PCI | 2012 PCI | Drop in PCI/Yr ³ | % Deduct due to | | Distress types |
|---|---|---|---|---|---|---|---|---|---|---|
| CTB | 1* | AAC | 13,800 | 1996 | 52 | 51 | 3.1 | 17 | 77 | Alligator cracking, depression, L&T cracking, weathering |

CKN CTB 001 swell (PCI = 51)

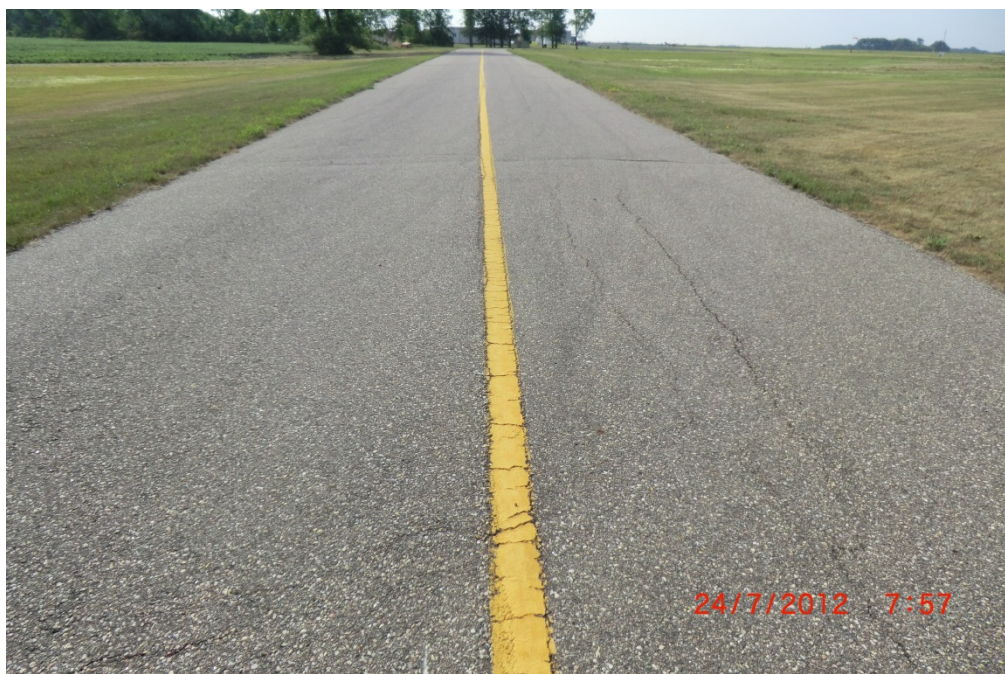
CKN CTB 001 (PCI = 51)

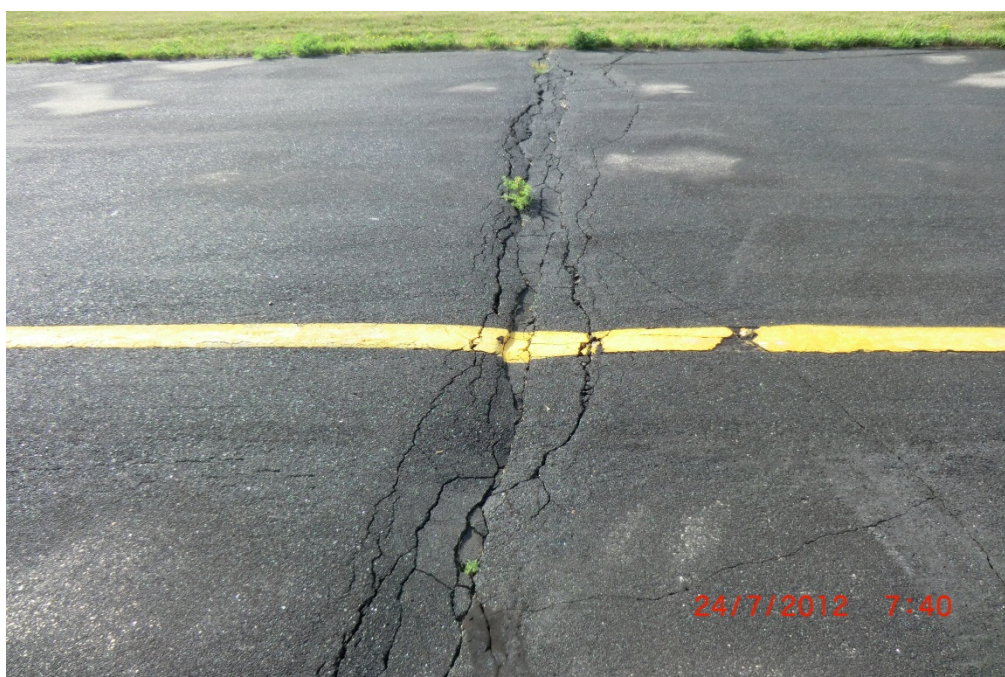
CKN PTA 001 (prior to 2012 rehabilitation)

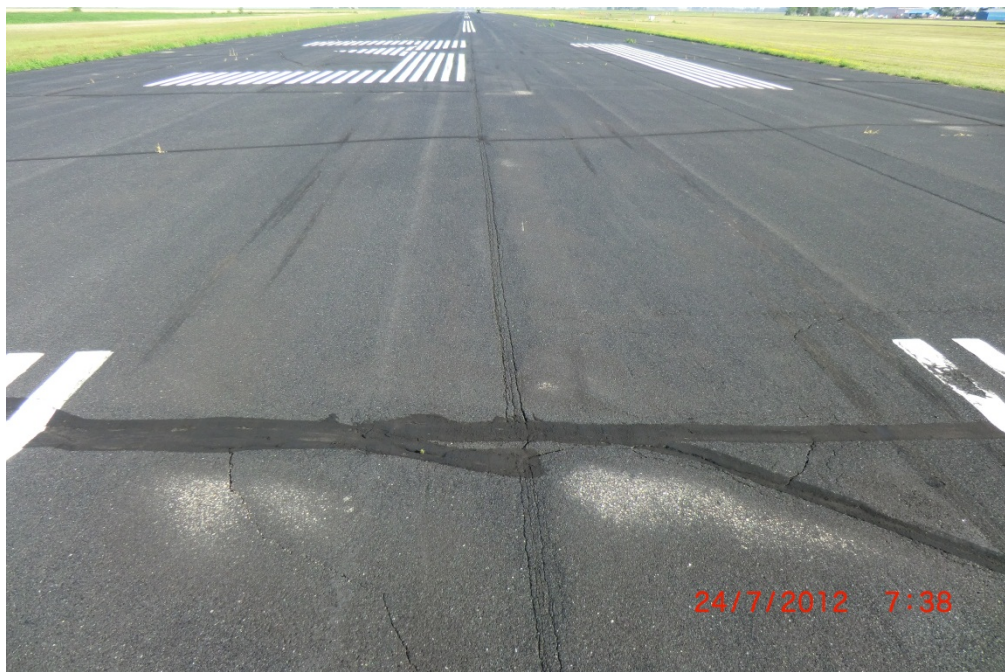
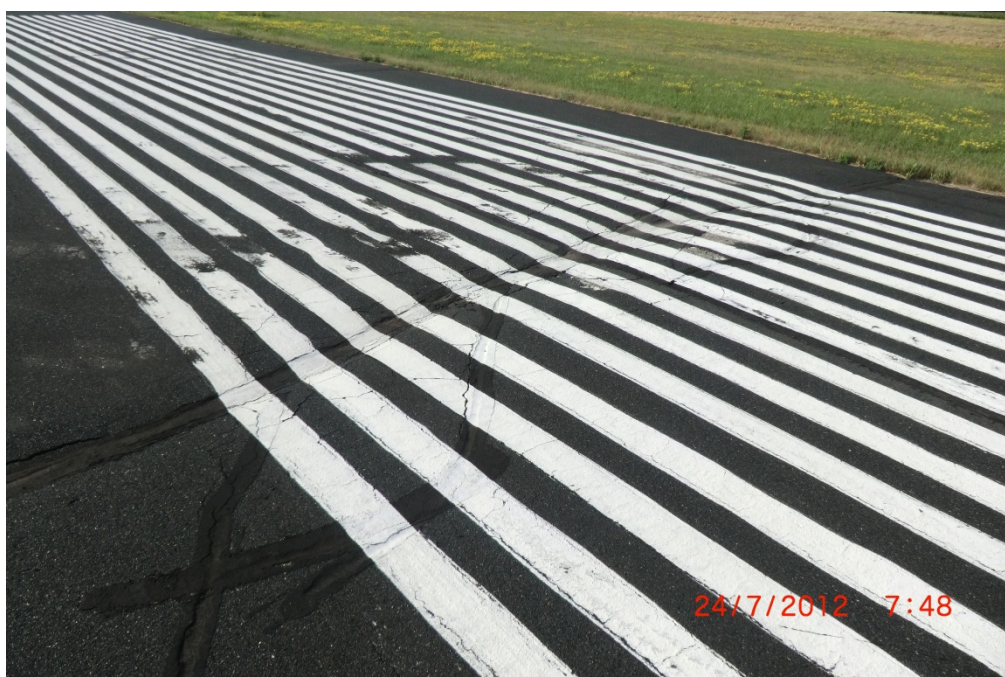
CKN RY1331 001 (prior to 2012 rehabilitation)

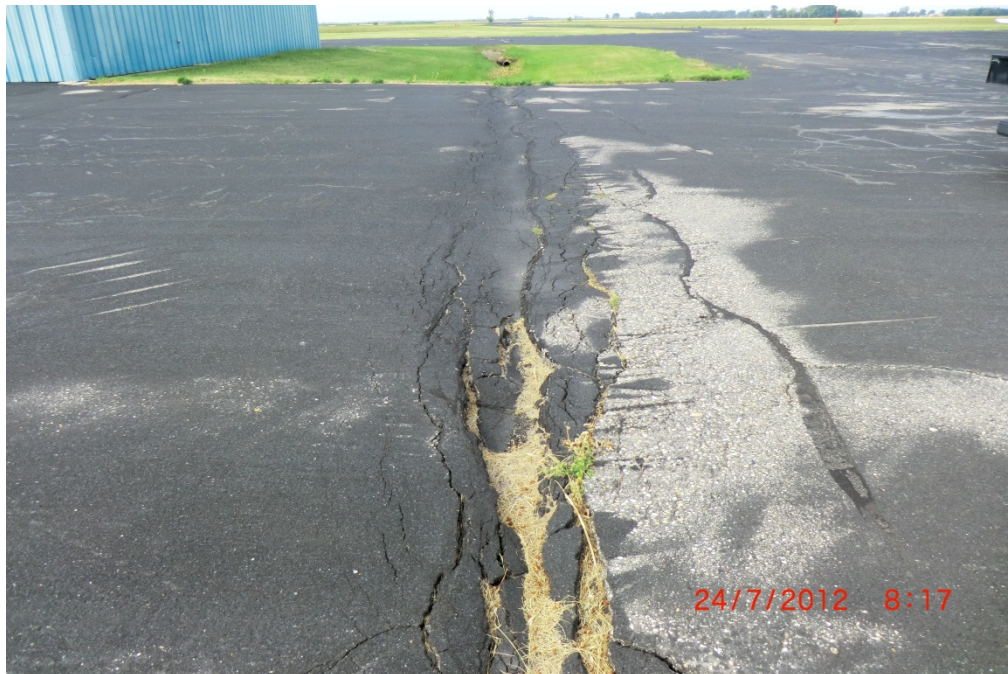
CKN TLA 002 culvert, (prior to 2012 rehabilitation)

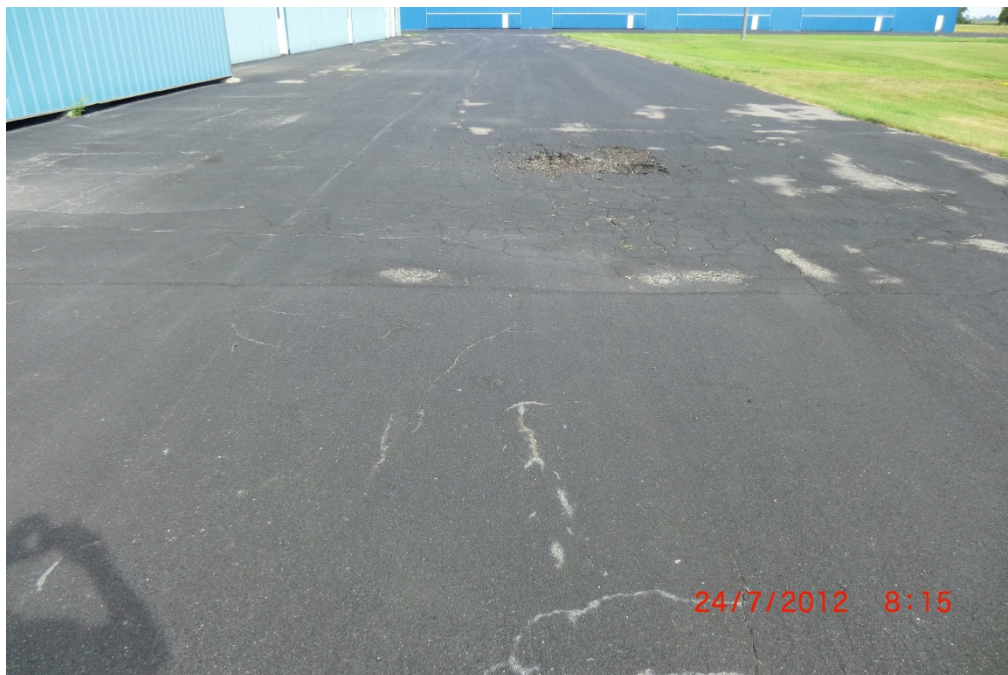
CKN TLA 002 (prior to 2012 rehabilitation)

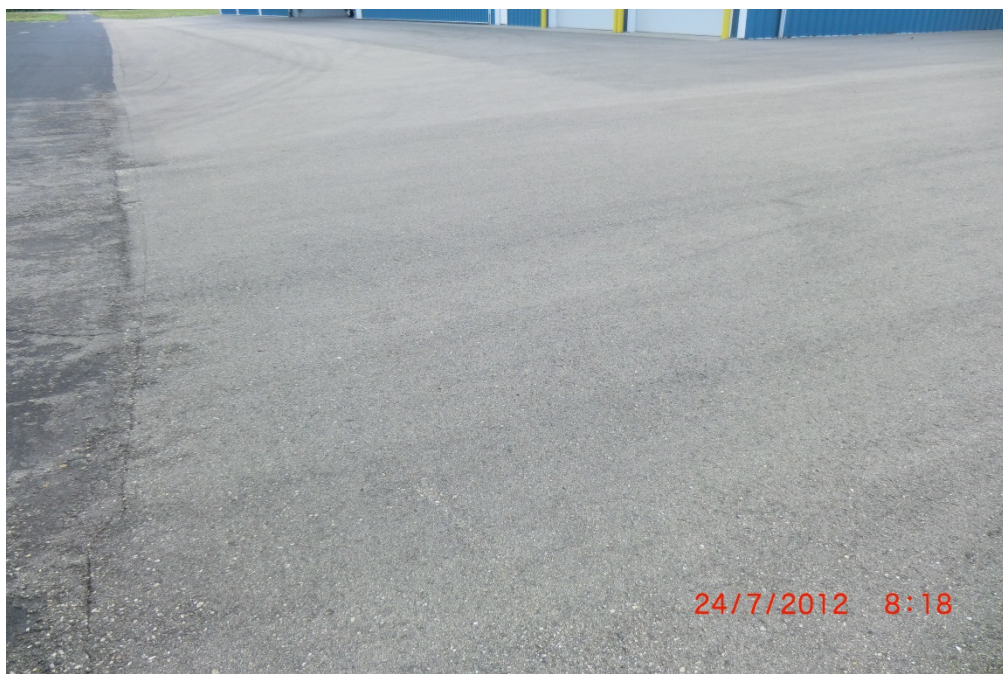
CKN TLA 003 (PCI = 100)
