Minnesota Airport System Pavement Evaluation 2012 Update

Eveleth-Virginia Municipal Airport (EVM)

Final Report

Applied Research Associates, Inc.
100 Trade Centre Dr., Suite 200
Champaign, IL 61820
(217) 356-4500

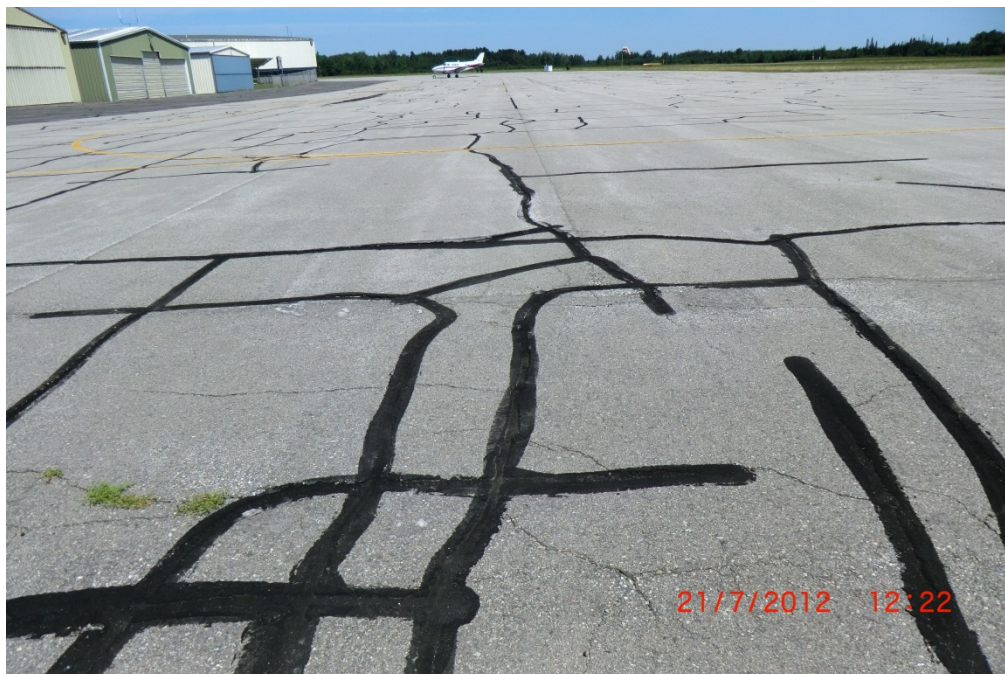
EVM APA 001 (PCI = 61)

Conditions: PCI : 61

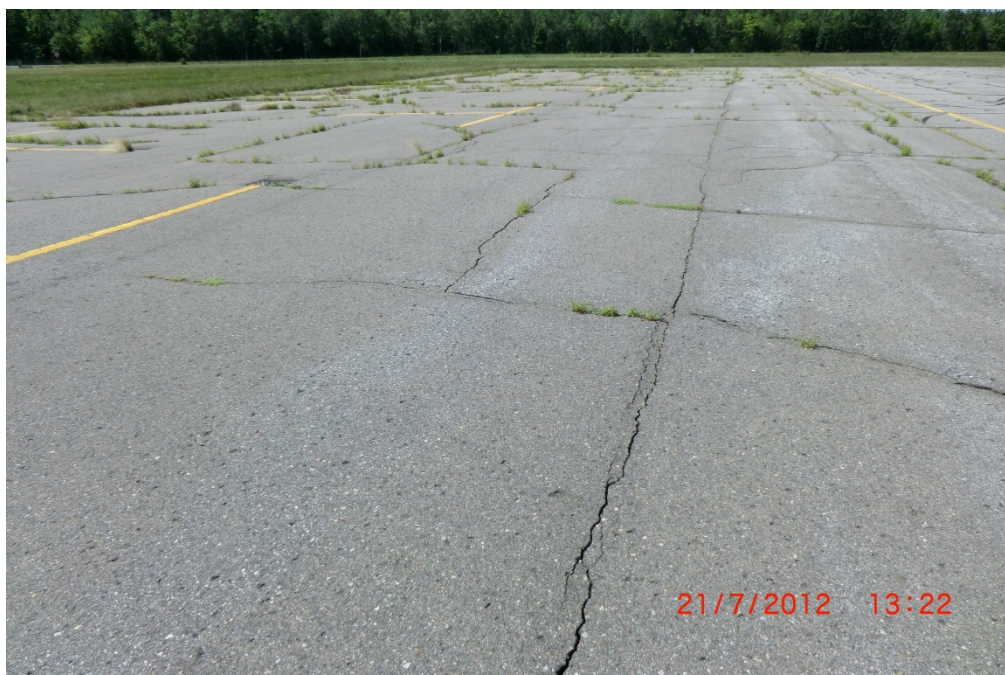
EVM APA 002 (PCI = 44)

Conditions: PCI: 44

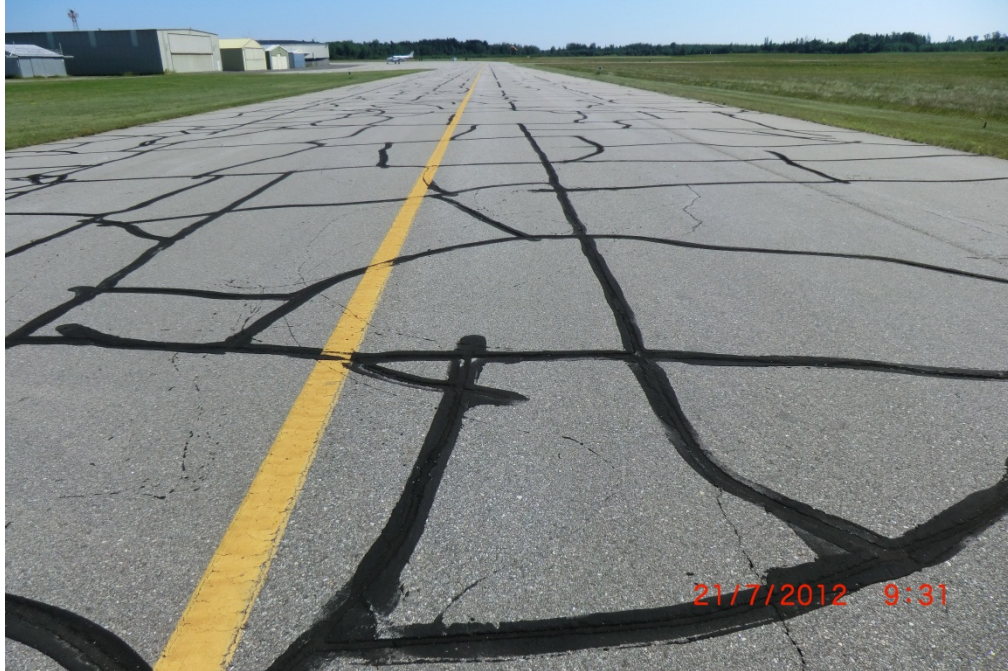
EVM CTA 001 (PCI = 56)

Conditions: PCI : 56

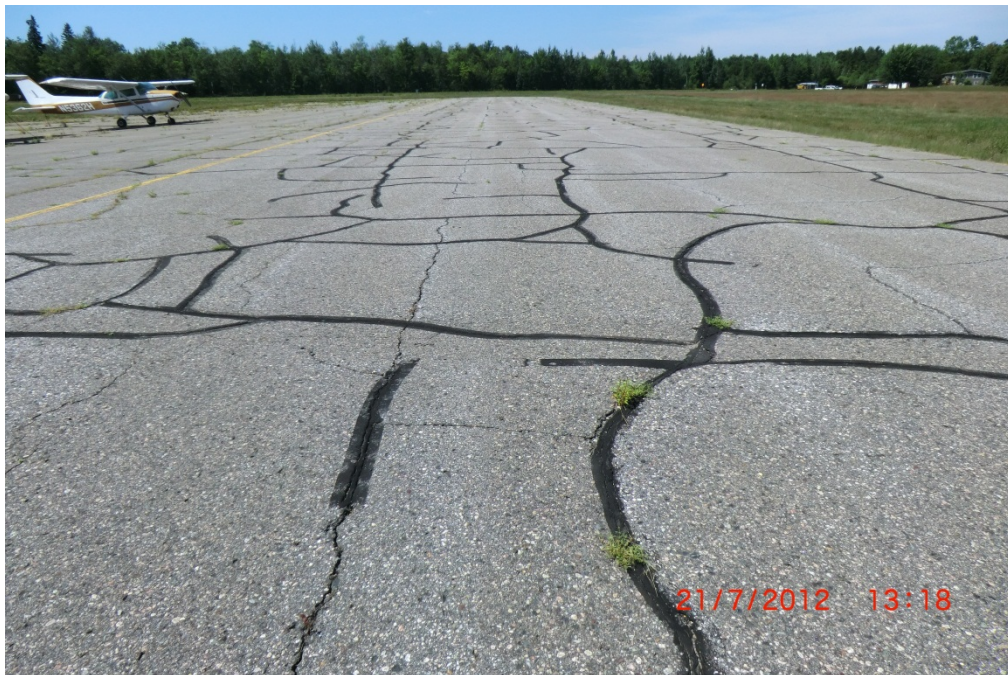
EVM CTA 002 (PCI = 49)

Conditions: PCI : 49

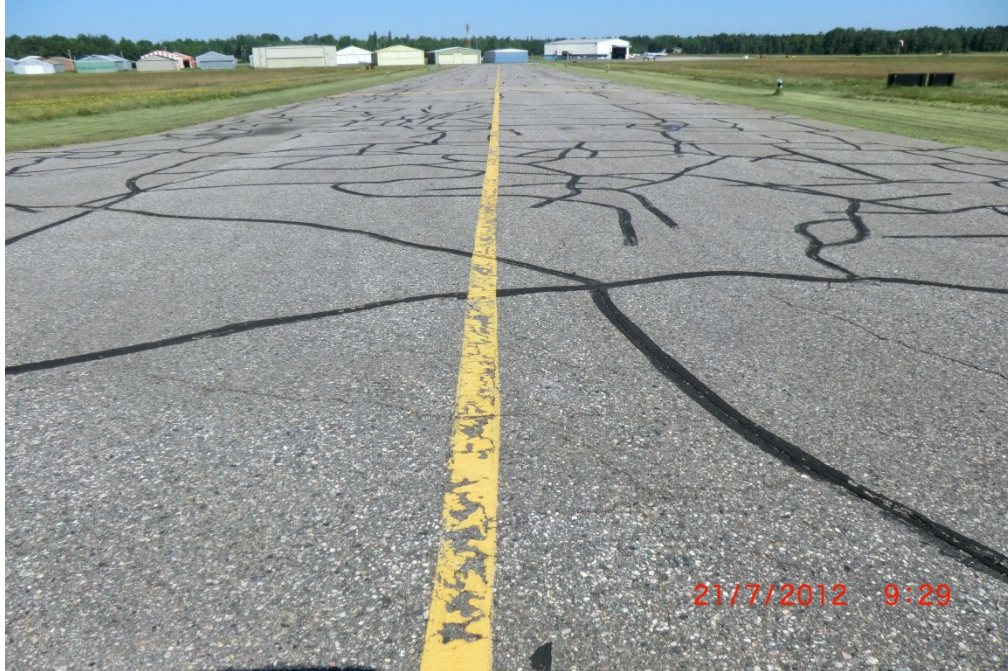
EVM CTB 001 (PCI = 42)

Conditions: PCI : 42

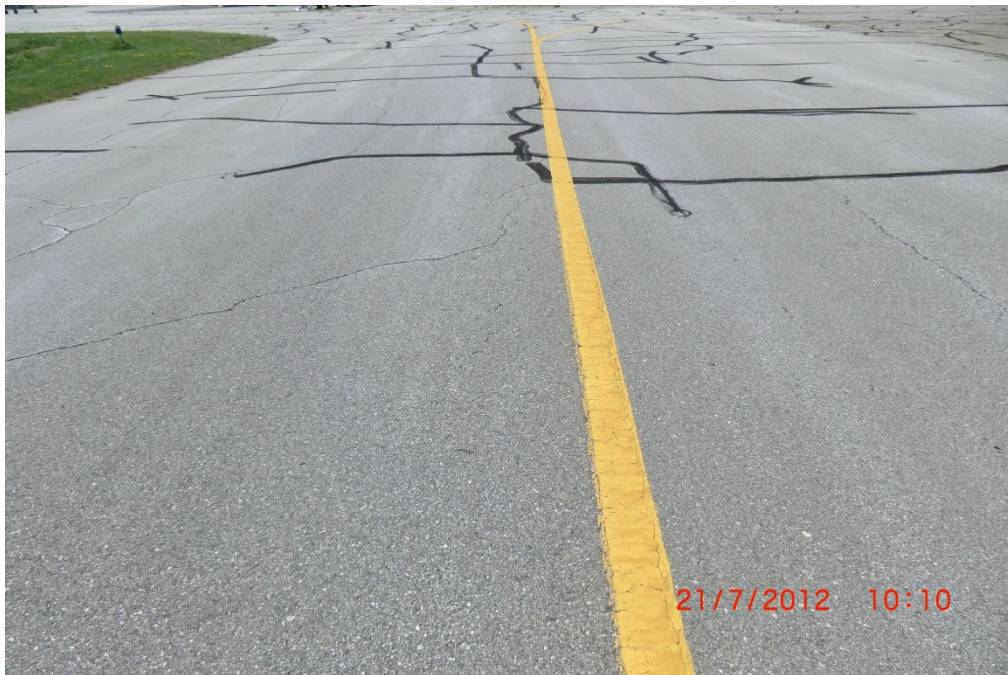
EVM CTC 001 (PCI = 51)

Conditions: PCI: 51

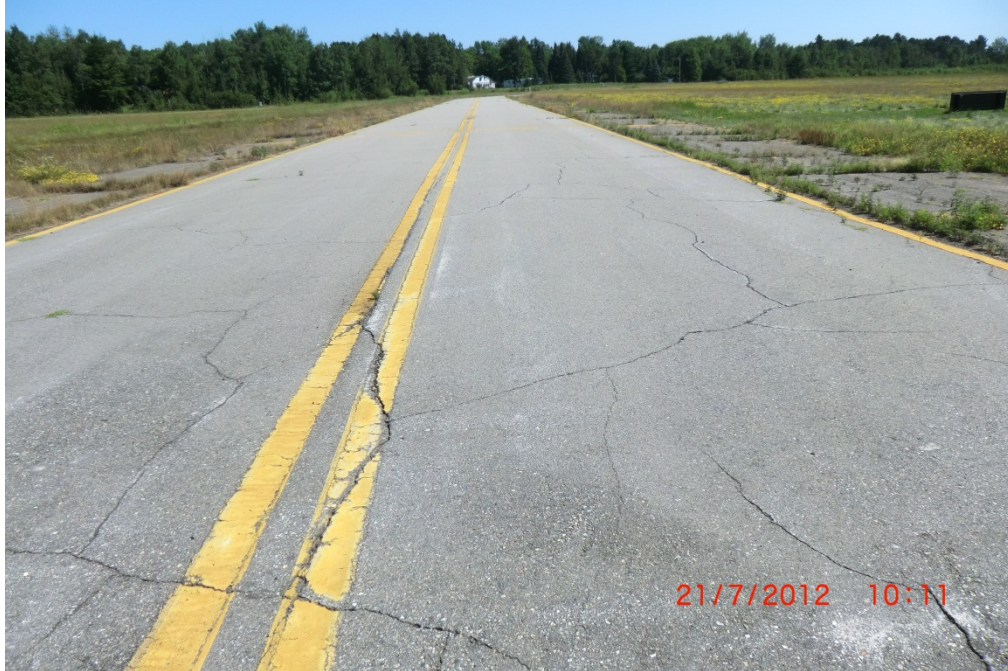
EVM CTC 002 (PCI = 74)

Conditions: PCI : 74

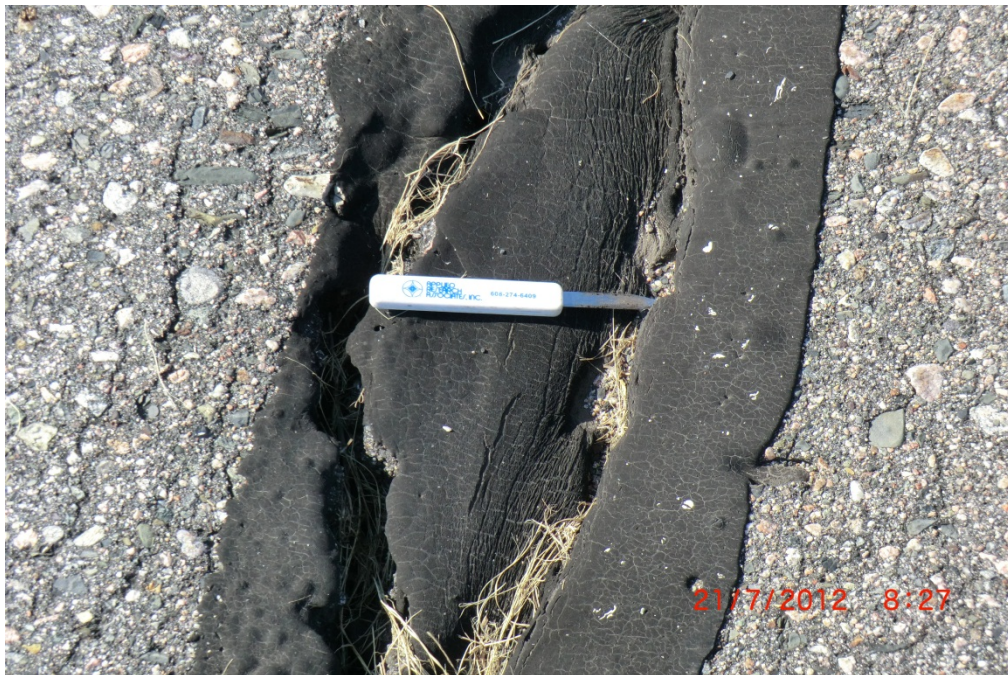
EVM RY927 001 L & T Cracking, (PCI = 43)

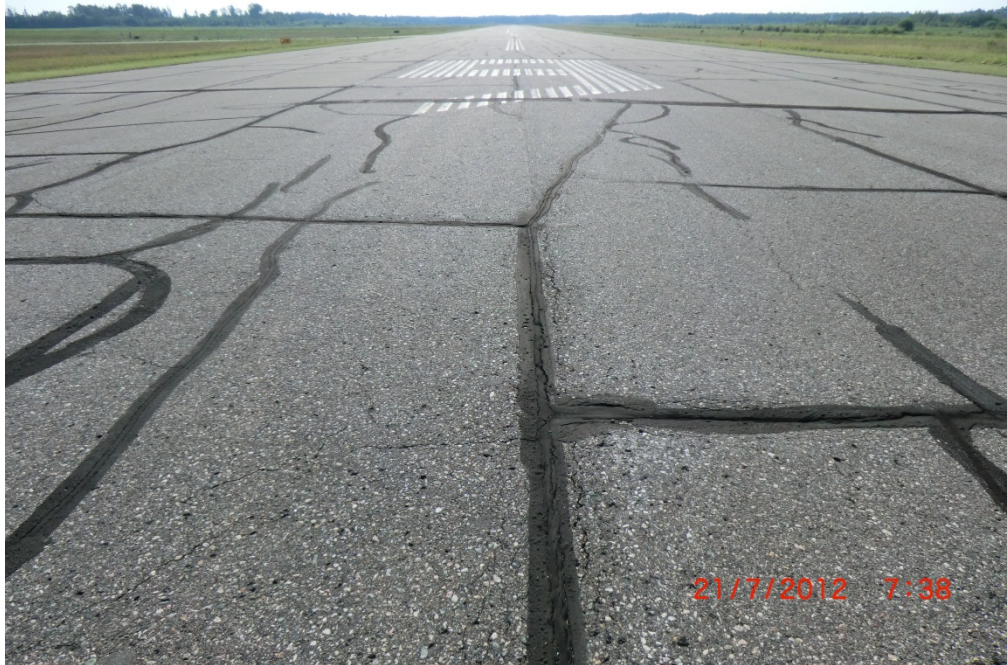
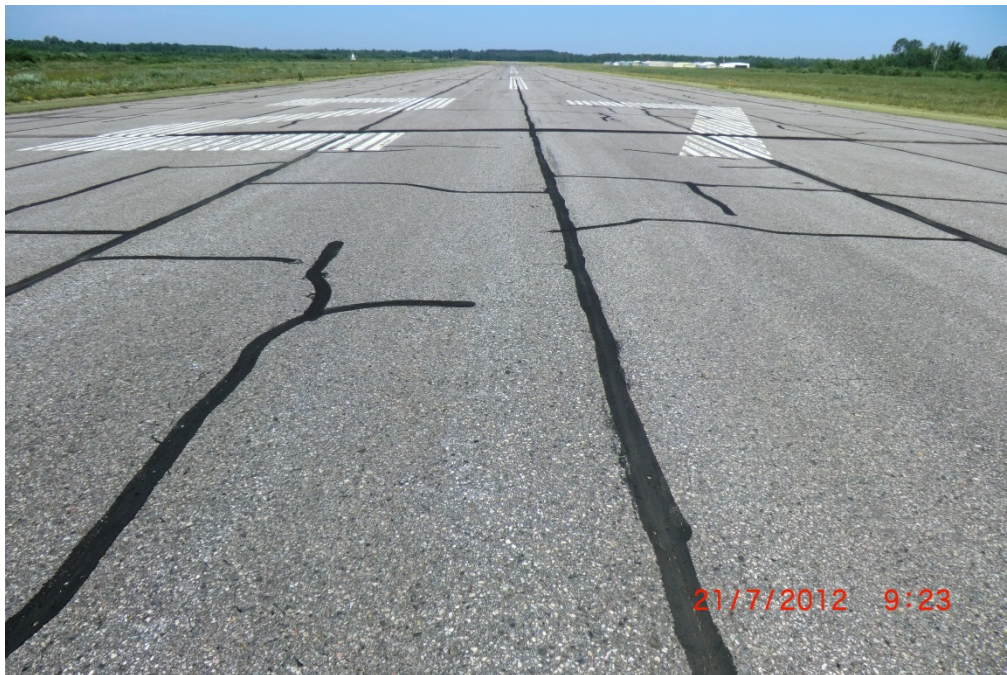
EVM RY927 001 (PCI = 43)

Conditions: PCI: 43

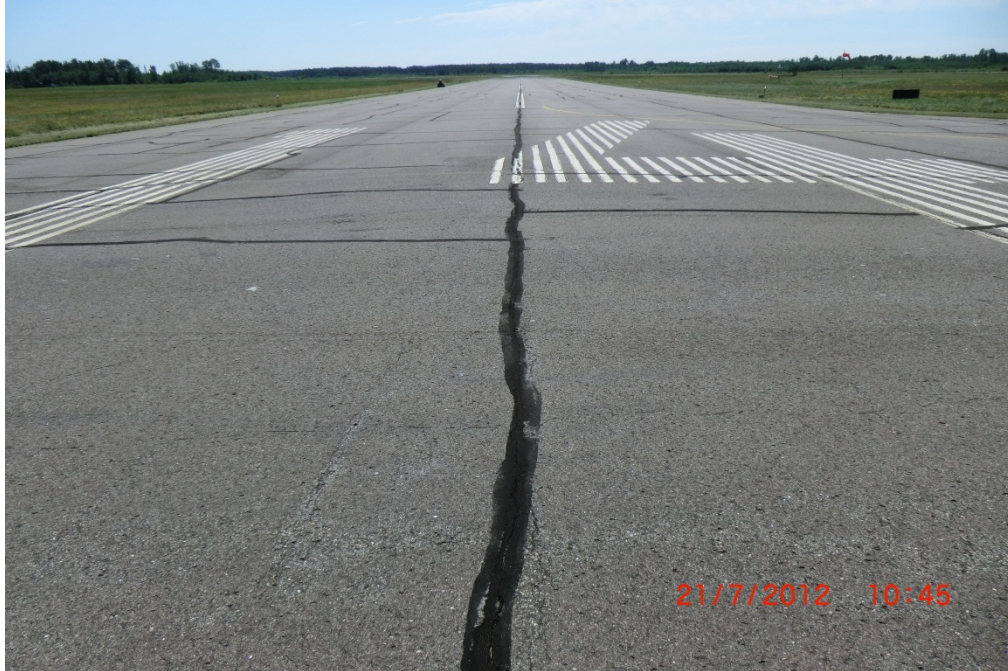
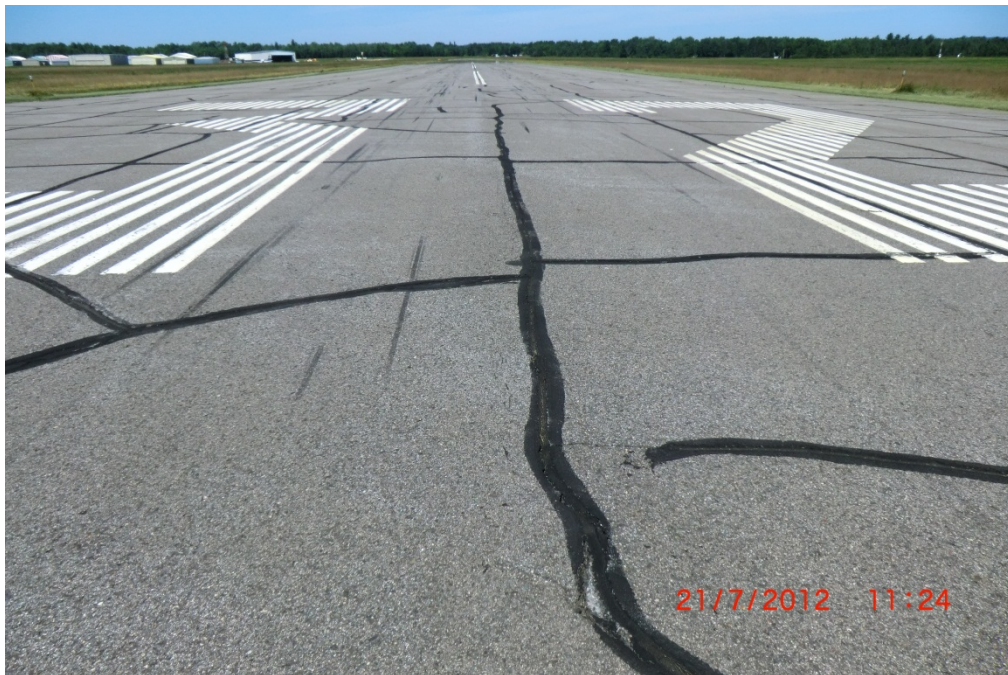
EVM RY1432 001 (PCI = 68)

Conditions: PCI : 68

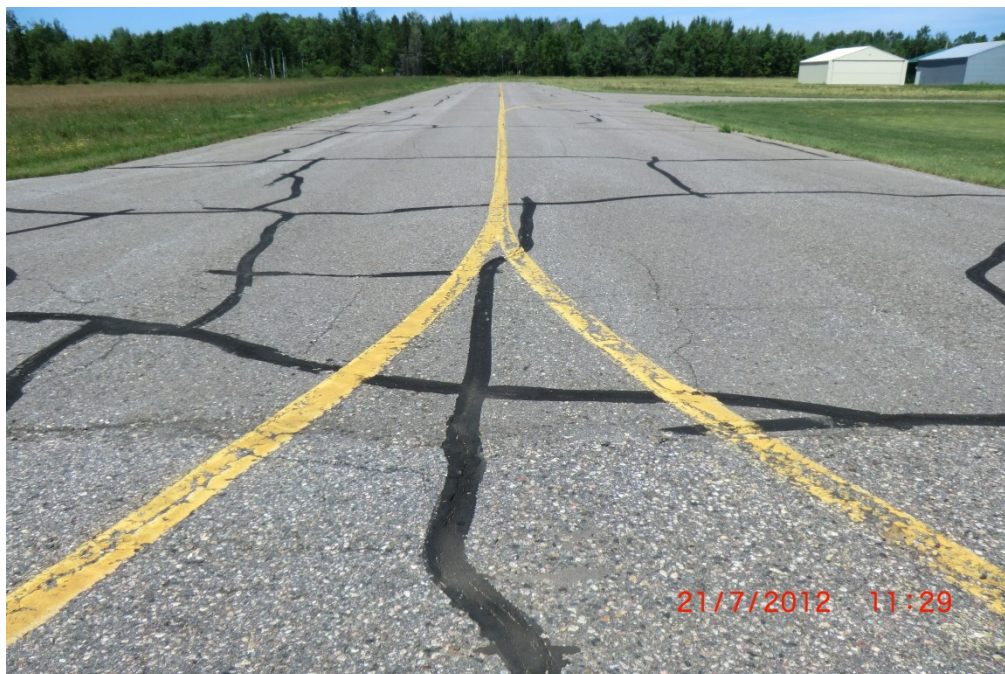
EVM TLA 001 (PCI = 42)

TLA	1	AC	34,000	1983*	52	42	2.0	26	74	Alligator cracking, block cracking, L&T cracking, raveling
TLA	2	AC	12,400	1987*	45	47	2.1	0	100	Block cracking, L&T cracking, raveling
TLB	1	AC	13,598	1998	45	50	3.6	0	98	Block cracking, depression, L&T cracking, raveling
