Minnesota Airport System Pavement Evaluation 2012 Update

Grand Marais-Cook County Airport (CKC)

Final Report

Mn/DOT Airport Pavement Management System 2012

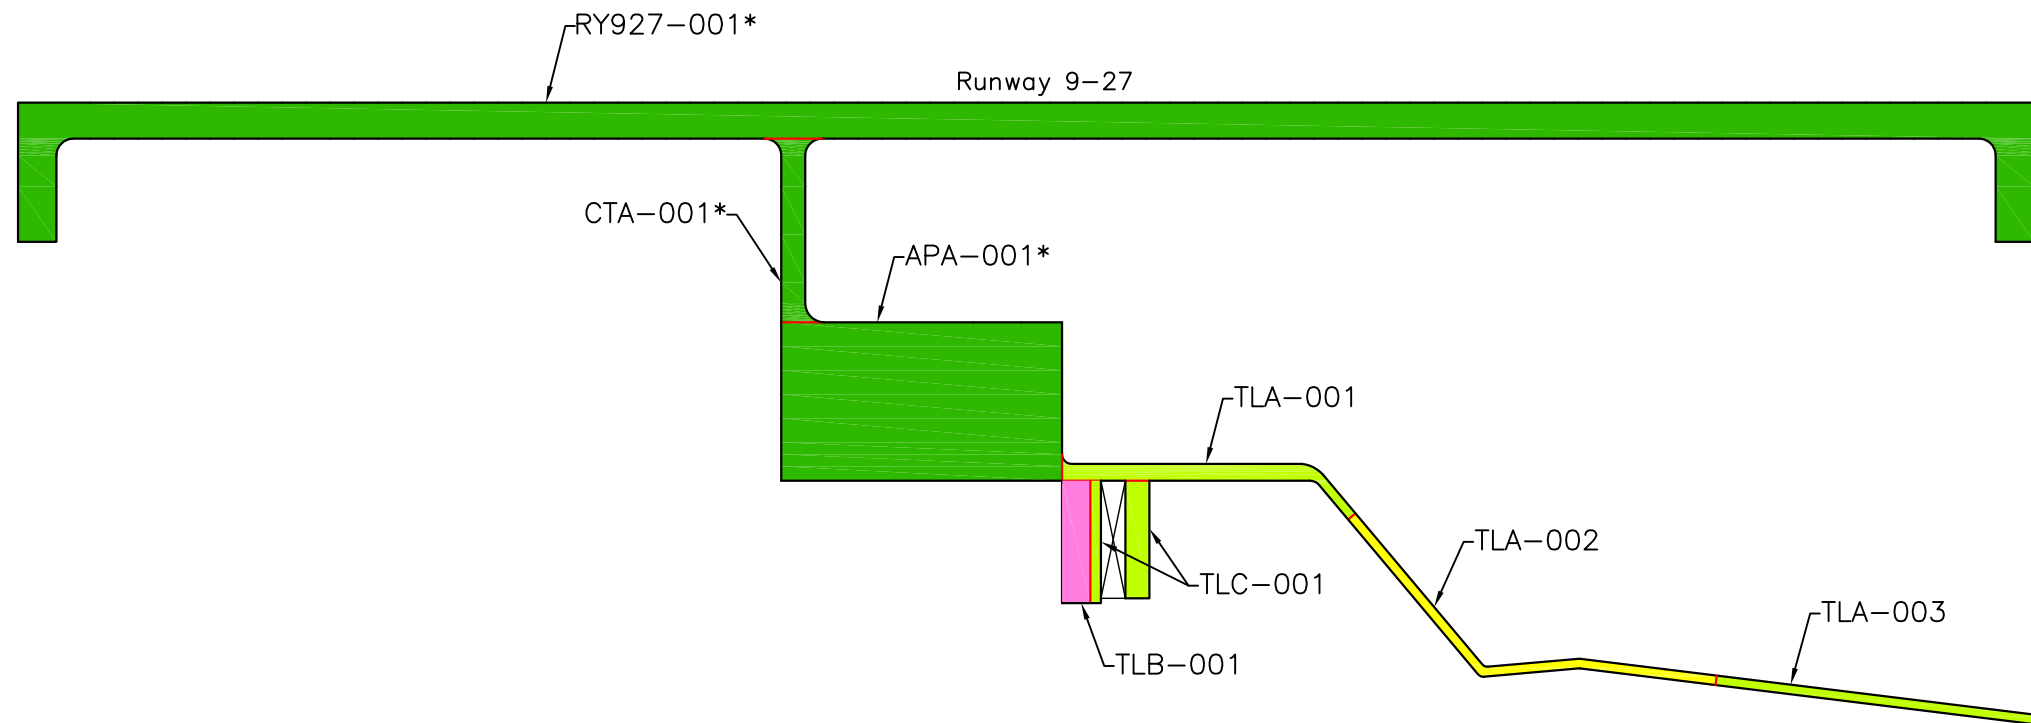
Figure 4. 2012 Pavement Condition Index Rating at Grand Marais-Cook County Airport (CKC).

Figures 5 and 6 present the overall PCI for CKC by area distribution and pavement use, respectively. Table 3 presents the PCI summary for each section at CKC, including the drop in PCI per year. Generally, pavement sections will deteriorate between 1 and 3 PCI points per year. Sections deteriorating at higher rates may need maintenance above the normal application rates and should be closely monitored in case major repairs become necessary.

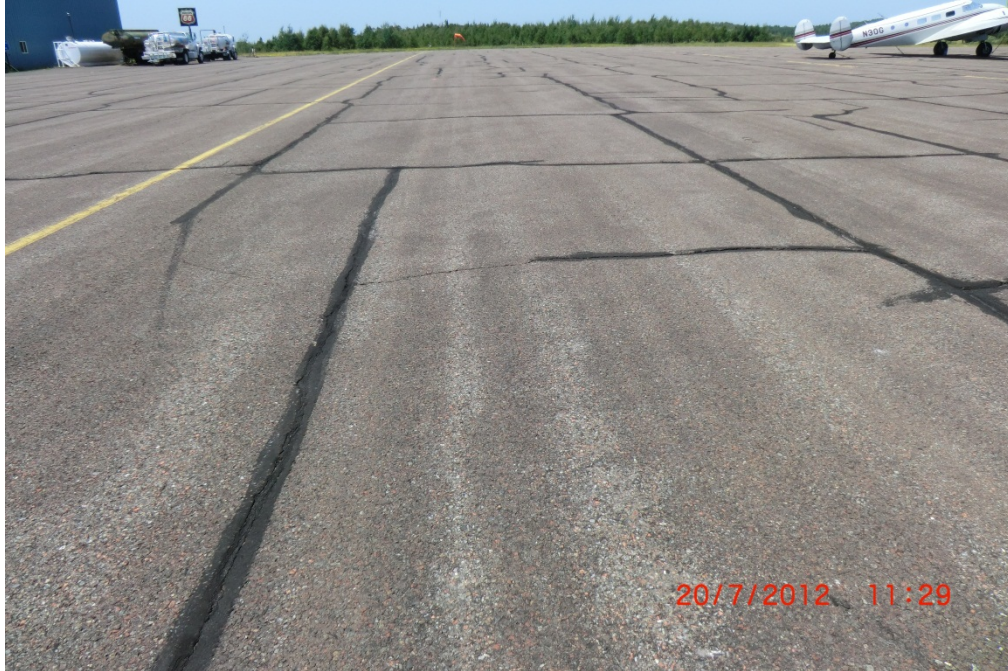
CKC APA 001 (prior to 2012 rehabilitation)

Section Comments: mill/replace 5" in Oct 2012 (PCI = 64)

48 LONGITUDINAL/TRANSVERSE CRACKING L 518.00 Ft Comments:
48 LONGITUDINAL/TRANSVERSE CRACKING M 220.00 Ft Comments:

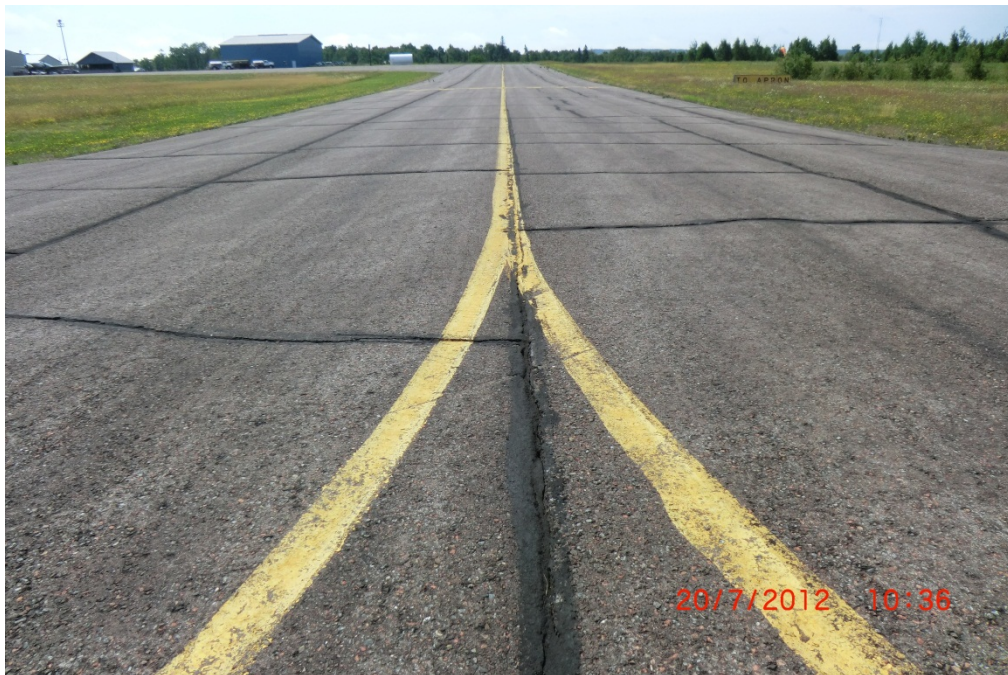
CKC CTA 001 (prior to 2012 rehabilitation)

Section Comments: mill/replace 5" in Oct 2012 (PCI = 55)

48 LONGITUDINAL/TRANSVERSE CRACKING L 330.00 Ft Comments:

48 LONGITUDINAL/TRANSVERSE CRACKING M 500.00 Ft Comments:

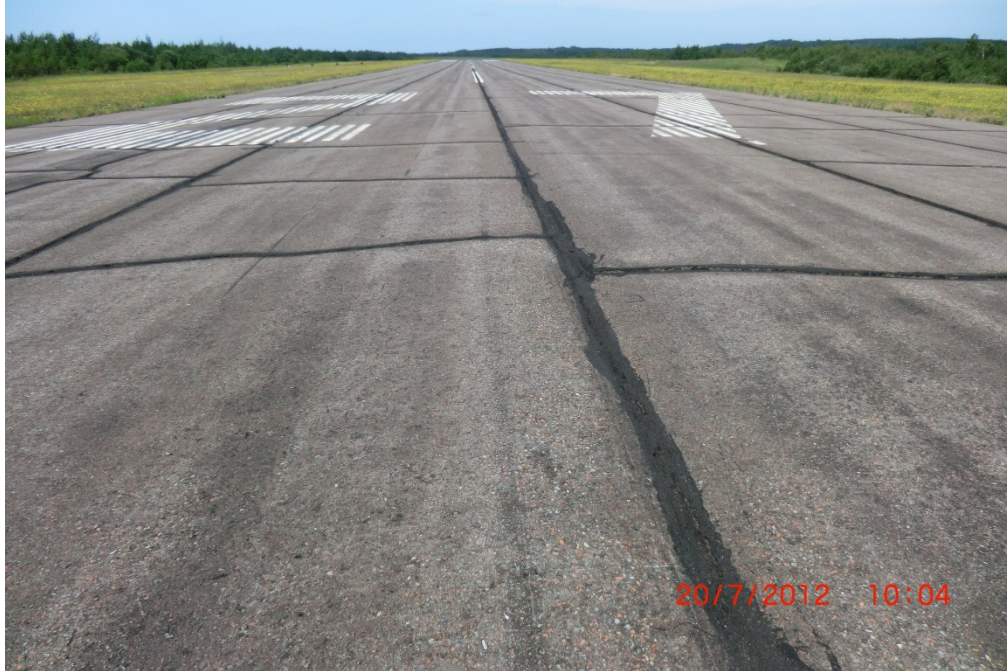
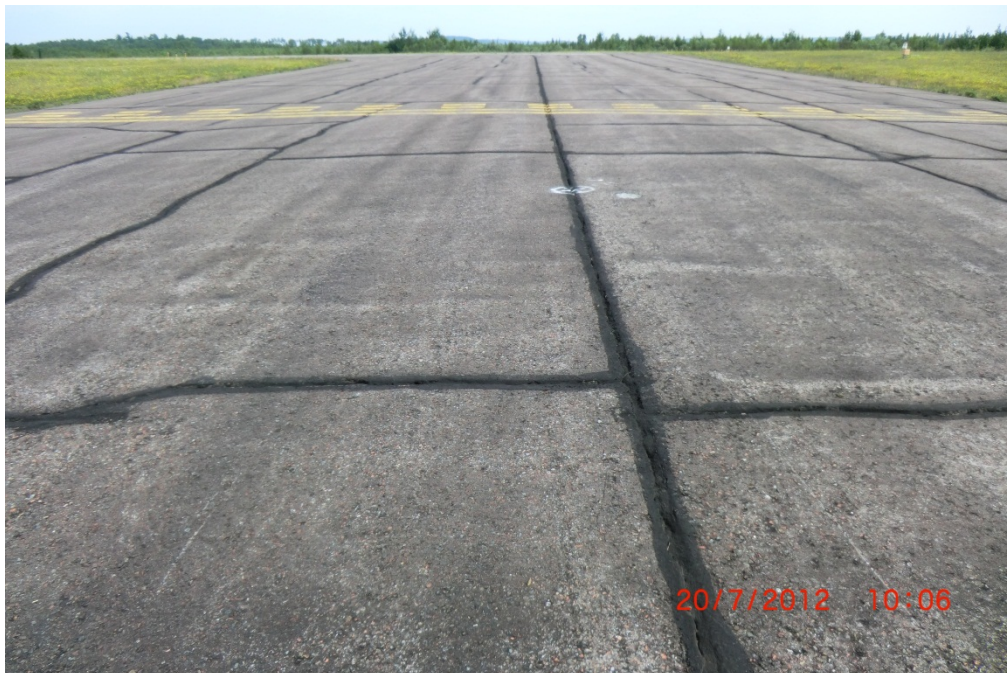
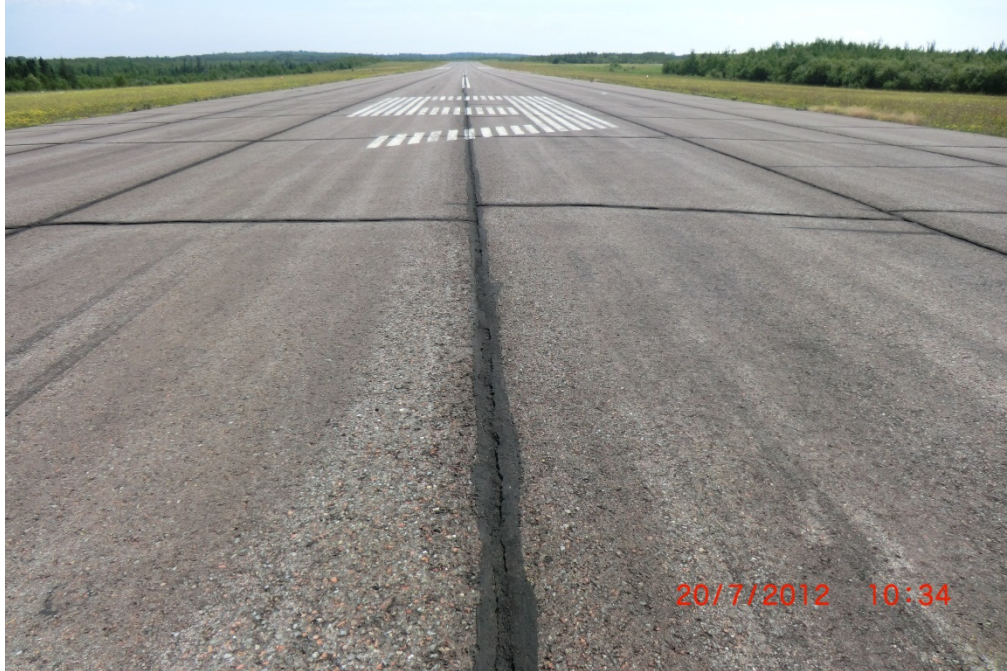
CKC RY927 001 (prior to 2012 rehabilitation)

Section Comments: mill/replace 5" in Oct 2012 (PCI = 49)

48 LONGITUDINAL/TRANSVERSE CRACKING L 24.00 Ft Comments:

48 LONGITUDINAL/TRANSVERSE CRACKING M 499.00 Ft Comments:

48 LONGITUDINAL/TRANSVERSE CRACKING H 26.00 Ft Comments:

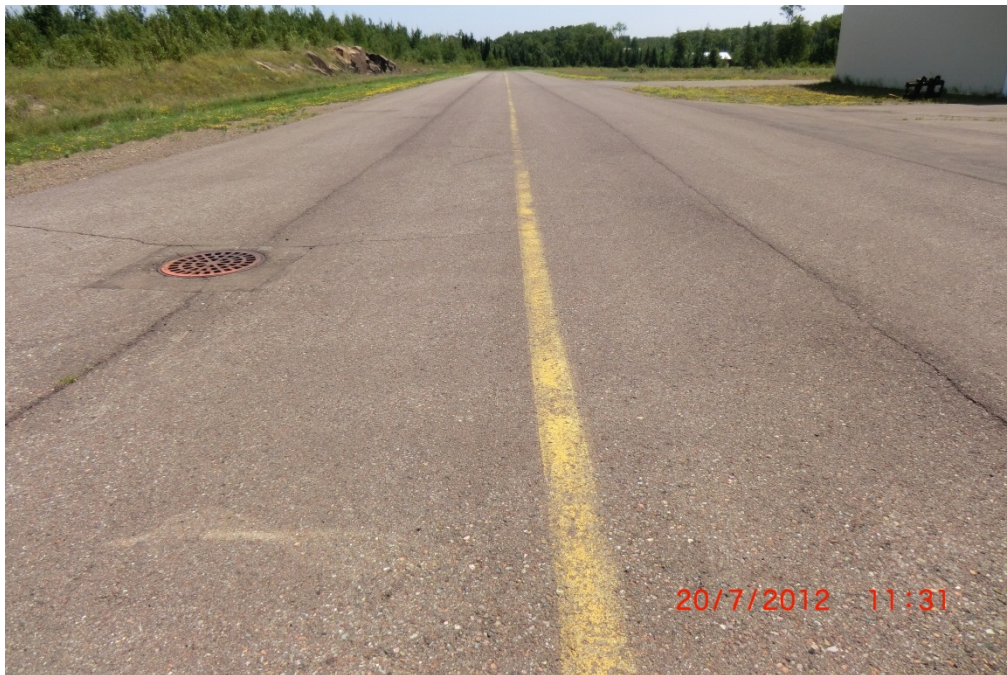
CKC TLA 001 (PCI = 73)

Conditions: PCI : 73

48 LONGITUDINAL/TRANSVERSE CRACKING L 209.00 Ft Comments:

48 LONGITUDINAL/TRANSVERSE CRACKING M 70.00 Ft Comments:

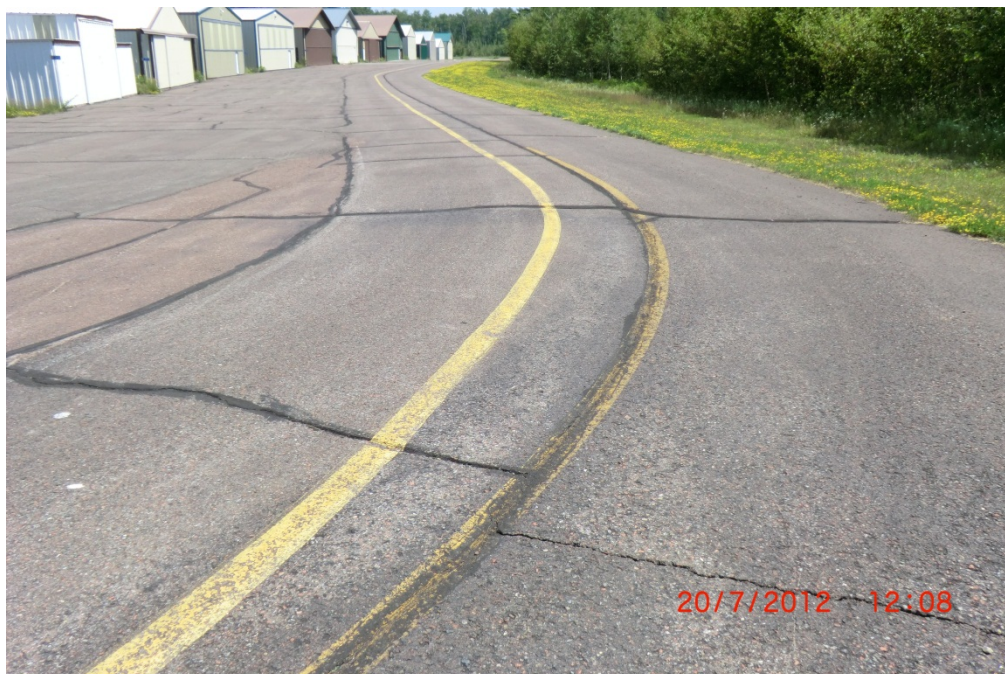
CKC TLA 002 (PCI = 66)

Conditions: PCI: 66

48	LONGITUDINAL/TRANSVERSE CRACKING	L	485.00 Ft	Comments:
48	LONGITUDINAL/TRANSVERSE CRACKING	M	57.00 Ft	Comments:
48	LONGITUDINAL/TRANSVERSE CRACKING	H	6.00 Ft	Comments:
57	WEATHERING	L	150.00 SqFt	Comments:

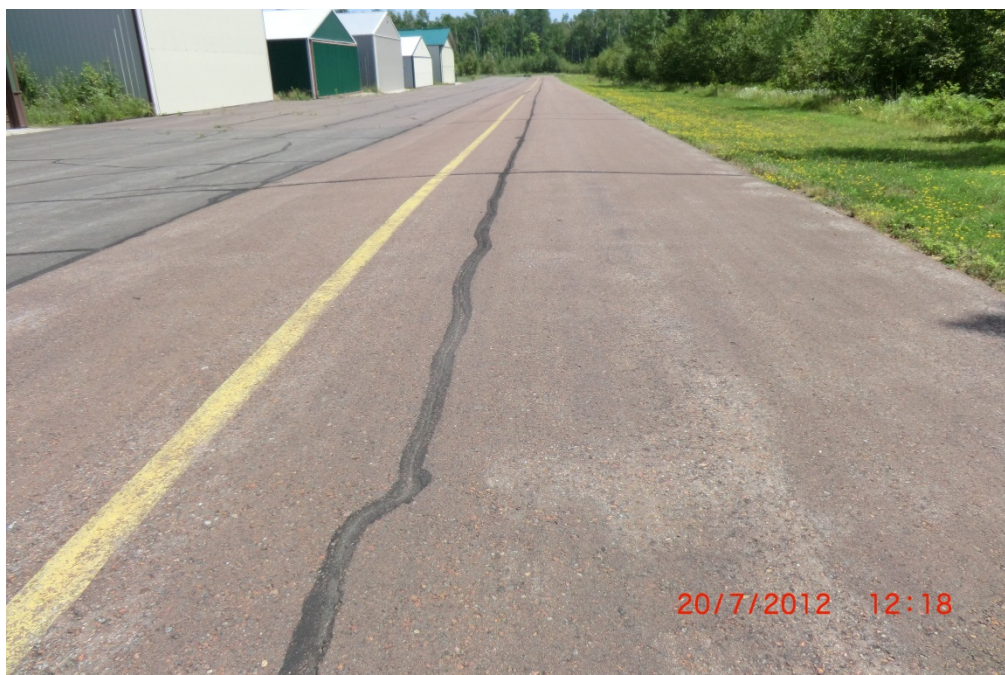
CKC TLA 003 (PCI = 79)

Conditions: PCI: 79

48 LONGITUDINAL/TRANSVERSE CRACKING L 326.00 Ft Comments:

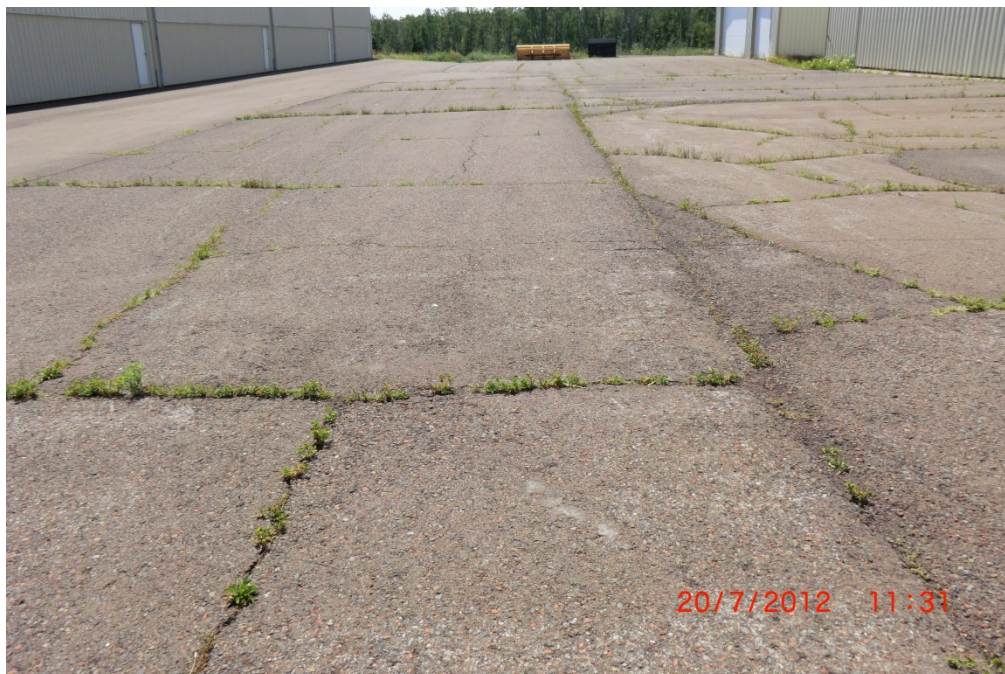
CKC TLB 001 (PCI = 47)

Conditions: PCI : 47

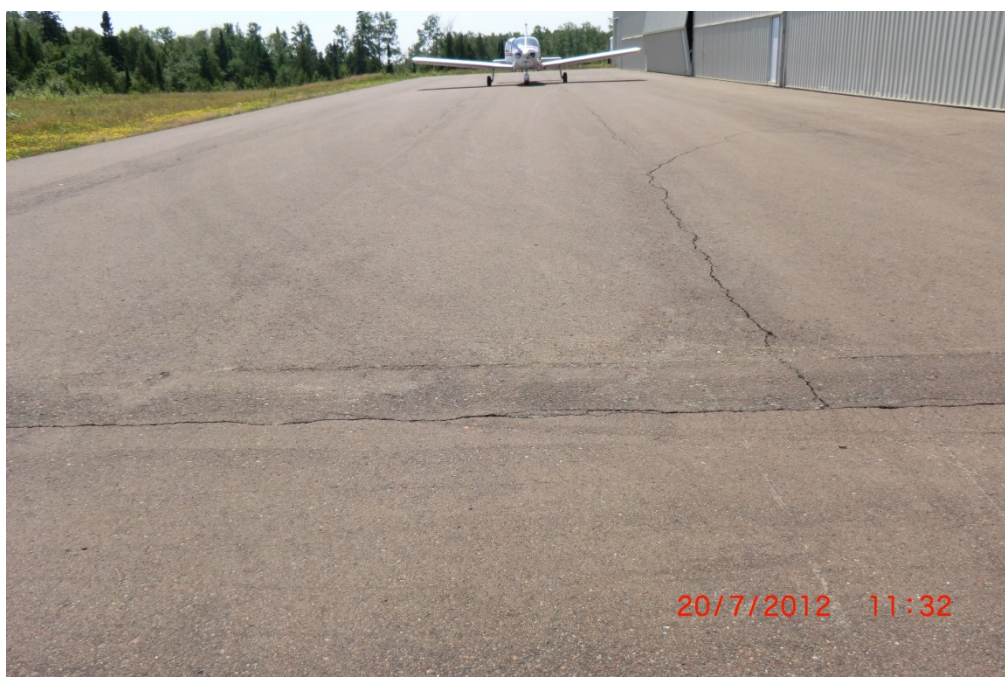
CKC TLC 001 (PCI = 80)

Conditions: PCI: 80

48 LONGITUDINAL/TRANSVERSE CRACKING L 227.00 Ft Comments:

48 LONGITUDINAL/TRANSVERSE CRACKING M 95.00 Ft Comments:
