# Minnesota Airport System Pavement Evaluation 2012 Update

Hector Municipal Airport (1D6)

Hector, Minnesota

January 2013

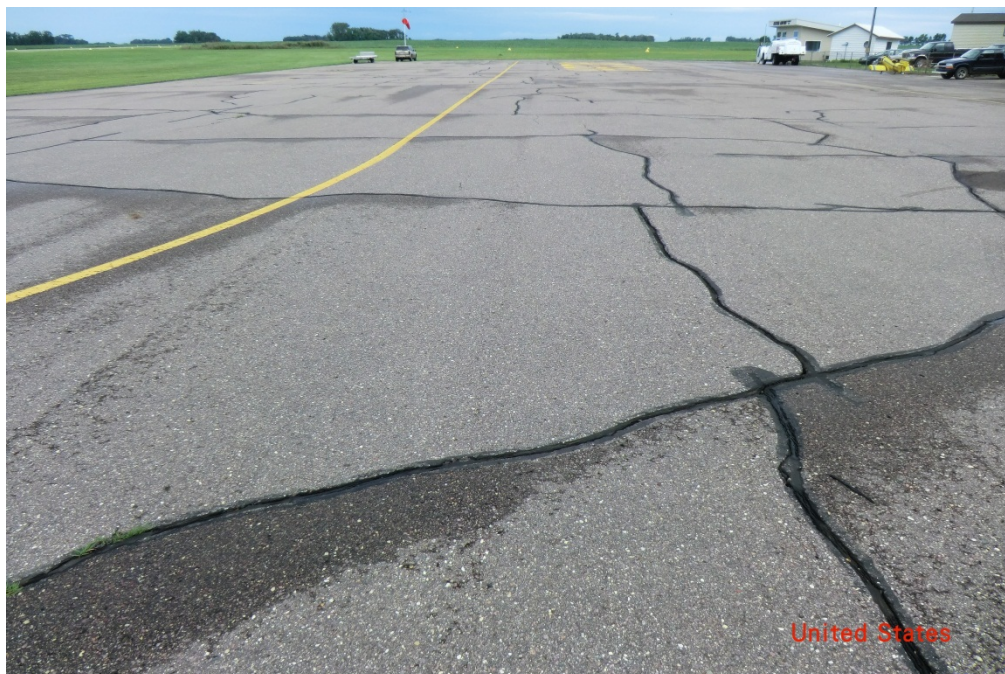
1D6 APA 001 (PCI = 67)

| Branch ID | Section ID | Surface type <sup>1</sup> | Section area (SF) | LCD <sup>2</sup> | 2009 PCI | 2012 PCI | Drop in PCI/Yr <sup>3</sup> | % Deduct due to | | Distress types |
|---|---|---|---|---|---|---|---|---|---|---|
| APA | 1 | AC | 39,600 | 1985 | 67 | 67 | 1.2 | 0 | 100 | Longitudinal & transverse (L&T) cracking, raveling |

48 LONGITUDINAL/TRANSVERSE CRACKING L 508.00 Ft Comments:  
48 LONGITUDINAL/TRANSVERSE CRACKING M 68.00 Ft Comments:  
52 RAVELING L 20.00 SqFt Comments:

48 LONGITUDINAL/TRANSVERSE CRACKING L 673.00 Ft Comments:  
48 LONGITUDINAL/TRANSVERSE CRACKING M 175.00 Ft Comments:  
52 RAVELING L 120.00 SqFt Comments:

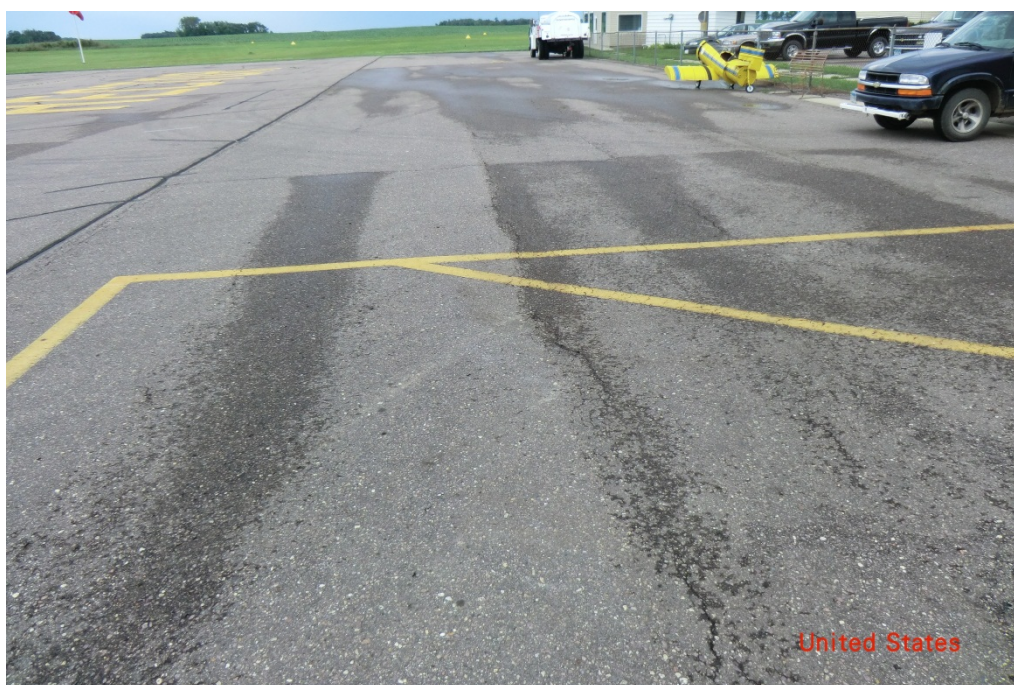
1D6 APA 002 (PCI = 77)

| Branch ID | Section ID | Surface type <sup>1</sup> | Section area (SF) | LCD <sup>2</sup> | 2009 PCI | 2012 PCI | Drop in PCI/Yr <sup>3</sup> | % Deduct due to | | Distress types |
|---|---|---|---|---|---|---|---|---|---|---|
| APA | 2 | AC | 12,400 | 1986 | 93 | 77 | 0.9 | 0 | 100 | L&T cracking |

48 LONGITUDINAL/TRANSVERSE CRACKING L 138.00 Ft Comments:  
48 LONGITUDINAL/TRANSVERSE CRACKING M 10.00 Ft Comments:  
48 LONGITUDINAL/TRANSVERSE CRACKING H 14.00 Ft Comments:

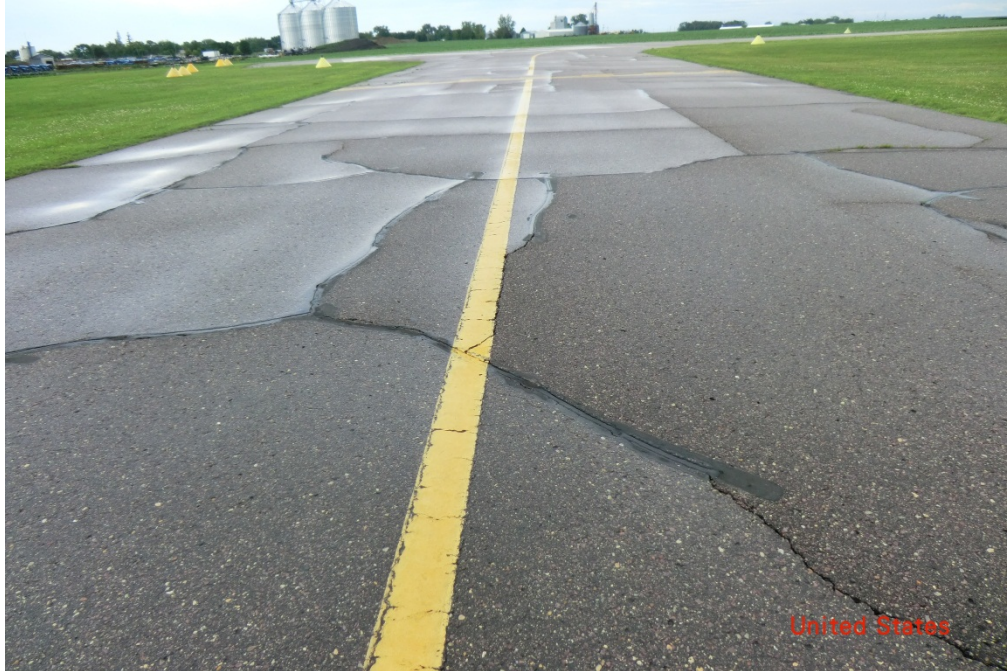
1D6 CTA 001 (PCI = 60)

| Branch ID | Section ID | Surface type <sup>1</sup> | Section area (SF) | LCD <sup>2</sup> | 2009 PCI | 2012 PCI | Drop in PCI/Yr <sup>3</sup> | % Deduct due to | | Distress types |
|---|---|---|---|---|---|---|---|---|---|---|
| CTA | 1 | AC | 6,900 | 1985 | 55 | 60 | 1.5 | 0 | 100 | L&T cracking, raveling |

48 LONGITUDINAL/TRANSVERSE CRACKING L 675.00 Ft Comments:

48 LONGITUDINAL/TRANSVERSE CRACKING M 126.00 Ft Comments:

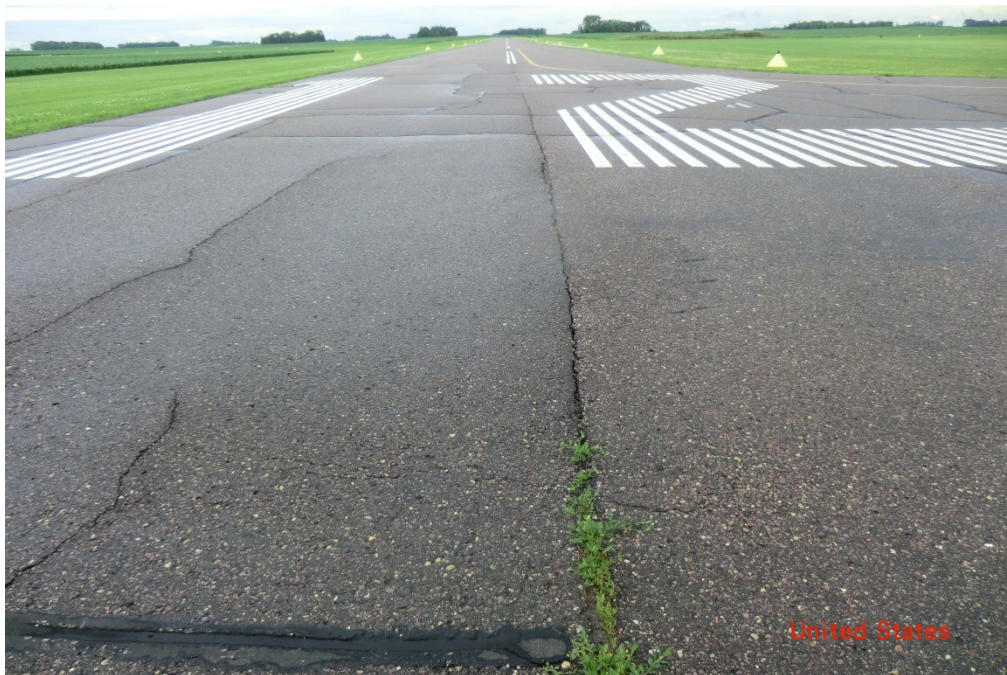
1D6 RY1230 001 (PCI = 60)

| Branch ID | Section ID | Surface type <sup>1</sup> | Section area (SF) | LCD <sup>2</sup> | 2009 PCI | 2012 PCI | Drop in PCI/Yr <sup>3</sup> | % Deduct due to | | Distress types |
|---|---|---|---|---|---|---|---|---|---|---|
| RY1230 | 1 | AC | 147,800 | 1985 | 68 | 60 | 1.5 | 29 | 71 | Alligator cracking, L&T cracking, raveling, rutting |

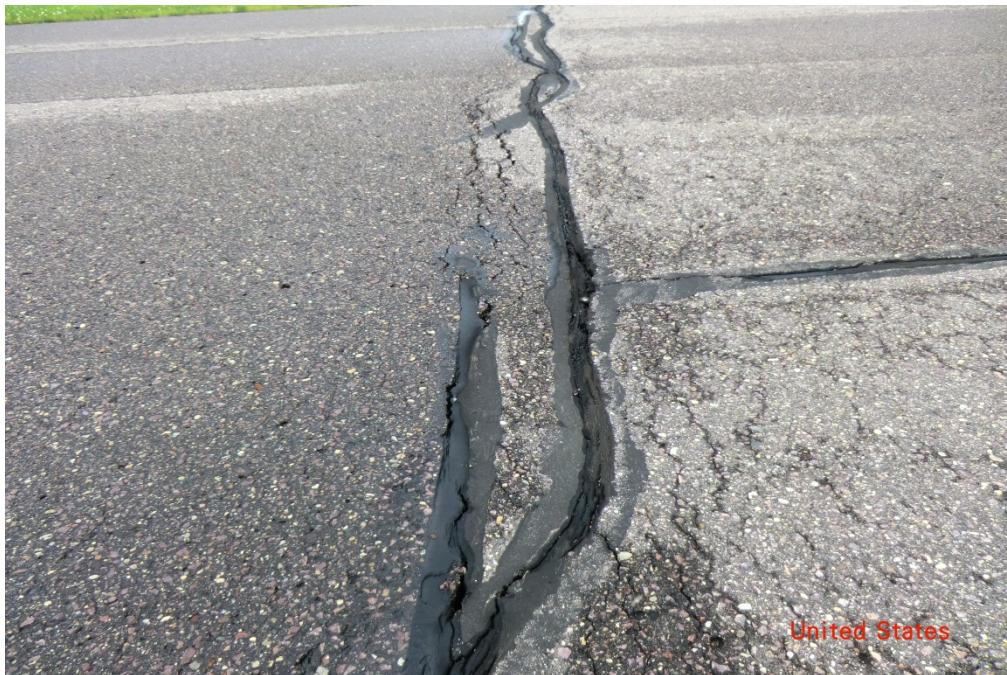
1D6 RY1230 001 Alligator Cracking (PCI = 60)

48 LONGITUDINAL/TRANSVERSE CRACKING L 657.00 Ft Comments:  
48 LONGITUDINAL/TRANSVERSE CRACKING M 103.00 Ft Comments:  
48 LONGITUDINAL/TRANSVERSE CRACKING H 15.00 Ft Comments:  
41 ALLIGATOR CRACKING L 8.00 SqFt Comments:  
53 RUTTING L 250.00 SqFt Comments:

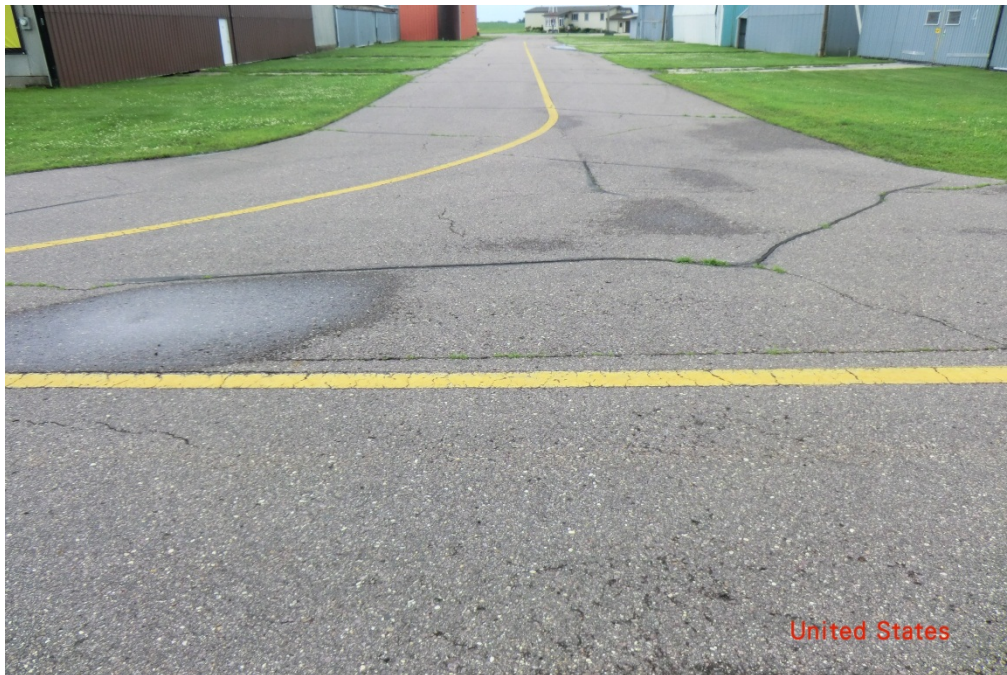
1D6 TLA 001 (PCI = 57)

| Branch ID | Section ID | Surface type <sup>1</sup> | Section area (SF) | LCD <sup>2</sup> | 2009 PCI | 2012 PCI | Drop in PCI/Yr <sup>3</sup> | % Deduct due to | | Distress types |
|---|---|---|---|---|---|---|---|---|---|---|
| TLA | 1 | AC | 20,875 | 1985 | 64 | 57 | 1.6 | 37 | 63 | Alligator cracking, L&T cracking, raveling |

| 48 LONGITUDINAL/TRANSVERSE CRACKING | H | 2.00 Ft | Comments: |
| 48 LONGITUDINAL/TRANSVERSE CRACKING | L | 606.00 Ft | Comments: |
| 48 LONGITUDINAL/TRANSVERSE CRACKING | M | 24.00 Ft | Comments: |
| 41 ALLIGATOR CRACKING | L | 85.00 SqFt | Comments: |

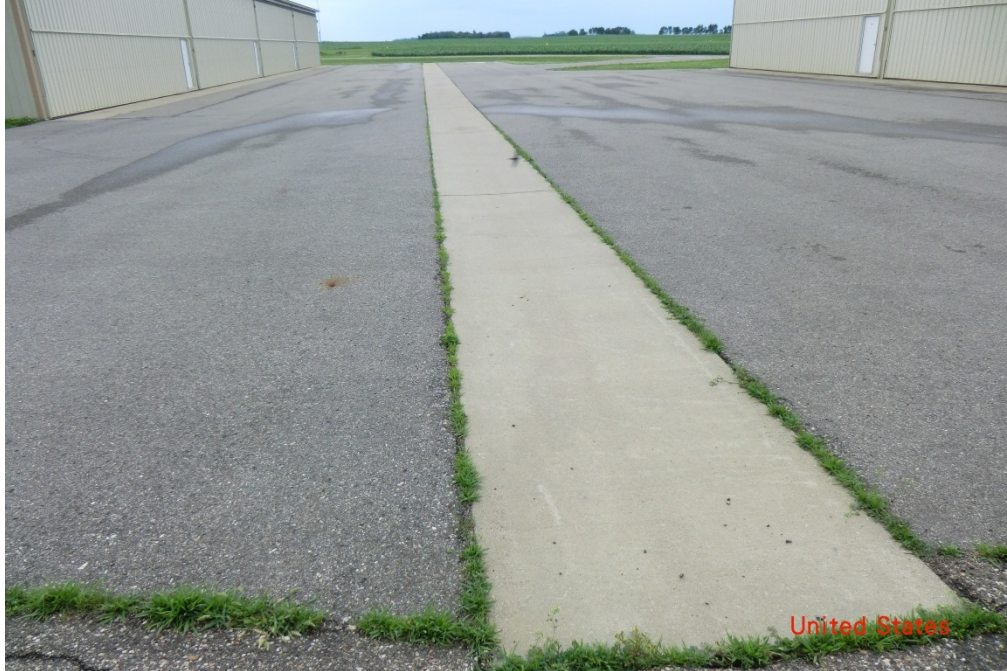
1D6 TLA 002 (PCI = 86)

| Branch ID | Section ID | Surface type <sup>1</sup> | Section area (SF) | LCD <sup>2</sup> | 2009 PCI | 2012 PCI | Drop in PCI/Yr <sup>3</sup> | % Deduct due to | | Distress types |
|---|---|---|---|---|---|---|---|---|---|---|
| TLA | 2 | AC | 14,738 | 2005 | 96 | 86 | 2.0 | 0 | 100 | L&T cracking |

48 LONGITUDINAL/TRANSVERSE CRACKING L 69.00 Ft Comments:

48 LONGITUDINAL/TRANSVERSE CRACKING M 25.00 Ft Comments:
