Minnesota Airport System Pavement Evaluation 2012 Update

McGregor-Isedor Iverson Airport (HZX)

Final Report

Mn/DOT Airport Pavement Management System 2012

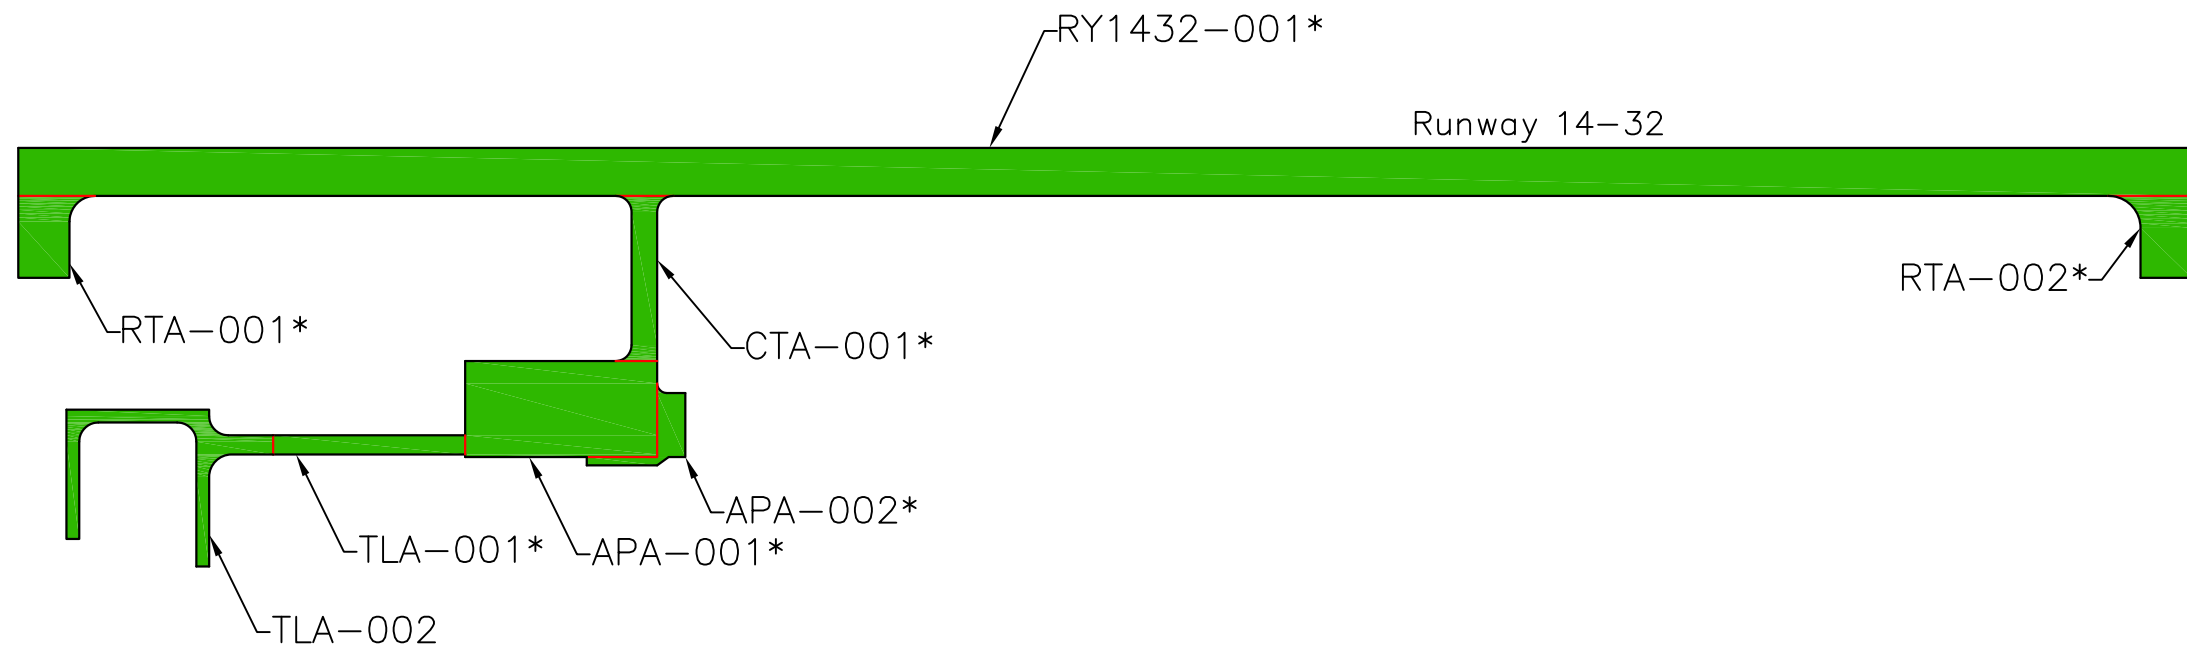
Figure 4. 2012 Pavement Condition Index Rating at McGregor-Isedor Iverson Airport (HZX).

* These sections were either under construction at the time of the inspection or were scheduled for rehabilitation during the 2012 construction season. The condition and layout for these sections assumes the successful completion of this construction project.

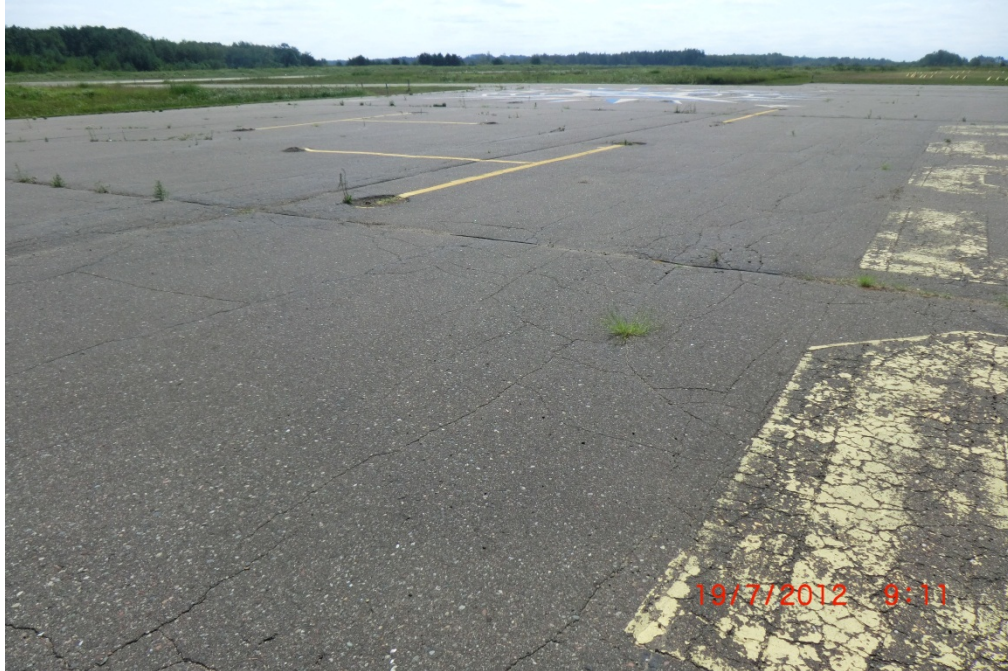
HZX APA 001 (prior to rehabilitation)

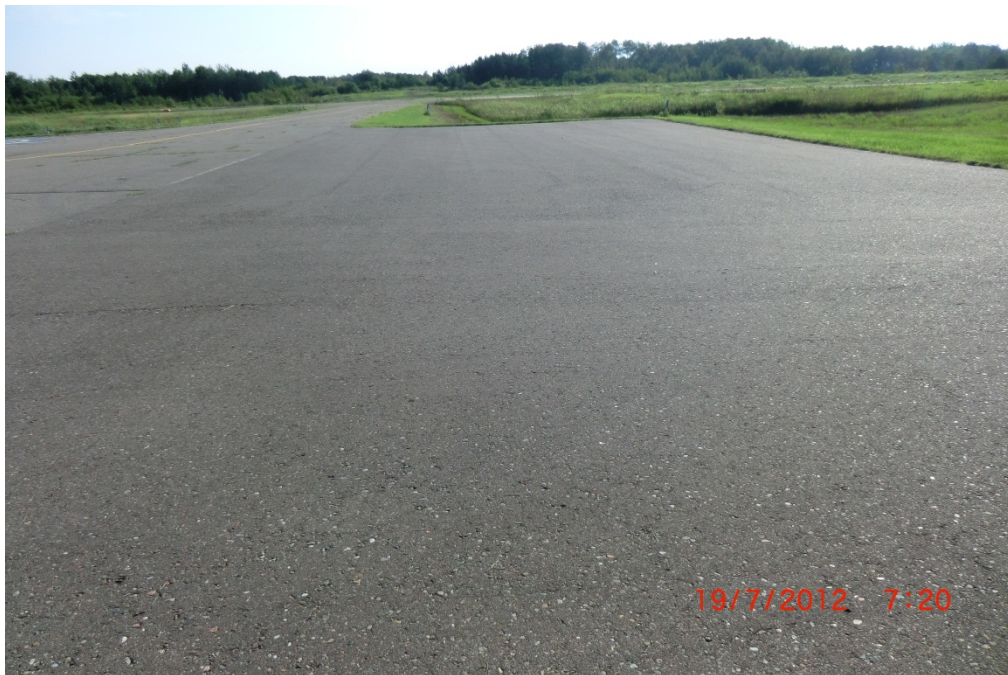
HZX APA 002 (prior to rehabilitation)

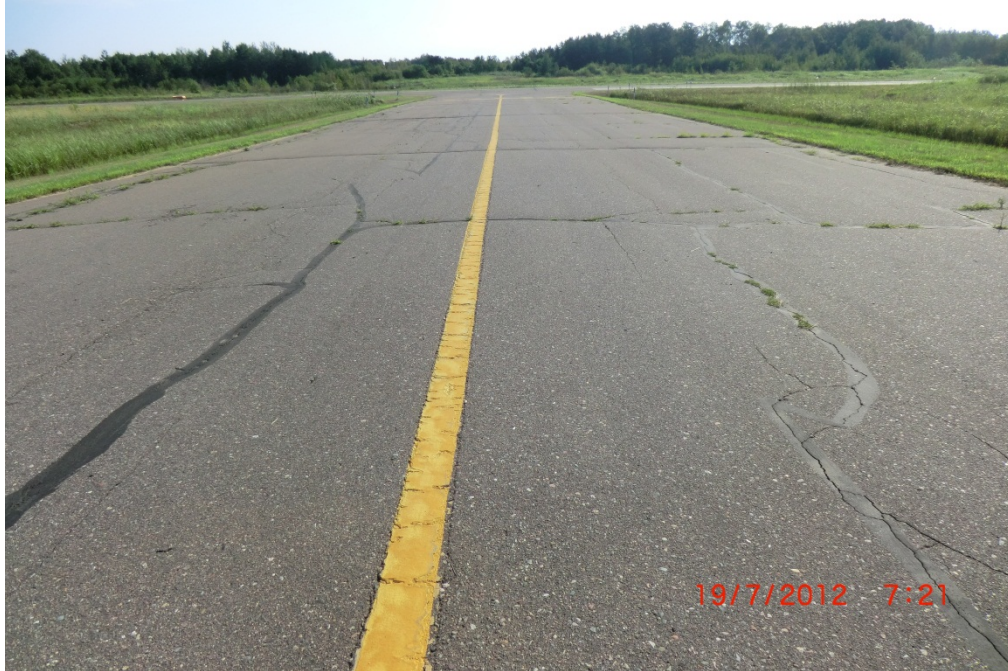
HZX CTA 001 (prior to rehabilitation)

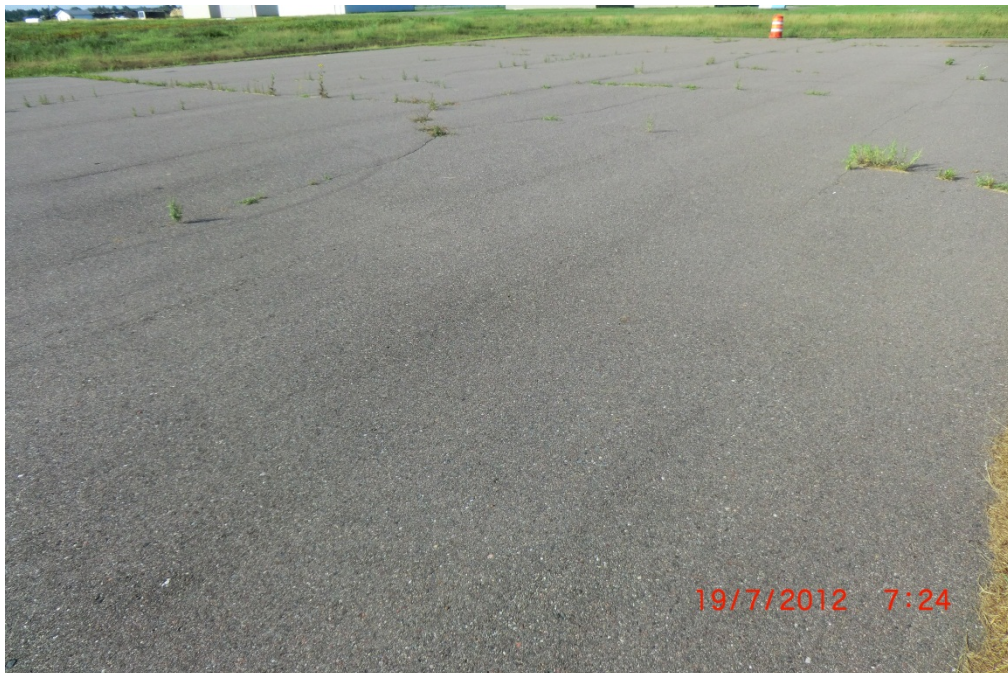
HZX RTA 001 (prior to rehabilitation)

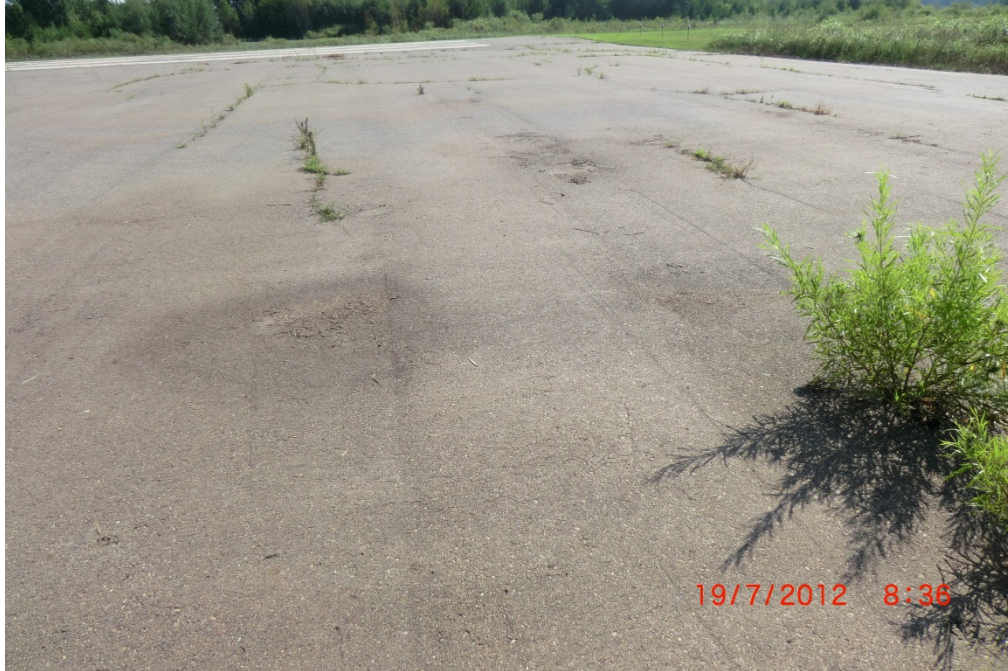
HZX RTA 002 (prior to rehabilitation)

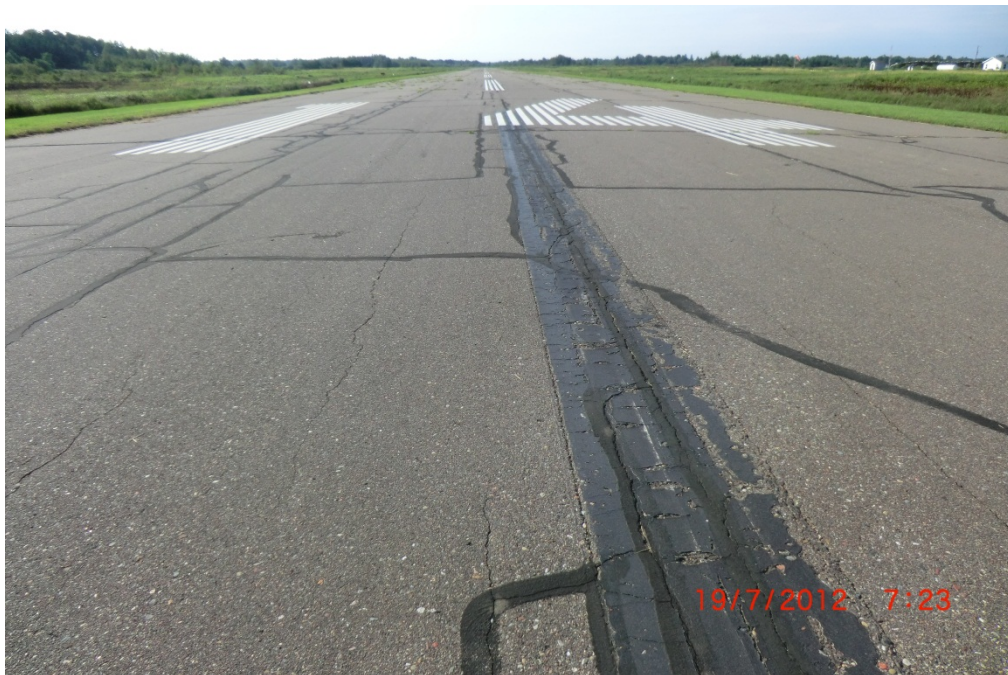
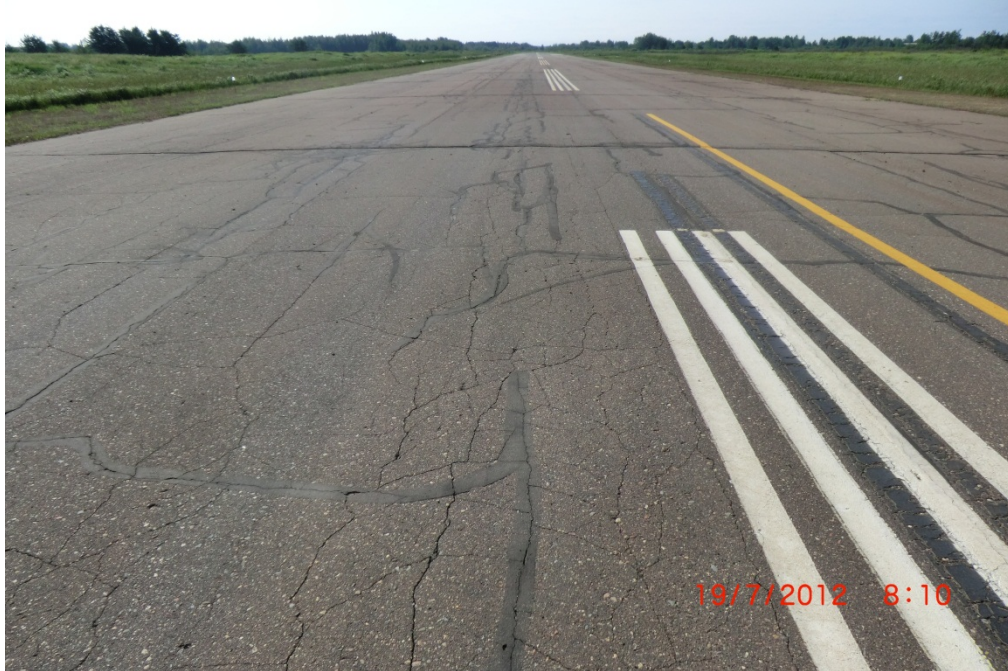
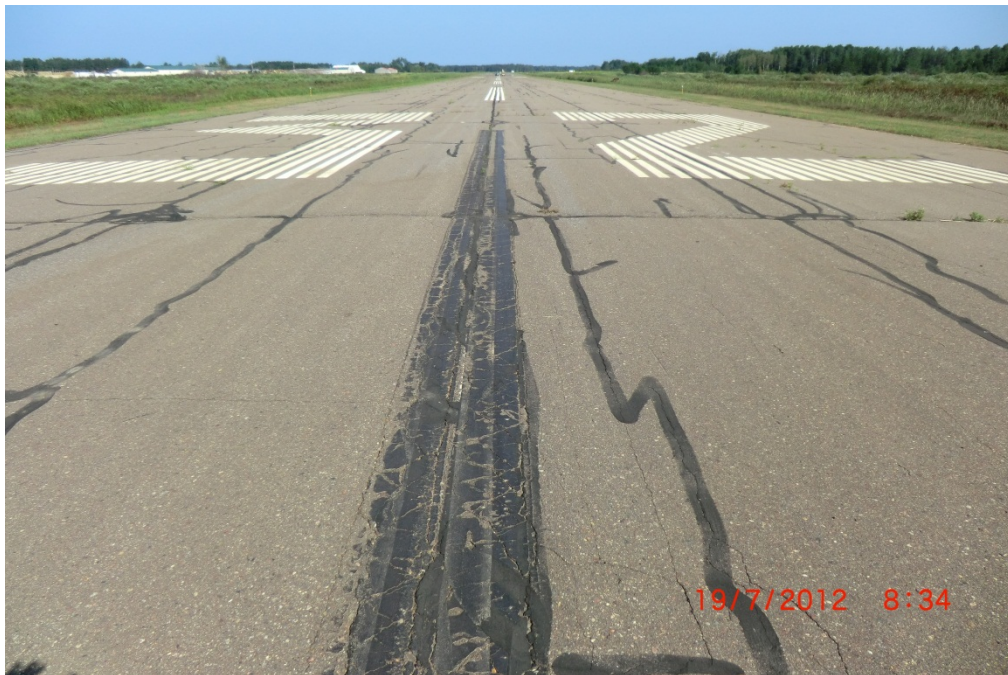
HZX RY1432 001 (prior to rehabilitation)

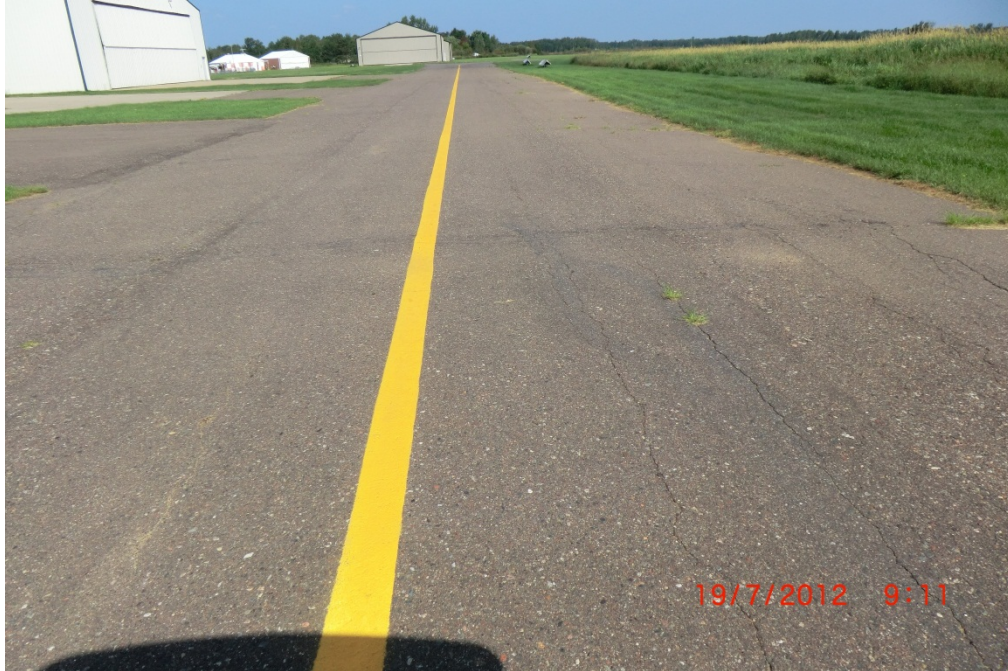
HZX TLA 001 (prior to rehabilitation)

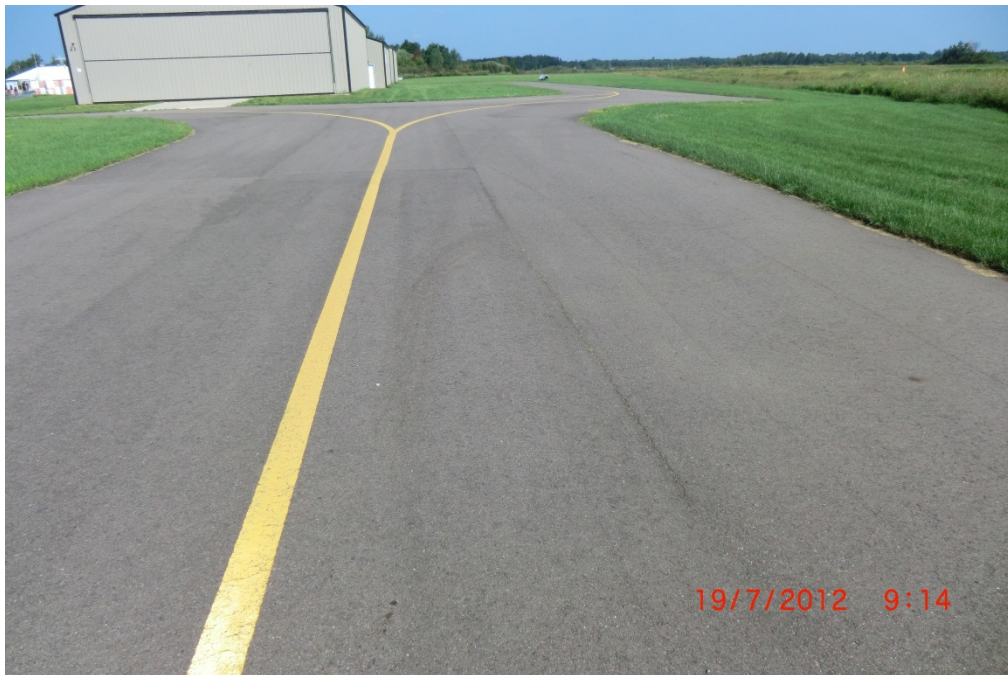
HZX TLA 002 (PCI = 97)
