# Minnesota Airport System Pavement Evaluation 2012 Update

Montevideo Airport (MVE)

January 2013

*Final Report*

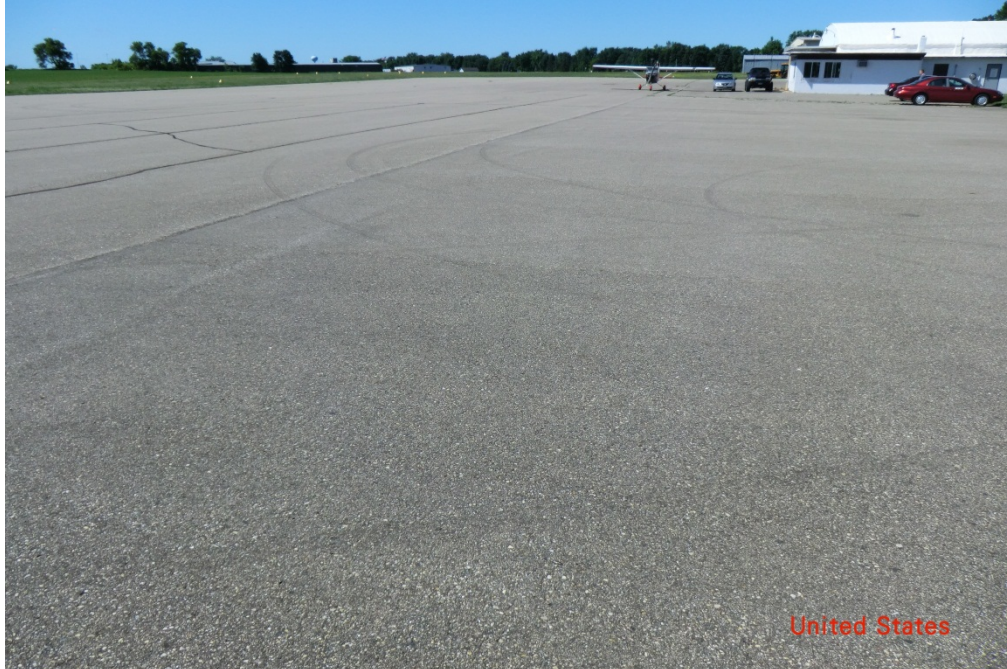
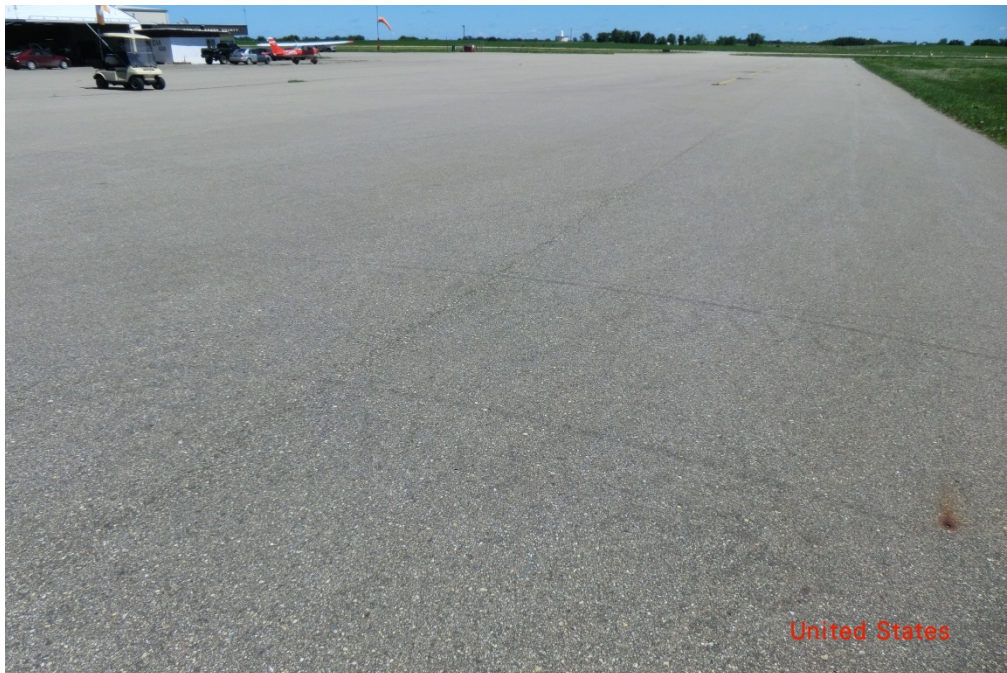
MVE APA 001 (PCI = 89)

| Branch ID | Section ID | Surface type <sup>1</sup> | Section area (SF) | LCD <sup>2</sup> | 2009 PCI | 2012 PCI | Drop in PCI/Yr <sup>3</sup> | % Deduct due to | | Distress types |
|---|---|---|---|---|---|---|---|---|---|---|
| APA | 1 | AAC | 113,000 | 2005 | 92 | 89 | 1.6 | 0 | 100 | Longitudinal & transverse (L&T) cracking |

Sample Number: 102 Type: R Area: 5,000.00SqFt PCI = 95  
Sample Comments:  
48 LONGITUDINAL/TRANSVERSE CRACKING L 60.00 Ft Comments:

Sample Number: 203 Type: R Area: 5,000.00SqFt PCI = 85  
Sample Comments:  
48 LONGITUDINAL/TRANSVERSE CRACKING L 70.00 Ft Comments:  
48 LONGITUDINAL/TRANSVERSE CRACKING M 38.00 Ft Comments:

Sample Number: 304 Type: R Area: 5,000.00SqFt PCI = 82  
Sample Comments:  
48 LONGITUDINAL/TRANSVERSE CRACKING L 207.00 Ft Comments:  
48 LONGITUDINAL/TRANSVERSE CRACKING M 15.00 Ft Comments:

Sample Number: 601 Type: R Area: 5,000.00SqFt PCI = 94  
Sample Comments:  
48 LONGITUDINAL/TRANSVERSE CRACKING L 71.00 Ft Comments:

Section Comments: maint. R&E (crack seal)

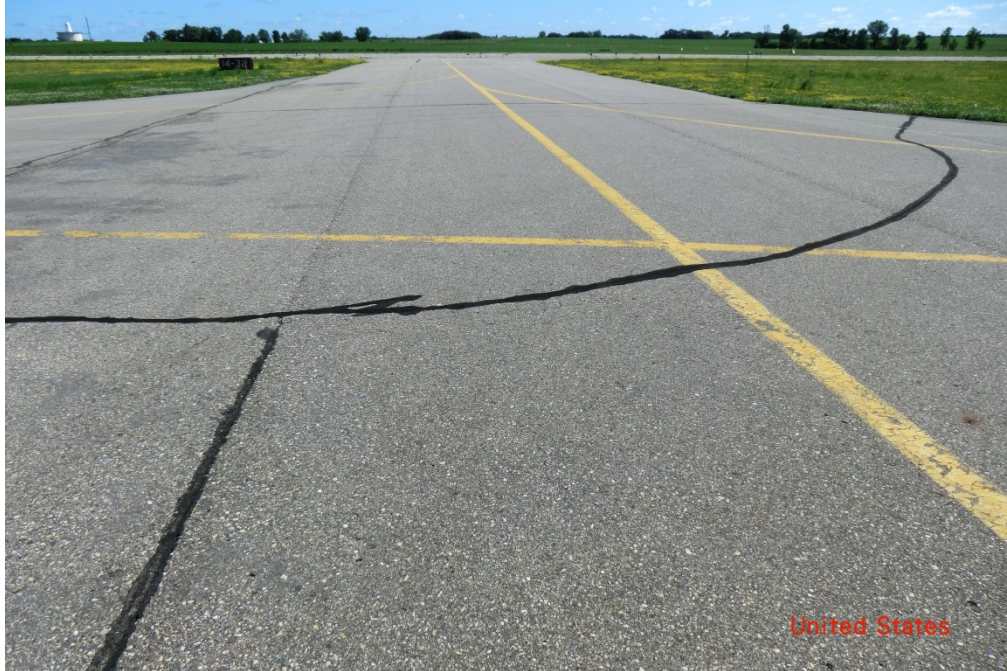
MVE CTA 001 (PCI = 80)

| Branch ID | Section ID | Surface type <sup>1</sup> | Section area (SF) | LCD <sup>2</sup> | 2009 PCI | 2012 PCI | Drop in PCI/Yr <sup>3</sup> | % Deduct due to | | Distress types |
|---|---|---|---|---|---|---|---|---|---|---|
| CTA | 1 | AAC | 11,200 | 2005 | 95 | 80 | 2.9 | 0 | 100 | L&T cracking |

48 LONGITUDINAL/TRANSVERSE CRACKING L 87.00 Ft Comments:

48 LONGITUDINAL/TRANSVERSE CRACKING M 7.00 Ft Comments:

Section Comments: maint. R&E (crack seal)

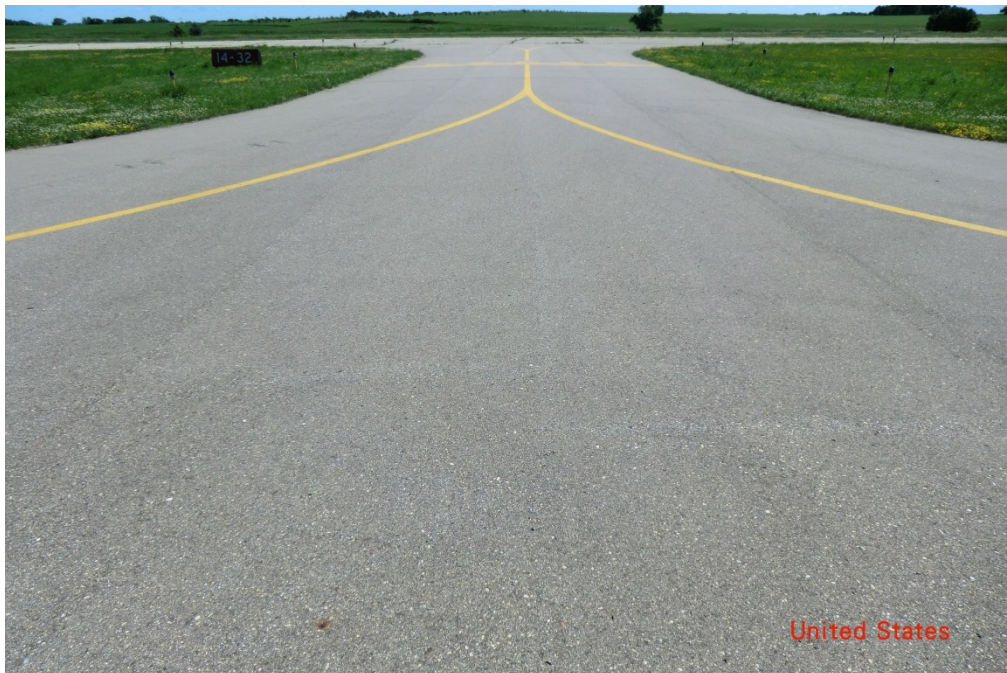
MVE CTB 001 (PCI = 96)

| Branch ID | Section ID | Surface type <sup>1</sup> | Section area (SF) | LCD <sup>2</sup> | 2009 PCI | 2012 PCI | Drop in PCI/Yr <sup>3</sup> | % Deduct due to | | Distress types |
|---|---|---|---|---|---|---|---|---|---|---|
| CTB | 1 | AC | 8,175 | 2008 | 100 | 96 | 1.0 | 0 | 100 | Joint seal damage, corner spalling |

48 LONGITUDINAL/TRANSVERSE CRACKING L 14.00 Ft Comments:

Section Comments: maint. R&E (crack seal)

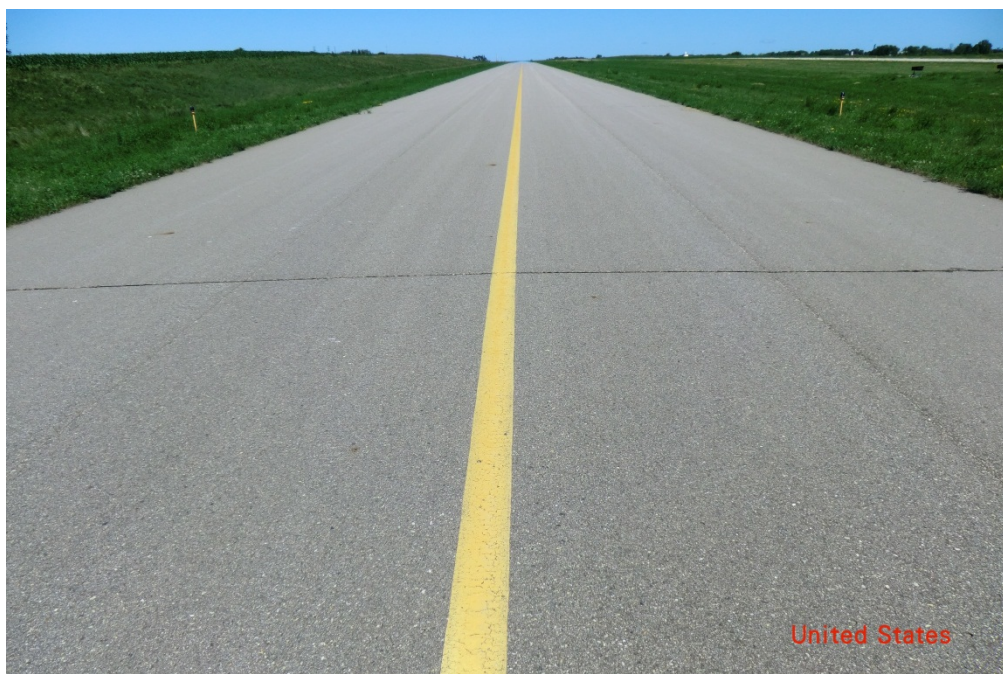
MVE PTA 001 (PCI = 99)

| Branch ID | Section ID | Surface type <sup>1</sup> | Section area (SF) | LCD <sup>2</sup> | 2009 PCI | 2012 PCI | Drop in PCI/Yr <sup>3</sup> | % Deduct due to | | Distress types |
|---|---|---|---|---|---|---|---|---|---|---|
| PTA | 1 | AC | 112,000 | 2008 | 100 | 99 | 0.3 | 0 | 100 | Alligator cracking, L&T cracking |

48 LONGITUDINAL/TRANSVERSE CRACKING L 29.00 Ft Comments:

Section Comments: maint. R&E (crack seal)

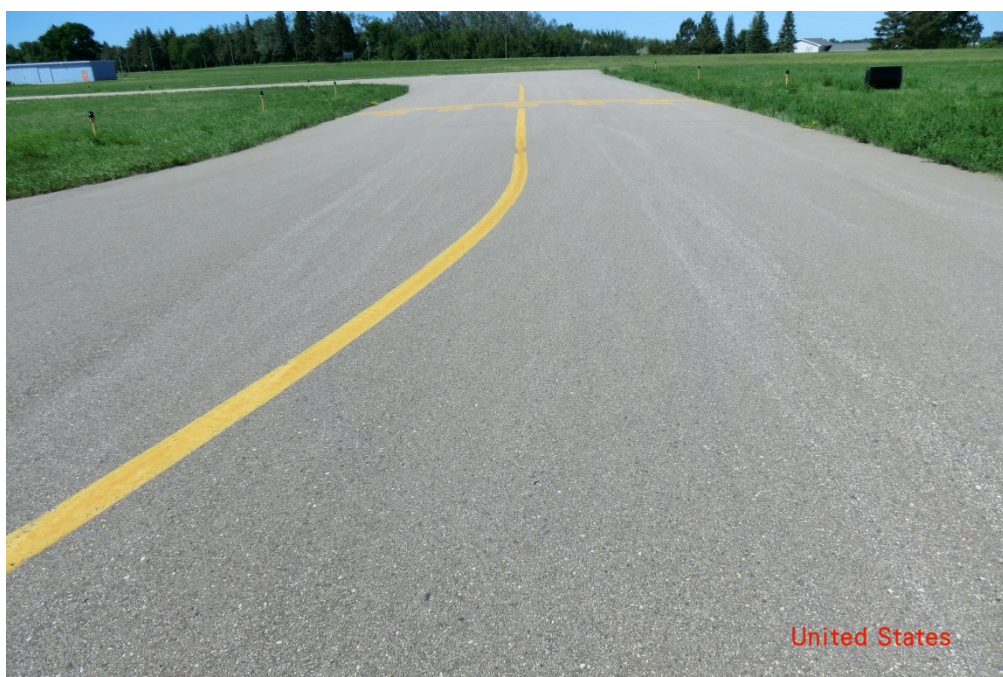
MVE PTA 002 (PCI = 100)

| Branch ID | Section ID | Surface type <sup>1</sup> | Section area (SF) | LCD <sup>2</sup> | 2009 PCI | 2012 PCI | Drop in PCI/Yr <sup>3</sup> | % Deduct due to | | Distress types |
|---|---|---|---|---|---|---|---|---|---|---|
| PTA | 2 | AC | 36,750 | 2008 | 100 | 100 | 0.0 | 0 | 0 | L&T cracking |

Section Comments: maint. R&E (crack seal)

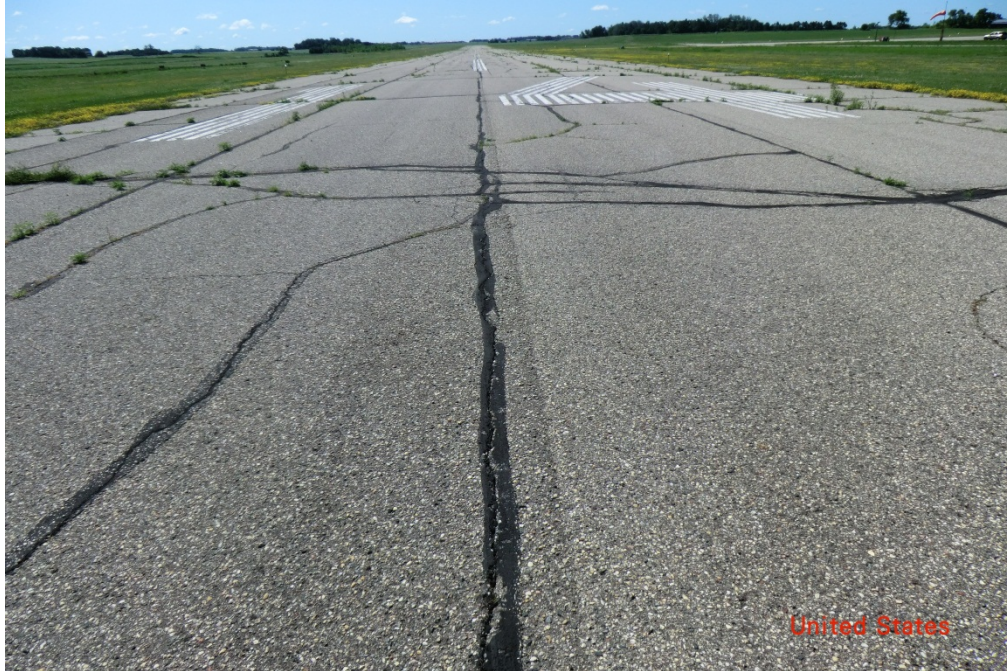
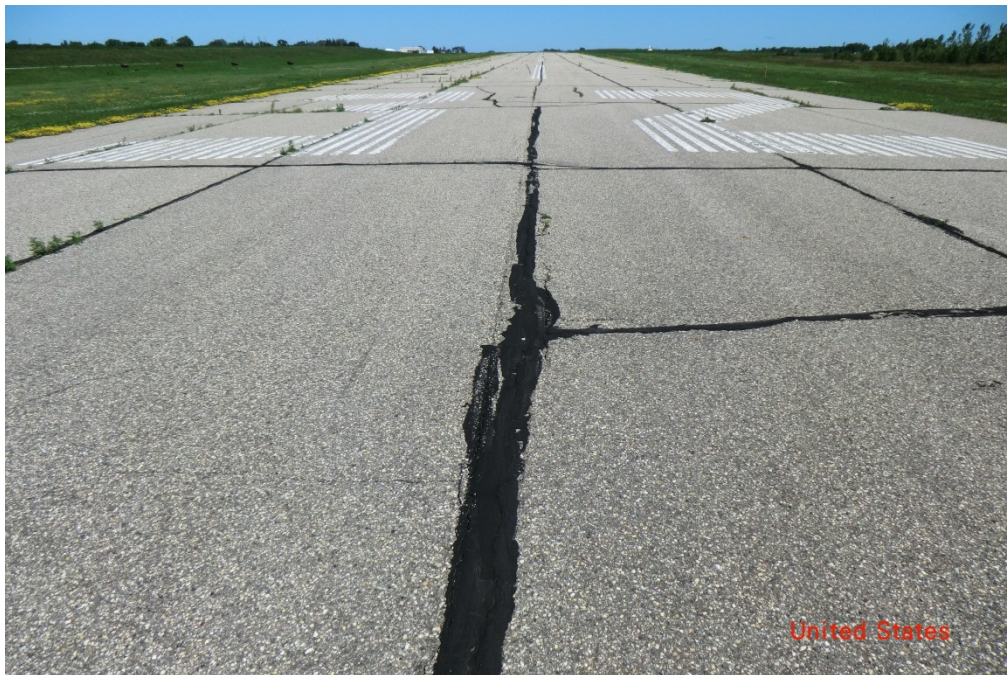
MVE RY1432 001 (prior to rehabilitation)

MVE RY1432 002 (prior to rehabilitation)

| 48 LONGITUDINAL/TRANSVERSE CRACKING | L | 300.00 Ft | Comments: |
| 48 LONGITUDINAL/TRANSVERSE CRACKING | M | 235.00 Ft | Comments: |
| 41 ALLIGATOR CRACKING | M | 24.00 SqFt | Comments: |

| 48 LONGITUDINAL/TRANSVERSE CRACKING | M | 380.00 Ft | Comments: |
| 41 ALLIGATOR CRACKING | M | 54.00 SqFt | Comments: |

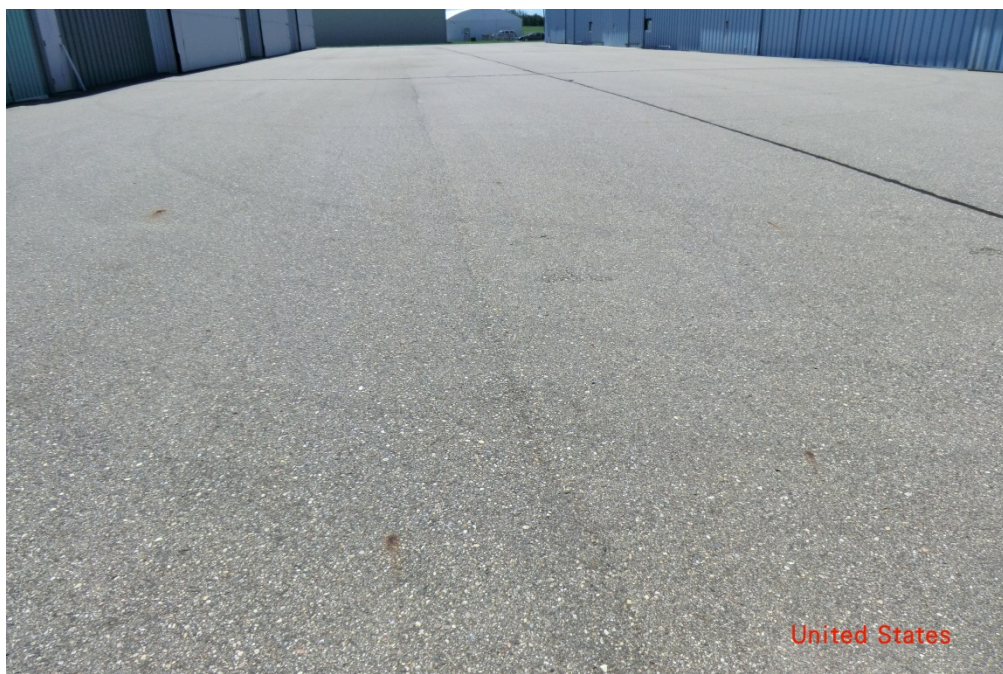
MVE TLA 001 (PCI = 93)

| Branch ID | Section ID | Surface type <sup>1</sup> | Section area (SF) | LCD <sup>2</sup> | 2009 PCI | 2012 PCI | Drop in PCI/Yr <sup>3</sup> | % Deduct due to | | Distress types |
|---|---|---|---|---|---|---|---|---|---|---|
| TLA | 1 | AAC | 57,700 | 2005 | 93 | 93 | 1.0 | 0 | 100 | L&T cracking |

48 LONGITUDINAL/TRANSVERSE CRACKING L 50.00 Ft Comments:  
57 WEATHERING L 300.00 SqFt Comments:

48 LONGITUDINAL/TRANSVERSE CRACKING L 100.00 Ft Comments:  
57 WEATHERING L 500.00 SqFt Comments:

48 LONGITUDINAL/TRANSVERSE CRACKING L 240.00 Ft Comments:  
57 WEATHERING L 400.00 SqFt Comments:

Section Comments: maint. R&E (crack seal)
