Minnesota Airport System Pavement Evaluation 2012 Update

Moorhead Municipal Airport (JKJ)

January 2013

Final Report

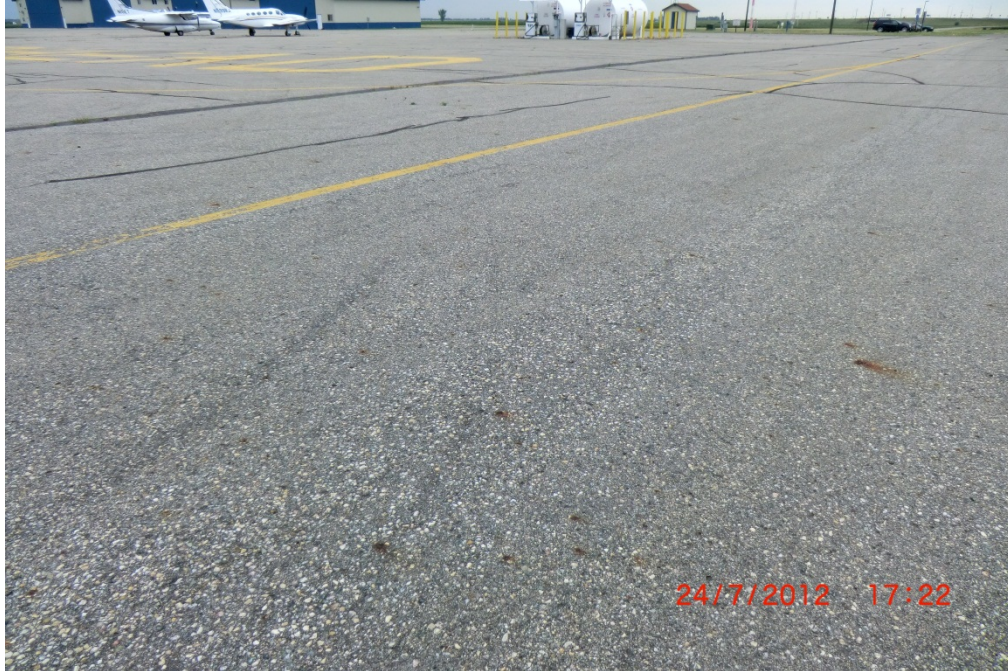
JKJ APA 001 (PCI = 56)

48 LONGITUDINAL/TRANSVERSE CRACKING	L	750.00 Ft	Comments:
48 LONGITUDINAL/TRANSVERSE CRACKING	M	3.00 Ft	Comments:
41 ALLIGATOR CRACKING	L	10.00 SqFt	Comments:
52 RAVELING	L	5,000.00 SqFt	Comments:

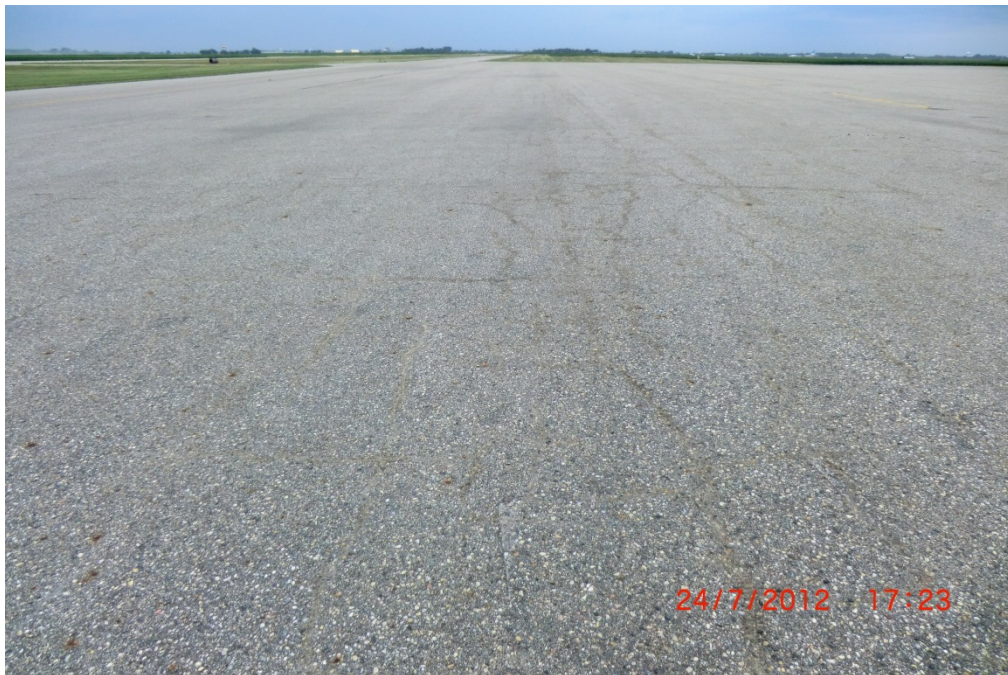
JKJ APA 002 (PCI = 76)

Sample Number: 106 Type: R Area: 5,000.00SqFt PCI = 77
Sample Comments:
48 LONGITUDINAL/TRANSVERSE CRACKING L 315.00 Ft Comments:
52 RAVELING L 1,750.00 SqFt Comments:

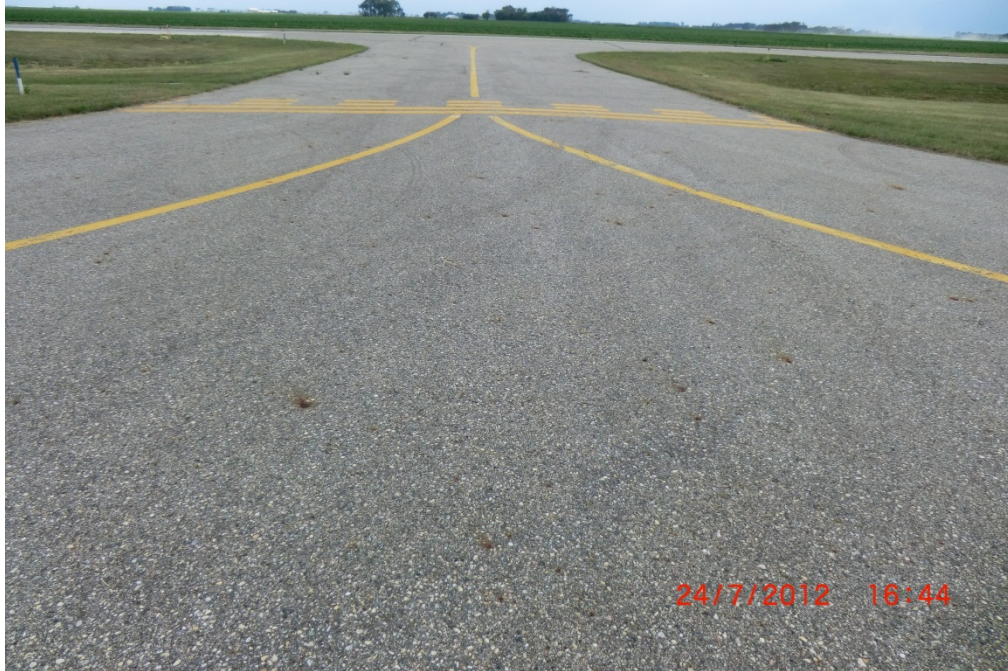
JKJ CTA2 001 (PCI = 84)

48 LONGITUDINAL/TRANSVERSE CRACKING L 104.00 Ft Comments:

48 LONGITUDINAL/TRANSVERSE CRACKING M 34.00 Ft Comments:

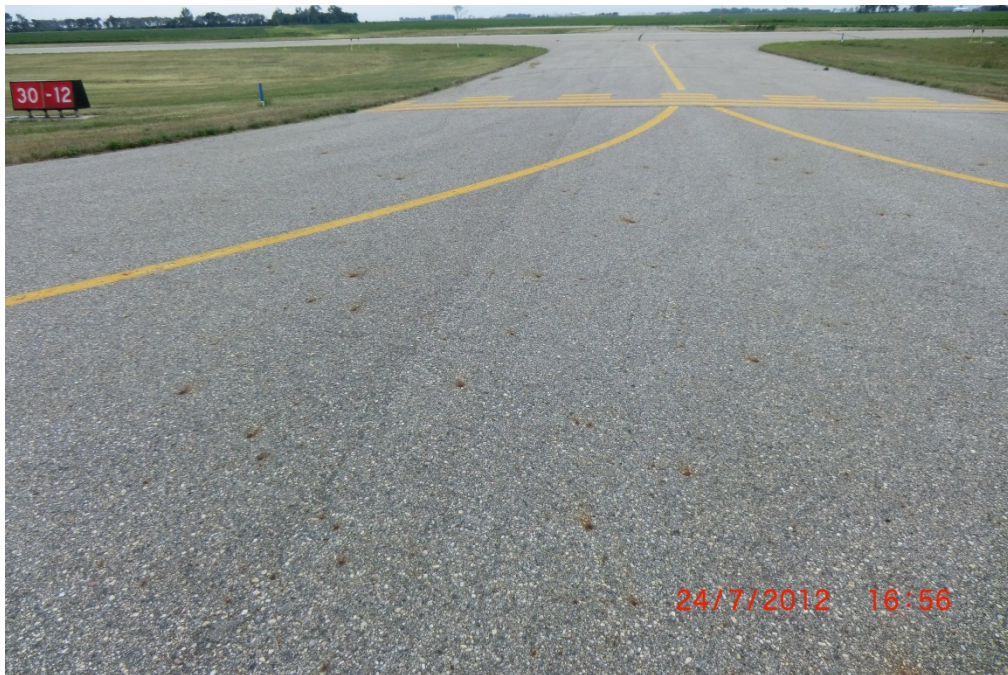
JKJ CTA3 001 (PCI = 92)

48 LONGITUDINAL/TRANSVERSE CRACKING L 90.00 Ft Comments:

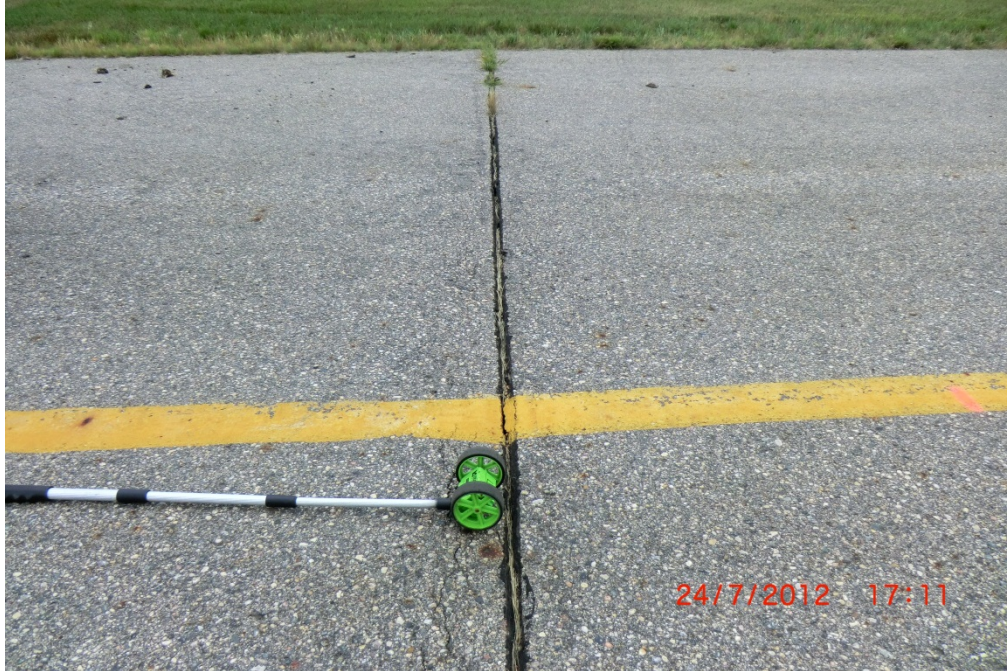
JKJ CTA4 001 L & T Cracking, (PCI = 84)

48 LONGITUDINAL/TRANSVERSE CRACKING L 66.00 Ft Comments:
57 WEATHERING L 38.00 SqFt Comments:

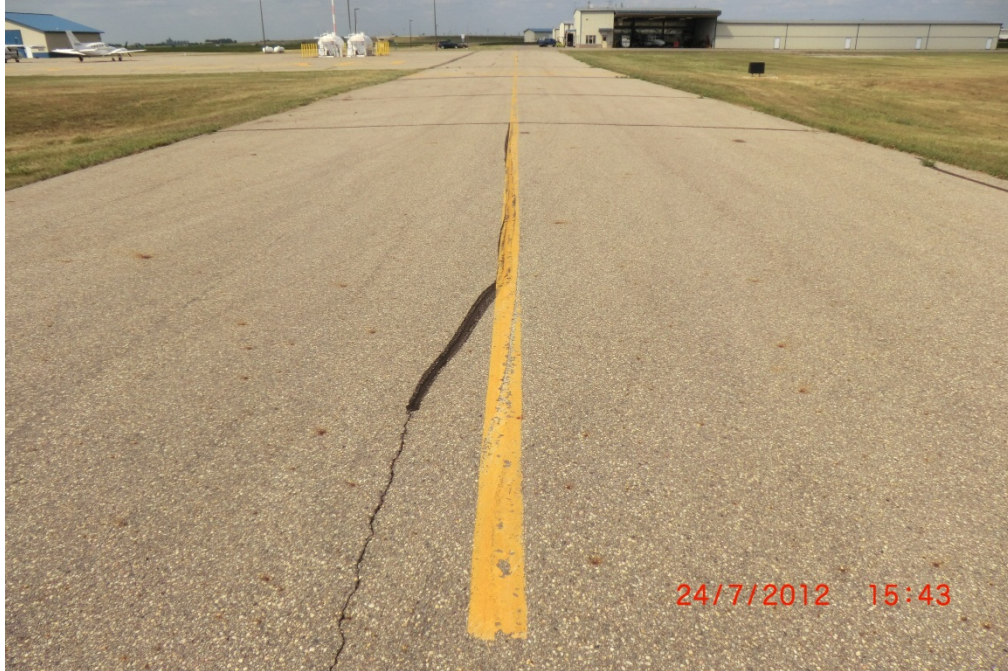
JKJ CTA5 001 (PCI = 77)

48 LONGITUDINAL/TRANSVERSE CRACKING L 201.00 Ft Comments:

48 LONGITUDINAL/TRANSVERSE CRACKING M 3.00 Ft Comments:

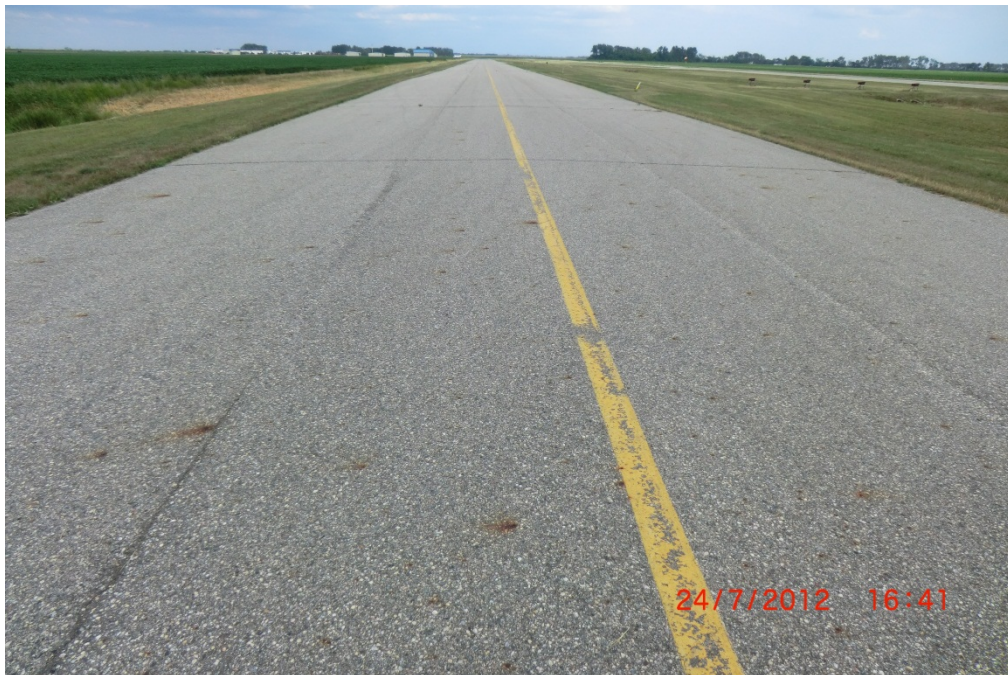
JKJ PTA 001 (PCI = 86)

48 LONGITUDINAL/TRANSVERSE CRACKING	L	72.00 Ft	Comments:
57 WEATHERING	L	25.00 SqFt	Comments:

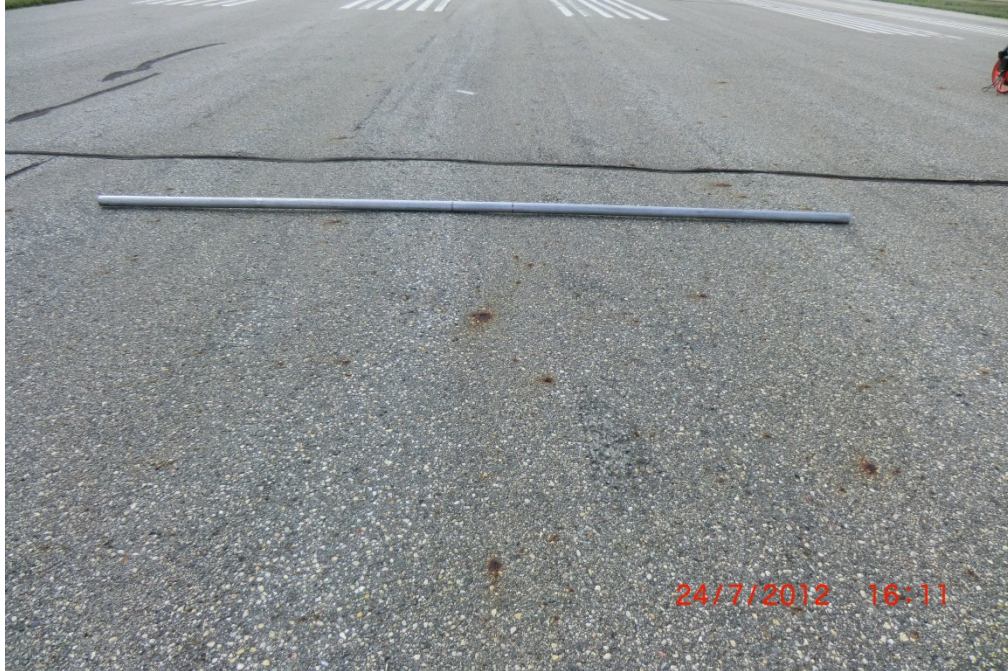
JKJ RY1230 002 Swell, (PCI = 83)

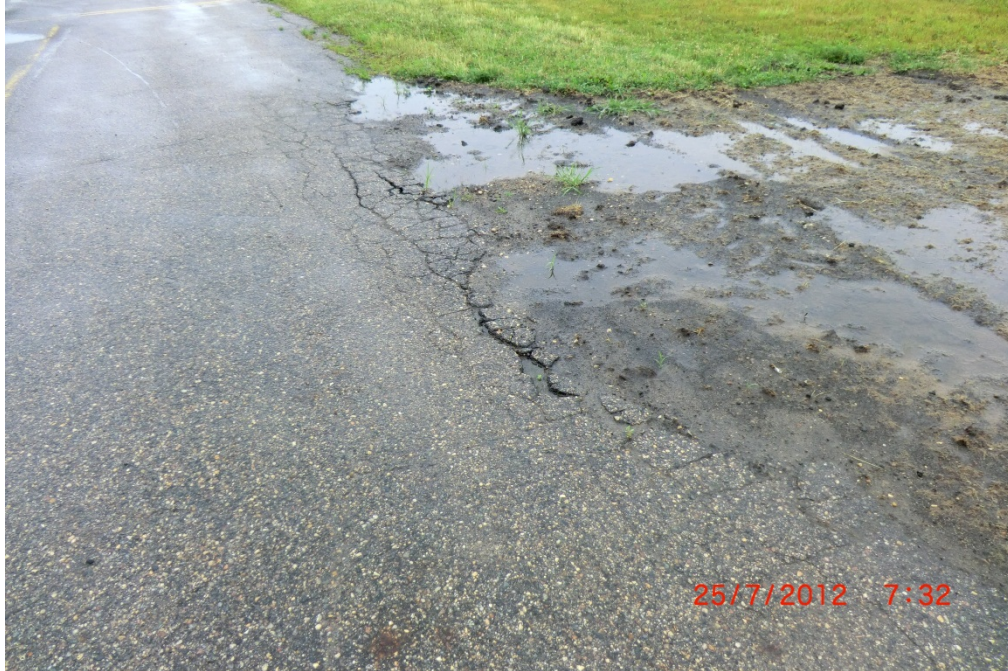
JKJ TLA 001 Alligator CR, (PCI = 66)

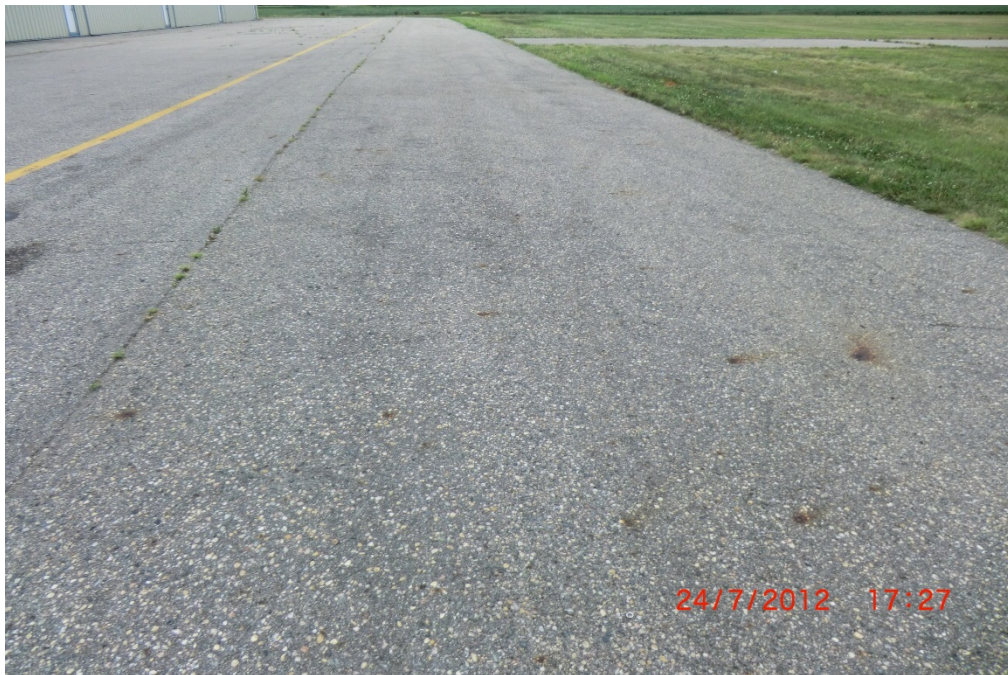
JKJ TLA 002 (PCI = 69)

TLA	2	AC	11,060	2004*	63	69	3.9	31	69	L&T cracking, raveling, rutting
TLA	3	AC	21,840	2012	n/a	100	0.0	0	0	-
TLB	1	AC	16,920	2006	100	98	0.3	0	100	L&T cracking
