Minnesota Airport System Pavement Evaluation 2012 Update

Olivia Regional Airport (OVL)

Final Report

Mn/DOT Airport Pavement Management System 2012

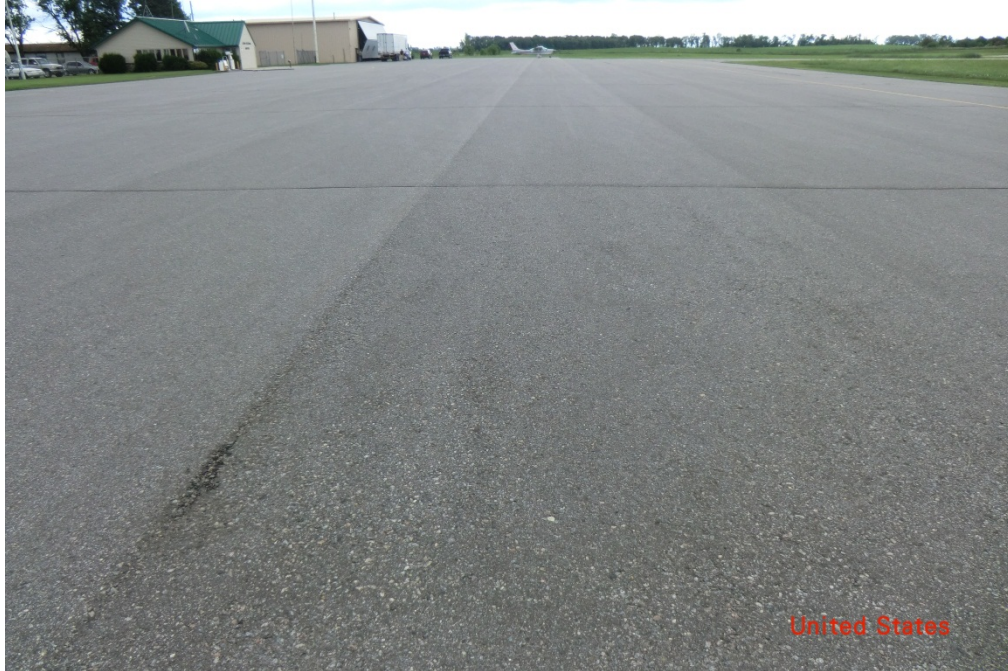
OVL APA 001 (PCI = 82)

Conditions: PCI : 82

48	LONGITUDINAL/TRANSVERSE CRACKING	L	45.00 Ft	Comments:
48	LONGITUDINAL/TRANSVERSE CRACKING	M	124.00 Ft	Comments:
48	LONGITUDINAL/TRANSVERSE CRACKING	H	11.00 Ft	Comments:

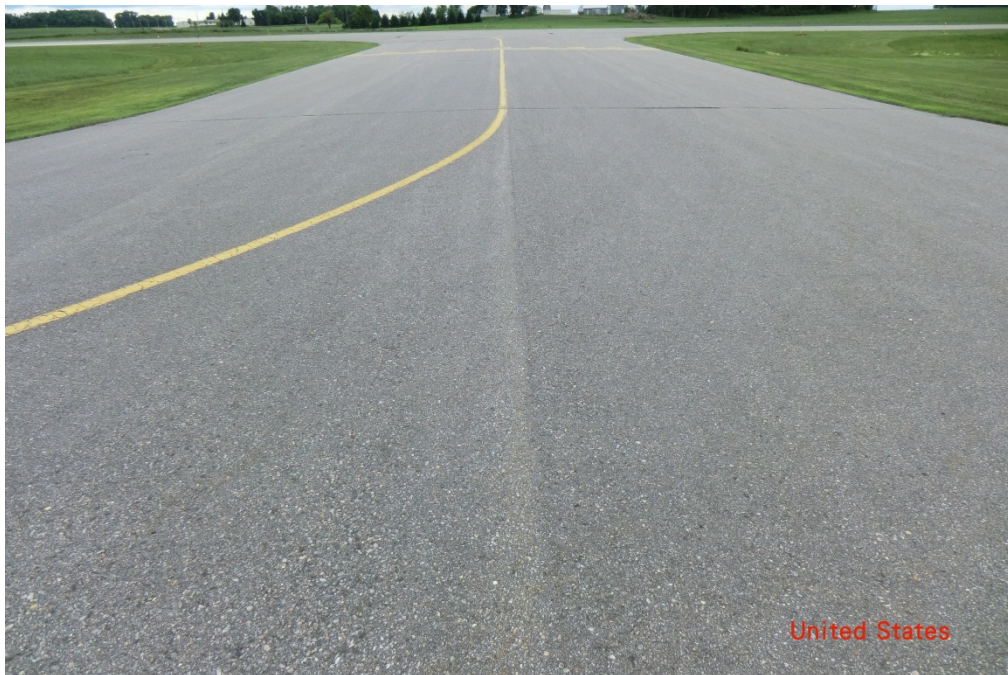
OVL CTA 001 (PCI = 82)

Conditions: PCI: 82

48	LONGITUDINAL/TRANSVERSE CRACKING	L	87.00 Ft	Comments:
48	LONGITUDINAL/TRANSVERSE CRACKING	M	17.00 Ft	Comments:
48	LONGITUDINAL/TRANSVERSE CRACKING	H	3.00 Ft	Comments:

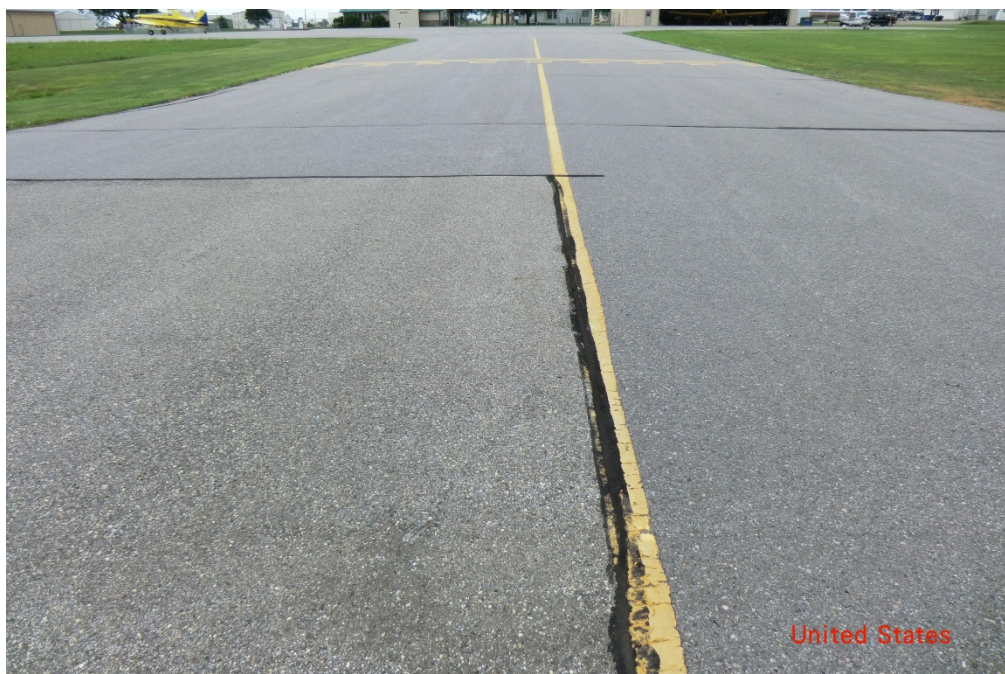
OVL CTB 001 (PCI = 67)

Conditions: PCI : 67

50 PATCHING	L	200.00 SqFt	Comments:
48 LONGITUDINAL/TRANSVERSE CRACKING	L	49.00 Ft	Comments:
48 LONGITUDINAL/TRANSVERSE CRACKING	M	31.00 Ft	Comments:
48 LONGITUDINAL/TRANSVERSE CRACKING	H	21.00 Ft	Comments:
56 SWELLING	L	63.00 SqFt	Comments:
52 RAVELING	L	20.00 SqFt	Comments:
41 ALLIGATOR CRACKING	L	10.00 SqFt	Comments:

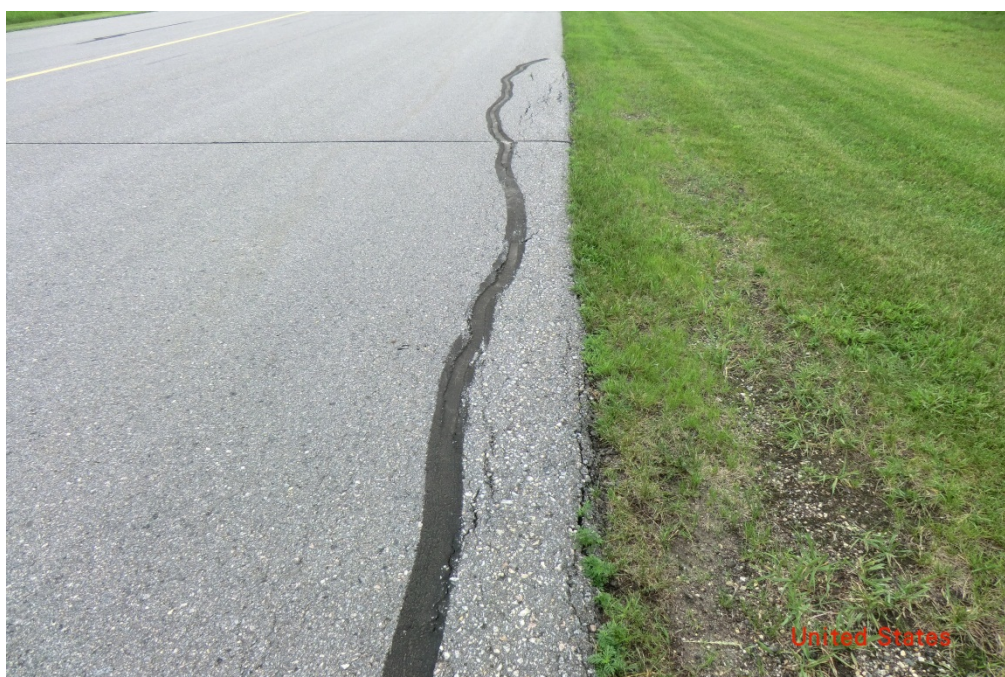
OVL PPTA 001 Alligator CR, (PCI = 80)

Conditions: PCI : 80

48	LONGITUDINAL/TRANSVERSE CRACKING	L	108.00 Ft	Comments:
48	LONGITUDINAL/TRANSVERSE CRACKING	M	60.00 Ft	Comments:
48	LONGITUDINAL/TRANSVERSE CRACKING	H	8.00 Ft	Comments:
52	RAVELING	L	120.00 SqFt	Comments:
41	ALLIGATOR CRACKING	L	18.00 SqFt	Comments:

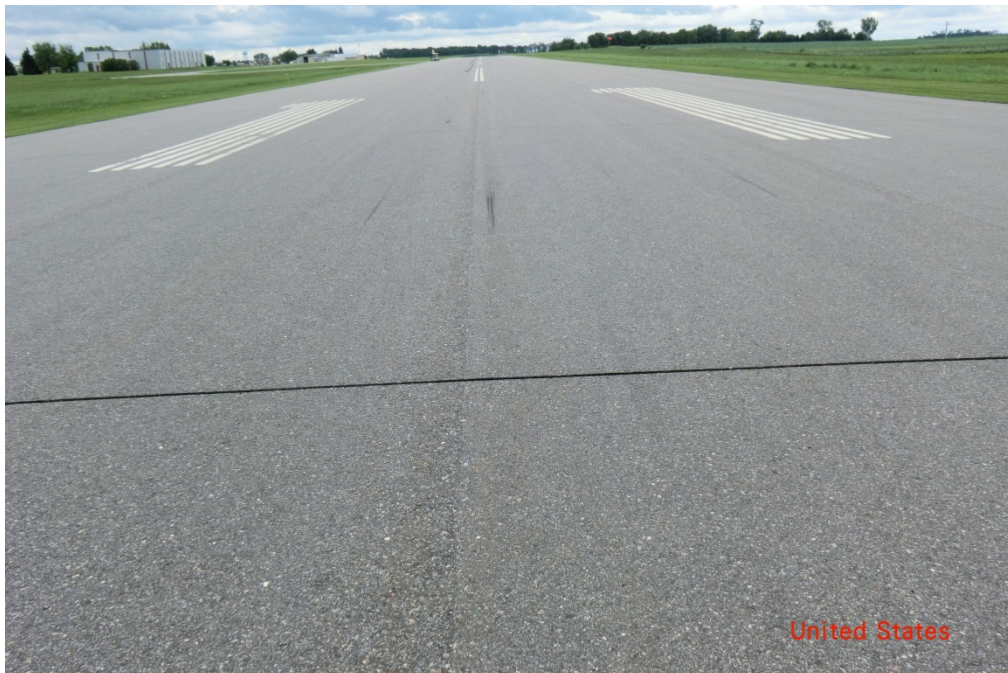
OVL RY1129 001 (PCI = 85)

Conditions: PCI : 85

48 LONGITUDINAL/TRANSVERSE CRACKING L 146.00 Ft Comments:
48 LONGITUDINAL/TRANSVERSE CRACKING M 22.00 Ft Comments:

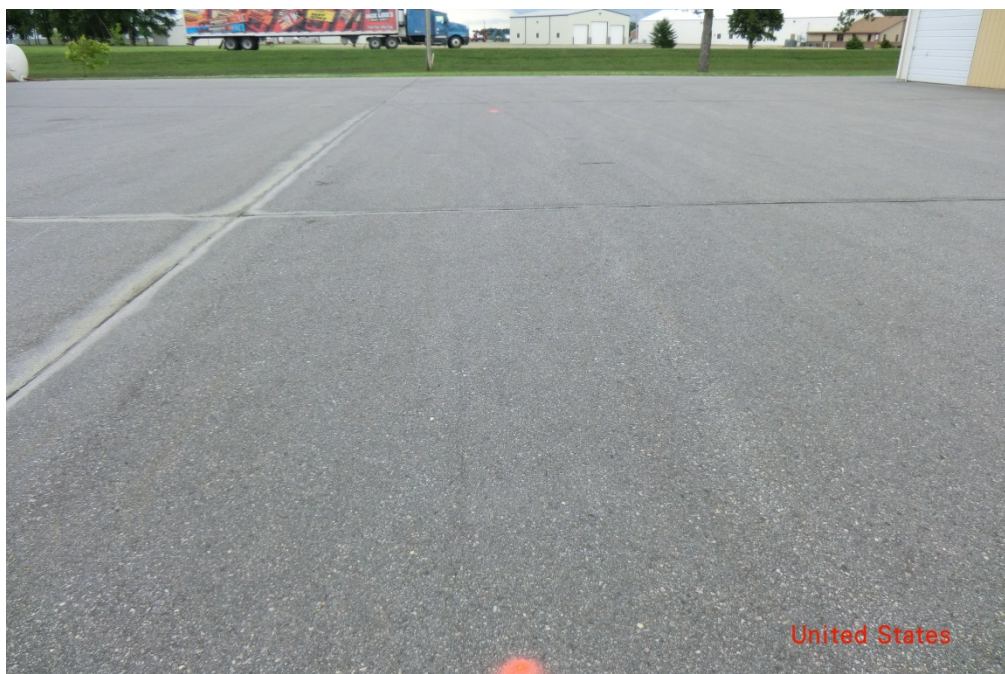
OVL TLA 001 (PCI = 80)

Conditions: PCI : 80

48 LONGITUDINAL/TRANSVERSE CRACKING L 105.00 Ft Comments:

48 LONGITUDINAL/TRANSVERSE CRACKING M 24.00 Ft Comments:
