Minnesota Airport System Pavement Evaluation 2012 Update

Paynesville Municipal Airport (PEX)

Final Report

Applied Research Associates, Inc.
100 Trade Centre Dr., Suite 200
Champaign, IL 61820
(217) 356-4500

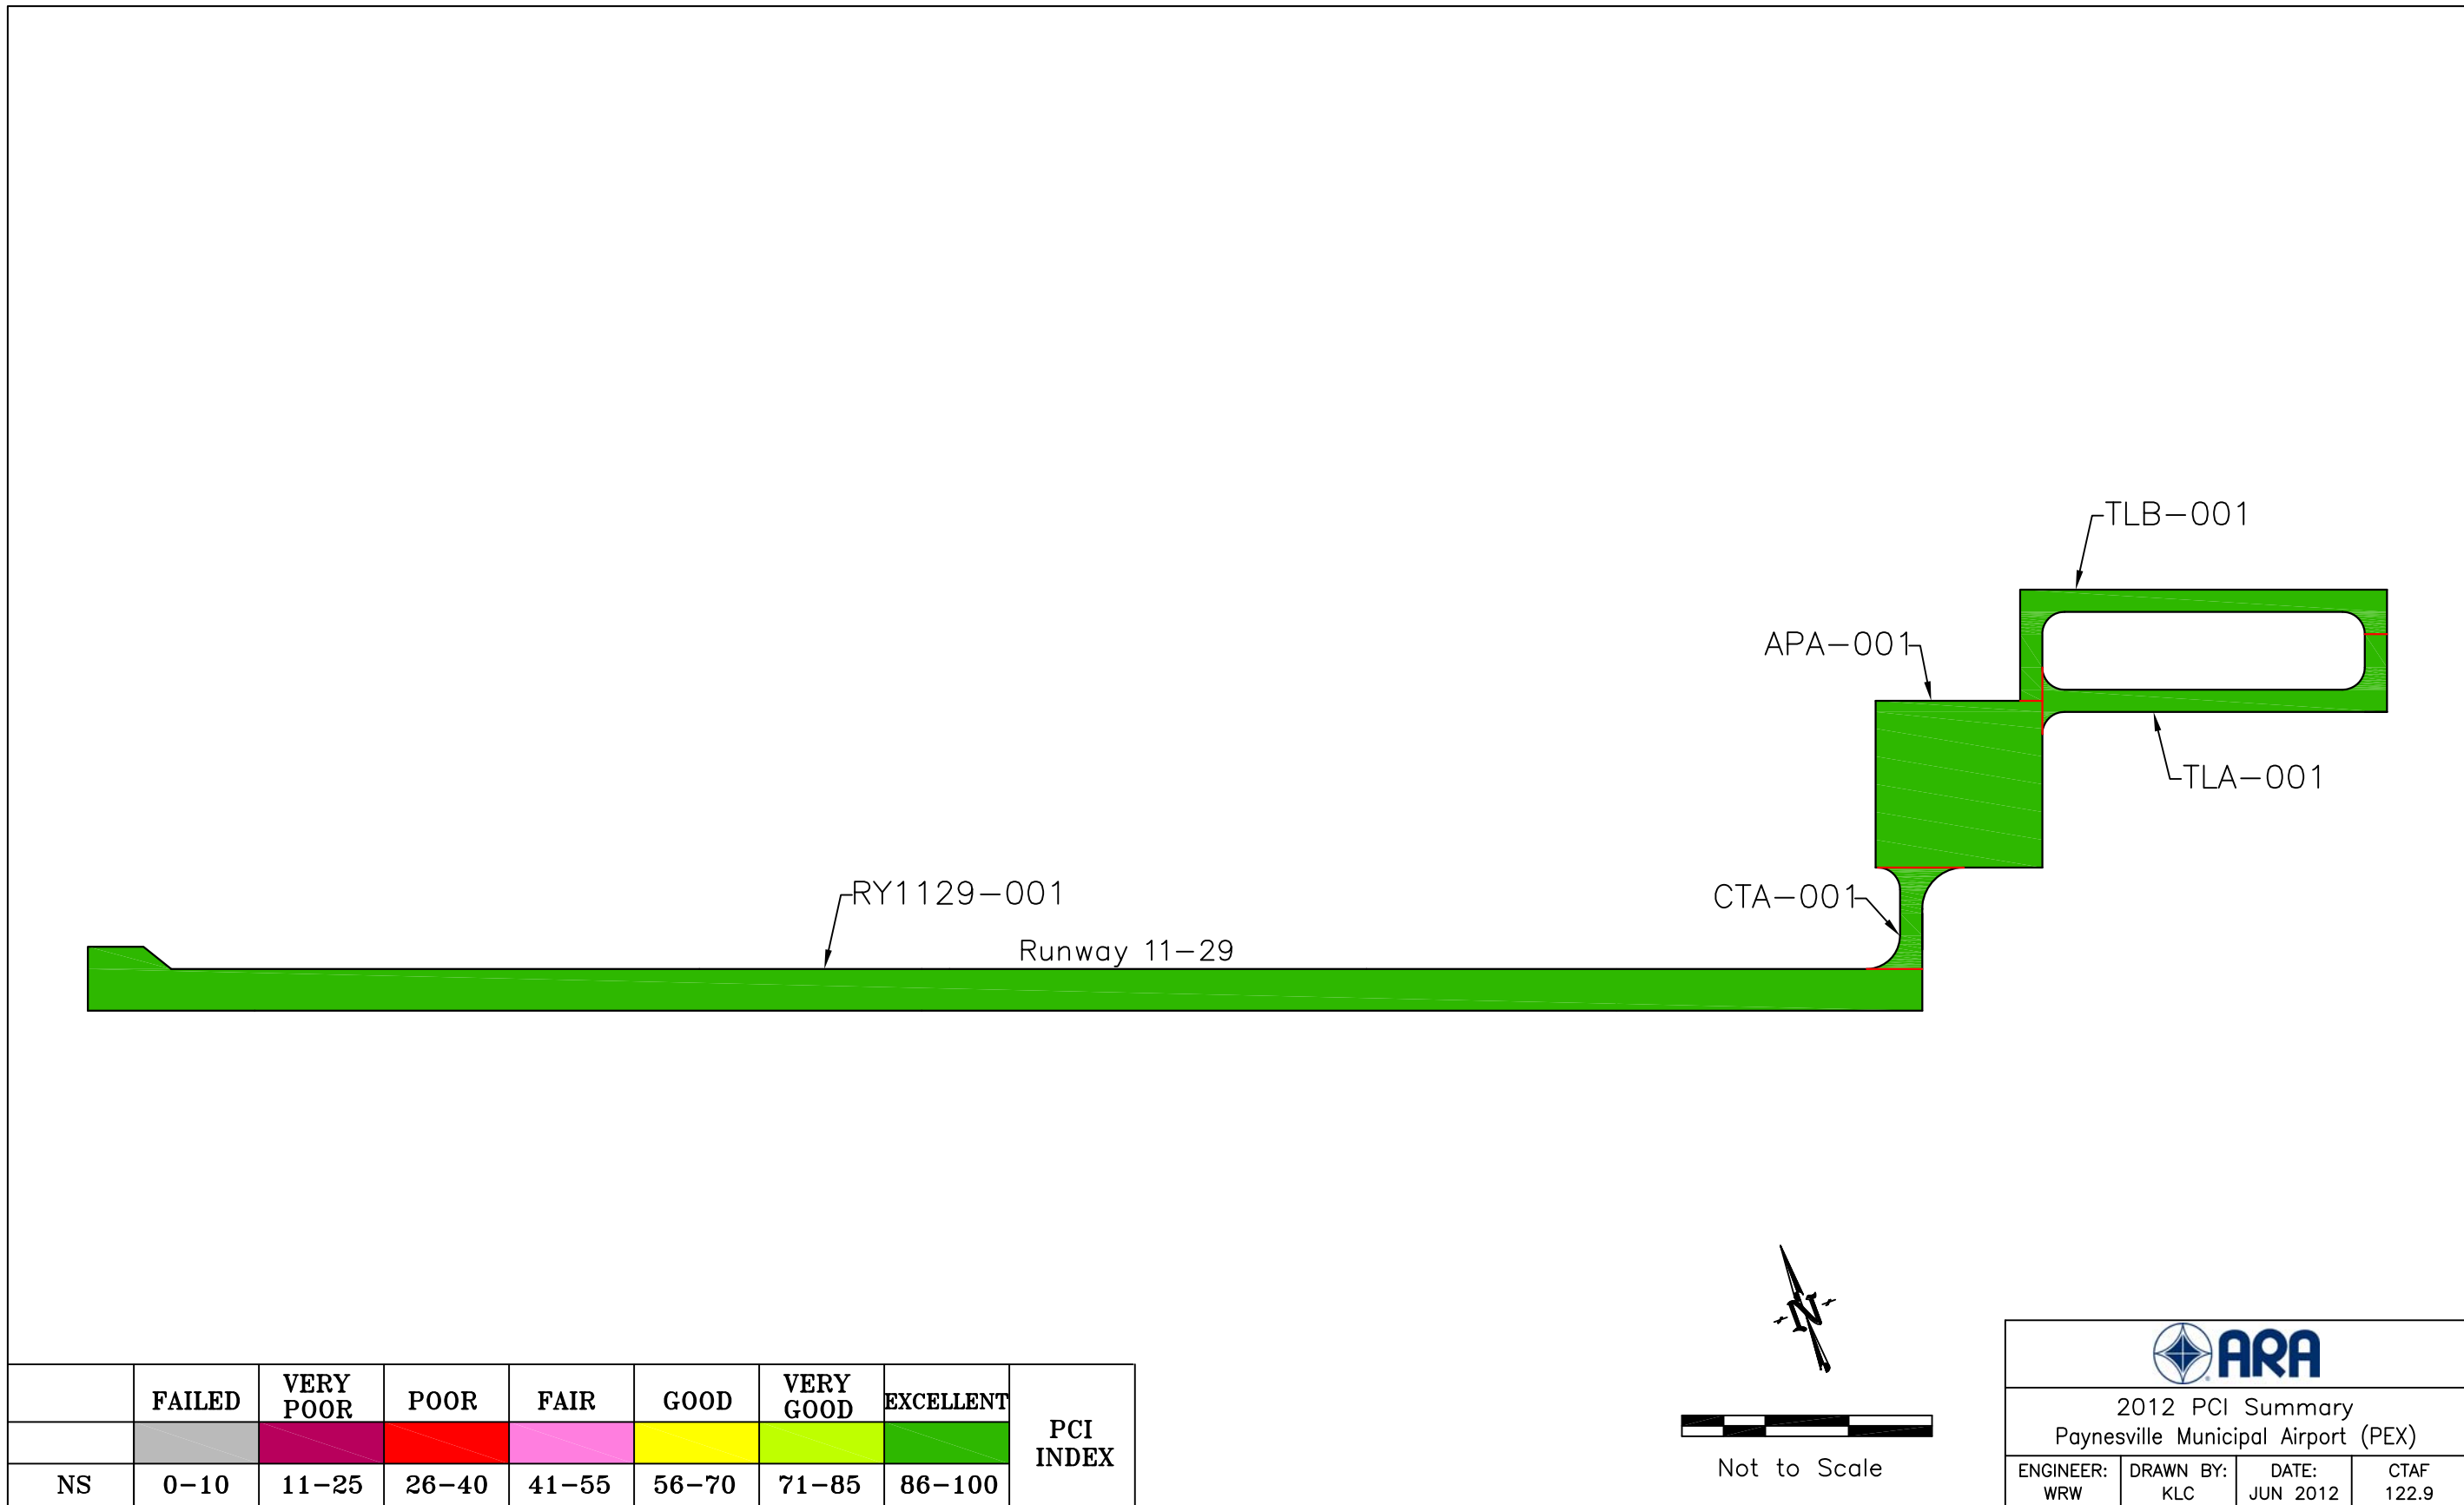
Figure 4. 2012 Pavement Condition Index Rating at Paynesville Municipal Airport (PEX).

Figures 5 and 6 present the overall PCI for PEX by area distribution and pavement use, respectively. Table 3 presents the PCI summary for each section at PEX, including the drop in PCI per year. Generally, pavement sections will deteriorate between 1 and 3 PCI points per year. Sections deteriorating at higher rates may need maintenance above the normal application rates and should be closely monitored in case major repairs become necessary.

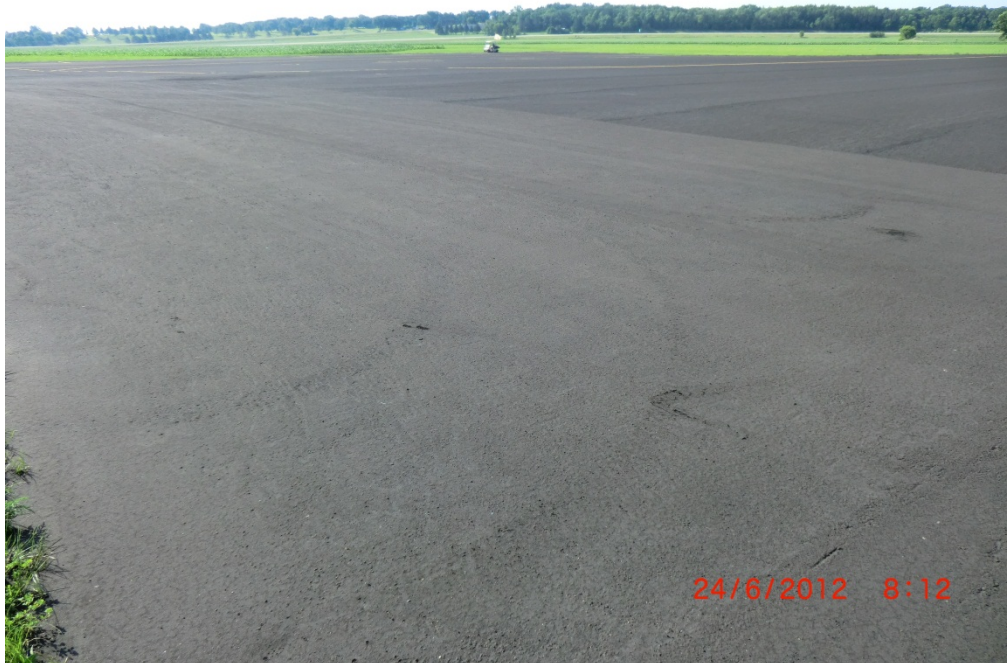
PEX APA 001 (PCI = 97)

Conditions: PCI : 97

48 LONGITUDINAL/TRANSVERSE CRACKING L 7.00 Ft Comments:

48 LONGITUDINAL/TRANSVERSE CRACKING L 28.00 Ft Comments:

48 LONGITUDINAL/TRANSVERSE CRACKING L 8.00 Ft Comments:

48 LONGITUDINAL/TRANSVERSE CRACKING L 10.00 Ft Comments:

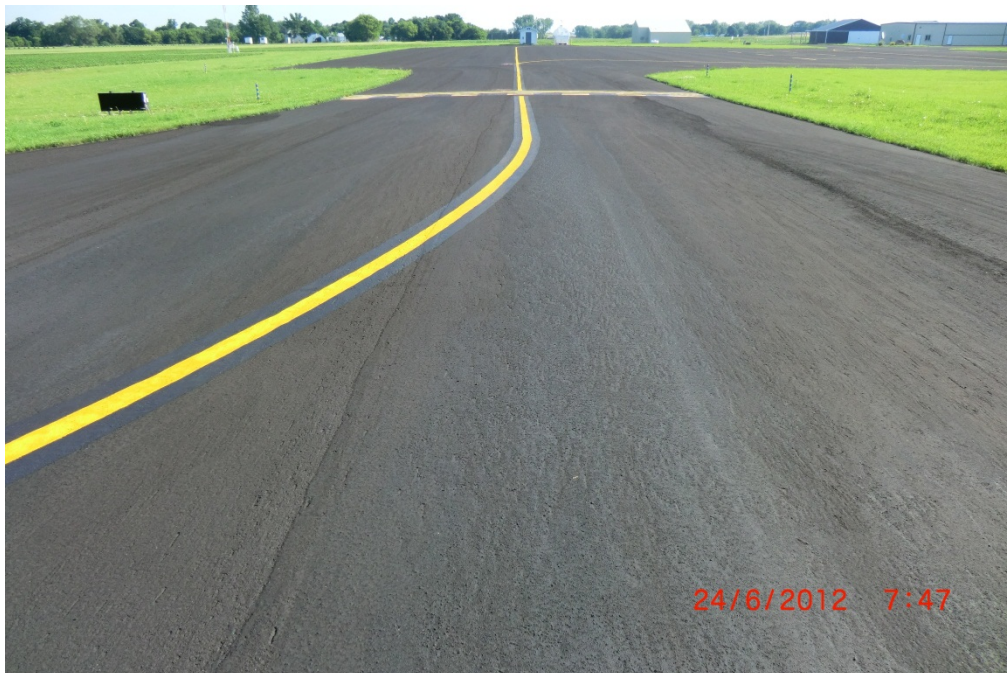
PEX CTA 001 (PCI = 94)

Conditions: PCI: 94

48 LONGITUDINAL/TRANSVERSE CRACKING L 67.00 Ft Comments:

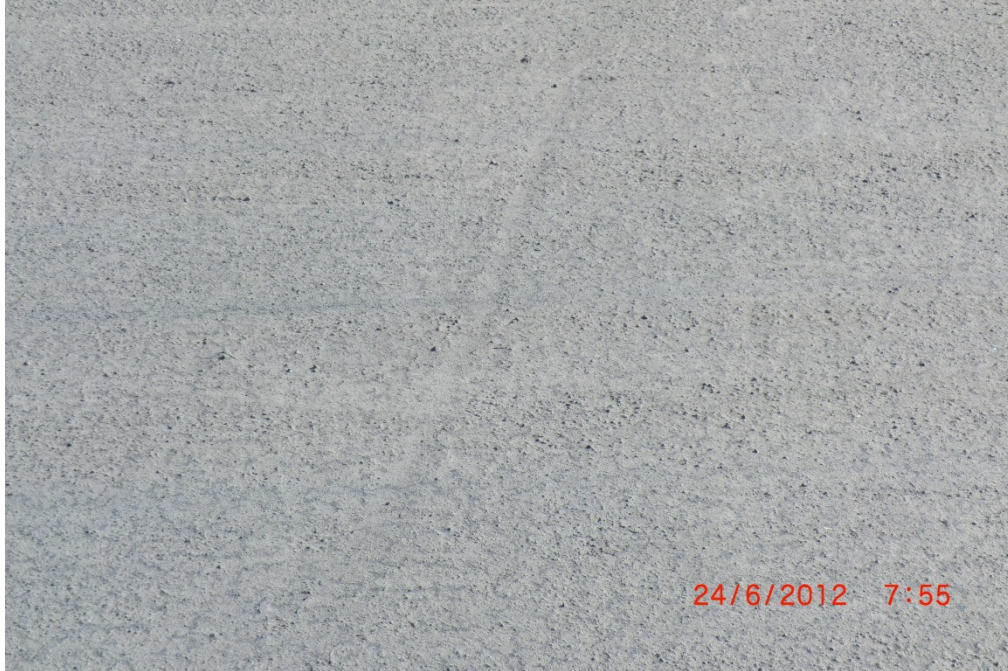
PEX RY1129 001 L & T Crack under slurry seal, (PCI = 95)

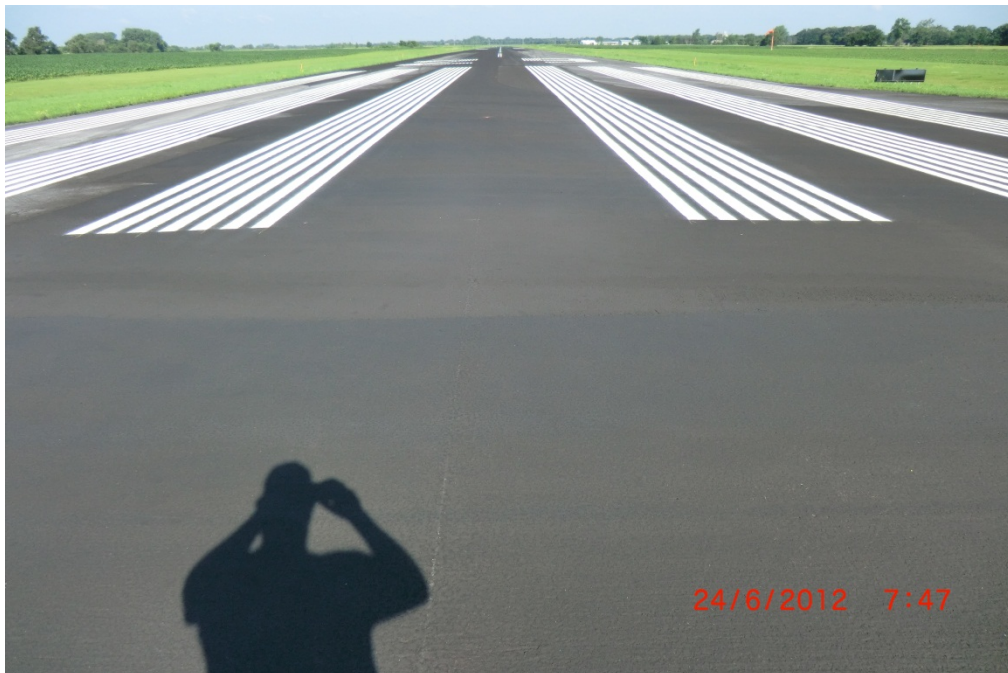
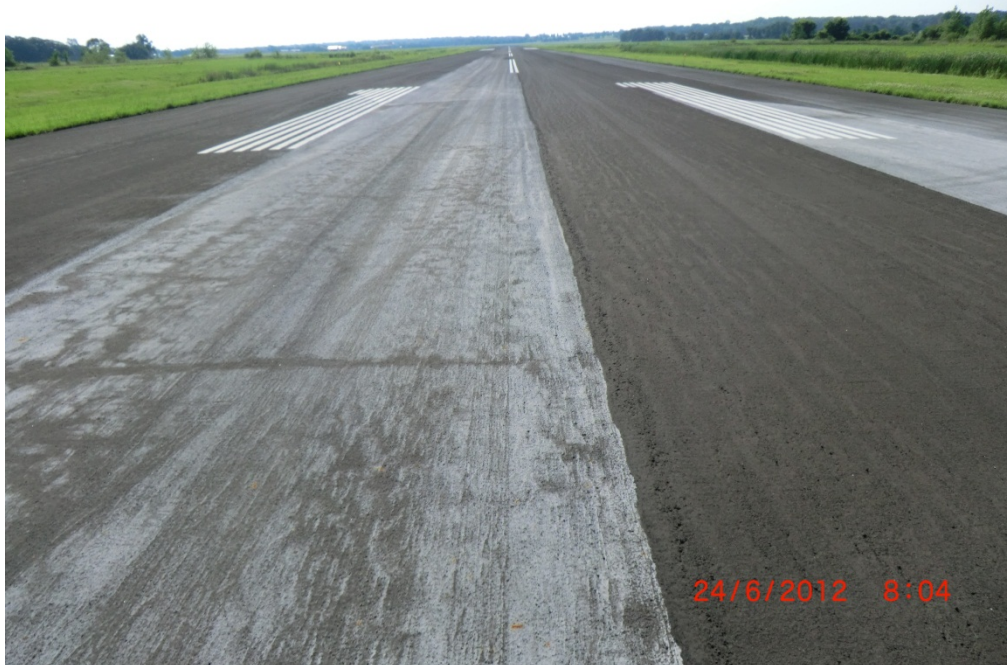
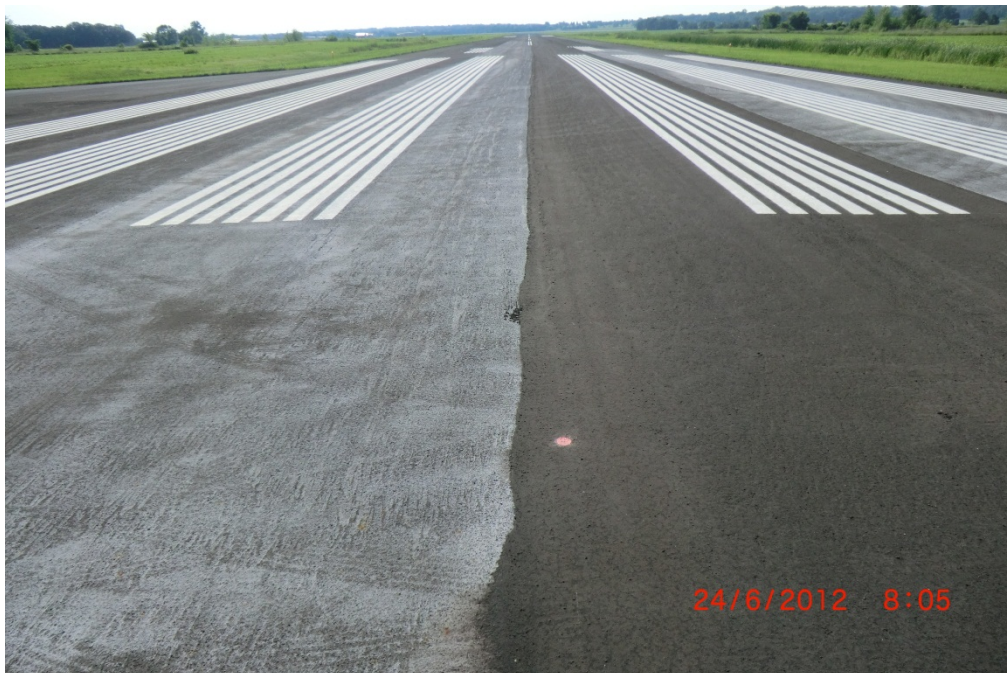
PEX RY1129 001 (PCI = 95)

Conditions: PCI : 95

Sample Number: 106 Type: R Area: 3,750.00SqFt PCI = 93
Sample Comments:
48 LONGITUDINAL/TRANSVERSE CRACKING L 63.00 Ft Comments:

Sample Number: 115 Type: R Area: 3,750.00SqFt PCI = 96
Sample Comments:
48 LONGITUDINAL/TRANSVERSE CRACKING L 19.00 Ft Comments:

Sample Number: 124 Type: R Area: 3,750.00SqFt PCI = 96
Sample Comments:
48 LONGITUDINAL/TRANSVERSE CRACKING L 14.00 Ft Comments:

Sample Number: 133 Type: R Area: 3,750.00SqFt PCI = 93
Sample Comments:
48 LONGITUDINAL/TRANSVERSE CRACKING L 63.00 Ft Comments:

Sample Number: 142 Type: R Area: 3,750.00SqFt PCI = 95
Sample Comments:
48 LONGITUDINAL/TRANSVERSE CRACKING L 38.00 Ft Comments:

Sample Number: 151 Type: R Area: 3,750.00SqFt PCI = 93
Sample Comments:
48 LONGITUDINAL/TRANSVERSE CRACKING L 62.00 Ft Comments:

Sample Number: 160 Type: R Area: 3,750.00SqFt PCI = 96
Sample Comments:
48 LONGITUDINAL/TRANSVERSE CRACKING L 23.00 Ft Comments:

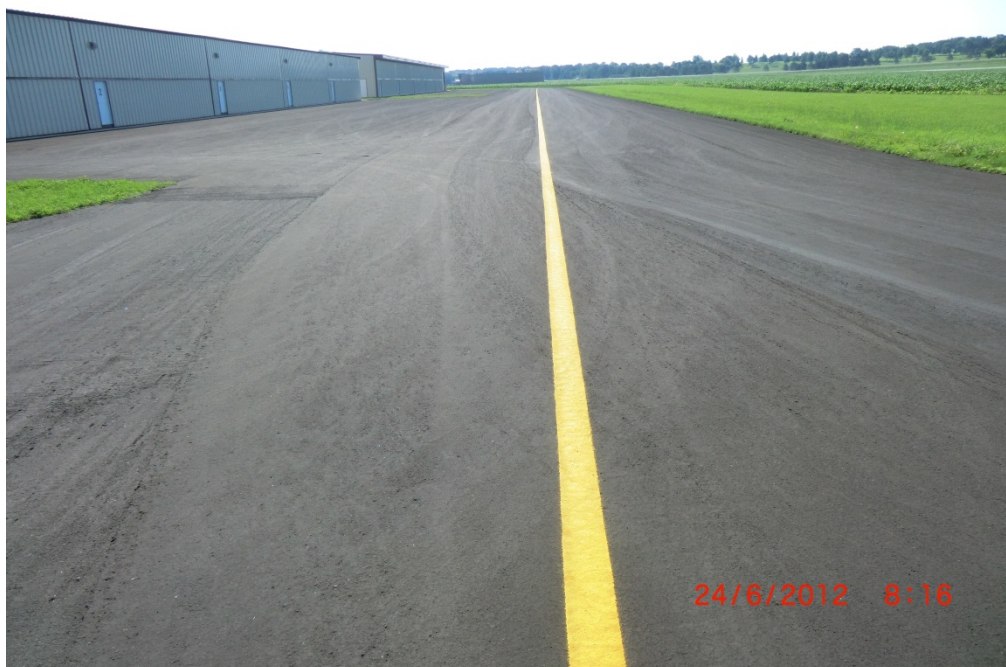
PEX TLA 001 (PCI = 89)

Conditions: PCI : 89

48 LONGITUDINAL/TRANSVERSE CRACKING L 169.00 Ft Comments:

48 LONGITUDINAL/TRANSVERSE CRACKING L 113.00 Ft Comments:

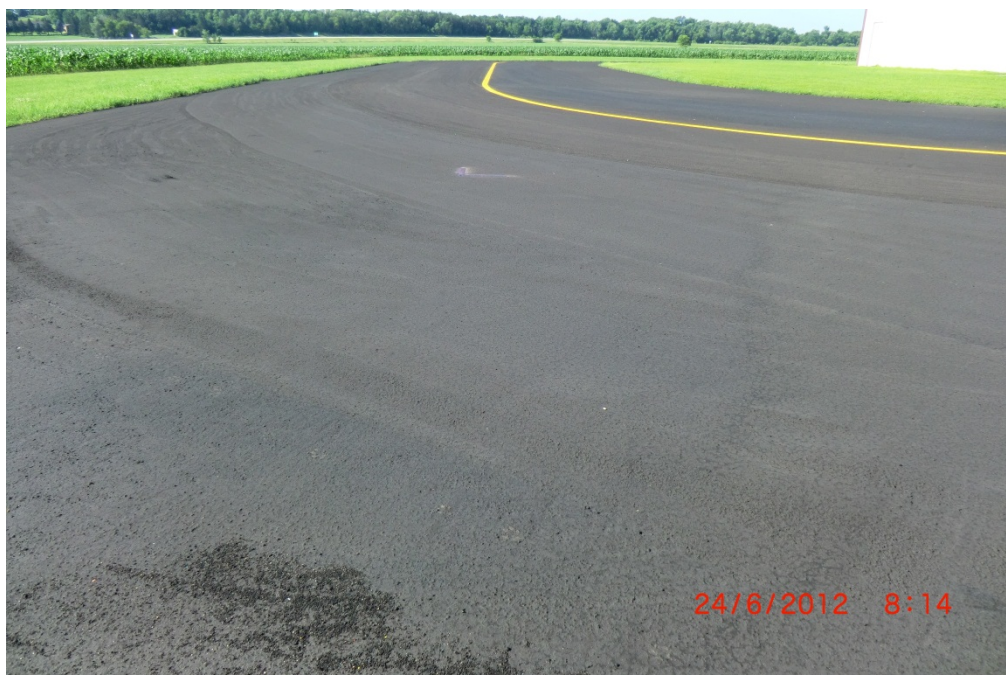
PEX TLB 001 (PCI = 92)

Conditions: PCI: 92

48 LONGITUDINAL/TRANSVERSE CRACKING L 19.00 Ft Comments:

48 LONGITUDINAL/TRANSVERSE CRACKING L 143.00 Ft Comments:
