Minnesota Airport System Pavement Evaluation 2012 Update

Redwood Falls Municipal Airport (RWF)

Redwood Falls, Minnesota

Final Report

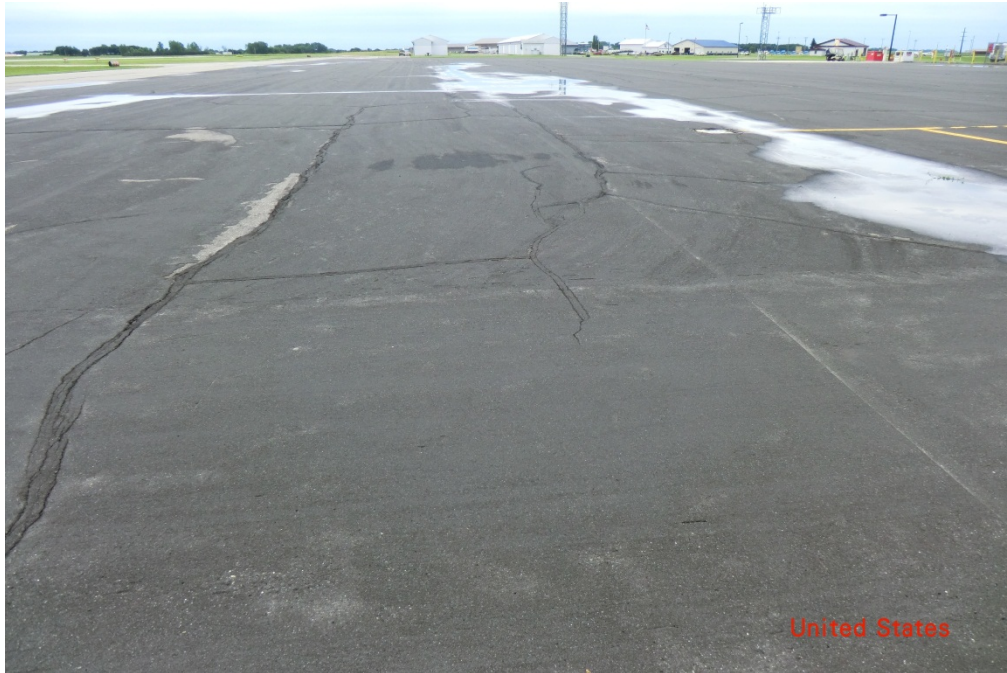
RWF APA 003 (PCI = 65)

Conditions: PCI : 65

48	LONGITUDINAL/TRANSVERSE CRACKING	L	558.00 Ft	Comments:
48	LONGITUDINAL/TRANSVERSE CRACKING	M	53.00 Ft	Comments:
48	LONGITUDINAL/TRANSVERSE CRACKING	H	3.00 Ft	Comments:
52	RAVELING	L	20.00 SqFt	Comments:

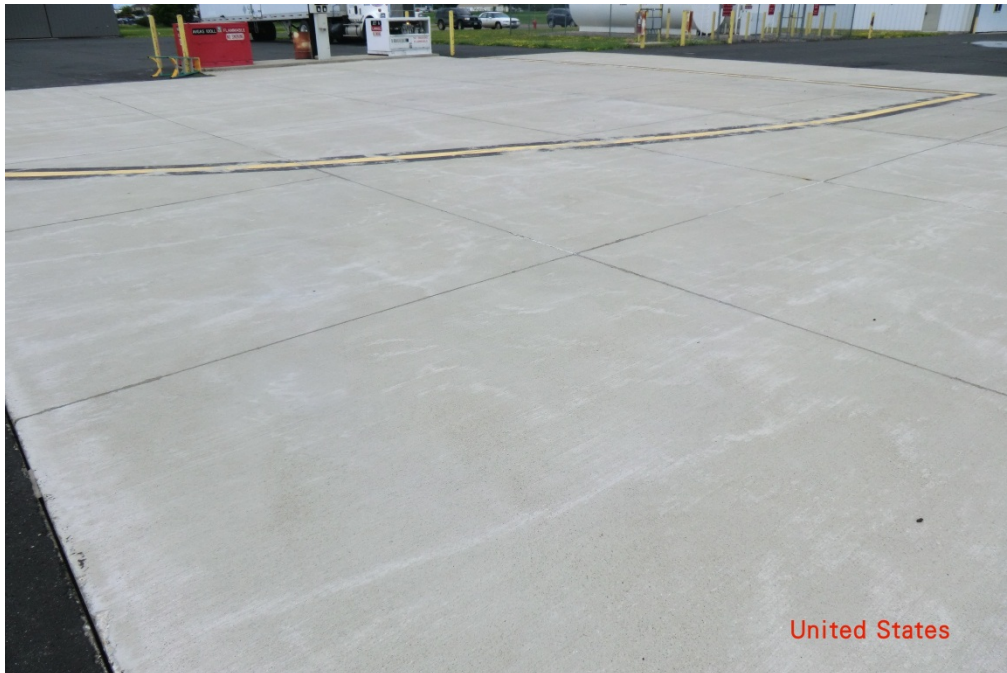
RWF APA 004 (PCI = 93)

Conditions: PCI : 93

65 JOINT SEAL DAMAGE M 18.00 Slabs Comments:

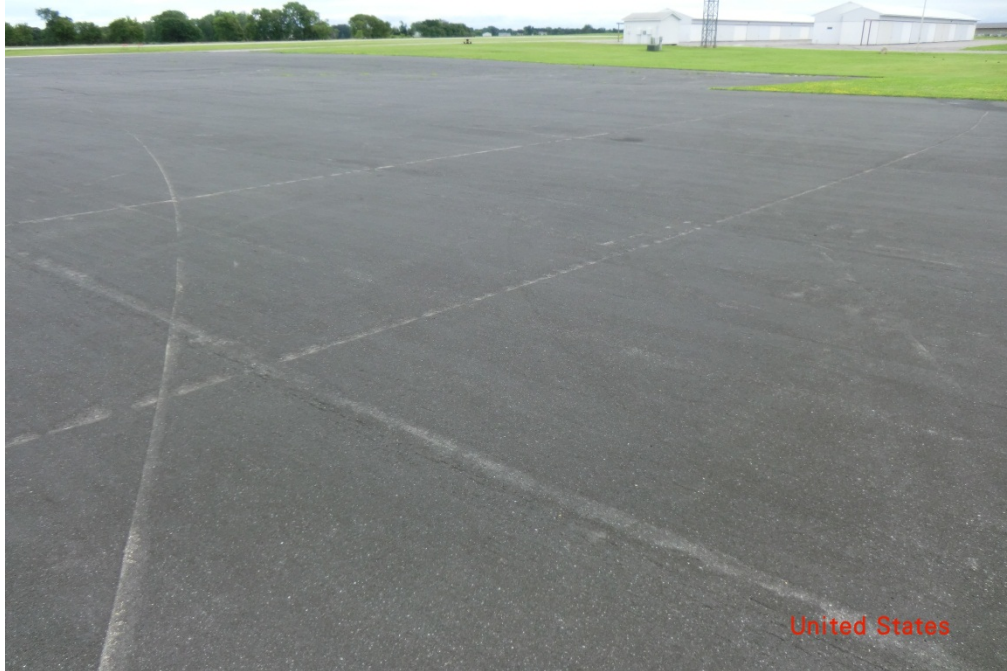
RWF APA 005 (PCI = 87)

Conditions: PCI : 87

48 LONGITUDINAL/TRANSVERSE CRACKING L 3.00 Ft Comments:

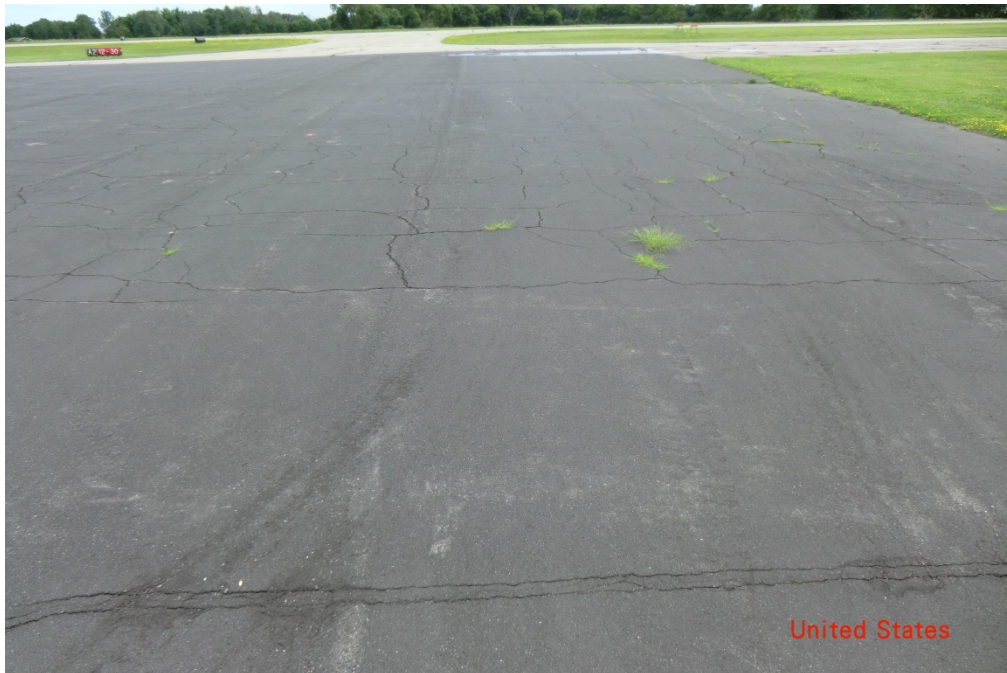
RWF APA 006 (PCI = 22)

Conditions: PCI: 22

43 BLOCK CRACKING	H	1,400.00 SqFt	Comments:
48 LONGITUDINAL/TRANSVERSE CRACKING	L	140.00 Ft	Comments:
48 LONGITUDINAL/TRANSVERSE CRACKING	M	19.00 Ft	Comments:
41 ALLIGATOR CRACKING	M	28.00 SqFt	Comments:

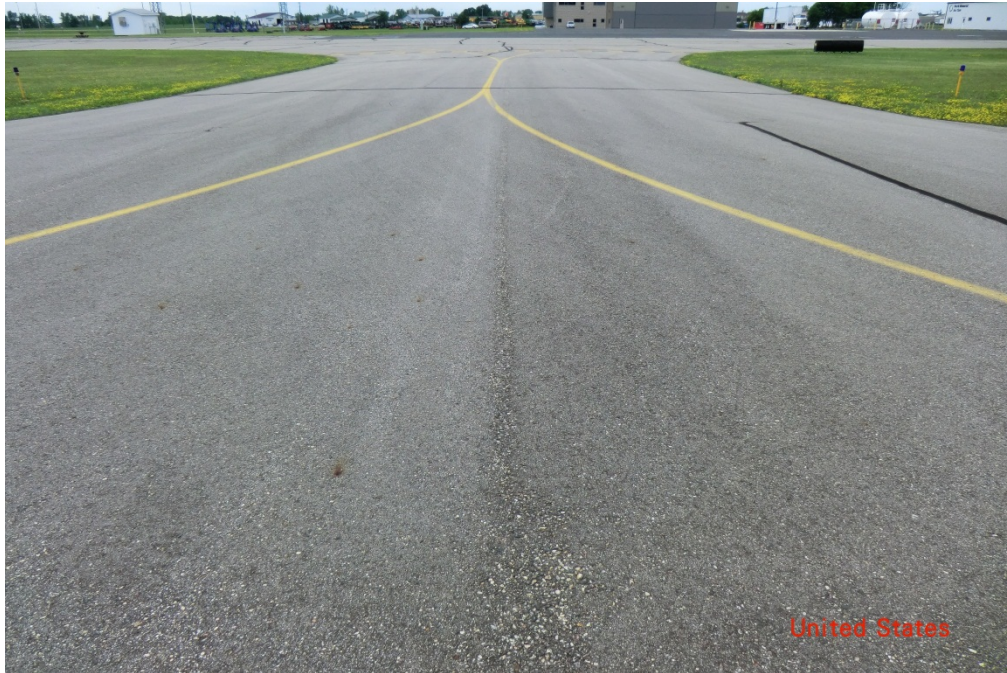
RWF CTA2 001 (PCI = 90)

Conditions: PCI: 90

48 LONGITUDINAL/TRANSVERSE CRACKING L 130.00 Ft Comments:

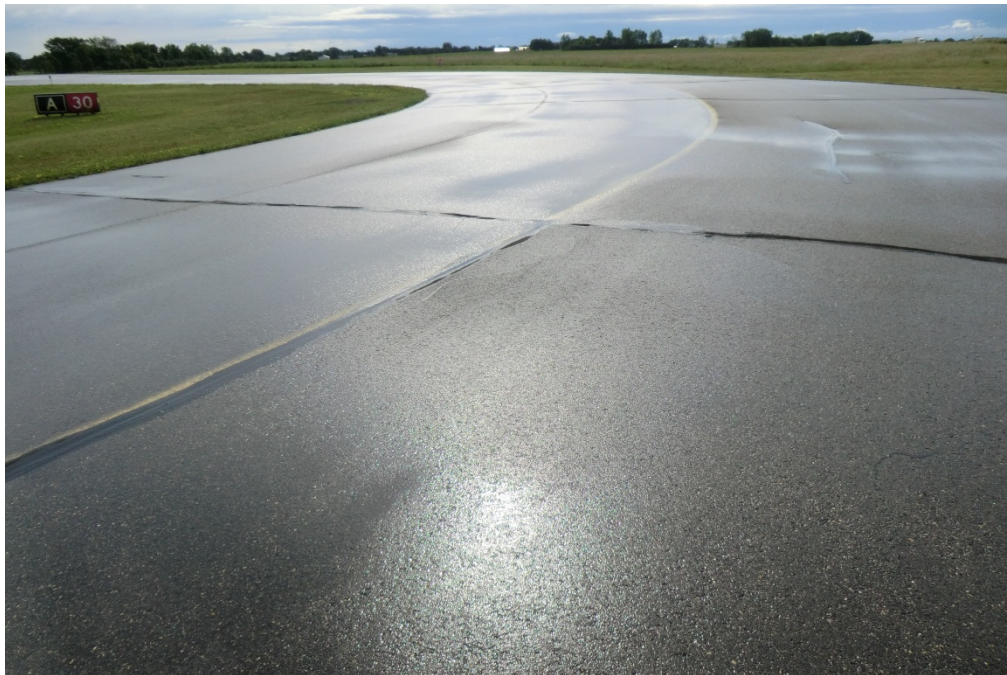
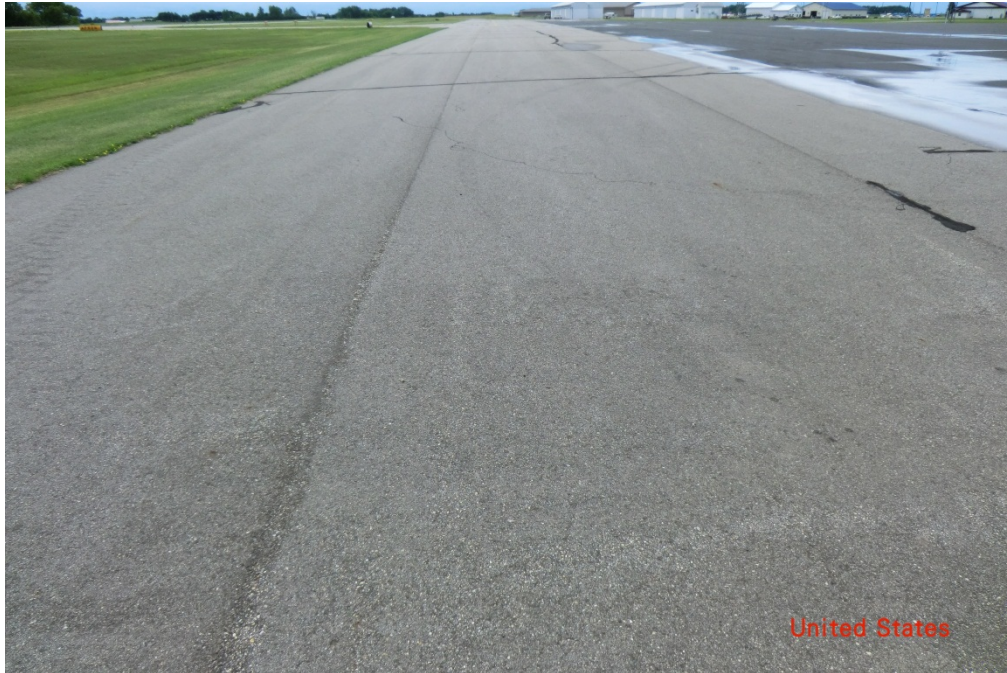
RWF PPTA 001 (PCI = 81)

Conditions: PCI : 81

Sample Number: 100 Type: R Area: 5,000.00SqFt PCI = 89
Sample Comments:
48 LONGITUDINAL/TRANSVERSE CRACKING L 171.00 Ft Comments:

Sample Number: 103 Type: R Area: 5,000.00SqFt PCI = 76
Sample Comments:
48 LONGITUDINAL/TRANSVERSE CRACKING L 386.00 Ft Comments:
48 LONGITUDINAL/TRANSVERSE CRACKING M 1.00 Ft Comments:

Sample Number: 106 Type: R Area: 5,000.00SqFt PCI = 77
Sample Comments:
48 LONGITUDINAL/TRANSVERSE CRACKING L 358.00 Ft Comments:
48 LONGITUDINAL/TRANSVERSE CRACKING M 6.00 Ft Comments:

Sample Number: 109 Type: R Area: 5,000.00SqFt PCI = 83
Sample Comments:
48 LONGITUDINAL/TRANSVERSE CRACKING L 312.00 Ft Comments:

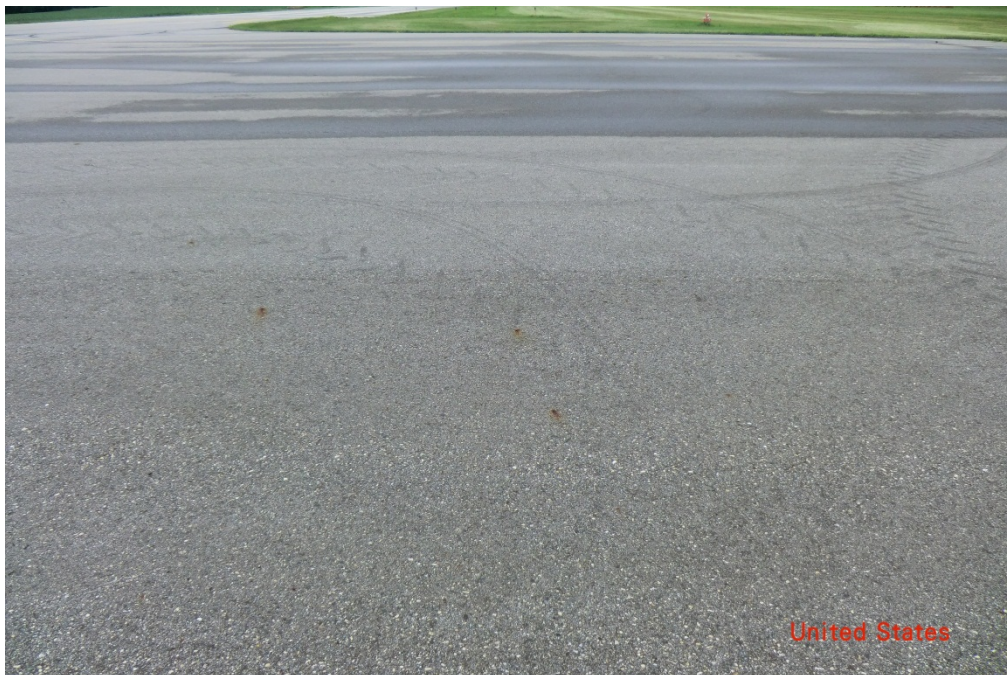
RWF RTA 001 (PCI = 97)

Conditions: PCI: 97

48 LONGITUDINAL/TRANSVERSE CRACKING L 10.00 Ft Comments:

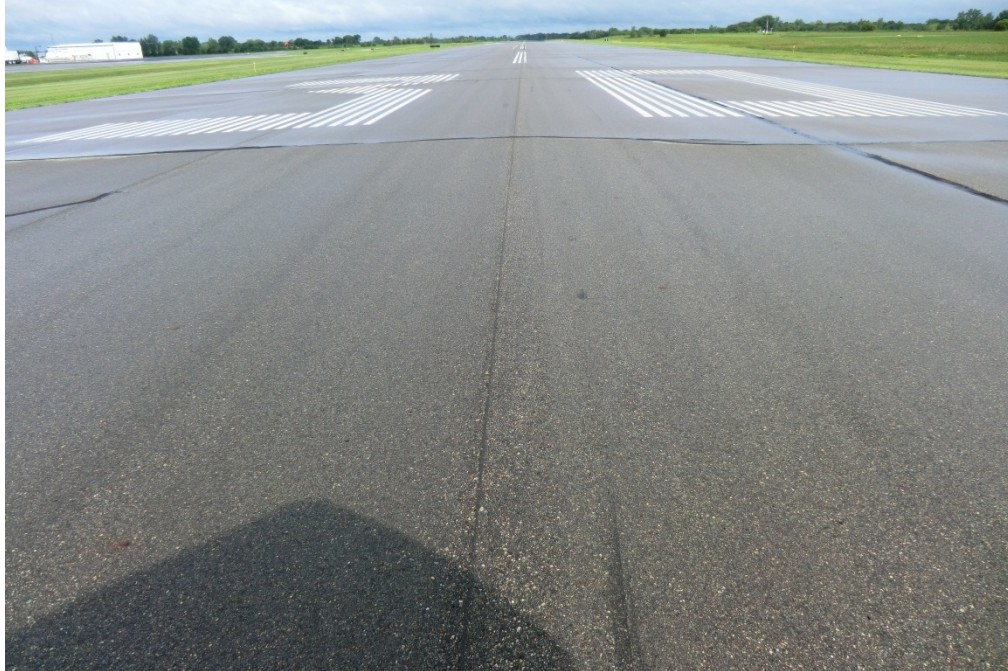
RWF RY1230 001 (PCI = 86)

Conditions: PCI : 86
