# Minnesota Airport System Pavement Evaluation 2012 Update

Rush City Regional Airport (ROS)

# Mn/DOT Airport Pavement Management System 2012

**January 2013**

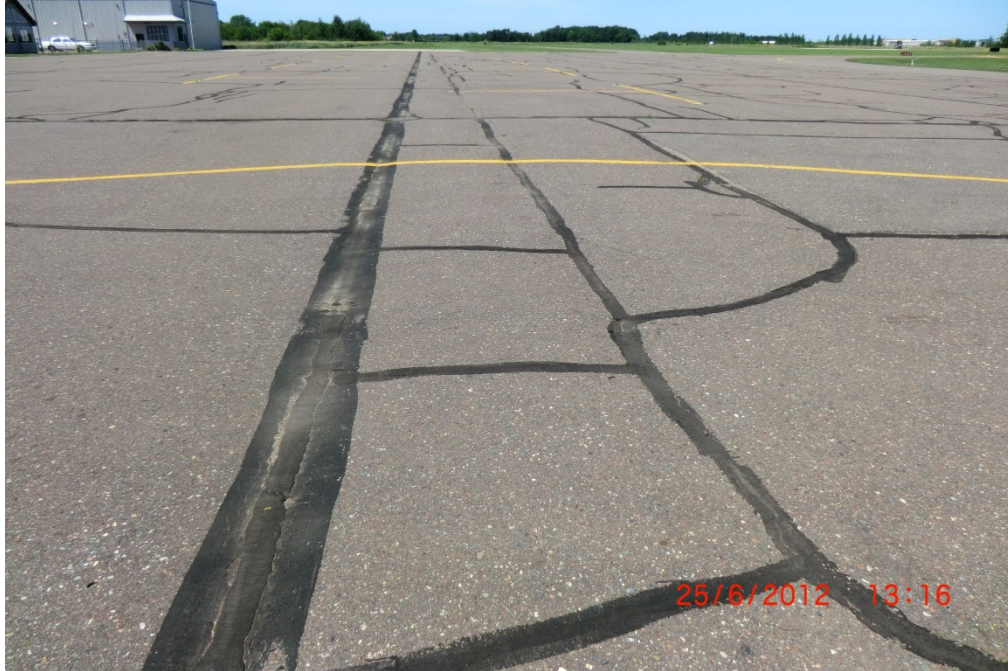
ROS APA 001 (PCI = 29)

Conditions: PCI: 29

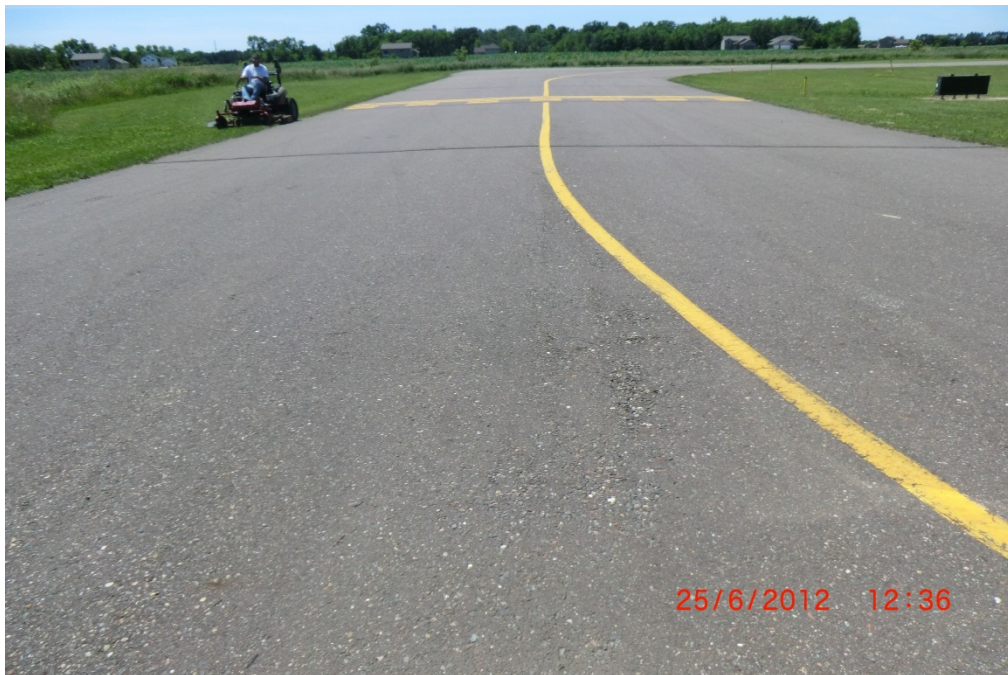
ROS CTA1 001 (PCI = 81)

Conditions: PCI : 81

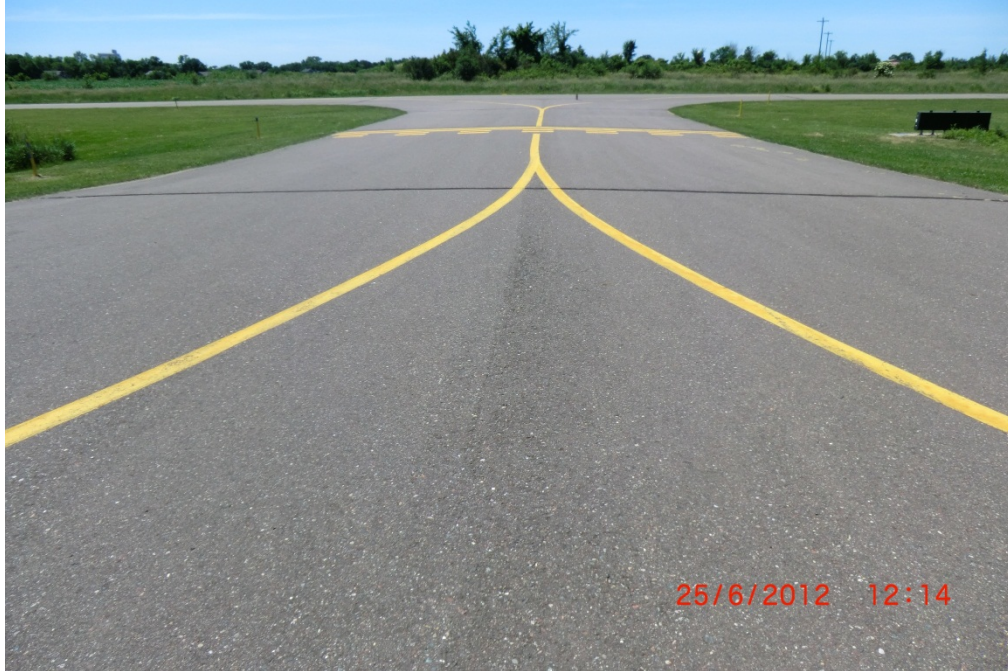
ROS CTA2 001 (PCI = 87)

Conditions: PCI : 87

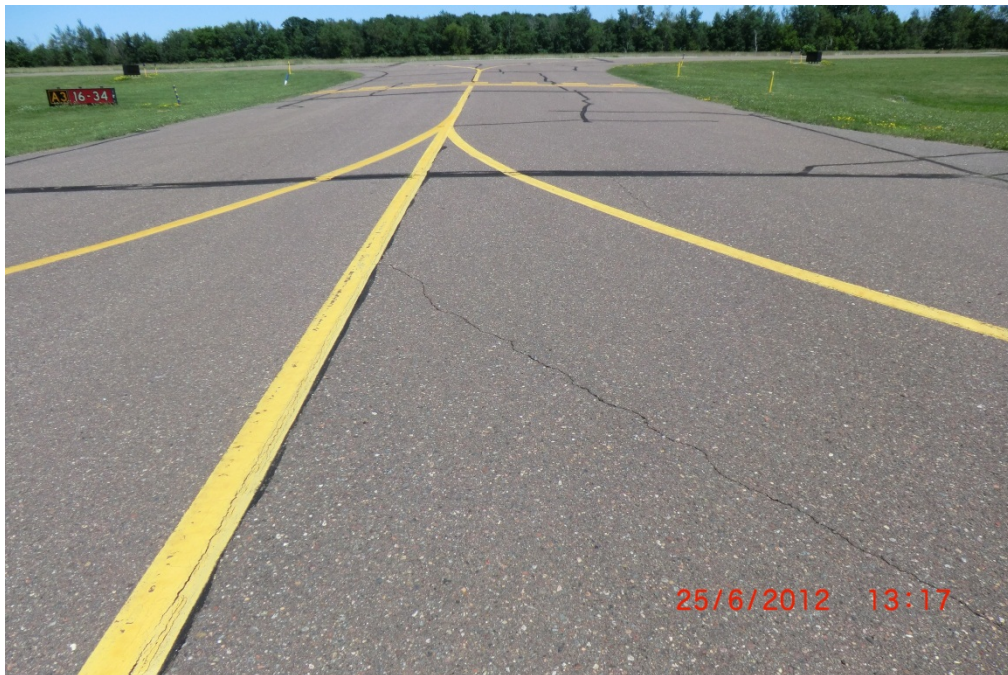
ROS CTA3 001 (PCI = 55)

Conditions: PCI : 55

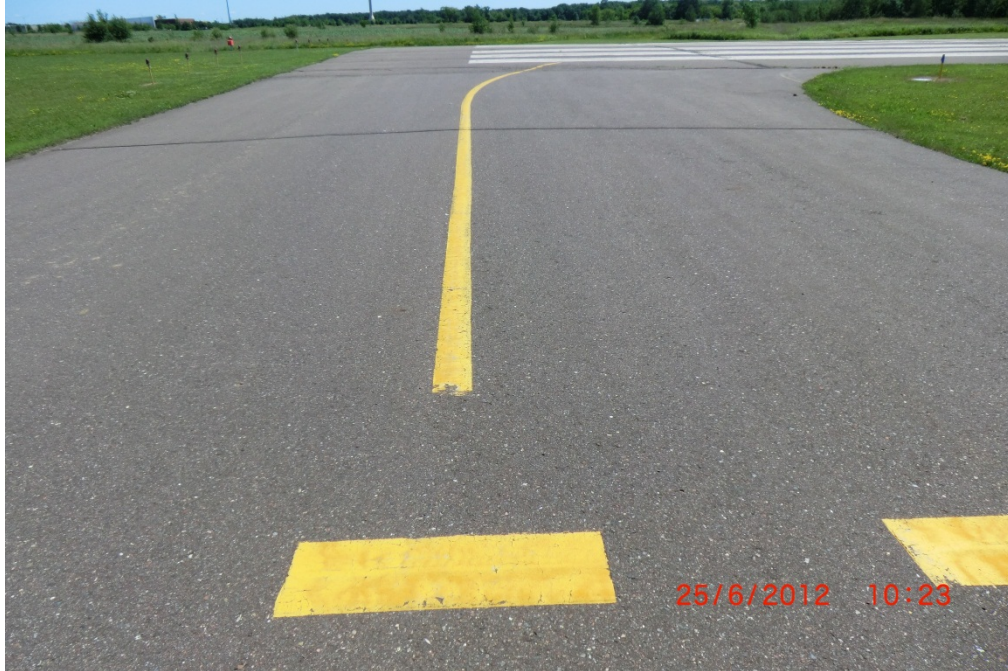
ROS CTA4 001 (PCI = 85)

Conditions: PCI : 85

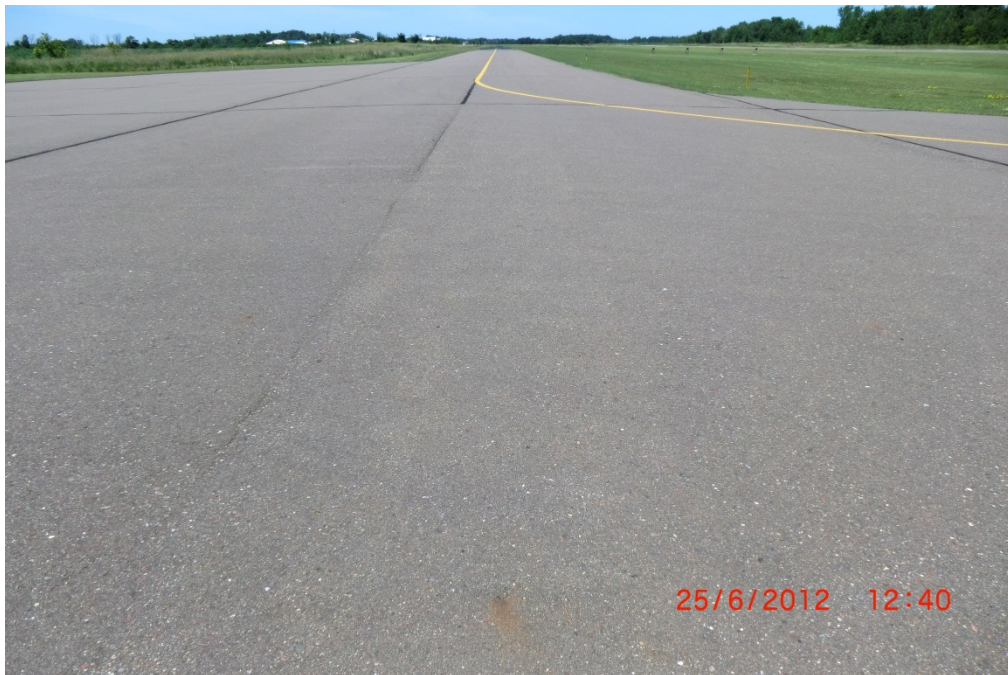
ROS PTA 001 (PCI = 75)

Conditions: PCI: 75

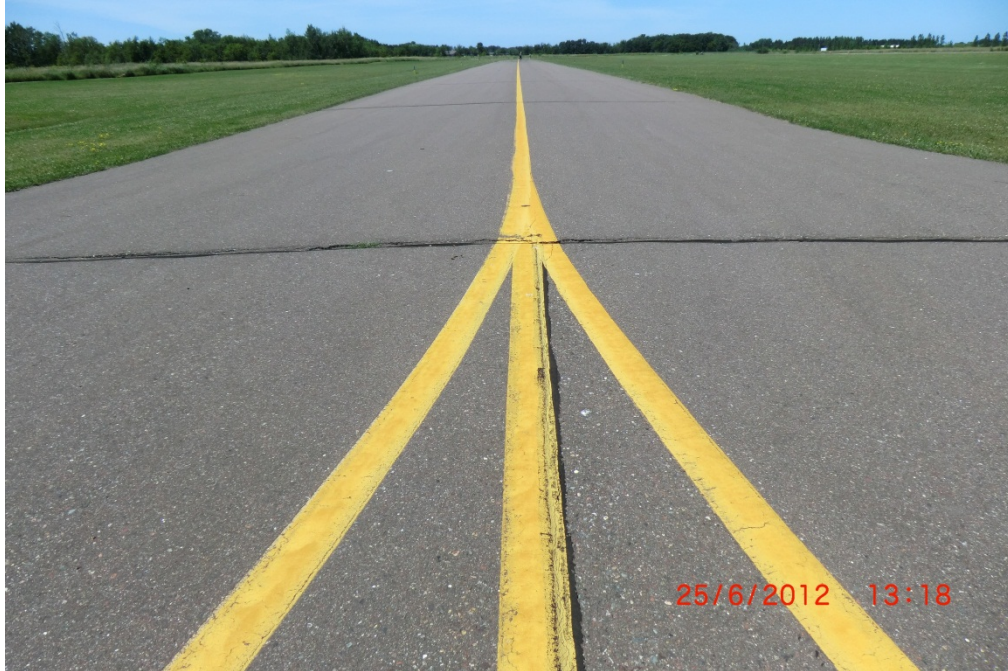
ROS PTA 002 (PCI = 76)

Conditions: PCI: 76

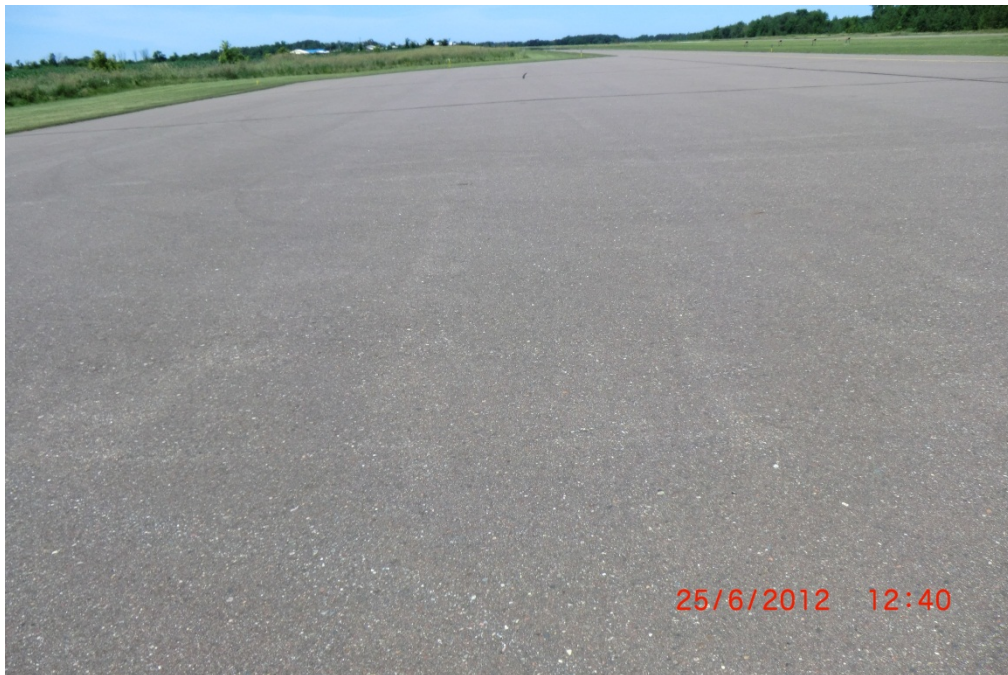
ROS RP1 001 (PCI = 78)

Conditions: PCI: 78

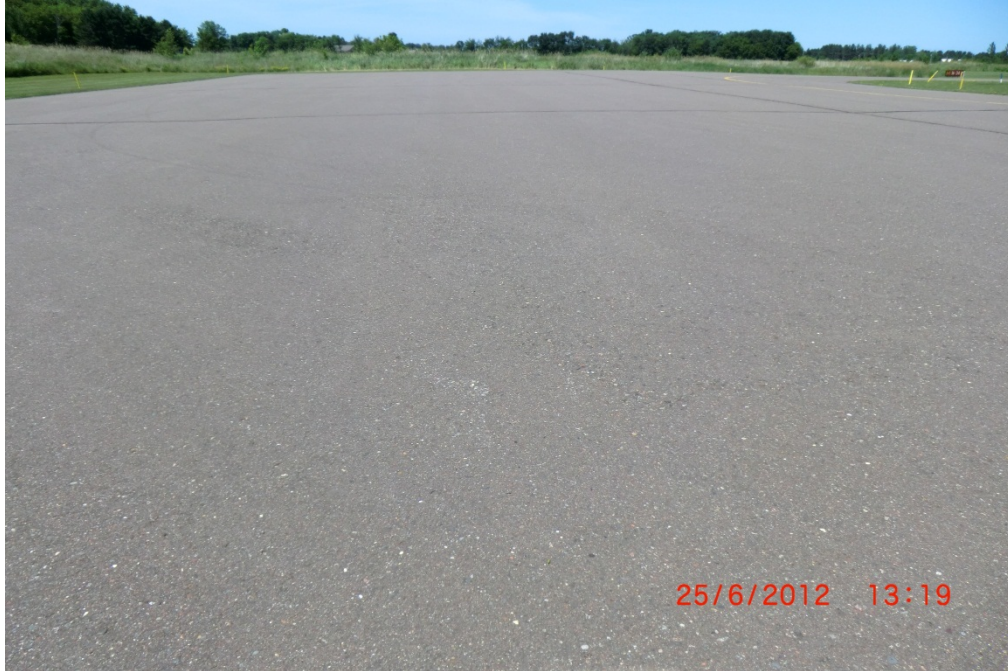
ROS RP2 001 (PCI = 68)

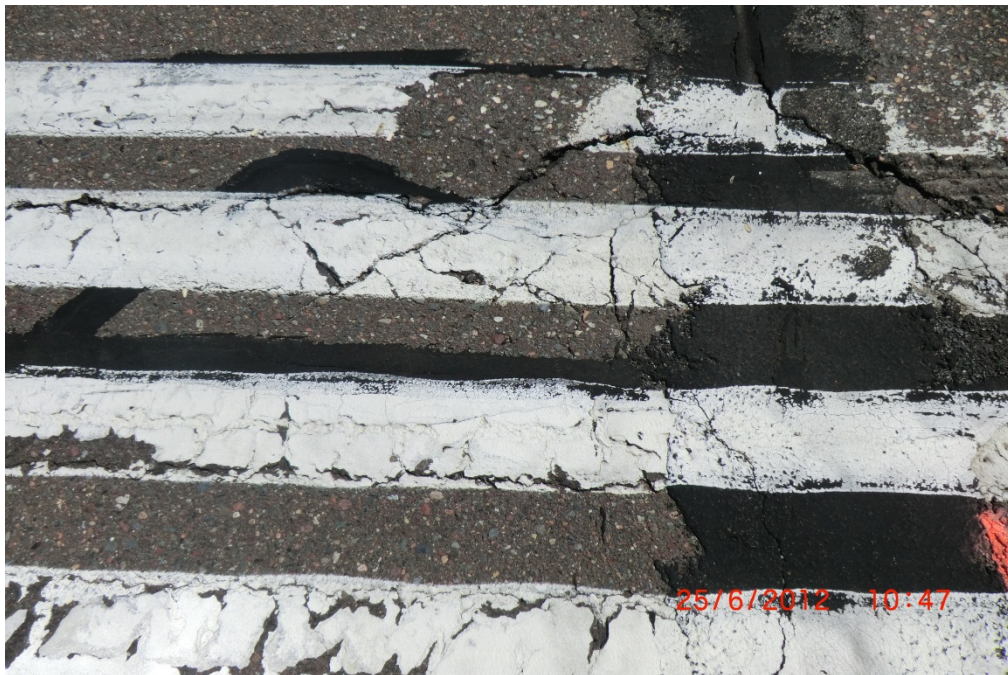
ROS RY1634 001 Alligator CR & Rutting, (PCI = 46)

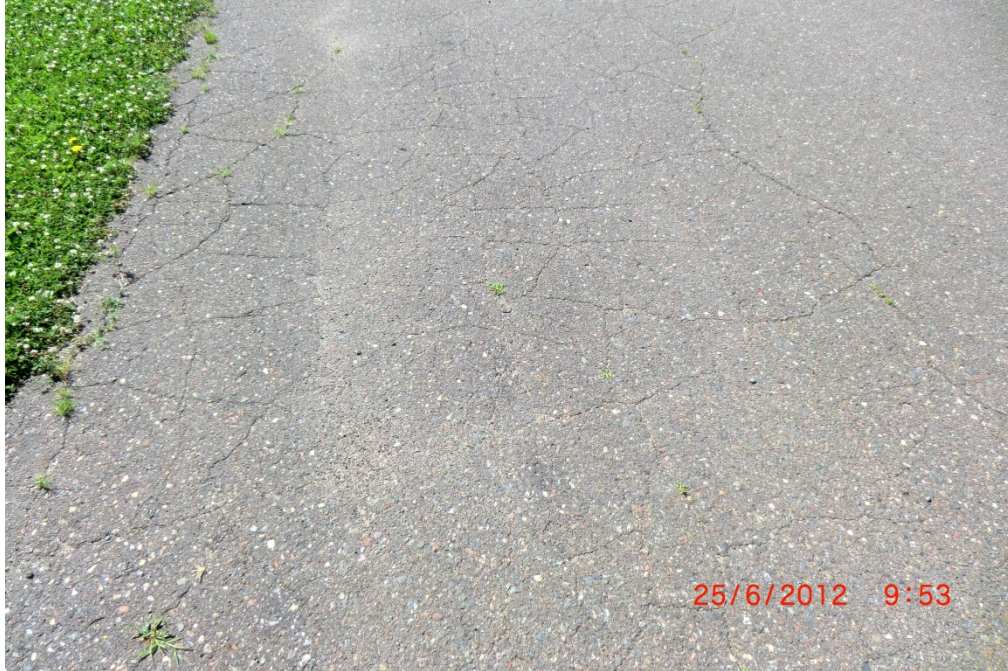
TLA	1	AC	35,365	1998	28	25	5.4	78	21	Alligator cracking, depression, L&T cracking, rutting
TLA	2	AC	38,360	2001*	74	60	3.6	0	99	Depression, L&T cracking, raveling, weathering

ROS TLA 001 Alligator Cracking, (PCI = 25)

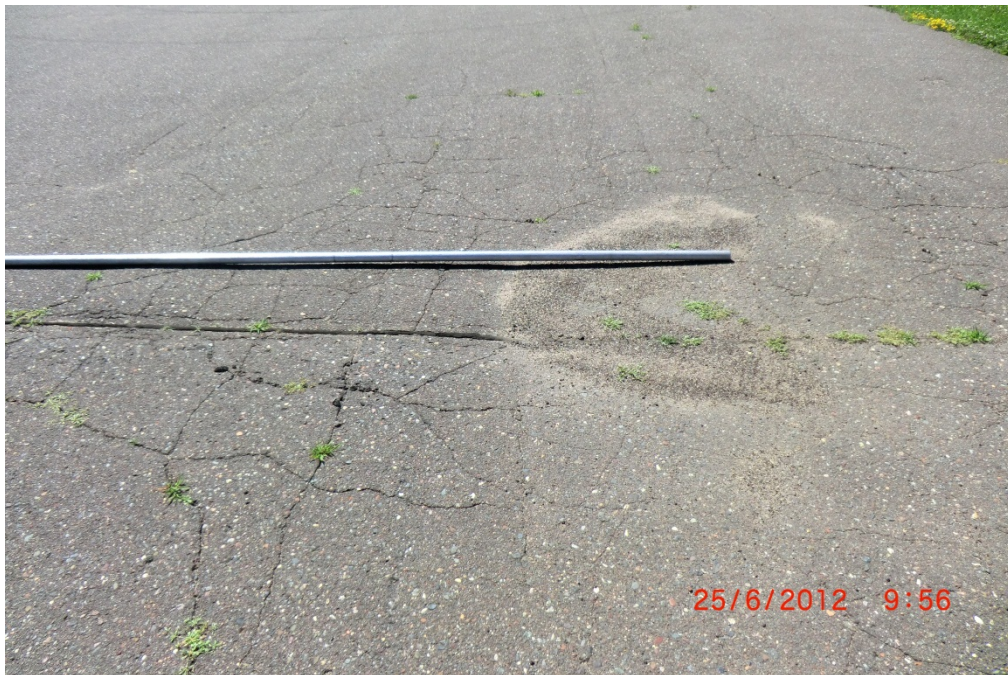
ROS TLA 001 Alligator Cracking & Rutting, (PCI = 25)
