# Minnesota Airport System Pavement Evaluation 2012 Update

Rushford Municipal Airport (55Y)

Rushford, Minnesota

January 2013

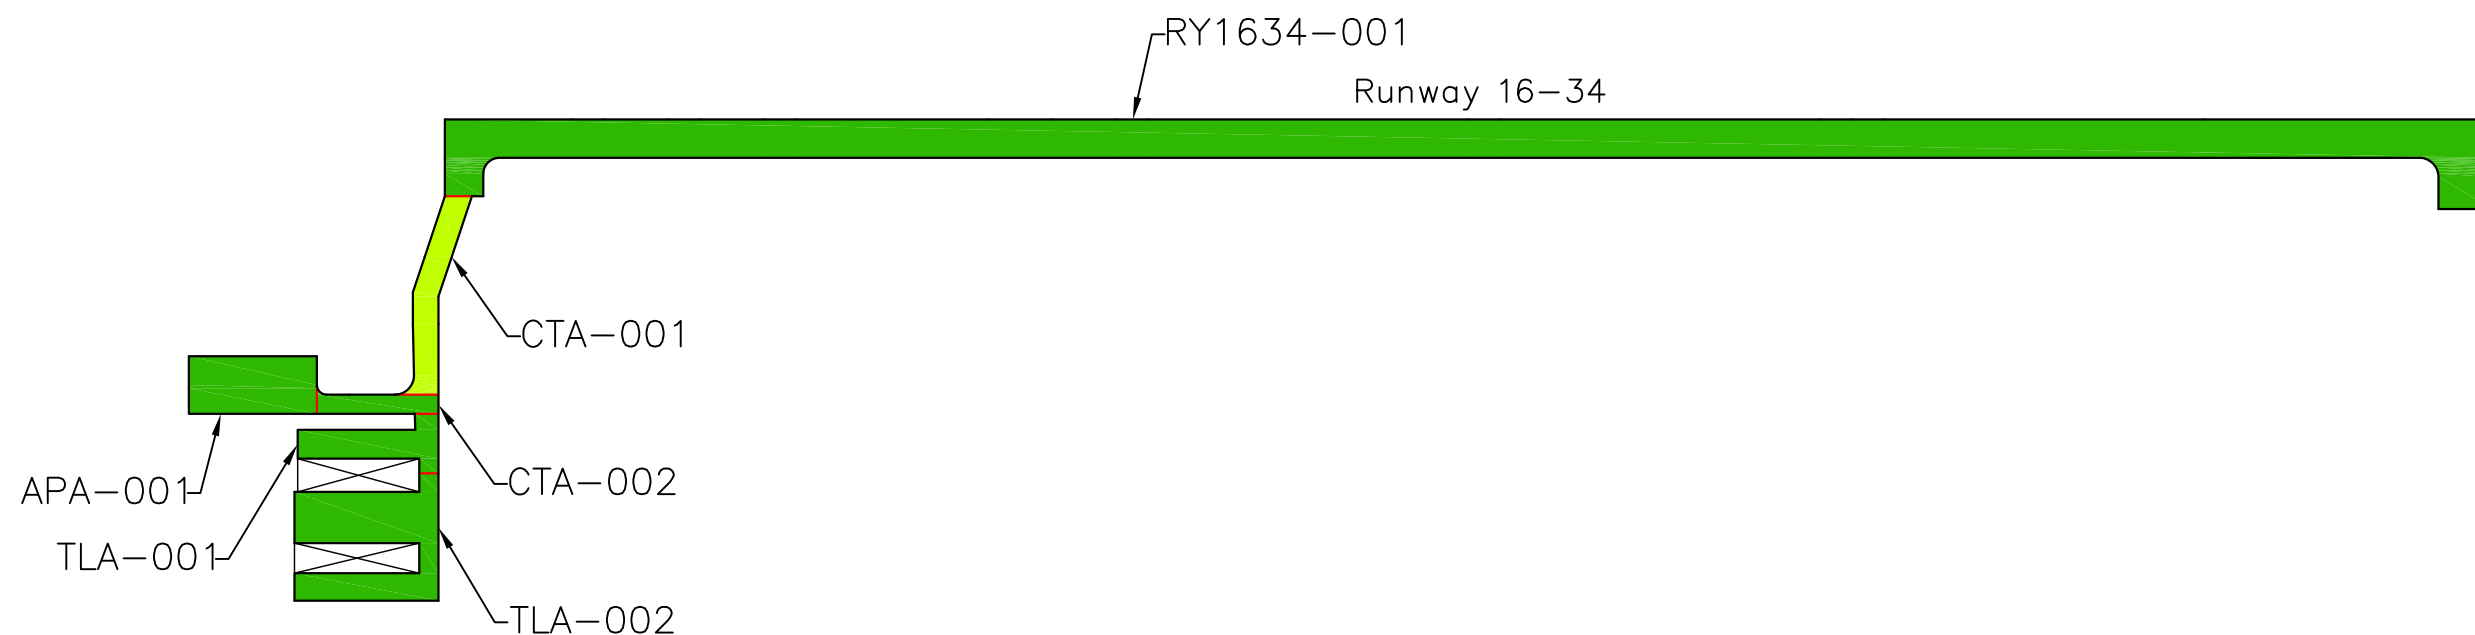
Figure 4. 2012 Pavement Condition Index Rating at Rushford Municipal Airport (55Y).

Figures 5 and 6 present the overall PCI for 55Y by area distribution and pavement use, respectively. Table 3 presents the PCI summary for each section at 55Y, including the drop in PCI per year. Generally, pavement sections will deteriorate between 1 and 3 PCI points per year. Sections deteriorating at higher rates may need maintenance above the normal application rates and should be closely monitored in case major repairs become necessary.

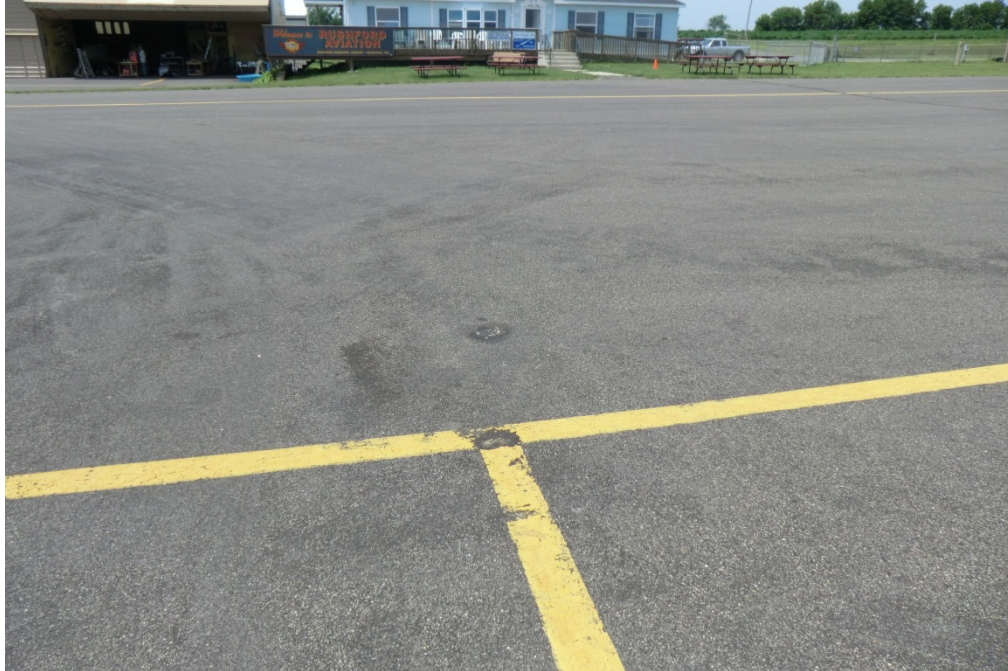
55Y APA 001 (PCI = 89)

Section Comments: maint R&E (crack seal)

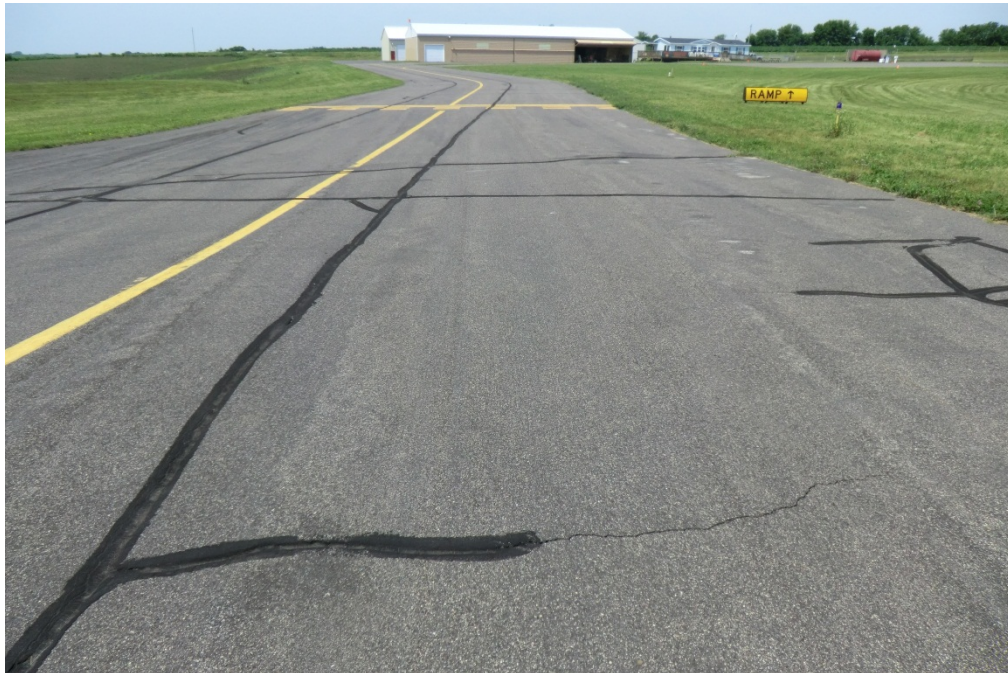
55Y CTA 001 (PCI = 75)

Section Comments: maint R&E (crack seal)

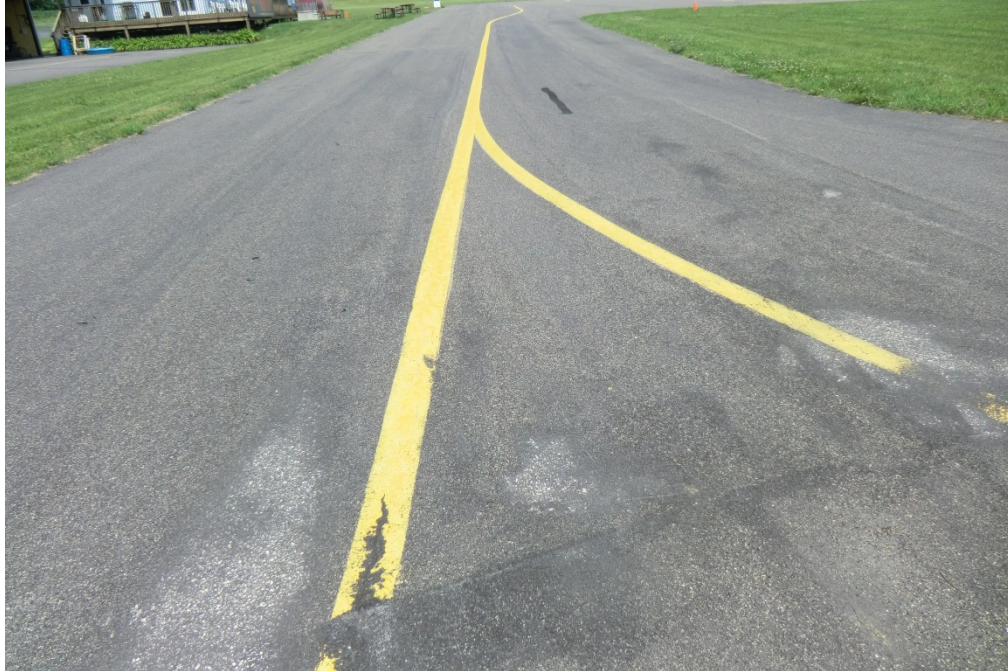
55Y CTA 002 (PCI = 89)

Section Comments: maint R&E (crack seal)

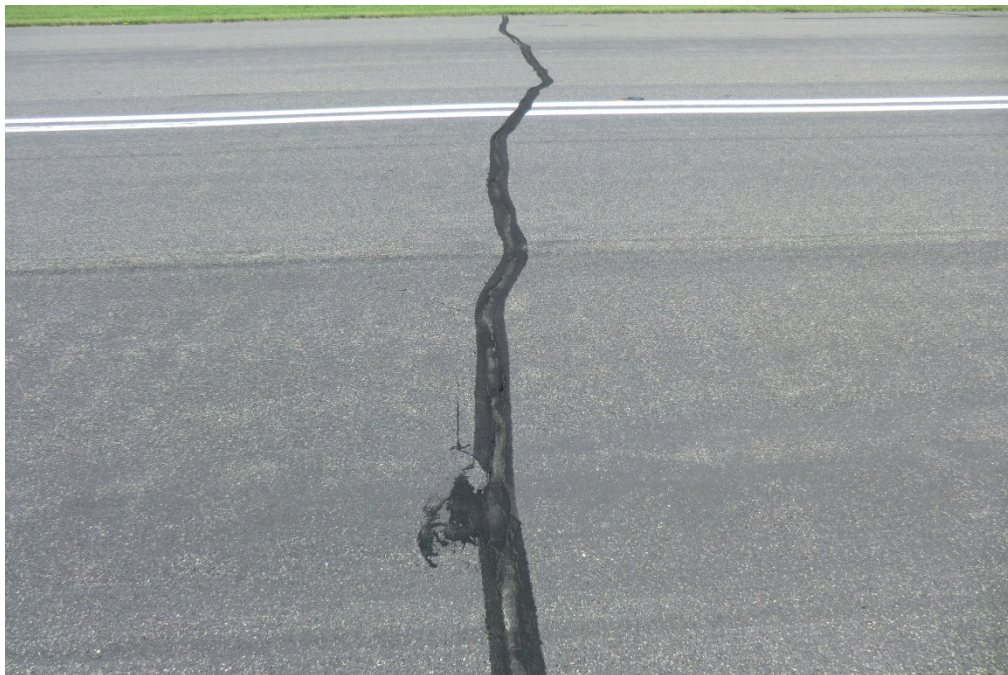
55Y RY1634 001 crack seal (PCI = 89)

Section Comments: maint R&E (crack seal)

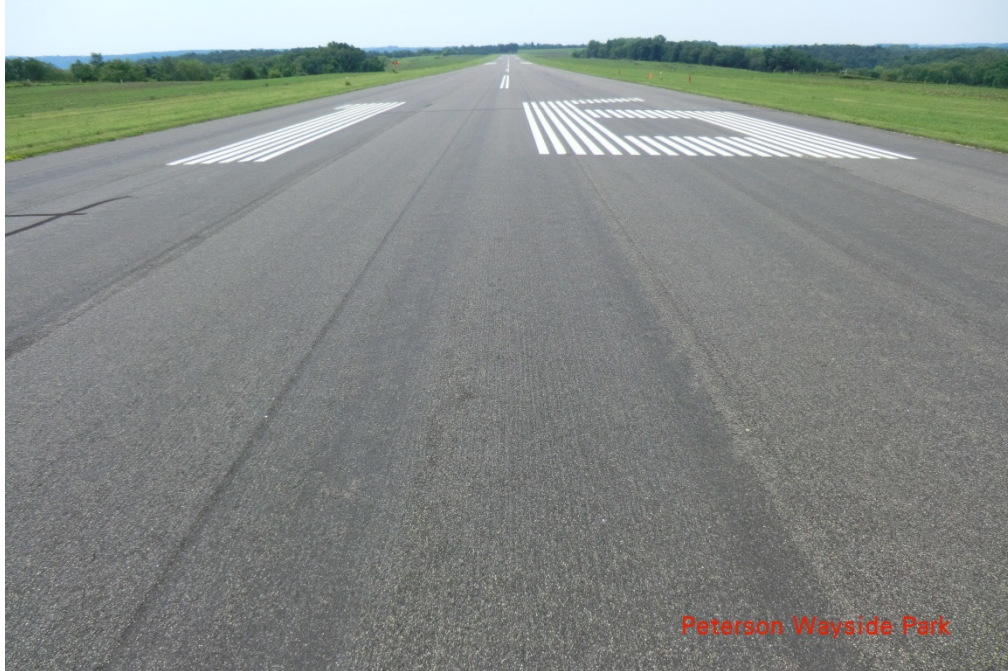
55Y RY1634 001 (PCI = 89)

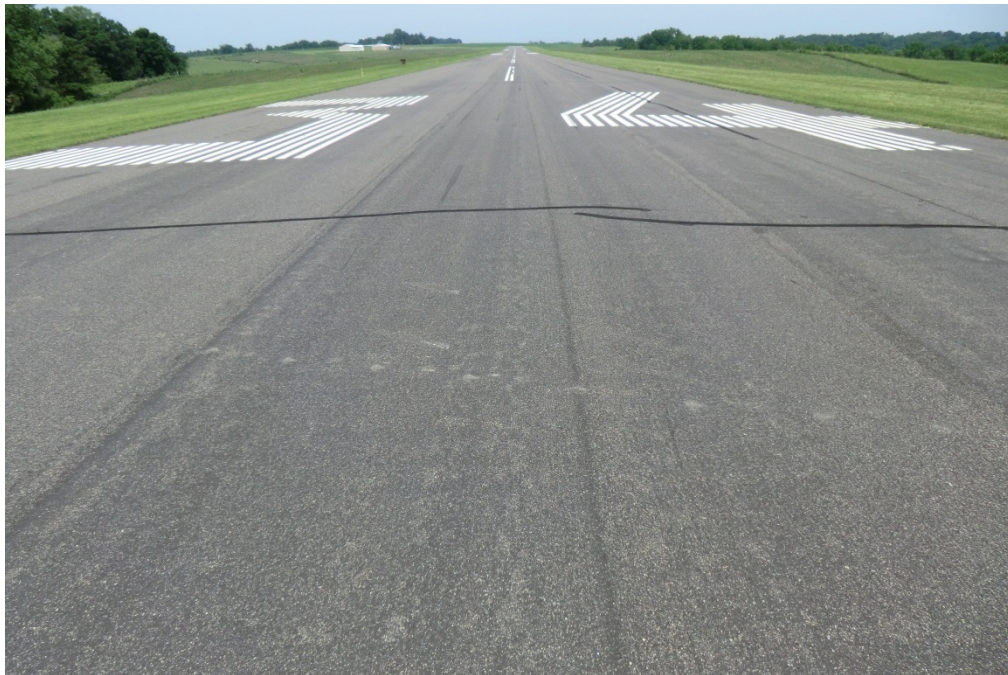
55Y RY1634 001 (PCI = 89)

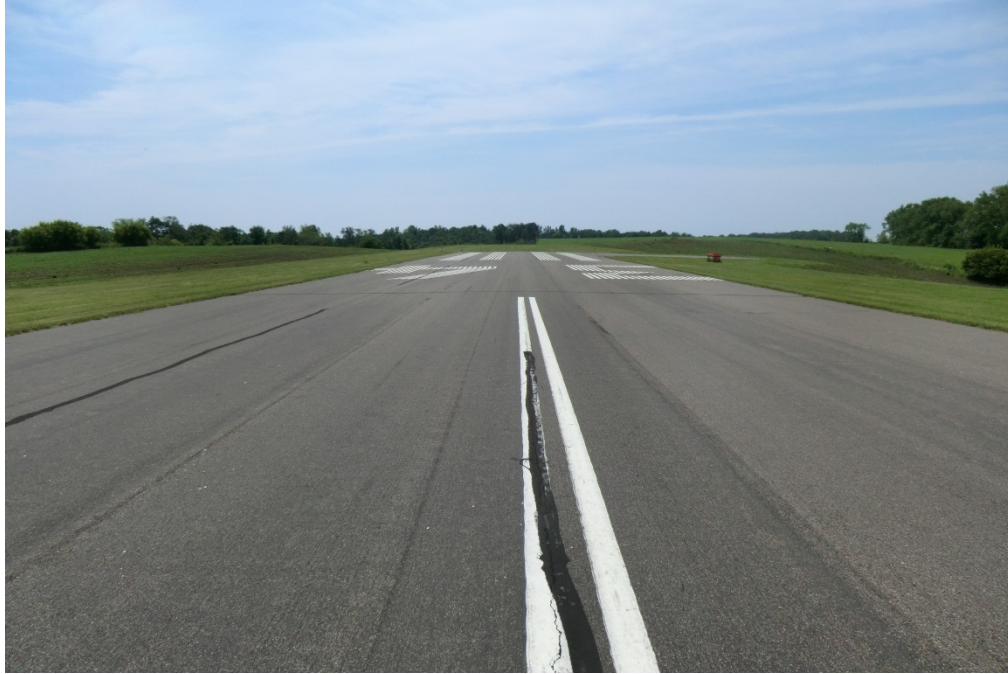
55Y RY1634 001 (PCI = 89)

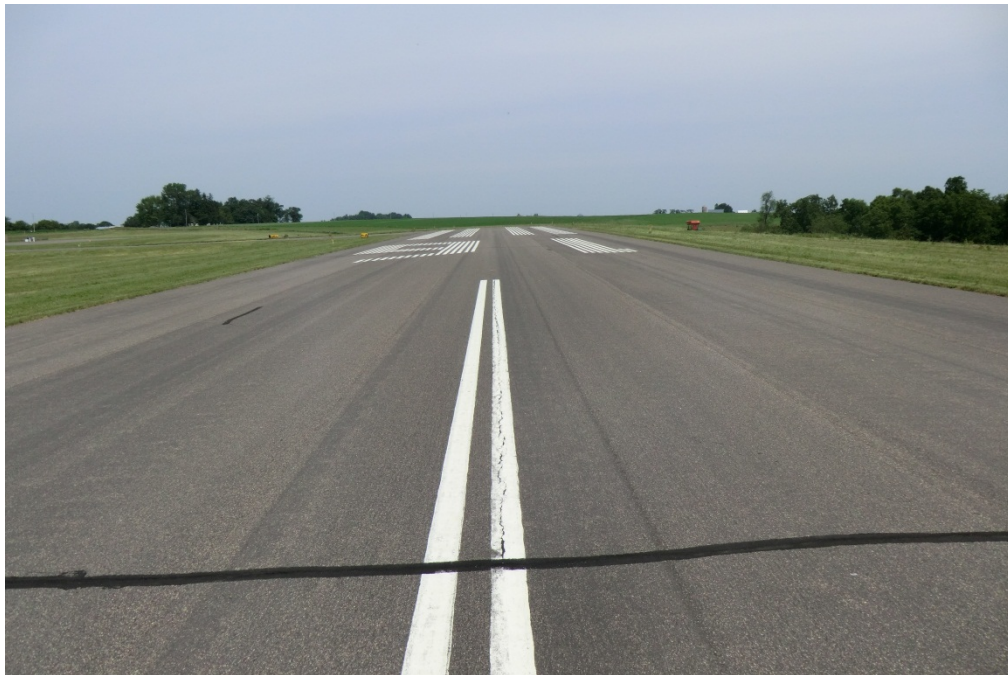
55Y RY1634 001 (PCI = 89)

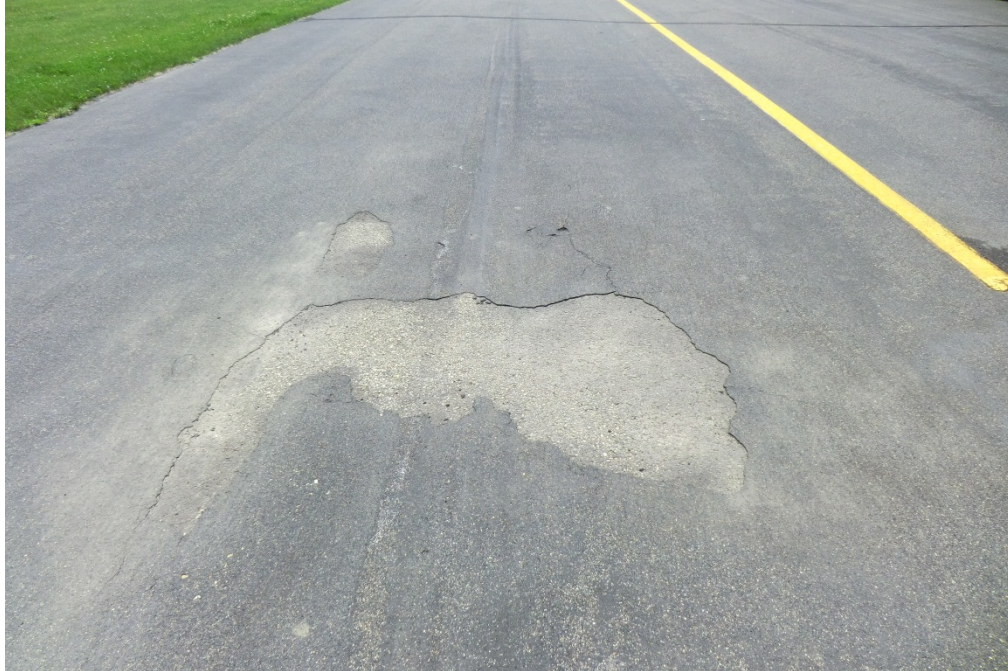
55Y TLA 001 raveling (PCI = 91)

Section Comments: maint R&E (crack seal)

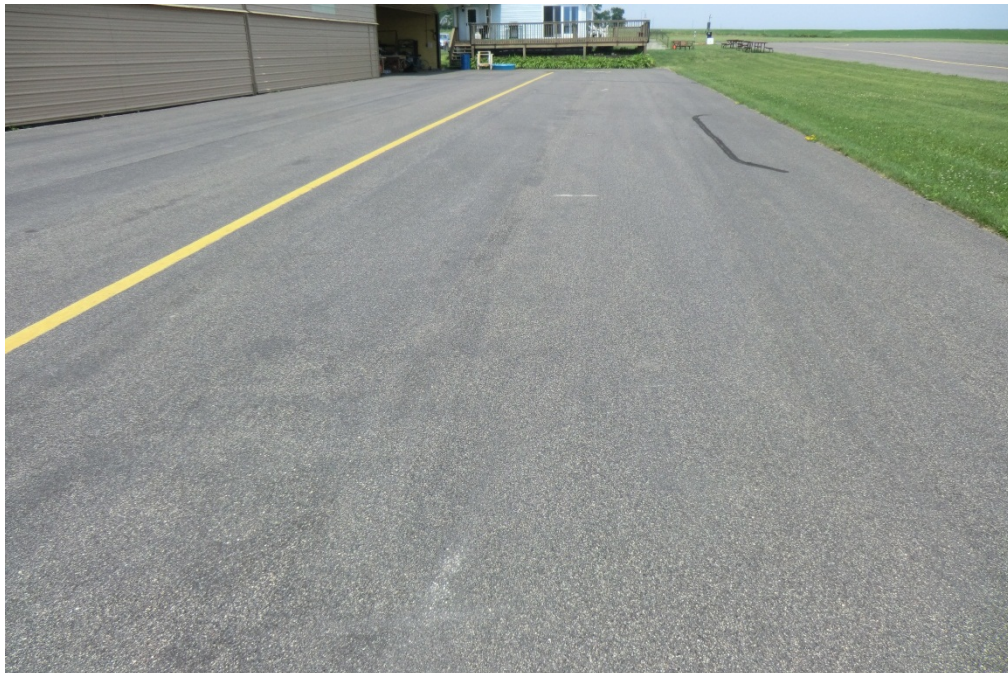
55Y TLA 001 (PCI = 91)

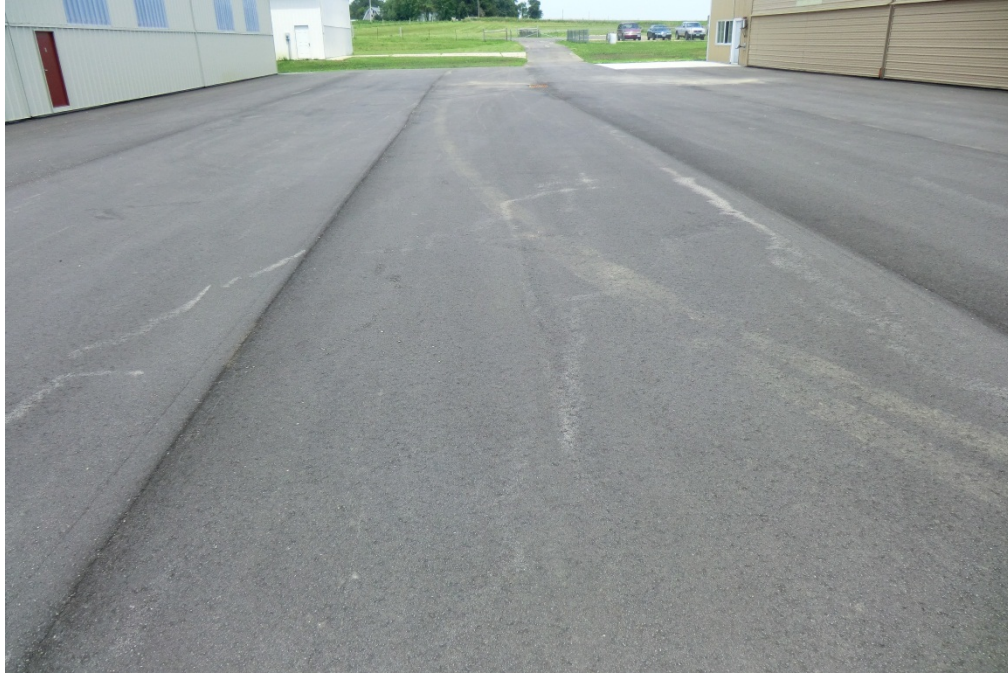
55Y TLA 002 (PCI = 100)
