# Minnesota Airport System Pavement Evaluation 2012 Update

Silver Bay Municipal Airport (BFW)

Silver Bay, Minnesota

January 2013

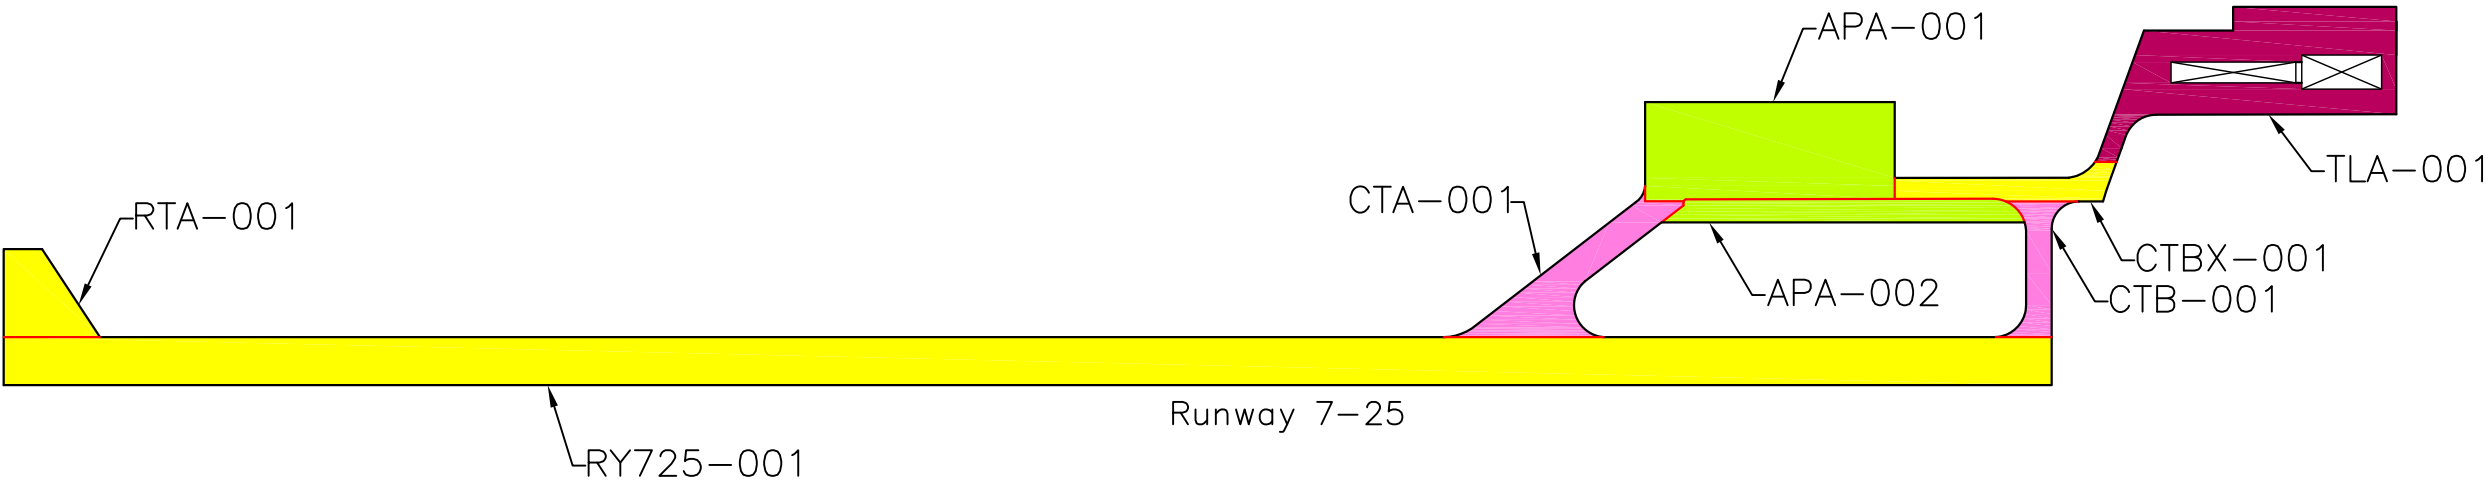
Figure 4. 2012 Pavement Condition Index Rating at Silver Bay Municipal Airport (BFW).

Figures 5 and 6 present the overall PCI for BFW by area distribution and pavement use, respectively. Table 3 presents the PCI summary for each section at BFW, including the drop in PCI per year. Generally, pavement sections will deteriorate between 1 and 3 PCI points per year. Sections deteriorating at higher rates may need maintenance above the normal application rates and should be closely monitored in case major repairs become necessary.

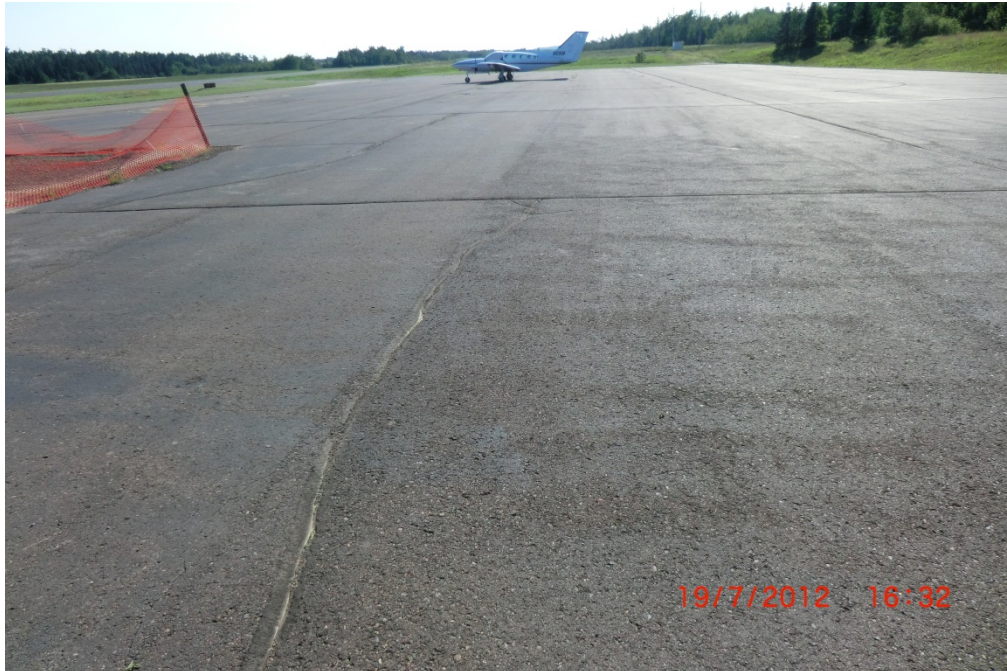
BFW APA 001 (PCI = 72)

| Branch ID | Section ID | Surface type <sup>1</sup> | Section area (SF) | LCD <sup>2</sup> | 2009 PCI | 2012 PCI | Drop in PCI/Yr <sup>3</sup> | % Deduct due to | | Distress types |
|---|---|---|---|---|---|---|---|---|---|---|
| APA | 1 | AC | 57,420 | 2001 | 70 | 72 | 2.5 | 32 | 62 | Alligator cracking, depression, Longitudinal & transverse (L&T) cracking, swelling |

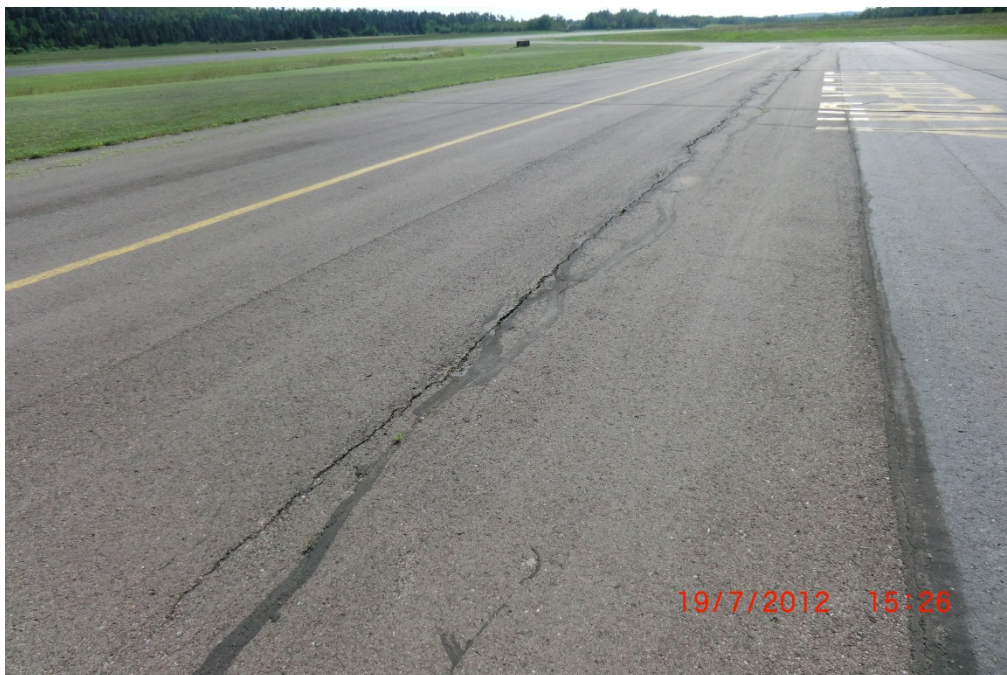
BFW APA 002 (PCI = 75)

| Branch ID | Section ID | Surface type <sup>1</sup> | Section area (SF) | LCD <sup>2</sup> | 2009 PCI | 2012 PCI | Drop in PCI/Yr <sup>3</sup> | % Deduct due to | | Distress types |
|---|---|---|---|---|---|---|---|---|---|---|
| APA | 2 | AC | 19,260 | 2006 | 77 | 75 | 4.2 | 0 | 78 | L&T cracking, swelling |

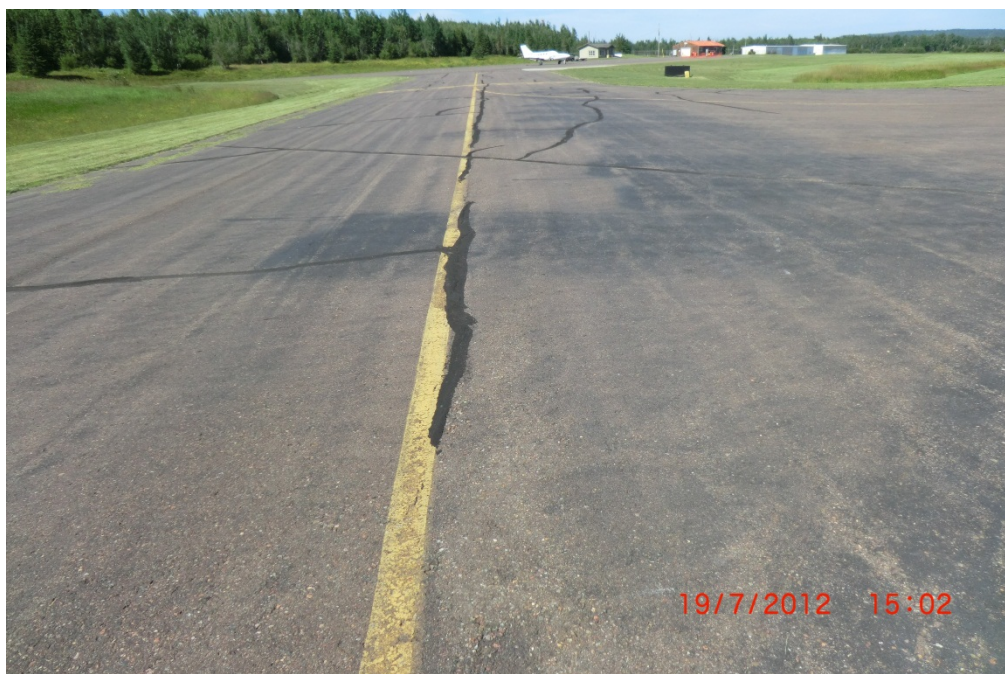
BFW CTA 001 (PCI = 41)

| Branch ID | Section ID | Surface type <sup>1</sup> | Section area (SF) | LCD <sup>2</sup> | 2009 PCI | 2012 PCI | Drop in PCI/Yr <sup>3</sup> | % Deduct due to | | Distress types |
|---|---|---|---|---|---|---|---|---|---|---|
| CTA | 1 | AC | 24,400 | 2001 | 63 | 41 | 5.4 | 61 | 37 | Alligator cracking, L&T cracking, raveling, rutting, swelling |

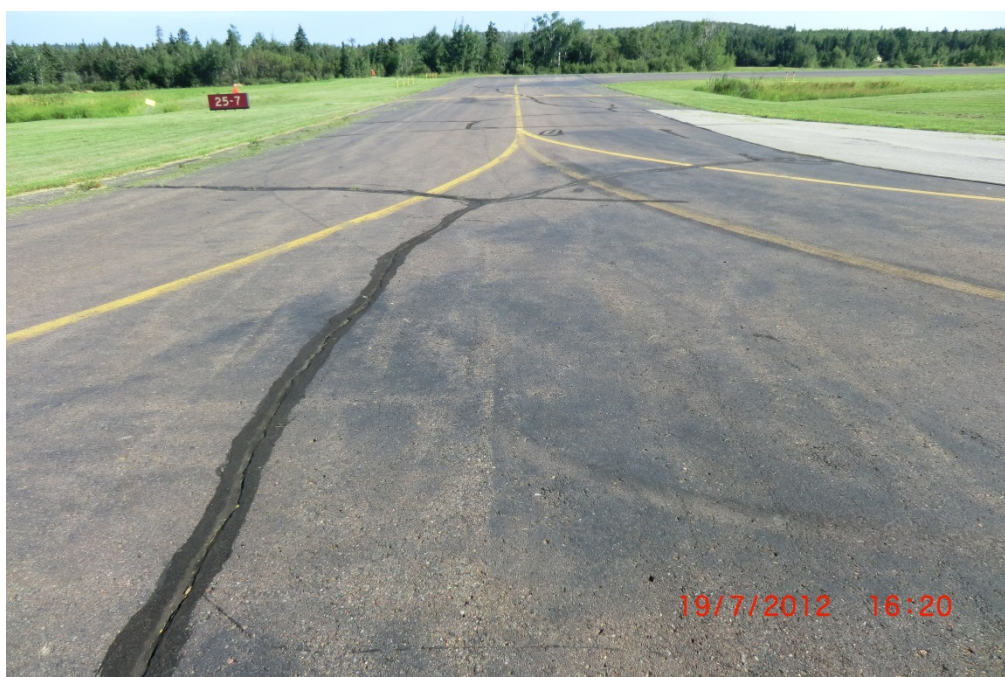
BFW CTB 001 (PCI = 49)

| Branch ID | Section ID | Surface type <sup>1</sup> | Section area (SF) | LCD <sup>2</sup> | 2009 PCI | 2012 PCI | Drop in PCI/Yr <sup>3</sup> | % Deduct due to | | Distress types |
|---|---|---|---|---|---|---|---|---|---|---|
| CTB | 1 | AC | 8,367 | 1982 | 56 | 49 | 1.7 | 51 | 37 | Alligator cracking, L&T cracking, rutting, swelling |

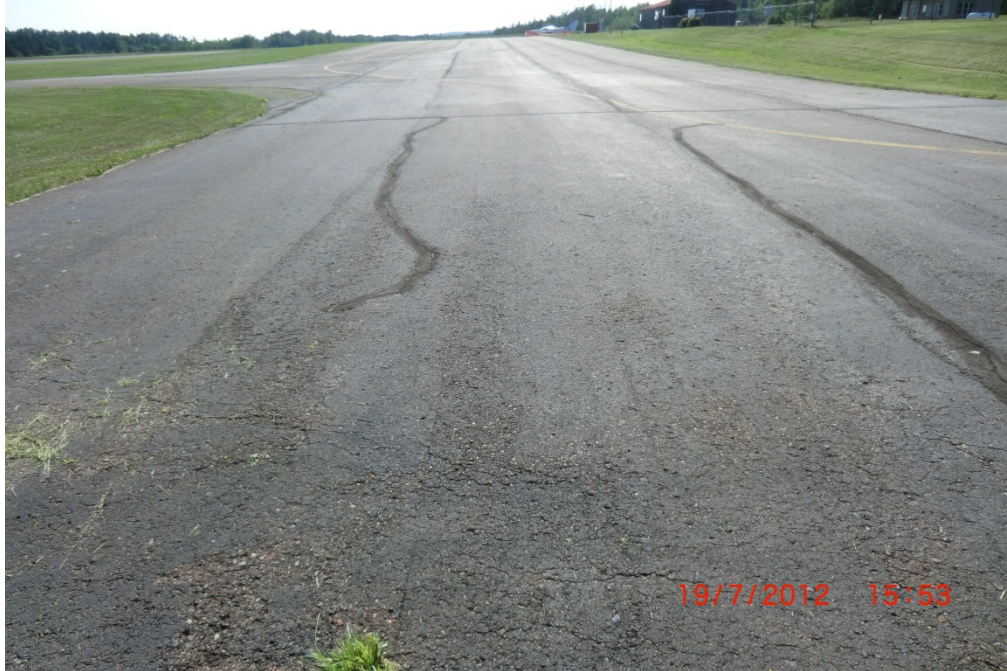
BFW CTBX 001 (PCI = 69)

| Branch ID | Section ID | Surface type <sup>1</sup> | Section area (SF) | LCD <sup>2</sup> | 2009 PCI | 2012 PCI | Drop in PCI/Yr <sup>3</sup> | % Deduct due to | | Distress types |
|---|---|---|---|---|---|---|---|---|---|---|
| CTBX | 1 | AC | 13,320 | 2001 | 72 | 69 | 2.8 | 0 | 100 | L&T cracking |

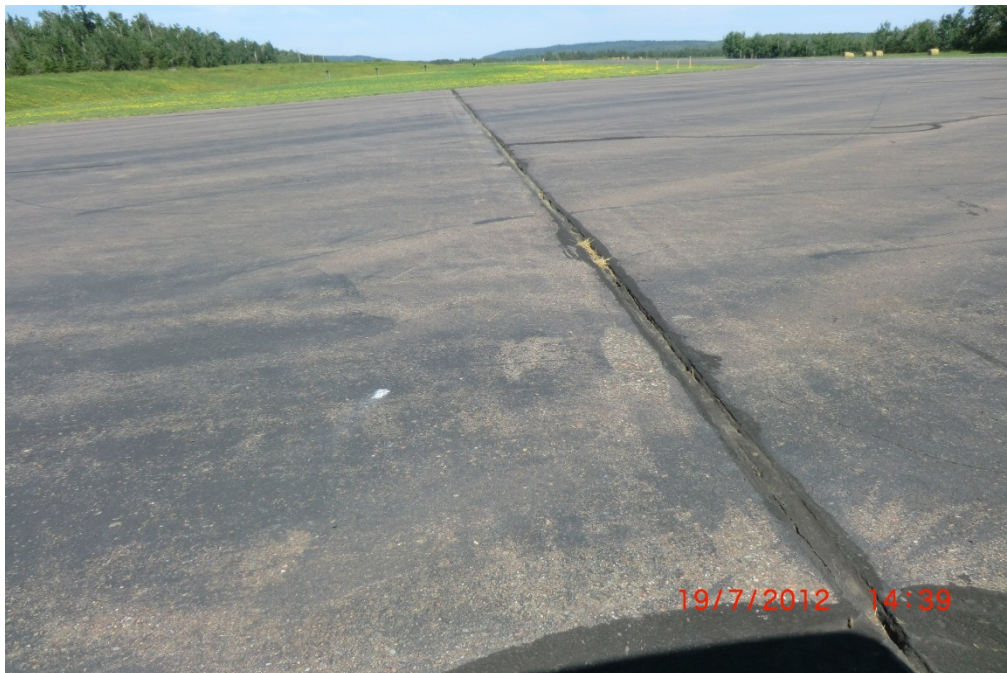
BFW RTA 001 (PCI = 57)

| Branch ID | Section ID | Surface type <sup>1</sup> | Section area (SF) | LCD <sup>2</sup> | 2009 PCI | 2012 PCI | Drop in PCI/Yr <sup>3</sup> | % Deduct due to | | Distress types |
|---|---|---|---|---|---|---|---|---|---|---|
| RTA | 1 | AC | 14,200 | 2001 | 66 | 57 | 3.9 | 65 | 35 | Alligator cracking, L&T cracking |

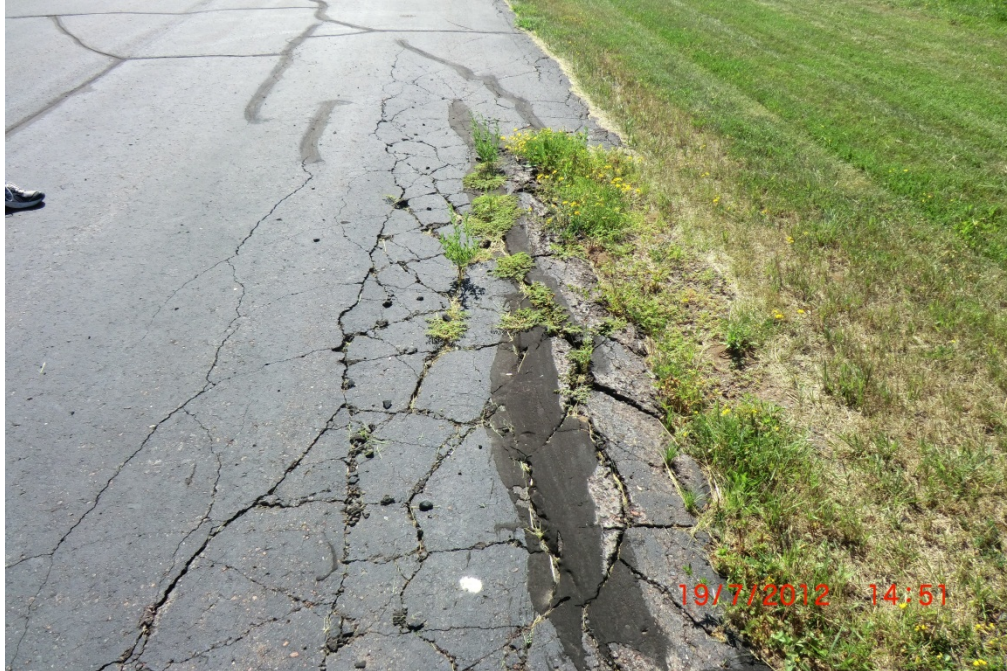
BFW RY725 001 Alligator Cracking & Swelling (PCI = 65)

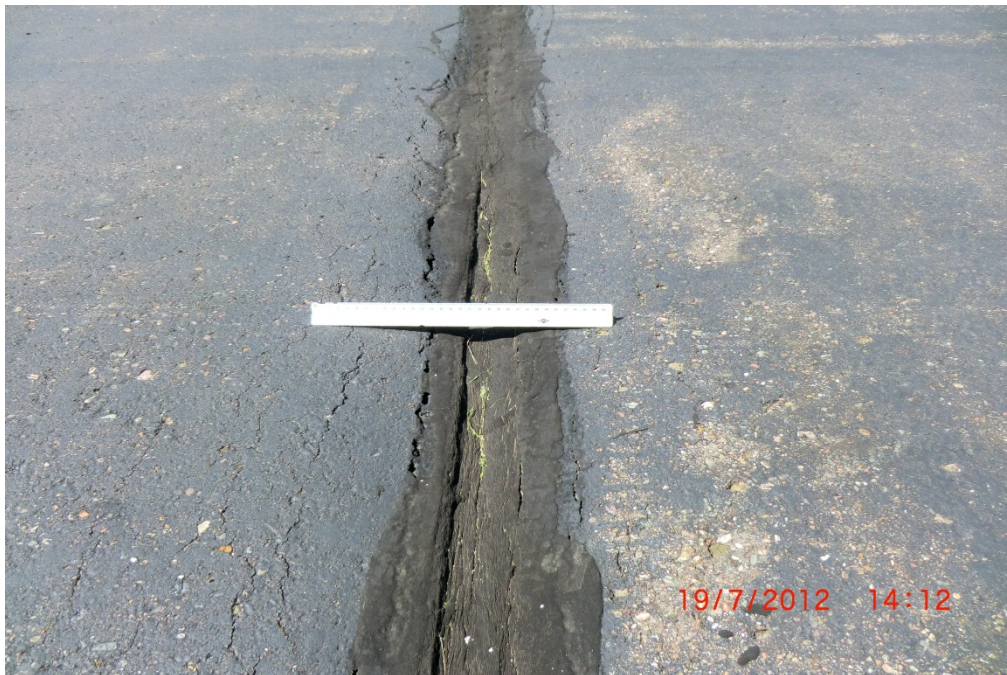
BFW RY725 001 L & T Cracking (PCI = 65)

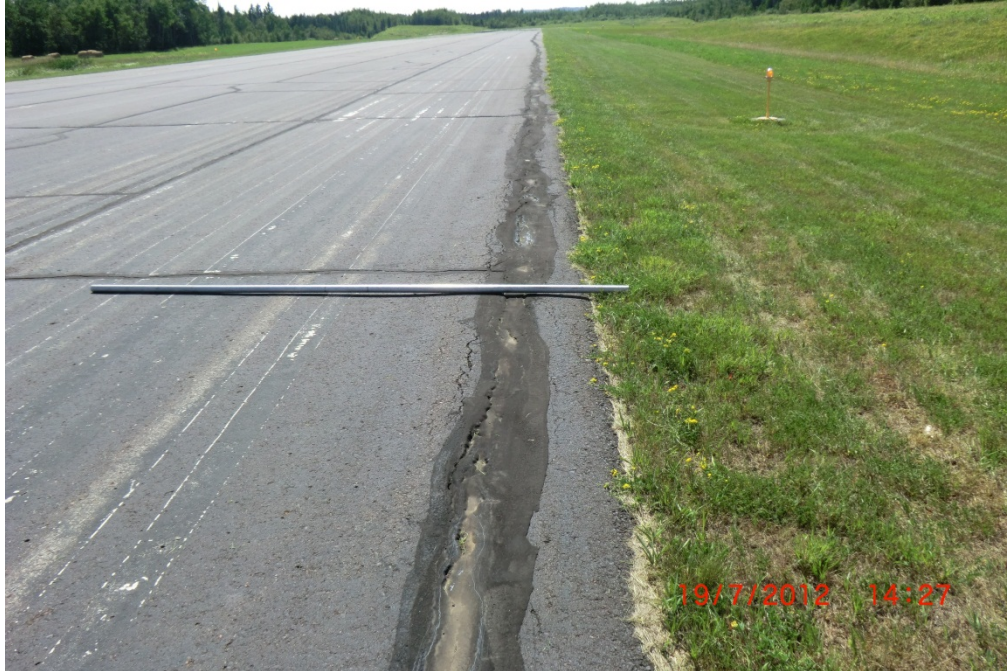
BFW RY725 001 Edge Cracking (PCI = 65)

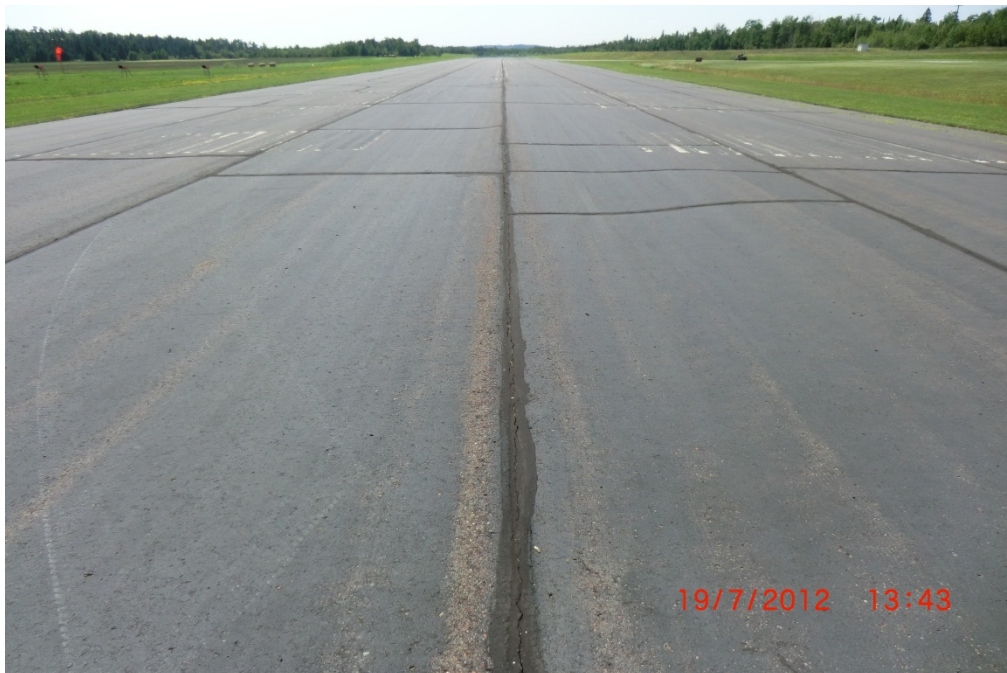
BFW RY725 001 (PCI = 65)

| Branch ID | Section ID | Surface type <sup>1</sup> | Section area (SF) | LCD <sup>2</sup> | 2009 PCI | 2012 PCI | Drop in PCI/Yr <sup>3</sup> | % Deduct due to | | Distress types |
|---|---|---|---|---|---|---|---|---|---|---|
| RY725 | 1 | AC | 240,000 | 2001 | 71 | 65 | 3.2 | 46 | 33 | Alligator cracking, depression, L&T cracking, rutting, swelling |

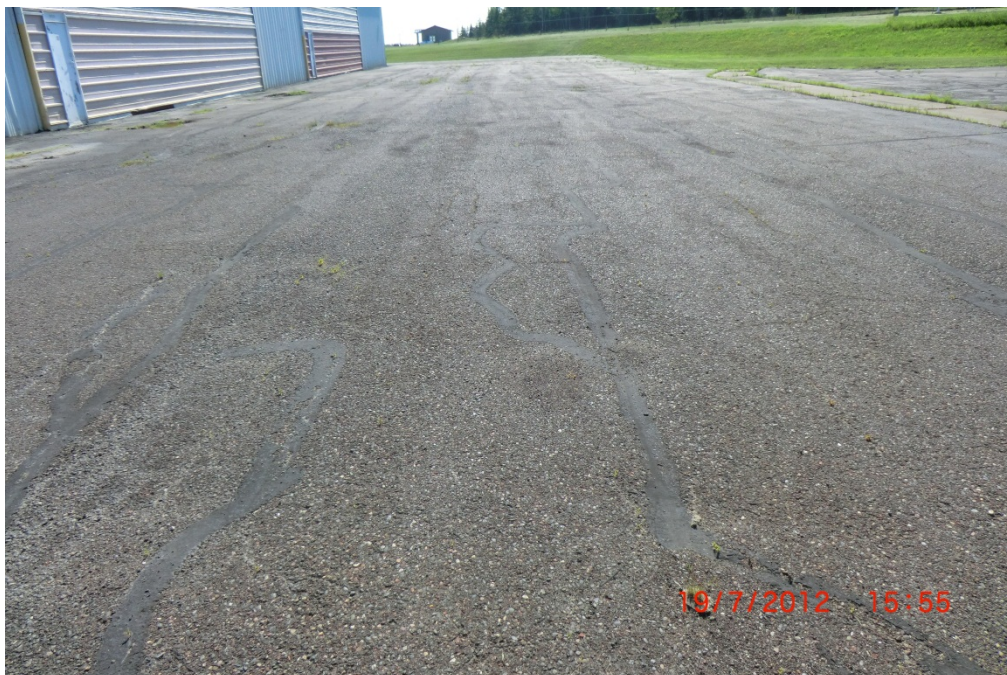
BFW TLA 001 (PCI = 13)

| Branch ID | Section ID | Surface type <sup>1</sup> | Section area (SF) | LCD <sup>2</sup> | 2009 PCI | 2012 PCI | Drop in PCI/Yr <sup>3</sup> | % Deduct due to | | Distress types |
|---|---|---|---|---|---|---|---|---|---|---|
| TLA | 1 | AC | 60,660 | 1982* | 22 | 13 | 2.9 | 65 | 27 | Alligator cracking, block cracking, depression, L&T cracking, patching, raveling, rutting, swelling |
