# Minnesota Airport System Pavement Evaluation 2012 Update

Springfield Municipal Airport (D42)

Springfield, Minnesota

January 2013

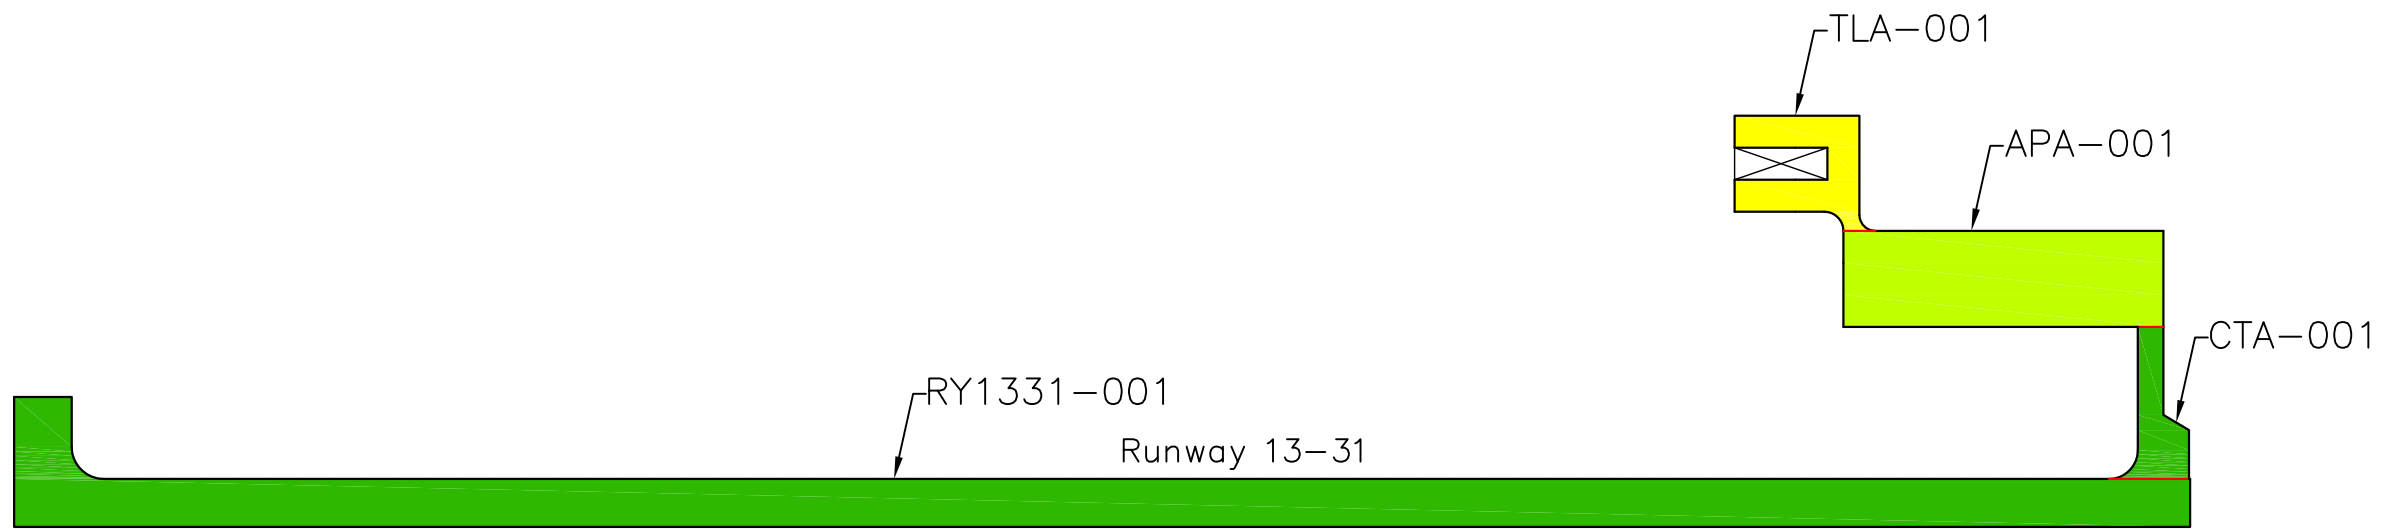
Figure 4. 2012 Pavement Condition Index Rating at Springfield Municipal Airport (D42).

Branch ID	Section ID	Surface type <sup>1</sup>	Section area (SF)	LCD <sup>2</sup>	2009 PCI	2012 PCI	Drop in PCI/Yr <sup>3</sup>	% Deduct due to		Distress types
								Load <sup>4</sup>	Climate <sup>5</sup>	
APA	1	AAC	75,000	2009	100	85	5.0	0	100	Longitudinal & transverse (L&T) cracking
CTA	1	AAC	12,000	2009	100	86	4.7	0	100	L&T cracking
RY1331	1	AAC	255,000	2009	100	86	4.7	0	100	L&T cracking
TLA	1	AAC	22,900	1994*	83	68	1.8	0	100	L&T cracking, raveling

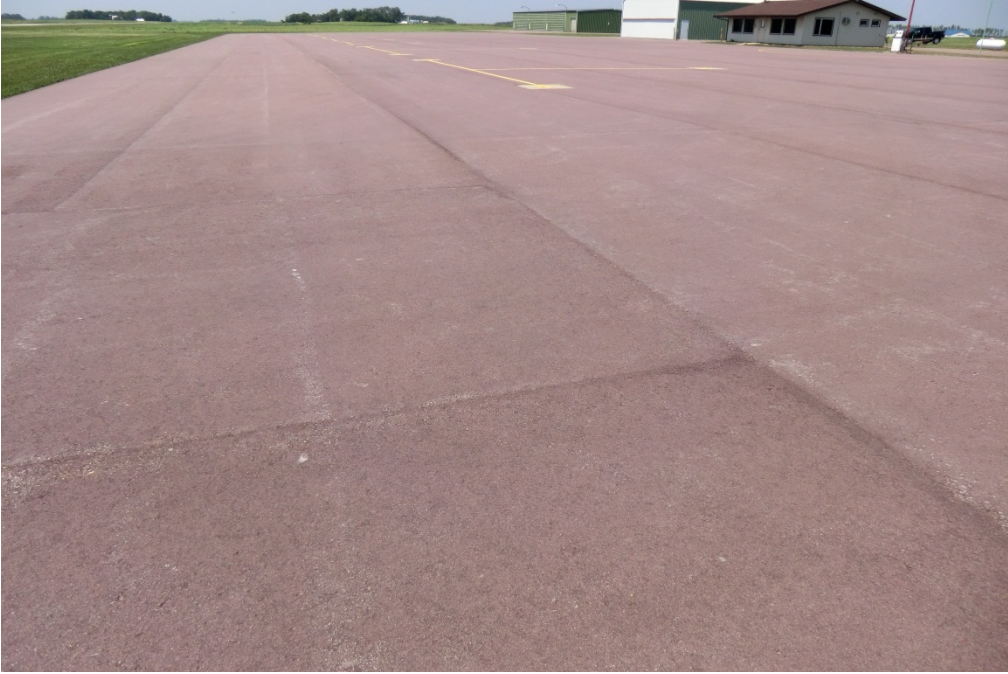
D42 APA 001 (PCI = 85)

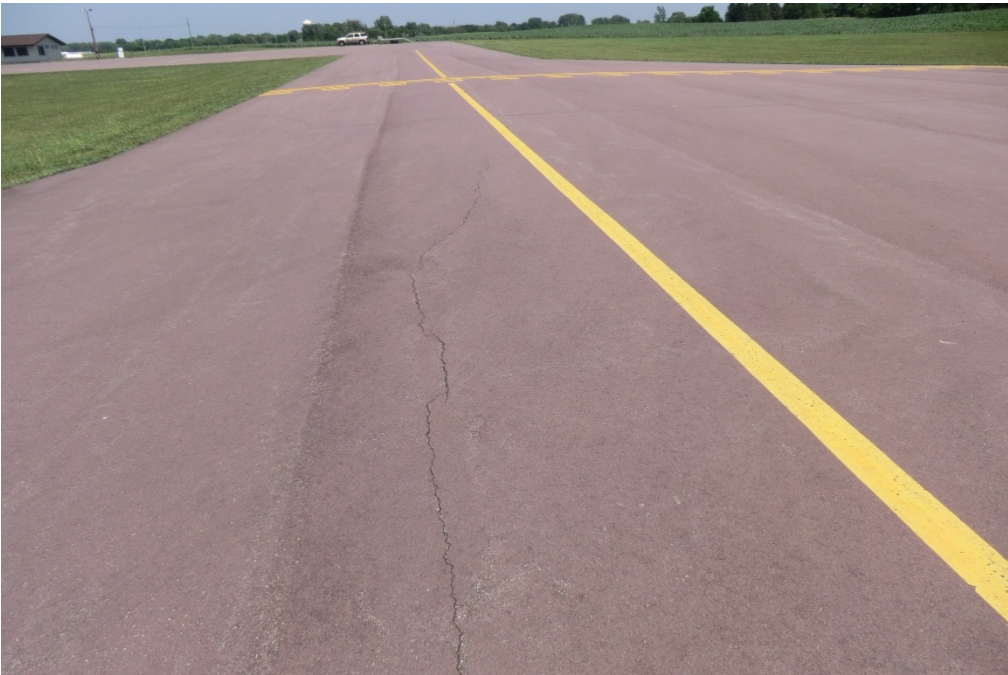
D42 CTA 001 (PCI = 86)

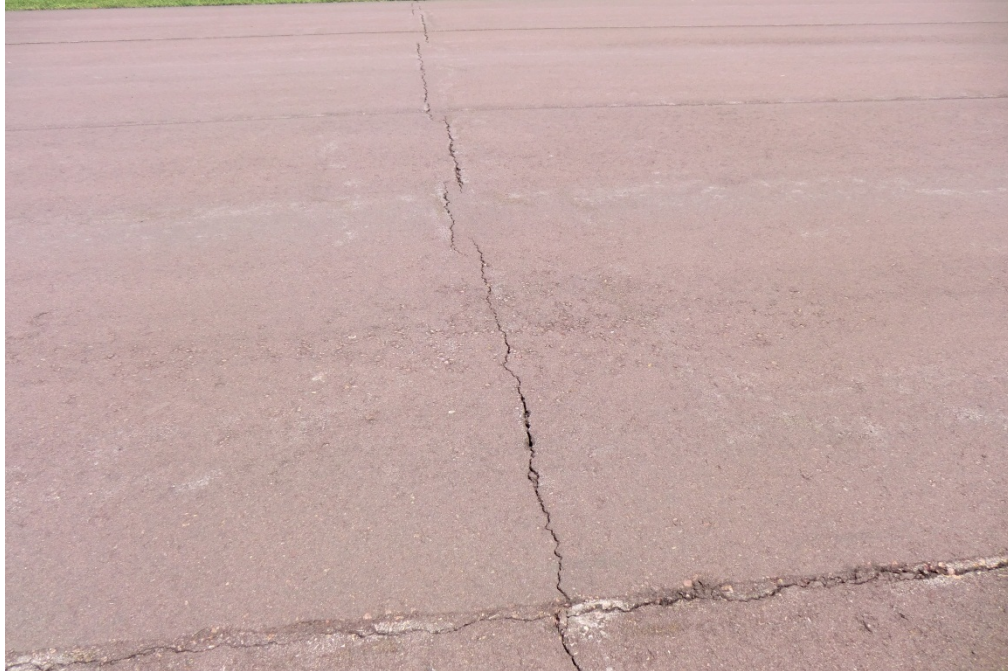
D42 RY1331 001 L & T CR (PCI = 86)

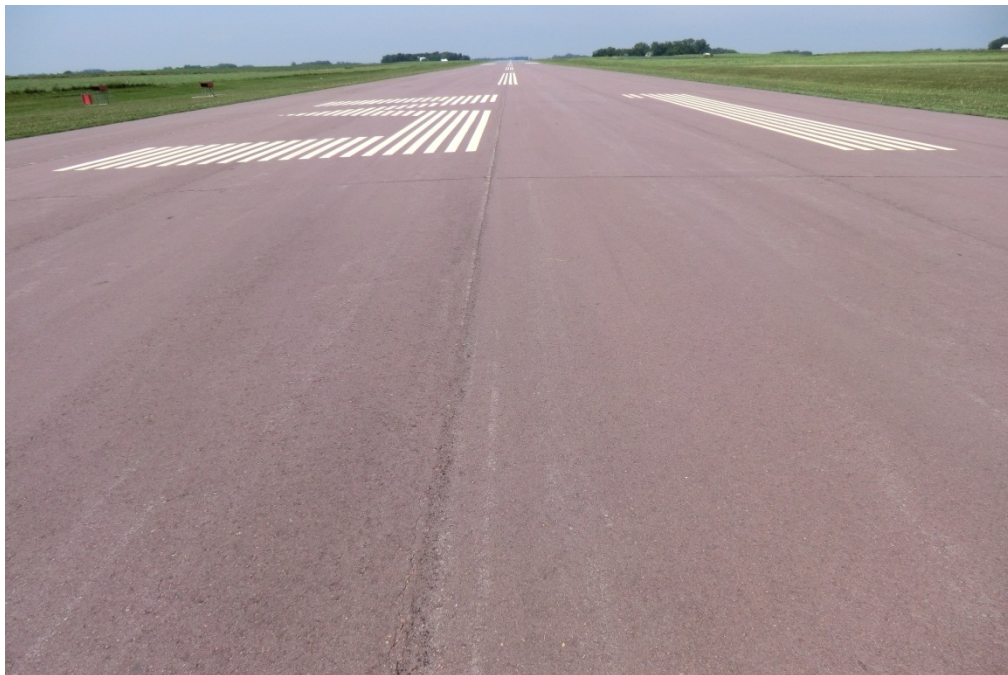
D42 RY1331 001 (PCI = 86)

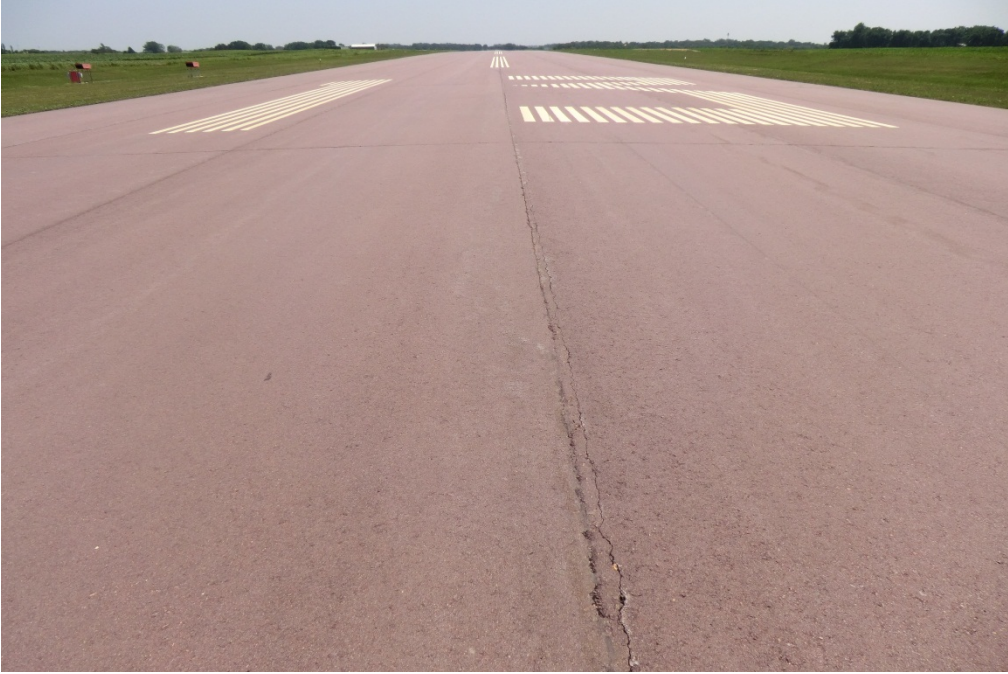
D42 RY1331 (PCI = 86)

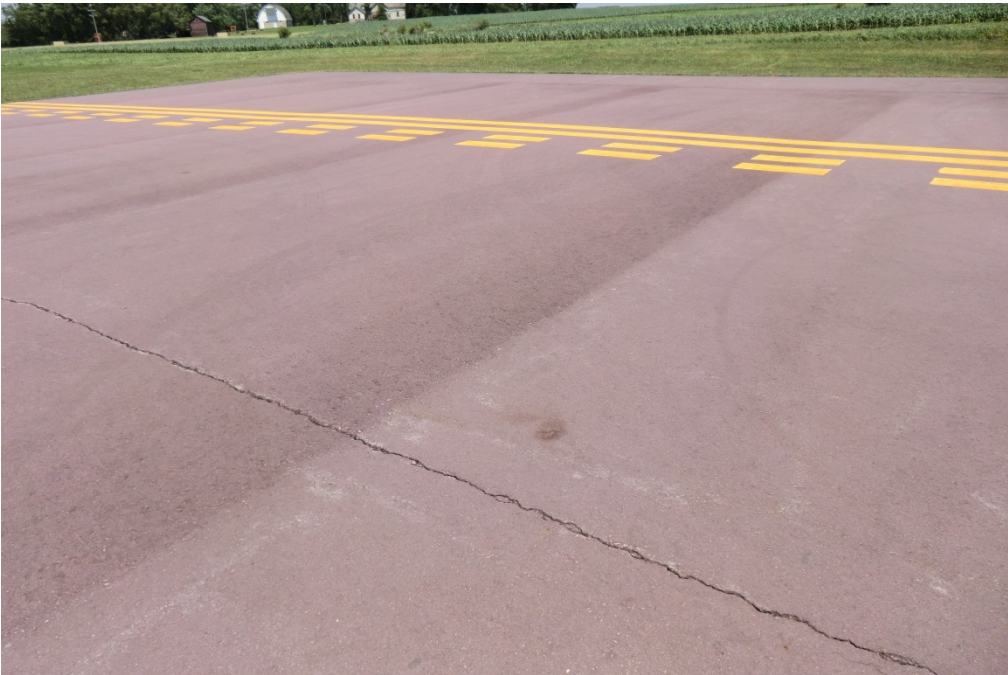
D42 RY1331 001 (PCI = 86)

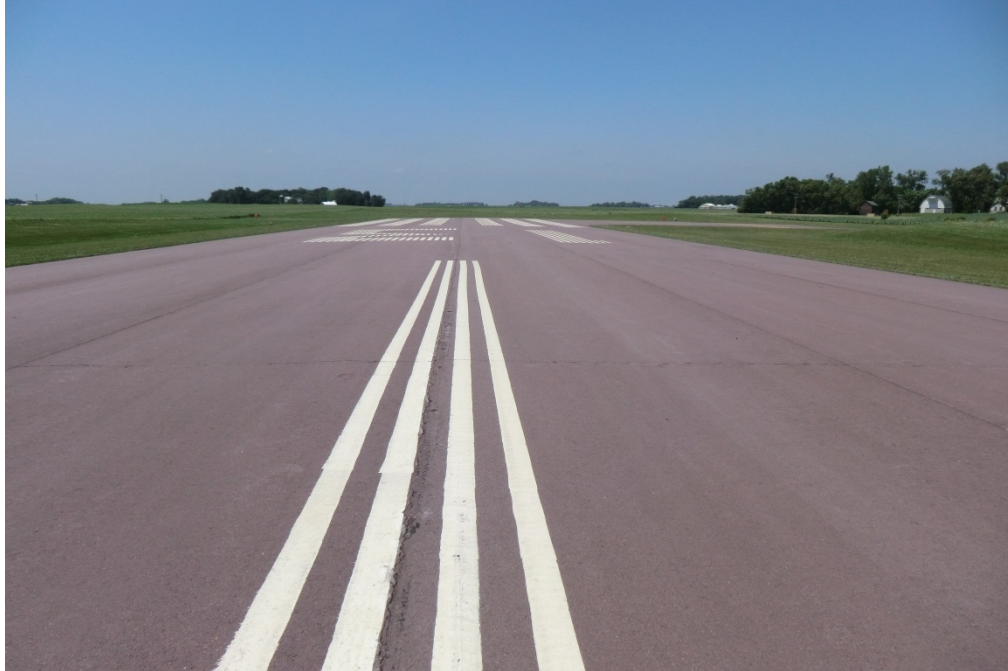
D42 RY1331 001 (PCI = 86)

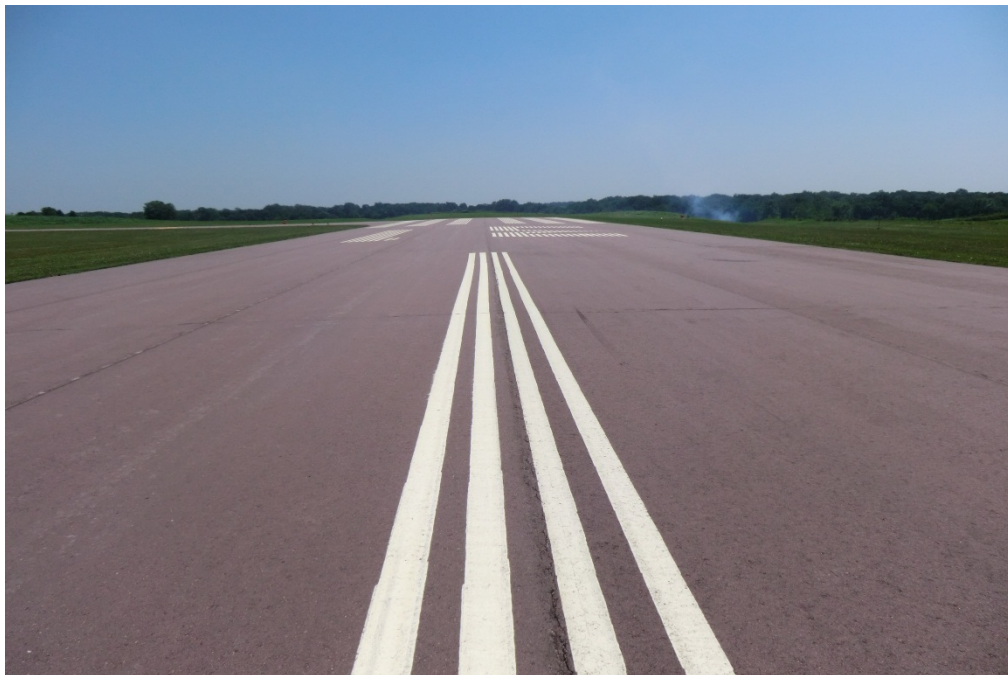
D42 RY1331 001 (PCI = 86)

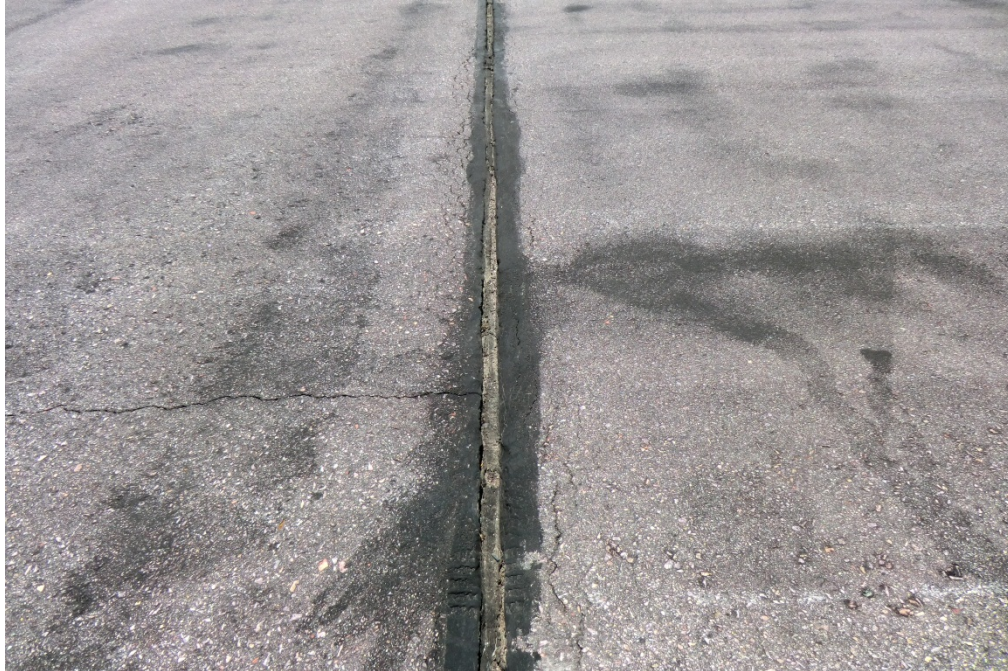
D42 TLA 001 L & T CR, (PCI = 68)

48	LONGITUDINAL/TRANSVERSE CRACKING	H	55.00 Ft	Comments:
52	RAVELING	L	25.00 SqFt	Comments:
48	LONGITUDINAL/TRANSVERSE CRACKING	L	32.00 Ft	Comments:
48	LONGITUDINAL/TRANSVERSE CRACKING	M	19.00 Ft	Comments:

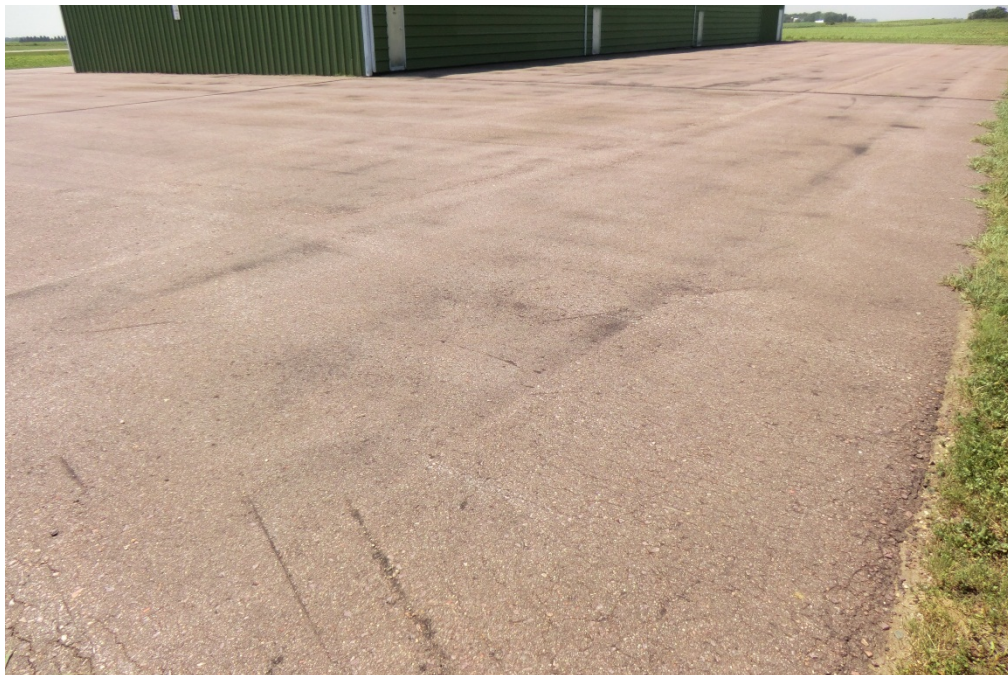
D42 TLA 001 (PCI = 68)
