# Minnesota Airport System Pavement Evaluation 2012 Update

St. Cloud Regional Airport (STC)

*Final Report*

Applied Research Associates, Inc.  
100 Trade Centre Dr., Suite 200  
Champaign, IL 61820  
(217) 356-4500

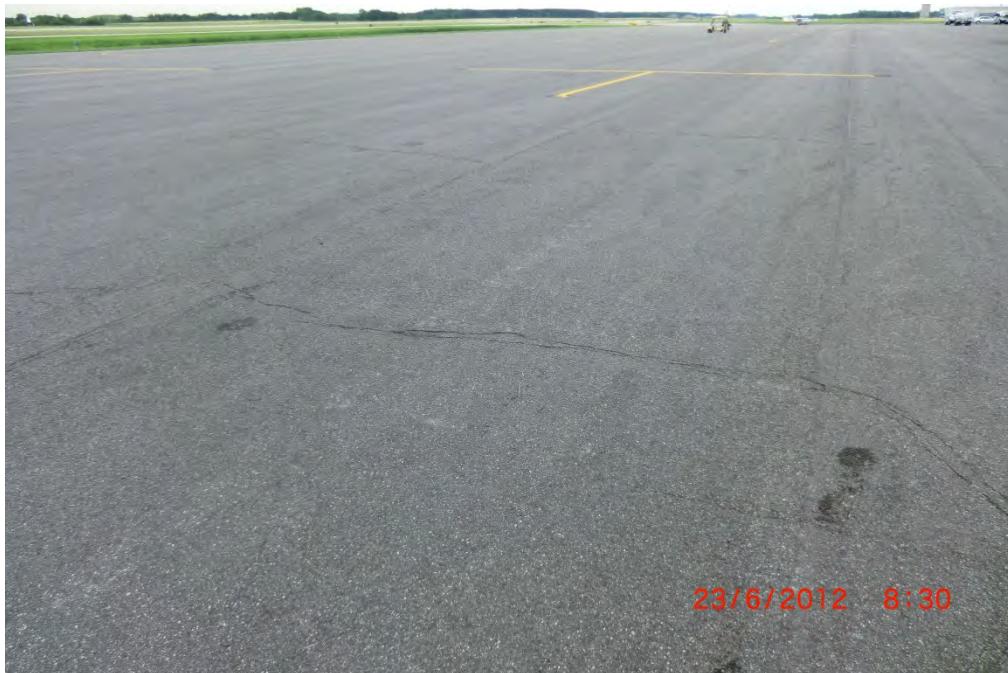
STC APB 001 (PCI = 65)

| Branch ID | Section ID | Surface type <sup>1</sup> | Section area (SF) | LCD <sup>2</sup> | 2009 PCI | 2012 PCI | Drop in PCI/Yr <sup>3</sup> | % Deduct due to | | Distress types |
|---|---|---|---|---|---|---|---|---|---|--|
| APB | 1** | AC | 225,000 | 1985 | 55 | 65 | 1.3 | 16 | 81 | Alligator cracking, block cracking, Longitudinal & transverse (L&T) cracking, oil spillage, raveling |

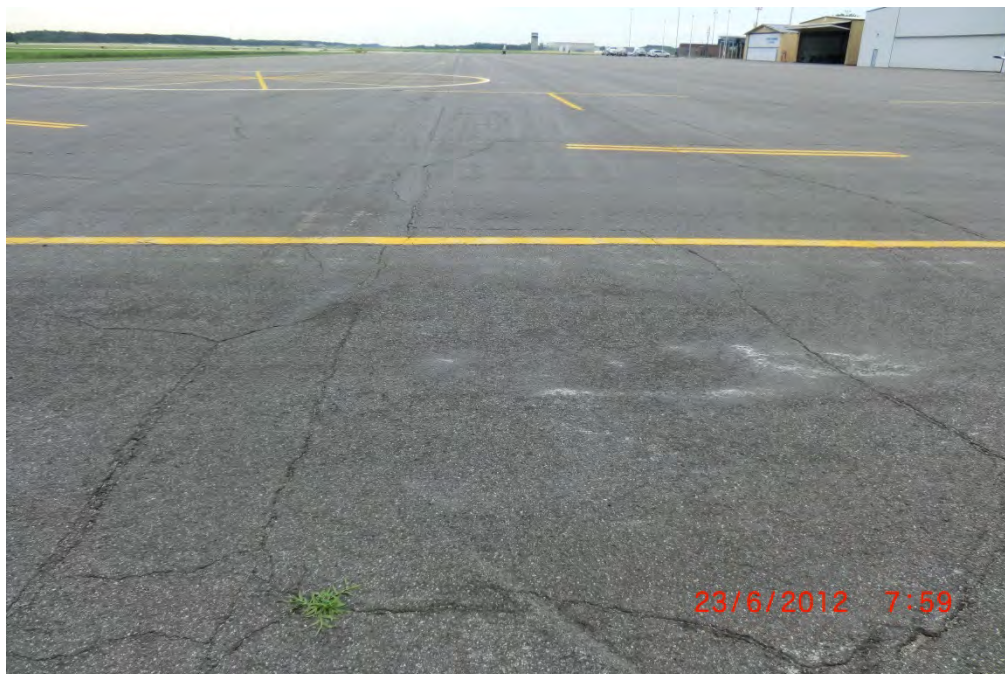
STC APB 002 (PCI = 65)

| Branch ID | Section ID | Surface type <sup>1</sup> | Section area (SF) | LCD <sup>2</sup> | 2009 PCI | 2012 PCI | Drop in PCI/Yr <sup>3</sup> | % Deduct due to | | Distress types |
|---|---|---|---|---|---|---|---|---|---|--|
| APB | 2** | AC | 43,750 | 1985 | 47 | 65 | 1.3 | 31 | 69 | Alligator cracking, L&T cracking |

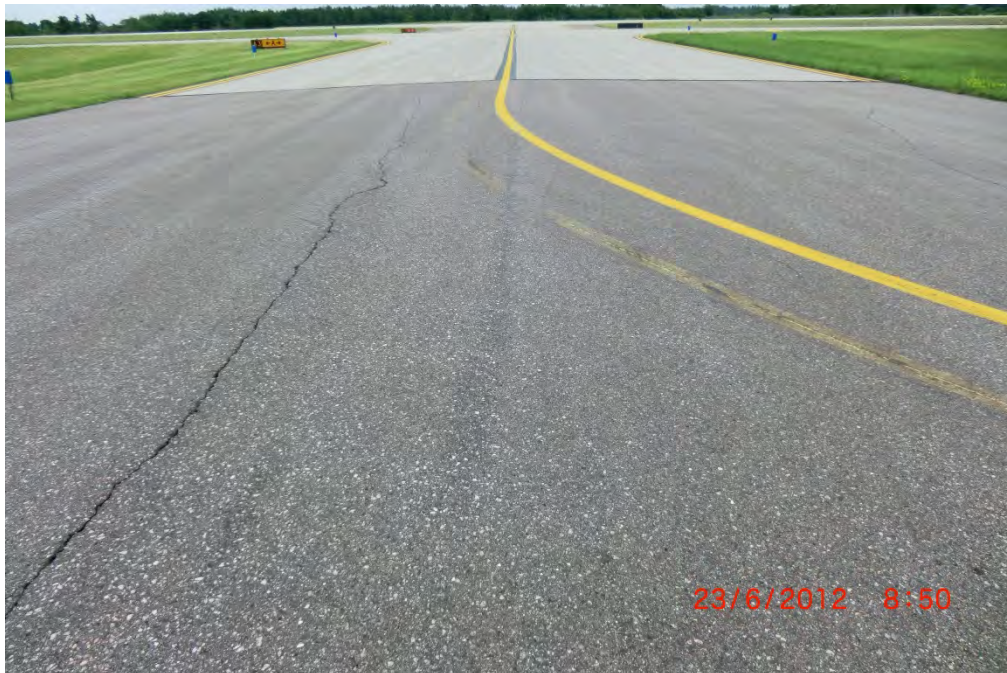
STC CTA3X 002 (PCI = 72)

| Branch ID | Section ID | Surface type <sup>1</sup> | Section area (SF) | LCD <sup>2</sup> | 2009 PCI | 2012 PCI | Drop in PCI/Yr <sup>3</sup> | % Deduct due to | | Distress types |
|---|---|---|---|---|---|---|---|---|---|--|
| CTA3X | 2 | AC | 4,270 | 2001 | 82 | 72 | 2.5 | 35 | 53 | Depression, L&T cracking, weathering |

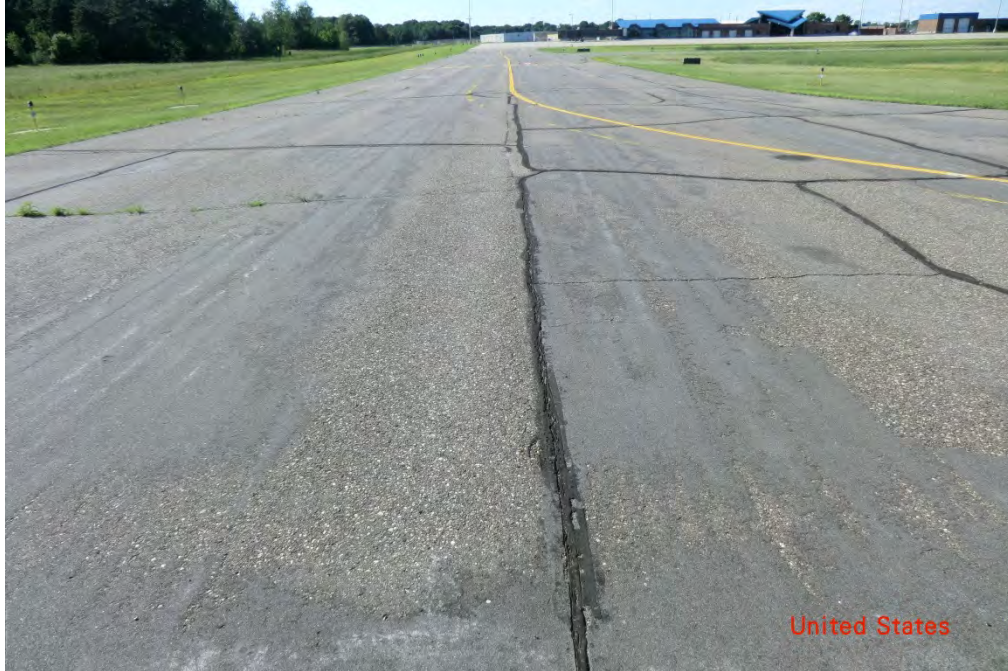
STC CTD1 001 (PCI = 54)

| Branch ID | Section ID | Surface type <sup>1</sup> | Section area (SF) | LCD <sup>2</sup> | 2009 PCI | 2012 PCI | Drop in PCI/Yr <sup>3</sup> | % Deduct due to | | Distress types |
|---|---|---|---|---|---|---|---|---|---|--|
| CTD1 | 1 | AC | 21,680 | 1985 | 58 | 54 | 1.7 | 19 | 81 | Alligator cracking, depression, L&T cracking, patching, raveling, |

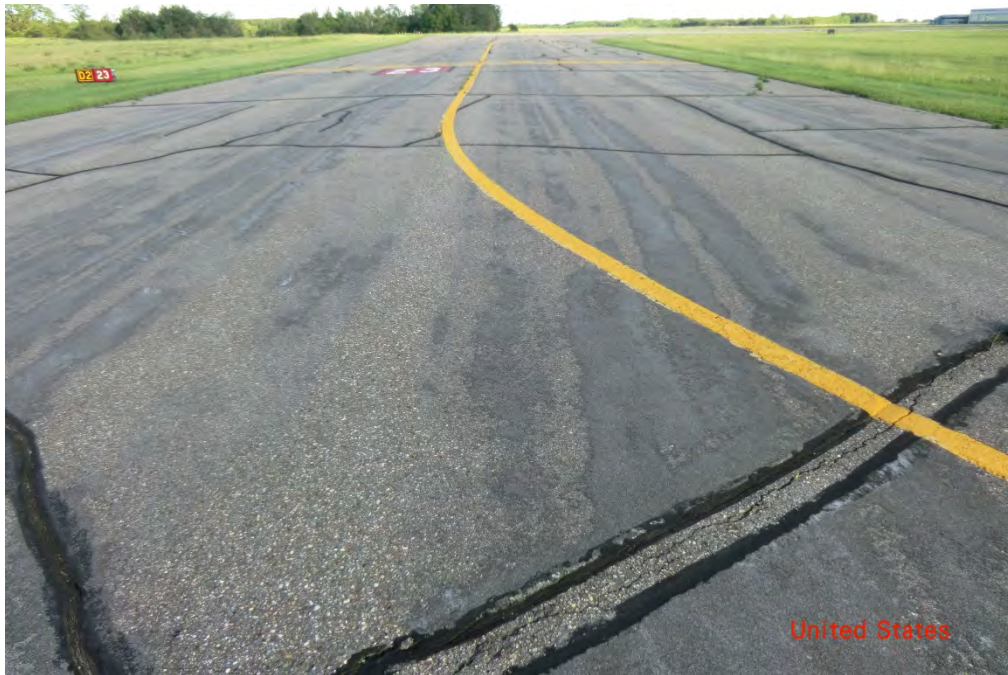
STC CTD2 001 (PCI = 53)

| Branch ID | Section ID | Surface type <sup>1</sup> | Section area (SF) | LCD <sup>2</sup> | 2009 PCI | 2012 PCI | Drop in PCI/Yr <sup>3</sup> | % Deduct due to | | Distress types |
|---|---|---|---|---|---|---|---|---|---|--|
| CTD2 | 1 | AC | 204,363 | 1985 | 51 | 53 | 1.7 | 24 | 76 | Alligator cracking, L&T cracking, patching, raveling |

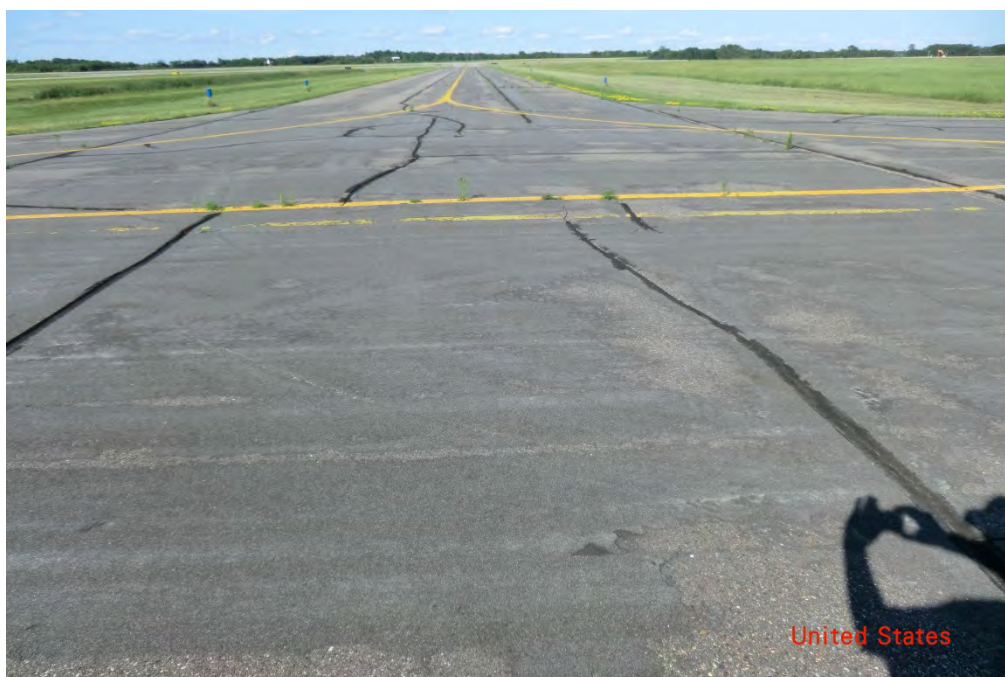
STC PTD 001 (PCI = 60)

| Branch ID | Section ID | Surface type <sup>1</sup> | Section area (SF) | LCD <sup>2</sup> | 2009 PCI | 2012 PCI | Drop in PCI/Yr <sup>3</sup> | % Deduct due to | | Distress types |
|---|---|---|---|---|---|---|---|---|---|--|
| PTD | 1 | AC | 48,000 | 1985 | 55 | 60 | 1.5 | 27 | 73 | Alligator cracking, depression, L&T cracking, patching, raveling, weathering |

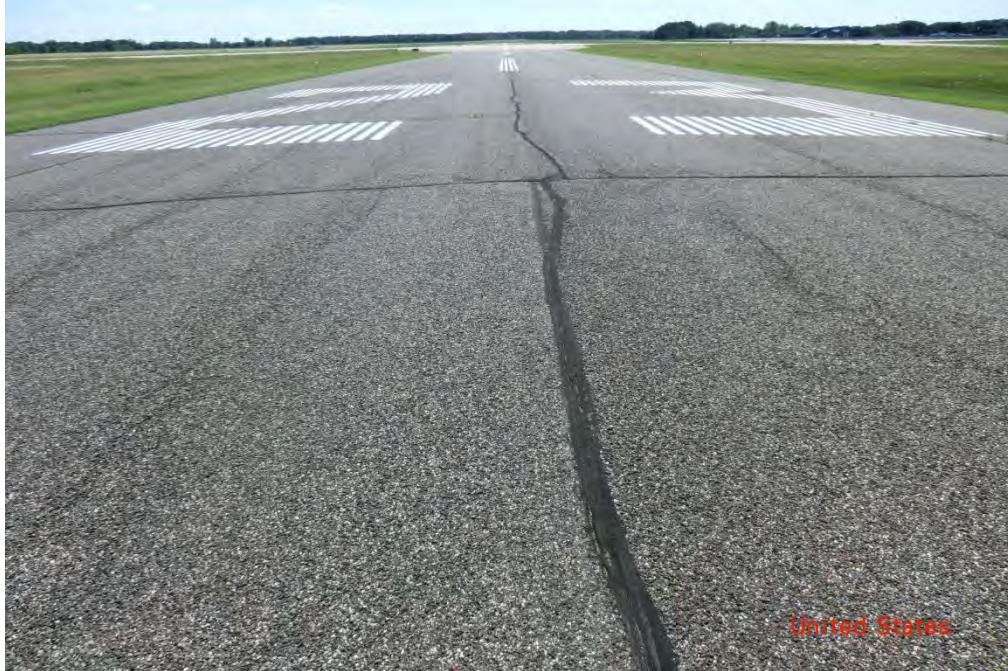
STC RY523 001 (PCI = 21)

| Branch ID | Section ID | Surface type <sup>1</sup> | Section area (SF) | LCD <sup>2</sup> | 2009 PCI | 2012 PCI | Drop in PCI/Yr <sup>3</sup> | % Deduct due to | | Distress types |
|---|---|---|---|---|---|---|---|---|---|--|
| RY523 | 1 | AC | 52,500 | 1985 | 28 | 21 | 2.9 | 36 | 64 | Alligator cracking, block cracking, depression, L&T cracking, raveling |

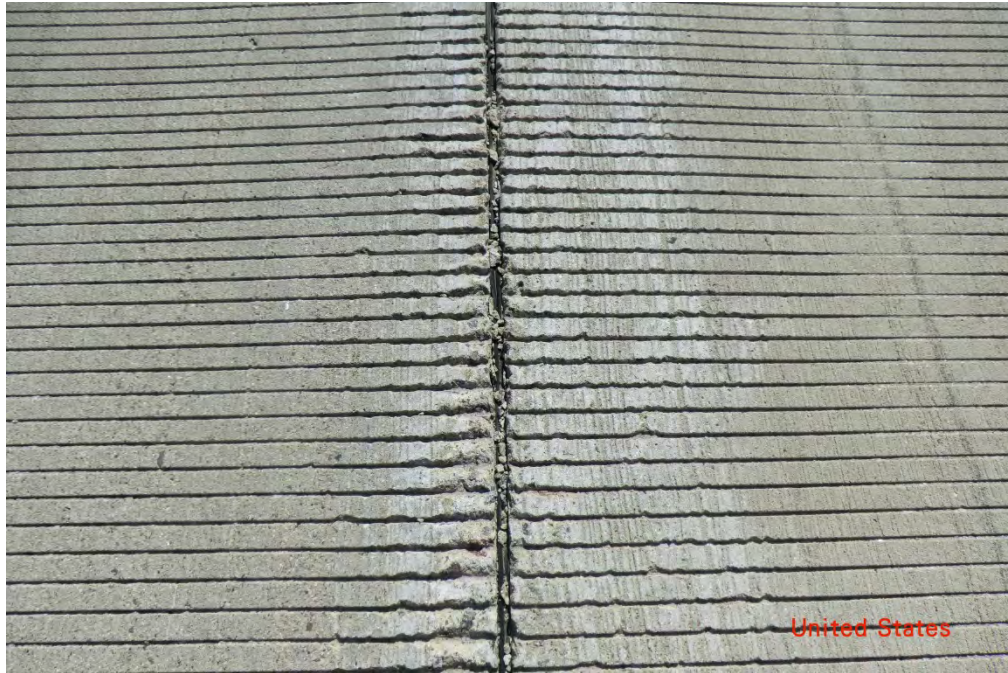
STC RY523 003 chipping along joint, (PCI = 98)

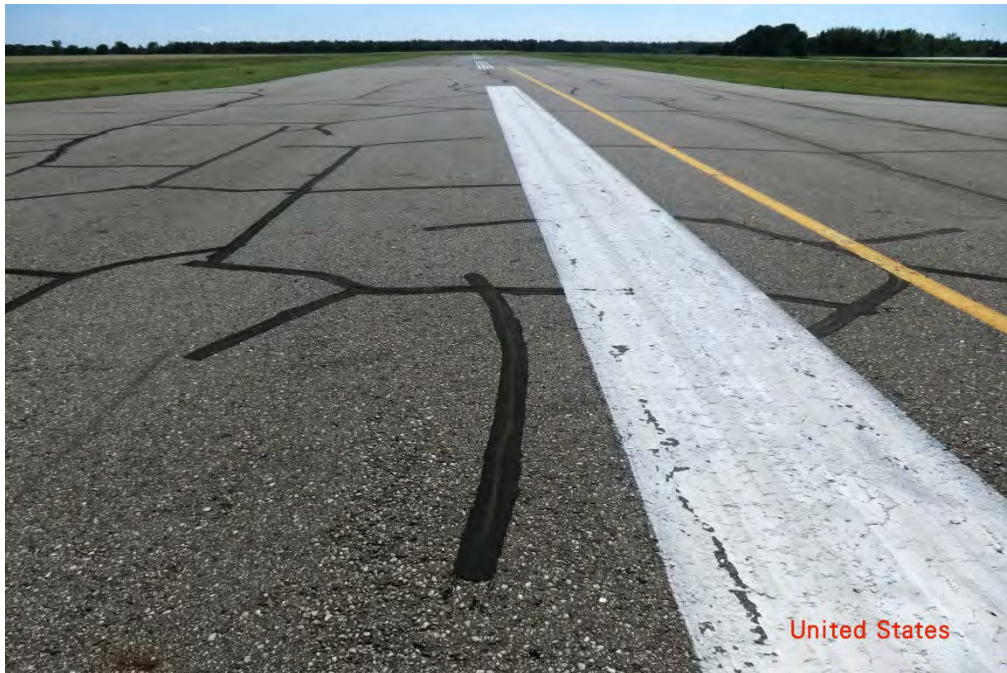
STC RY523 004 (PCI = 62)

| Branch ID | Section ID | Surface type <sup>1</sup> | Section area (SF) | LCD <sup>2</sup> | 2009 PCI | 2012 PCI | Drop in PCI/Yr <sup>3</sup> | % Deduct due to | | Distress types |
|---|---|---|---|---|---|---|---|---|---|--|
| RY523 | 4** | AC | 17,500 | 2001 | 61 | 62 | 3.5 | 0 | 91 | L&T cracking, raveling, shoving |

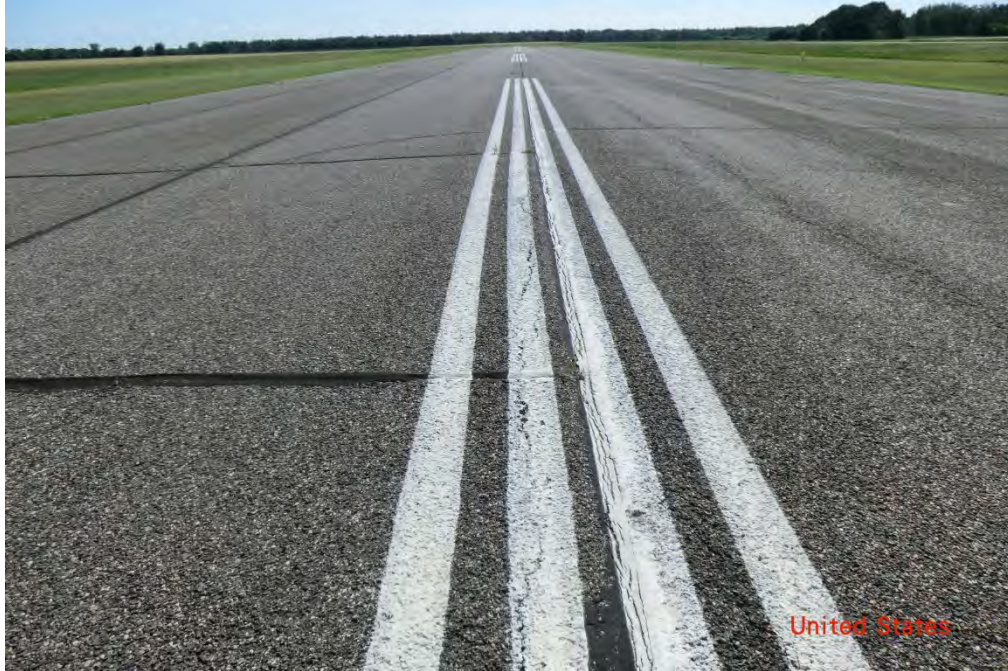
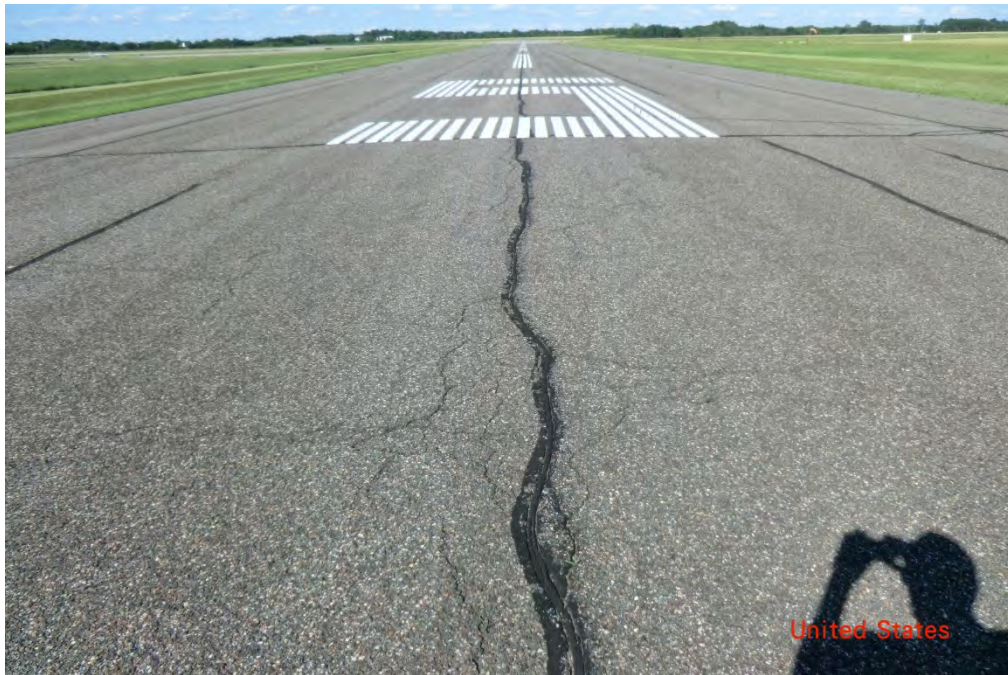
STC RY523 005 (PCI = 16)

| Branch ID | Section ID | Surface type <sup>1</sup> | Section area (SF) | LCD <sup>2</sup> | 2009 PCI | 2012 PCI | Drop in PCI/Yr <sup>3</sup> | % Deduct due to | | Distress types |
|---|---|---|---|---|---|---|---|---|---|--|
| RY523 | 5 | AC | 90,000 | 1985 | 27 | 16 | 3.1 | 34 | 66 | Alligator cracking, block cracking, depression, L&T cracking, raveling |

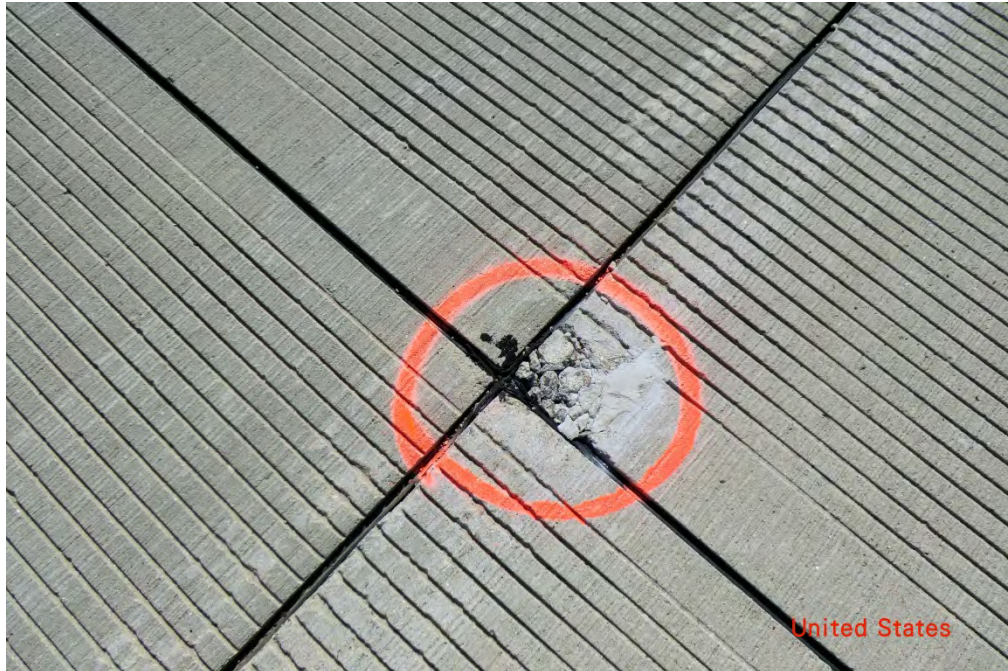
STC RY1331 001 Corner spall, (PCI = 98)

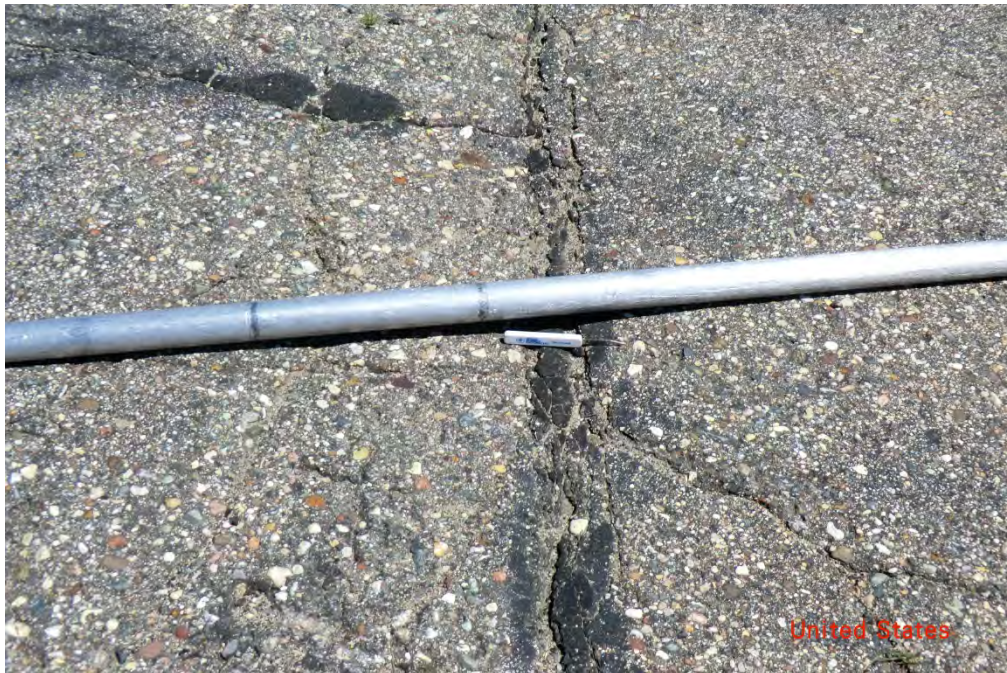
| Branch ID | Section ID | Surface type <sup>1</sup> | Section area (SF) | LCD <sup>2</sup> | 2009 PCI | 2012 PCI | Drop in PCI/Yr <sup>3</sup> | % Deduct due to | | Distress types |
|---|---|---|---|---|---|---|---|---|---|--|
| TLA | 1 | AAC | 117,000 | 1970* | 24 | 20 | 1.9 | 35 | 65 | Alligator cracking, block cracking, depression, L&T cracking, raveling, rutting, weathering |

STC TLA 001 Rutting, (PCI = 20)

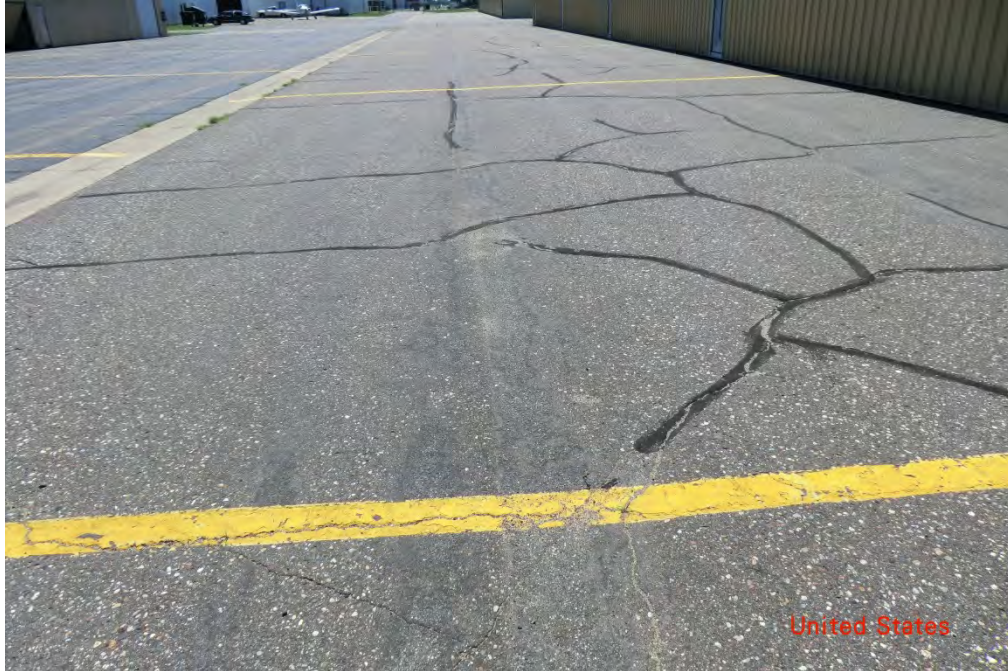
STC TLA 002 (PCI = 42)

| Branch ID | Section ID | Surface type <sup>1</sup> | Section area (SF) | LCD <sup>2</sup> | 2009 PCI | 2012 PCI | Drop in PCI/Yr <sup>3</sup> | % Deduct due to | | Distress types |
|---|---|---|---|---|---|---|---|---|---|--|
| TLA | 2 | AC | 7,840 | 1990* | 53 | 42 | 2.6 | 39 | 50 | Alligator cracking, depression, L&T cracking, weathering |

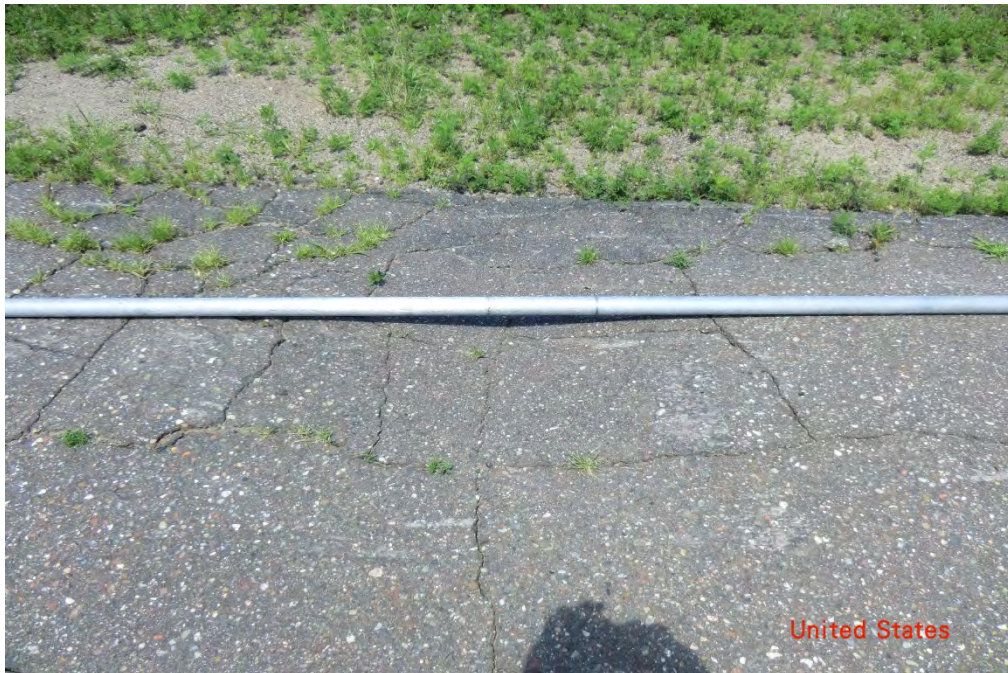
| Branch ID | Section ID | Surface type <sup>1</sup> | Section area (SF) | LCD <sup>2</sup> | 2009 PCI | 2012 PCI | Drop in PCI/Yr <sup>3</sup> | % Deduct due to | | Distress types |
|---|---|---|---|---|---|---|---|---|---|--|
| TLA | 3 | AAC | 102,550 | 1995* | 76 | 48 | 3.1 | 43 | 48 | Alligator cracking, block cracking, depression, L&T cracking, raveling, swelling, weathering |

STC TLA 003 Depression, (PCI = 48)

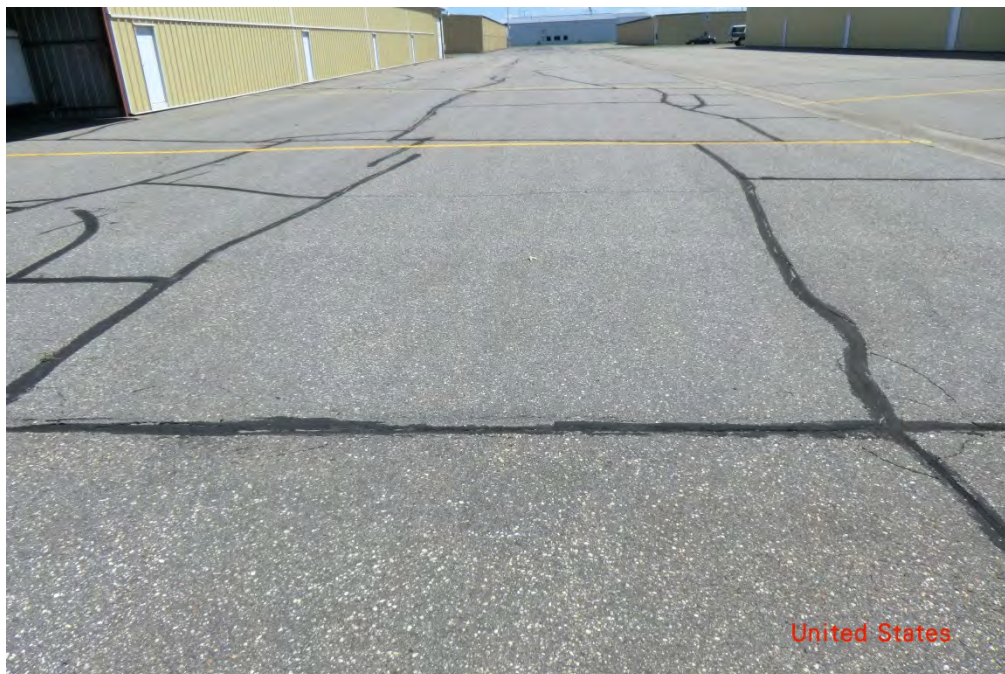
STC TLA 004 (PCI = 27)

| Branch ID | Section ID | Surface type <sup>1</sup> | Section area (SF) | LCD <sup>2</sup> | 2009 PCI | 2012 PCI | Drop in PCI/Yr <sup>3</sup> | % Deduct due to | | Distress types |
|---|---|---|---|---|---|---|---|---|---|--|
| TLA | 4 | AAC | 37,750 | 1995* | 71 | 27 | 4.3 | 24 | 76 | Alligator cracking, block cracking, L&T cracking, raveling, weathering |

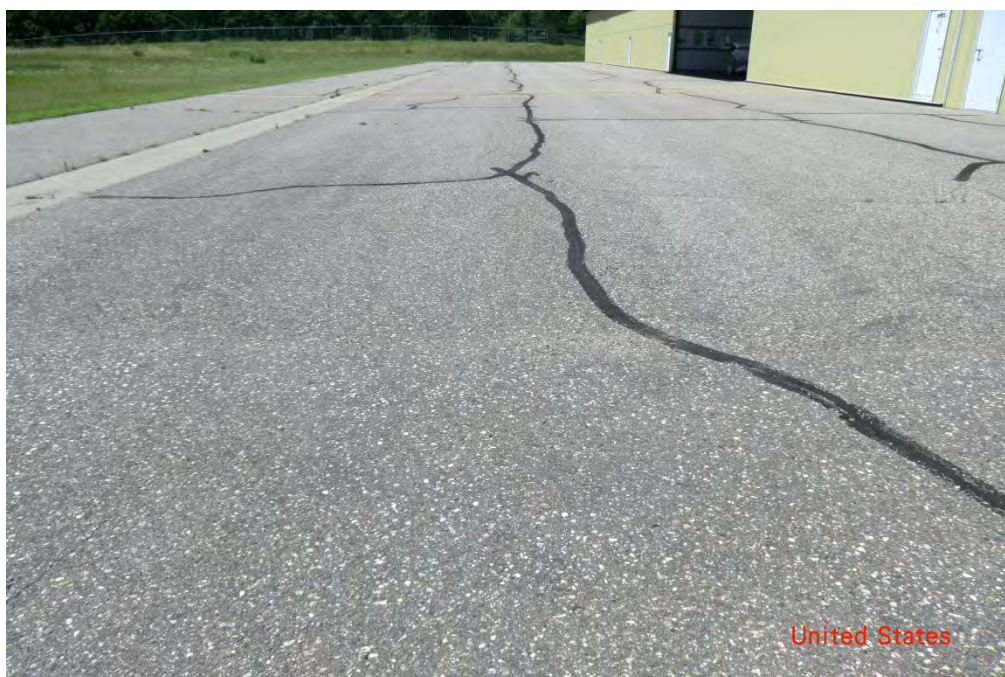
STC TLA 005 (PCI = 60)

| Branch ID | Section ID | Surface type <sup>1</sup> | Section area (SF) | LCD <sup>2</sup> | 2009 PCI | 2012 PCI | Drop in PCI/Yr <sup>3</sup> | % Deduct due to | | Distress types |
|---|---|---|---|---|---|---|---|---|---|--|
| TLA | 5** | AAC | 40,750 | 1995* | 75 | 60 | 2.4 | 12 | 88 | Alligator cracking, L&T cracking, raveling, weathering |
