# Minnesota Airport System Pavement Evaluation 2012 Update

Warren Municipal Airport (D37)

Warren, Minnesota

January 2013

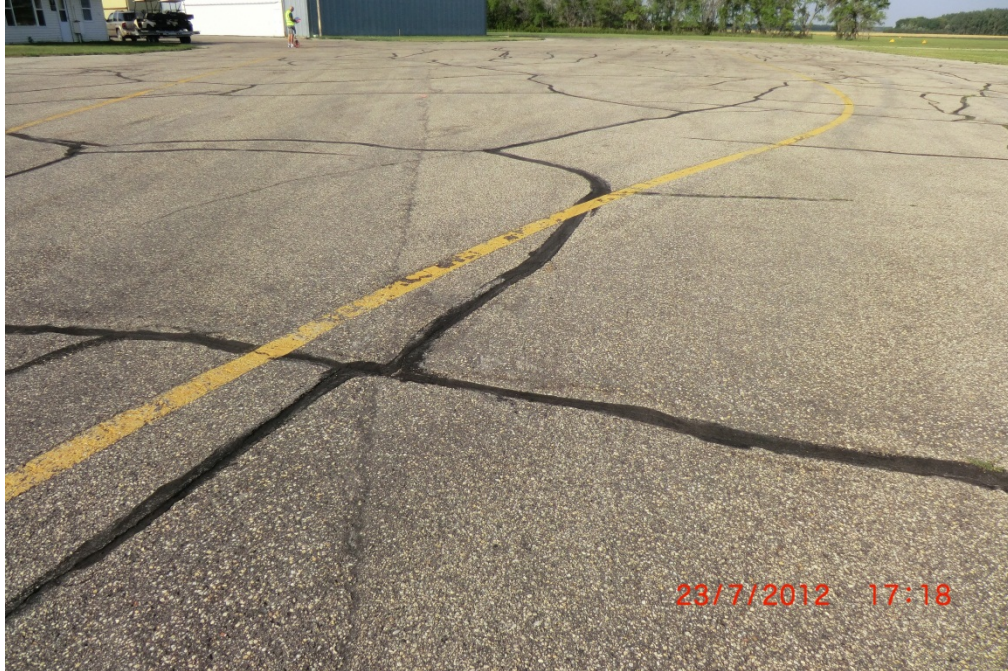
D37 APA 001 (PCI = 47)

Conditions: PCI : 47

48 LONGITUDINAL/TRANSVERSE CRACKING L 852.00 Ft Comments:

48 LONGITUDINAL/TRANSVERSE CRACKING M 32.00 Ft Comments:

41 ALLIGATOR CRACKING L 124.00 SqFt Comments:

48 LONGITUDINAL/TRANSVERSE CRACKING L 600.00 Ft Comments:

48 LONGITUDINAL/TRANSVERSE CRACKING M 70.00 Ft Comments:

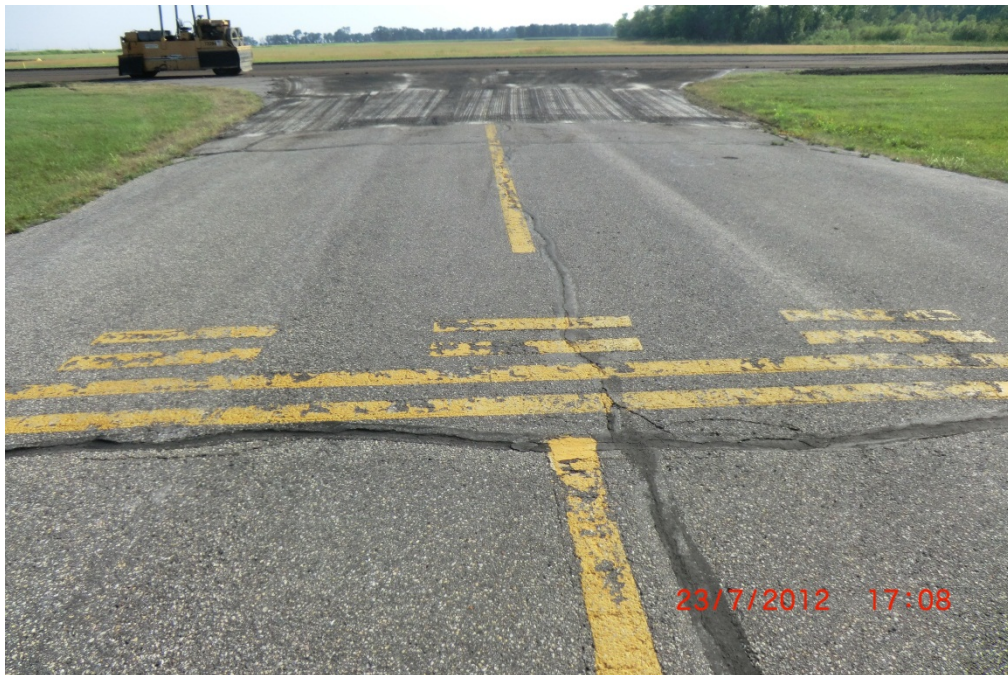
D37 CTA 001 (PCI = 43)

Conditions: PCI : 43

41 ALLIGATOR CRACKING	L	16.00 SqFt	Comments:
41 ALLIGATOR CRACKING	M	24.00 SqFt	Comments:
45 DEPRESSION	L	7.00 SqFt	Comments:
48 LONGITUDINAL/TRANSVERSE CRACKING	L	116.00 Ft	Comments:
48 LONGITUDINAL/TRANSVERSE CRACKING	M	17.00 Ft	Comments:
52 RAVELING	L	10.00 SqFt	Comments:
57 WEATHERING	L	688.00 SqFt	Comments:

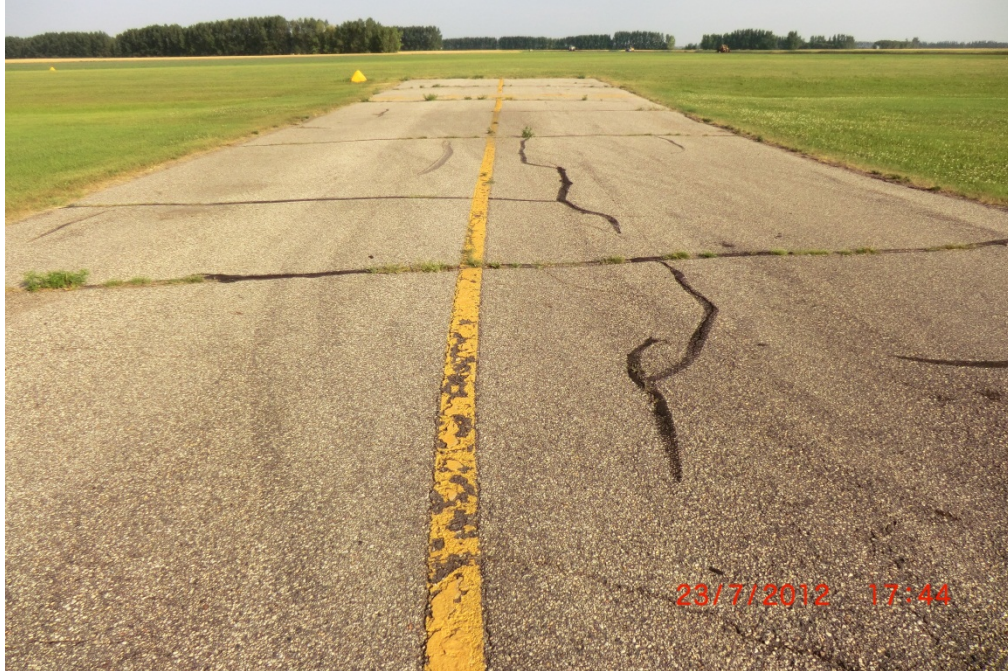
D37 CTB 001 (PCI = 30)

Conditions: PCI : 30

41 ALLIGATOR CRACKING	L	92.00 SqFt	Comments:
41 ALLIGATOR CRACKING	M	6.00 SqFt	Comments:
45 DEPRESSION	L	400.00 SqFt	Comments:
48 LONGITUDINAL/TRANSVERSE CRACKING	L	285.00 Ft	Comments:
48 LONGITUDINAL/TRANSVERSE CRACKING	M	86.00 Ft	Comments:
53 RUTTING	L	42.00 SqFt	Comments:
53 RUTTING	M	12.00 SqFt	Comments:
56 SWELLING	L	120.00 SqFt	Comments:
57 WEATHERING	L	2,618.00 SqFt	Comments:
57 WEATHERING	M	1,300.00 SqFt	Comments:
57 WEATHERING	H	66.00 SqFt	Comments:

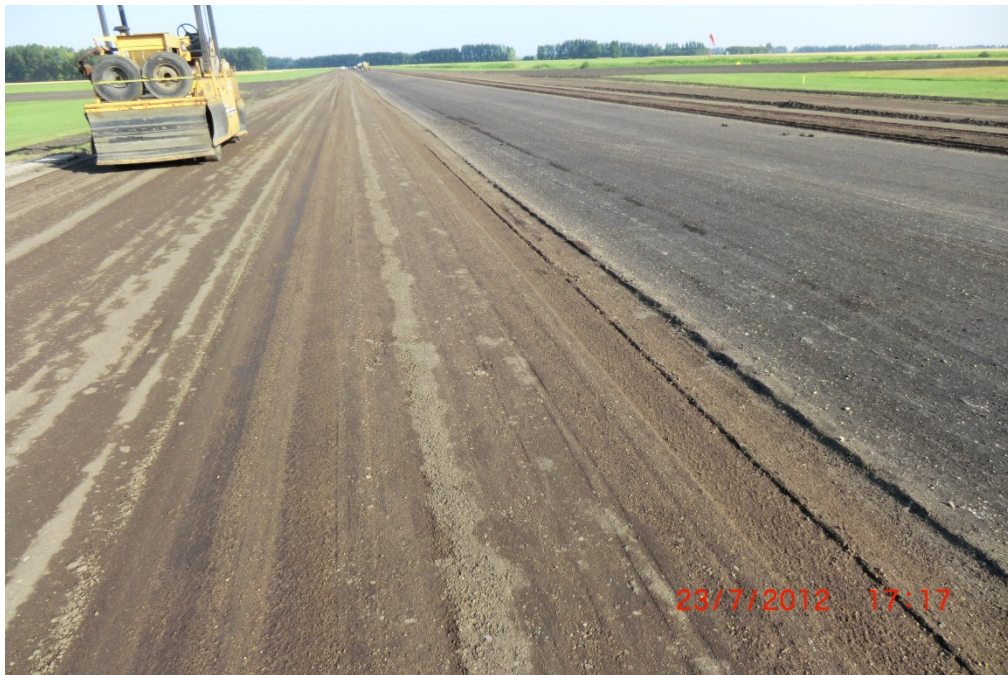
D37 RY1230 001 during construction

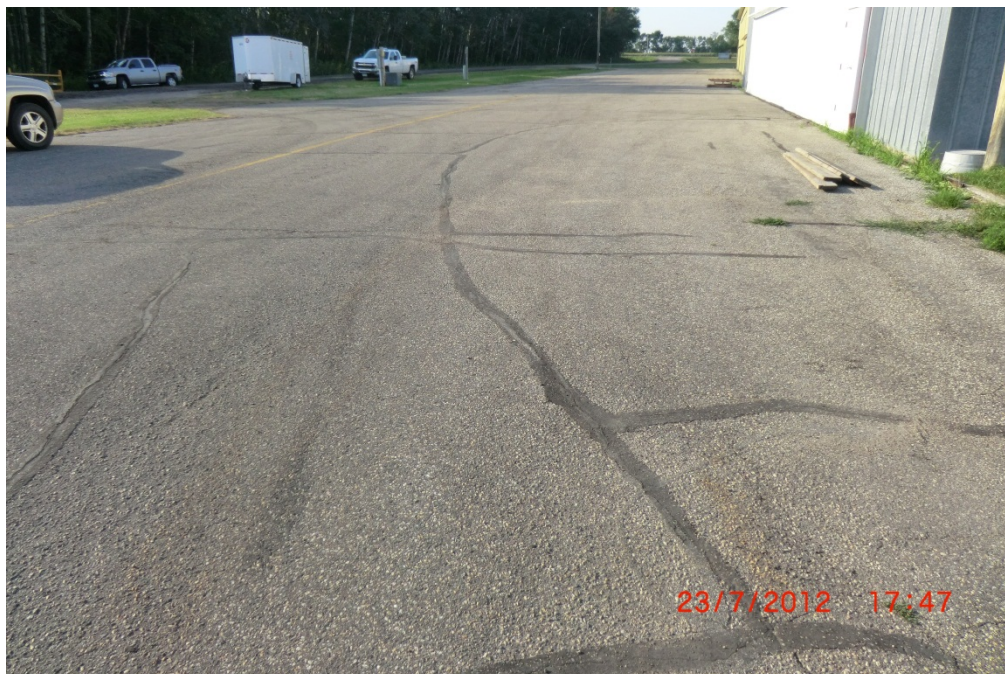
D37 TLA 001 (PCI = 35)

Conditions: PCI : 35

43	BLOCK CRACKING	L	2,550.00	SqFt	Comments:
48	LONGITUDINAL/TRANSVERSE CRACKING	L	618.00	Ft	Comments:
48	LONGITUDINAL/TRANSVERSE CRACKING	M	58.00	Ft	Comments:
57	WEATHERING	H	300.00	SqFt	Comments:
41	ALLIGATOR CRACKING	M	44.00	SqFt	Comments:
45	DEPRESSION	L	24.00	SqFt	Comments:
45	DEPRESSION	L	50.00	SqFt	Comments:
57	WEATHERING	M	5,250.00	SqFt	Comments:

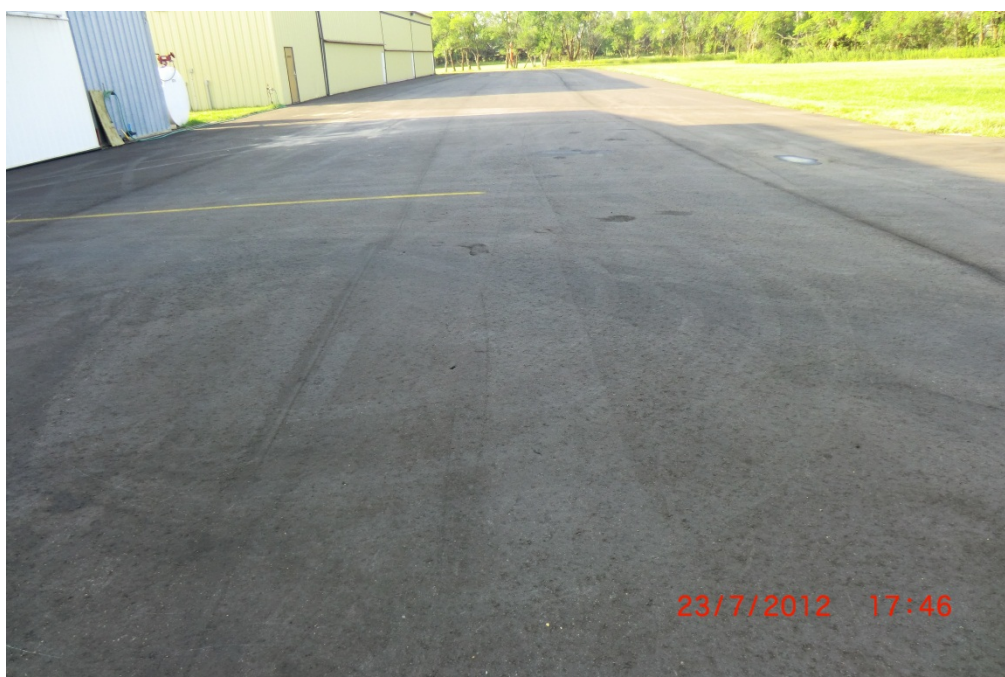
D37 TLA 002 (PCI = 100)

Conditions: PCI: 100
