# Minnesota Airport System Pavement Evaluation 2012 Update

Warroad International Memorial Airport  
(RRT)

Warroad, Minnesota

January 2013

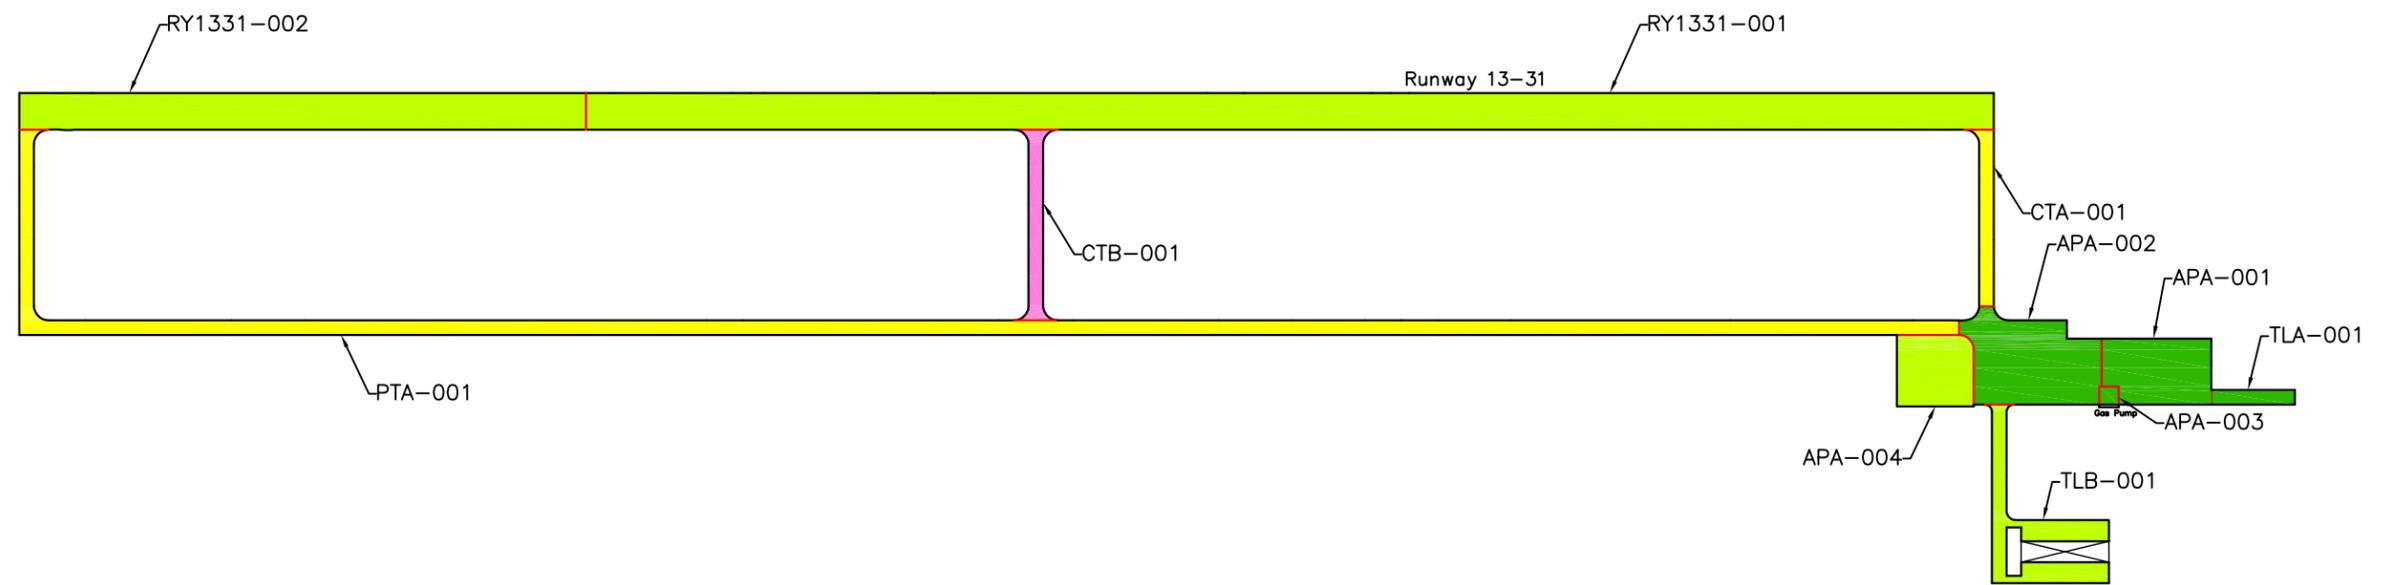
Figure 4. 2012 Pavement Condition Index Rating at Warroad International Memorial Airport (RRT).

Branch ID	Section ID	Surface type <sup>1</sup>	Section area (SF)	LCD <sup>2</sup>	2009 PCI	2012 PCI	Drop in PCI/Yr <sup>3</sup>	% Deduct due to		Distress types
								Load <sup>4</sup>	Climate <sup>5</sup>	
APA	1	AAC	50,000	2012	(70)	100	0.0	0	0	-
APA	2	AAC	73,750	2012	(51)	100	0.0	0	0	-
APA	3	PCC	2,700	1991	100	100	0.0	0	0	-
APA	4	AC	40,615	2004	77	74	3.3	13	60	Alligator cracking, Longitudinal & transverse (L&T) cracking, patching, raveling, swelling
CTA	1	AC	20,088	1991	57	67	1.6	0	79	Bleeding, L&T cracking, patching
CTB	1	AC	22,144	1991	53	47	2.5	39	45	Alligator cracking, L&T cracking, swelling
PTA	1	AC	233,136	1991	69	65	1.7	0	95	L&T cracking
RY1331	1	AC	385,000	2008	91	84	4.0	0	100	L&T cracking
RY1331	2	AC	155,000	2008	85	79	5.3	0	100	L&T cracking, raveling
TLA	1	AAC	7,200	2012	(70)	100	0.0	0	0	-
TLB	1	AC	41,000	2003	86	81	2.1	0	100	L&T cracking, weathering

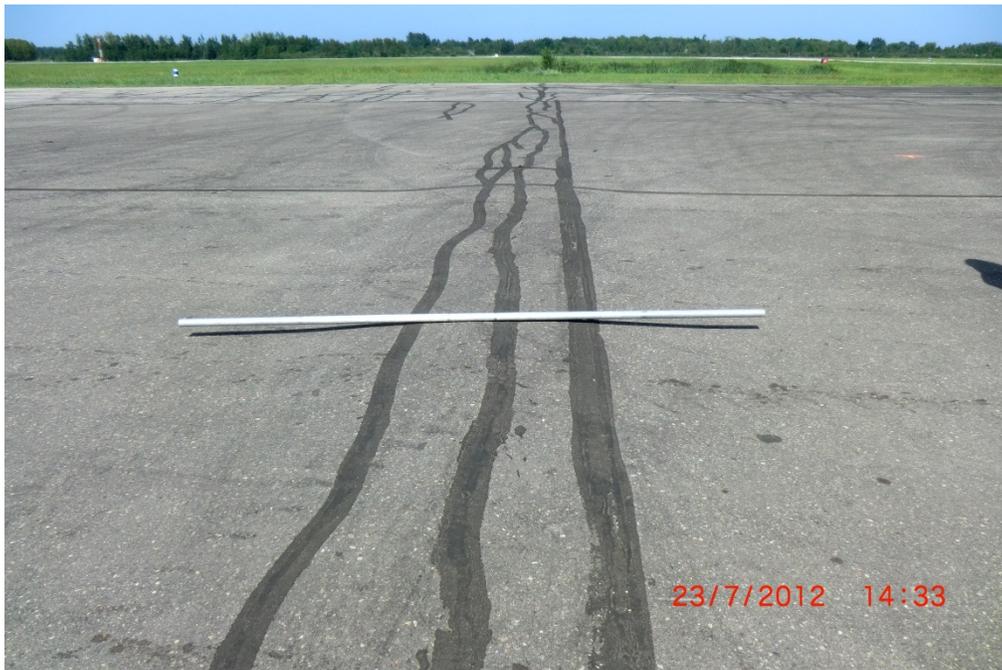
RRT APA 004 Swell, (PCI = 74)

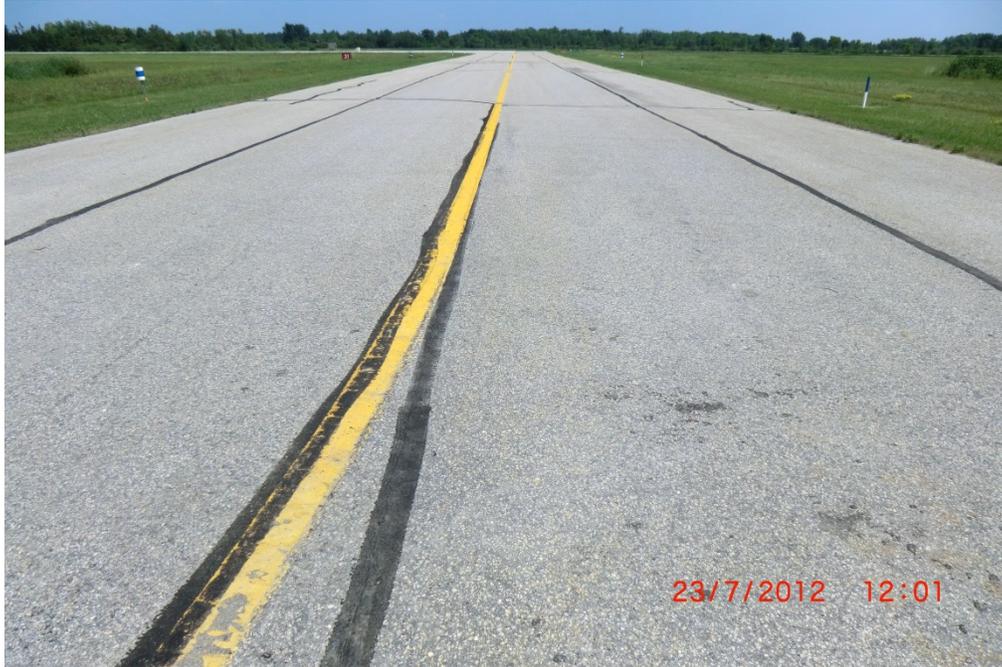
RRT CTA 001 (PCI = 67)

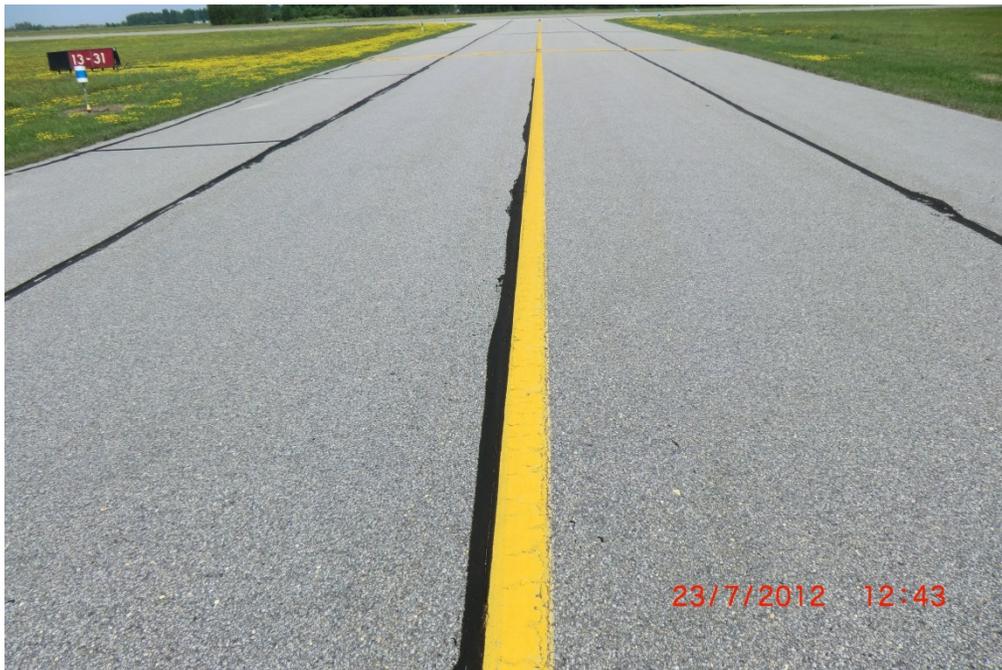
RRT CTB 001 (PCI = 47)

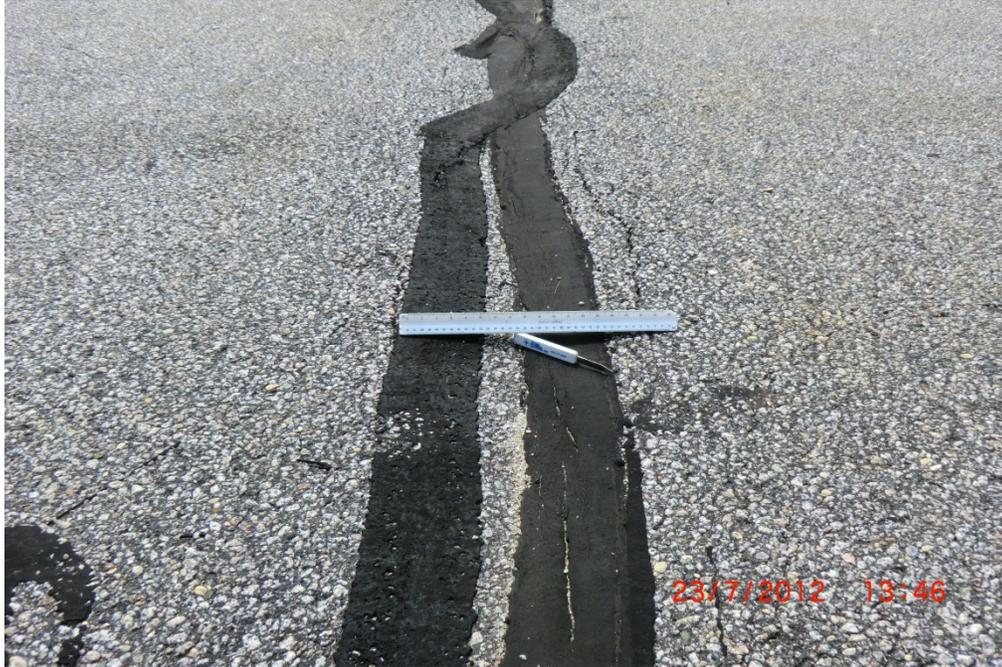
RRT PTA 001 L & T CR, (PCI = 65)

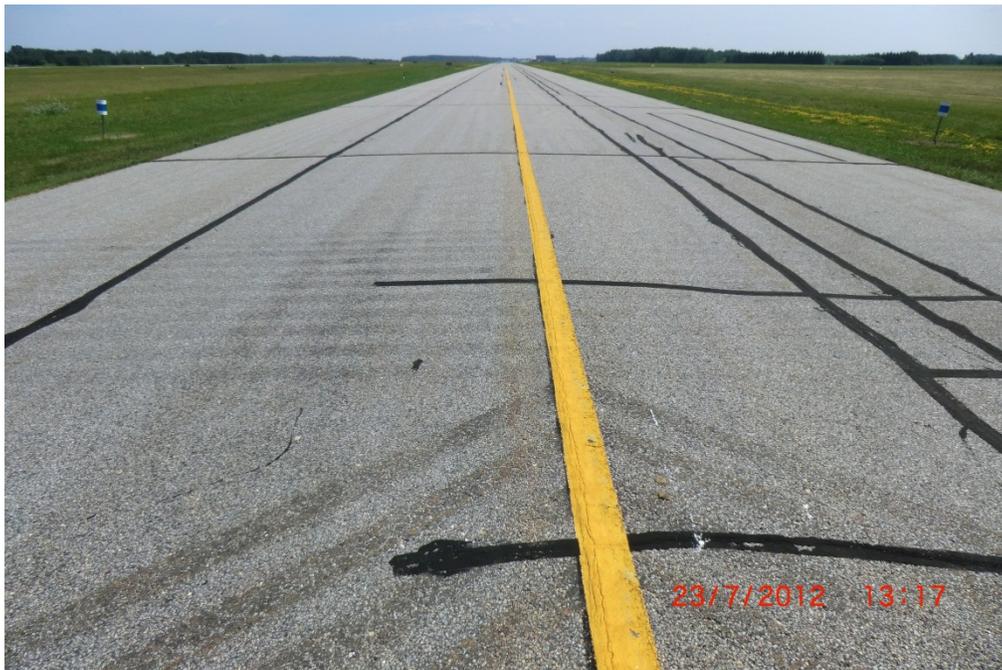
RRT PTA 001 (PCI = 65)

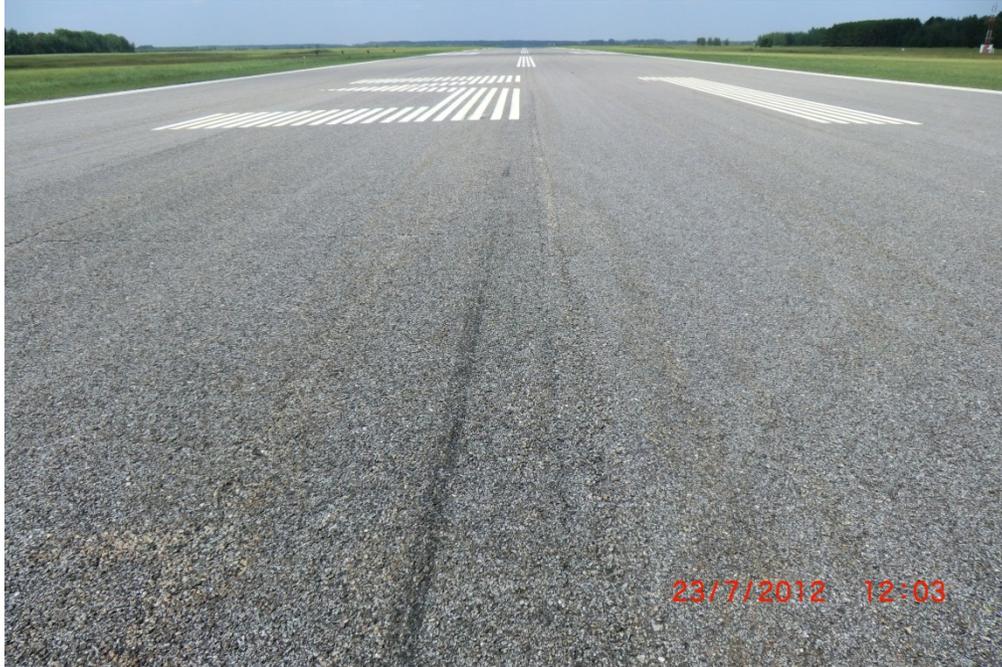
RRT RY1331 001 (PCI = 84)

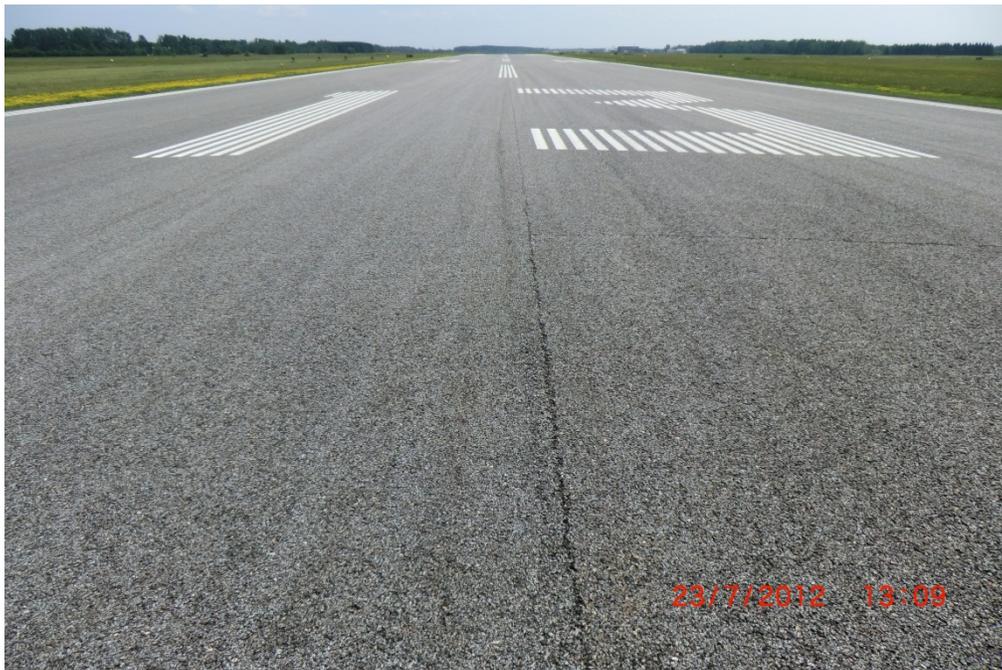
RRT RY1331 002 (PCI = 79)

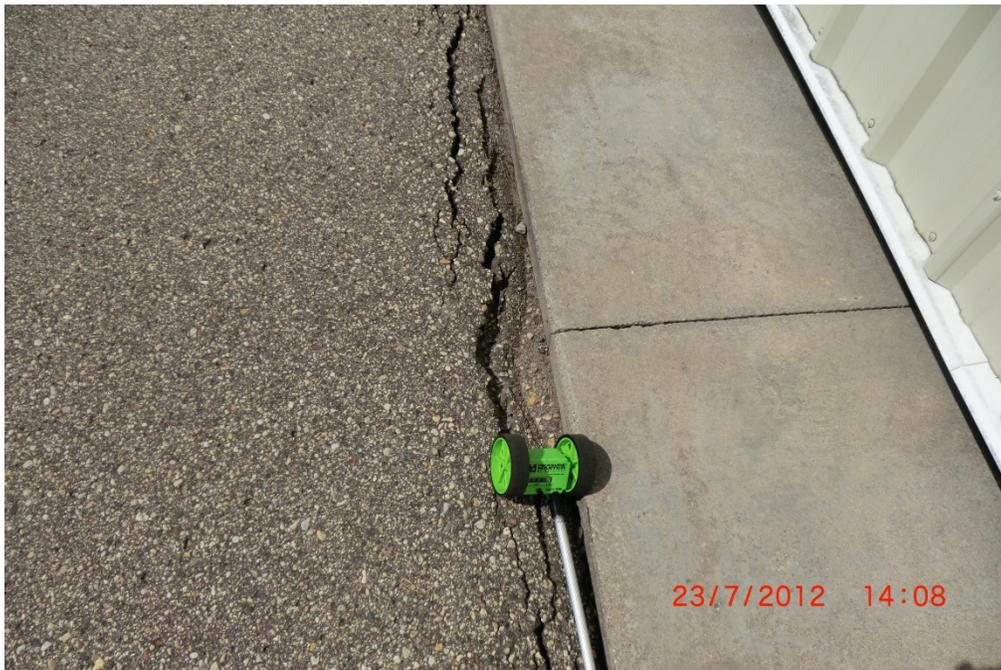
RRT TLB 001 L & T Cracking, (PCI = 81)

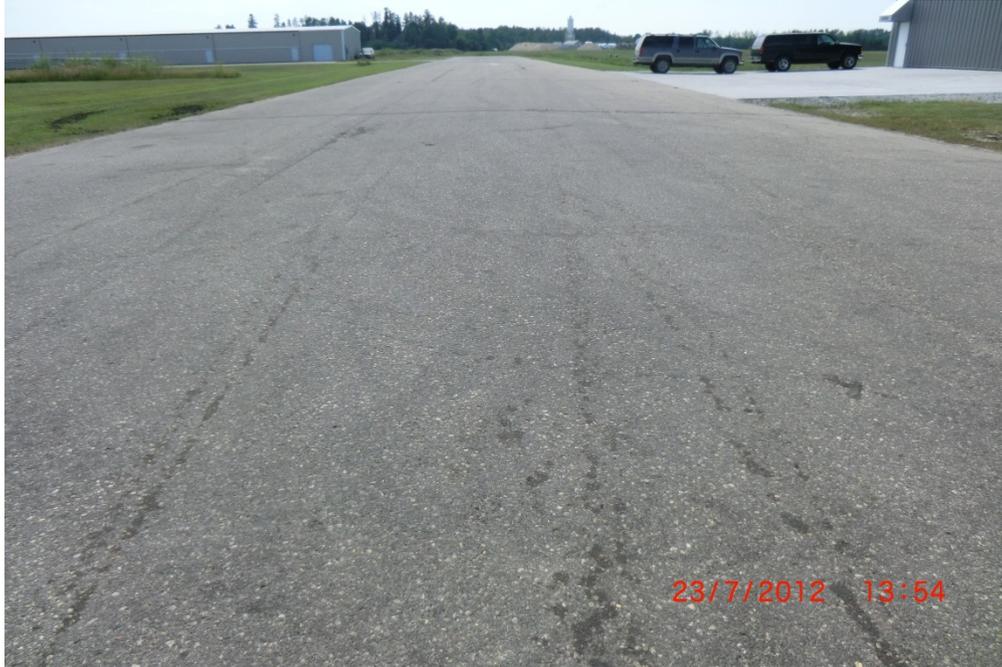
RRT TLB 001 (PCI = 81)
