Minnesota Airport System Pavement Evaluation 2012 Update

Worthington Municipal Airport (OTG)

Worthington, Minnesota

Final Report

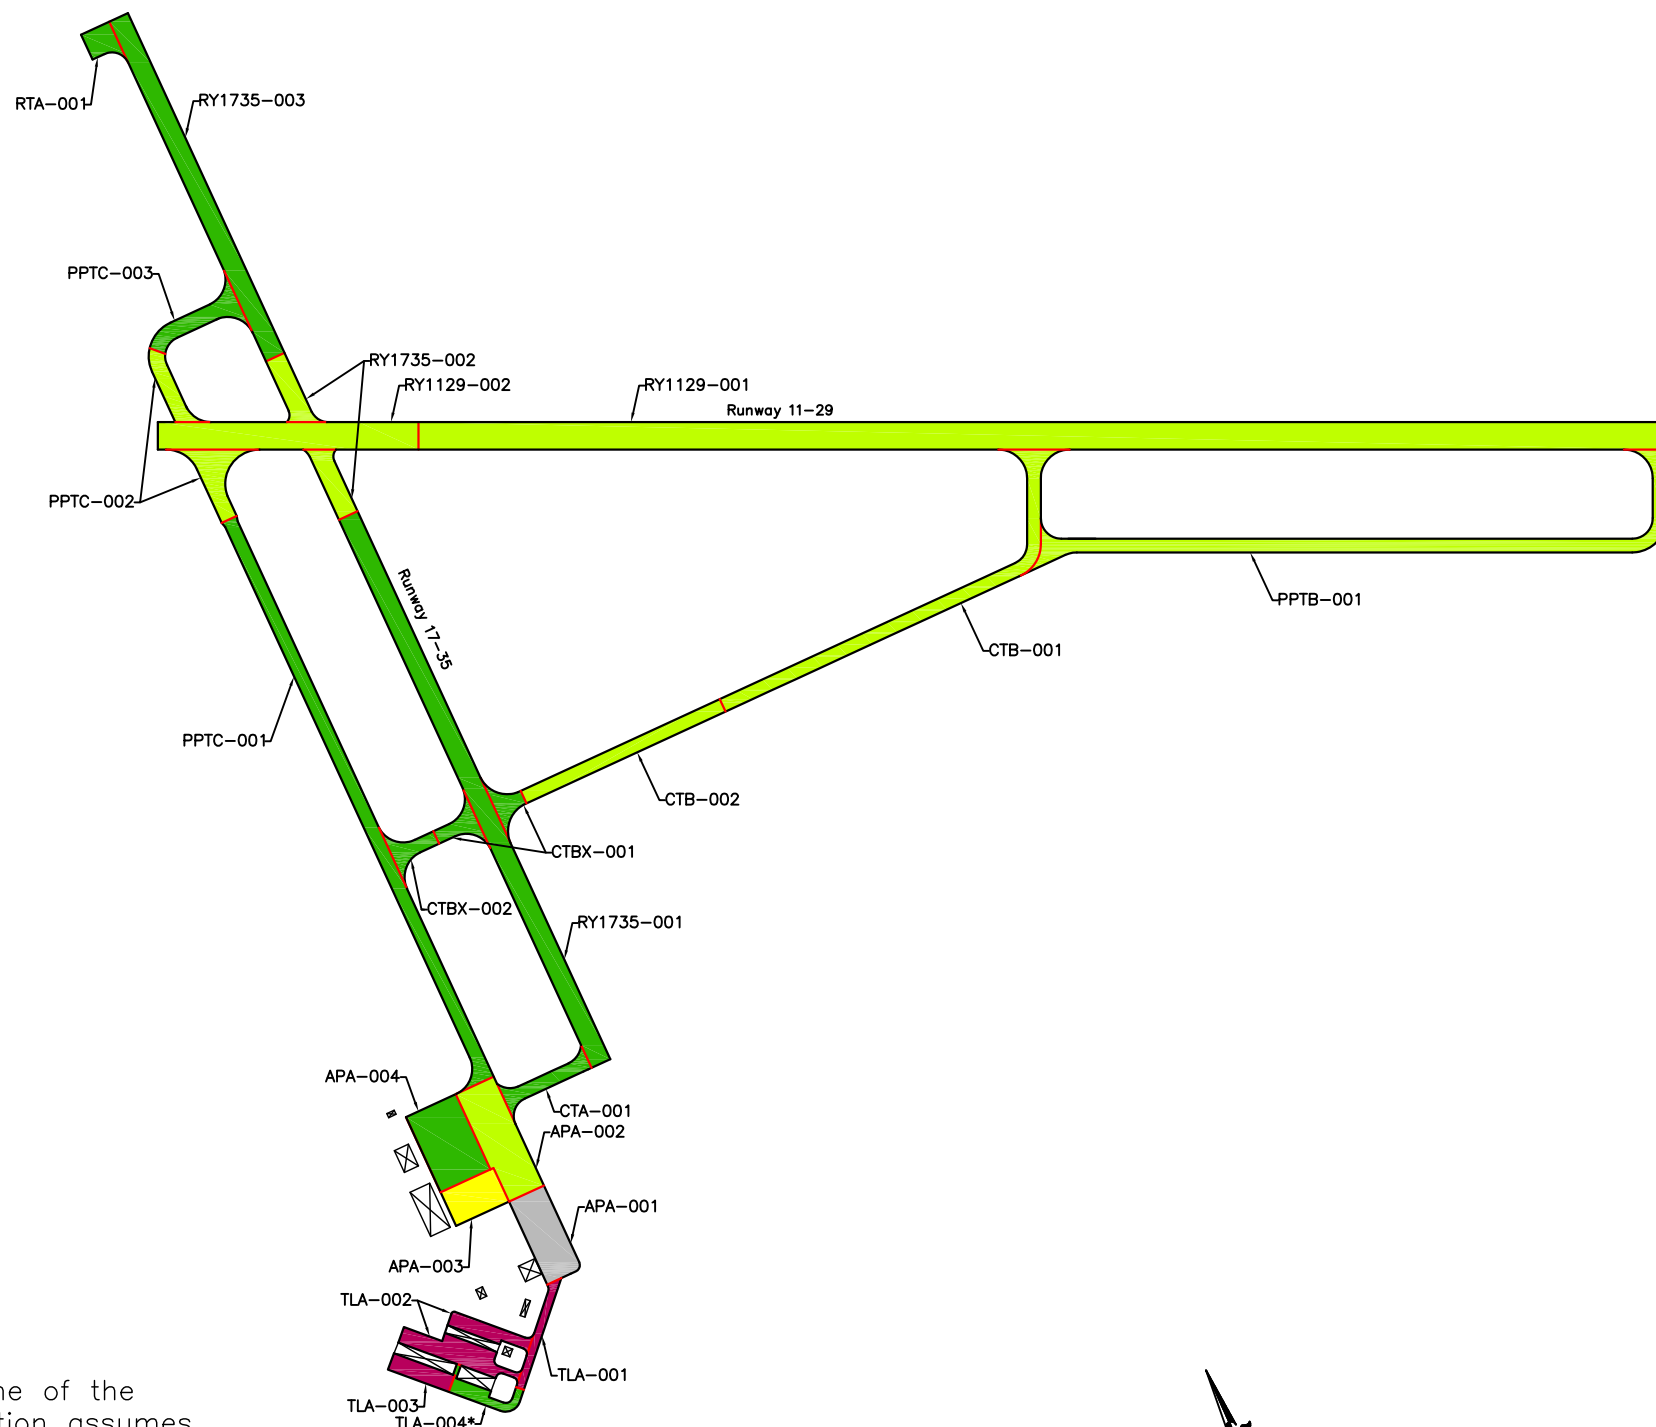
Figure 4. 2012 Pavement Condition Index Rating at Worthington Municipal Airport (OTG).

* This section was under construction at the time of the inspection. The condition and layout for this section assumes the successful completion of this construction project.

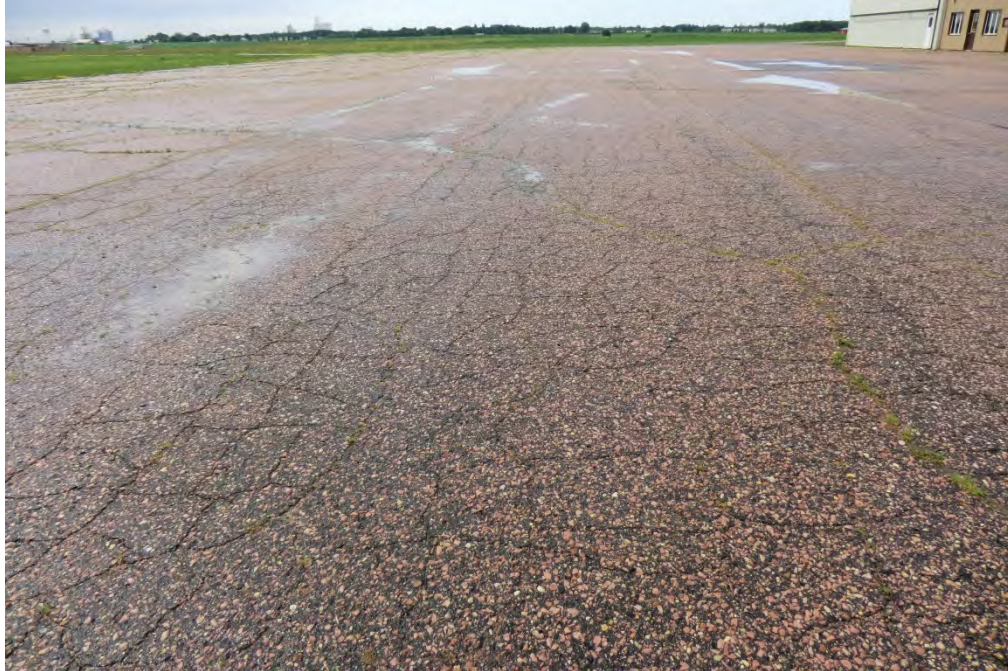
OTG APA 001 (PCI = 6)

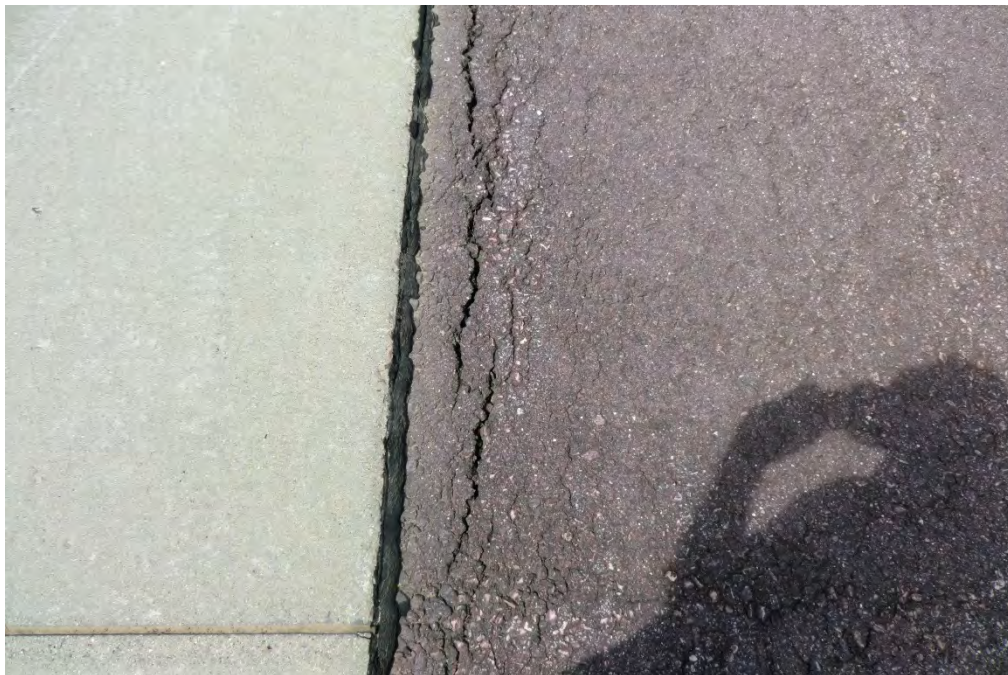
OTG APA 002 L & T Cracking, (PCI = 85)

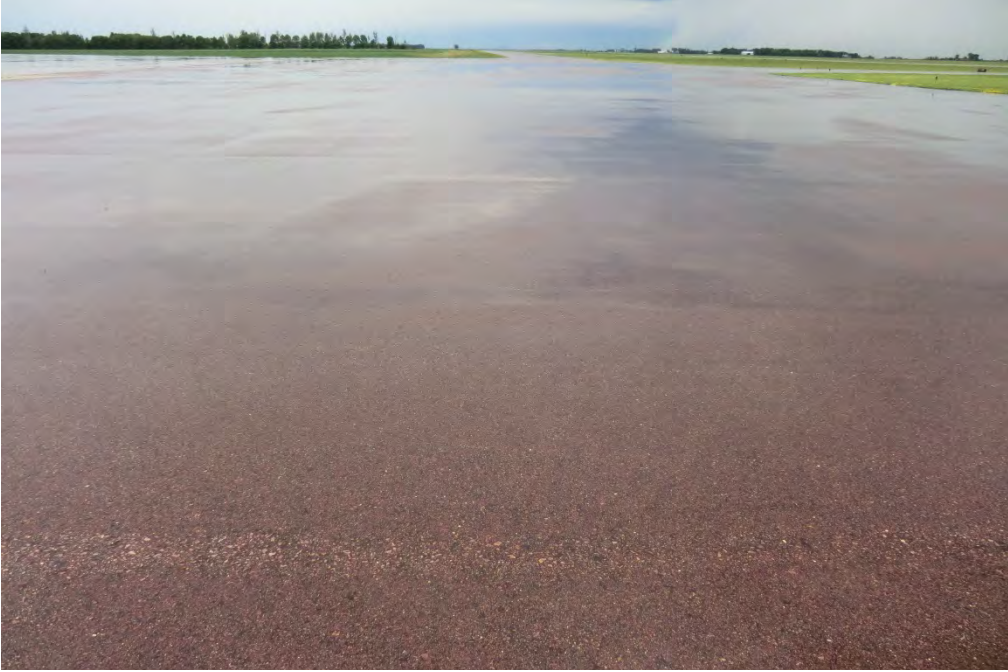
OTG APA 002 (PCI = 85)

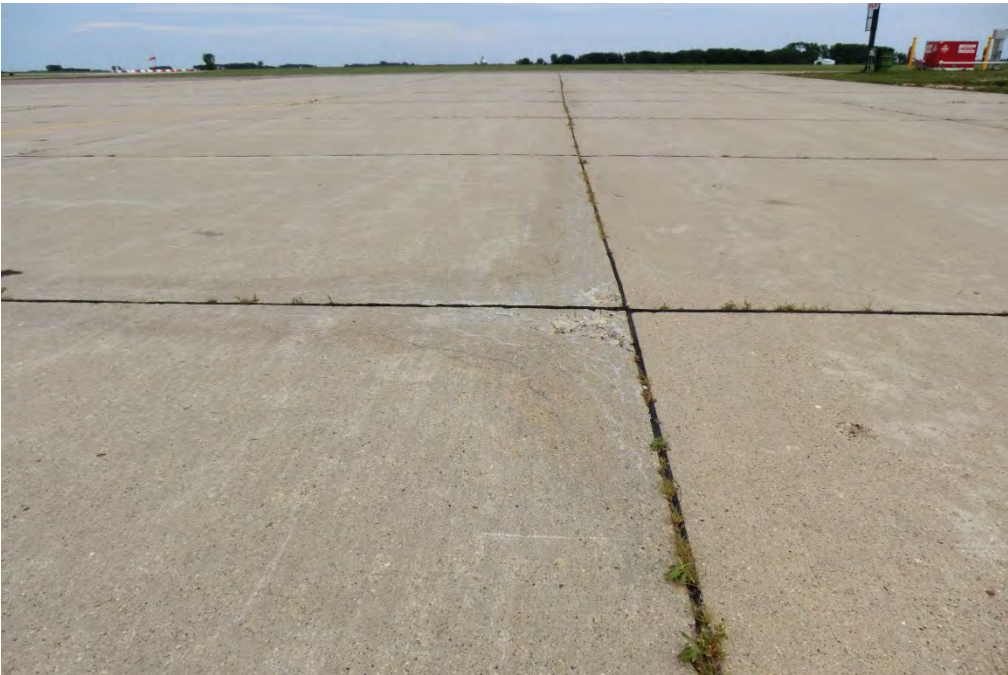
OTG APA 003 Durability CR, (PCI = 57)

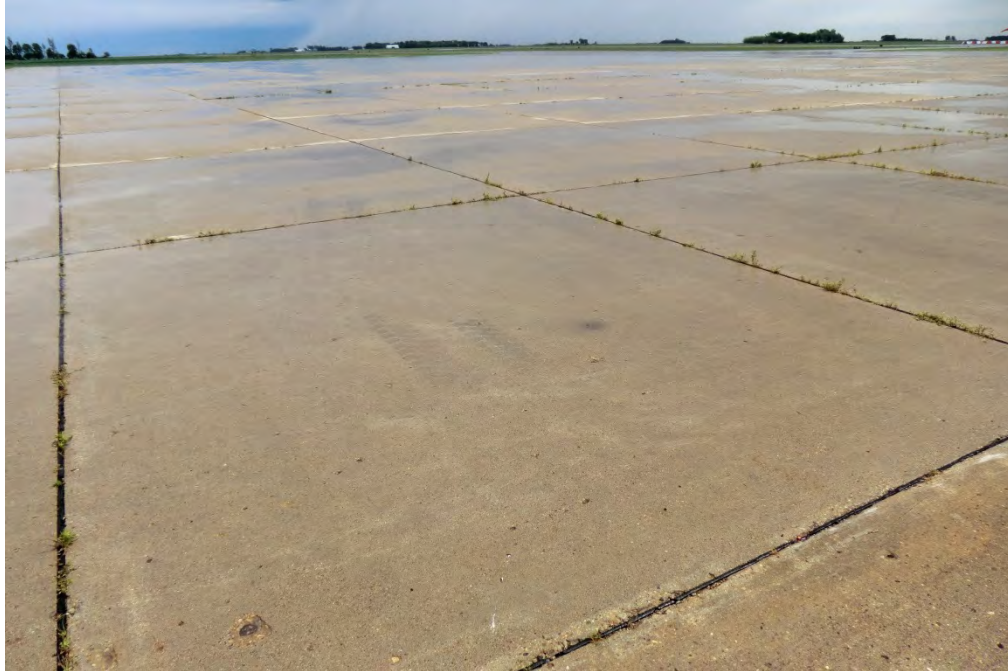
OTG APA 003 (PCI = 57)

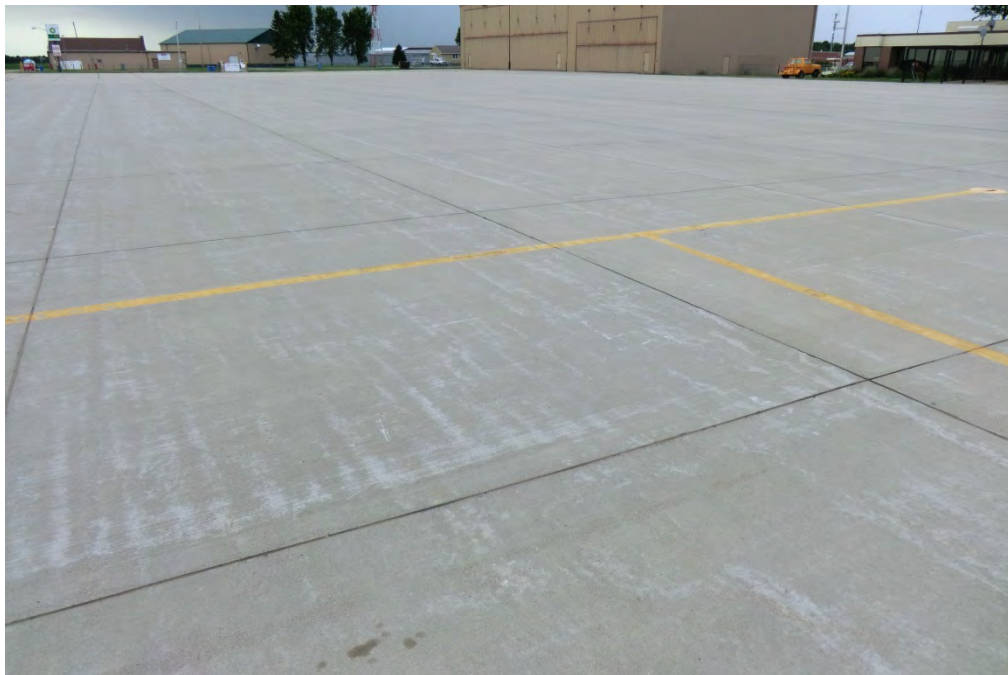
OTG APA 004 (PCI = 99)

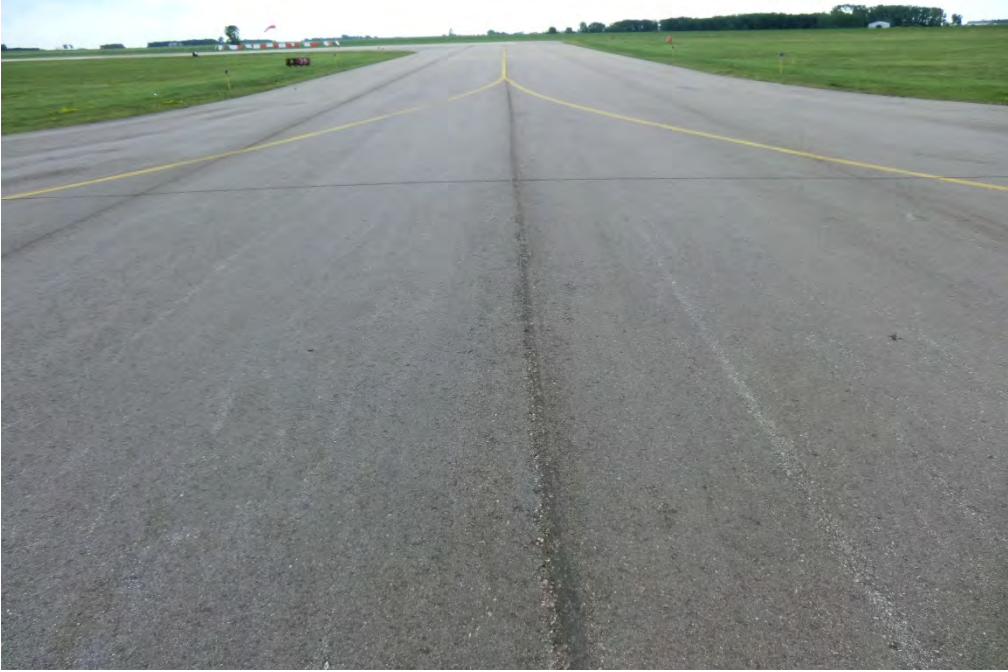
OTG CTA 001 (PCI = 100)

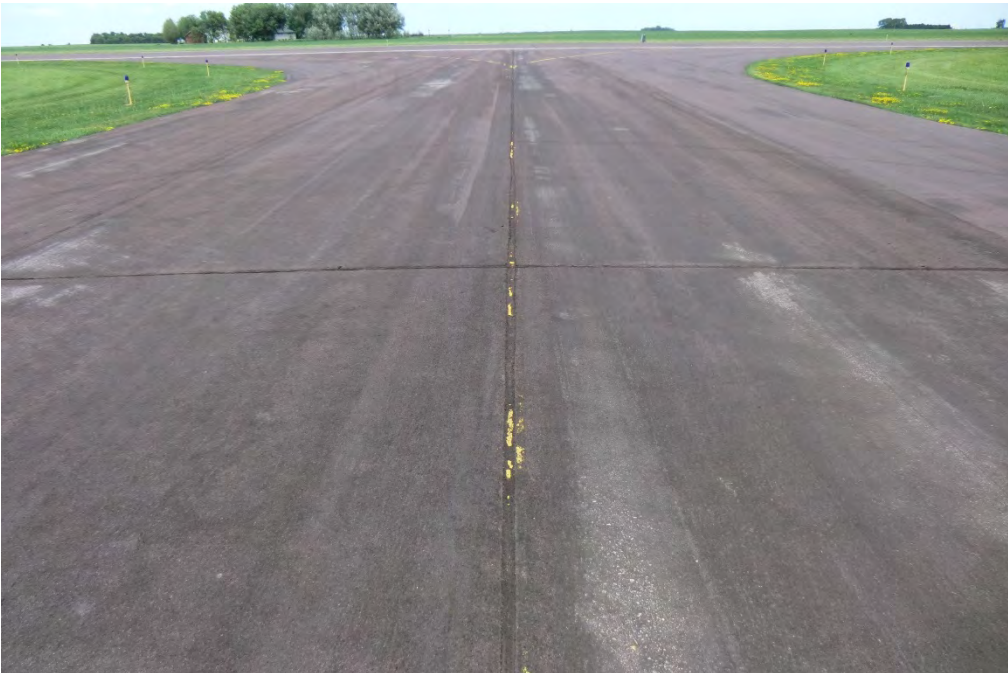
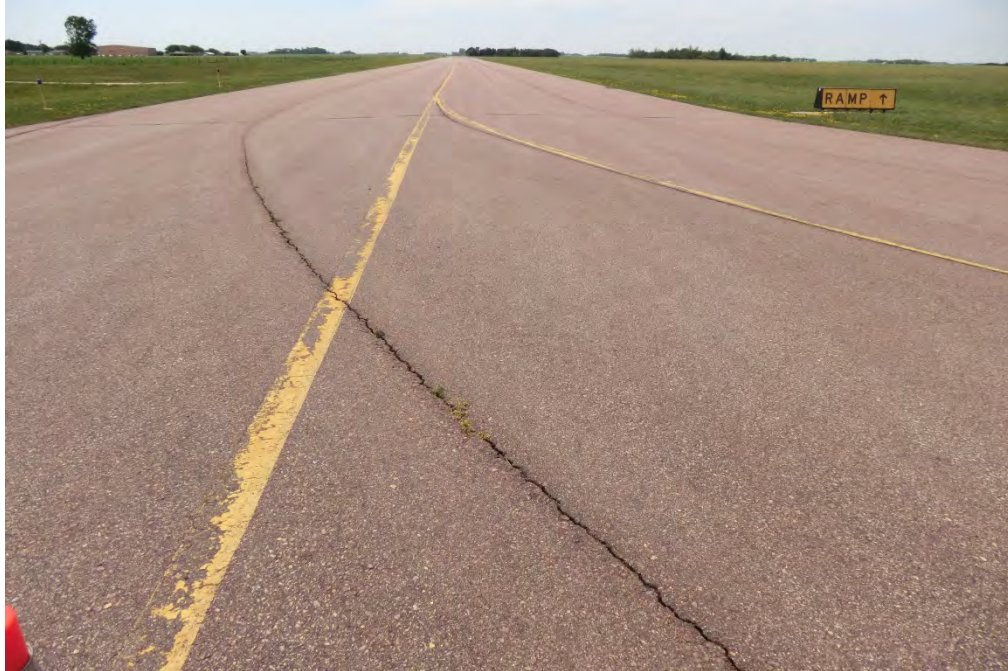
OTG CTB 001 (PCI = 77)

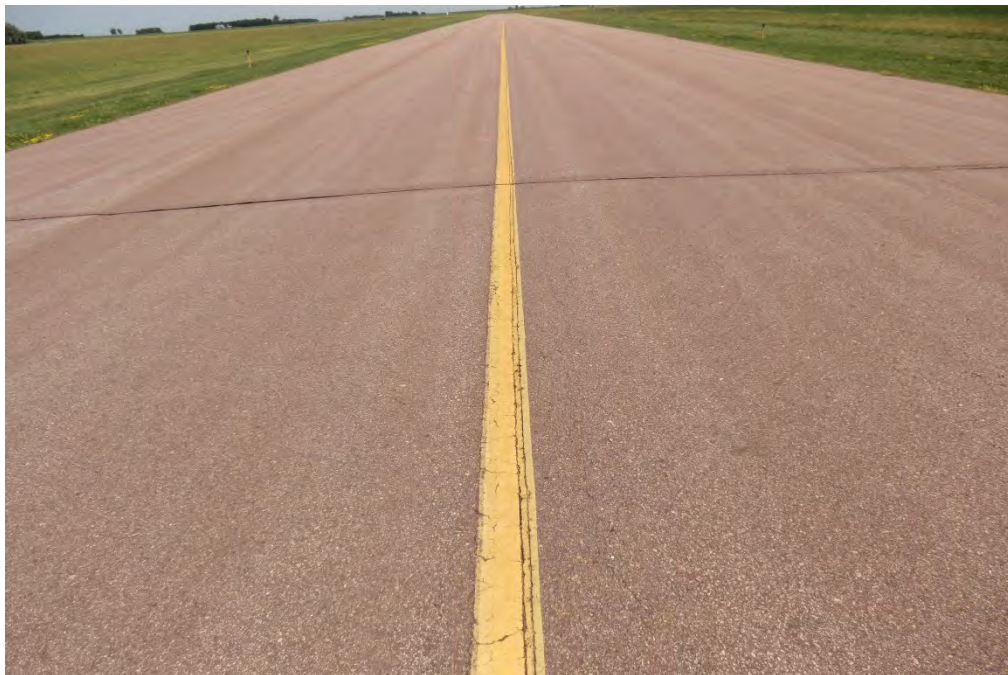
OTG CTB 002 (PCI = 72)

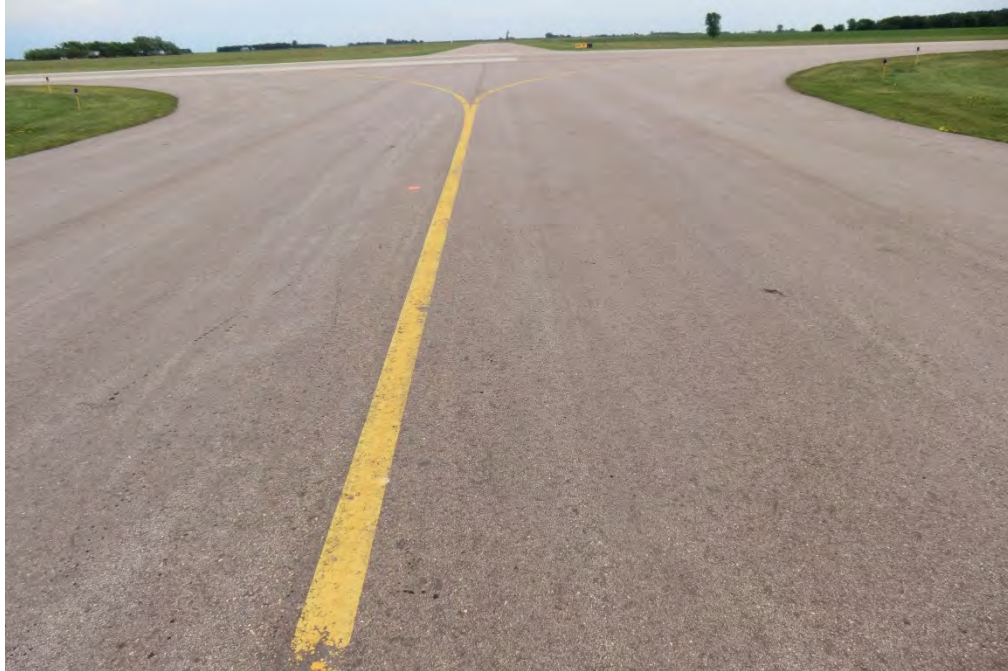
OTG CTBX 001 (PCI = 96)

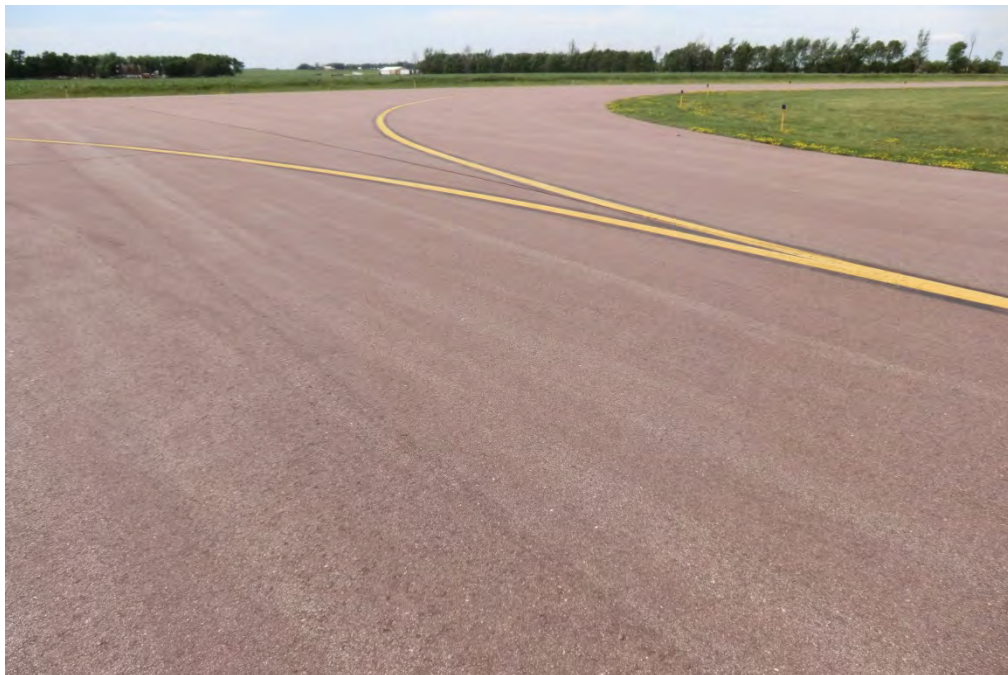
OTG CTBX 002 (PCI = 95)

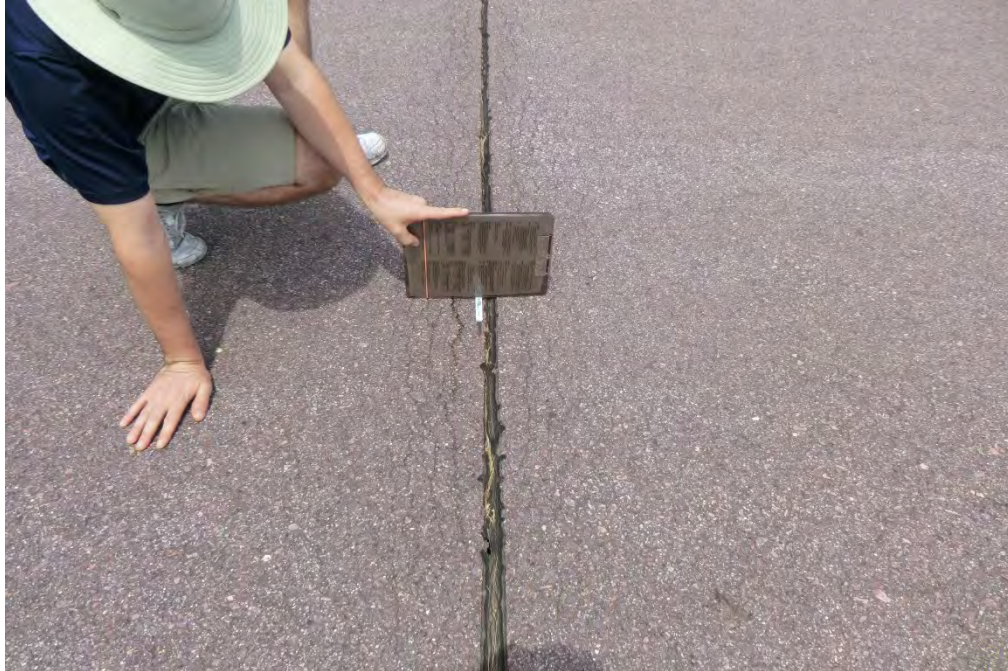
OTG PPTB 001 Alligator CR, (PCI = 72)

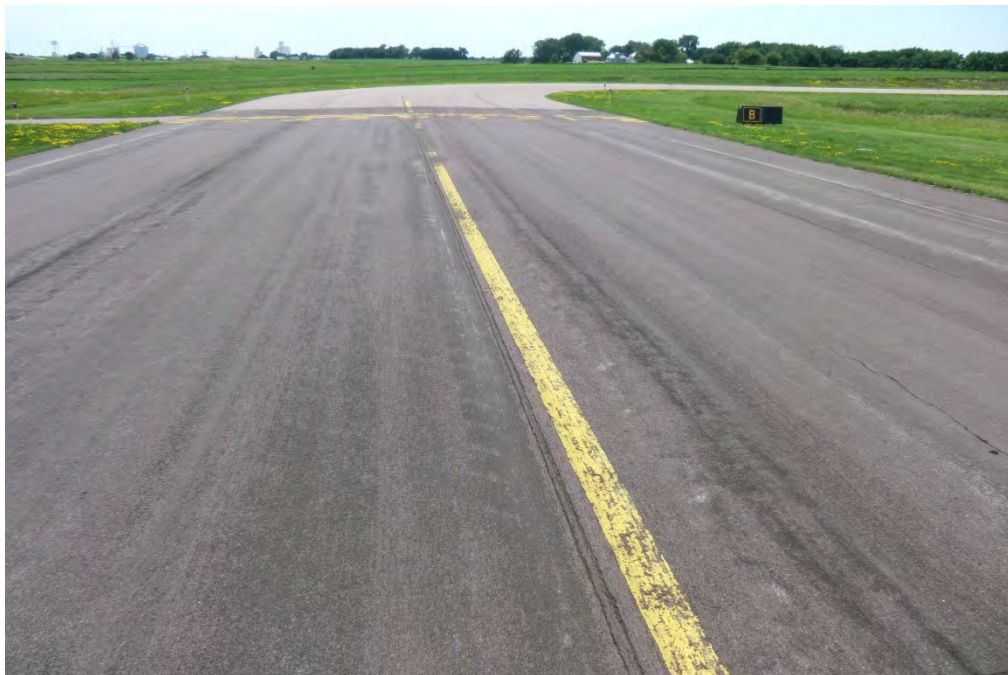
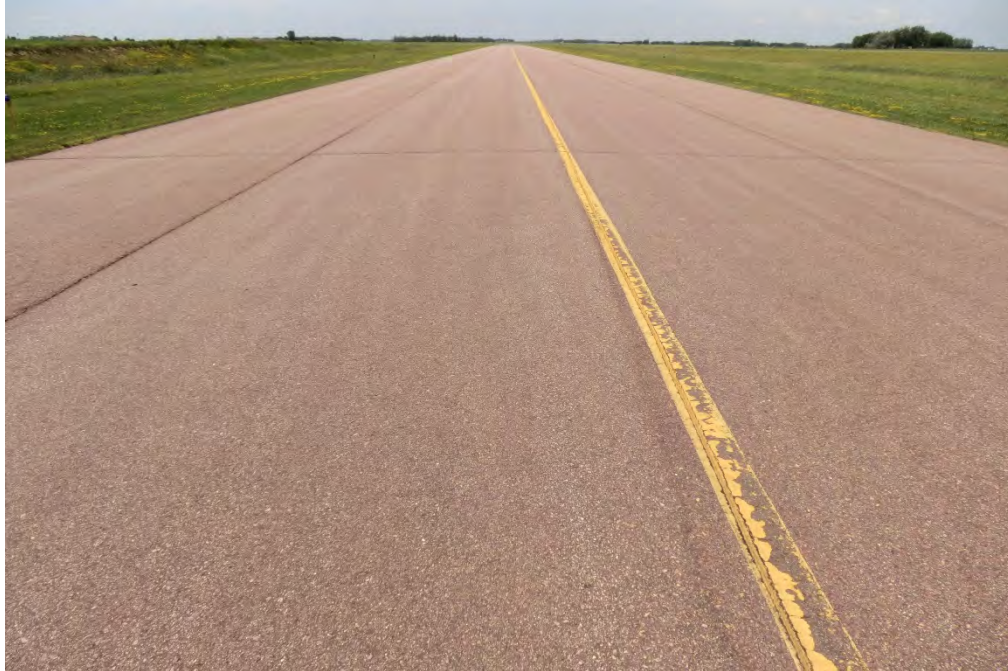
OTG PPTB 001 (PCI = 72)

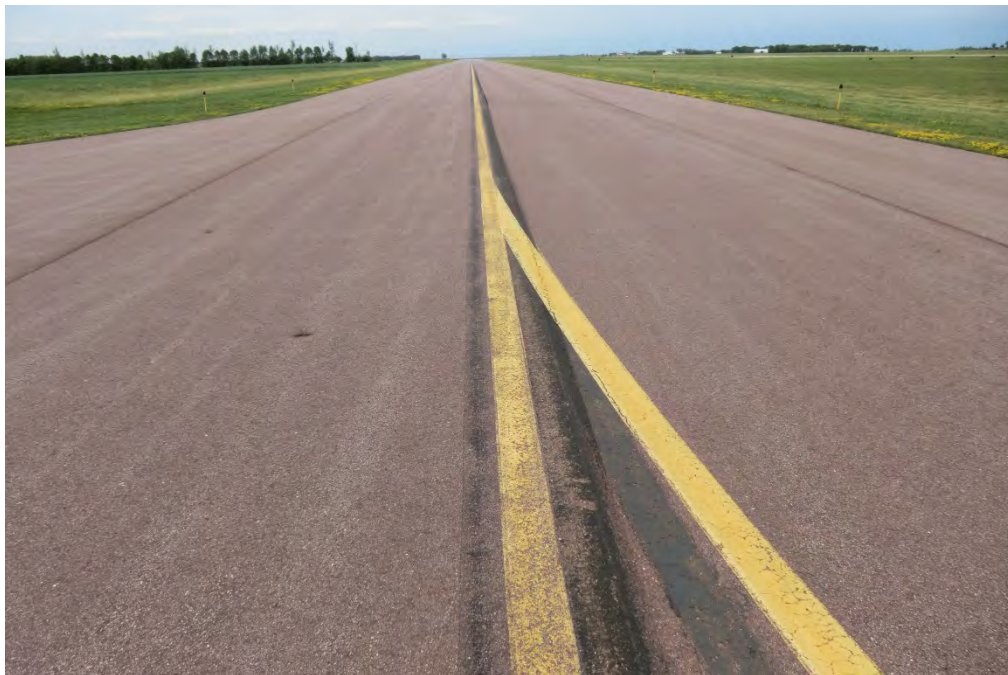
OTG PPTC 001 (PCI = 90)

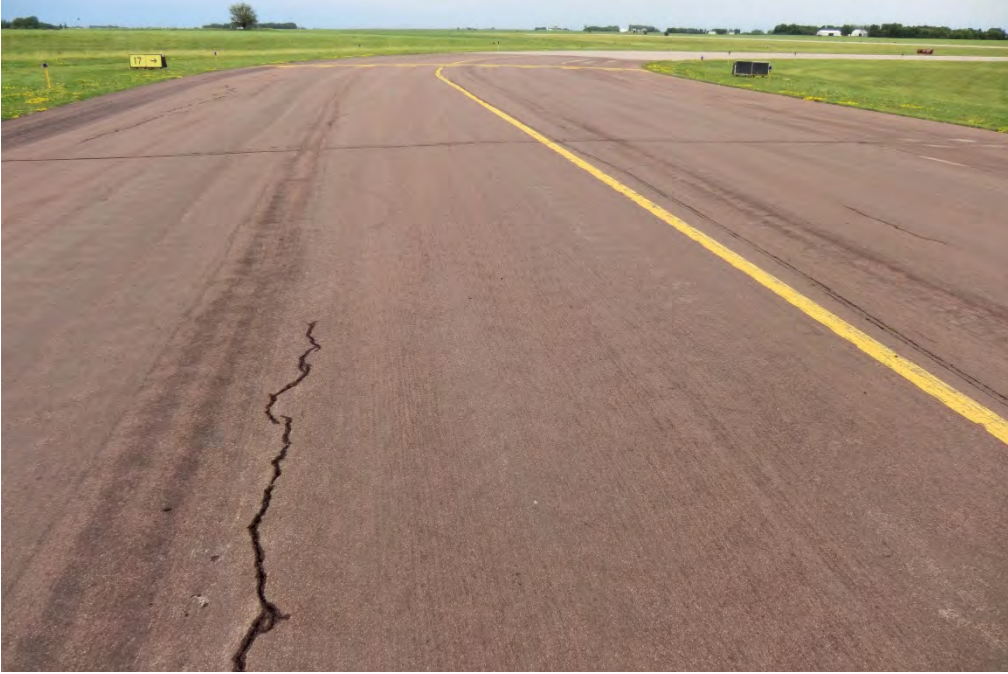
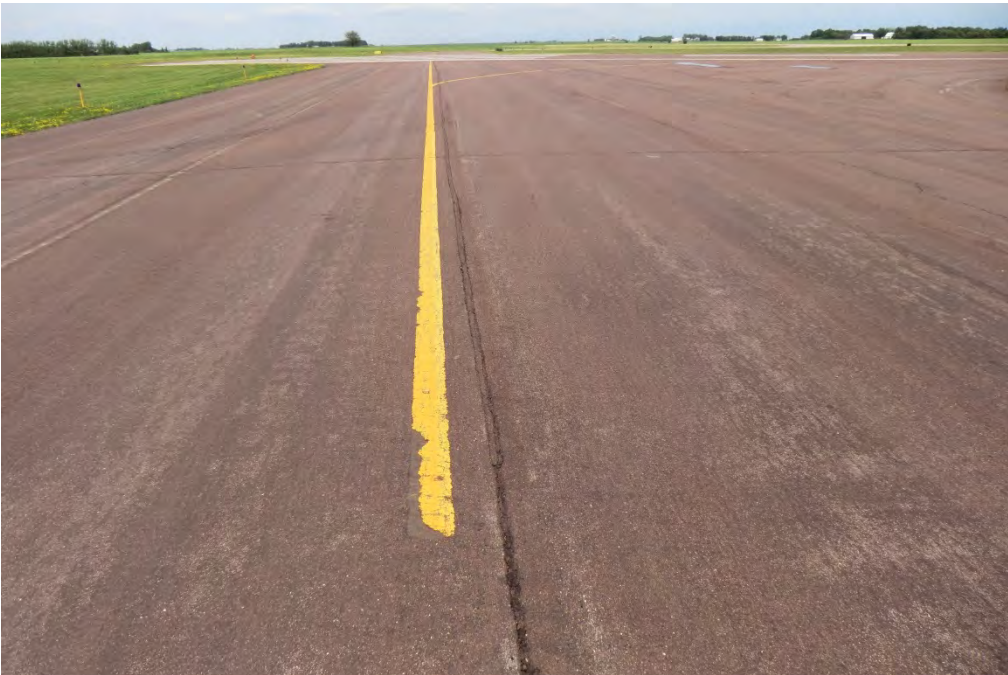
OTG PPTC 002 (PCI = 77)

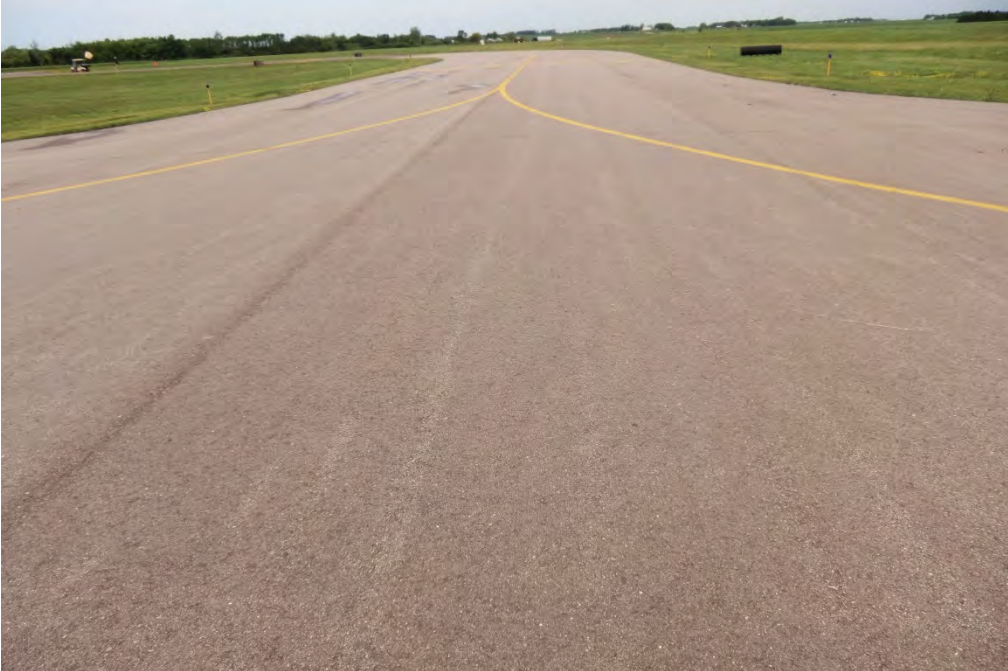
OTG PPTC 003 (PCI = 95)

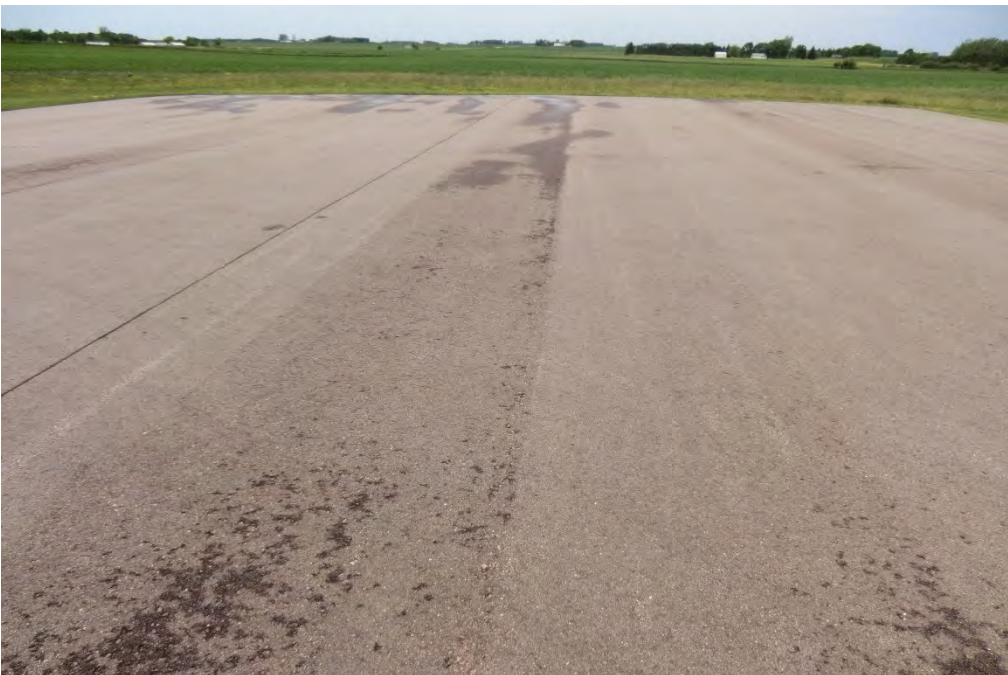
OTG RTA 001 (PCI = 98)

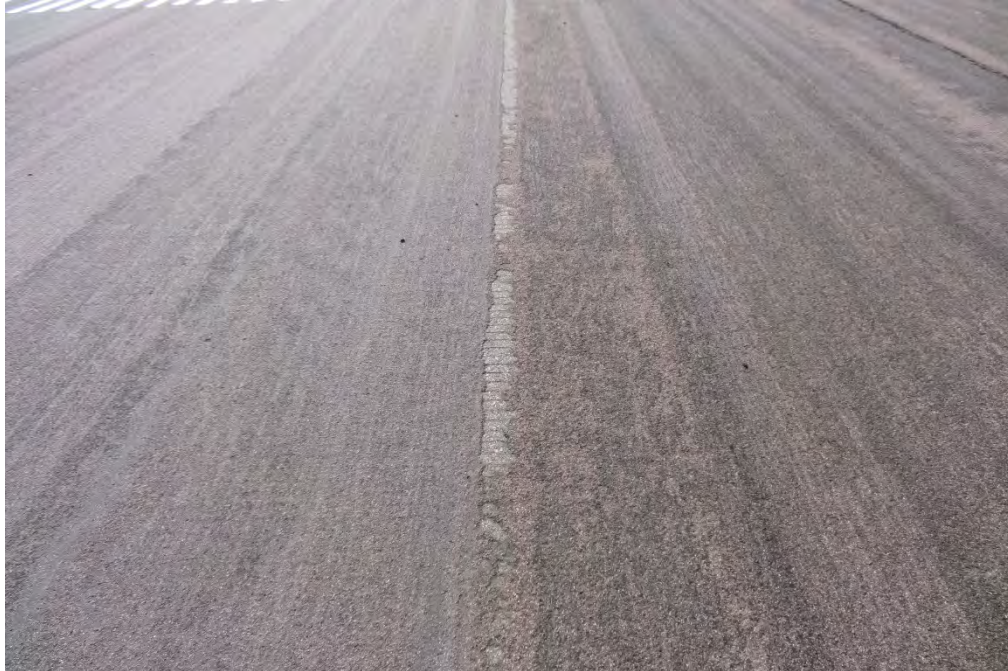
OTG RY1129 001 slurry seal, (PCI = 80)

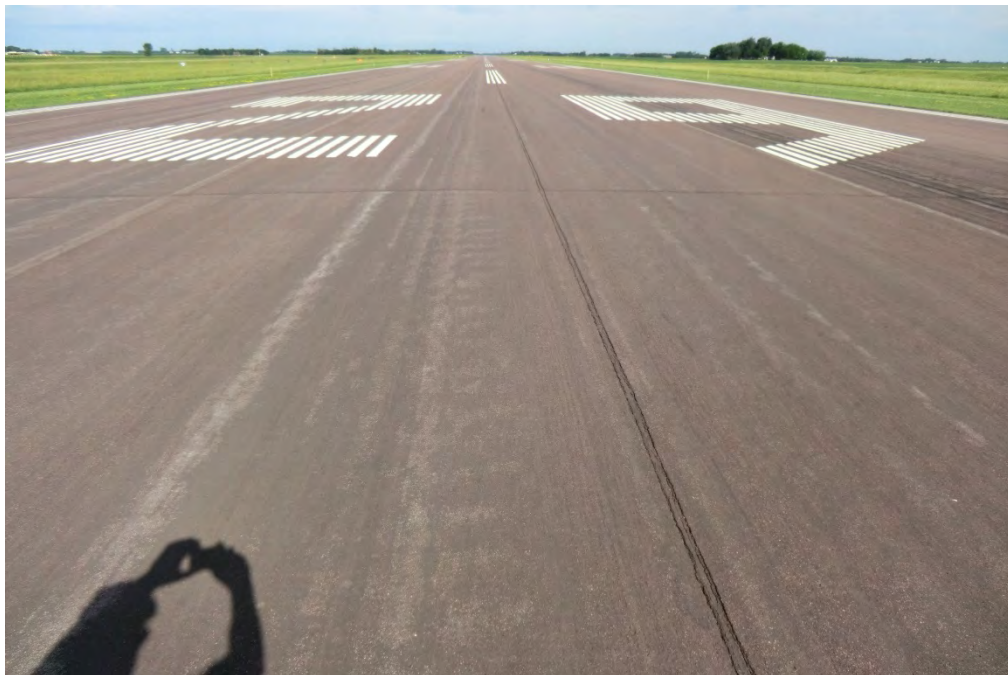
OTG RY1129 001 (PCI = 80)

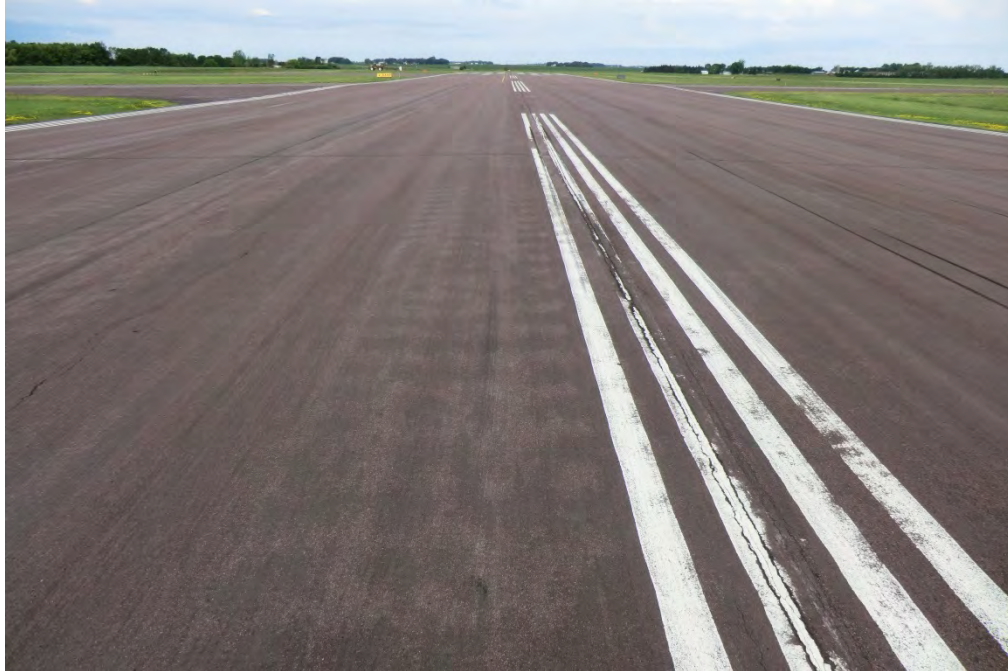
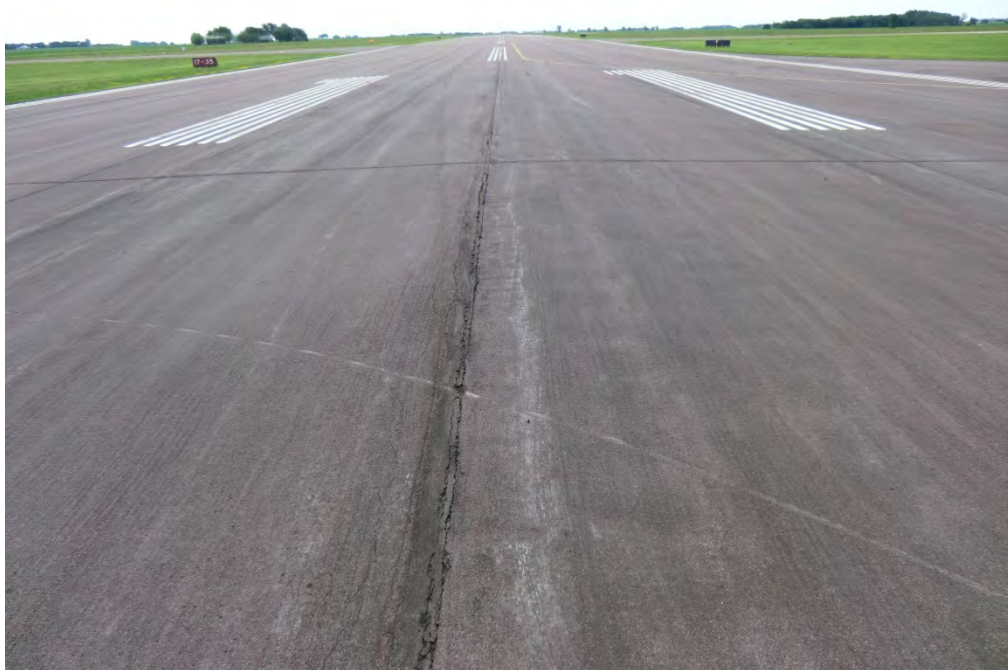
OTG RY1129 002 (PCI = 74)

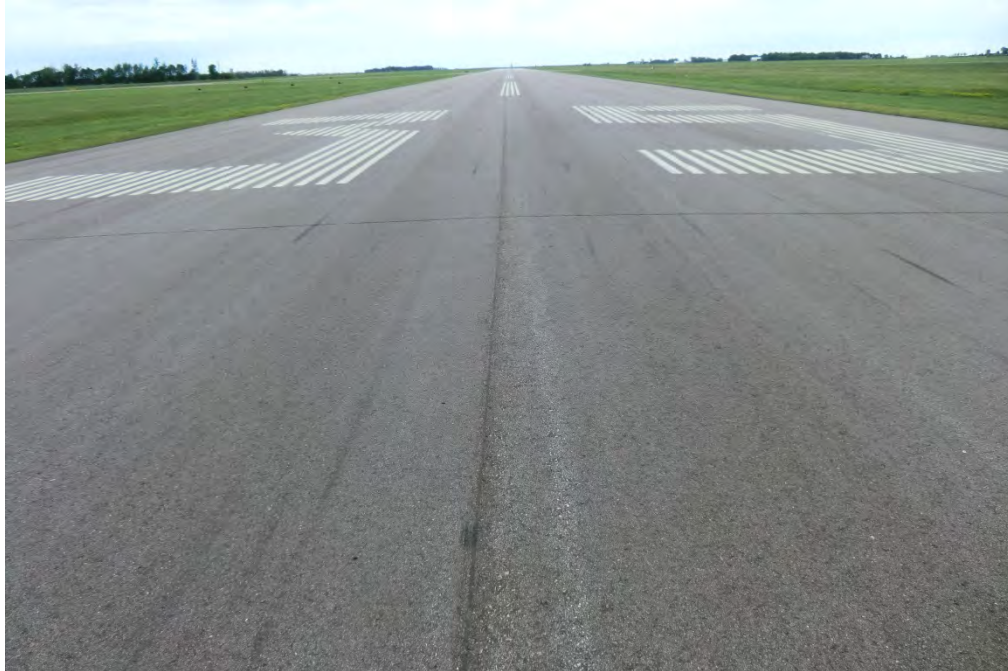
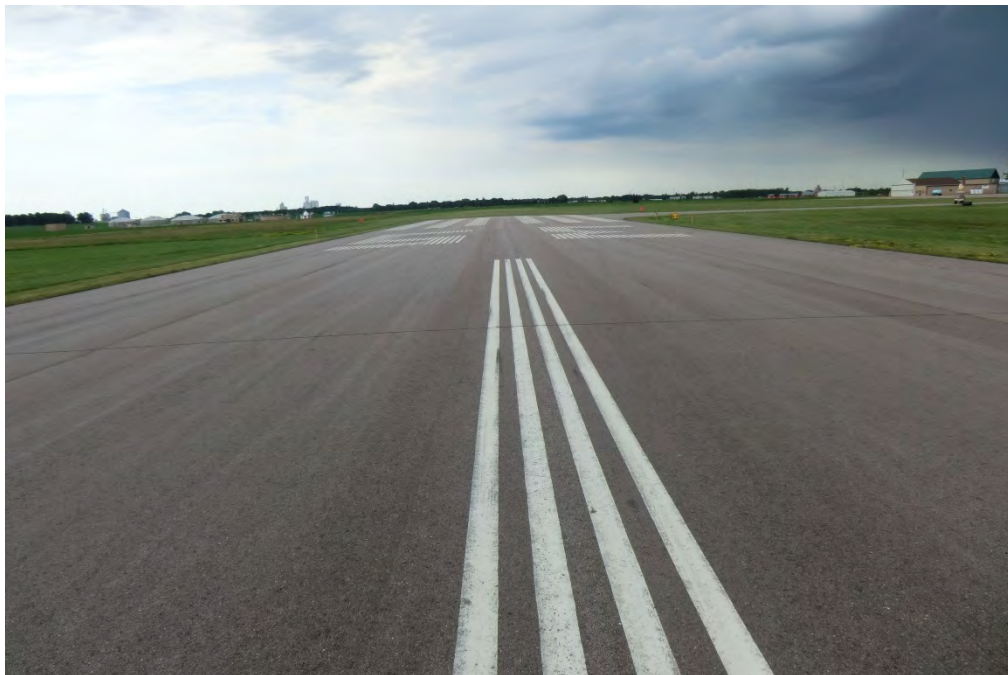
OTG RY1735 001 (PCI = 98)

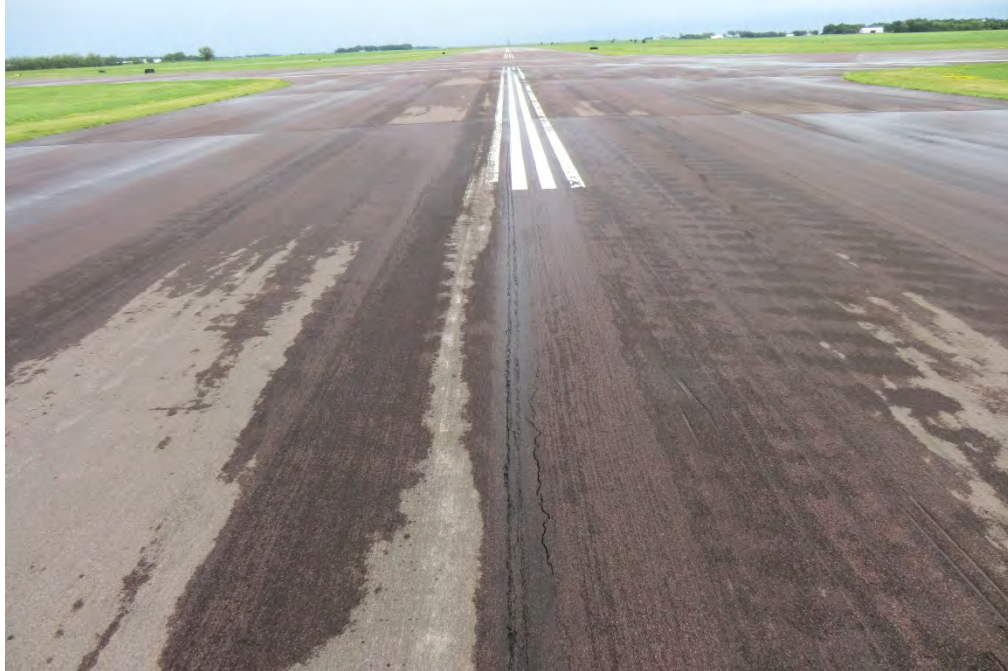
OTG RY1735 002 (PCI = 74)

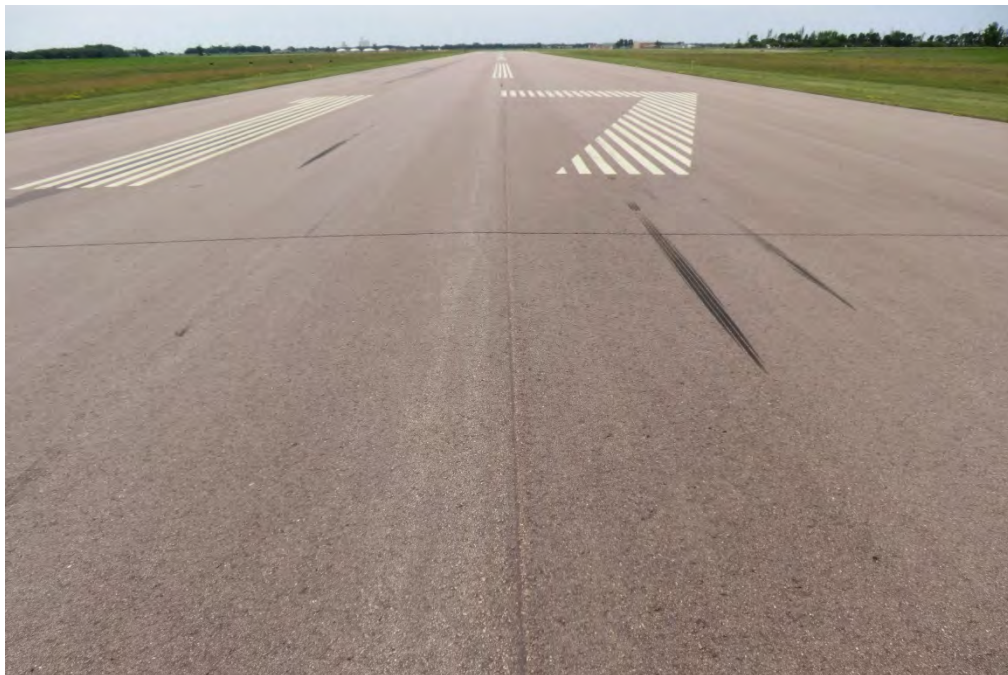
OTG RY1735 003 (PCI = 100)

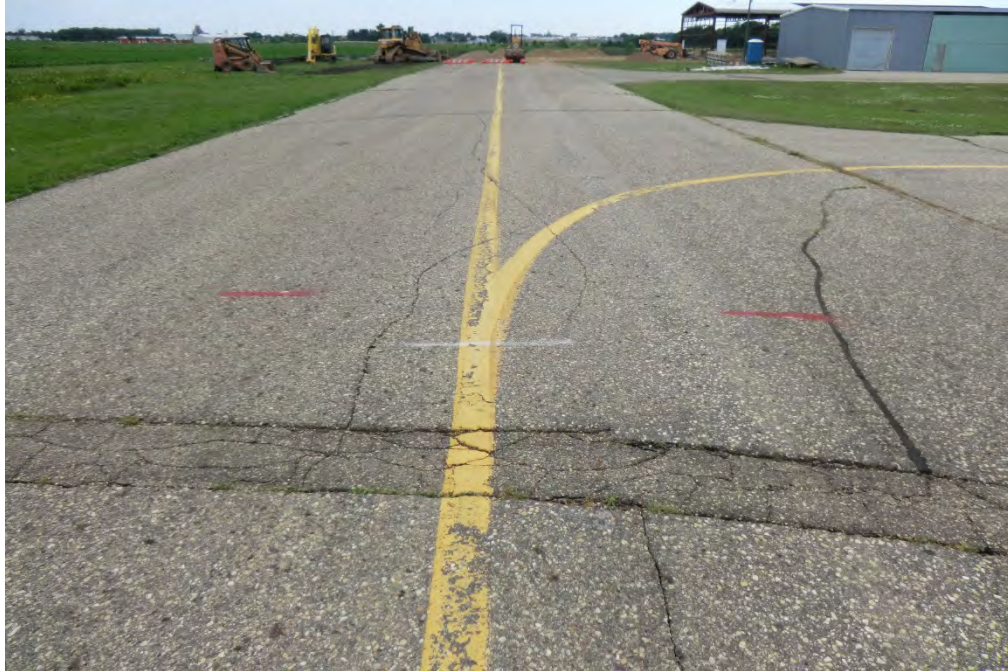
OTG TLA 001 (PCI = 23)
