Minnesota Airport System Pavement Evaluation 2012 Update

Worthington Municipal Airport (OTG)

Worthington, Minnesota

Final Report

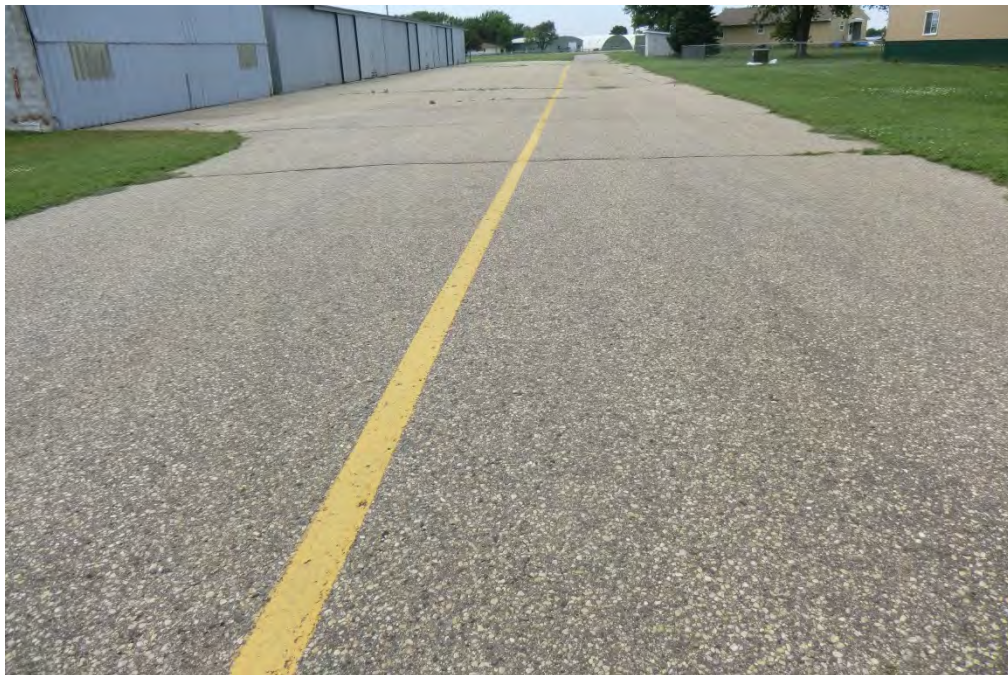
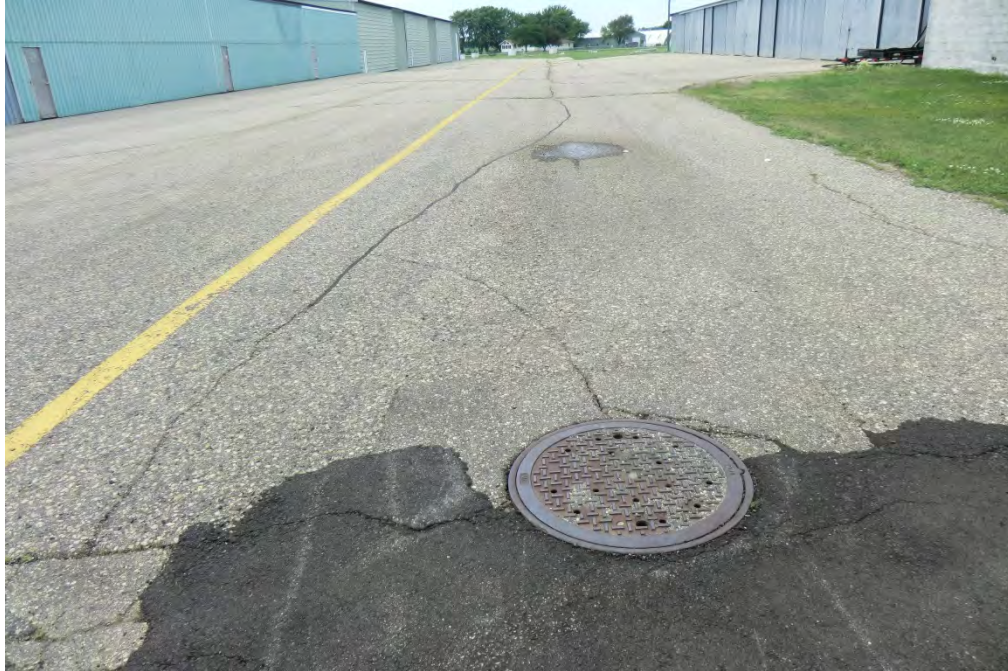
OTG TLA 002 (PCI = 18)

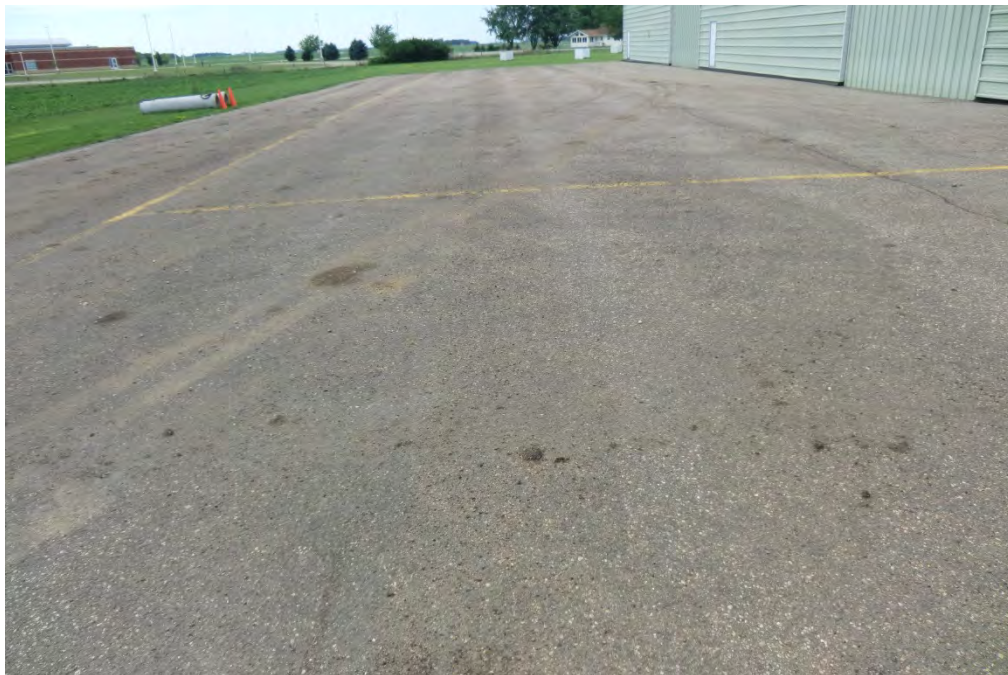
OTG TLA 003 (PCI = 22)

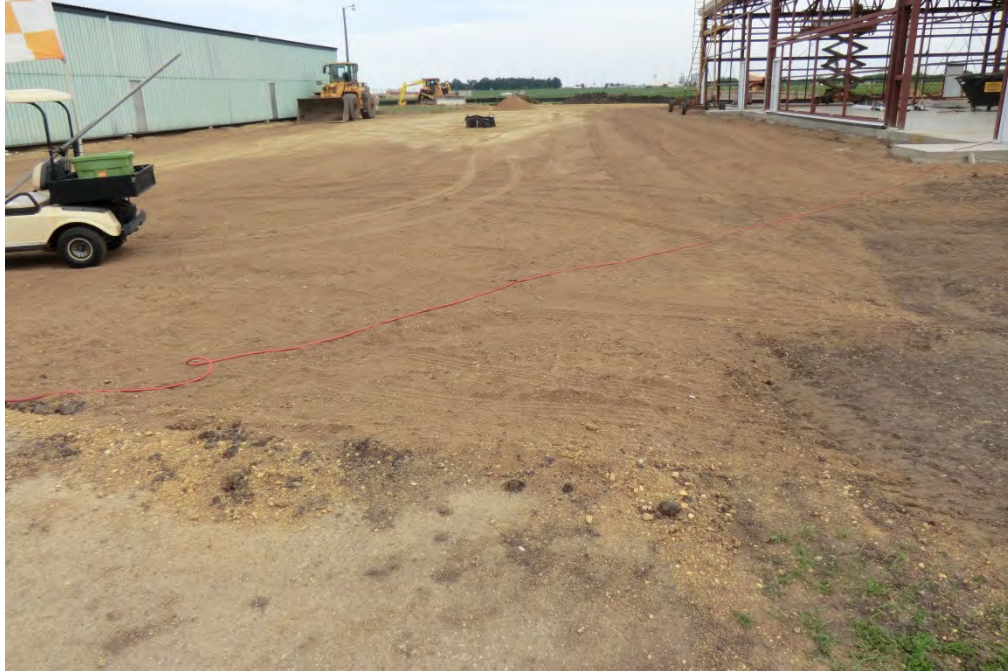
OTG TLA 004 during construction
