# Minnesota Airport System Pavement Evaluation 2013 Update

Long Prairie Municipal Airport (14Y)

Long Prairie, Minnesota

October 2013

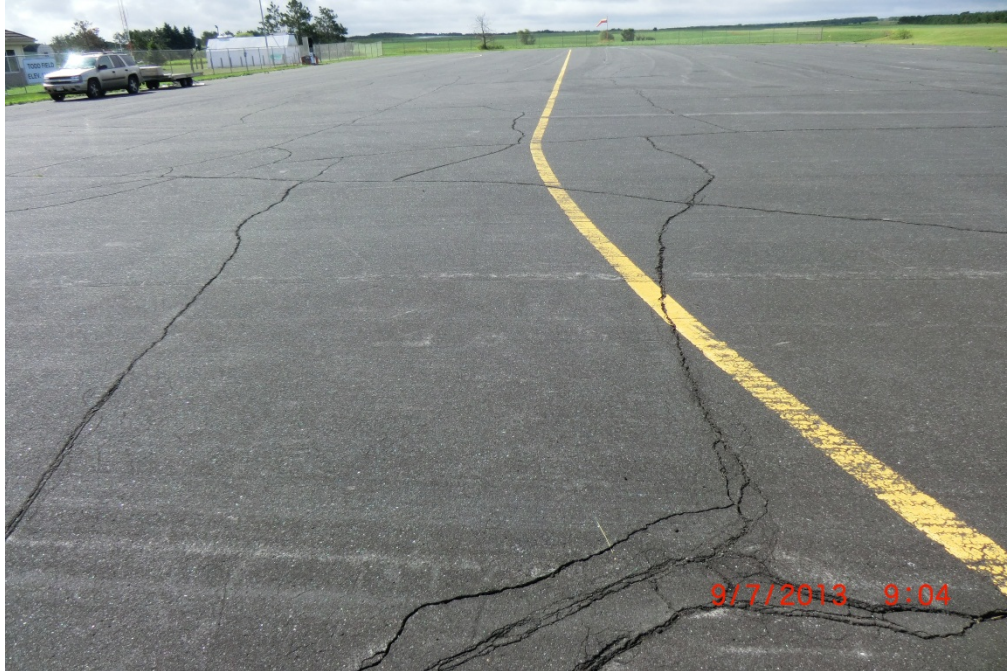
14Y APA 001 (PCI = 58, prior to rehabilitation)

Conditions: PCI : 58

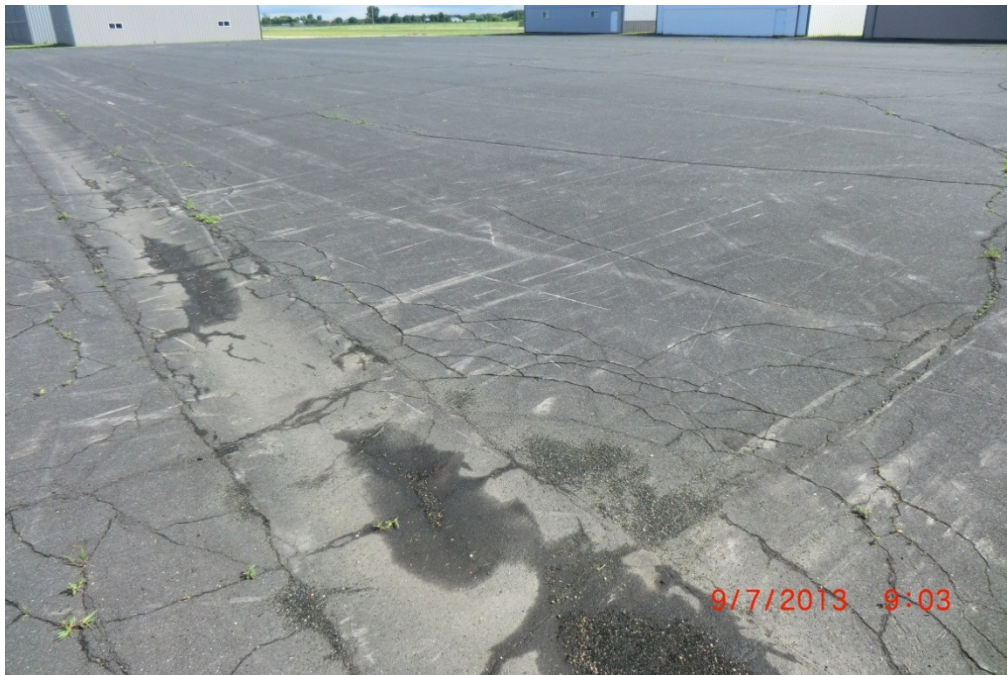
14Y APA 002 (PCI = 57, prior to rehabilitation)

Conditions: PCI : 57

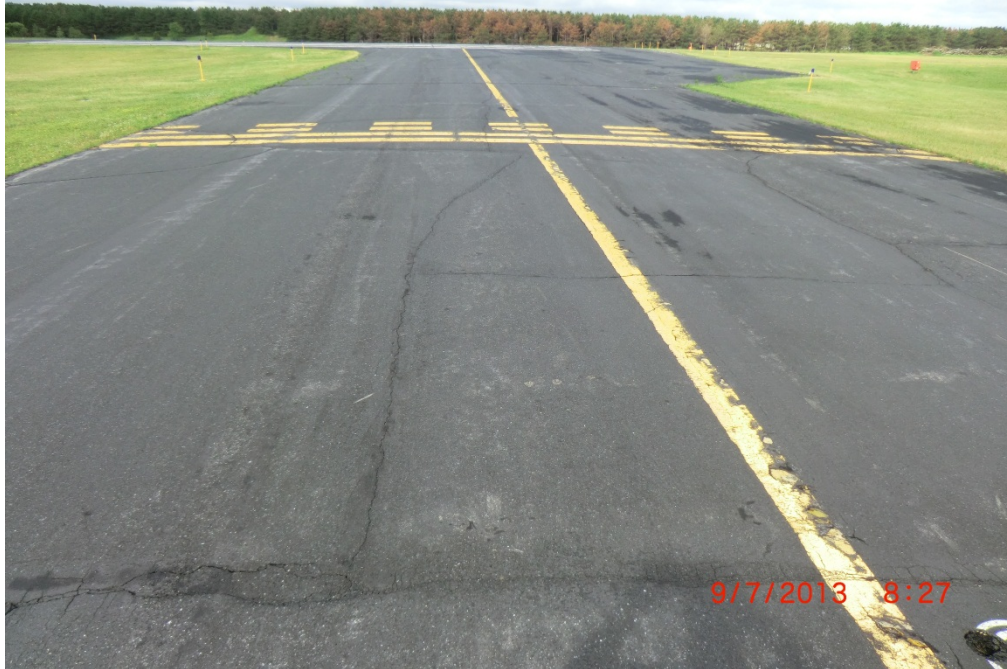
14Y CTA 001 (PCI = 57, prior to rehabilitation)

Conditions: PCI : 57

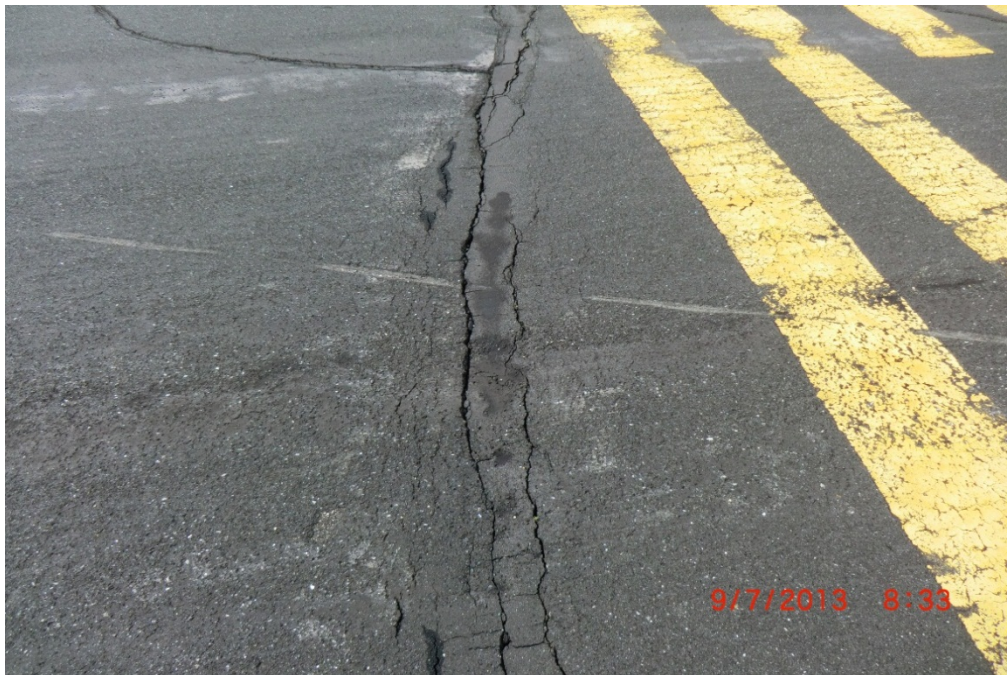
14Y CTA 001 (High-Severity L&T Crack, prior to rehabilitation)

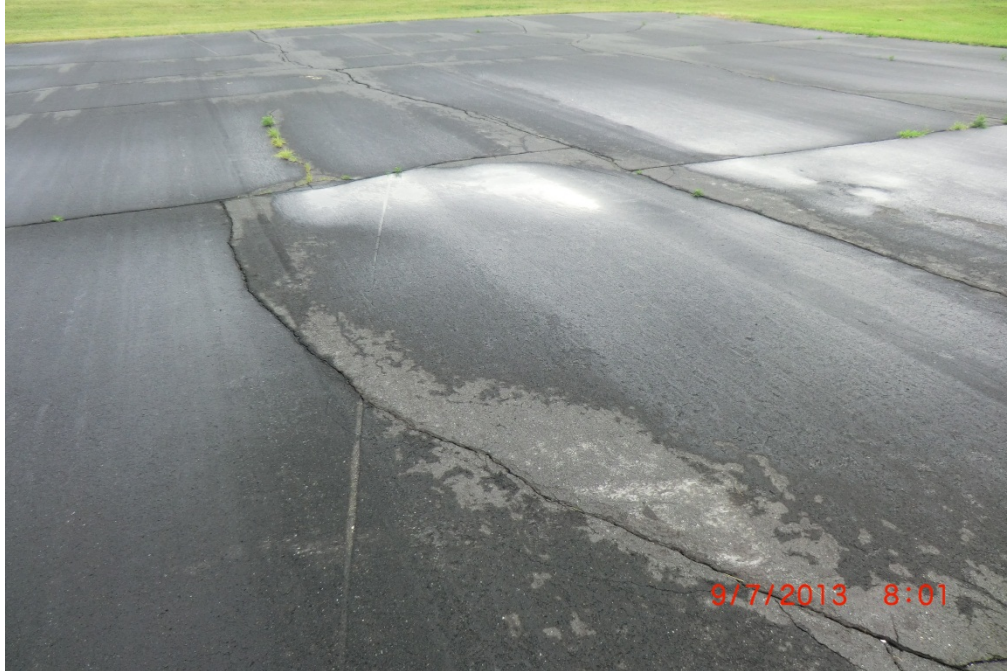
14Y RTA 001 (PCI = 53, prior to rehabilitation)

Conditions: PCI : 53

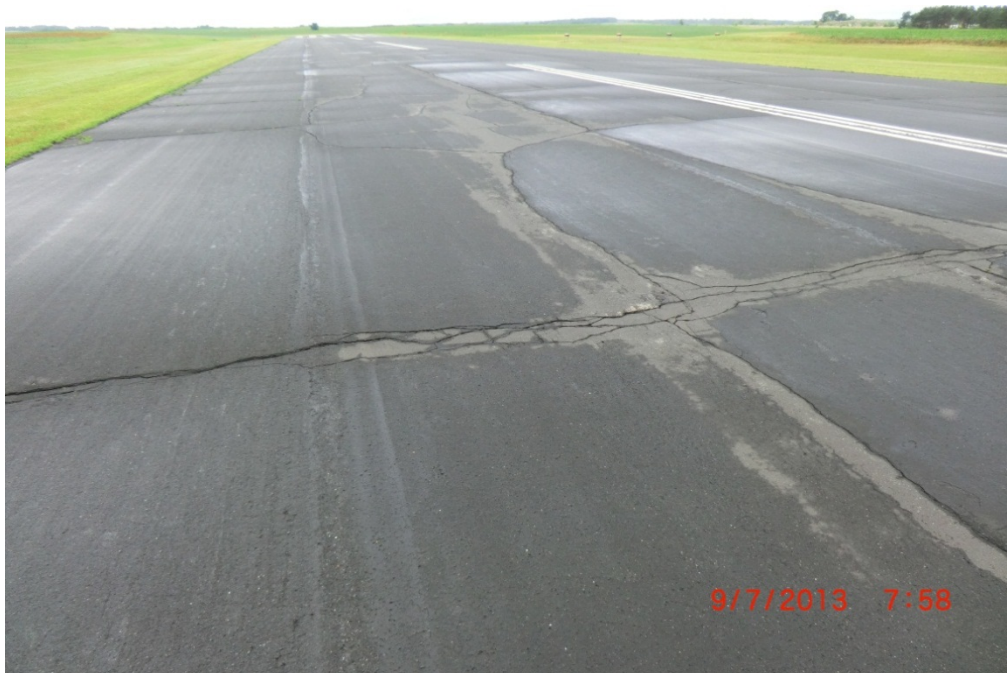
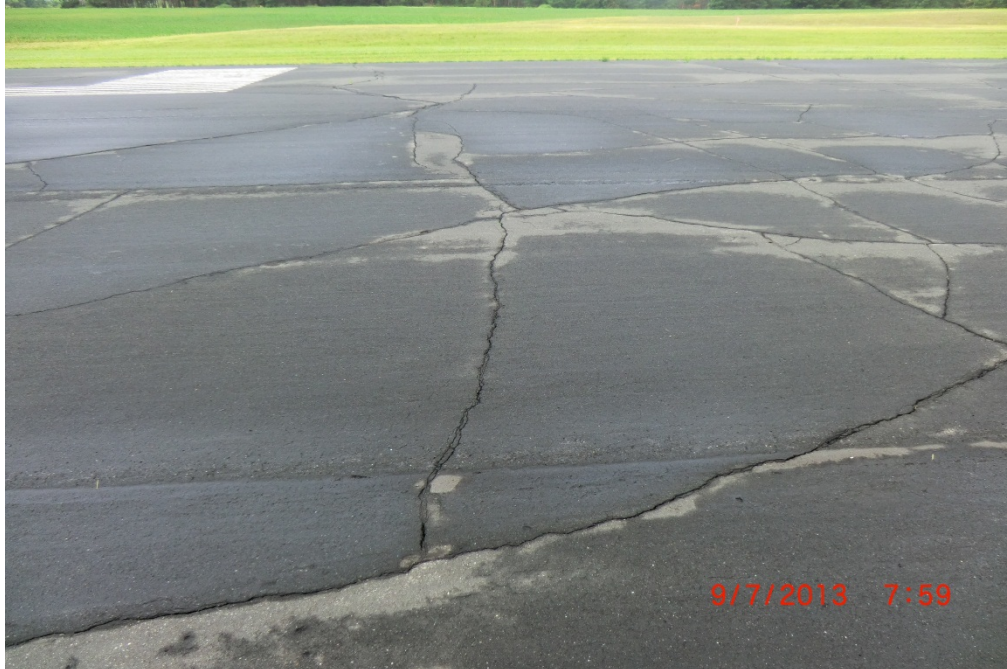
14Y RY1634 001 (PCI = 58, prior to rehabilitation)

Conditions: PCI : 58

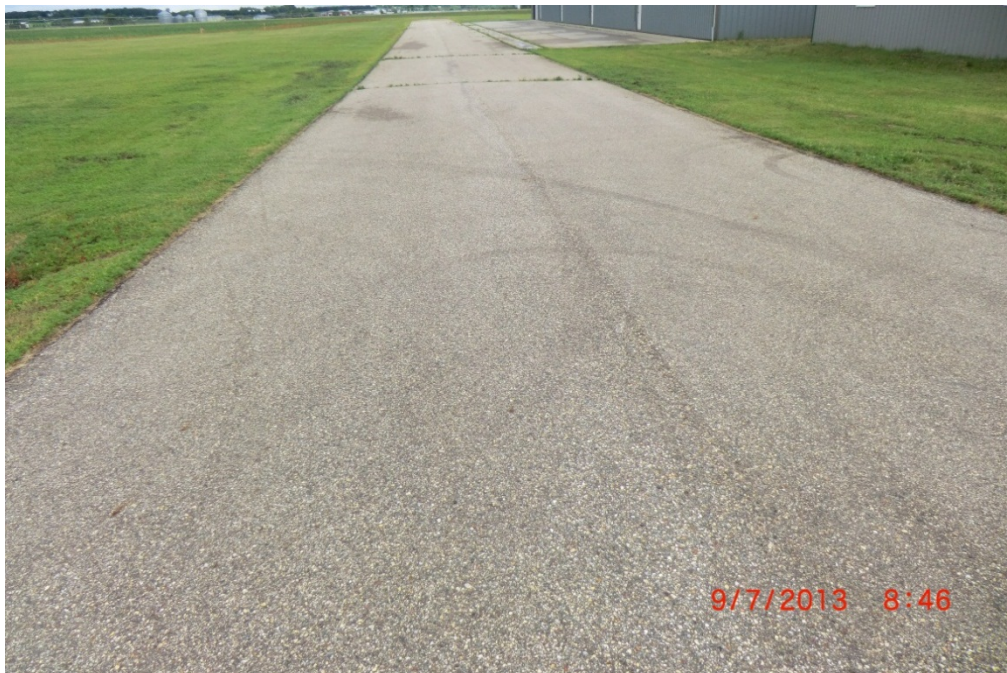
| Branch ID | Section ID | Surface type <sup>1</sup> | Section area (SF) | LCD <sup>2</sup> | 2010 PCI | 2013 PCI | Drop in PCI/Yr <sup>3</sup> | % Deduct due to | | Distress types |
|---|---|---|---|---|---|---|---|---|---|---|
| TLA | 1 | AC | 9,100 | 2008* | 95 | 80 | 4.0 | 0 | 100 | Longitudinal & transverse (L&T) cracking, raveling |

14Y TLA 001 (PCI = 80)

Conditions: PCI : 80

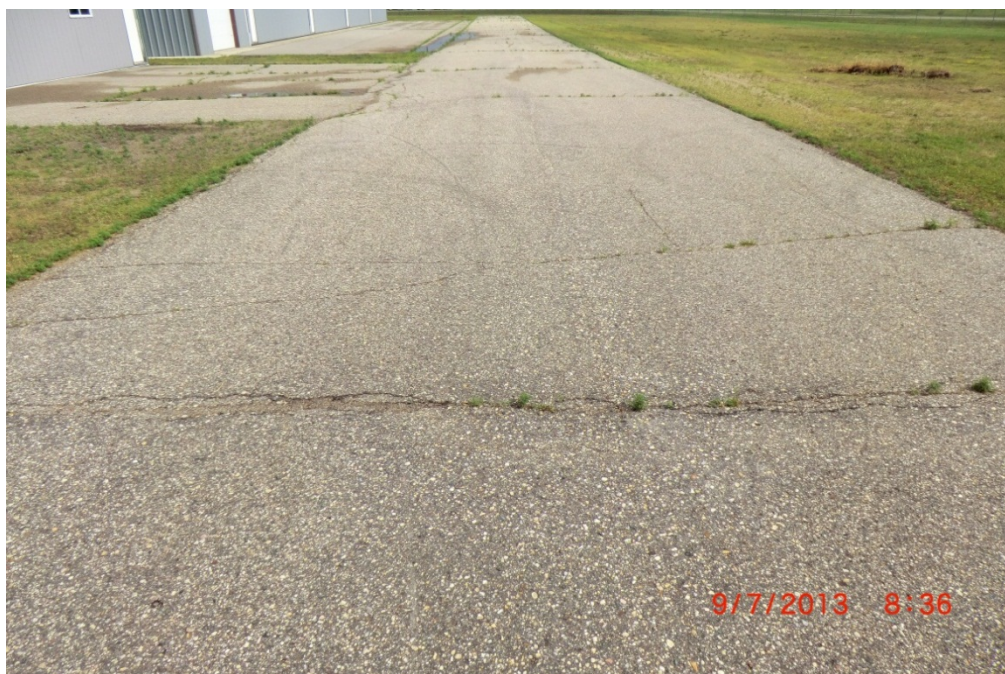
14Y TLA 002 (PCI = 36, prior to rehabilitation)

Conditions: PCI : 36
