Minnesota Airport System Pavement Evaluation 2013 Update

Perham Municipal Airport (16D)

Perham, Minnesota

Final Report

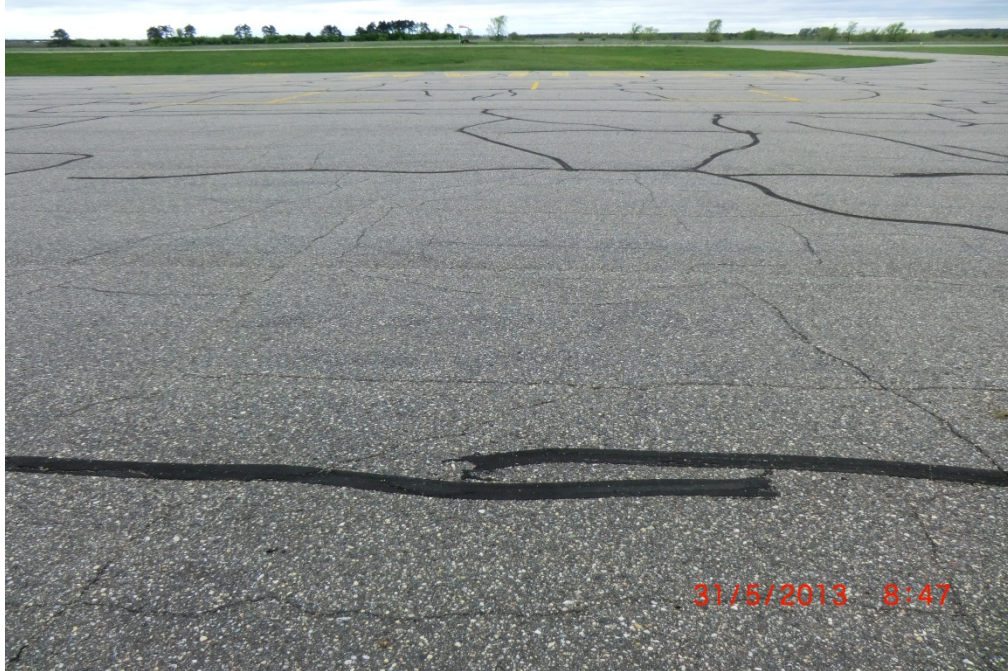
16D APA 001 (PCI = 48)

Conditions: PCI : 48

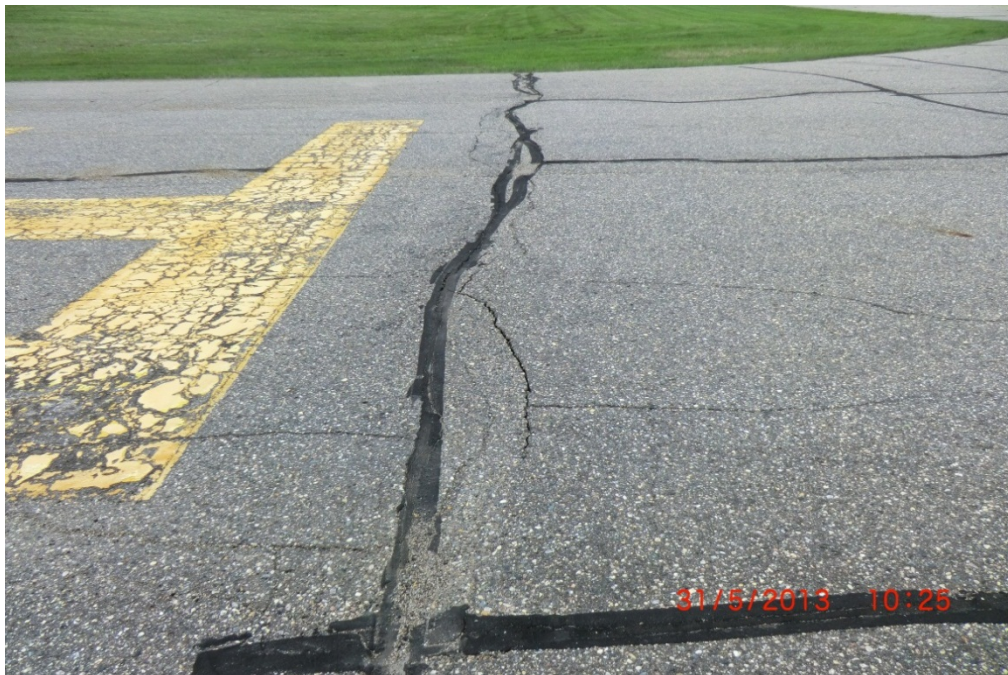
16D APA 001 (High-Severity L&T Crack)

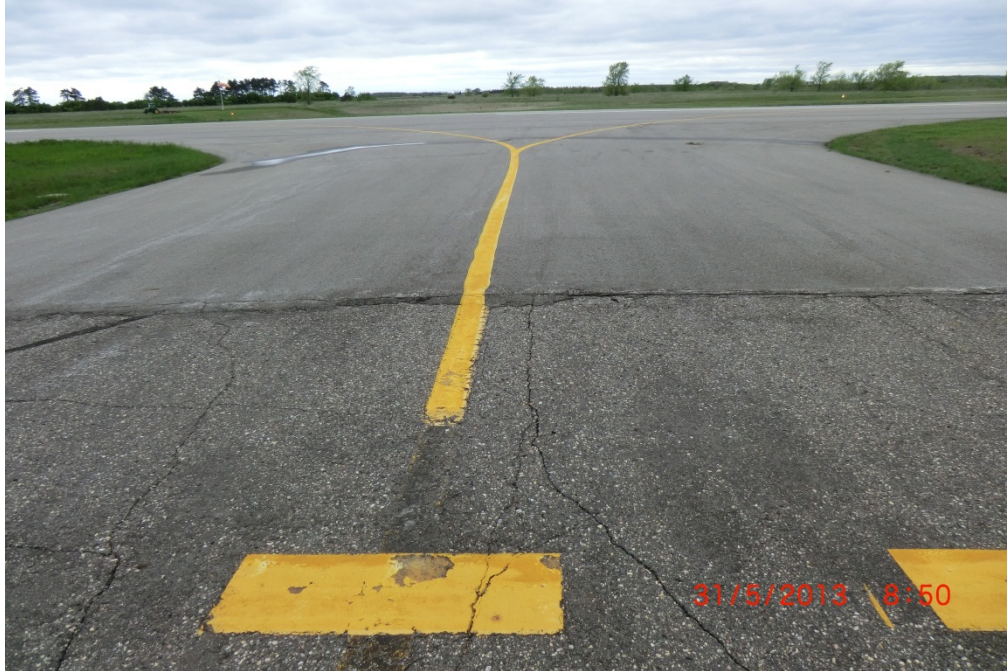
16D CTA 001 (PCI = 93, Section 001 in Background)

Conditions: PCI: 93

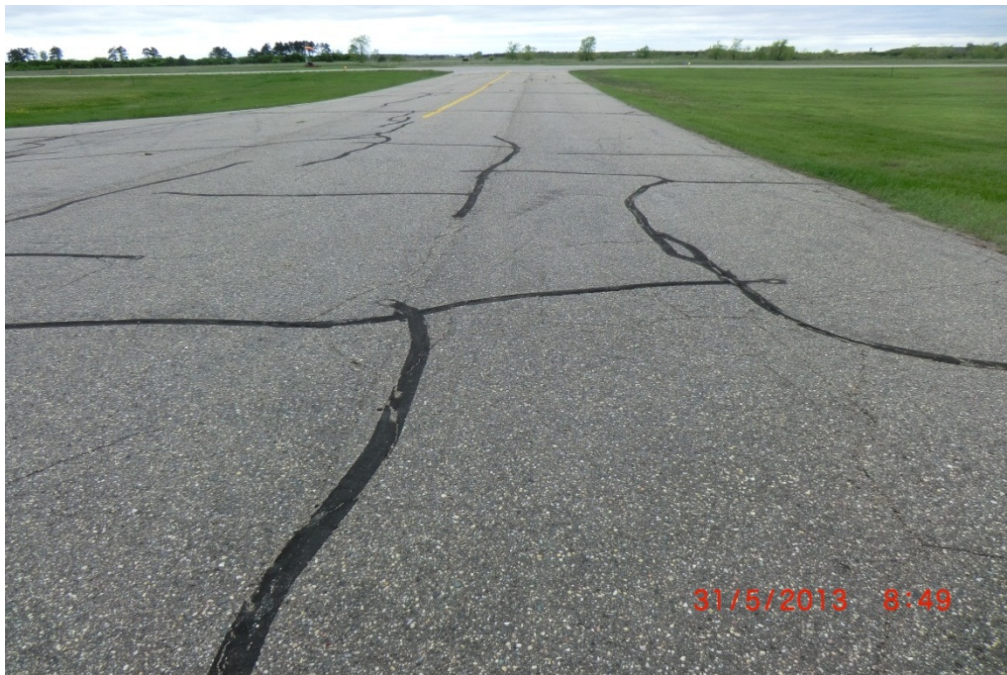
16D CTA 002 (PCI = 36, Several Distress Types Not Visible in Photo)

Conditions: PCI: 36

41 ALLIGATOR CRACKING	L	30.00 SqFt	Comments:
41 ALLIGATOR CRACKING	M	21.00 SqFt	Comments:
48 LONGITUDINAL/TRANSVERSE CRACKING	L	440.00 Ft	Comments:
48 LONGITUDINAL/TRANSVERSE CRACKING	M	100.00 Ft	Comments:
43 BLOCK CRACKING	L	1,080.00 SqFt	Comments:
52 RAVELING	L	1,000.00 SqFt	Comments:
57 WEATHERING	L	4,000.00 SqFt	Comments:

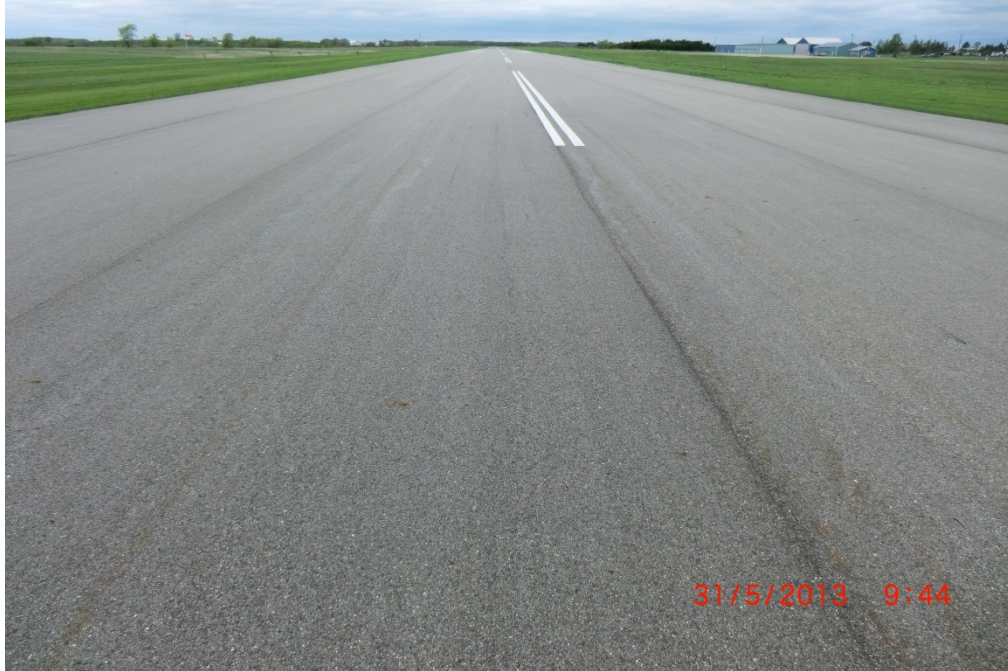
16D RY1230 001 (PCI = 91)

Conditions: PCI : 91

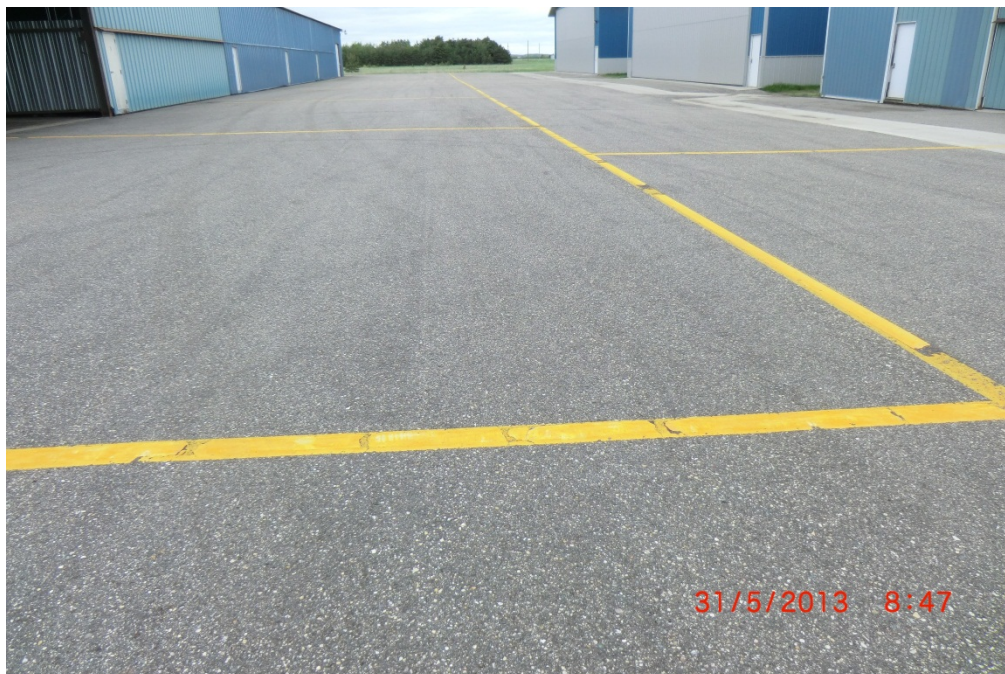
16D TLA 001 (PCI = 71)

Conditions: PCI: 71

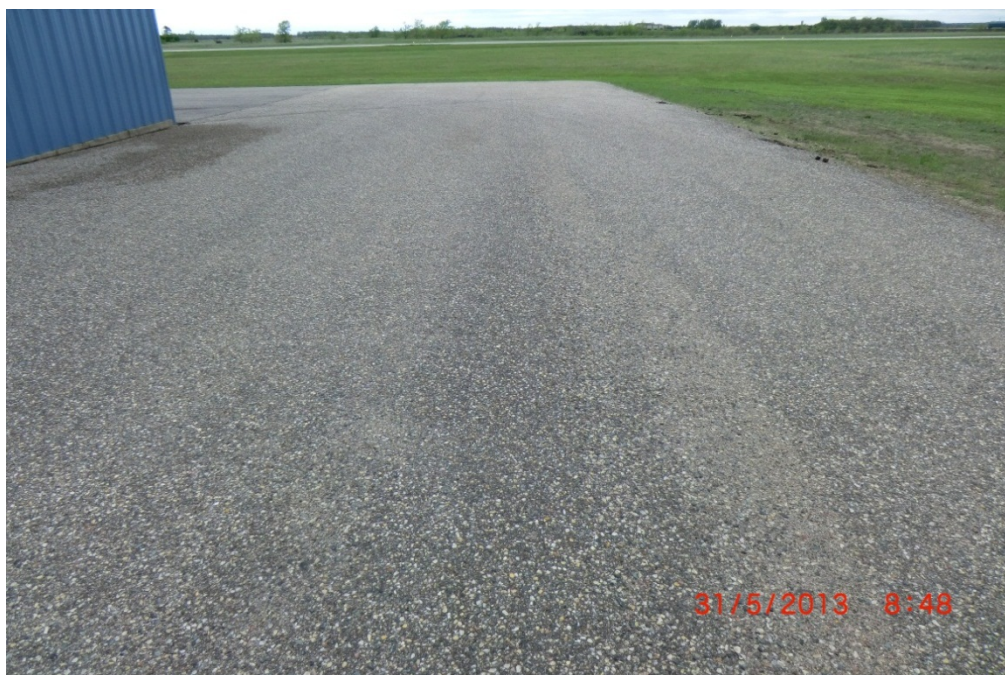
16D TLA 002 (PCI = 23, Several Distress Types Not Visible in Photo)

Conditions: PCI: 23
