Minnesota Airport System Pavement Evaluation 2013 Update

Mahnomen County Airport (3N8)

Mahnomen, Minnesota

Final Report

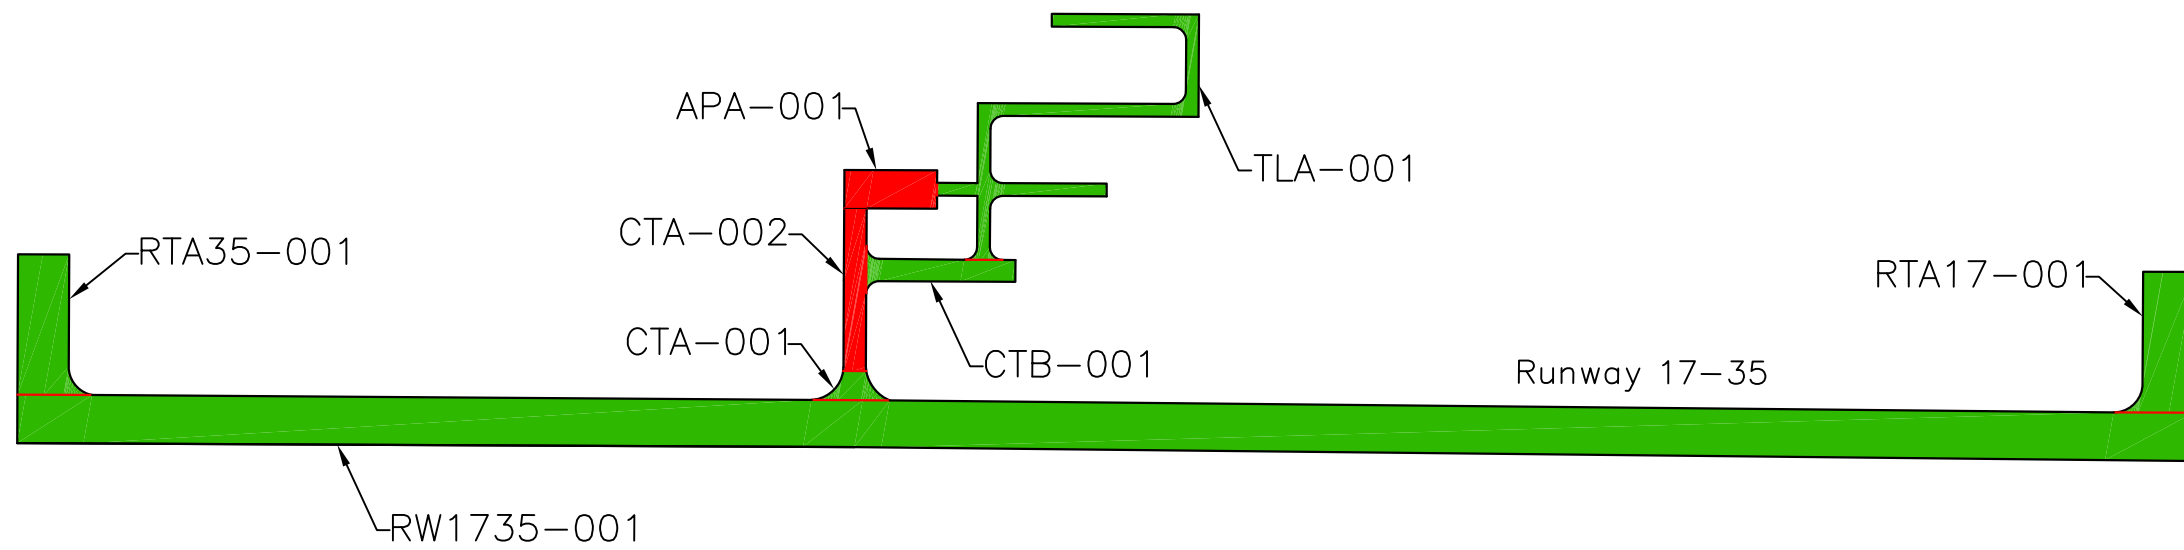
Figure 4. 2013 Pavement Condition Index Rating at Mahanomen County Airport (3N8).

Figures 5 and 6 present the overall PCI for 3N8 by area distribution and pavement use, respectively. Table 3 presents the PCI summary for each section at 3N8, including the drop in PCI per year. Generally, pavement sections will deteriorate between 1 and 3 PCI points per year. Sections deteriorating at higher rates may need maintenance above the normal application rates and should be closely monitored in case major repairs become necessary.

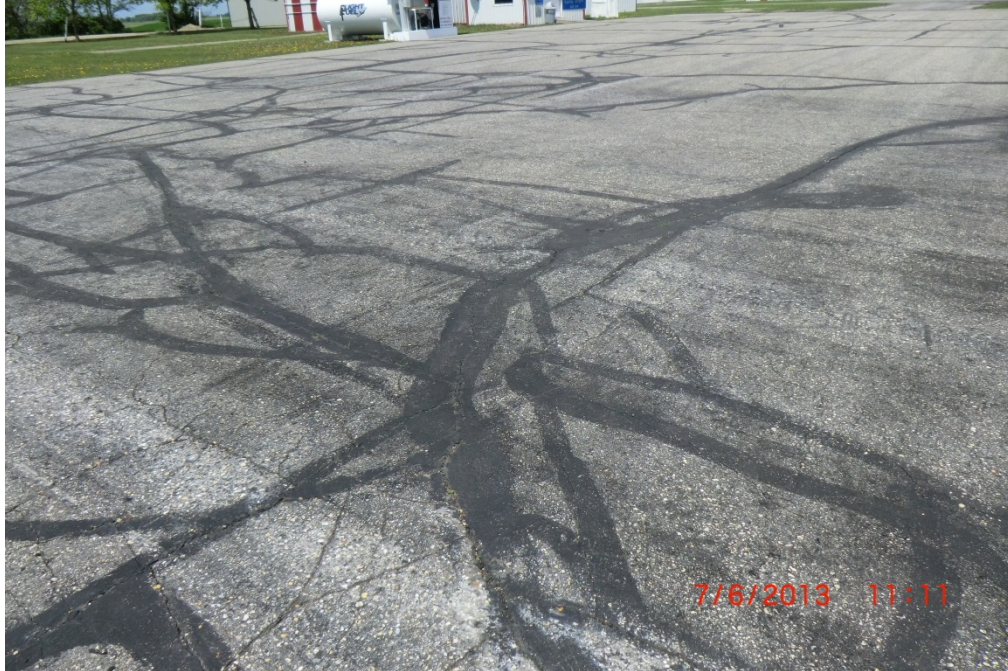
3N8 APA 001 (PCI = 35)

Conditions: PCI : 35

41 ALLIGATOR CRACKING	M	130.00 SqFt	Comments:
48 LONGITUDINAL/TRANSVERSE CRACKING	L	359.00 Ft	Comments:
48 LONGITUDINAL/TRANSVERSE CRACKING	M	92.00 Ft	Comments:
48 LONGITUDINAL/TRANSVERSE CRACKING	H	12.00 Ft	Comments:
57 WEATHERING	L	1,350.00 SqFt	Comments:

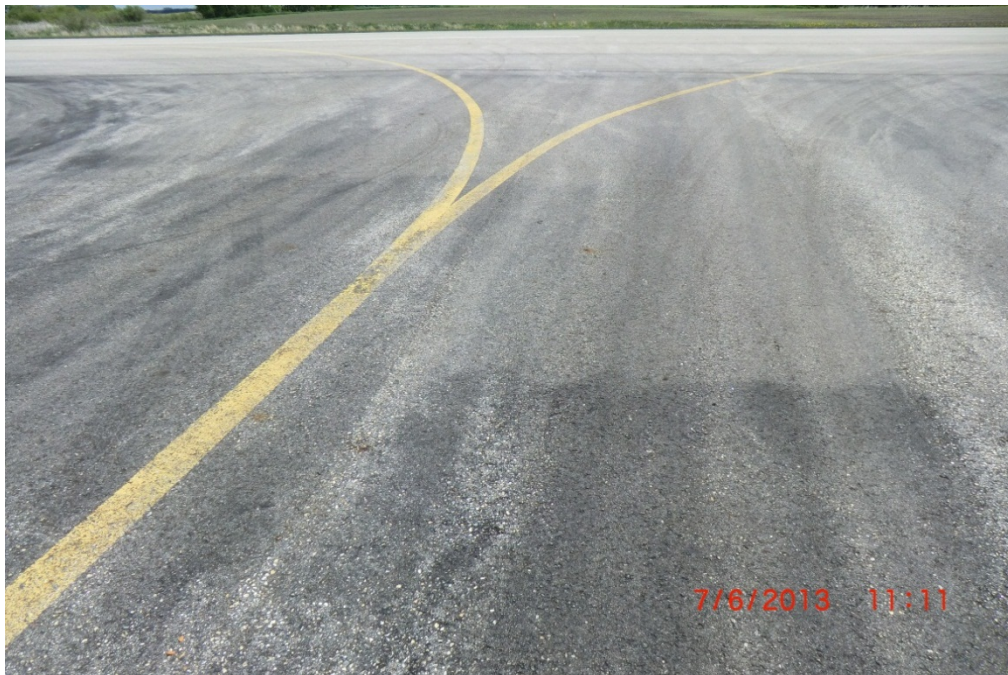
3N8 CTA 001 (PCI = 100)

Conditions: PCI: 100

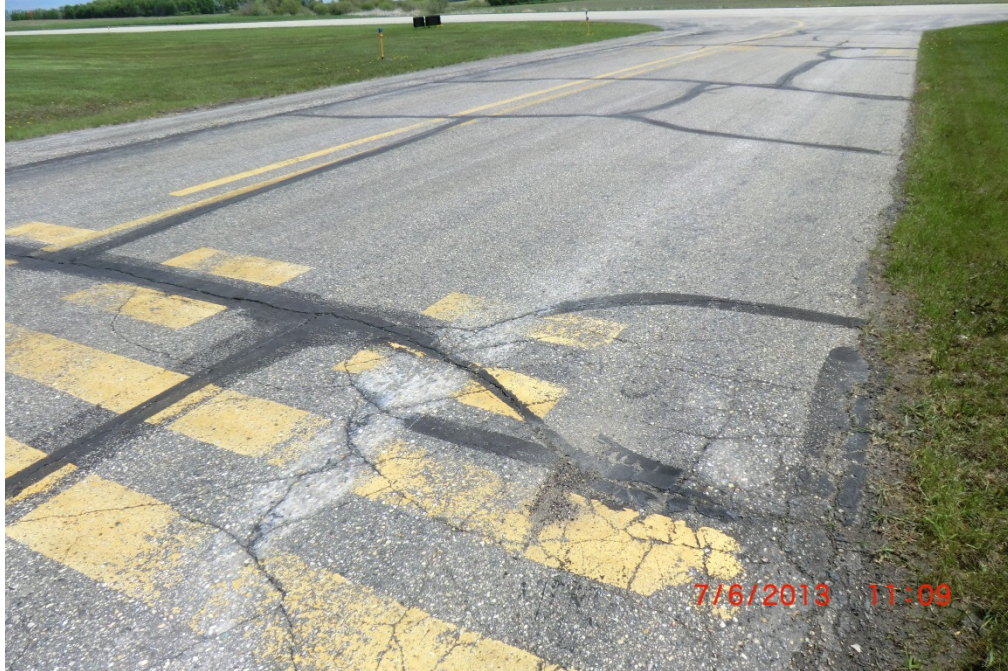
3N8 CTA 002 (PCI = 31)

Conditions: PCI : 31

48	LONGITUDINAL/TRANSVERSE CRACKING	L	274.00 Ft	Comments:
48	LONGITUDINAL/TRANSVERSE CRACKING	M	91.00 Ft	Comments:
41	ALLIGATOR CRACKING	M	99.00 SqFt	Comments:
45	DEPRESSION	L	72.00 SqFt	Comments:
53	RUTTING	L	24.00 SqFt	Comments:
52	RAVELING	H	35.00 SqFt	Comments:
52	RAVELING	M	38.00 SqFt	Comments:

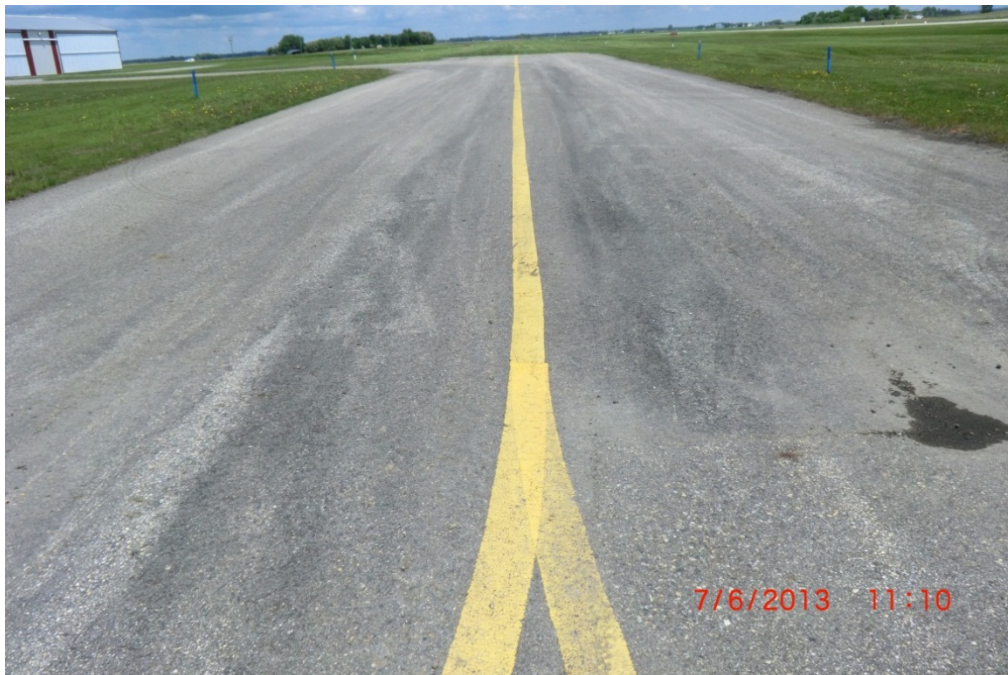
3N8 CTB 001 (PCI = 89)

Conditions: PCI: 89

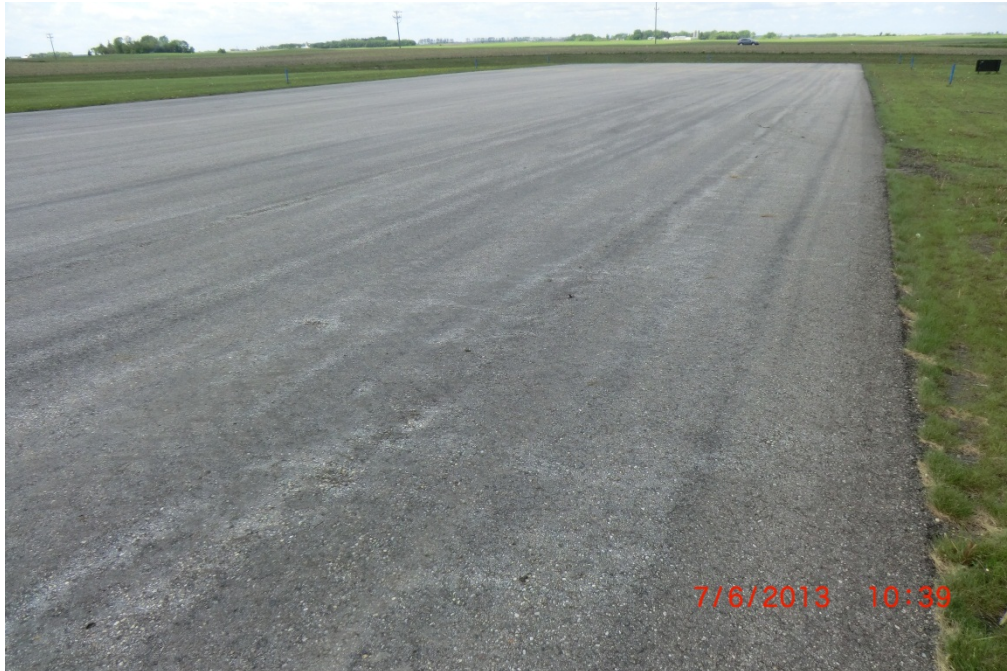
3N8 RTA17 001 (PCI = 97)

Conditions: PCI: 97

48 LONGITUDINAL/TRANSVERSE CRACKING L 9.00 Ft Comments:

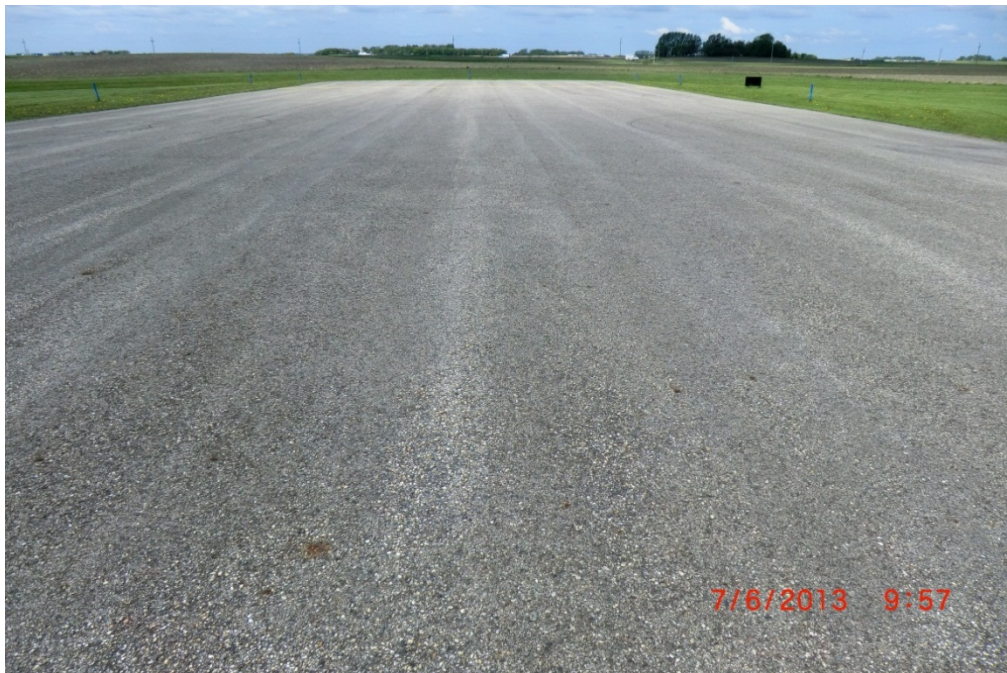
3N8 RTA35 001 (PCI = 95)

Conditions: PCI: 95

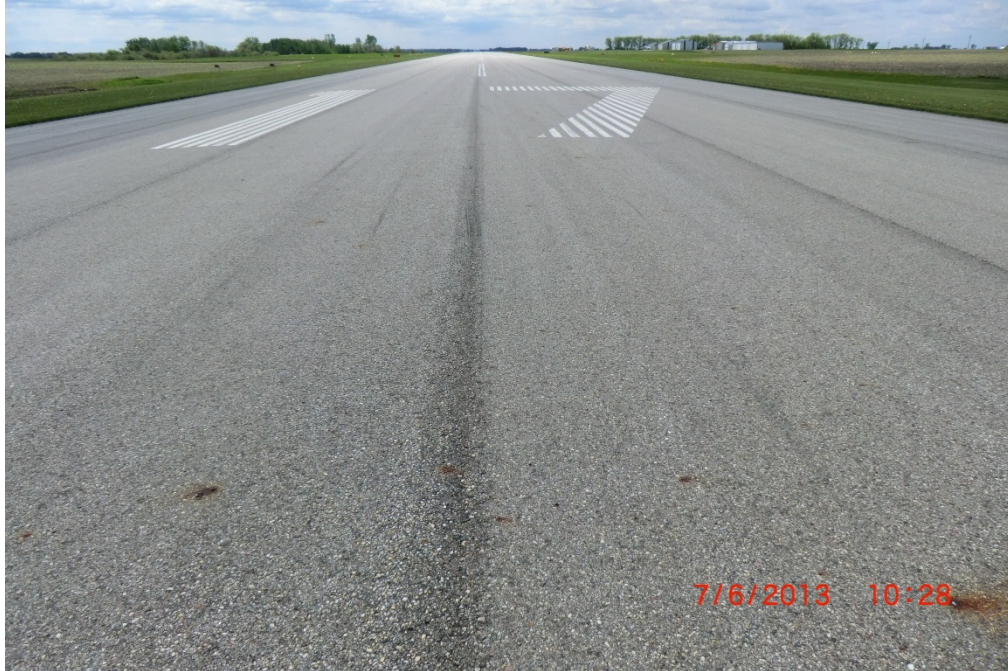
3N8 RY1735 001 (PCI = 98)

Conditions: PCI: 98

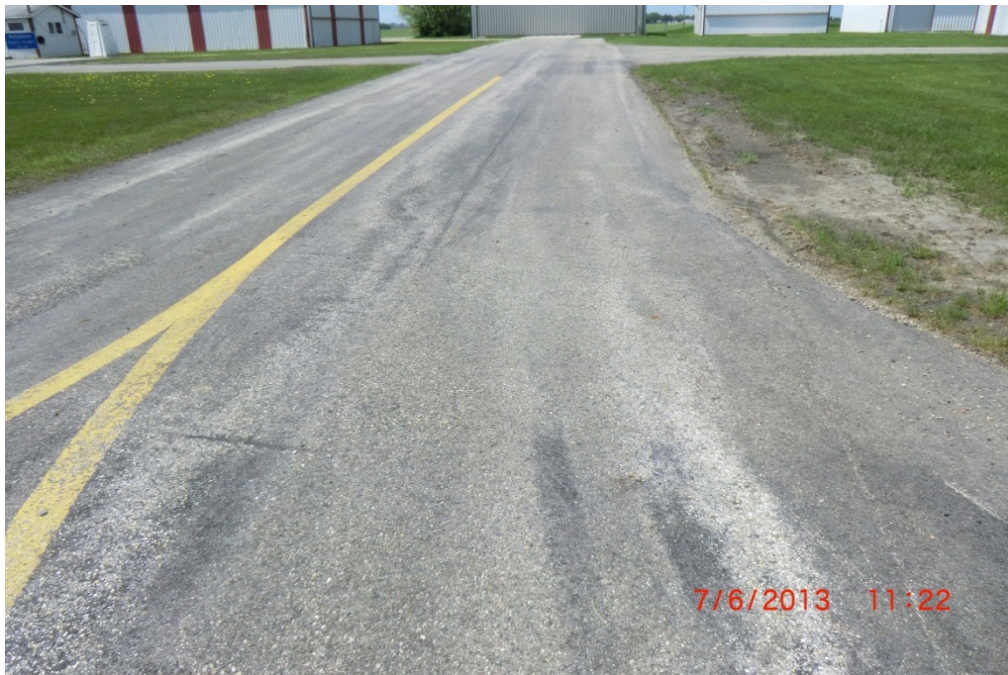
3N8 TLA 001 (PCI = 96)

Conditions: PCI: 96
