Minnesota Airport System Pavement Evaluation 2013 Update

Bagley Municipal Airport (7Y4)

Final Report

Applied Research Associates, Inc.
100 Trade Centre Dr., Suite 200
Champaign, IL 61820
(217) 356-4500

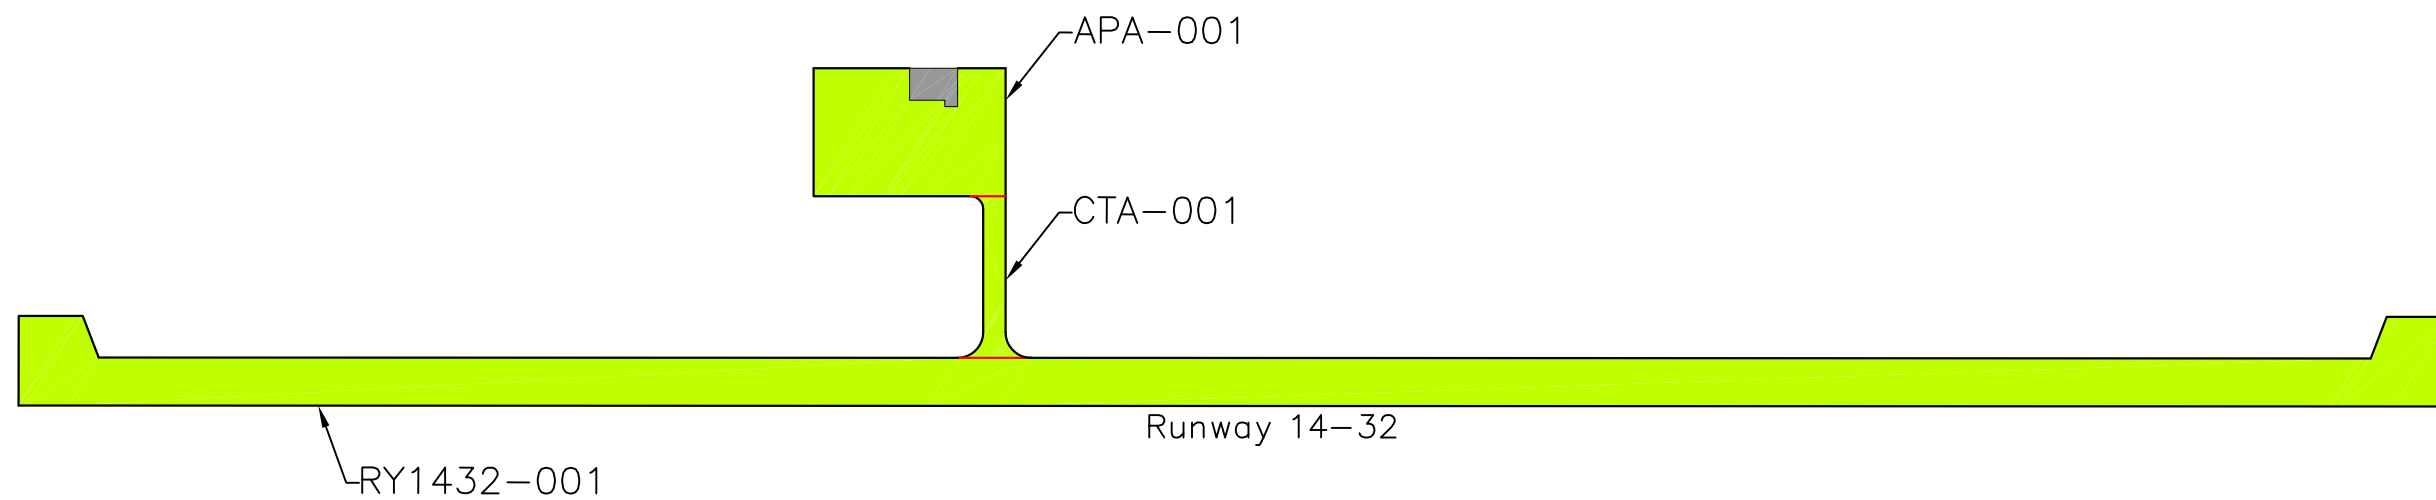
Figure 4. 2013 Pavement Condition Index Rating at Bagley Municipal Airport (7Y4).

Branch ID	Section ID	Surface type ¹	Section area (SF)	LCD ²	2010 PCI	2013 PCI	Drop in PCI/Yr ³	% Deduct due to		Distress types
								Load ⁴	Climate ⁵	
APA	1	AAC	60,000	2004	76	78	2.4	0	100	Longitudinal & transverse (L&T) cracking
CTA	1	AAC	9,538	2004	80	78	2.4	0	100	L&T cracking
RY1432	1	AAC	301,000	2004	77	75	2.8	0	100	L&T cracking, Patching

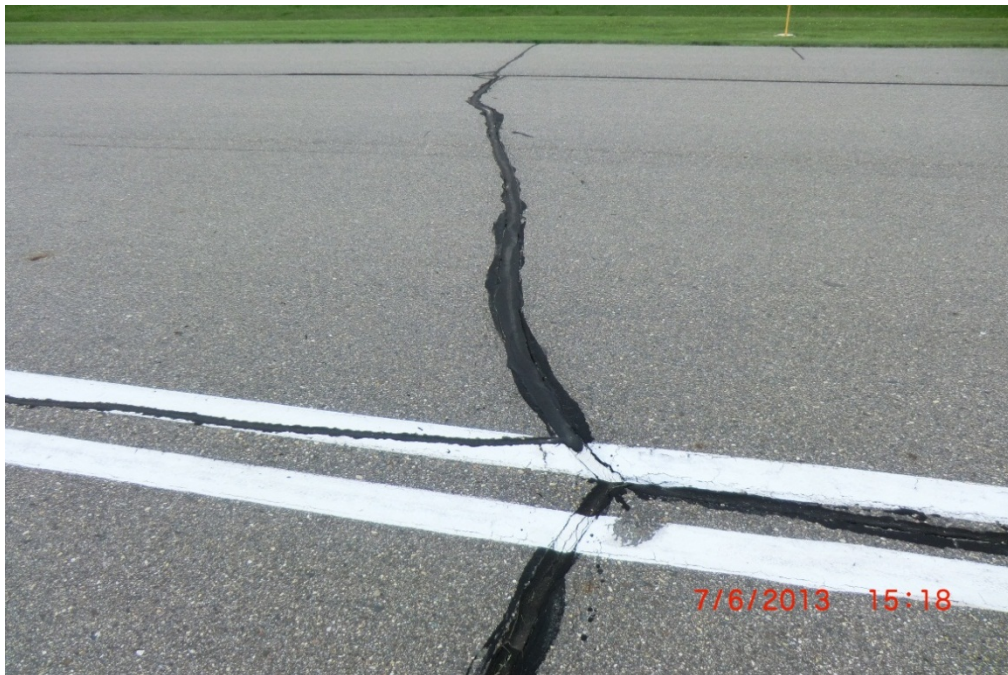
7Y4 RY1432 001 (High Severity L&T Crack)

Branch ID	Section ID	Distress Type	Severity	Treatment	Estimated Quantity	Unit	Cost
APA	1	L & T CR	M	Crack Sealing - AC	1,388	Ft	\$1,638
CTA	1	L & T CR	M	Crack Sealing - AC	153	Ft	\$180
RY1432	1	L & T CR	M	Crack Sealing - AC	2,177	Ft	\$2,569
RY1432	1	L & T CR	H	Crack Sealing - AC	421	Ft	\$497
Airport Total							\$4,884
