# Minnesota Airport System Pavement Evaluation 2013 Update

Aitkin Municipal Airport (AIT)

Aitkin, Minnesota

October 2013

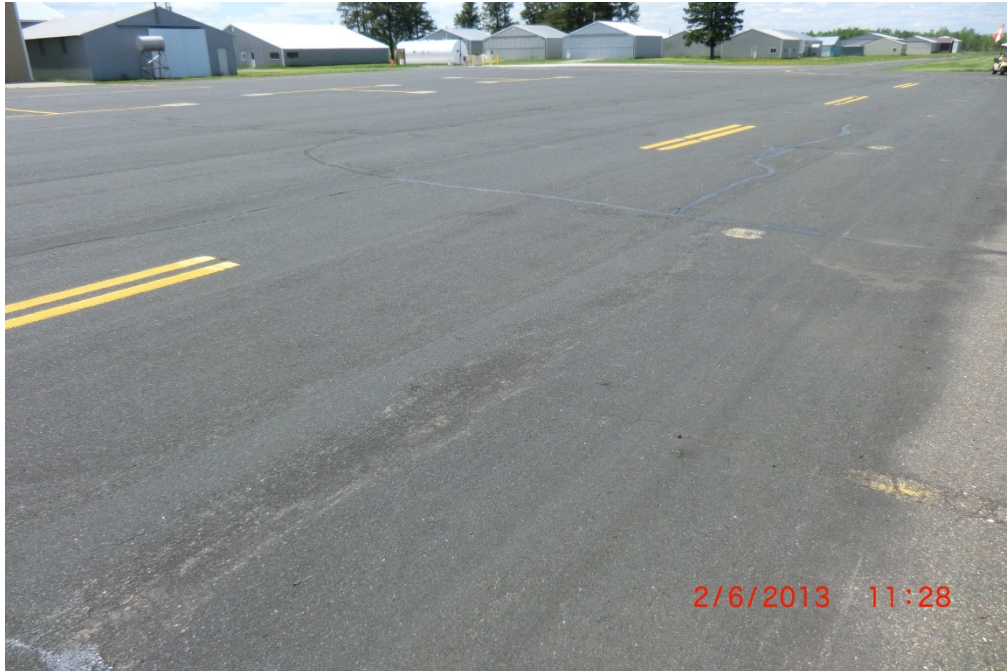
AIT APA 001 (PCI = 63)

| Branch ID | Section ID | Surface type <sup>1</sup> | Section area (SF) | LCD <sup>2</sup> | 2010 PCI | 2013 PCI | Drop in PCI/Yr <sup>3</sup> | % Deduct due to | | Distress types |
|---|---|---|---|---|---|---|---|---|---|---|
| APA | 1 | AAC | 75,000 | 1992 | 64 | 63 | 1.8 | 29 | 70 | Alligator cracking, Block cracking, Longitudinal & transverse (L&T) cracking, Rutting, Swelling |

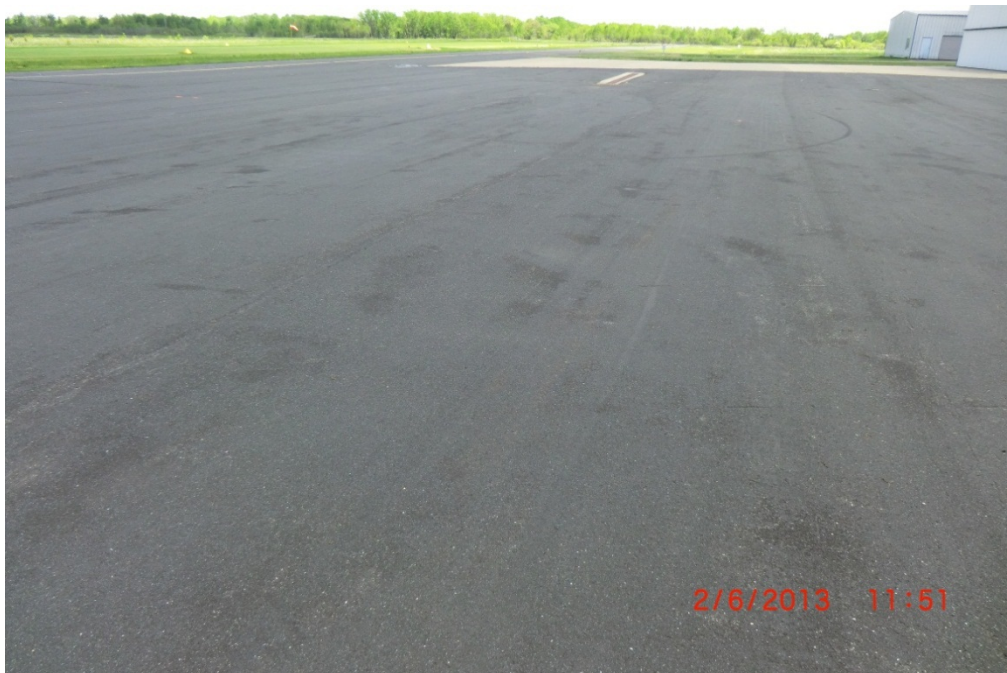
AIT APA 002 (PCI = 96)

| Branch ID | Section ID | Surface type <sup>1</sup> | Section area (SF) | LCD <sup>2</sup> | 2010 PCI | 2013 PCI | Drop in PCI/Yr <sup>3</sup> | % Deduct due to | | Distress types |
|---|---|---|---|---|---|---|---|---|---|---|
| APA | 2 | AC | 17,800 | 2008 | 100 | 96 | 0.8 | 0 | 100 | L&T cracking |

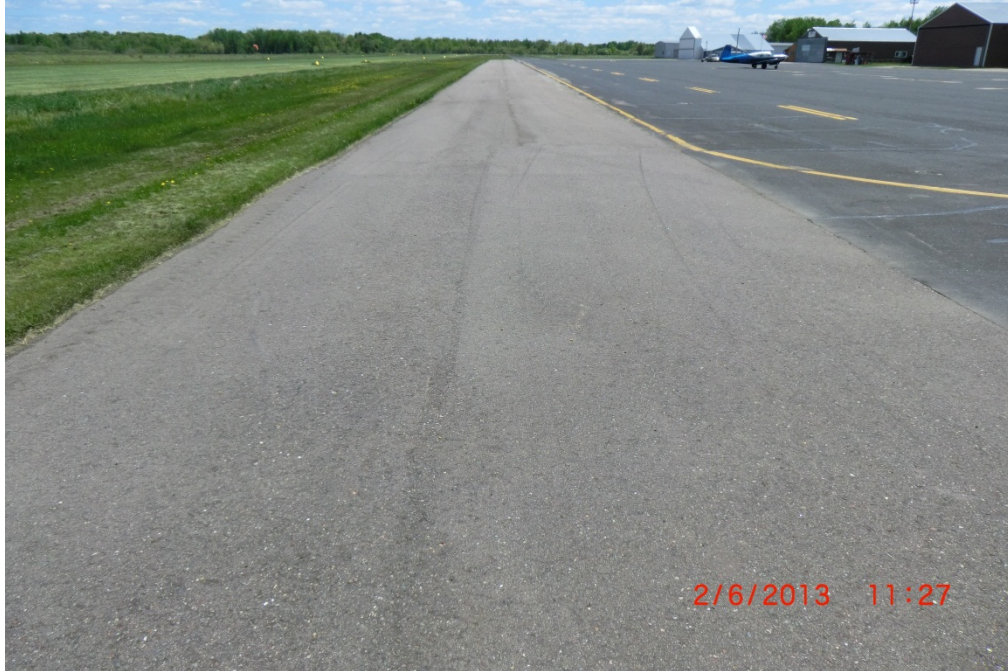
AIT APA 003 (PCI = 96)

| Branch ID | Section ID | Surface type <sup>1</sup> | Section area (SF) | LCD <sup>2</sup> | 2010 PCI | 2013 PCI | Drop in PCI/Yr <sup>3</sup> | % Deduct due to | | Distress types |
|---|---|---|---|---|---|---|---|---|---|---|
| APA | 3 | AC | 10,494 | 2008 | 100 | 96 | 0.8 | 0 | 100 | L&T cracking |

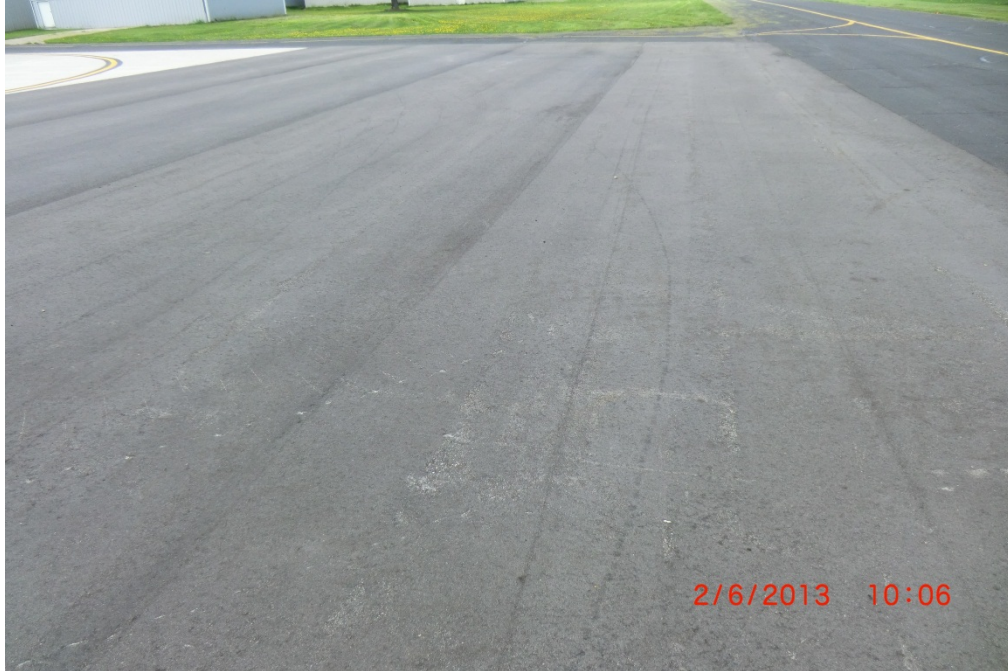
AIT APA 005 (PCI = 96)

| Branch ID | Section ID | Surface type <sup>1</sup> | Section area (SF) | LCD <sup>2</sup> | 2010 PCI | 2013 PCI | Drop in PCI/Yr <sup>3</sup> | % Deduct due to | | Distress types |
|---|---|---|---|---|---|---|---|---|---|---|
| APA | 5 | AC | 4,264 | 2012 | - | 96 | 4.0 | 0 | 100 | L&T cracking |

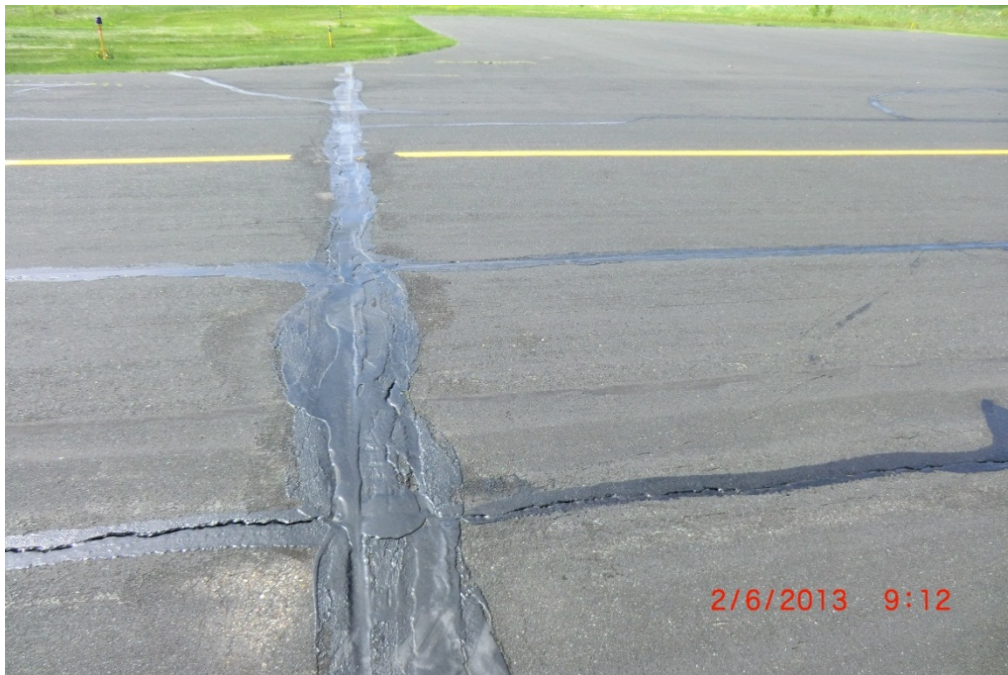
AIT CTA 001 (PCI = 72)

| Branch ID | Section ID | Surface type <sup>1</sup> | Section area (SF) | LCD <sup>2</sup> | 2010 PCI | 2013 PCI | Drop in PCI/Yr <sup>3</sup> | % Deduct due to | | Distress types |
|---|---|---|---|---|---|---|---|---|---|---|
| CTA | 1 | AAC | 59,460 | 1998 | 69 | 72 | 1.9 | 30 | 70 | Alligator cracking, L&T cracking |

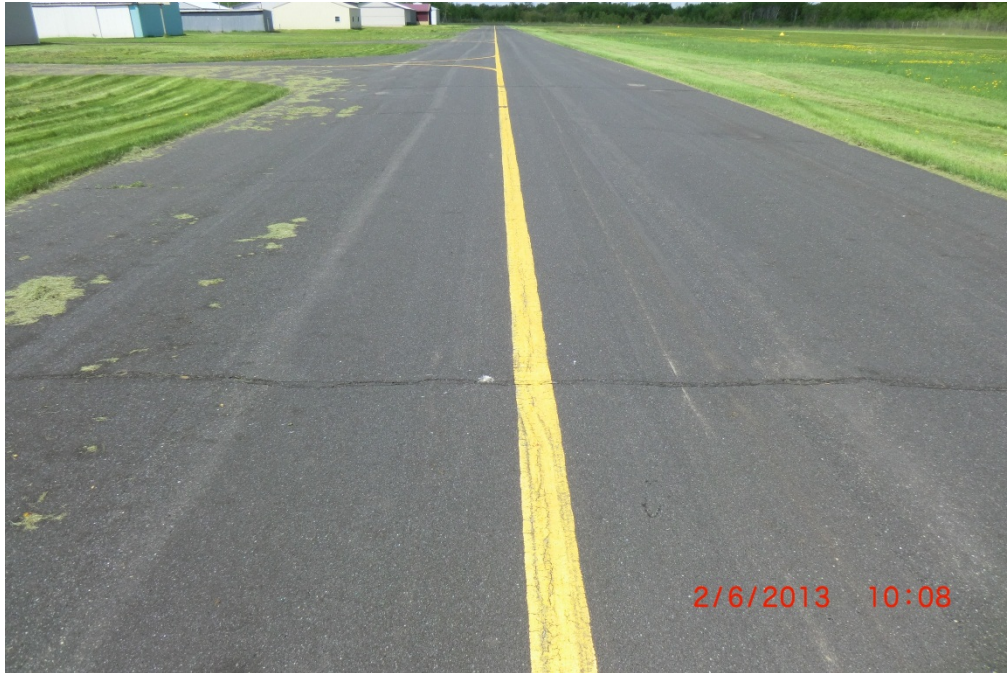
AIT CTB 001 (PCI = 67)

| Branch ID | Section ID | Surface type <sup>1</sup> | Section area (SF) | LCD <sup>2</sup> | 2010 PCI | 2013 PCI | Drop in PCI/Yr <sup>3</sup> | % Deduct due to | | Distress types |
|---|---|---|---|---|---|---|---|---|---|---|
| CTB | 1 | AC | 20,640 | 1991 | 70 | 67 | 1.5 | 26 | 74 | Alligator cracking, L&T cracking |

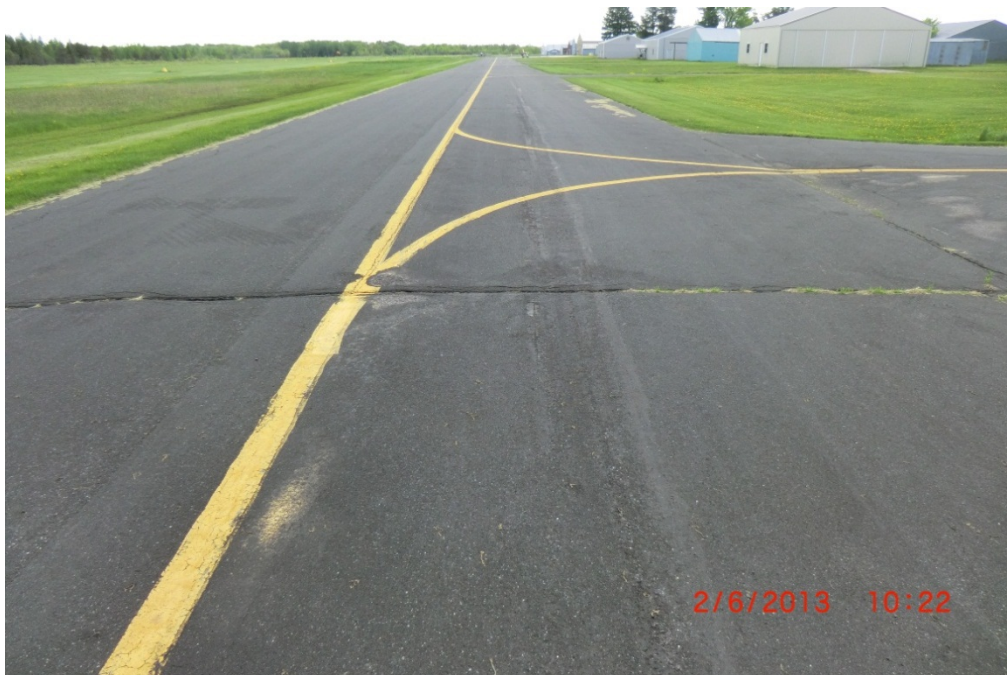
AIT CTB 002 (PCI = 65)

| Branch ID | Section ID | Surface type <sup>1</sup> | Section area (SF) | LCD <sup>2</sup> | 2010 PCI | 2013 PCI | Drop in PCI/Yr <sup>3</sup> | % Deduct due to | | Distress types |
|---|---|---|---|---|---|---|---|---|---|---|
| CTB | 2 | AC | 17,220 | 1998 | 76 | 65 | 2.3 | 38 | 62 | Alligator cracking, L&T cracking |

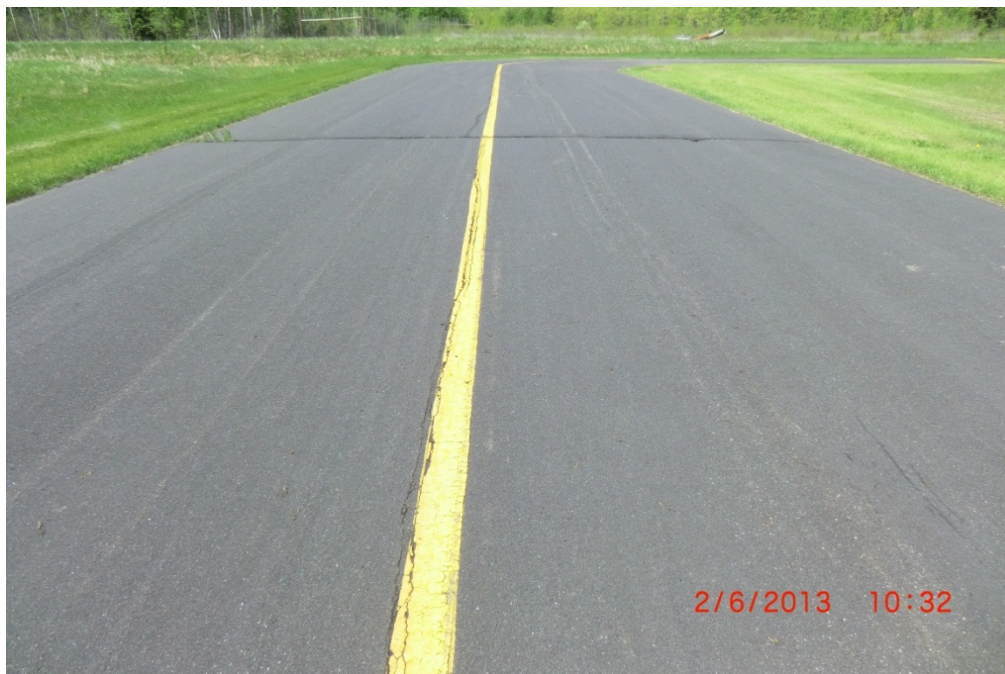
AIT CTB 003 (PCI = 65)

| Branch ID | Section ID | Surface type <sup>1</sup> | Section area (SF) | LCD <sup>2</sup> | 2010 PCI | 2013 PCI | Drop in PCI/Yr <sup>3</sup> | % Deduct due to | | Distress types |
|---|---|---|---|---|---|---|---|---|---|---|
| CTB | 3 | AAC | 14,460 | 2004 | 84 | 65 | 3.9 | 39 | 61 | L&T cracking, Rutting |

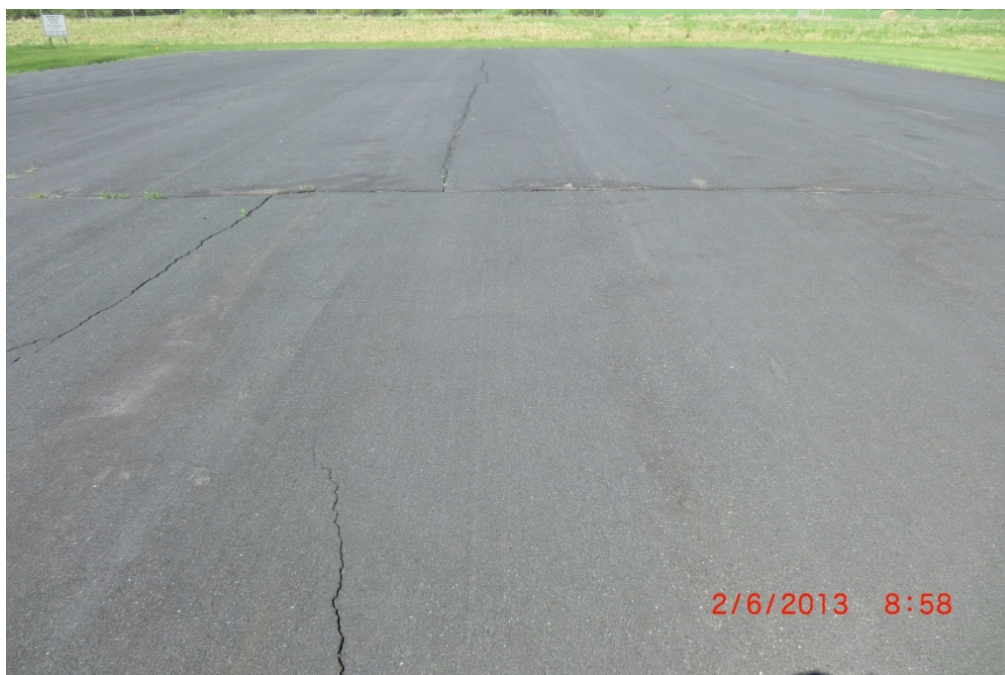
AIT RTA 001 (PCI = 70)

| Branch ID | Section ID | Surface type <sup>1</sup> | Section area (SF) | LCD <sup>2</sup> | 2010 PCI | 2013 PCI | Drop in PCI/Yr <sup>3</sup> | % Deduct due to | | Distress types |
|---|---|---|---|---|---|---|---|---|---|---|
| RTA | 1 | AC | 11,135 | 1998 | 70 | 70 | 2.0 | 0 | 100 | L&T cracking |

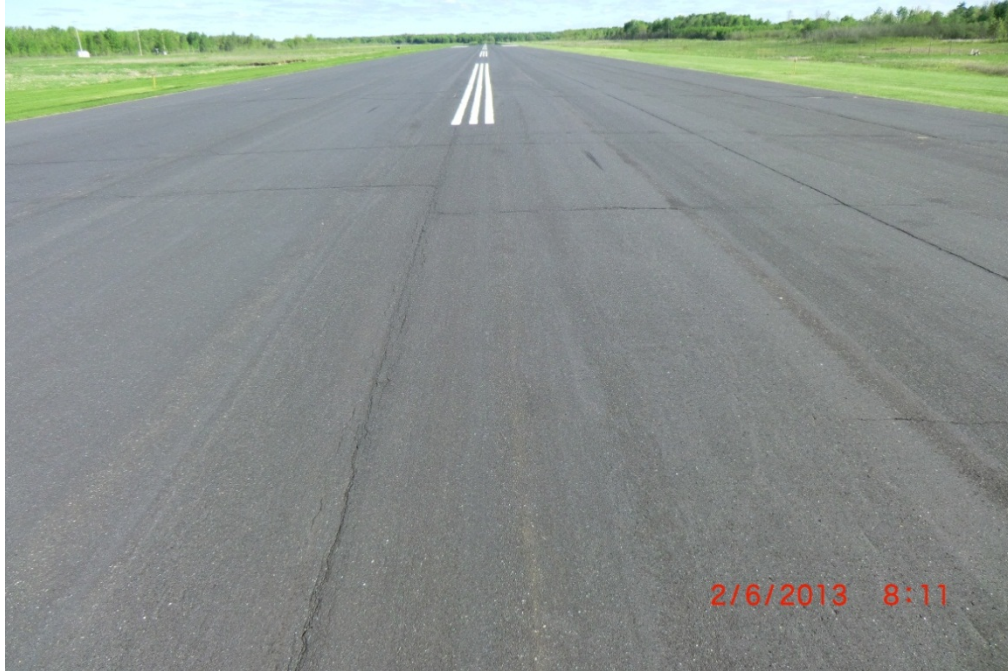
AIT RY1634 001 (PCI = 65)

| Branch ID | Section ID | Surface type <sup>1</sup> | Section area (SF) | LCD <sup>2</sup> | 2010 PCI | 2013 PCI | Drop in PCI/Yr <sup>3</sup> | % Deduct due to | | Distress types |
|---|---|---|---|---|---|---|---|---|---|---|
| RY1634 | 1 | AAC | 301,350 | 1998 | 72 | 65 | 2.3 | 16 | 75 | Alligator cracking, Depression, L&T cracking |

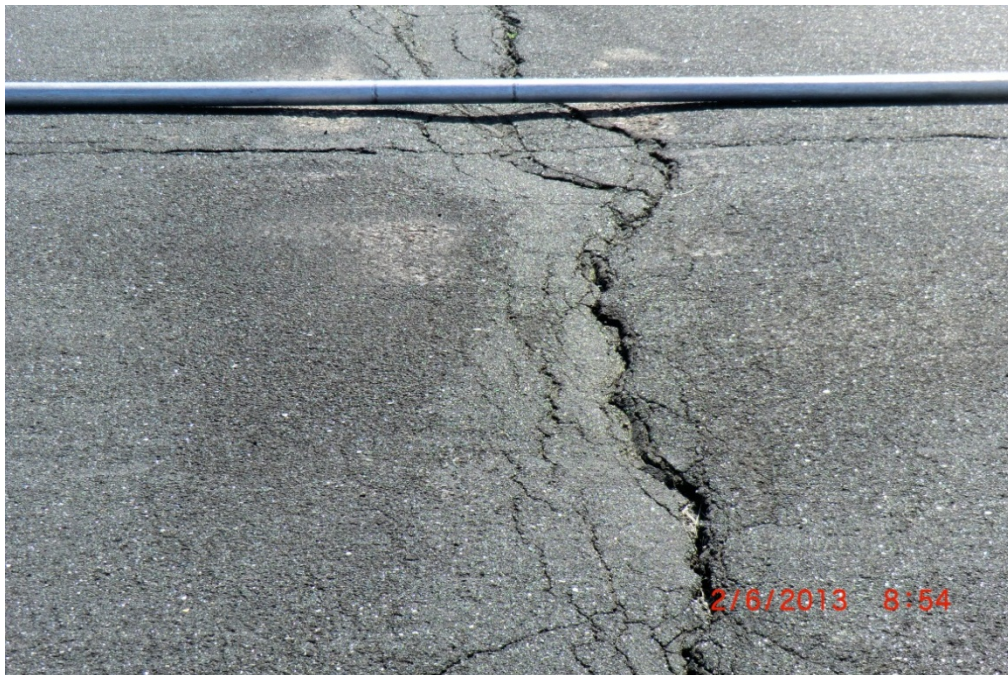
AIT RY1634 001 (Crack with Medium-Severity Depression)

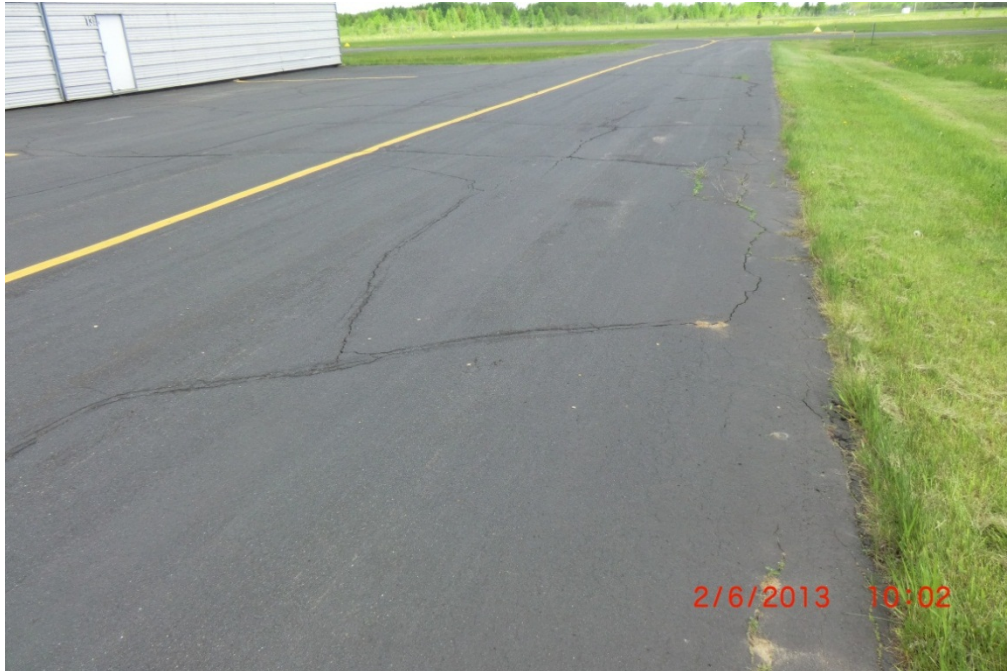
AIT TLA 001 (PCI = 53)

| Branch ID | Section ID | Surface type <sup>1</sup> | Section area (SF) | LCD <sup>2</sup> | 2010 PCI | 2013 PCI | Drop in PCI/Yr <sup>3</sup> | % Deduct due to | | Distress types |
|---|---|---|---|---|---|---|---|---|---|---|
| TLA | 1 | AAC | 15,900 | 1981 | 53 | 53 | 1.5 | 35 | 65 | Alligator cracking, Block cracking, L&T cracking, , Rutting |

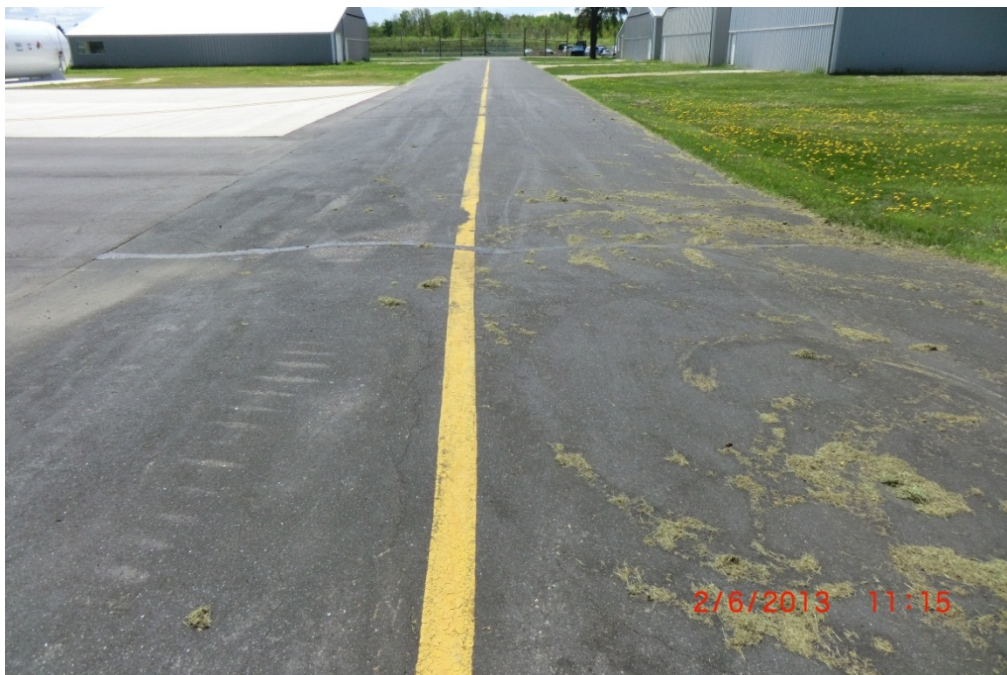
AIT TLB 001 (PCI = 28)

| Branch ID | Section ID | Surface type <sup>1</sup> | Section area (SF) | LCD <sup>2</sup> | 2010 PCI | 2013 PCI | Drop in PCI/Yr <sup>3</sup> | % Deduct due to | | Distress types |
|---|---|---|---|---|---|---|---|---|---|---|
| TLB | 1 | AAC | 5,580 | 1998 | 36 | 28 | 4.8 | 84 | 14 | Alligator cracking, L&T cracking, Rutting, Swelling |

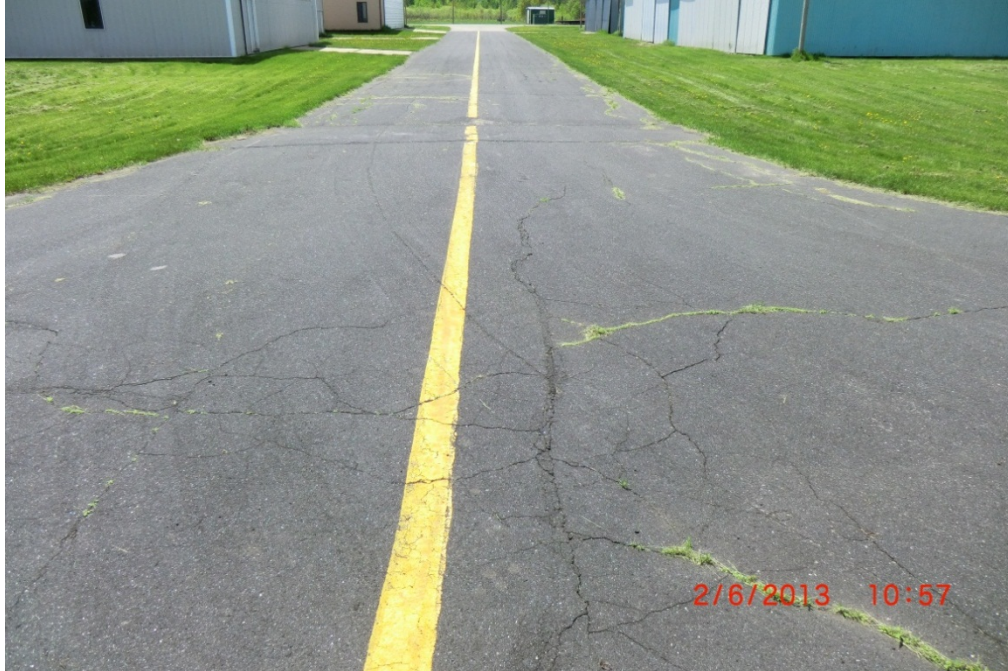
AIT TLC 001 (PCI = 15)

| Branch ID | Section ID | Surface type <sup>1</sup> | Section area (SF) | LCD <sup>2</sup> | 2010 PCI | 2013 PCI | Drop in PCI/Yr <sup>3</sup> | % Deduct due to | | Distress types |
|---|---|---|---|---|---|---|---|---|---|---|
| TLC | 1 | AC | 16,735 | 1990 | 31 | 15 | 3.7 | 93 | 7 | Alligator cracking, L&T cracking, Rutting |

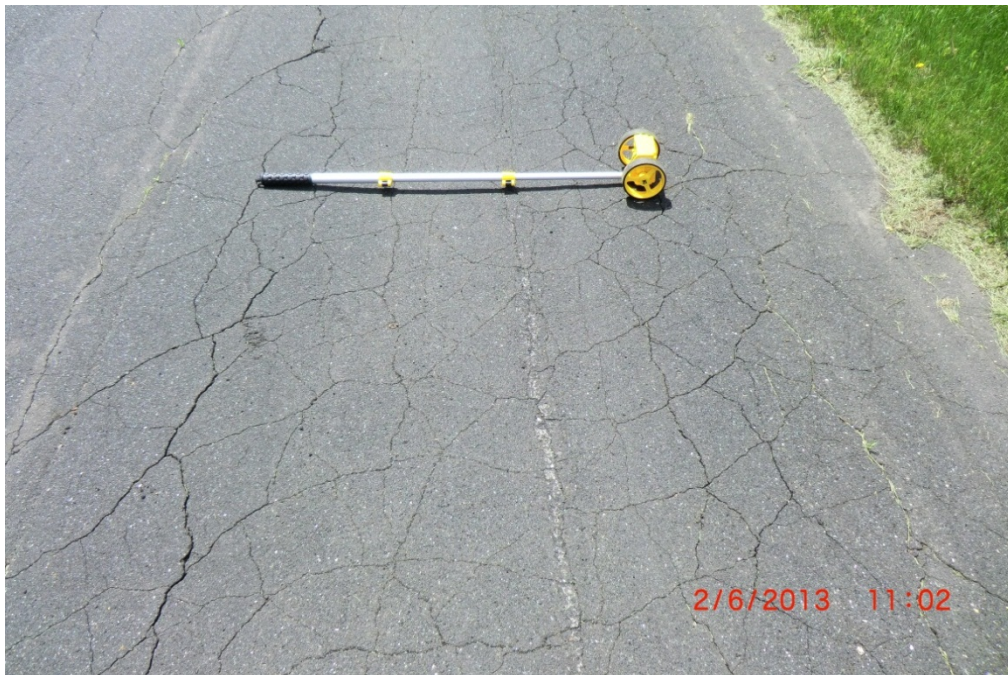
AIT TLC 001 (Medium-Severity Alligator Cracking and Rutting)

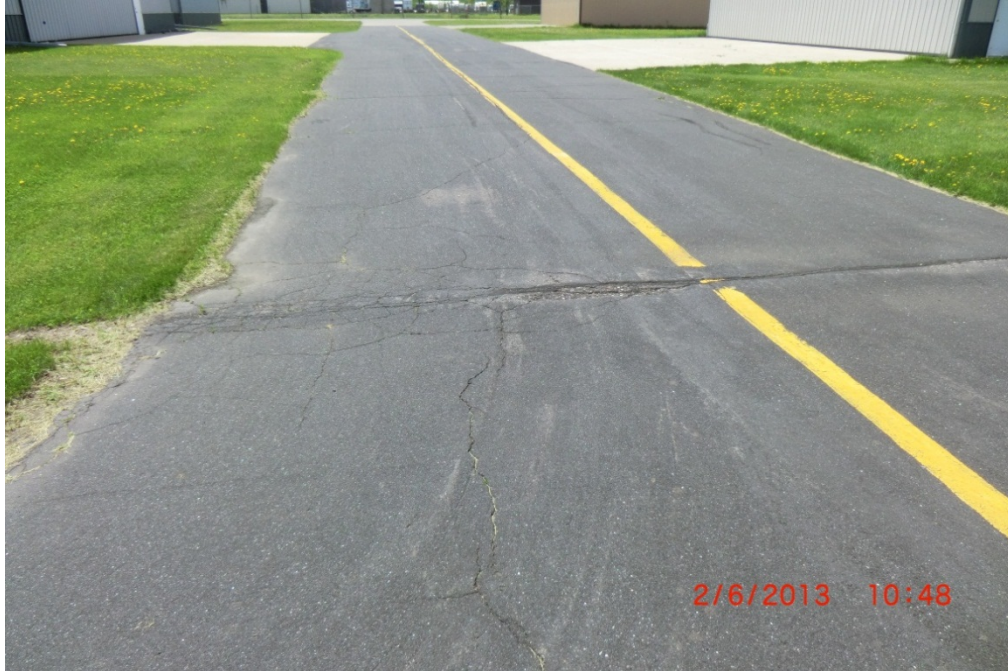
AIT TLD 001 (PCI = 46)

| Branch ID | Section ID | Surface type <sup>1</sup> | Section area (SF) | LCD <sup>2</sup> | 2010 PCI | 2013 PCI | Drop in PCI/Yr <sup>3</sup> | % Deduct due to | | Distress types |
|---|---|---|---|---|---|---|---|---|---|---|
| TLD | 1 | AAC | 9,390 | 2001 | 61 | 46 | 4.5 | 45 | 50 | Alligator cracking, L&T cracking, Swelling |

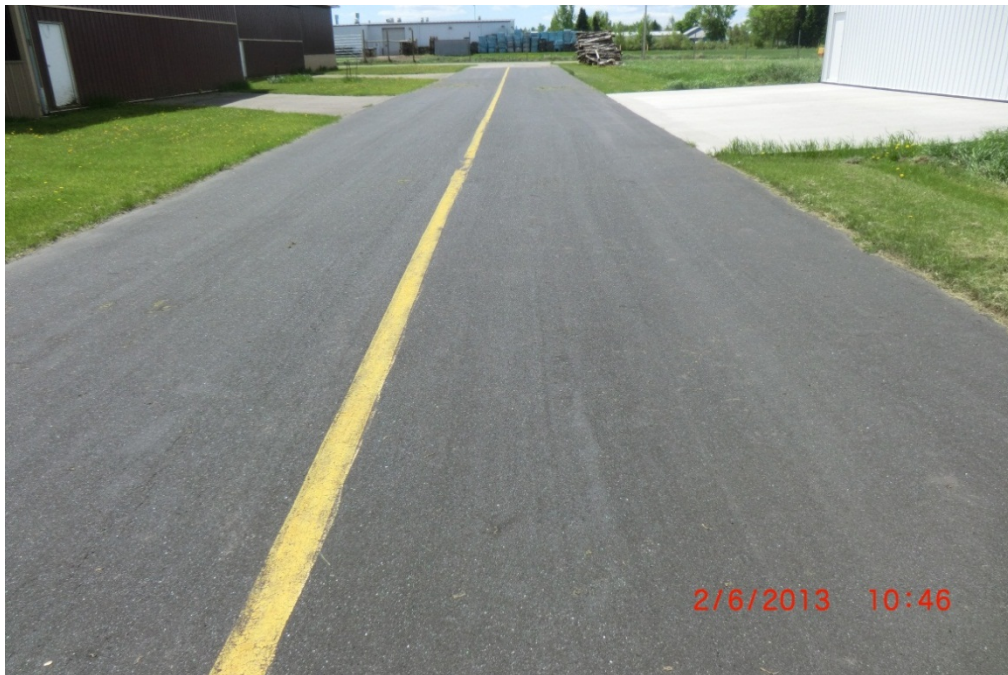
AIT TLE 001 (PCI = 87)

| Branch ID | Section ID | Surface type <sup>1</sup> | Section area (SF) | LCD <sup>2</sup> | 2010 PCI | 2013 PCI | Drop in PCI/Yr <sup>3</sup> | % Deduct due to | | Distress types |
|---|---|---|---|---|---|---|---|---|---|---|
| TLE | 1 | AAC | 8,990 | 2004 | 91 | 87 | 1.4 | 0 | 100 | L&T cracking |
