# Minnesota Airport System Pavement Evaluation 2013 Update

Alexandria Municipal Airport (AXN)

Alexandria, Minnesota

*Final Report*

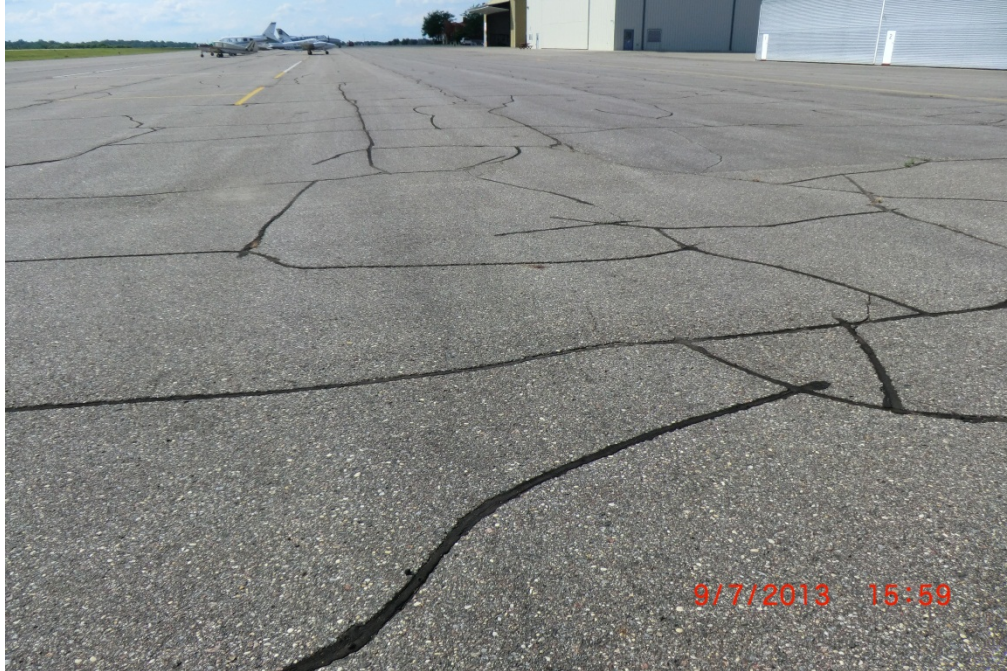
| Branch ID | Section ID | Surface type <sup>1</sup> | Section area (SF) | LCD <sup>2</sup> | 2010 PCI | 2013 PCI | Drop in PCI/Yr <sup>3</sup> | % Deduct due to | | Distress types |
|---|---|---|---|---|---|---|---|---|---|---|
| APA | 1 | AAC | 183,400 | 1995 | 64 | 56 | 2.4 | 6 | 94 | Alligator cracking, Block cracking, Longitudinal & transverse (L&T) cracking, raveling, weathering |

AXN APA 001 (PCI = 56)

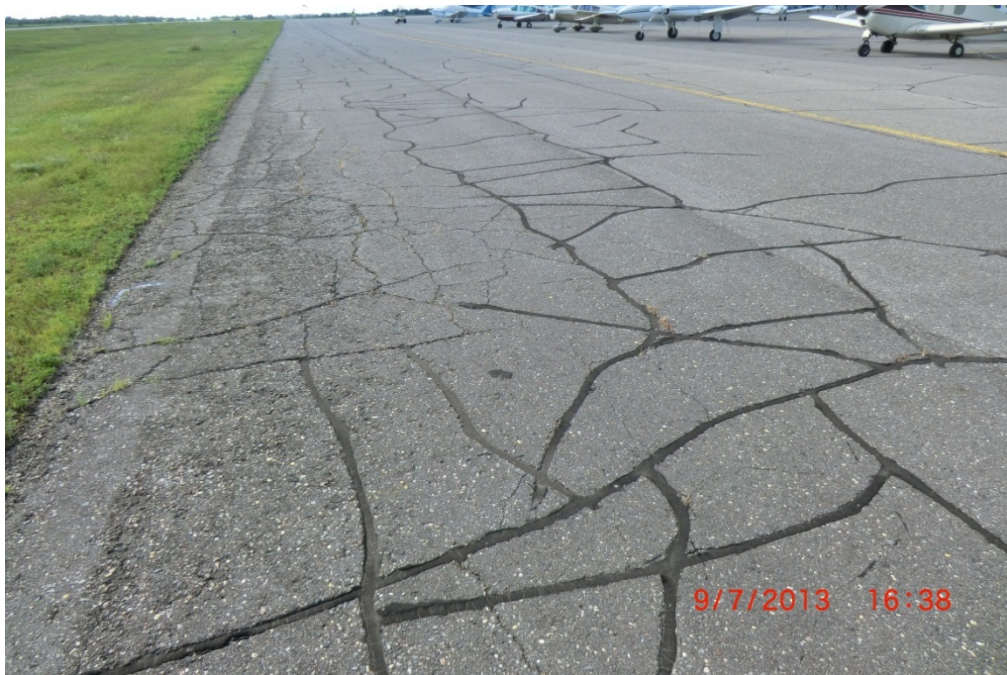
AXN APA 001 (High-Severity Block Cracking and Raveling)

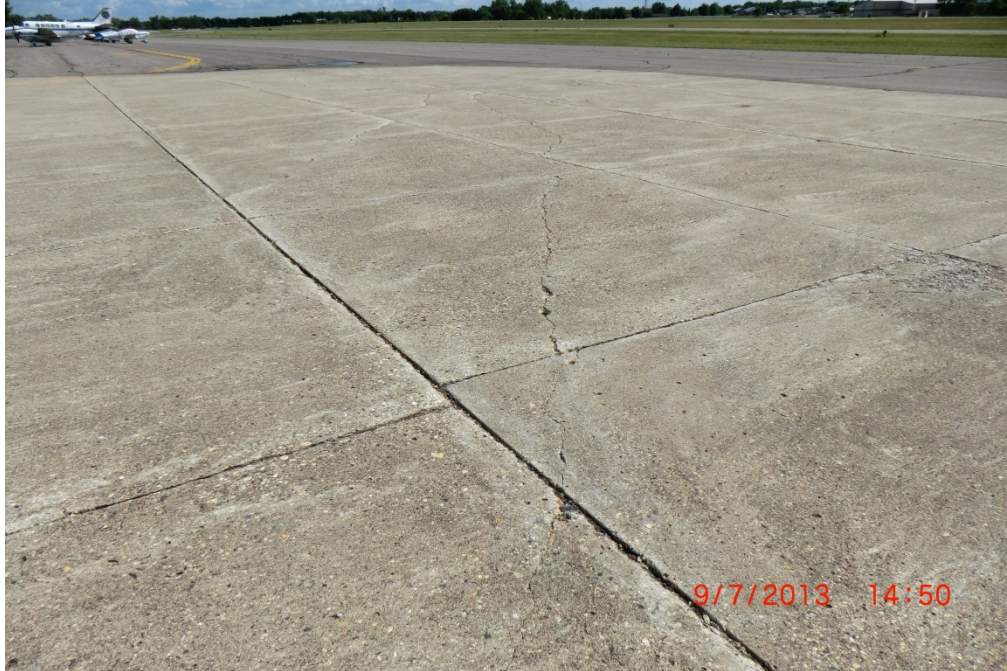
| Branch ID | Section ID | Surface type <sup>1</sup> | Section area (SF) | LCD <sup>2</sup> | 2010 PCI | 2013 PCI | Drop in PCI/Yr <sup>3</sup> | % Deduct due to | | Distress types |
|---|---|---|---|---|---|---|---|---|---|---|
| APA | 2 | PCC | 40,337 | 1982* | 60 | 50 | 1.6 | 13 | 55 | Corner break, Linear cracking, D-cracking, Joint seal damage, Small patch, Faulting, Shrinkage cracking, Joint spall, Corner spall |

AXN APA 002 (PCI = 50)

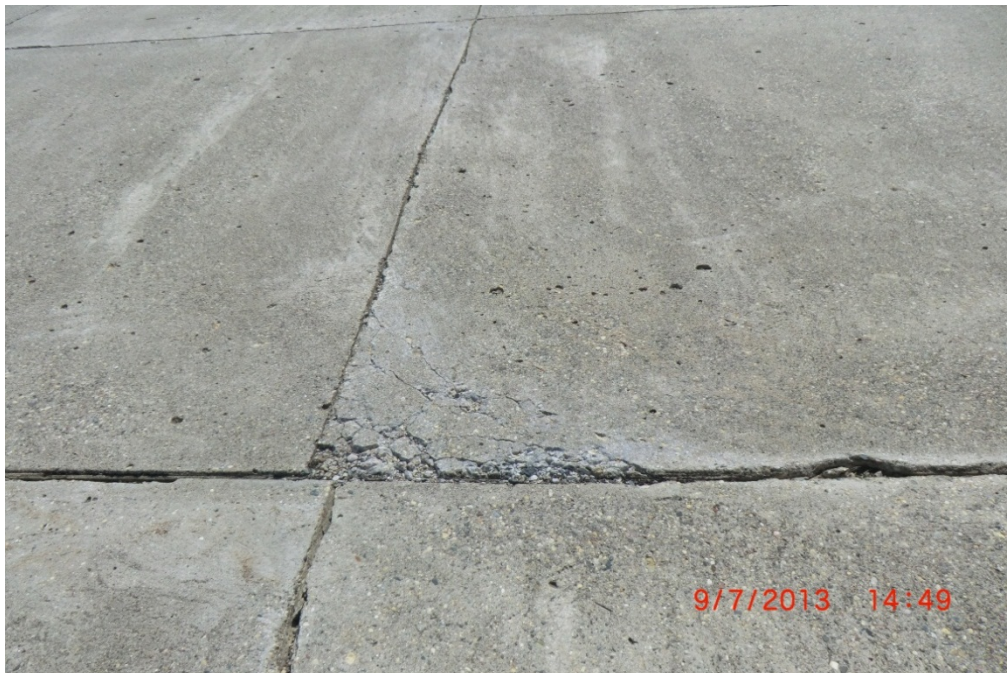
AXN APA 002 (Medium-Severity D Cracking)

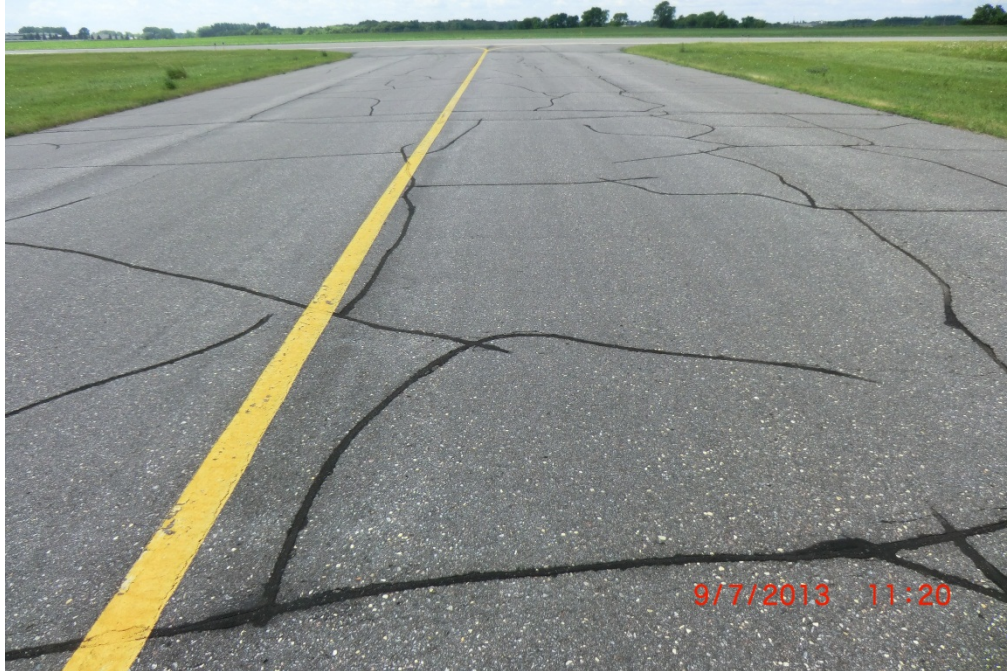
| Branch ID | Section ID | Surface type <sup>1</sup> | Section area (SF) | LCD <sup>2</sup> | 2010 PCI | 2013 PCI | Drop in PCI/Yr <sup>3</sup> | % Deduct due to | | Distress types |
|---|---|---|---|---|---|---|---|---|---|---|
| CTC | 1 | AAC | 14,425 | 1995 | 64 | 64 | 2.0 | 0 | 100 | Block cracking |

AXN CTC 001 (PCI = 64)

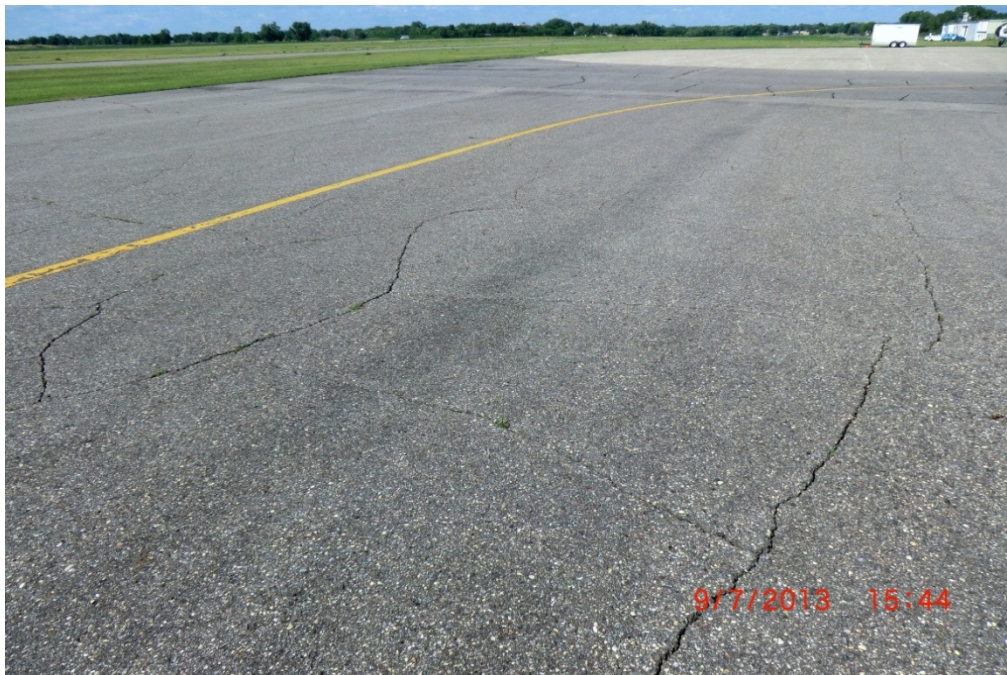
| Branch ID | Section ID | Surface type <sup>1</sup> | Section area (SF) | LCD <sup>2</sup> | 2010 PCI | 2013 PCI | Drop in PCI/Yr <sup>3</sup> | % Deduct due to | | Distress types |
|---|---|---|---|---|---|---|---|---|---|---|
| CTD | 1 | AAC | 8,175 | 1995 | 64 | 54 | 2.6 | 0 | 100 | Block cracking, Raveling |

AXN CTD 001 (PCI = 54)

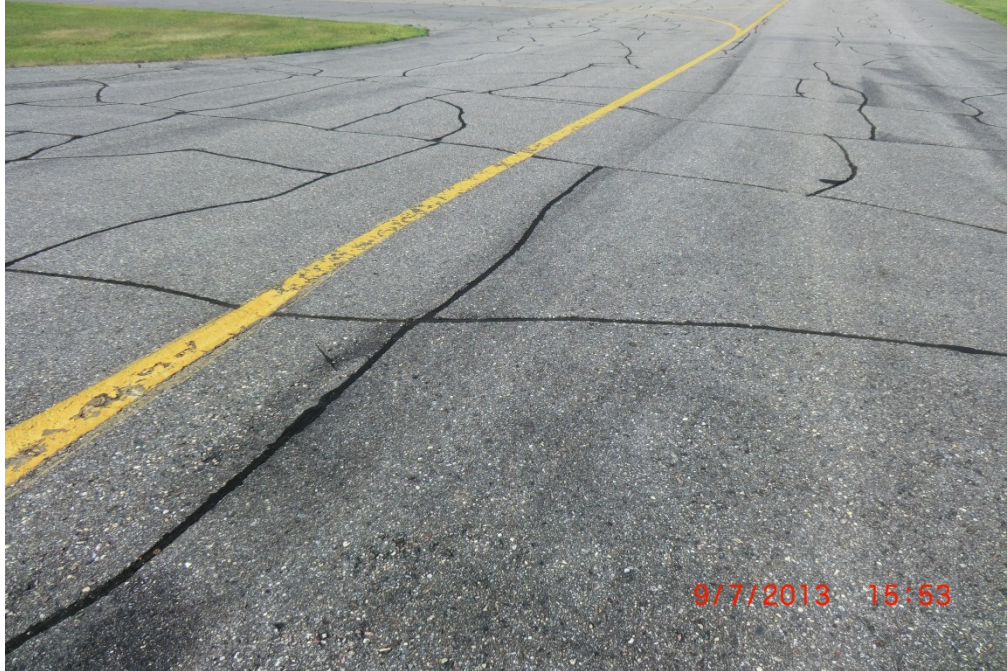
| Branch ID | Section ID | Surface type <sup>1</sup> | Section area (SF) | LCD <sup>2</sup> | 2010 PCI | 2013 PCI | Drop in PCI/Yr <sup>3</sup> | % Deduct due to | | Distress types |
|---|---|---|---|---|---|---|---|---|---|---|
| CTE | 1 | AAC | 4,425 | 1995 | 64 | 50 | 2.8 | 0 | 100 | Block cracking |

AXN CTE 001 (PCI = 50)

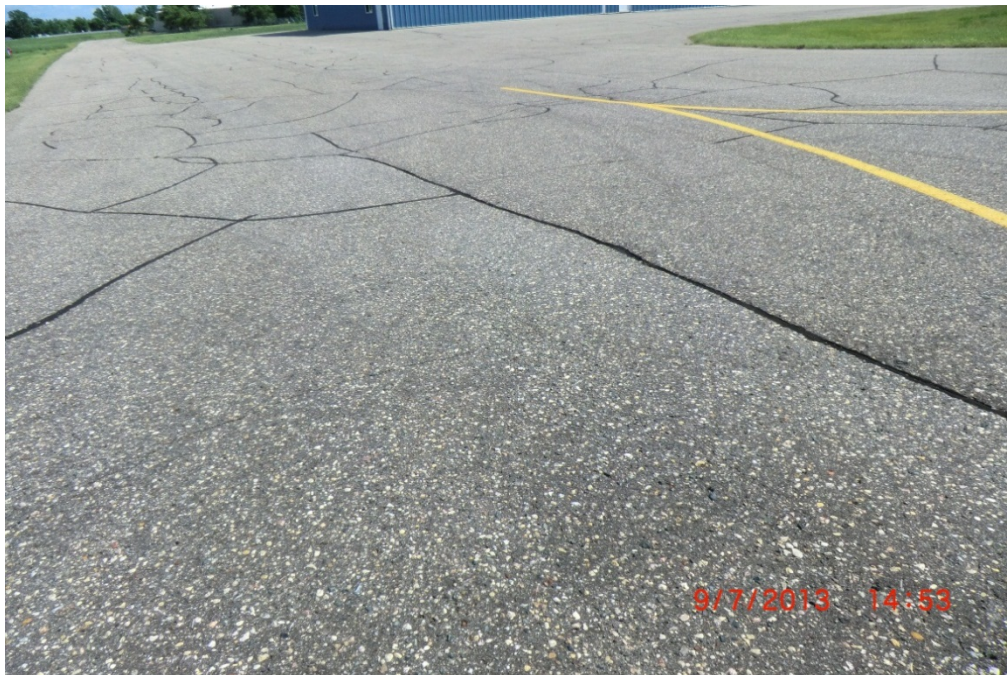
| Branch ID | Section ID | Surface type <sup>1</sup> | Section area (SF) | LCD <sup>2</sup> | 2010 PCI | 2013 PCI | Drop in PCI/Yr <sup>3</sup> | % Deduct due to | | Distress types |
|---|---|---|---|---|---|---|---|---|---|---|
| CTF | 1 | AAC | 5,075 | 1998 | 59 | 48 | 3.5 | 0 | 100 | Block cracking, Raveling |

AXN CTF 001 (PCI = 48)

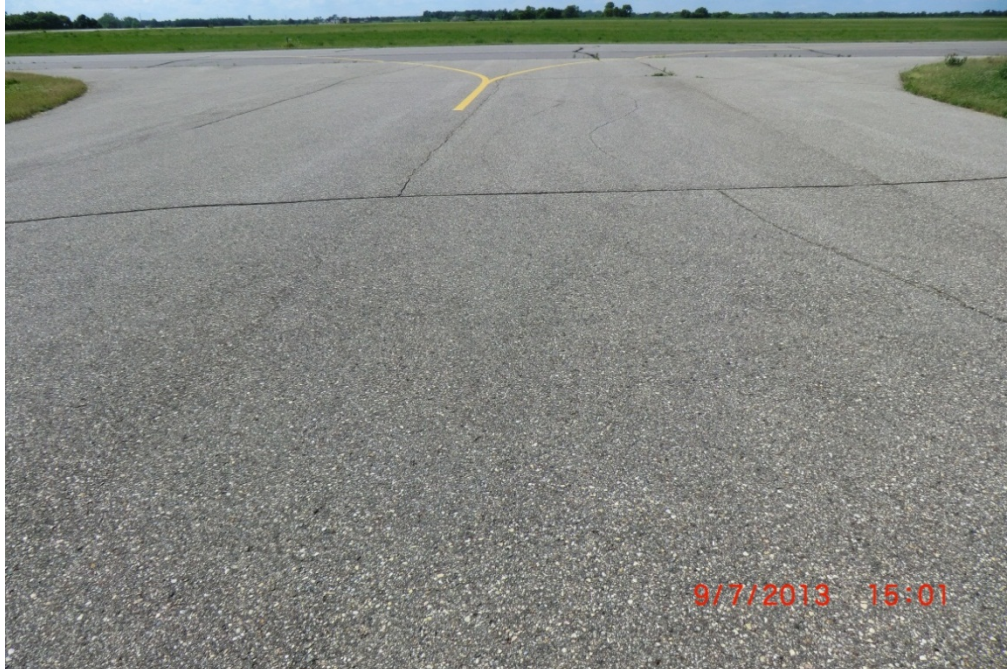
| Branch ID | Section ID | Surface type <sup>1</sup> | Section area (SF) | LCD <sup>2</sup> | 2010 PCI | 2013 PCI | Drop in PCI/Yr <sup>3</sup> | % Deduct due to | | Distress types |
|---|---|---|---|---|---|---|---|---|---|---|
| CTG | 1 | AC | 4,675 | 2007 | 76 | 73 | 4.5 | 0 | 100 | L&T cracking, Raveling |

AXN CTG 001 (PCI = 73)

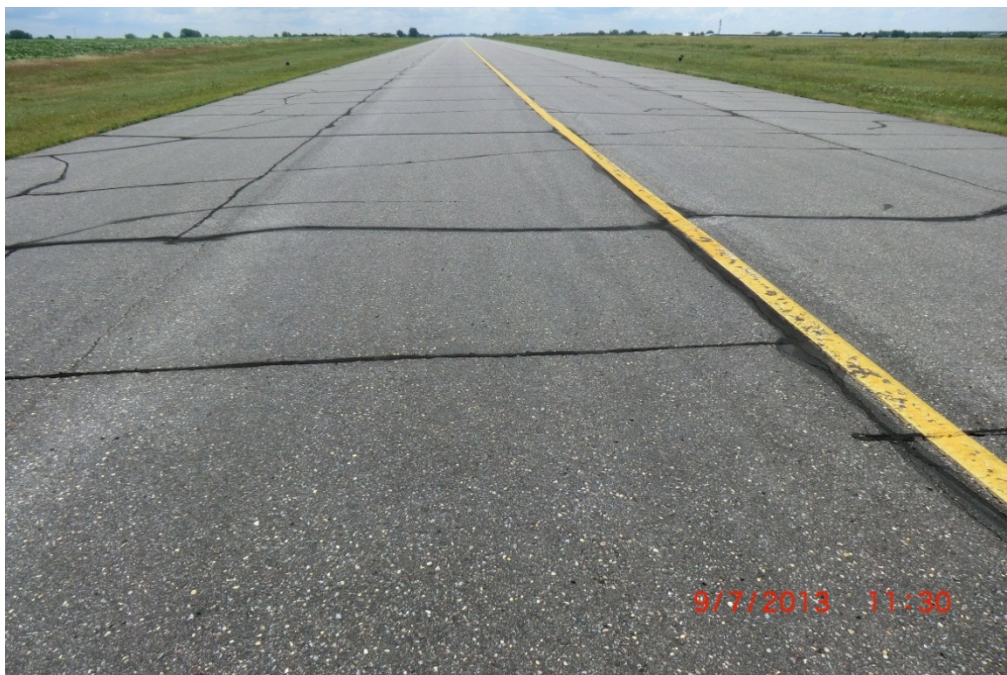
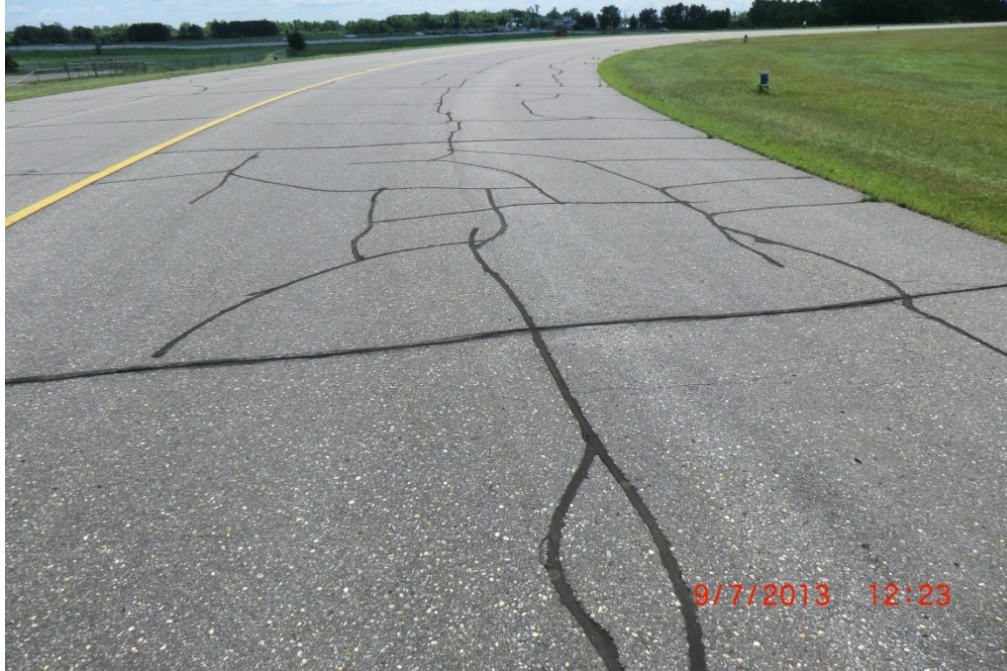
| Branch ID | Section ID | Surface type <sup>1</sup> | Section area (SF) | LCD <sup>2</sup> | 2010 PCI | 2013 PCI | Drop in PCI/Yr <sup>3</sup> | % Deduct due to | | Distress types |
|---|---|---|---|---|---|---|---|---|---|---|
| PTA | 1 | AAC | 275,665 | 1995 | 64 | 62 | 2.1 | 0 | 100 | Block cracking, L&T cracking |

AXN PTA 001 (PCI = 62)

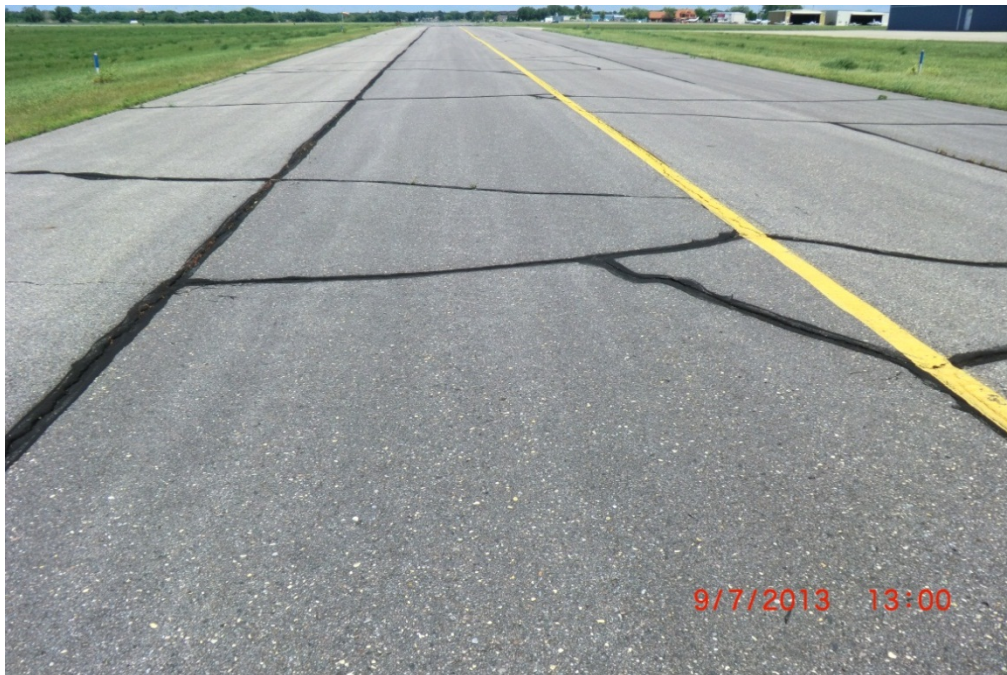
| Branch ID | Section ID | Surface type <sup>1</sup> | Section area (SF) | LCD <sup>2</sup> | 2010 PCI | 2013 PCI | Drop in PCI/Yr <sup>3</sup> | % Deduct due to | | Distress types |
|---|---|---|---|---|---|---|---|---|---|---|
| PTB | 1 | AAC | 110,580 | 1995 | 70 | 68 | 1.8 | 0 | 100 | L&T cracking, Raveling |

AXN PTB 001 (PCI = 68)

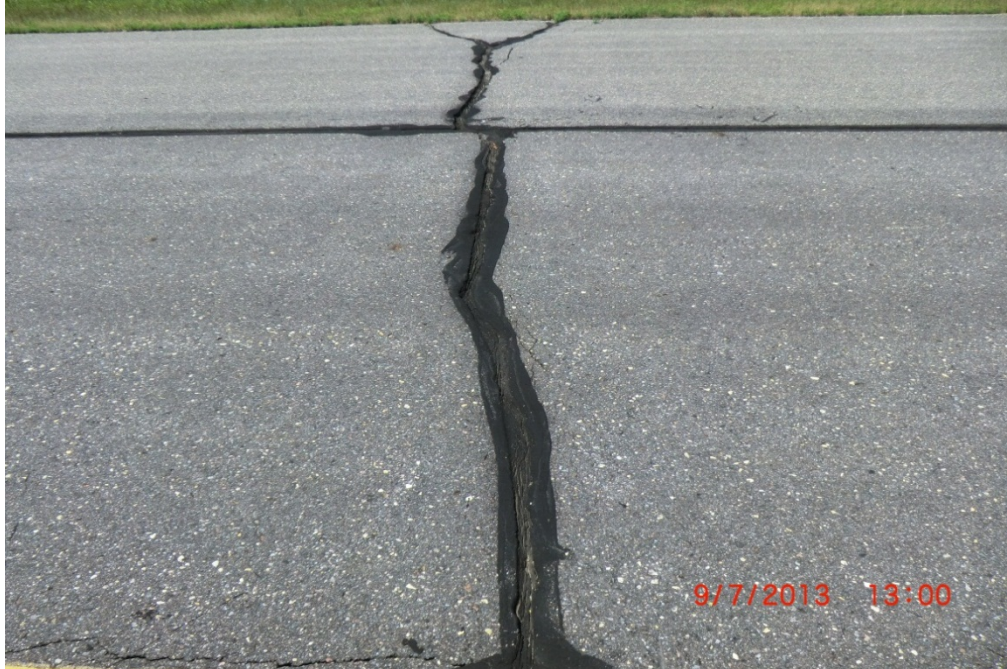
AXN PTB 001 48L (Low-Severity L&T Crack)

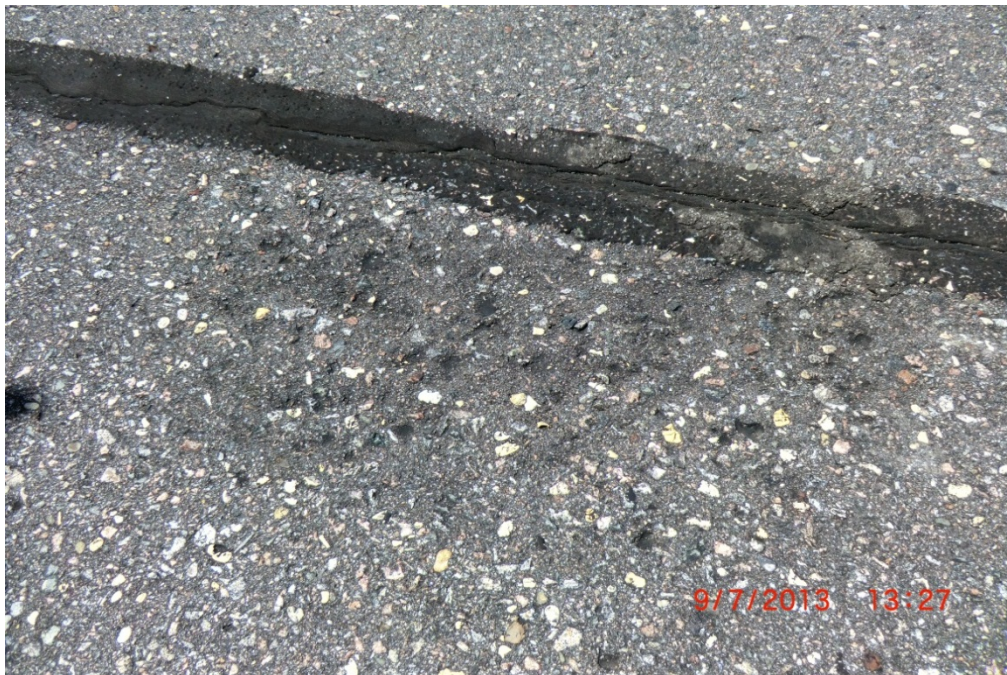
AXN PTB 001 52H (High-Severity Raveling)

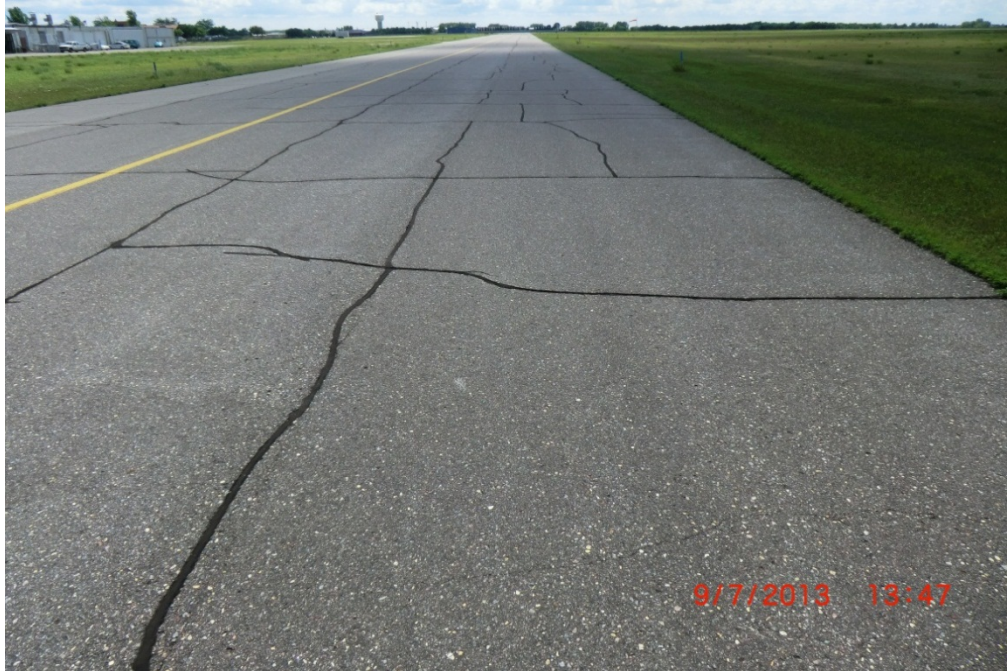
| Branch ID | Section ID | Surface type <sup>1</sup> | Section area (SF) | LCD <sup>2</sup> | 2010 PCI | 2013 PCI | Drop in PCI/Yr <sup>3</sup> | % Deduct due to | | Distress types |
|---|---|---|---|---|---|---|---|---|---|---|
| PTB | 2 | AAC | 121,830 | 1995 | 60 | 60 | 2.2 | 9 | 91 | Alligator cracking, Block cracking, L&T cracking, Raveling, Weathering |

AXN PTB 002 (PCI = 60)

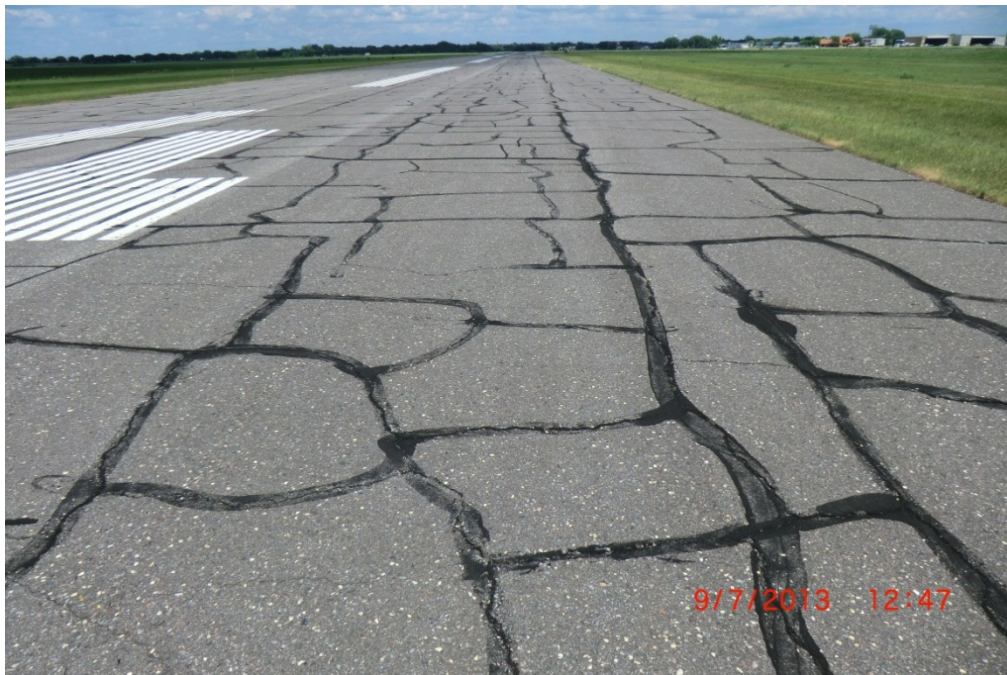
| Branch ID | Section ID | Surface type <sup>1</sup> | Section area (SF) | LCD <sup>2</sup> | 2010 PCI | 2013 PCI | Drop in PCI/Yr <sup>3</sup> | % Deduct due to | | Distress types |
|---|---|---|---|---|---|---|---|---|---|---|
| RY422 | 1 | AAC | 118,500 | 1995 | 64 | 53 | 2.6 | 0 | 100 | Block cracking, Patching |

AXN RY422 001 (PCI = 53)

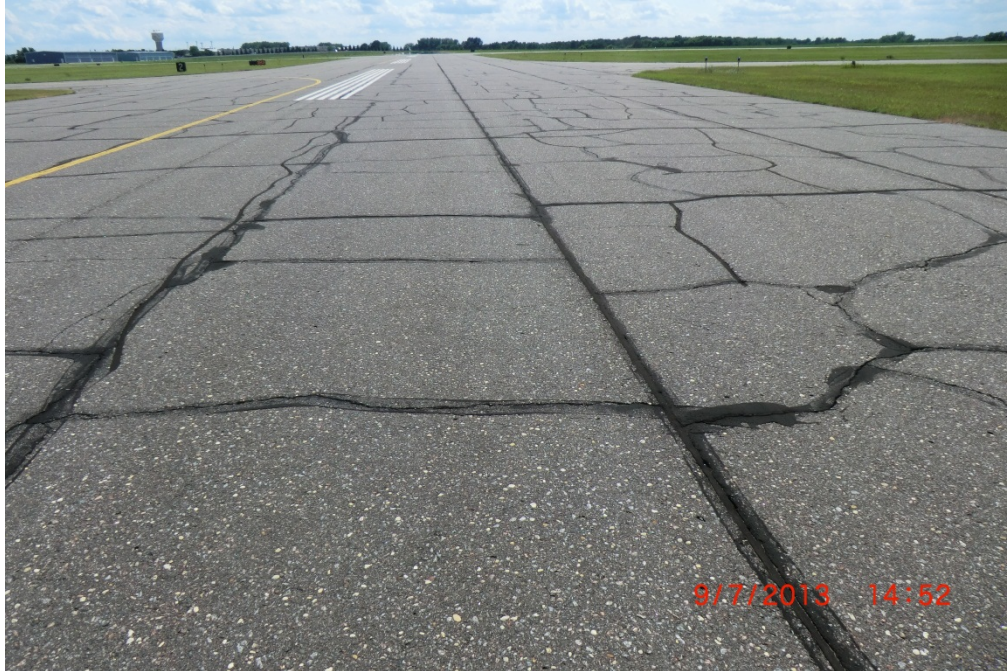
| Branch ID | Section ID | Surface type <sup>1</sup> | Section area (SF) | LCD <sup>2</sup> | 2010 PCI | 2013 PCI | Drop in PCI/Yr <sup>3</sup> | % Deduct due to | | Distress types |
|---|---|---|---|---|---|---|---|---|---|---|
| RY422 | 2 | AAC | 174,000 | 1995 | 64 | 60 | 2.2 | 0 | 100 | Block cracking |

AXN RY422 002 (PCI = 60)

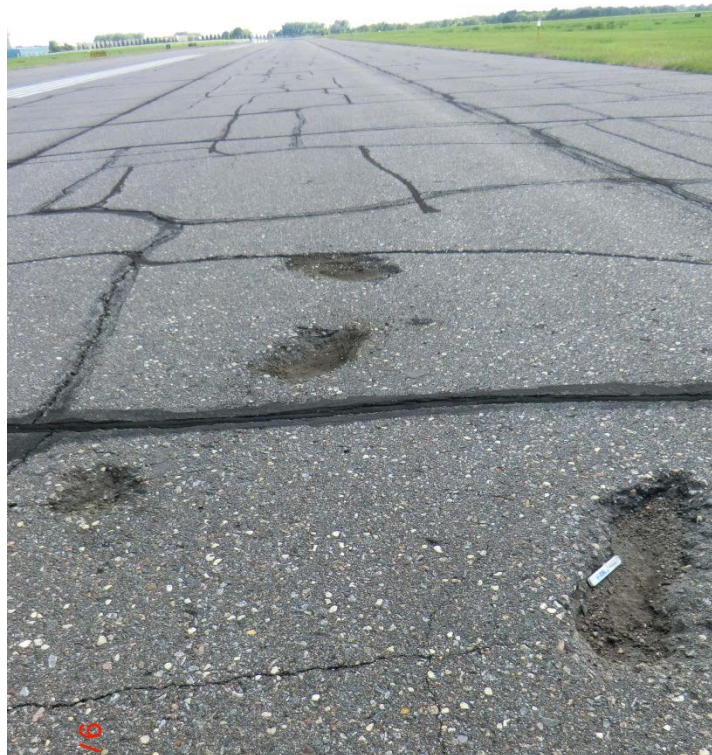
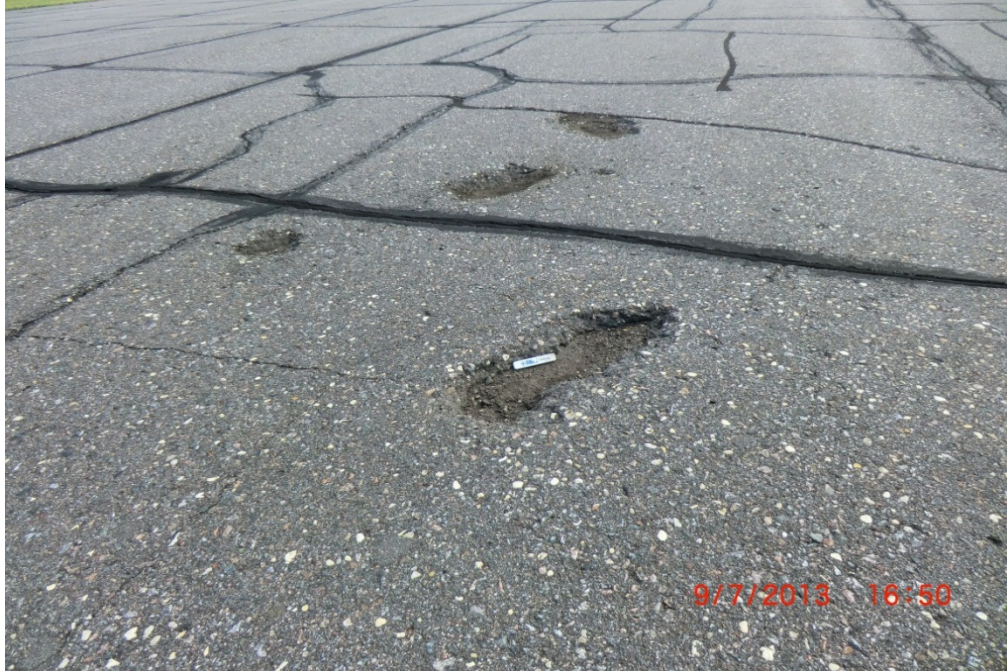
AXN RY422 002 (Lightning Strike)

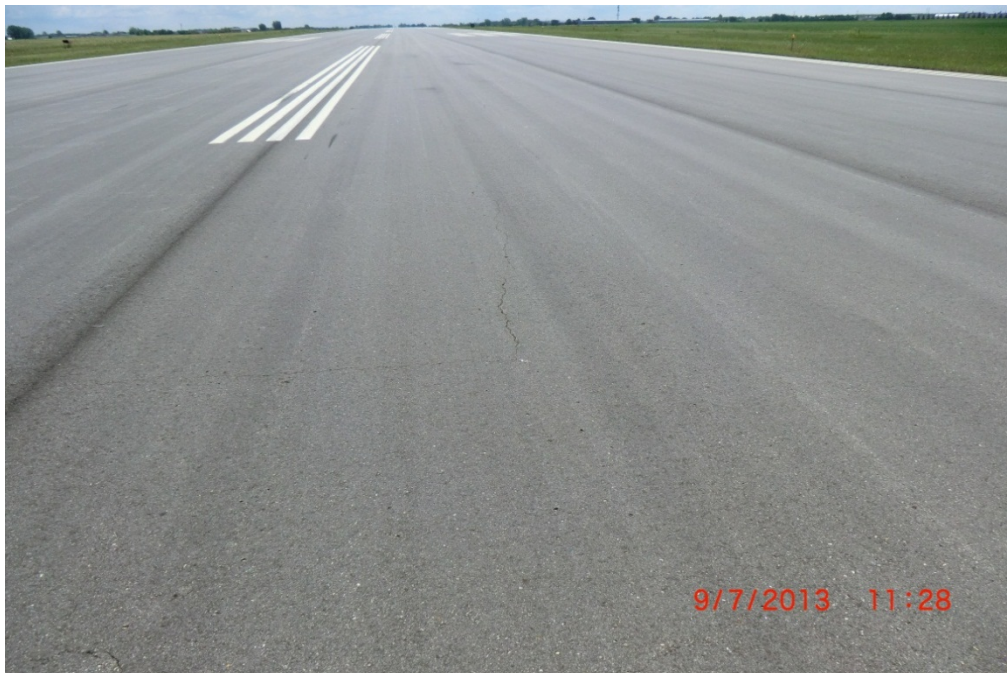
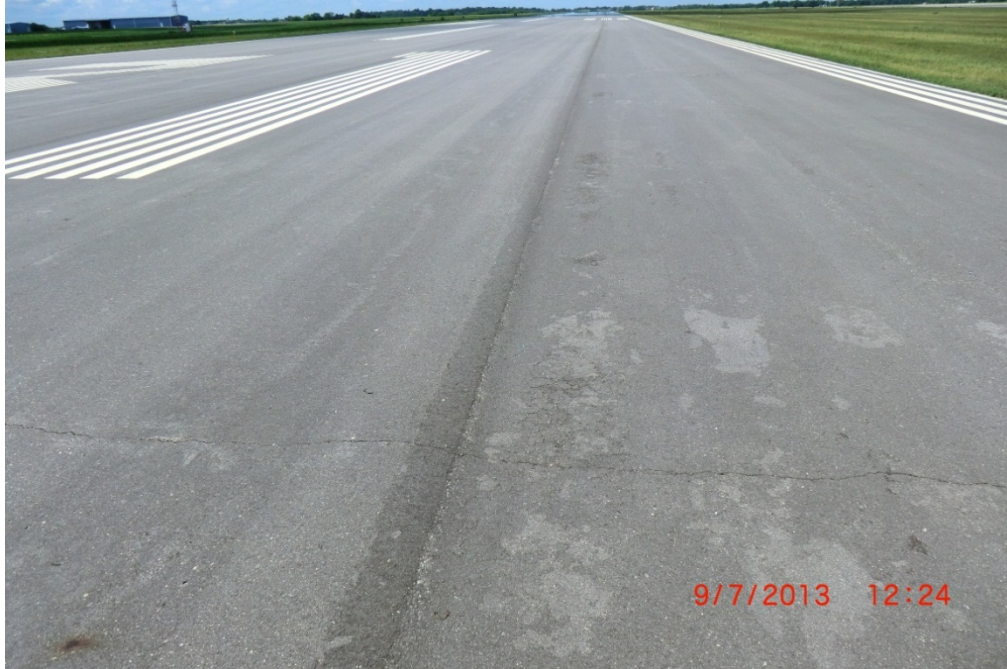
| Branch ID | Section ID | Surface type <sup>1</sup> | Section area (SF) | LCD <sup>2</sup> | 2010 PCI | 2013 PCI | Drop in PCI/Yr <sup>3</sup> | % Deduct due to | | Distress types |
|---|---|---|---|---|---|---|---|---|---|---|
| RY1331 | 1 | AAC | 531,375 | 2012 | 61 | 83 | 17.0 | 0 | 100 | L&T cracking |

Note: The high deterioration rate for RY1331 is caused by the reflection of cracks from the previous surface which had a 1" mill/2" overlay placed in September 2012.

AXN RY1331 001 (PCI = 83)

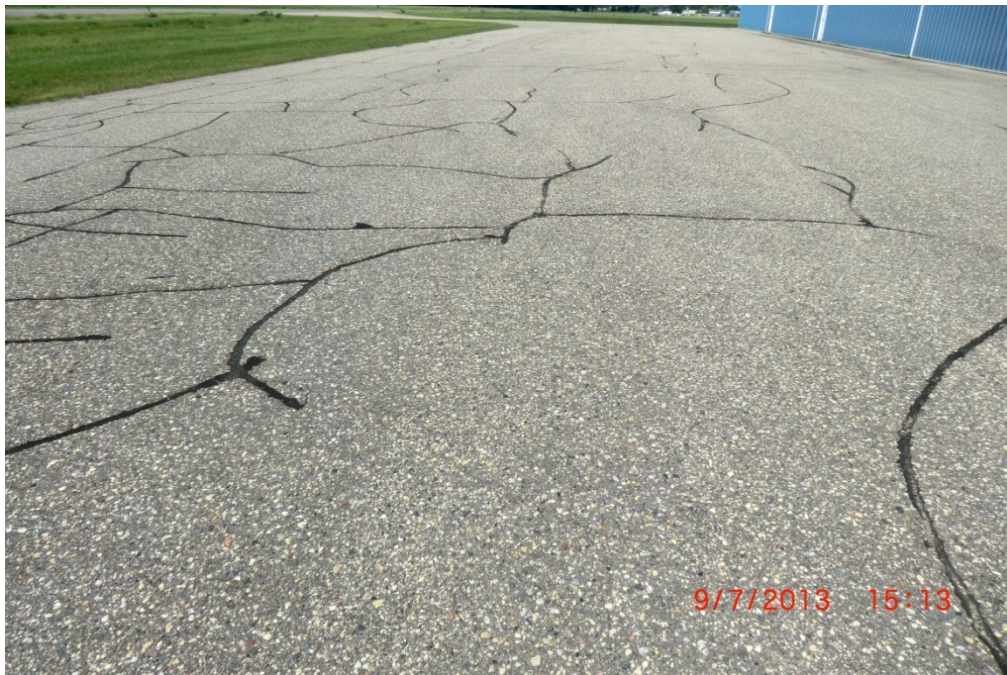
| Branch ID | Section ID | Surface type <sup>1</sup> | Section area (SF) | LCD <sup>2</sup> | 2010 PCI | 2013 PCI | Drop in PCI/Yr <sup>3</sup> | % Deduct due to | | Distress types |
|---|---|---|---|---|---|---|---|---|---|---|
| TLA | 1 | AAC | 38,880 | 1998 | 59 | 44 | 3.7 | 0 | 100 | Block cracking, L&T cracking, Raveling, Weathering |

AXN TLA 001 (PCI = 44)

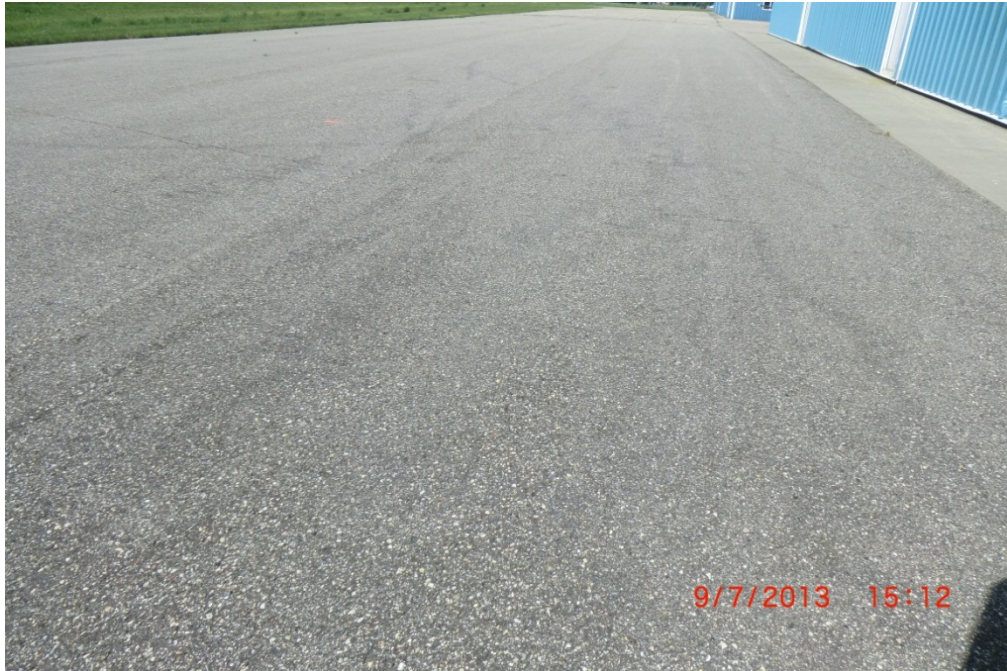
| Branch ID | Section ID | Surface type <sup>1</sup> | Section area (SF) | LCD <sup>2</sup> | 2010 PCI | 2013 PCI | Drop in PCI/Yr <sup>3</sup> | % Deduct due to | | Distress types |
|---|---|---|---|---|---|---|---|---|---|---|
| TLA | 2 | AC | 42,732 | 2007 | 88 | 82 | 3.0 | 0 | 100 | L&T cracking |

AXN TLA 002 (PCI = 82)

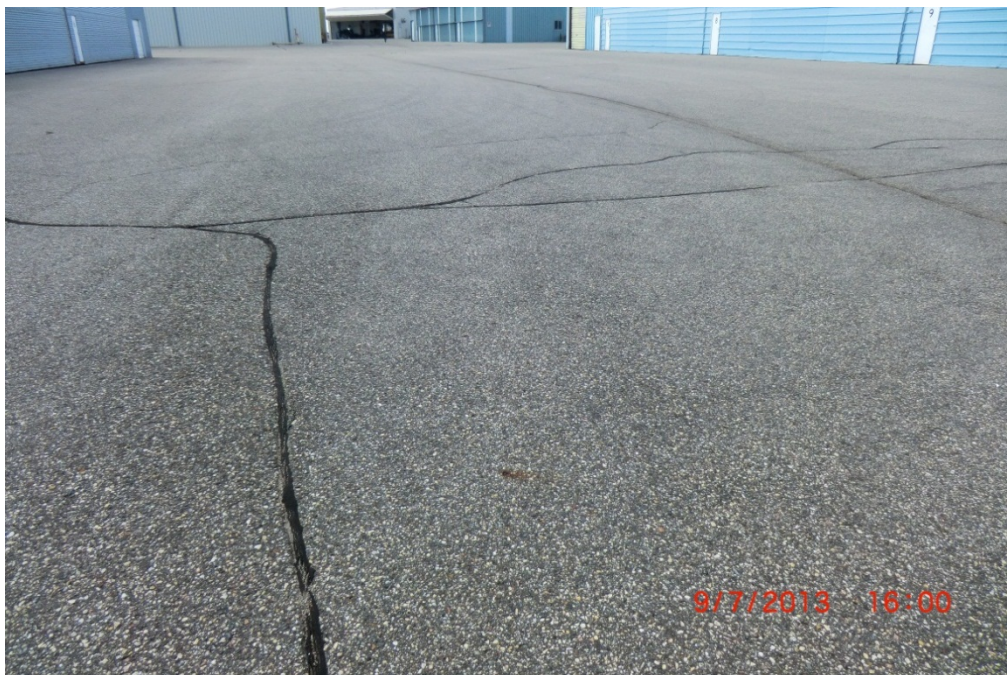
| Branch ID | Section ID | Surface type <sup>1</sup> | Section area (SF) | LCD <sup>2</sup> | 2010 PCI | 2013 PCI | Drop in PCI/Yr <sup>3</sup> | % Deduct due to | | Distress types |
|---|---|---|---|---|---|---|---|---|---|---|
| TLB | 1 | AC | 95,000 | 2006 | 92 | 89 | 1.6 | 0 | 100 | L&T cracking |

AXN TLB 001 (PCI = 89)

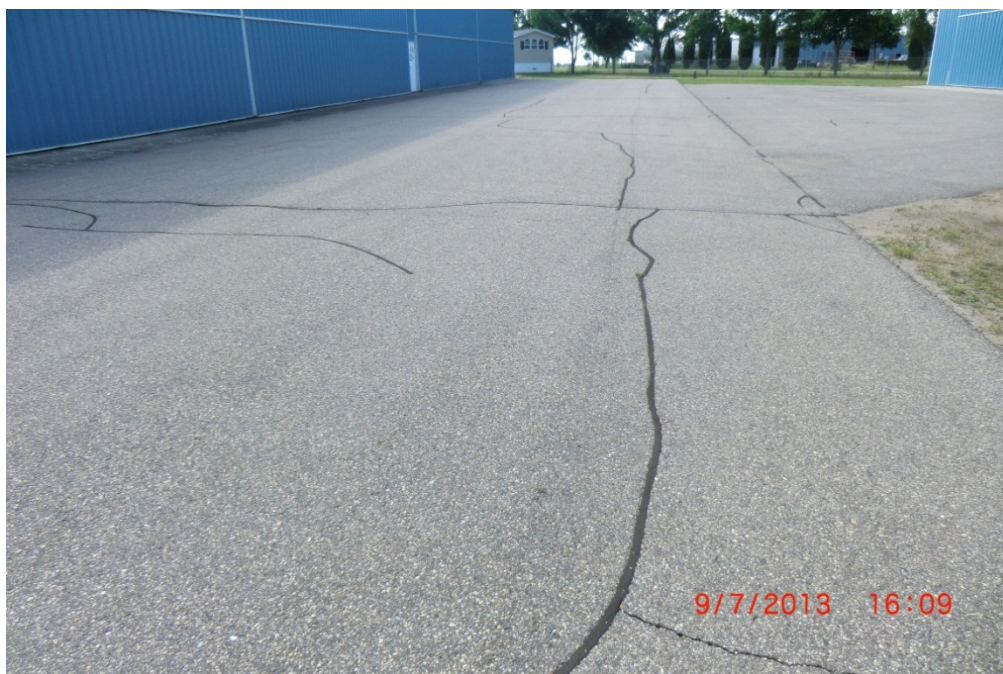
| Branch ID | Section ID | Surface type <sup>1</sup> | Section area (SF) | LCD <sup>2</sup> | 2010 PCI | 2013 PCI | Drop in PCI/Yr <sup>3</sup> | % Deduct due to | | Distress types |
|---|---|---|---|---|---|---|---|---|---|---|
| TLB | 2 | AAC | 8,575 | 2006 | 77 | 75 | 3.6 | 0 | 100 | L&T cracking |

AXN TLB 002 (PCI = 75)

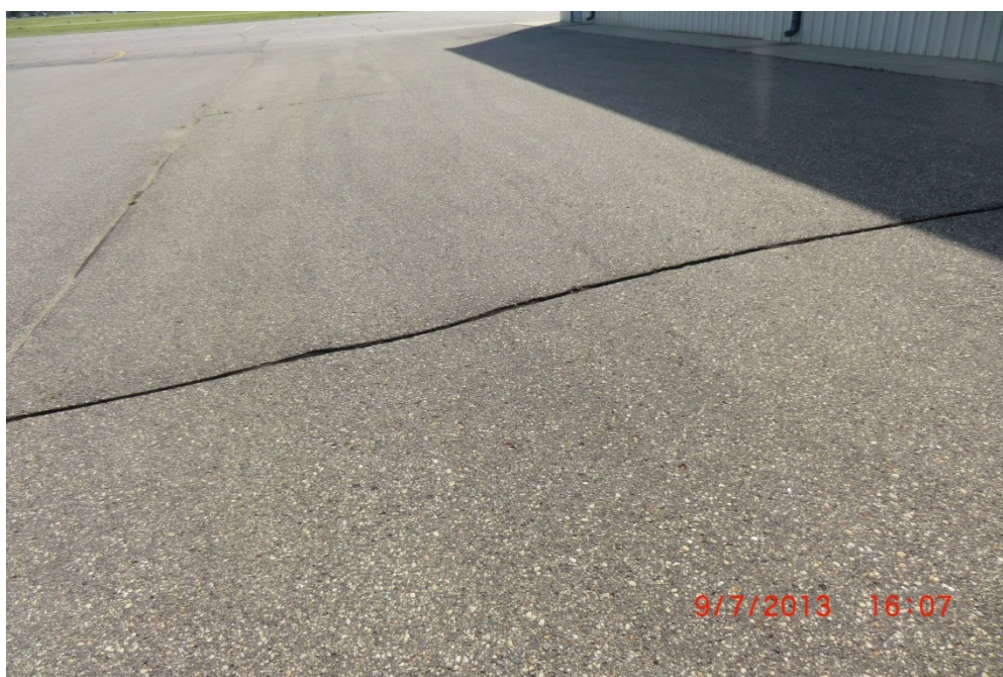
| Branch ID | Section ID | Surface type <sup>1</sup> | Section area (SF) | LCD <sup>2</sup> | 2010 PCI | 2013 PCI | Drop in PCI/Yr <sup>3</sup> | % Deduct due to | | Distress types |
|---|---|---|---|---|---|---|---|---|---|---|
| TLB | 3 | AAC | 5,100 | 2003 | 78 | 74 | 2.6 | 0 | 90 | L&T cracking, Oil spill |

AXN TLB 003 (PCI = 74)
