# Minnesota Airport System Pavement Evaluation 2013 Update

Stephen Municipal Airport (D41)

Stephen, Minnesota

October 2013

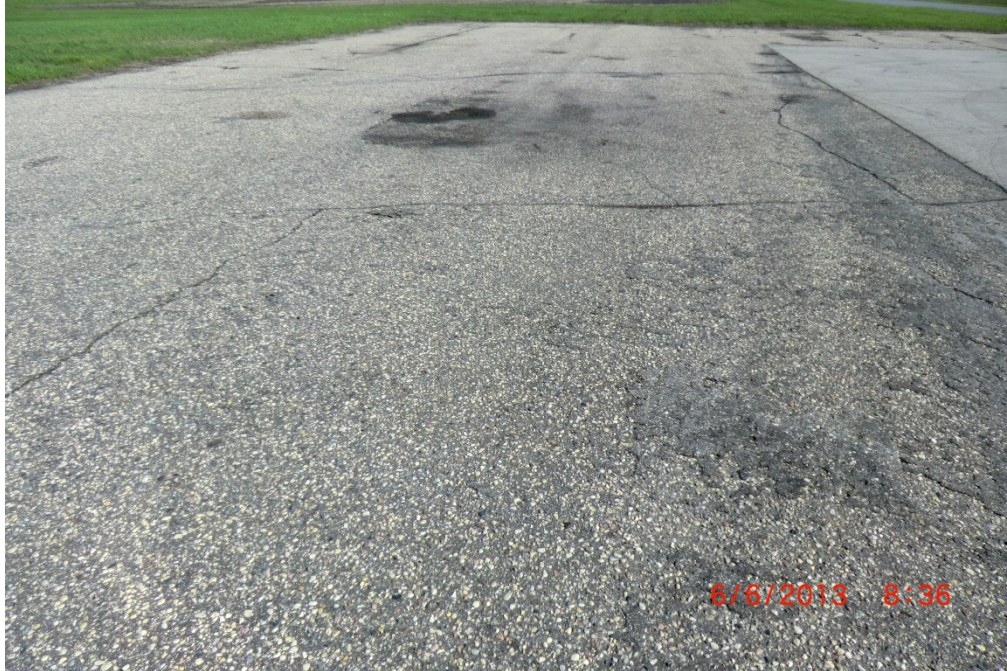
D41 APA 001 (PCI = 25)

| Branch ID | Section ID | Surface type <sup>1</sup> | Section area (SF) | LCD <sup>2</sup> | 2010 PCI | 2013 PCI | Drop in PCI/Yr <sup>3</sup> | % Deduct due to | | Distress types |
|---|---|---|---|---|---|---|---|---|---|---|
| APA | 1 | AC | 8,500 | 1973* | 42 | 25 | 1.9 | 24 | 76 | Alligator cracking, Longitudinal & transverse (L&T) cracking, Weathering |

Conditions: PCI : 25

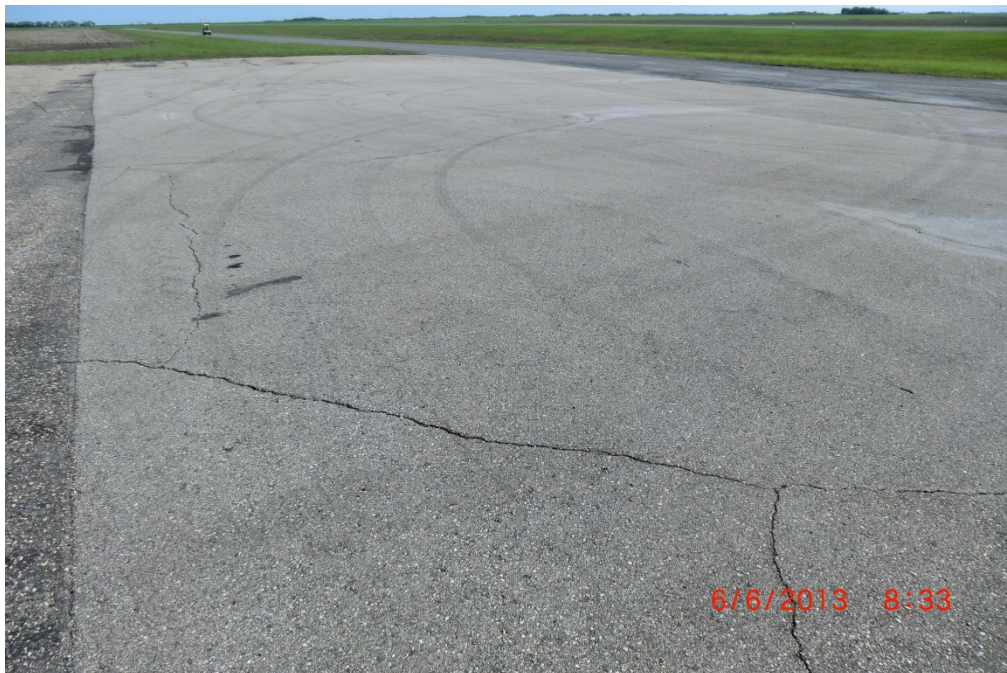
D41 APA 002 (PCI = 68)

| Branch ID | Section ID | Surface type <sup>1</sup> | Section area (SF) | LCD <sup>2</sup> | 2010 PCI | 2013 PCI | Drop in PCI/Yr <sup>3</sup> | % Deduct due to | | Distress types |
|---|---|---|---|---|---|---|---|---|---|---|
| APA | 2 | AAC | 5,000 | 2004* | 70 | 68 | 3.6 | 22 | 78 | L&T cracking, Rutting |

Conditions: PCI : 68

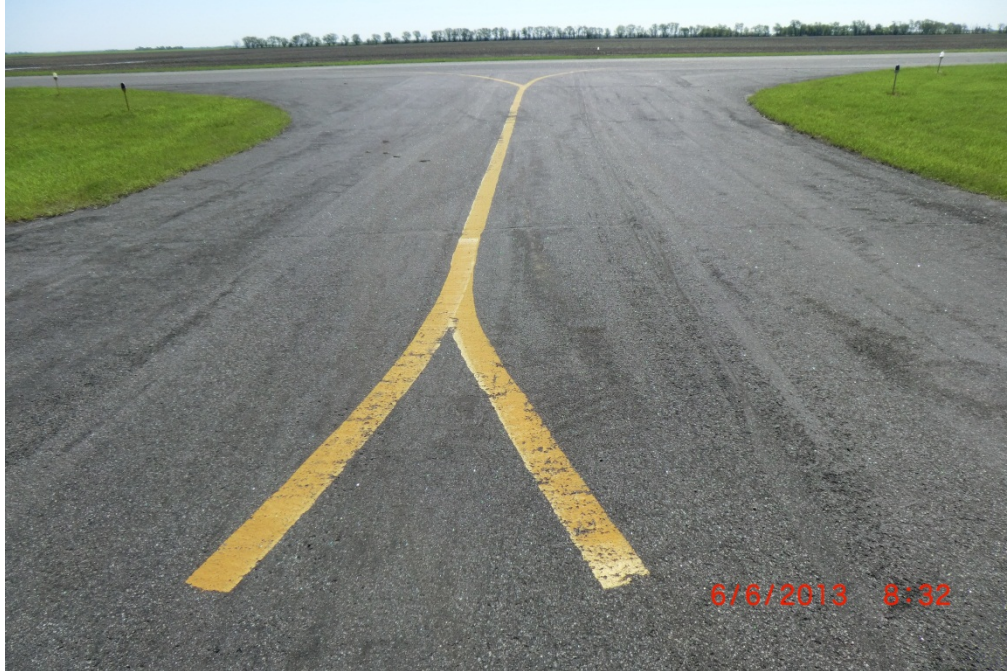
D41 CTA 001 (PCI = 81)

| Branch ID | Section ID | Surface type <sup>1</sup> | Section area (SF) | LCD <sup>2</sup> | 2010 PCI | 2013 PCI | Drop in PCI/Yr <sup>3</sup> | % Deduct due to | | Distress types |
|---|---|---|---|---|---|---|---|---|---|---|
| CTA | 1 | AC | 3,925 | 1998 | 79 | 81 | 1.3 | 0 | 100 | L&T cracking |

Conditions: PCI : 81

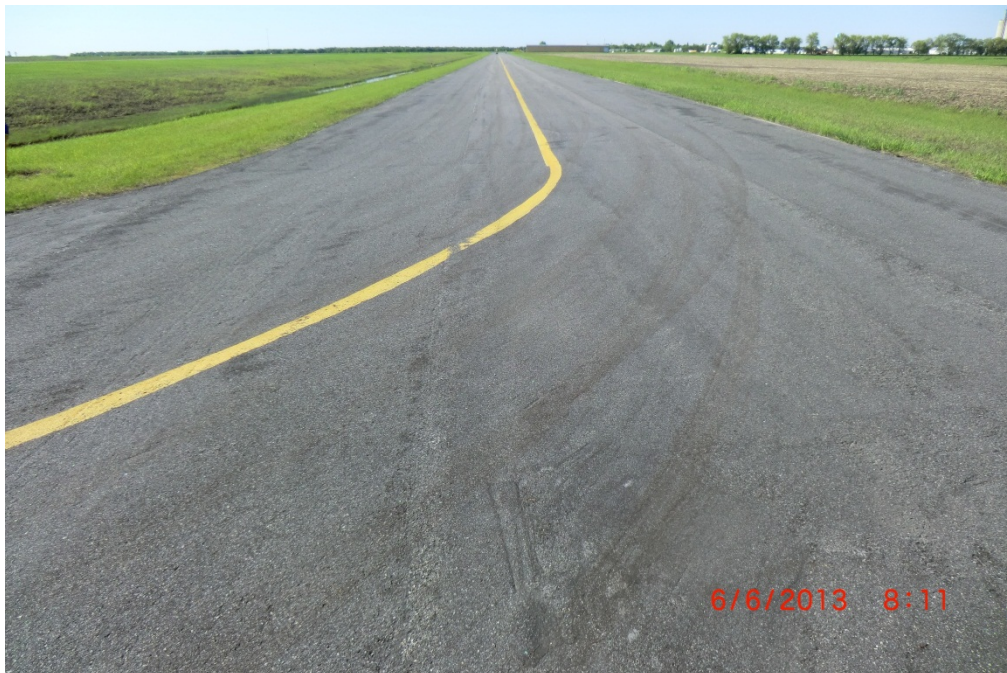
D41 PTA 002 (PCI = 84)

| Branch ID | Section ID | Surface type <sup>1</sup> | Section area (SF) | LCD <sup>2</sup> | 2010 PCI | 2013 PCI | Drop in PCI/Yr <sup>3</sup> | % Deduct due to | | Distress types |
|---|---|---|---|---|---|---|---|---|---|---|
| PTA | 2 | AC | 51,150 | 2004 | 88 | 84 | 1.8 | 0 | 93 | L&T cracking, Swelling |

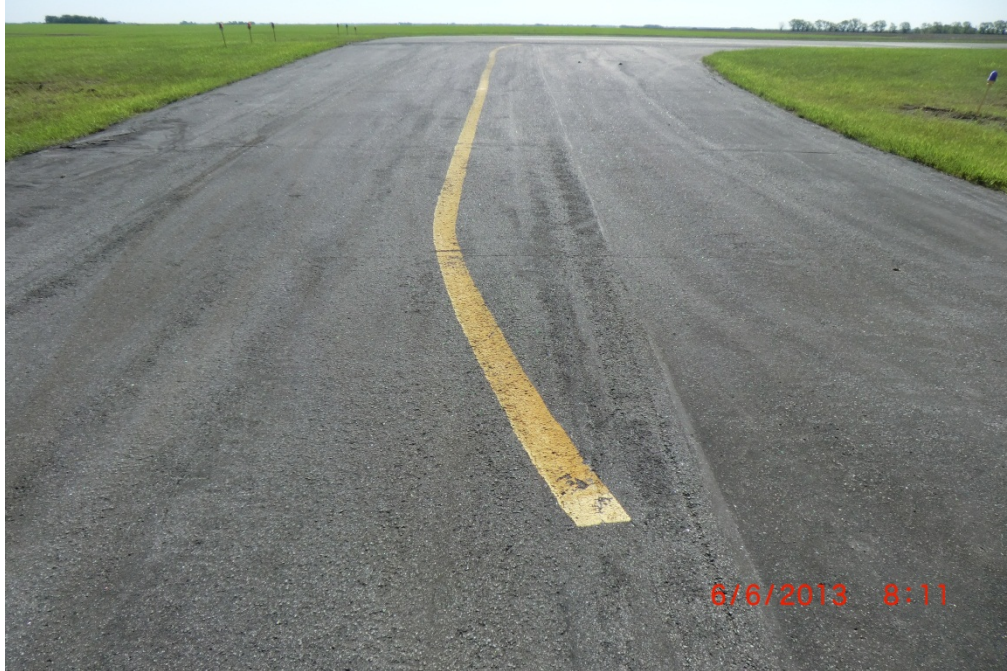
D41 PTA 003 (PCI = 63)

| Branch ID | Section ID | Surface type <sup>1</sup> | Section area (SF) | LCD <sup>2</sup> | 2010 PCI | 2013 PCI | Drop in PCI/Yr <sup>3</sup> | % Deduct due to | | Distress types |
|---|---|---|---|---|---|---|---|---|---|---|
| PTA | 3 | AC | 4,125 | 2004 | 66 | 63 | 4.1 | 38 | 46 | Alligator cracking, L&T cracking, Swelling |

Conditions: PCI : 63

48 LONGITUDINAL/TRANSVERSE CRACKING L 208.00 Ft Comments:

48 LONGITUDINAL/TRANSVERSE CRACKING M 18.00 Ft Comments:

41 ALLIGATOR CRACKING L 37.00 SqFt Comments:

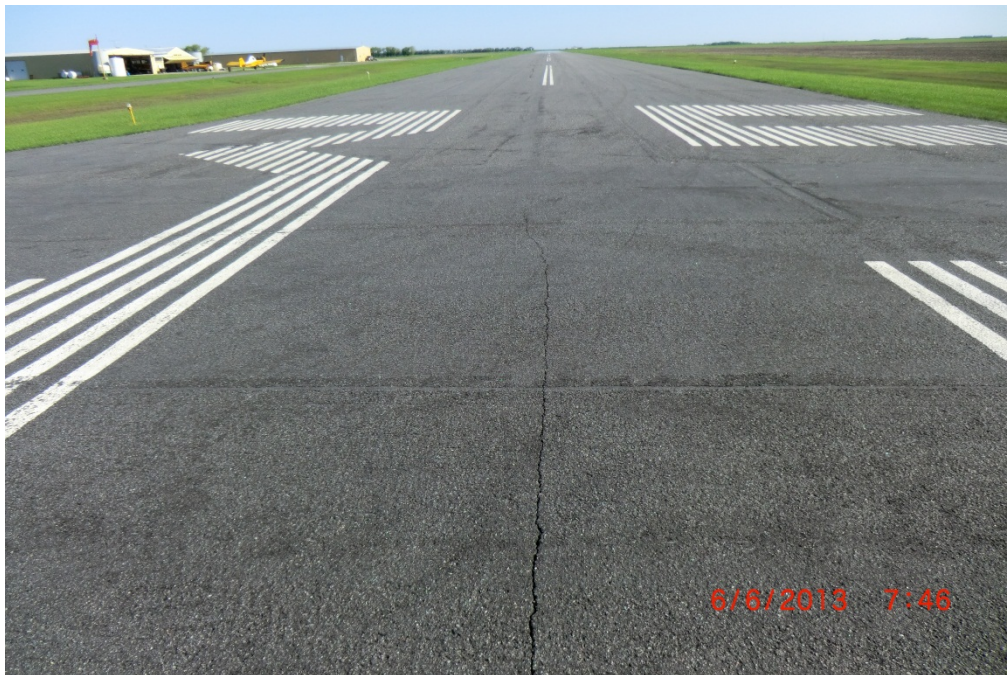
D41 RY1735 001 (PCI = 81)

| Branch ID | Section ID | Surface type <sup>1</sup> | Section area (SF) | LCD <sup>2</sup> | 2010 PCI | 2013 PCI | Drop in PCI/Yr <sup>3</sup> | % Deduct due to | | Distress types |
|---|---|---|---|---|---|---|---|---|---|---|
| RY1735 | 1 | AC | 162,000 | 1998 | 85 | 81 | 1.3 | 0 | 100 | L&T cracking |

Conditions: PCI : 81

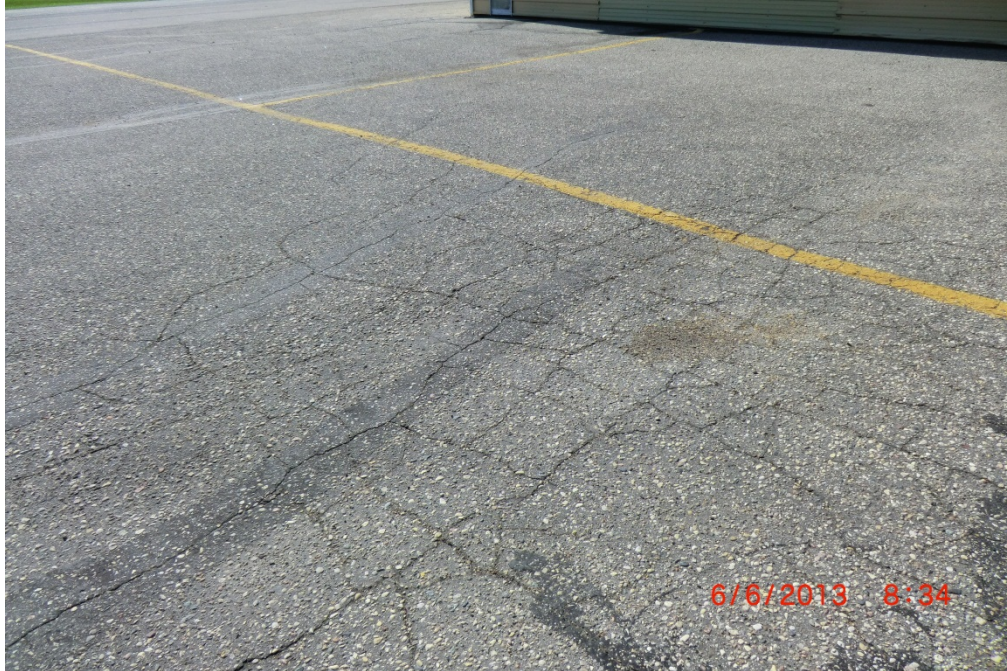
D41 TLA 001 (PCI = 14)

| Branch ID | Section ID | Surface type <sup>1</sup> | Section area (SF) | LCD <sup>2</sup> | 2010 PCI | 2013 PCI | Drop in PCI/Yr <sup>3</sup> | % Deduct due to | | Distress types |
|---|---|---|---|---|---|---|---|---|---|---|
| TLA | 1 | AC | 20,335 | 1973 | 12 | 14 | 2.2 | 59 | 41 | Alligator cracking, L&T cracking, Weathering |

Conditions: PCI : 14
