Minnesota Airport System Pavement Evaluation 2013 Update

Red Lake Falls Municipal Airport (D81)

Final Report

Applied Research Associates, Inc.
100 Trade Centre Dr., Suite 200
Champaign, IL 61820
(217) 356-4500

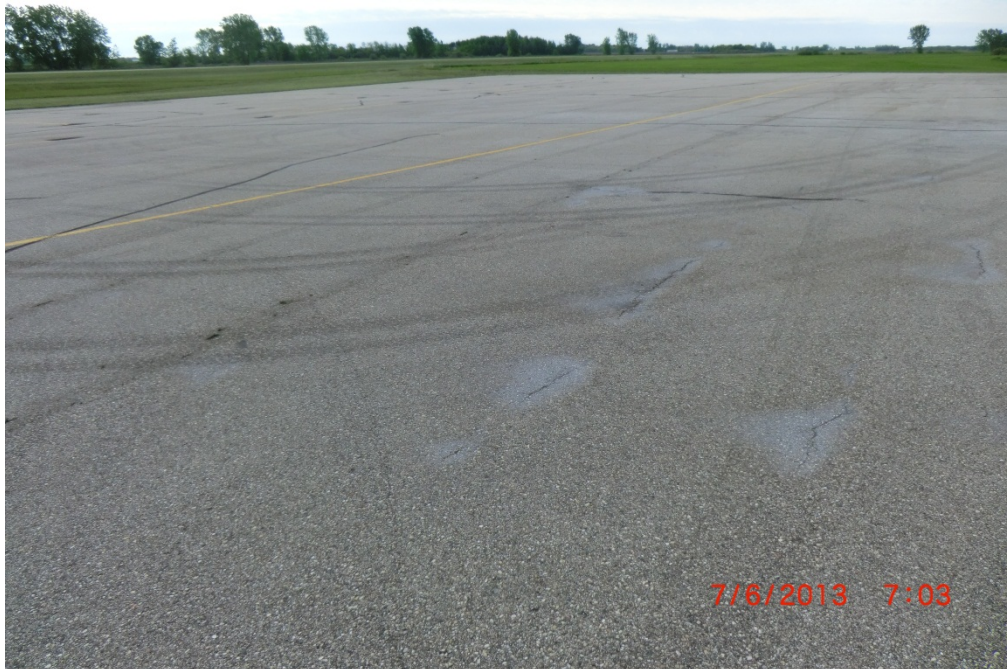
D81 APA 001 (PCI = 76)

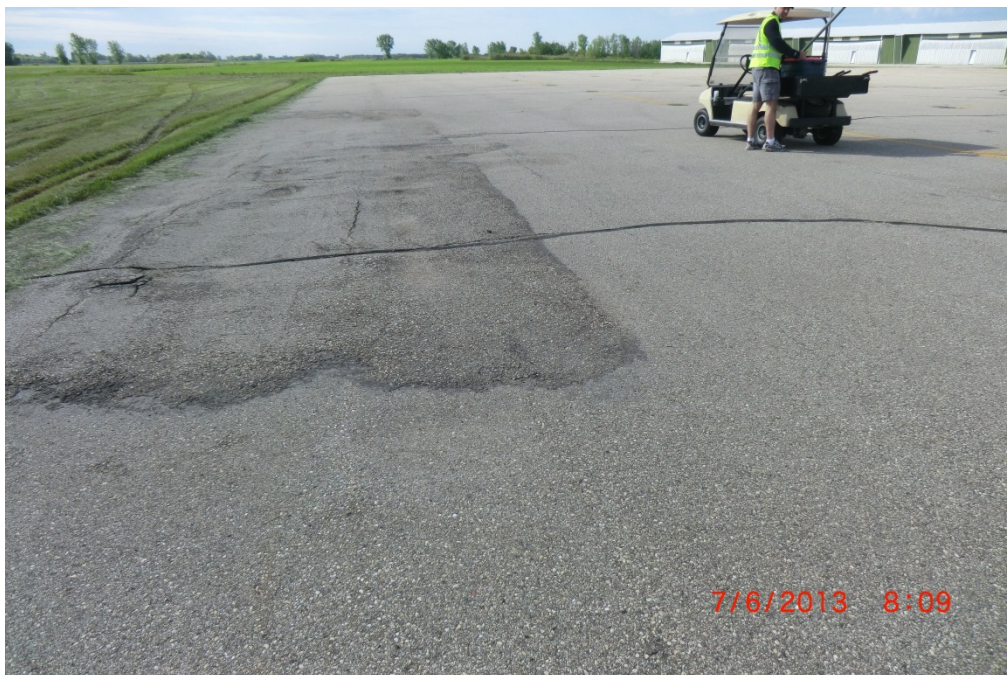
D81 APA 001 (Low-Severity Swelling)

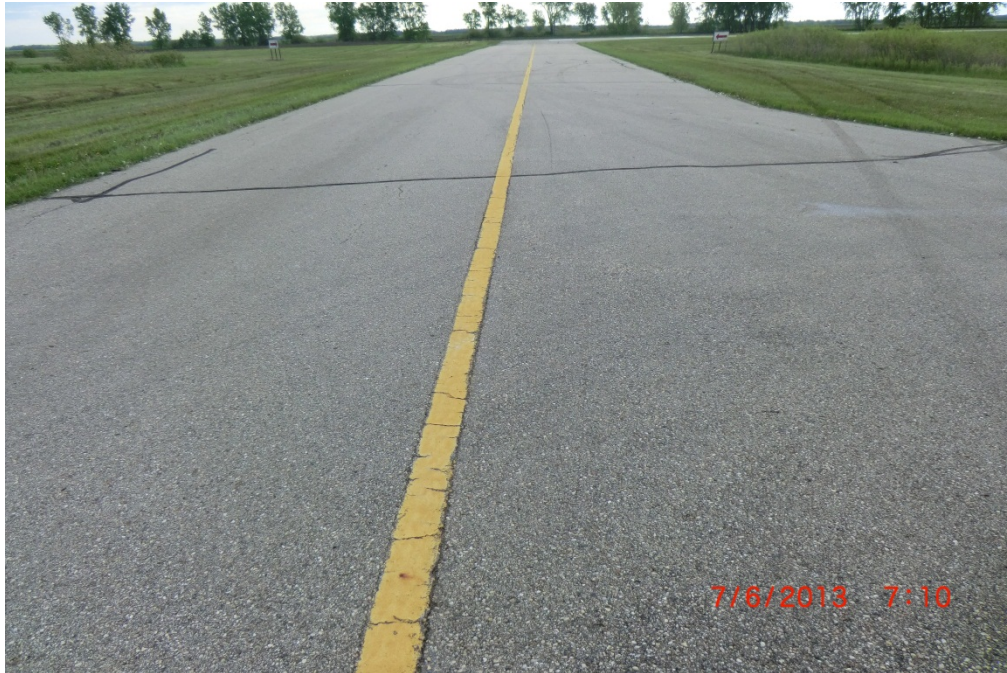
D81 CTA 001 (PCI = 70)

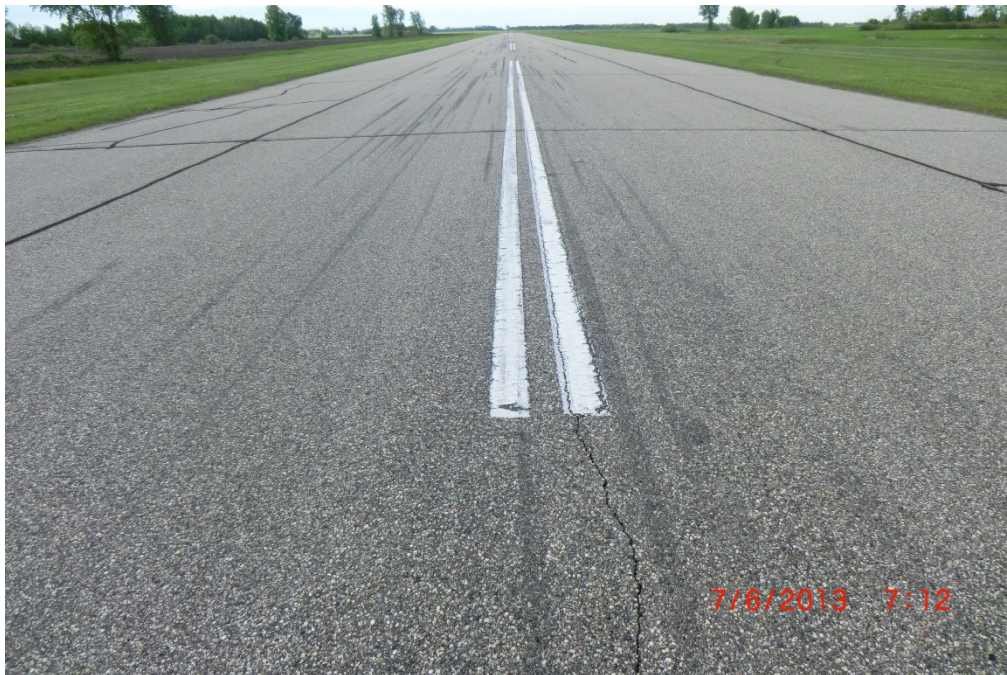
D81 RY1533 001 (PCI = 56)

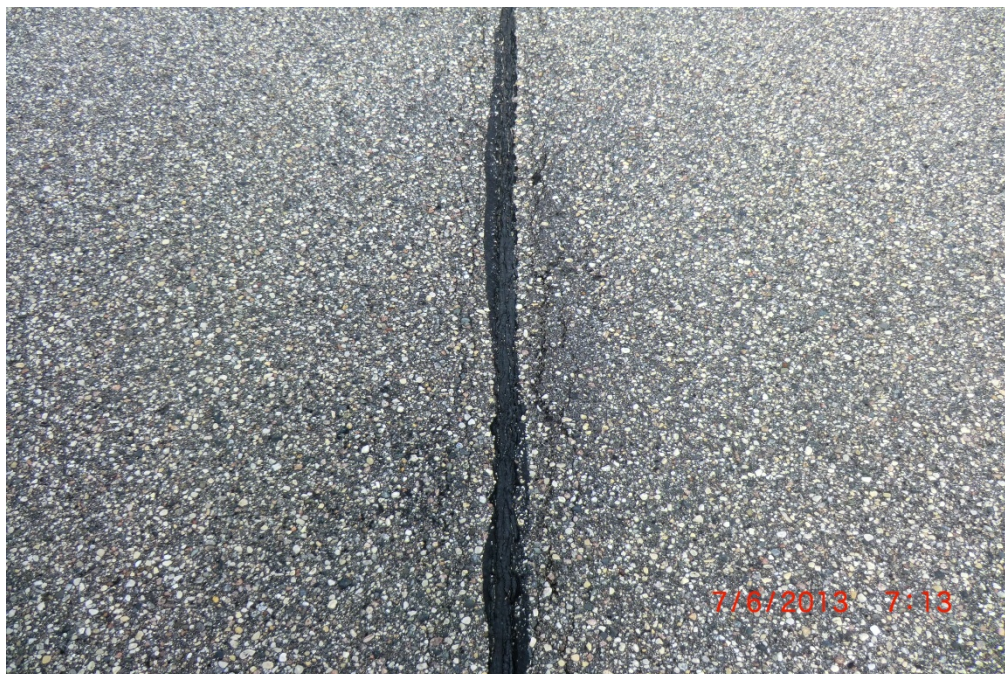
D81 RY1533 001 (Medium-Severity L&T Crack)

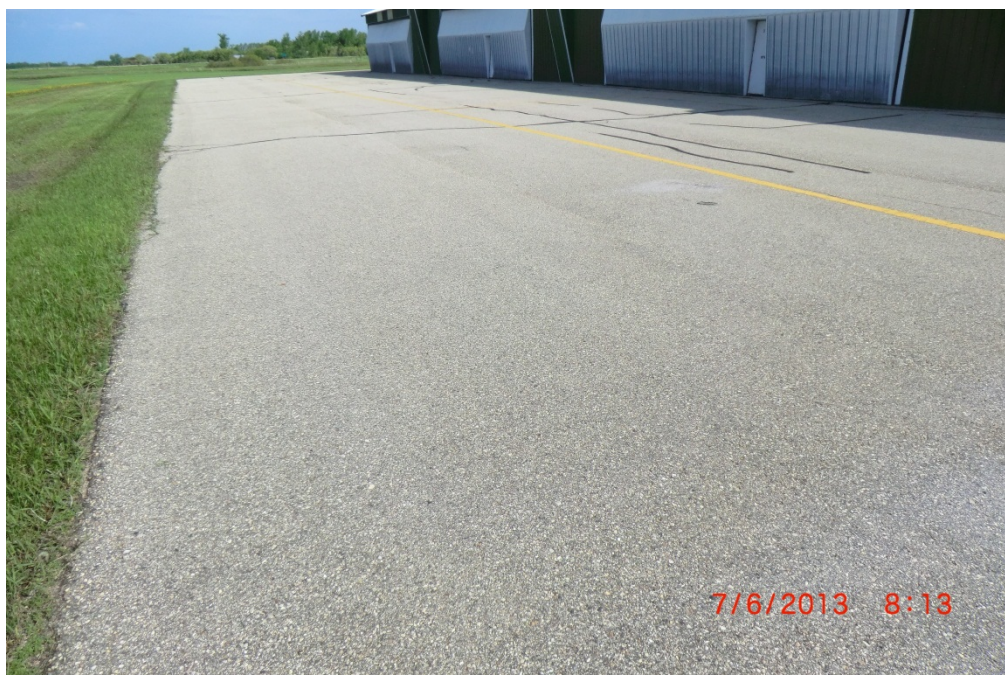
D81 TLA 001 (PCI = 70)
