Minnesota Airport System Pavement Evaluation 2013 Update

Lac Qui Parle County Airport (DXX)

Madison, Minnesota

Final Report

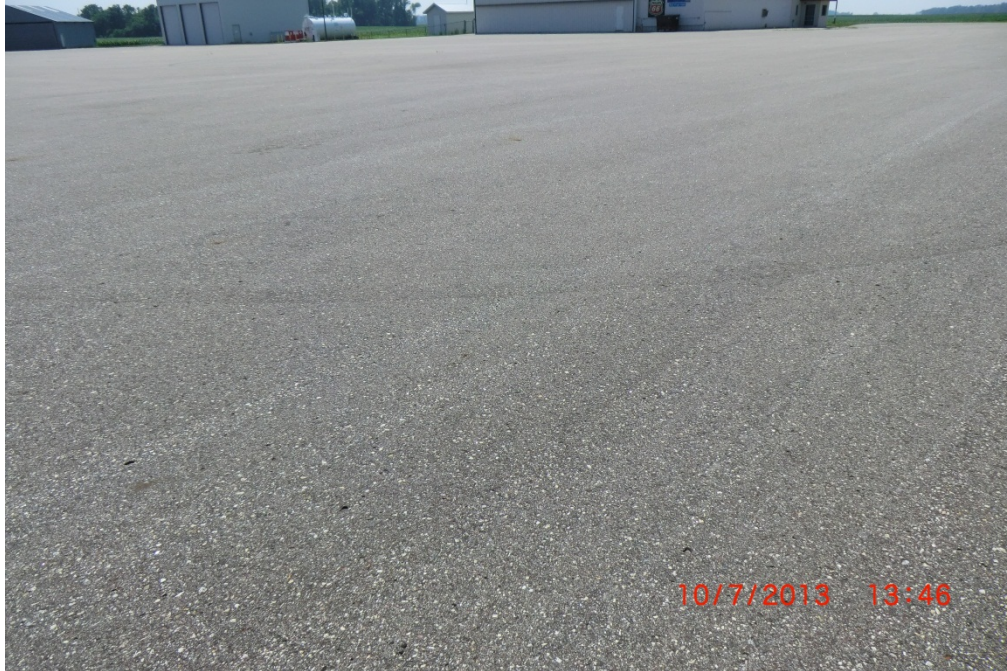
DXX APA 001 (PCI = 96)

Conditions: PCI: 96

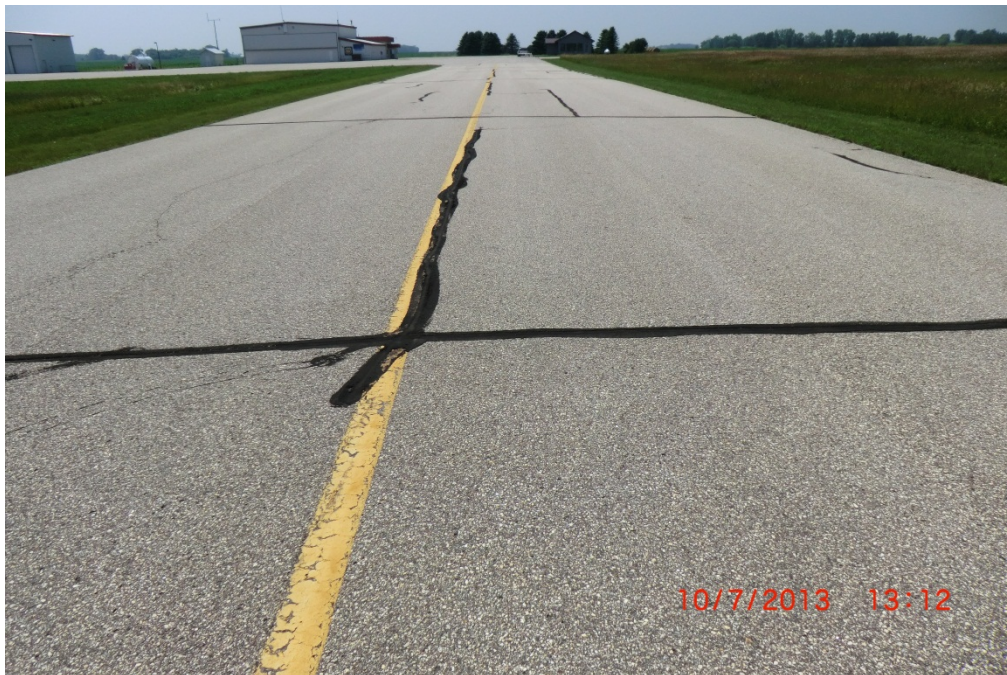
DXX CTA 001 (PCI = 65)

Conditions: PCI : 65

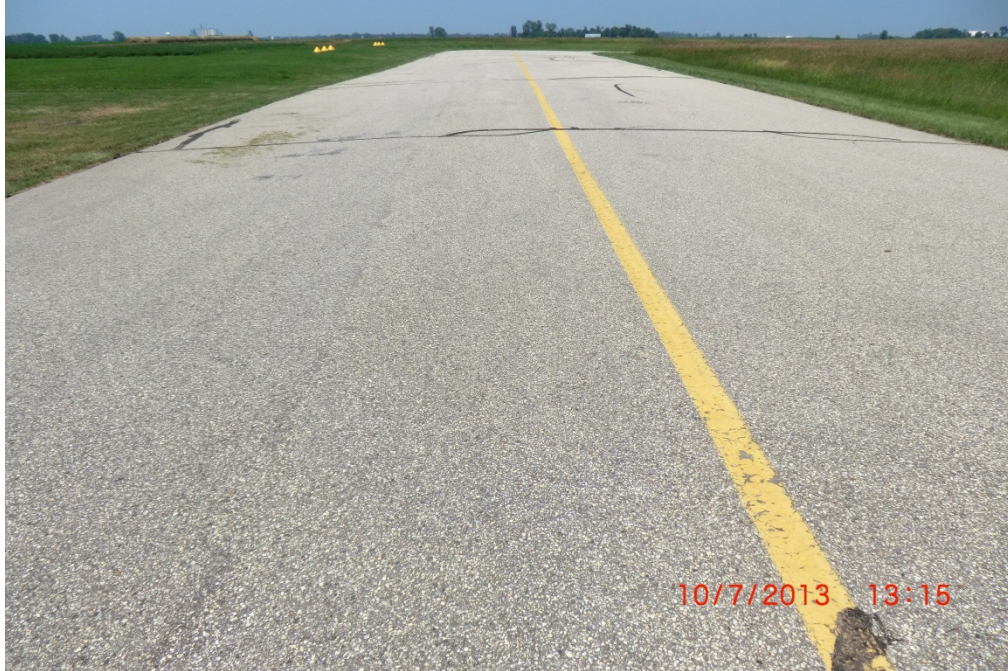
DXX CTB 001 (PCI = 60)

Conditions: PCI : 60

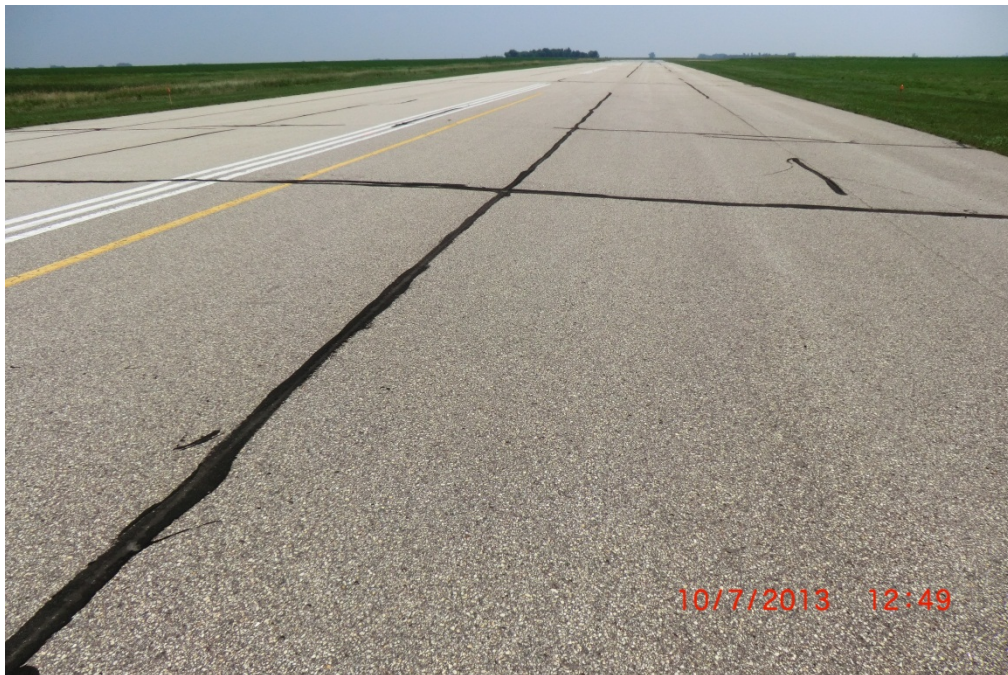
DXX RY1432 001 (PCI = 62)

Conditions: PCI: 62

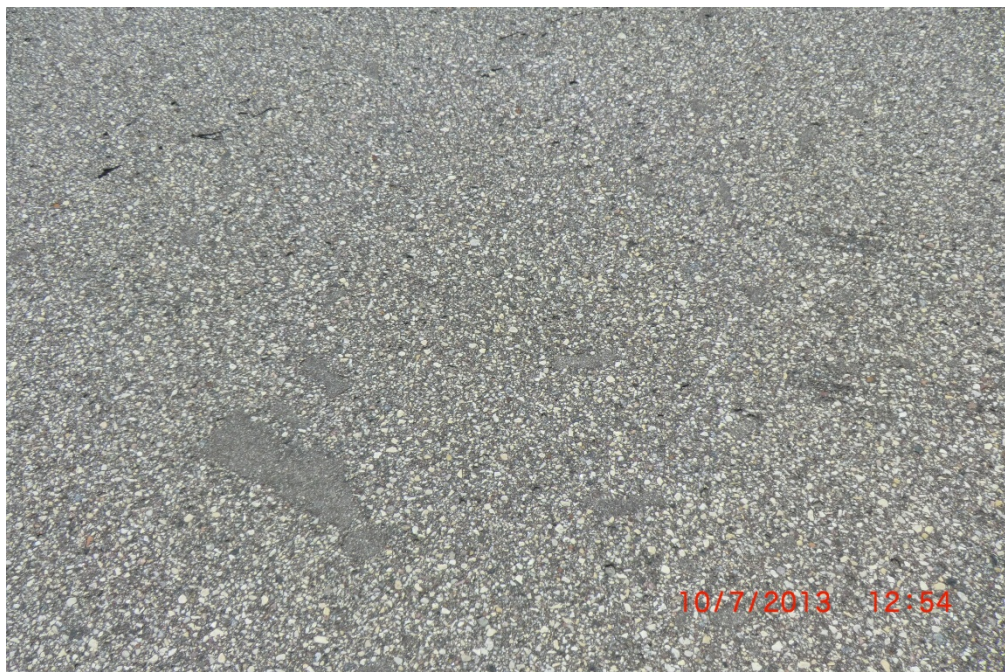
DXX RY1432 001 (Low-Severity Raveling and Weathering)

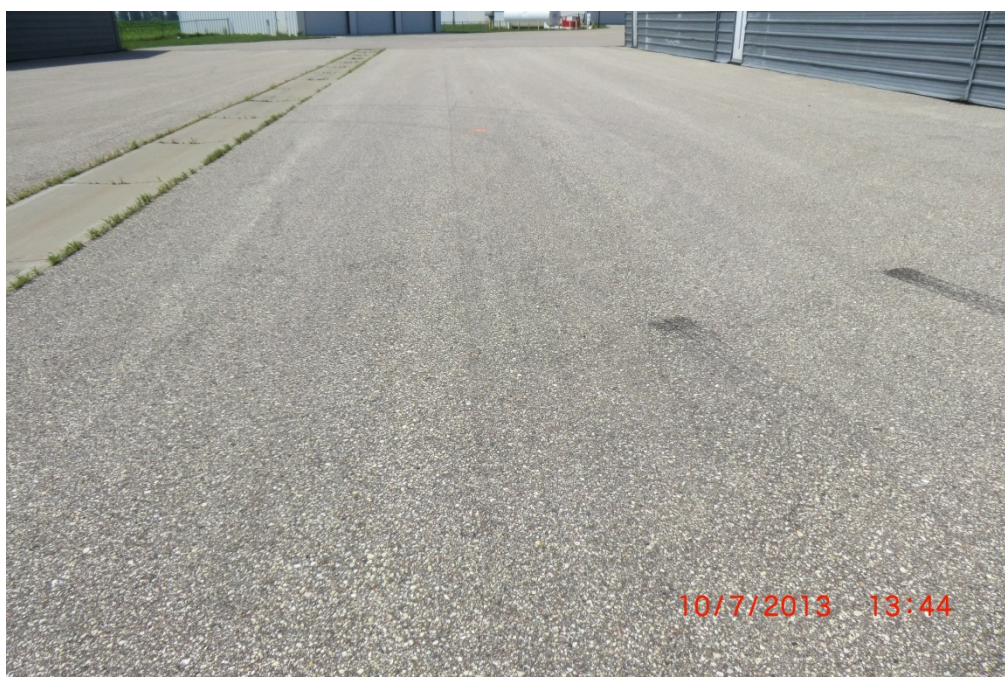
DXX TLA 001 (PCI = 72)

Conditions: PCI: 72

48	LONGITUDINAL/TRANSVERSE CRACKING	L	33.00 Ft	Comments:
52	RAVELING	L	1,875.00 SqFt	Comments:
57	WEATHERING	L	3,750.00 SqFt	Comments:

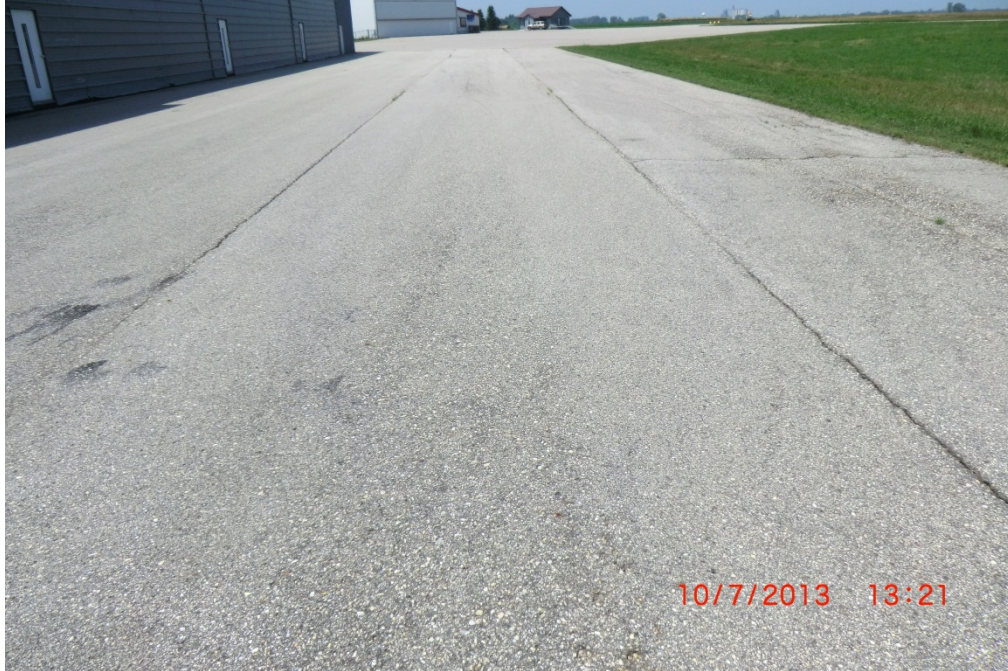
DXX TLA 002 (PCI = 19)

Section Comments: seperate section due to condition

Conditions: PCI: 19

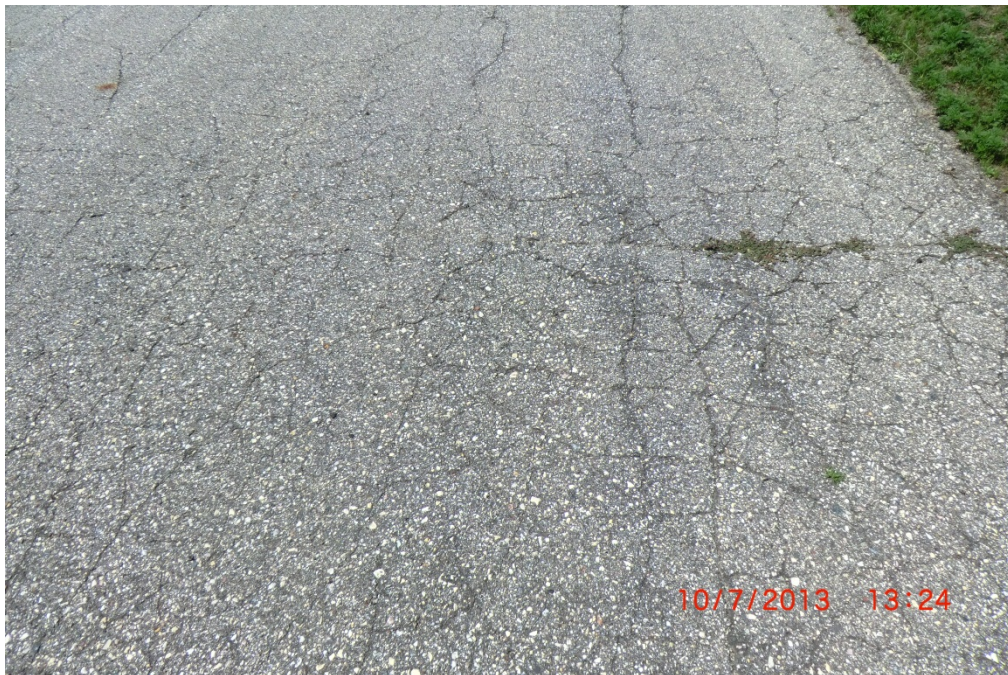
DXX TLA 002 (Medium-Severity Alligator Cracking)

41 ALLIGATOR CRACKING	M	811.00 SqFt	Comments:
41 ALLIGATOR CRACKING	L	80.00 SqFt	Comments:
48 LONGITUDINAL/TRANSVERSE CRACKING	L	120.00 Ft	Comments:
48 LONGITUDINAL/TRANSVERSE CRACKING	M	6.00 Ft	Comments:
52 RAVELING	L	2,400.00 SqFt	Comments:
57 WEATHERING	L	4,800.00 SqFt	Comments:
53 RUTTING	L	5.00 SqFt	Comments:
