Minnesota Airport System Pavement Evaluation 2013 Update

Granite Falls Municipal Airport (GDB)

Granite Falls, Minnesota

Final Report

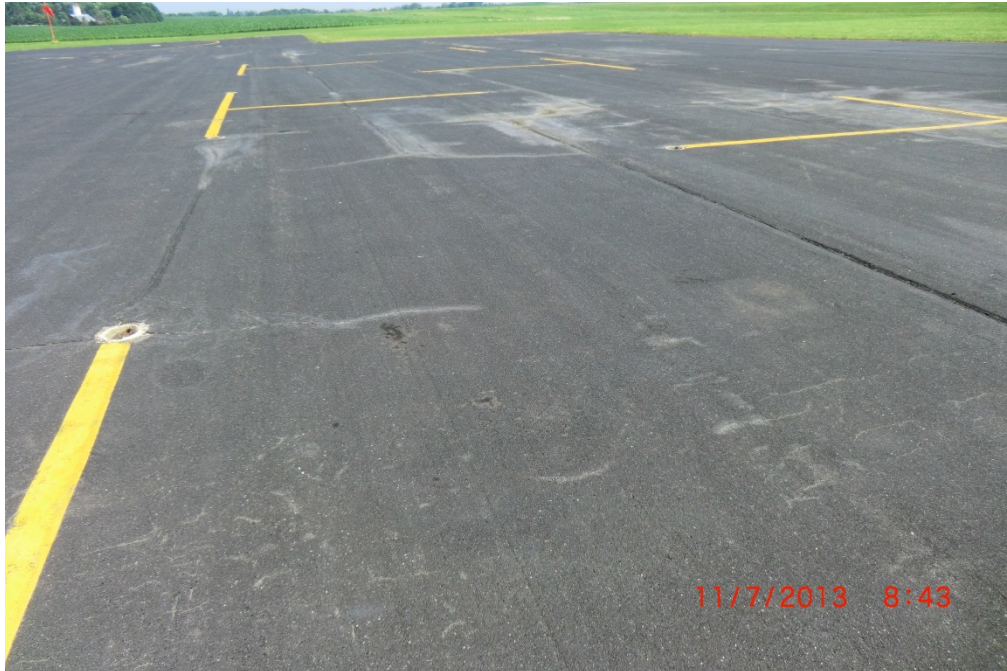
GDB APA 001 (PCI = 62)

Conditions: PCI : 62

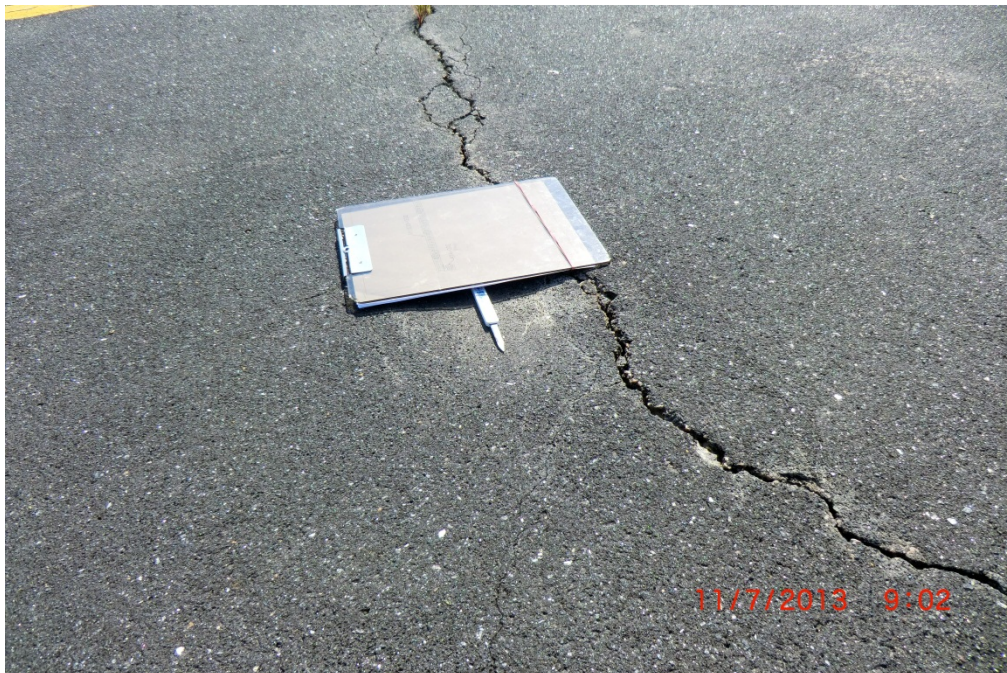
GDB APA 001 (Low-Severity Rutting)

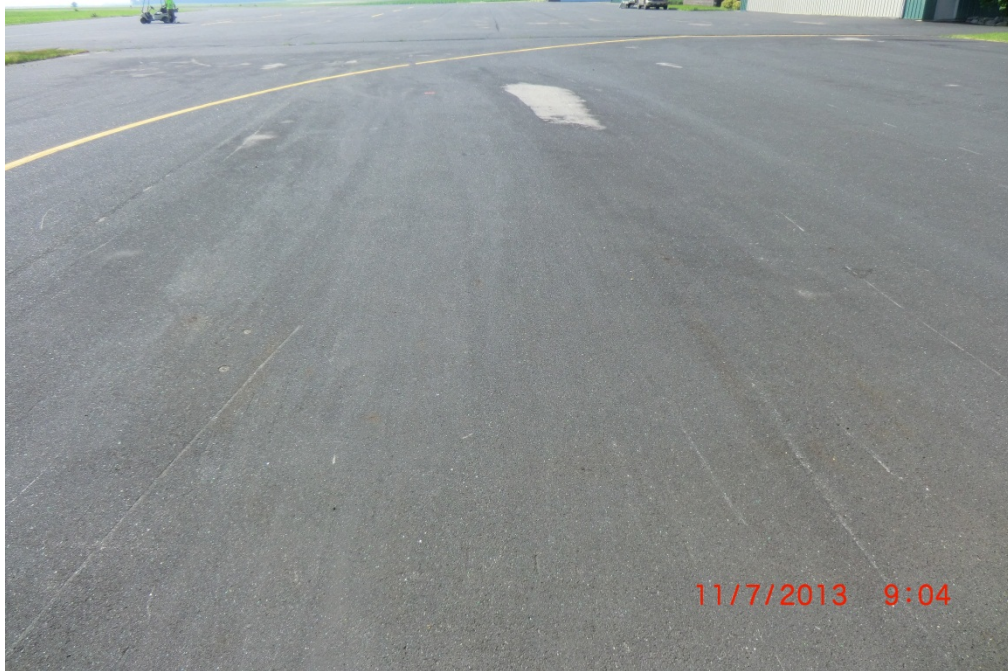
GDB APA 002 (PCI = 98)

Conditions: PCI: 98

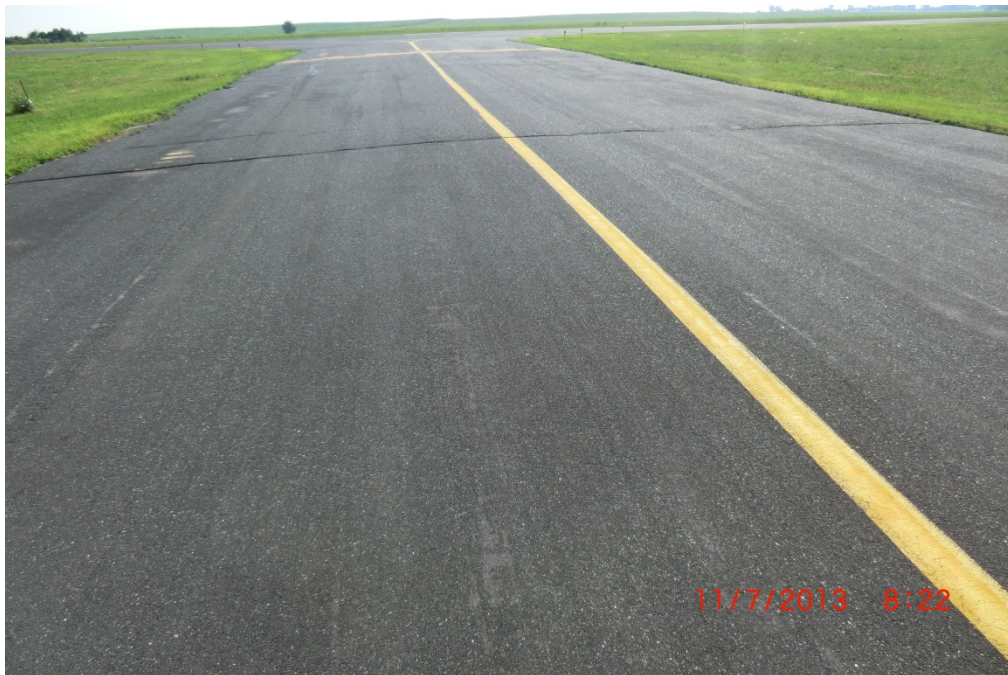
GDB CTA 001 (PCI = 75)

Conditions: PCI: 75

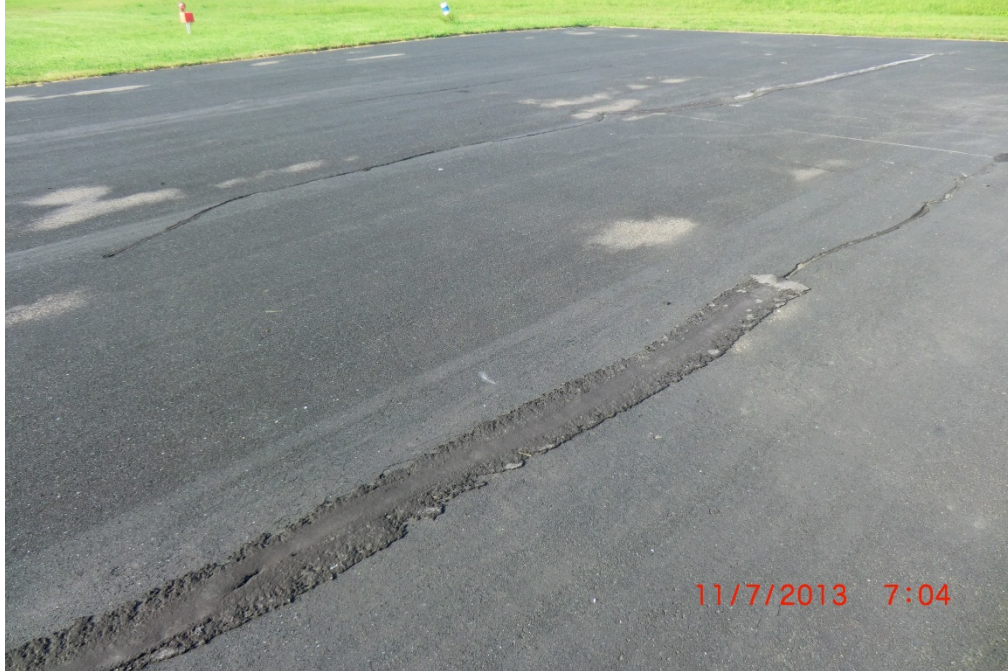
GDB RTA 001 (PCI = 37)

Conditions: PCI : 37

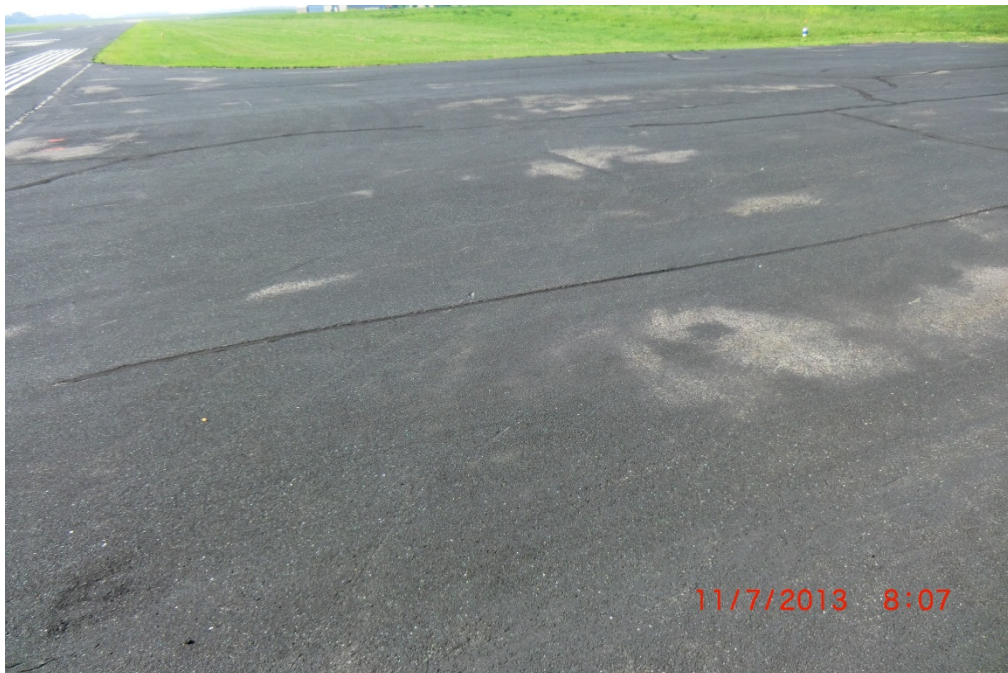
GDB RTA 002 (PCI = 59)

Conditions: PCI: 59

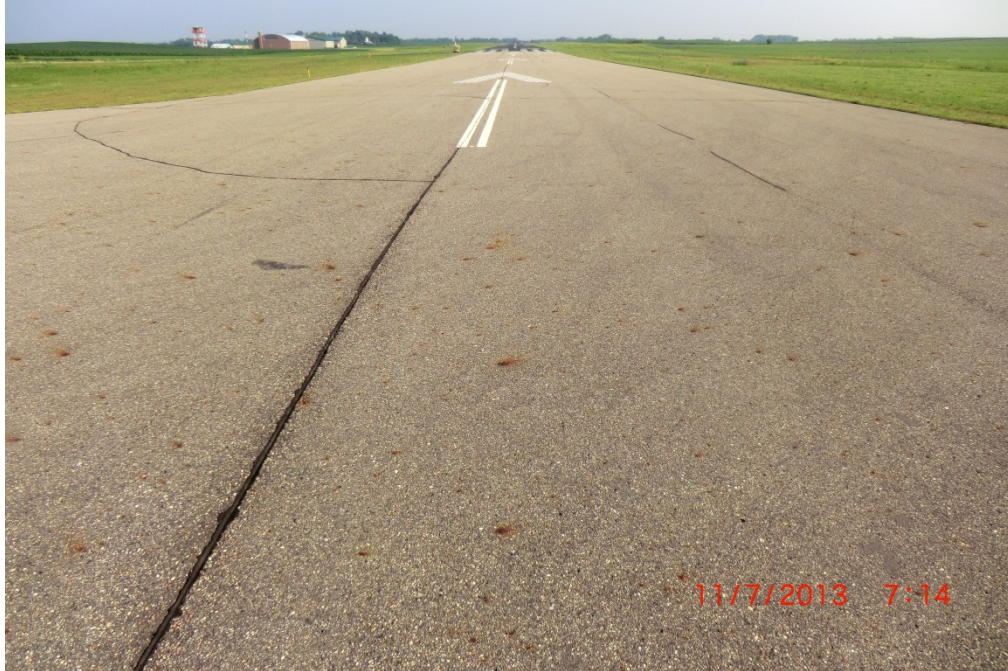
GDB RY1533 001 (PCI = 70)

Conditions: PCI : 70

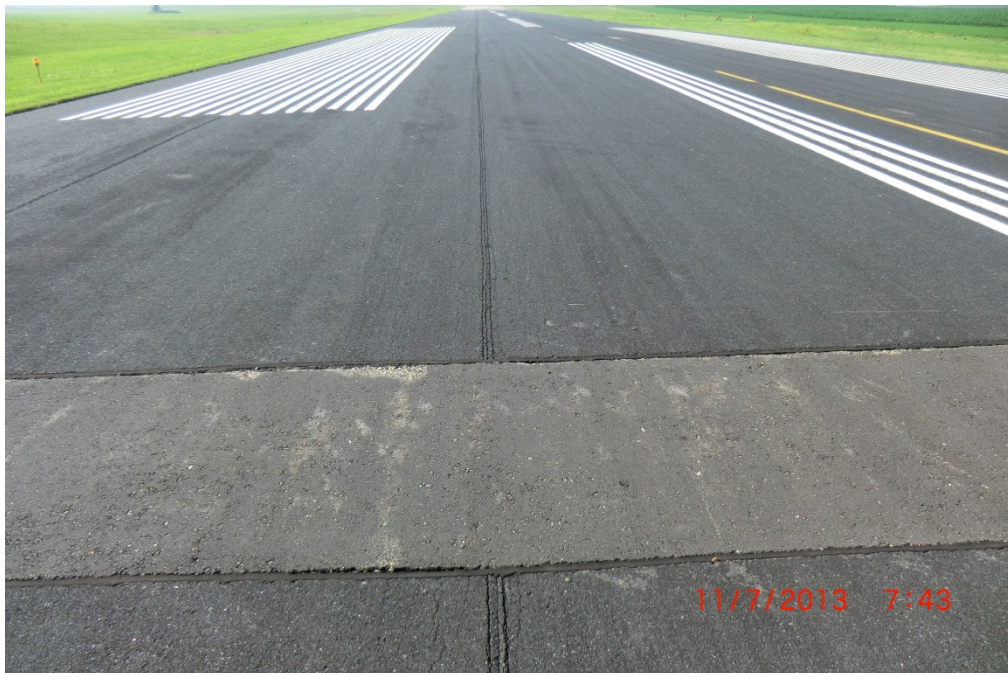
GDB RY1533 002 (PCI = 74)

Conditions: PCI: 74

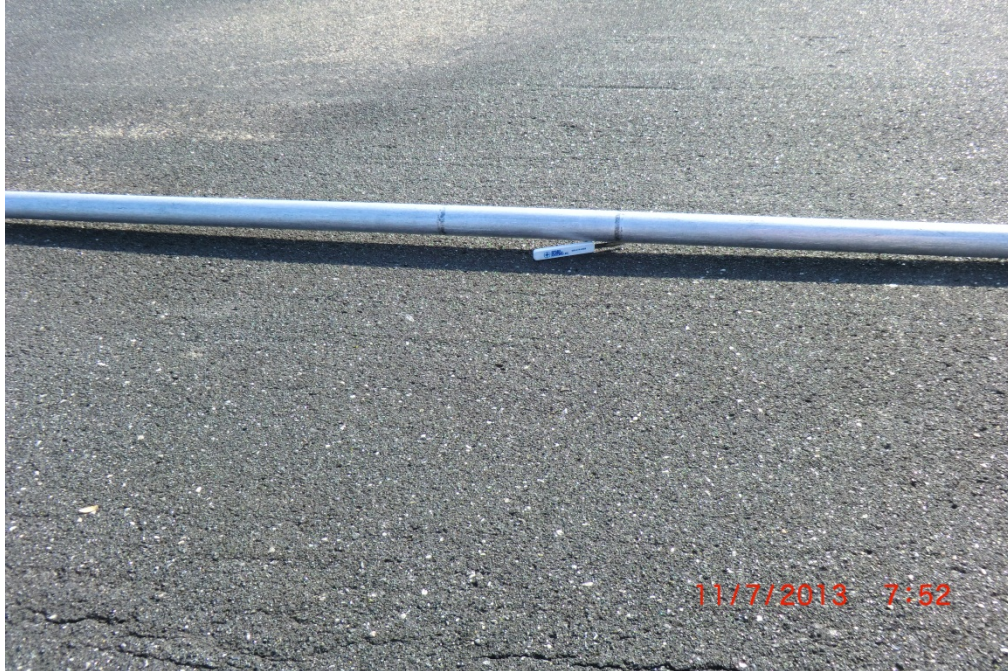
GDB RY1533 002 (Low-Severity Depression)

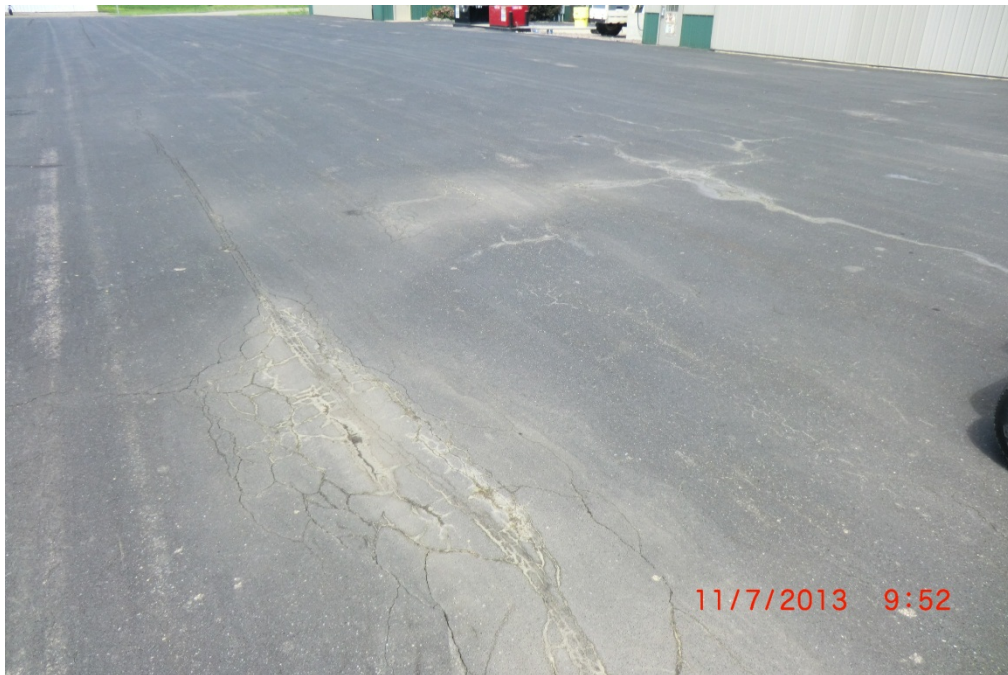
GDB TLA 001 (PCI = 44)

Conditions: PCI: 44

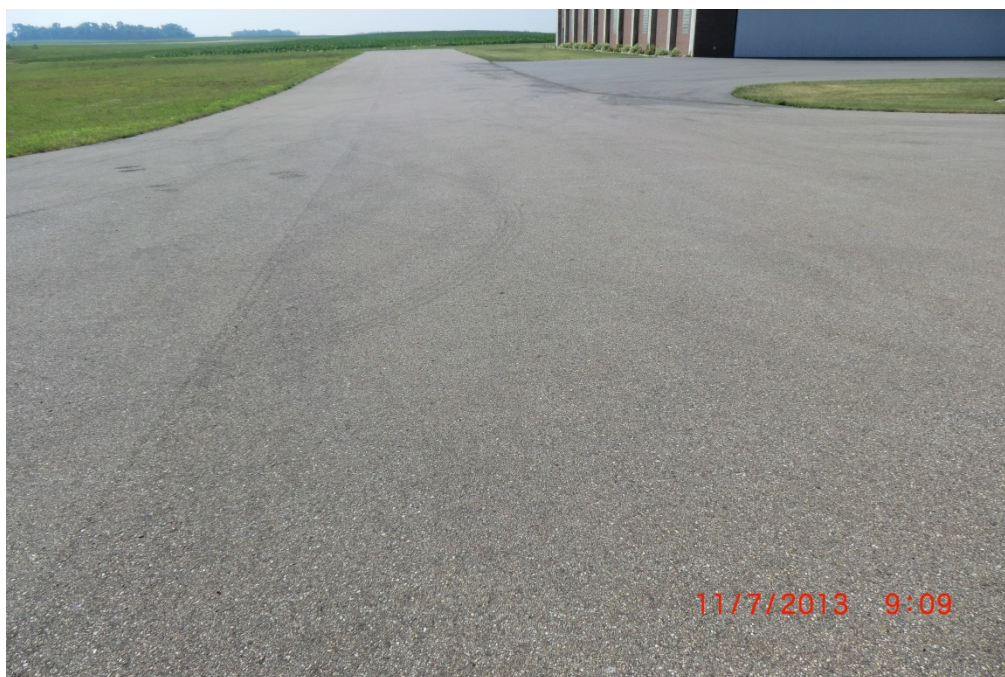
GDB TLA 002 (PCI = 93)

Conditions: PCI : 93
