Minnesota Airport System Pavement Evaluation 2013 Update

Grand Rapids – Itasca County Airport
(GPZ)

Grand Rapids, Minnesota

Final Report

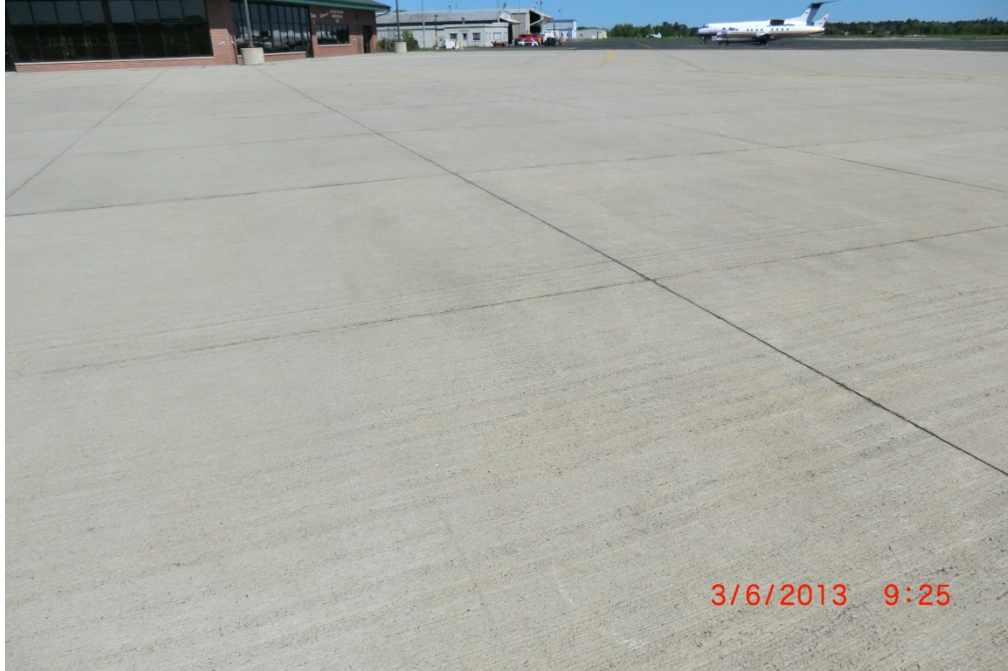
GPZ APA 001 (PCI = 98)

75 CORNER SPALL M 1.00 Slabs Comments:

75 CORNER SPALL L 1.00 Slabs Comments:

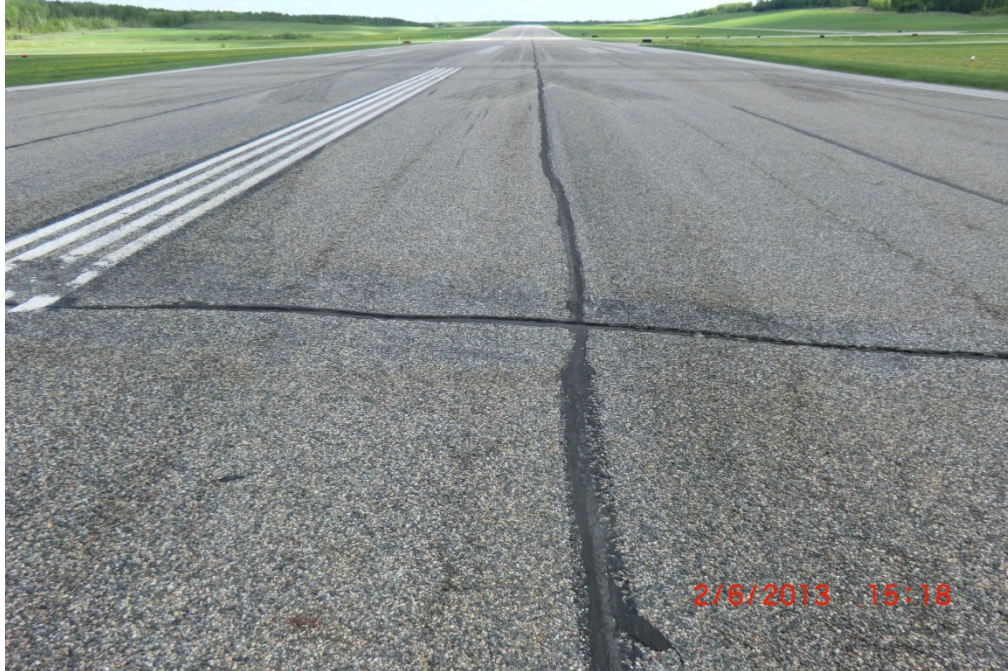
GPZ RY1634 001 (PCI = 65)

Sample Number: 125 Type: R Area: 5,000.00SqFt PCI = 64
Sample Comments:
48 LONGITUDINAL/TRANSVERSE CRACKING L 630.00 Ft Comments:
52 RAVELING M 172.00 SqFt Comments:
52 RAVELING L 550.00 SqFt Comments:

Sample Number: 135 Type: R Area: 5,000.00SqFt PCI = 51
Sample Comments:
48 LONGITUDINAL/TRANSVERSE CRACKING L 829.00 Ft Comments:
48 LONGITUDINAL/TRANSVERSE CRACKING M 13.00 Ft Comments:
52 RAVELING L 850.00 SqFt Comments:
52 RAVELING H 2.00 SqFt Comments:
45 DEPRESSION L 26.00 SqFt Comments:

Sample Number: 145 Type: R Area: 5,000.00SqFt PCI = 68
Sample Comments:
48 LONGITUDINAL/TRANSVERSE CRACKING L 645.00 Ft Comments:
42 BLEEDING N 8.00 SqFt Comments:
52 RAVELING L 171.00 SqFt Comments:

Sample Number: 155 Type: R Area: 5,000.00SqFt PCI = 71
Sample Comments:
48 LONGITUDINAL/TRANSVERSE CRACKING L 540.00 Ft Comments:
52 RAVELING L 250.00 SqFt Comments:

Sample Number: 165 Type: R Area: 5,000.00SqFt PCI = 70
Sample Comments:
48 LONGITUDINAL/TRANSVERSE CRACKING L 553.00 Ft Comments:
52 RAVELING L 320.00 SqFt Comments:

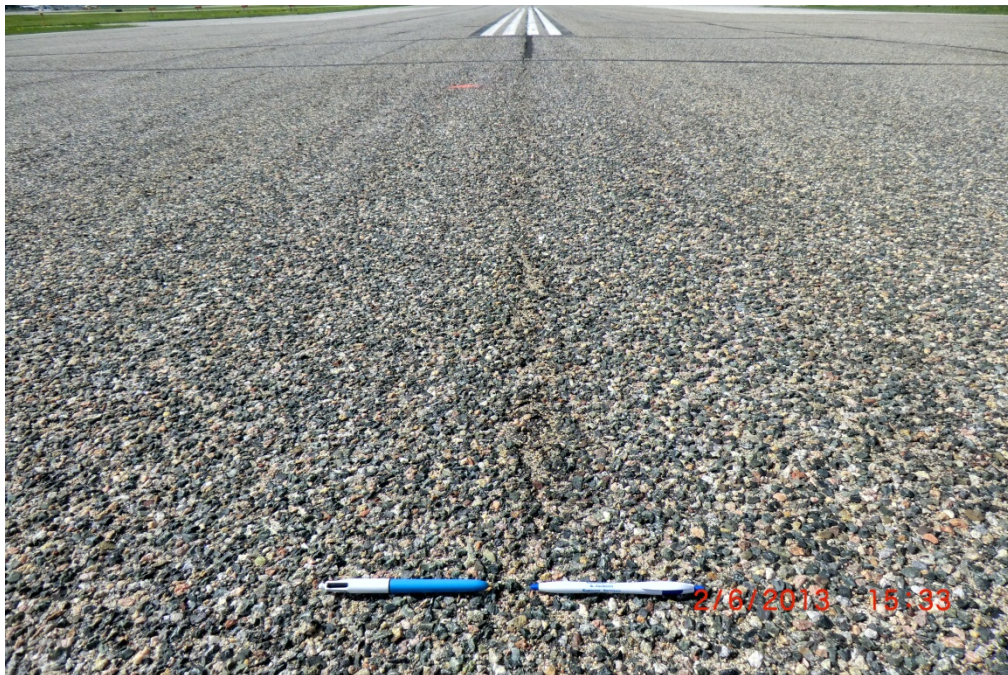
GPZ RY1634 001 (Low-Severity L&T Crack)

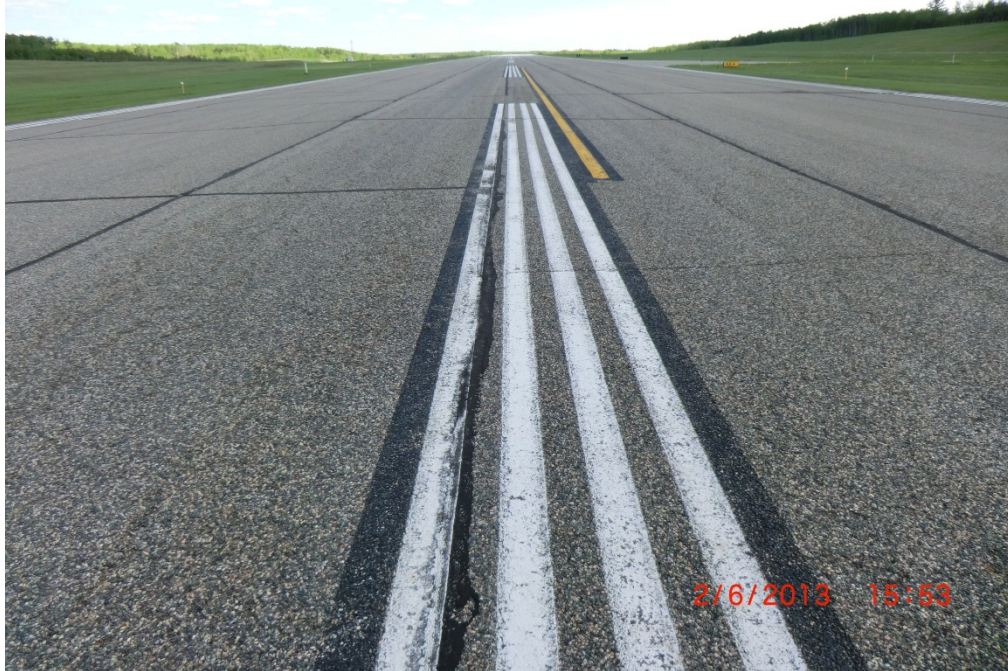
GPZ RY1634 002 (PCI = 66)

48 LONGITUDINAL/TRANSVERSE CRACKING L 530.00 Ft Comments:
52 RAVELING L 550.00 SqFt Comments:

48 LONGITUDINAL/TRANSVERSE CRACKING L 522.00 Ft Comments:
45 DEPRESSION L 60.00 SqFt Comments:
48 LONGITUDINAL/TRANSVERSE CRACKING M 30.00 Ft Comments:
52 RAVELING L 600.00 SqFt Comments:

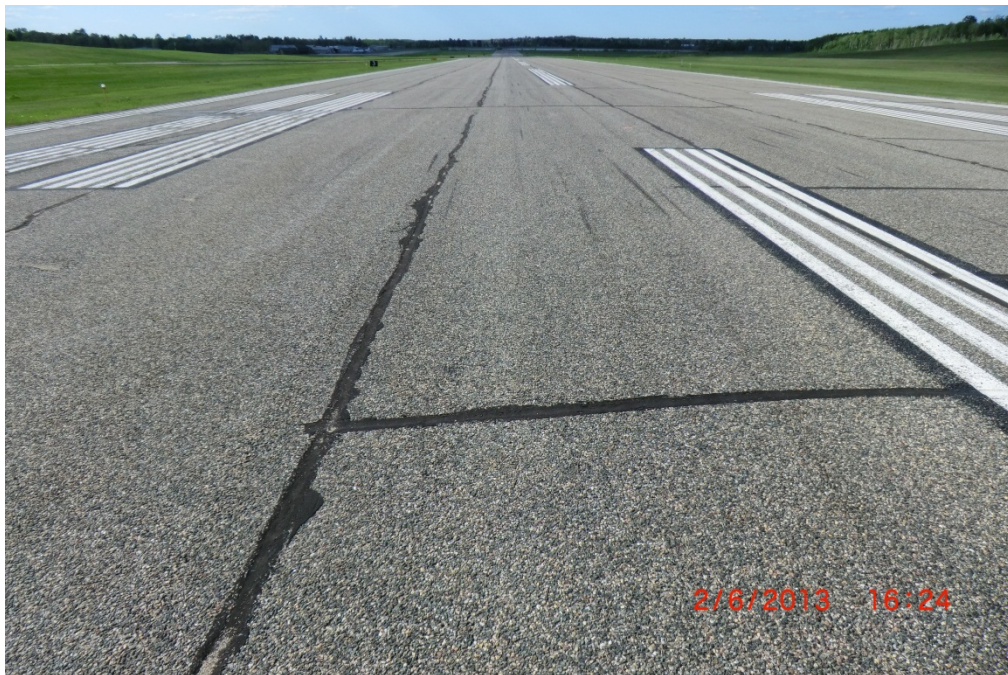
GPZ RY1634 003 (PCI = 56)

48	LONGITUDINAL/TRANSVERSE CRACKING	L	513.00	Ft	Comments:
52	RAVELING	M	50.00	SqFt	Comments:
52	RAVELING	L	750.00	SqFt	Comments:

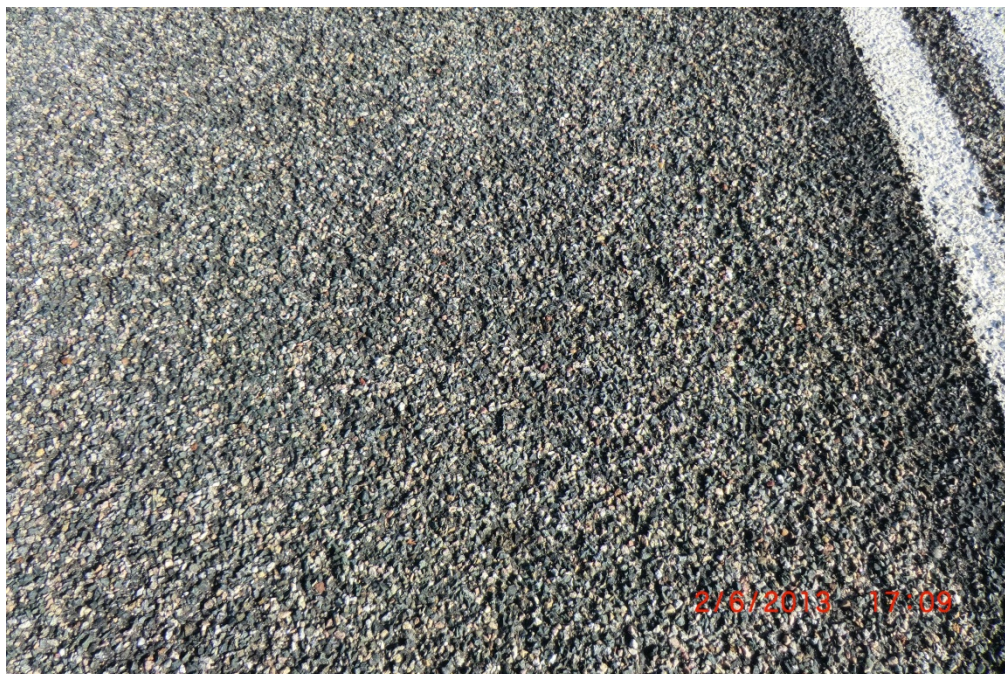
GPZ RY1634 003 (Medium-Severity Raveling)

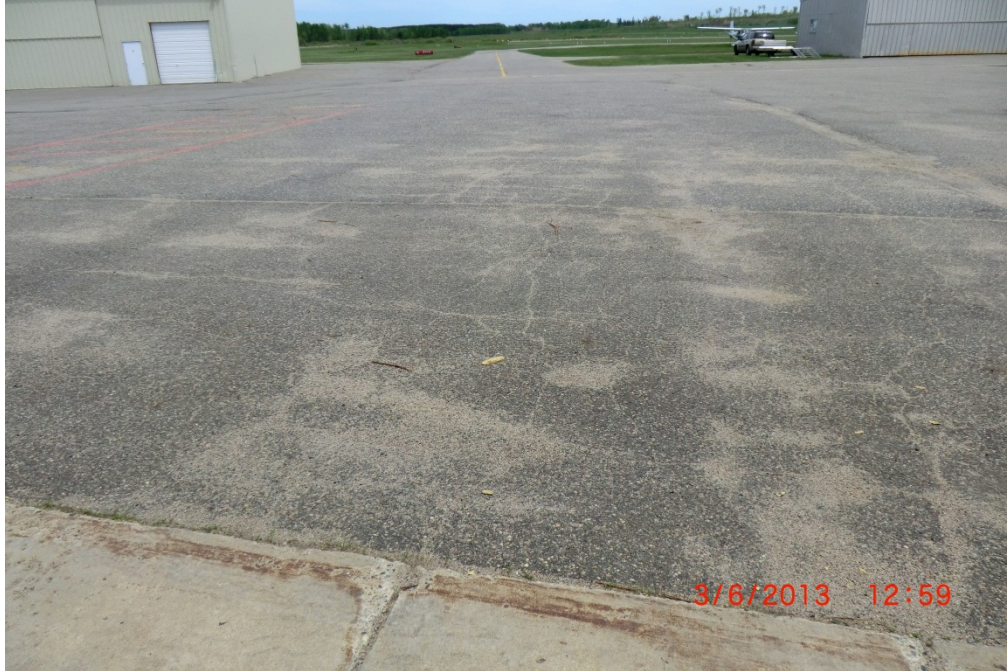
GPZ TLD 001 (Prior to Reconstruction)
