Minnesota Airport System Pavement Evaluation 2013 Update

Glencoe Municipal Airport (GYL)

Glencoe, Minnesota

Final Report

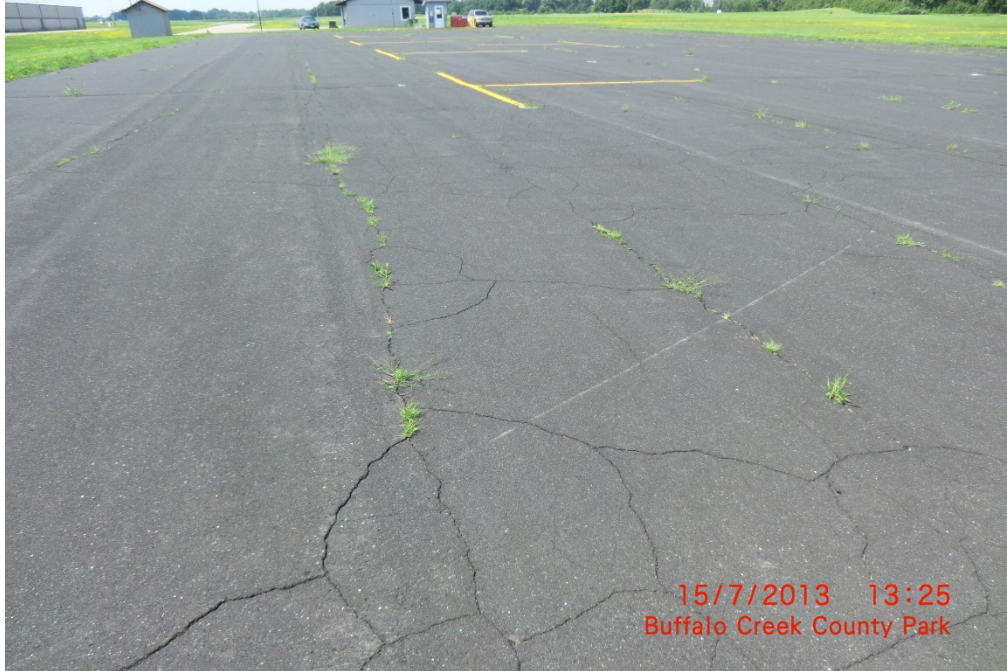
GYL APA 001 (PCI = 15)

Note: The dramatic drop in PCI for the sections at this airport is due to the rapid appearance of alligator cracking that is prevalent throughout the paved surfaces indicating that the snow plow equipment has been the main contributor in causing this distress. A slurry seal applied in 2009 may have “masked” the underlying condition during the 2010 inspection.

Section Comments: 2009 slurry seal masked true condition of pvmt.

Conditions: PCI: 15

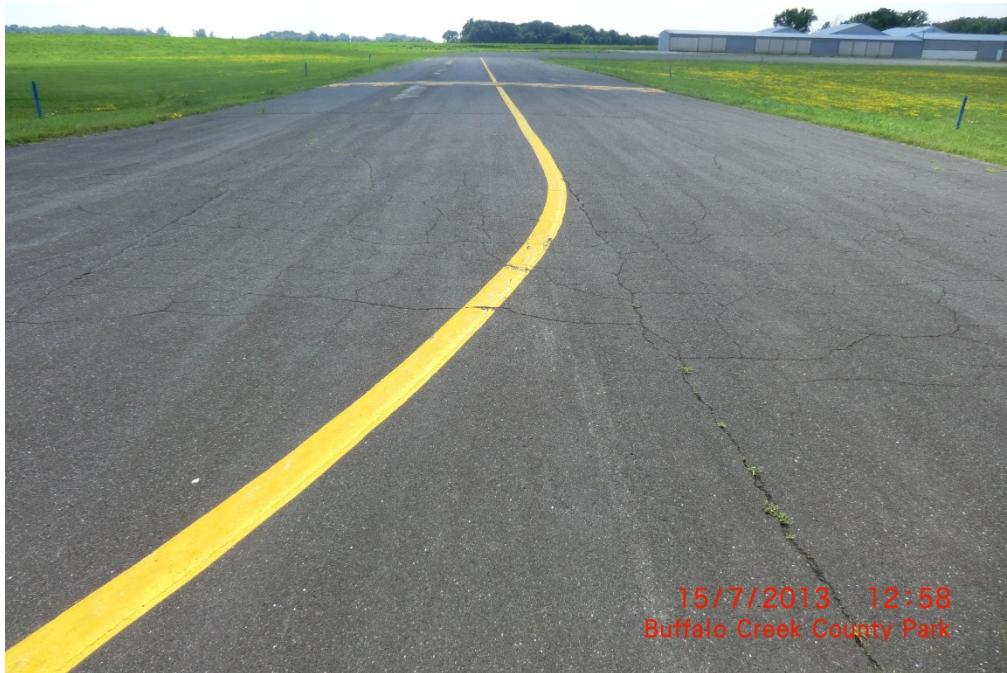
GYL CTA 001 (PCI = 21)

Section Comments: 2009 slurry seal masked true condition of pvmt.

Conditions: PCI: 21

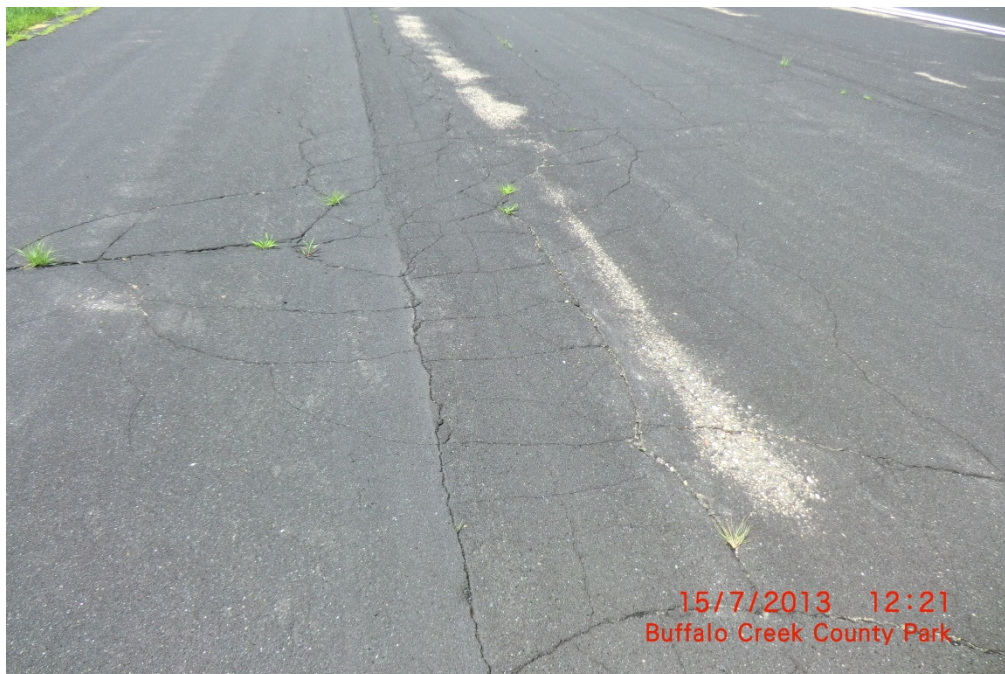
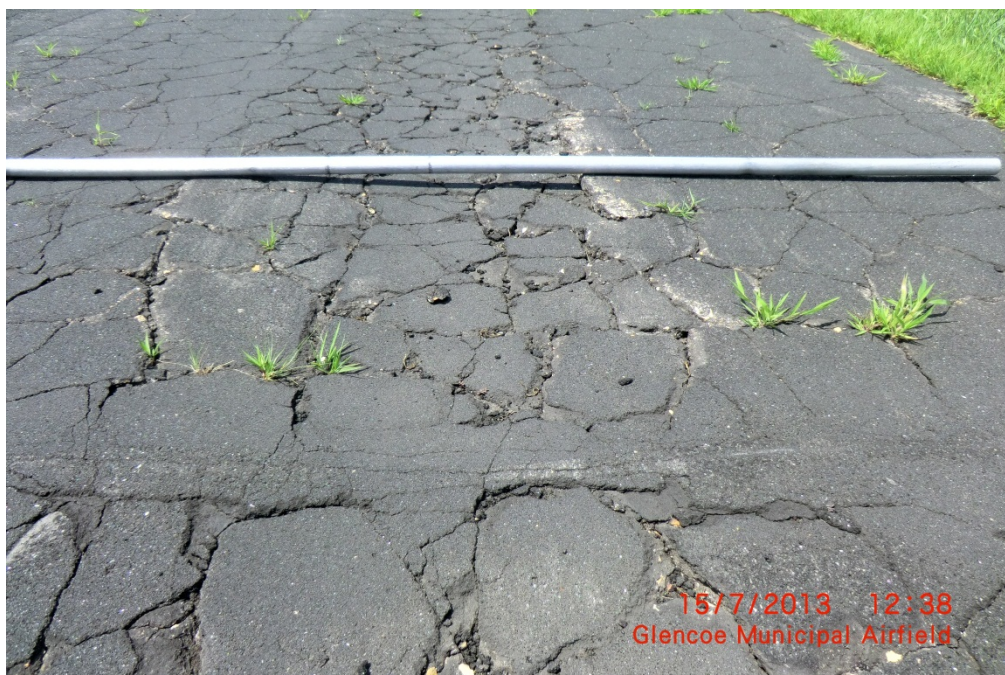
GYL RY1331 001 (PCI = 21)

Section Comments: 2009 slurry seal masked true condition of pvmt.

Conditions: PCI: 21

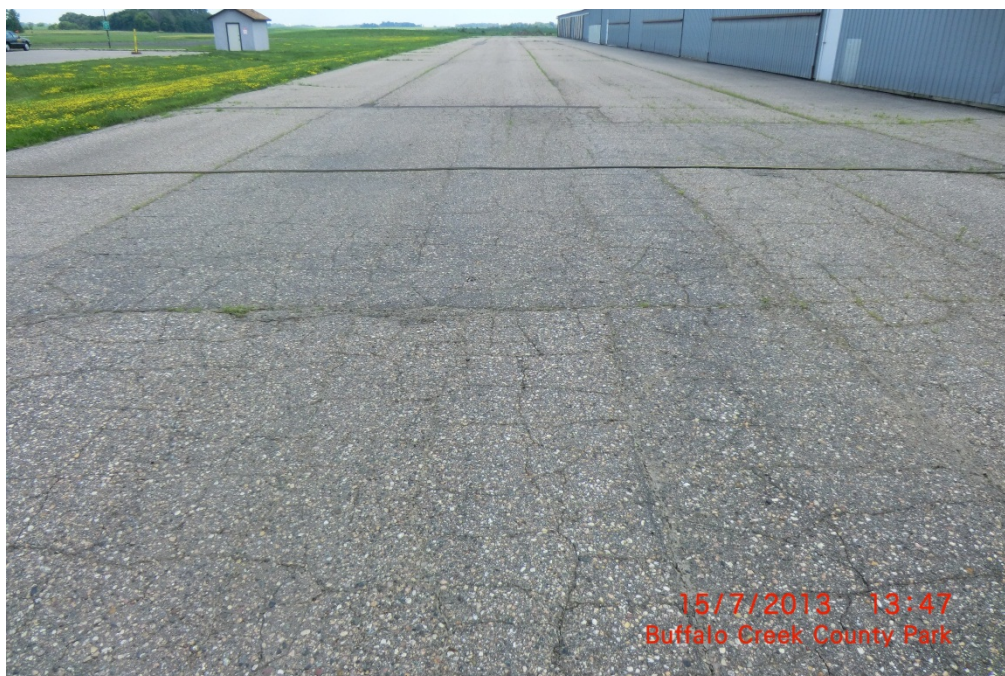
GYL TLA 001_2237 (PCI = 10)

Conditions: PCI : 10

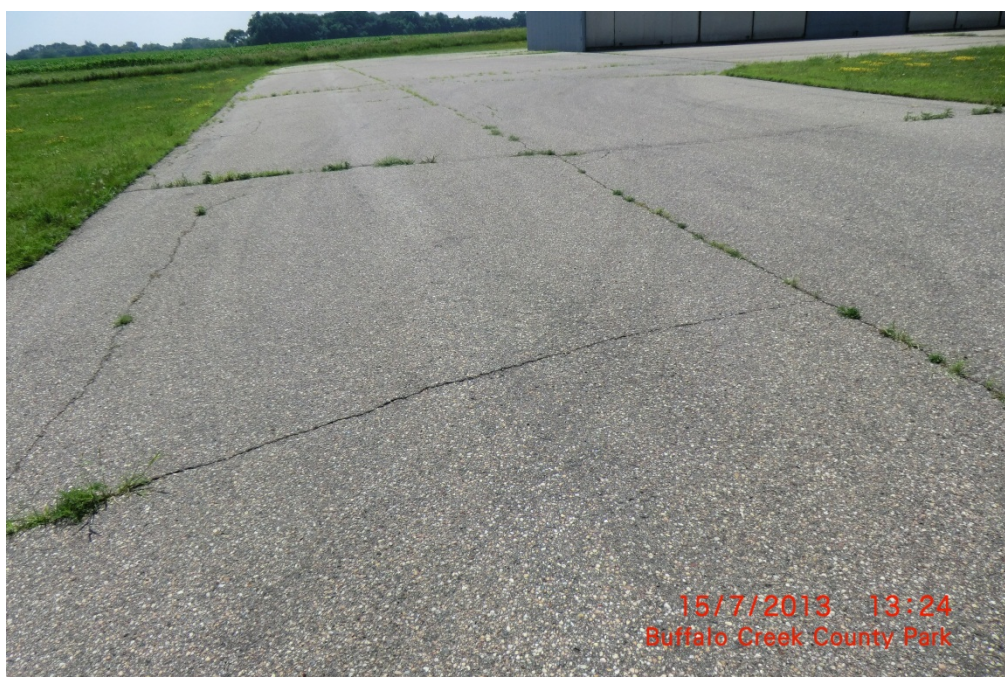
GYL TLA 002_2234 (PCI = 33)

Conditions: PCI : 33
