Minnesota Airport System Pavement Evaluation 2013 Update

Hutchinson Municipal Airport (HCD)

Final Report

Applied Research Associates, Inc.
100 Trade Centre Dr., Suite 200
Champaign, IL 61820
(217) 356-4500

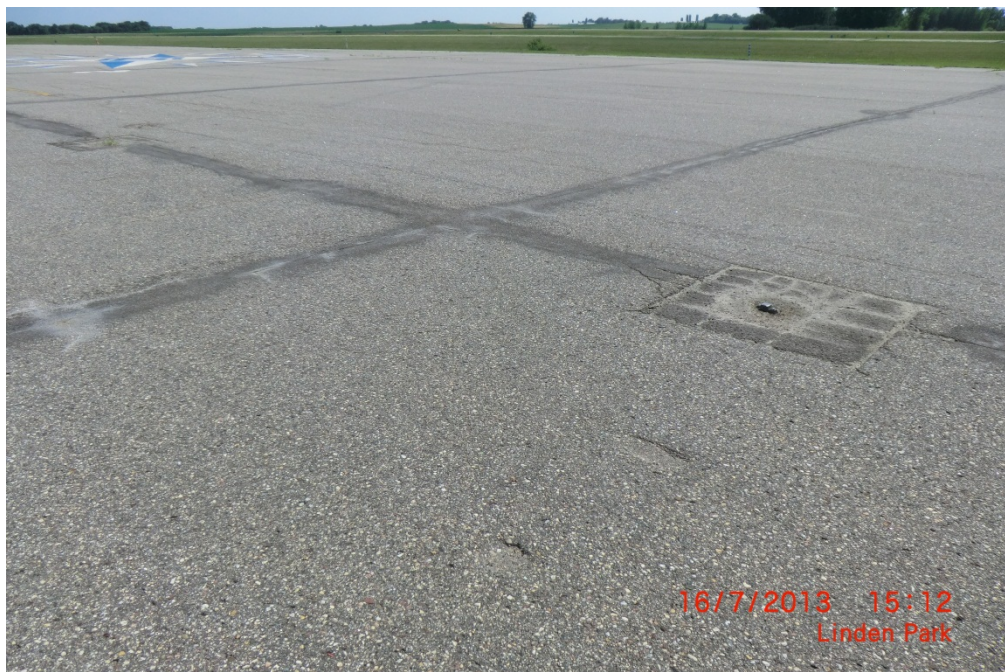
HCD APB 001 (PCI = 70)

Conditions: PCI : 70

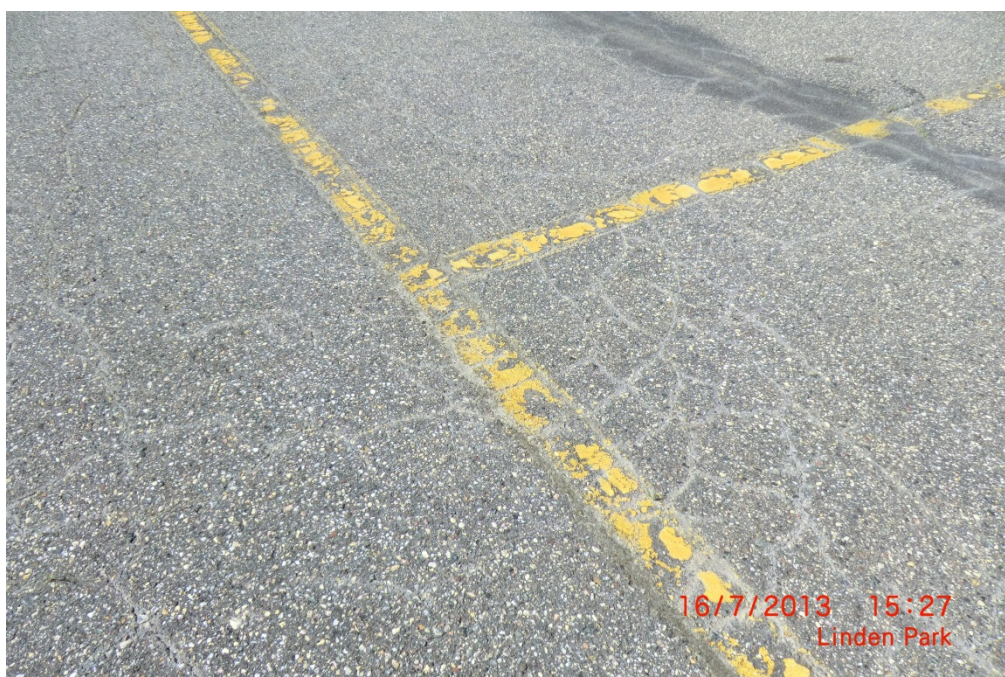
HCD APB 001 (Medium-Severity Alligator Cracking)

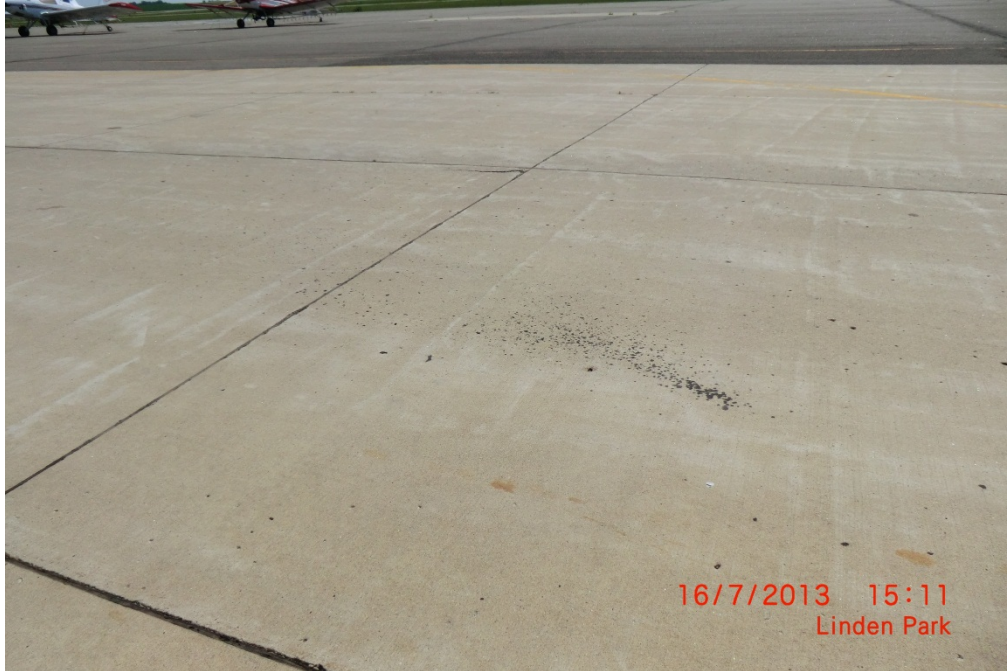
HCD APB 002 (PCI = 87)

Conditions: PCI : 87

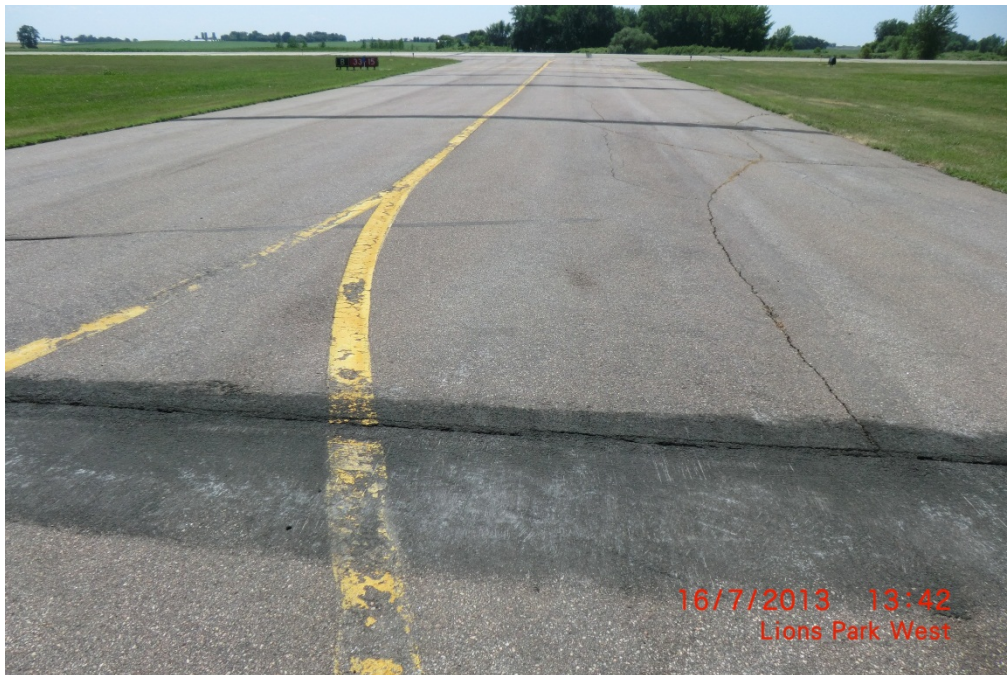
HCD CTB 001 (PCI = 65)

Conditions: PCI : 65

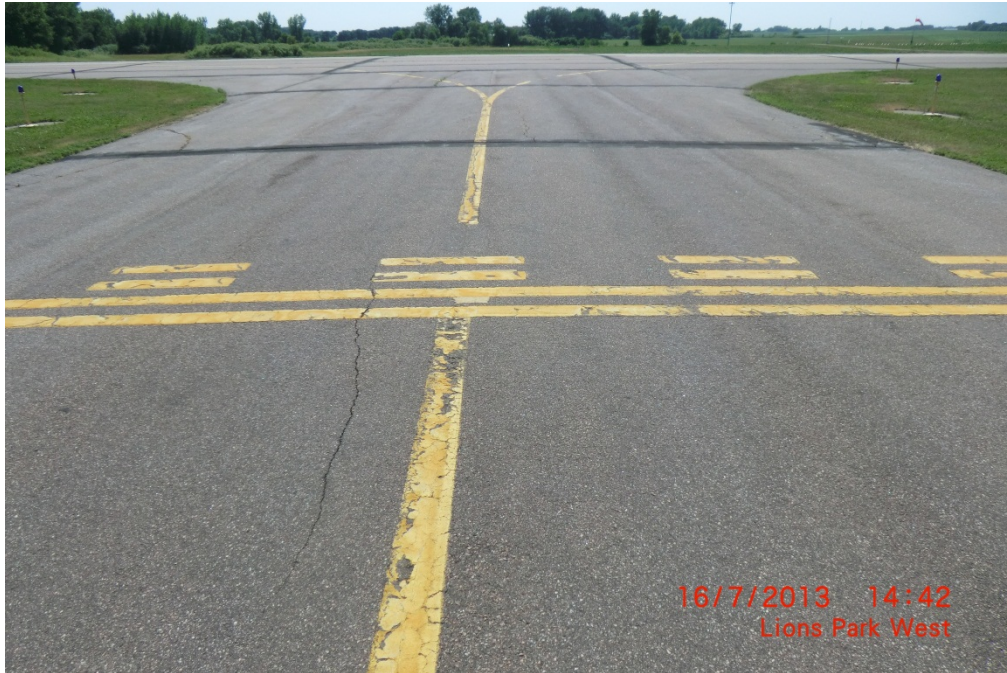
HCD CTC 001 (PCI = 60)

Conditions: PCI : 60

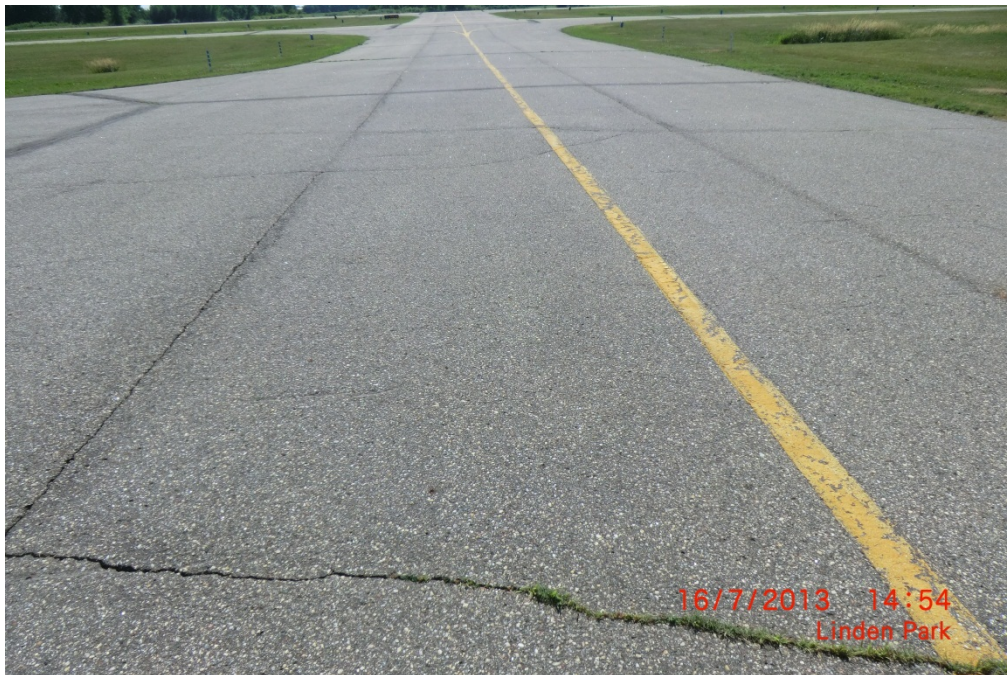
HCD CTCX 001 (PCI = 64)

Conditions: PCI : 64

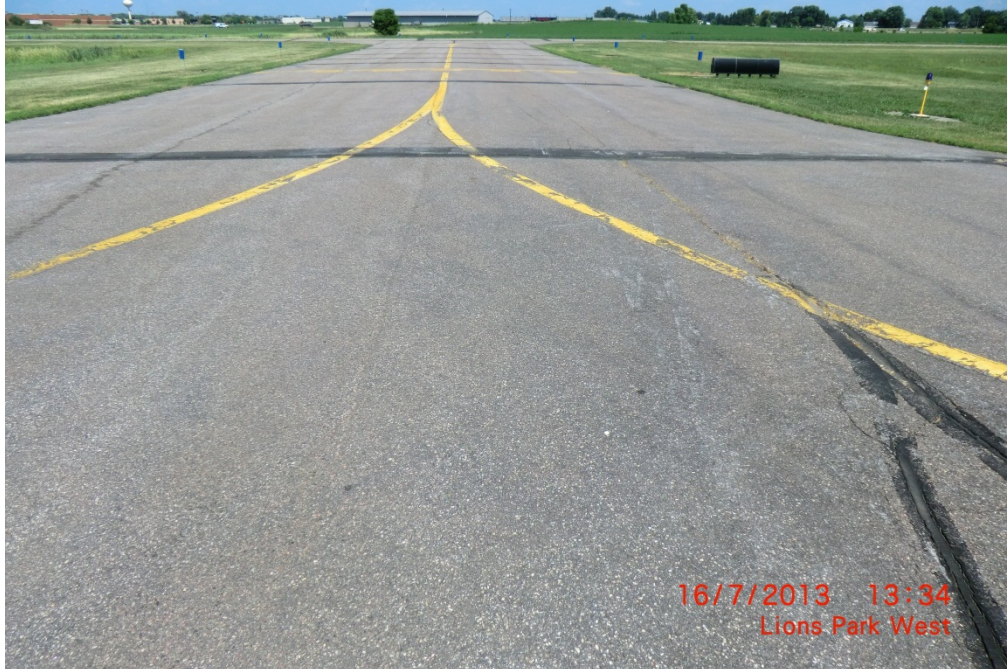
HCD CTD 001 (PCI = 79)

Conditions: PCI: 79

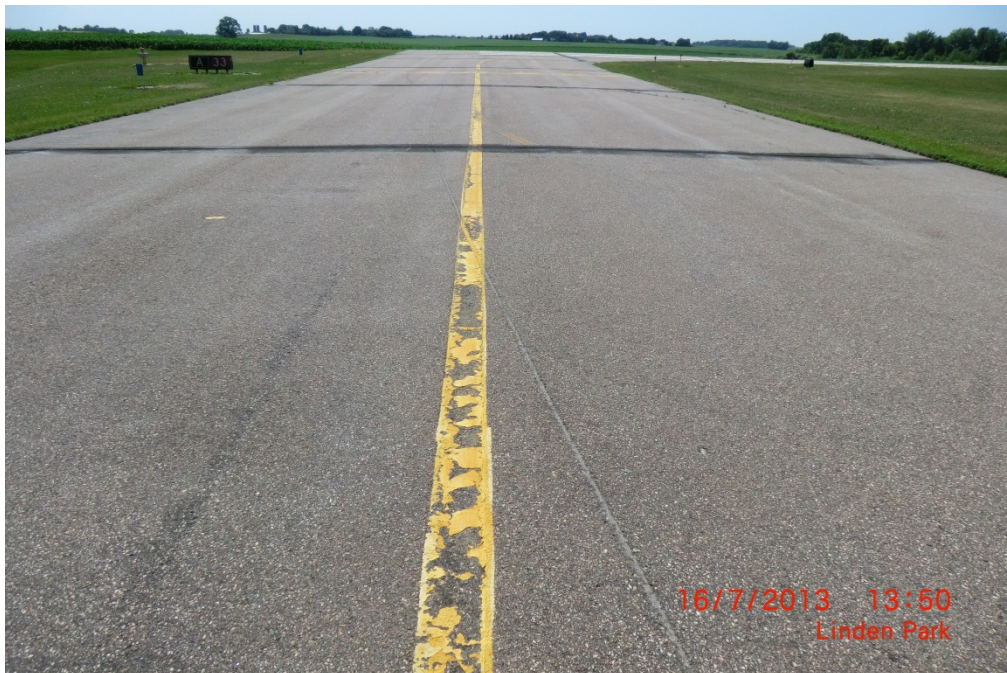
HCD PTA 001 (PCI = 73)

Conditions: PCI: 73

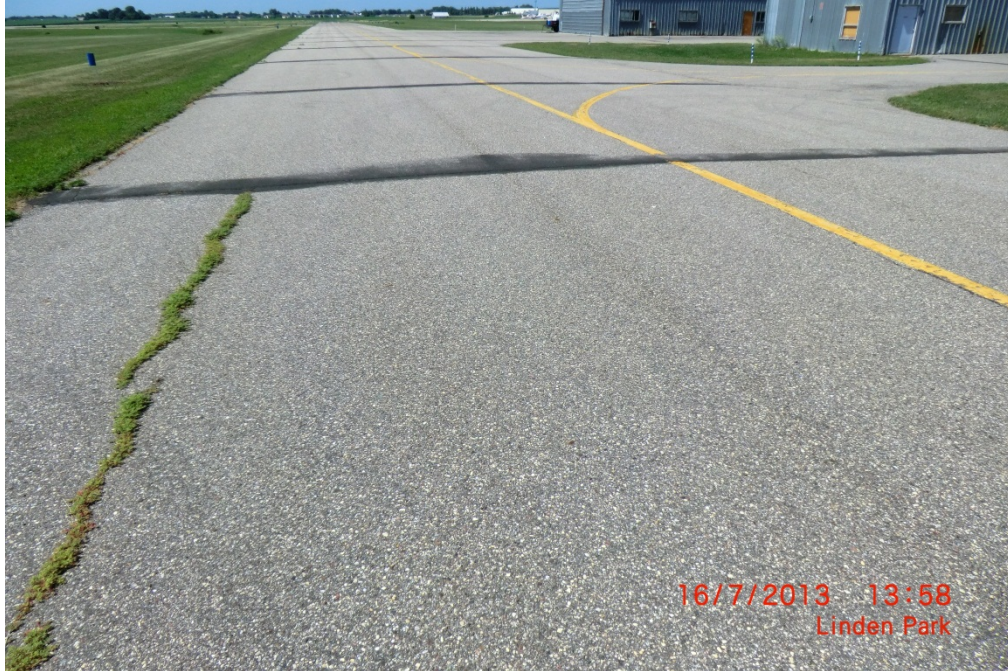
HCD PTA 002 (PCI = 71)

Conditions: PCI : 71

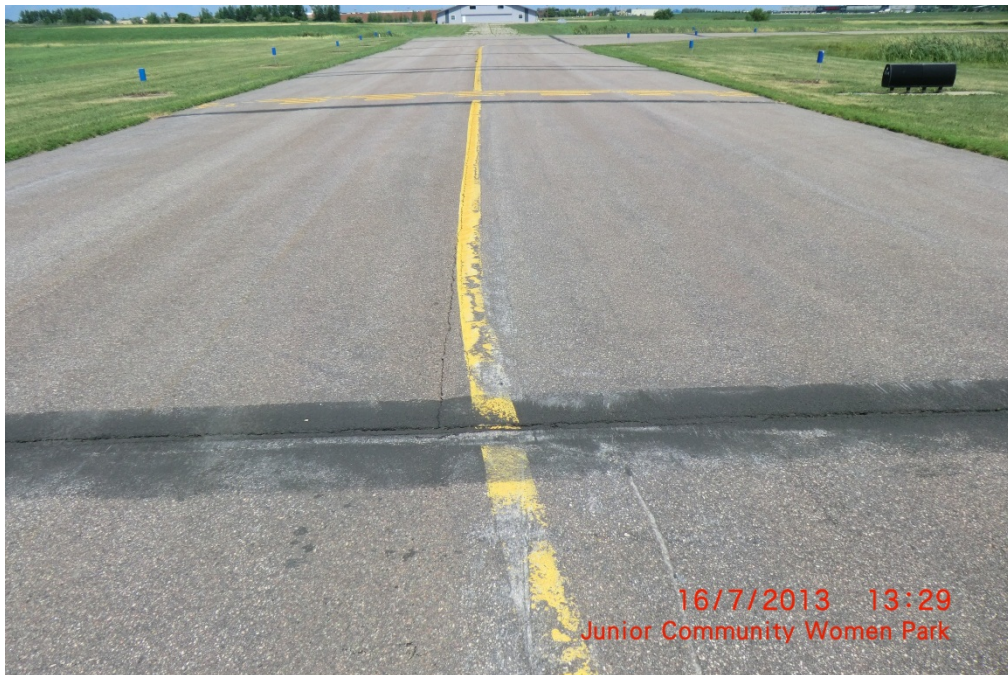
HCD PTA 003 (PCI = 68)

Conditions: PCI: 68

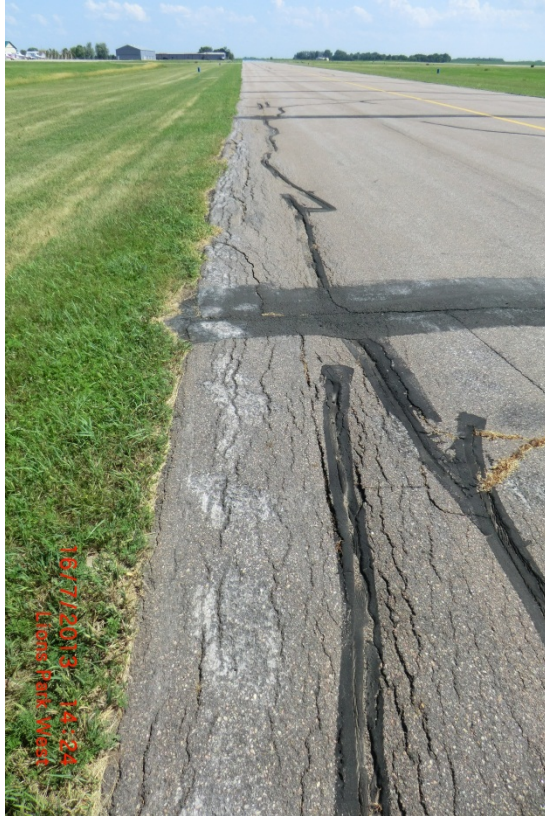
HCD PTA 003 (Alligator Cracking and Swelling)

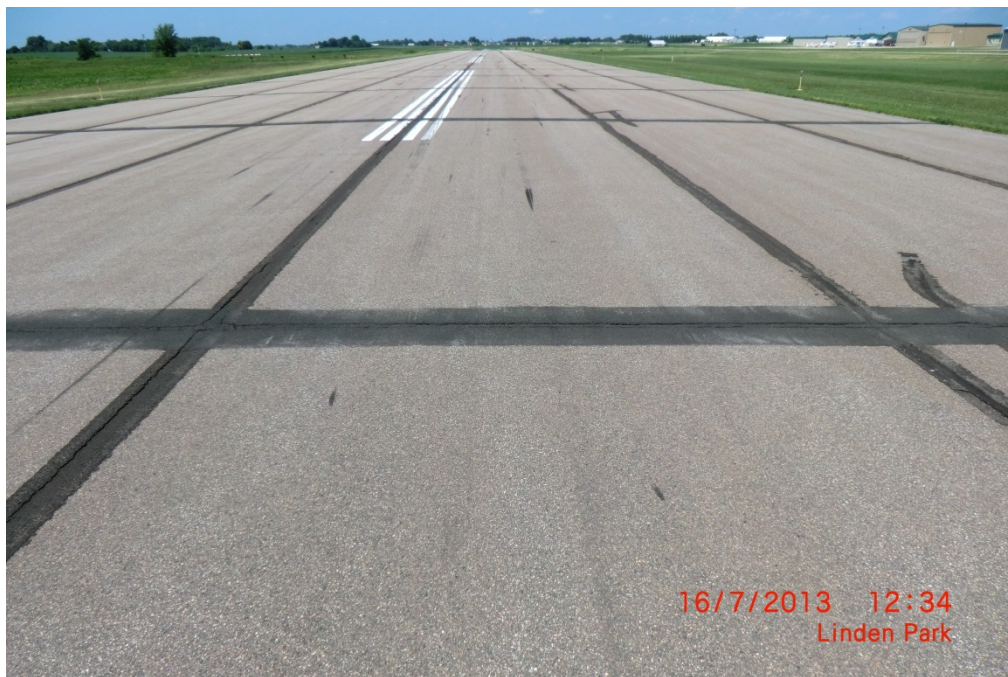
HCD RY1533 001 (PCI = 66)

Conditions: PCI: 66

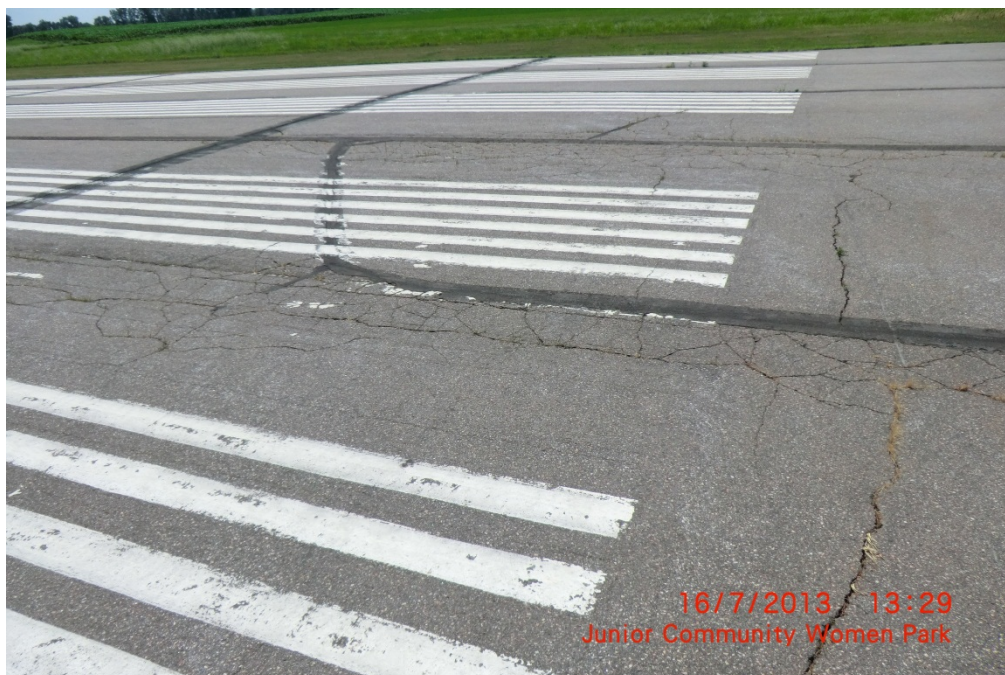
HCD RY1533 001 (Medium-Severity Alligator Cracking)

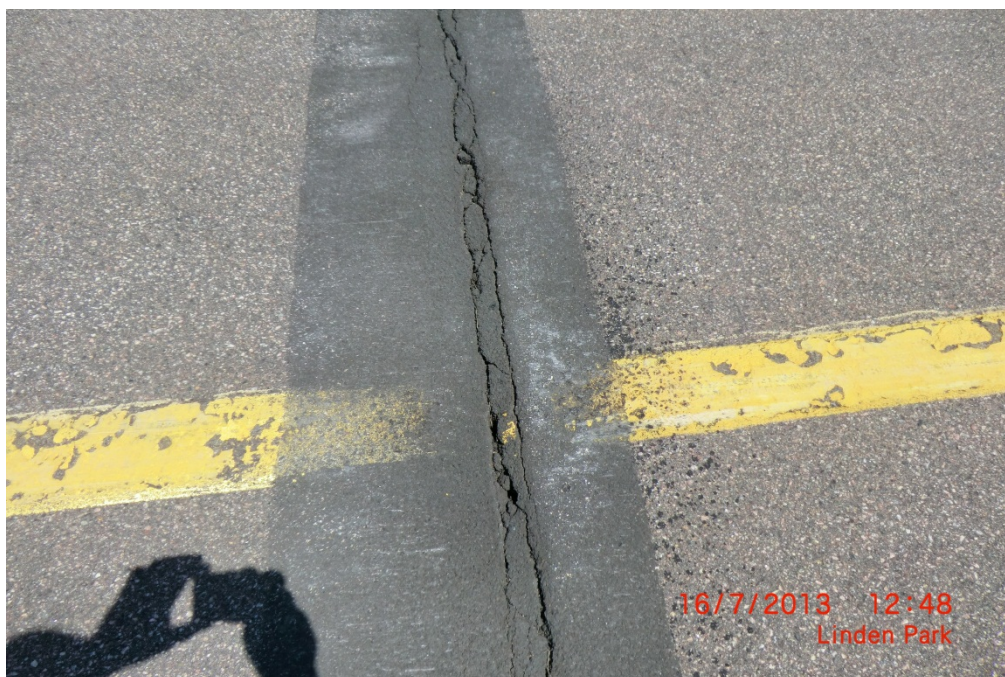
HCD RY1533 001 (L&T Crack Repair)

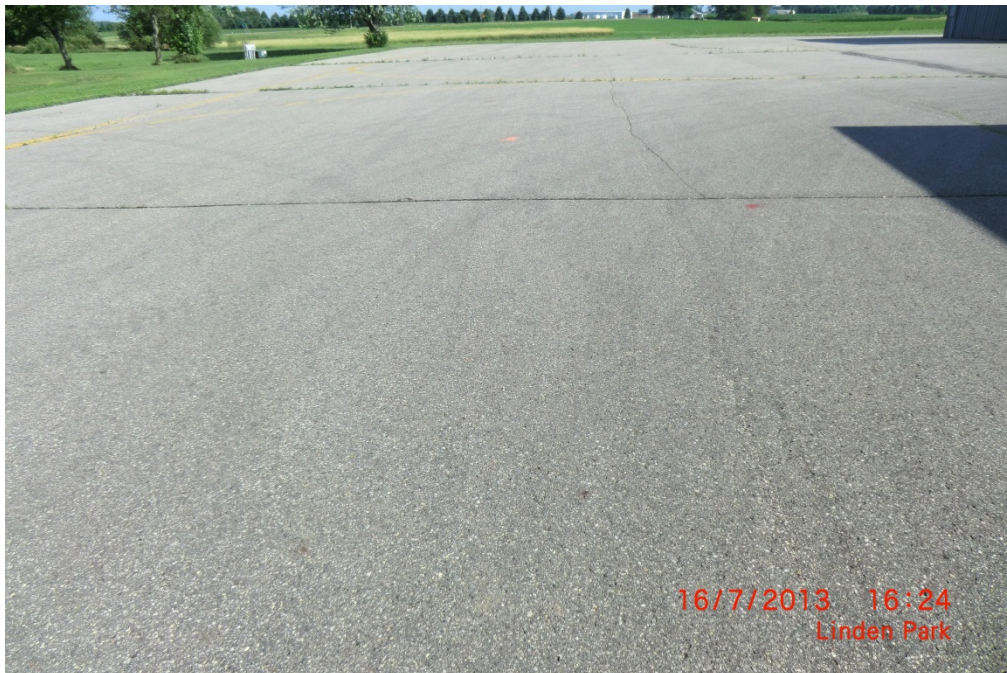
TLA	2	AC	20,600	2002*	67	66	3.1	0	100	L&T cracking, Raveling
TLA	3	AC	47,700	1990*	52	40	2.6	21	79	Alligator cracking, L&T cracking, Raveling
TLA	4	PCC	6,400	1990*	38	26	3.2	87	10	Corner break, Linear cracking, Joint seal damage, Small patch, Faulting, Shattered slab, Shrinkage cracking
TLA	5	AC	8,250	2000*	79	71	2.2	0	100	L&T cracking, Raveling
TLB	1	AC	52,825	2000	79	75	1.9	0	100	L&T cracking, Weathering

HCD TLA 002 (PCI = 66)

Conditions: PCI : 66

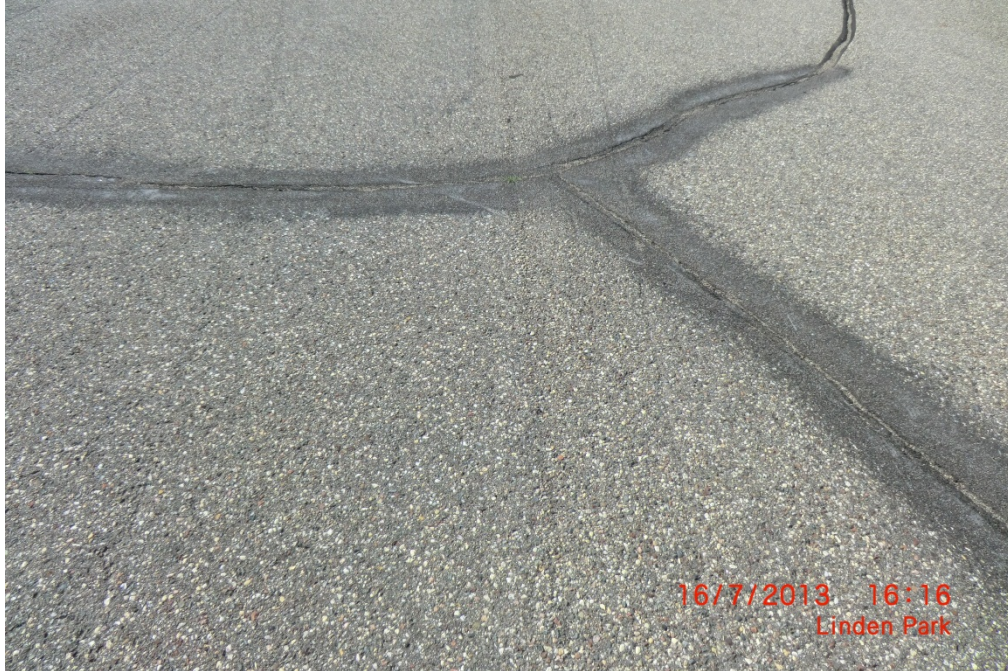
HCD TLA 003 (PCI = 40)

Conditions: PCI : 40

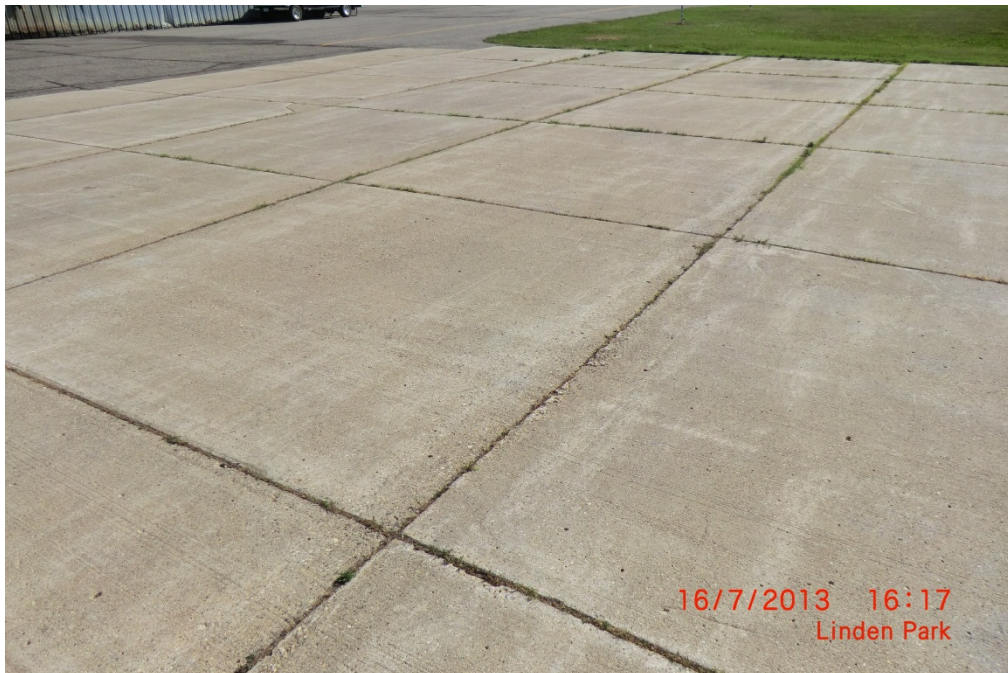
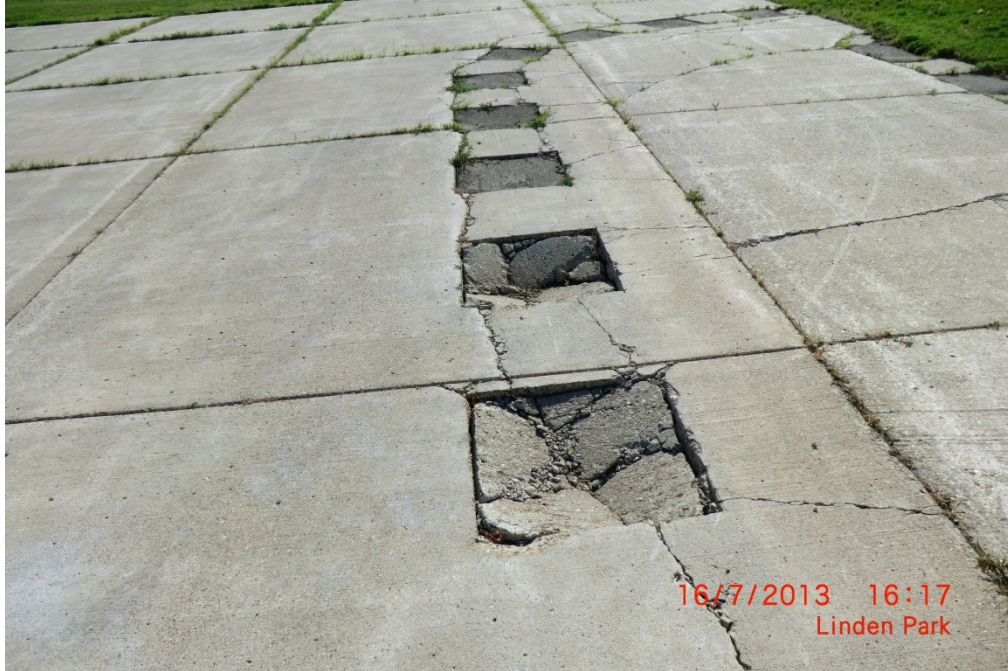
HCD TLA 004 (PCI = 26)

Conditions: PCI: 26

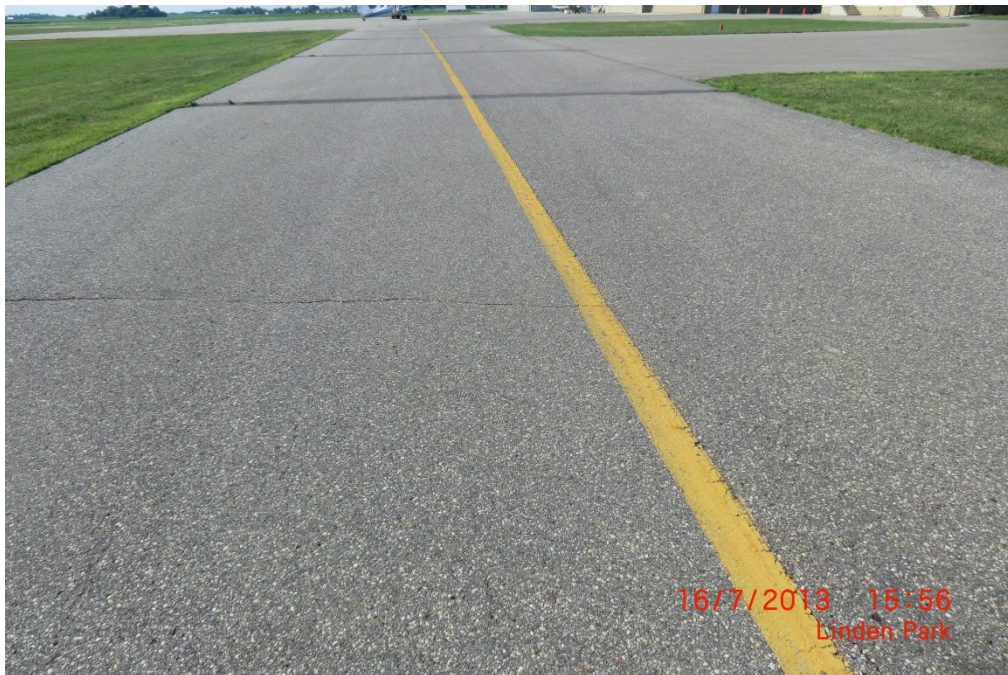
HCD TLA 005 (PCI = 71)

Conditions: PCI : 71

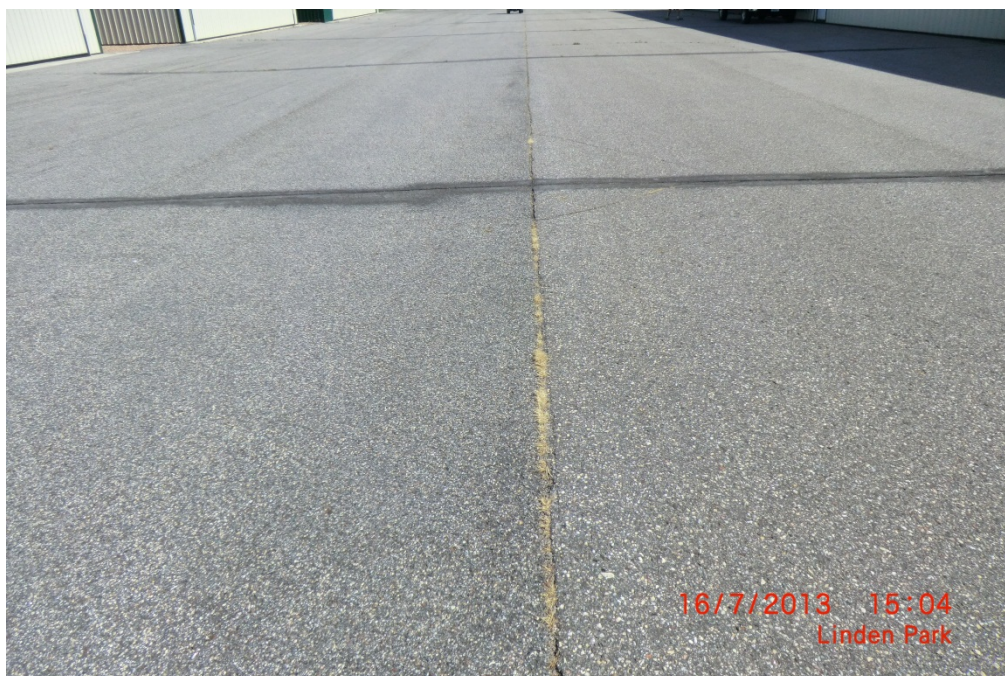
HCD TLB 001 (PCI = 75)

Conditions: PCI : 75
