# Minnesota Airport System Pavement Evaluation 2013 Update

Falls International Airport (INL)

International Falls, Minnesota

October 2013

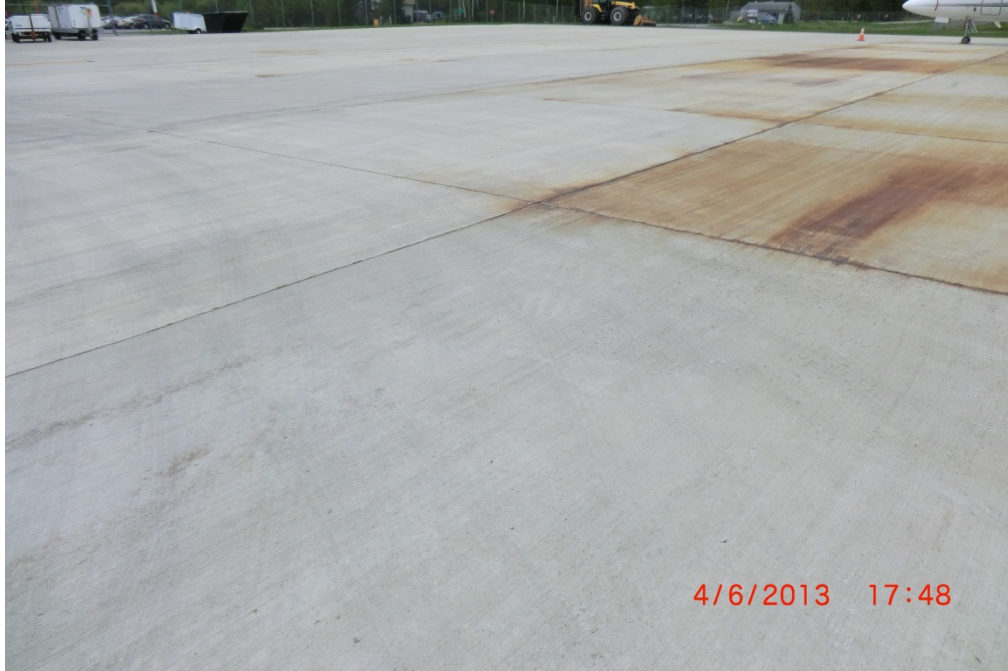
INL APA 001 (PCI = 68)

Conditions: PCI : 68

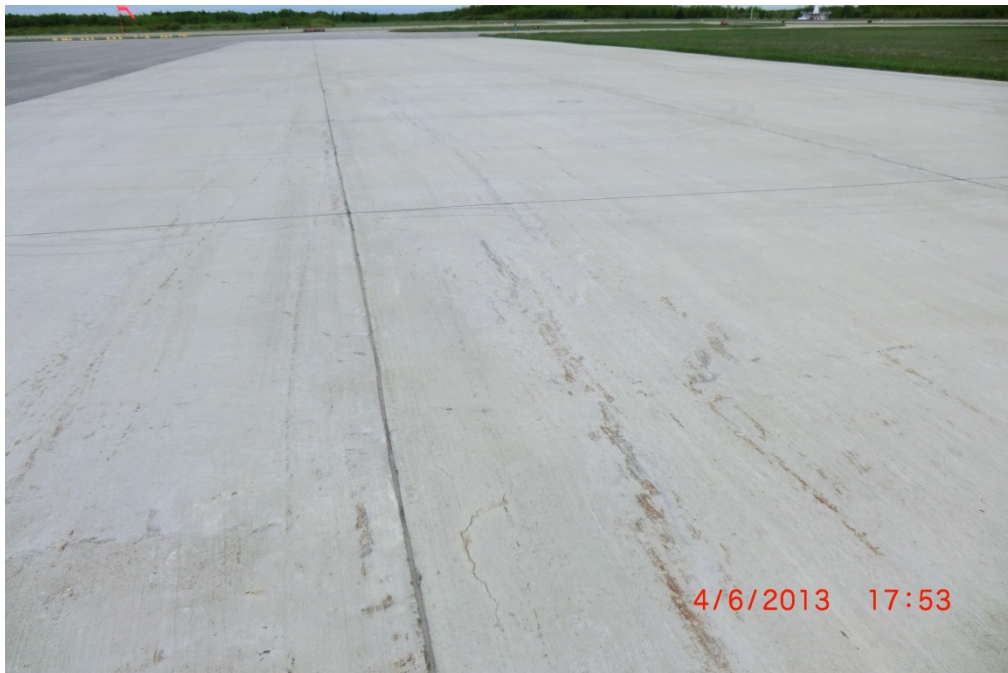
INL APA 002 (PCI = 98)

Conditions: PCI : 98

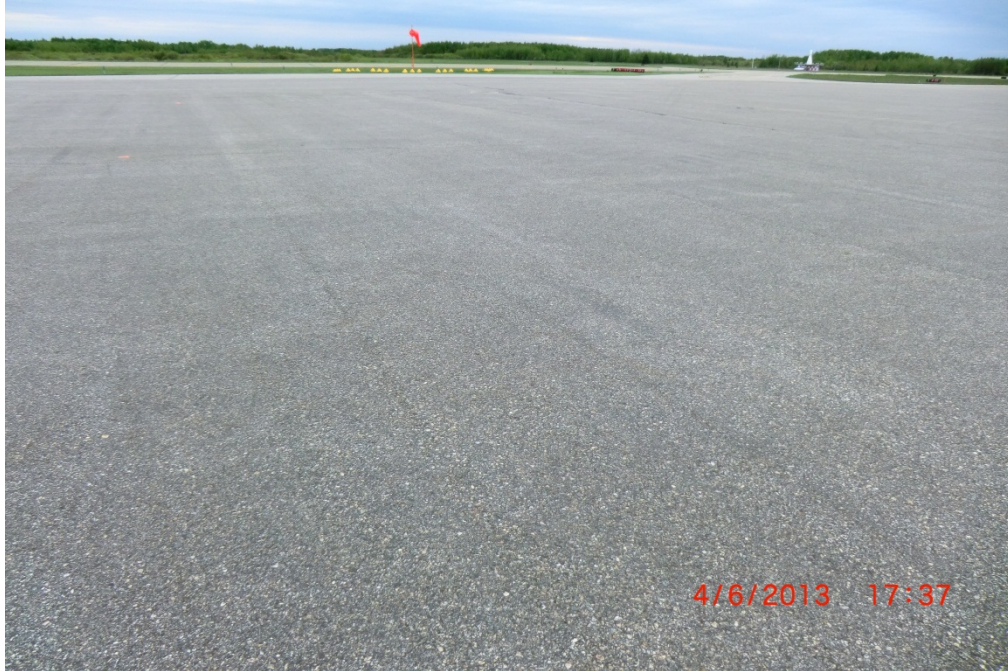
INL APA 003 (PCI = 88)

Conditions: PCI : 88

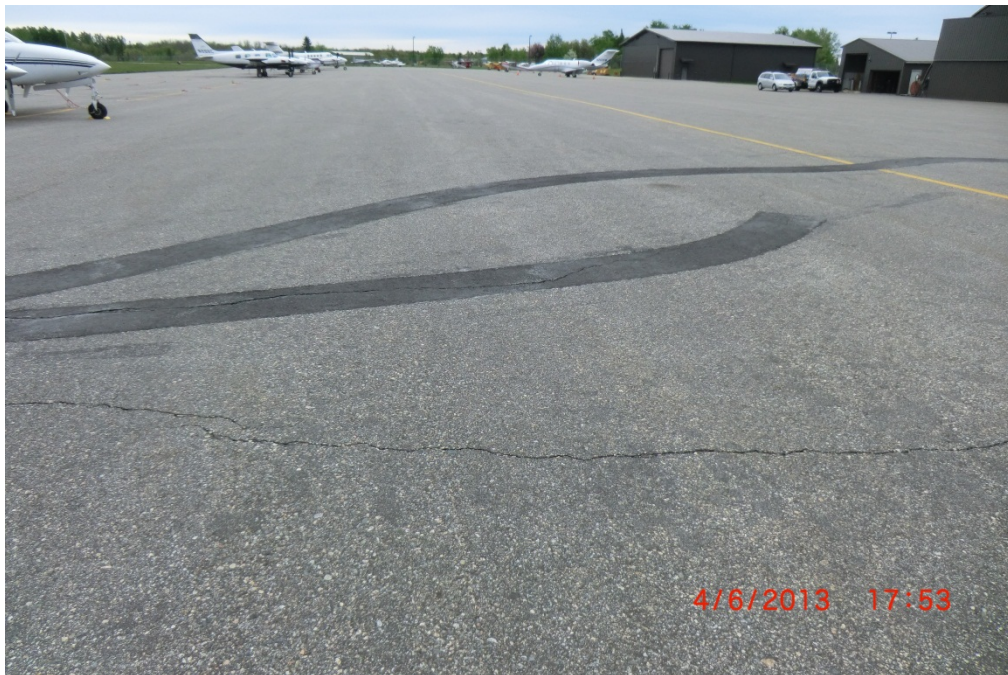
INL APB 001 (PCI = 85)

Conditions: PCI : 85

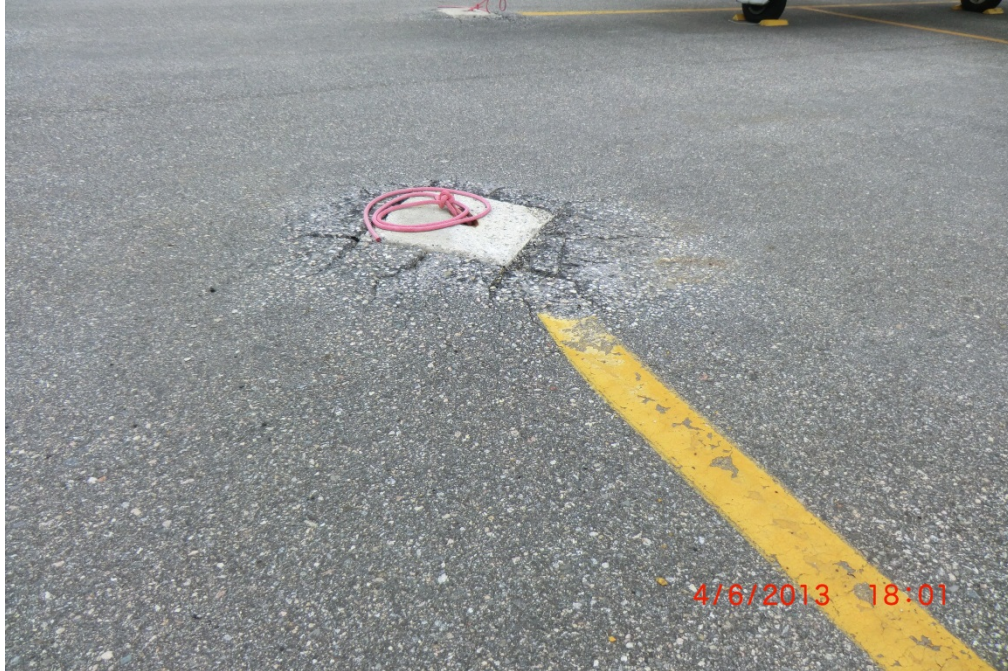
INL APB 001 (Low-Severity Swelling)

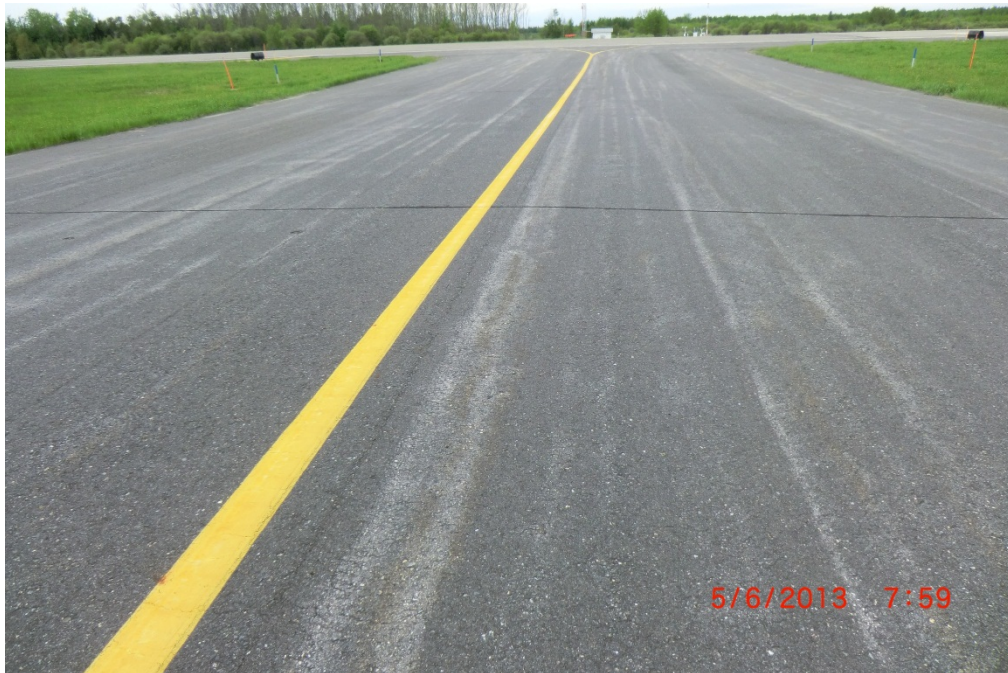
INL CTA1 001 (PCI = 97)

Conditions: PCI: 97

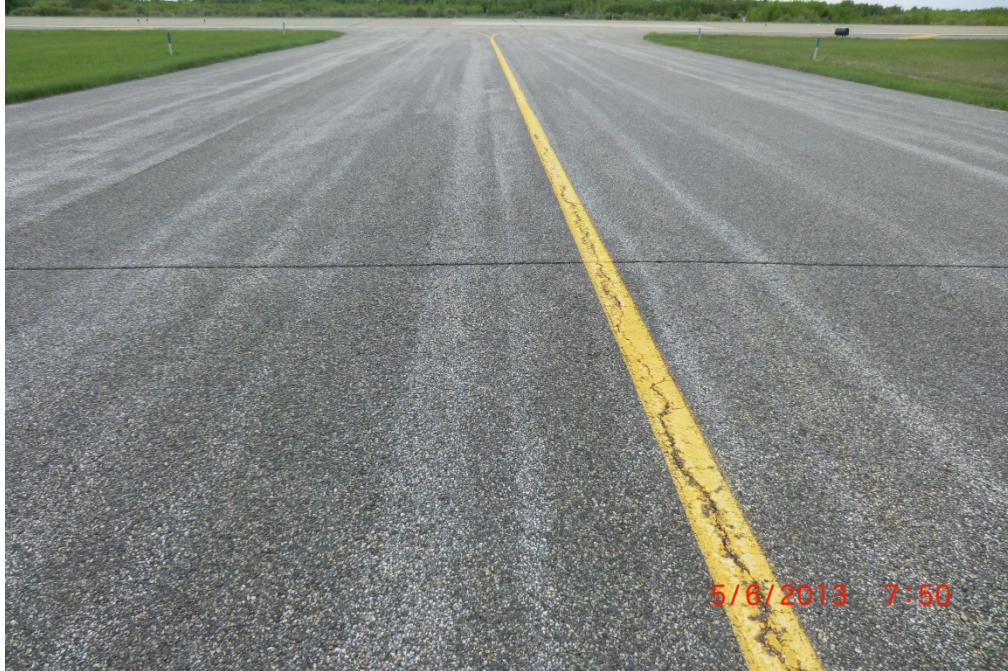
INL CTA2 001 (PCI = 77)

Conditions: PCI: 77

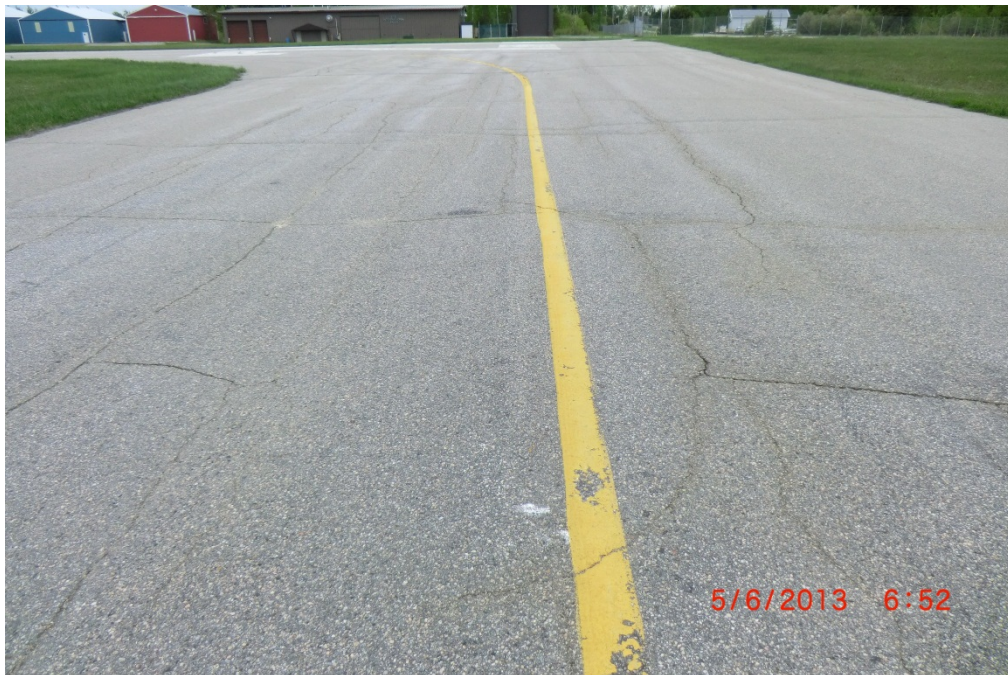
INL CTC 001 (PCI = 52)

Branch ID	Section ID	Surface type <sup>1</sup>	Section area (SF)	LCD <sup>2</sup>	2010 PCI	2013 PCI	Drop in PCI/Yr <sup>3</sup>	% Deduct due to		Distress types
								Load <sup>4</sup>	Climate <sup>5</sup>	
APA	1	PCC	54,000	2004	72	68	3.6	3	39	Linear cracking, Durability cracking, Joint seal damage, Pumping, Faulting, Shrinkage cracking, Joint spall, Corner spall
APA	2	PCC	20,800	2004	99	98	0.2	0	0	Shrinkage cracking, Corner spall
APA	3	AC	164,950	2004	90	88	1.3	0	100	Longitudinal & transverse (L&T) cracking, raveling, weathering
APB	1	AC	193,400	2004	89	85	1.7	0	53	L&T cracking
CTA1	1	AC	19,050	2006	100	97	0.4	0	100	L&T cracking
CTA2	1	AC	13,875	2006	82	77	3.3	0	100	L&T cracking
CTA3	1	AC	13,875	1996	80	80	1.2	0	100	L&T cracking
CTA4	1	AC	24,050	1979	89	81	0.6	0	92	L&T cracking, Swelling
CTB	1	AC	18,000	1996	78	70	1.8	0	100	L&T cracking
CTB	2	AC	5,250	1996	69	68	1.9	0	100	L&T cracking
CTC	1	AC	5,750	2004*	48	52	5.3	27	73	Alligator cracking, L&T cracking, Rutting

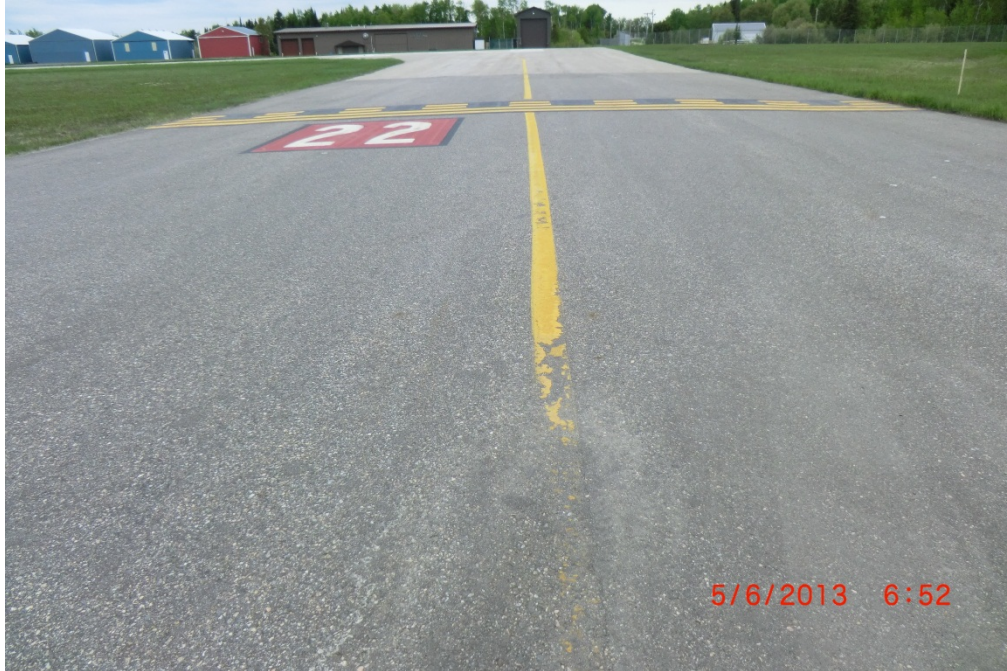
INL CTC 002 (PCI = 79)

CTC	2	AAC	5,915	2004	79	79	2.3	0	58	Depression, L&T cracking
PTA	1	AAC	110,400	2006	95	90	1.4	25	58	Alligator cracking, Depression, L&T cracking, Raveling
PTA	2	AAC	142,200	1996	61	51	2.9	48	47	Alligator cracking, Depression, L&T cracking, Rutting
PTA	3	AAC	13,800	1996	56	28	4.2	42	58	Alligator cracking, Block cracking, L&T cracking
PTA	4	AAC	204,600	1996	66	61	2.3	34	66	L&T cracking, Patching, Rutting
PTA	5	AAC	29,031	1996	84	75	1.5	0	100	L&T cracking
RY1331	1	AC	49,500	2006	100	100	0.0	0	0	-
RY1331	2	AAC	49,500	2006	92	89	1.6	0	72	Depression, L&T cracking, Patching
RY1331	3	AC	49,500	2006	100	100	0.0	0	0	-
RY1331	4	AAC	320,500	1996	84	81	1.1	0	100	L&T cracking
RY1331	5	AAC	320,500	1996	78	77	1.4	0	99	Depression, L&T cracking, Patching, Raveling
RY1331	6	AAC	320,500	1996	90	82	1.1	0	100	L&T cracking

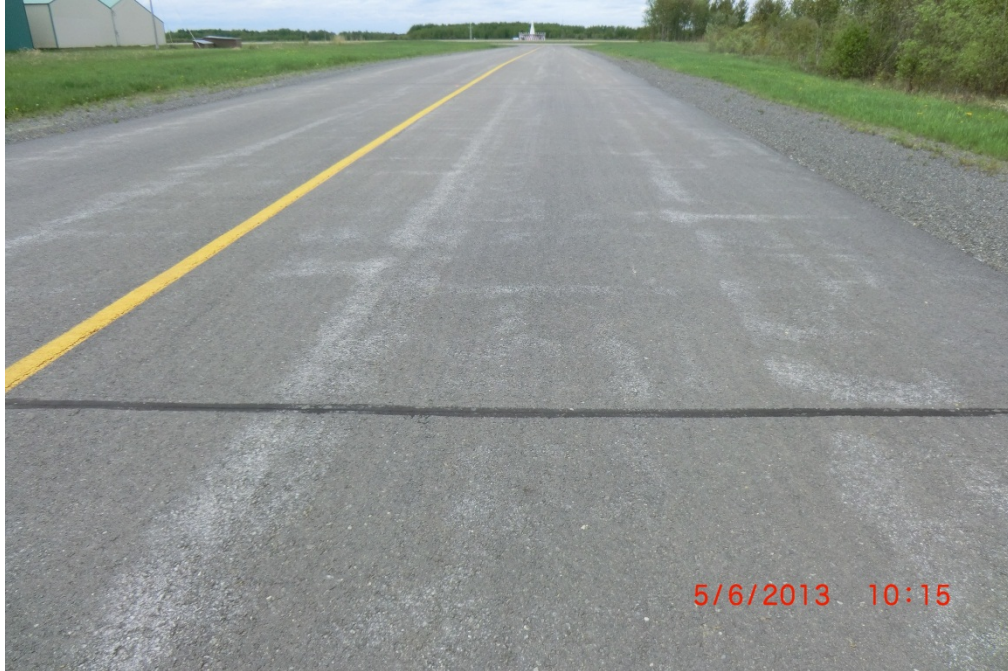
INL TLB 001 (PCI = 91)

Branch ID	Section ID	Surface type <sup>1</sup>	Section area (SF)	LCD <sup>2</sup>	2010 PCI	2013 PCI	Drop in PCI/Yr <sup>3</sup>	% Deduct due to		Distress types
								Load <sup>4</sup>	Climate <sup>5</sup>	
RY422	1	AAC	224,925	2002*	73	69	2.8	0	97	Depression, L&T cracking, Patching
TLA	1	AC	15,300	1996	34	36	3.8	46	54	Alligator cracking, L&T cracking
TLB	1	AC	28,530	2009	97	91	2.3	0	100	L&T cracking
