Minnesota Airport System Pavement Evaluation 2013 Update

St James Municipal Airport (JYG)

St James, Minnesota

Final Report

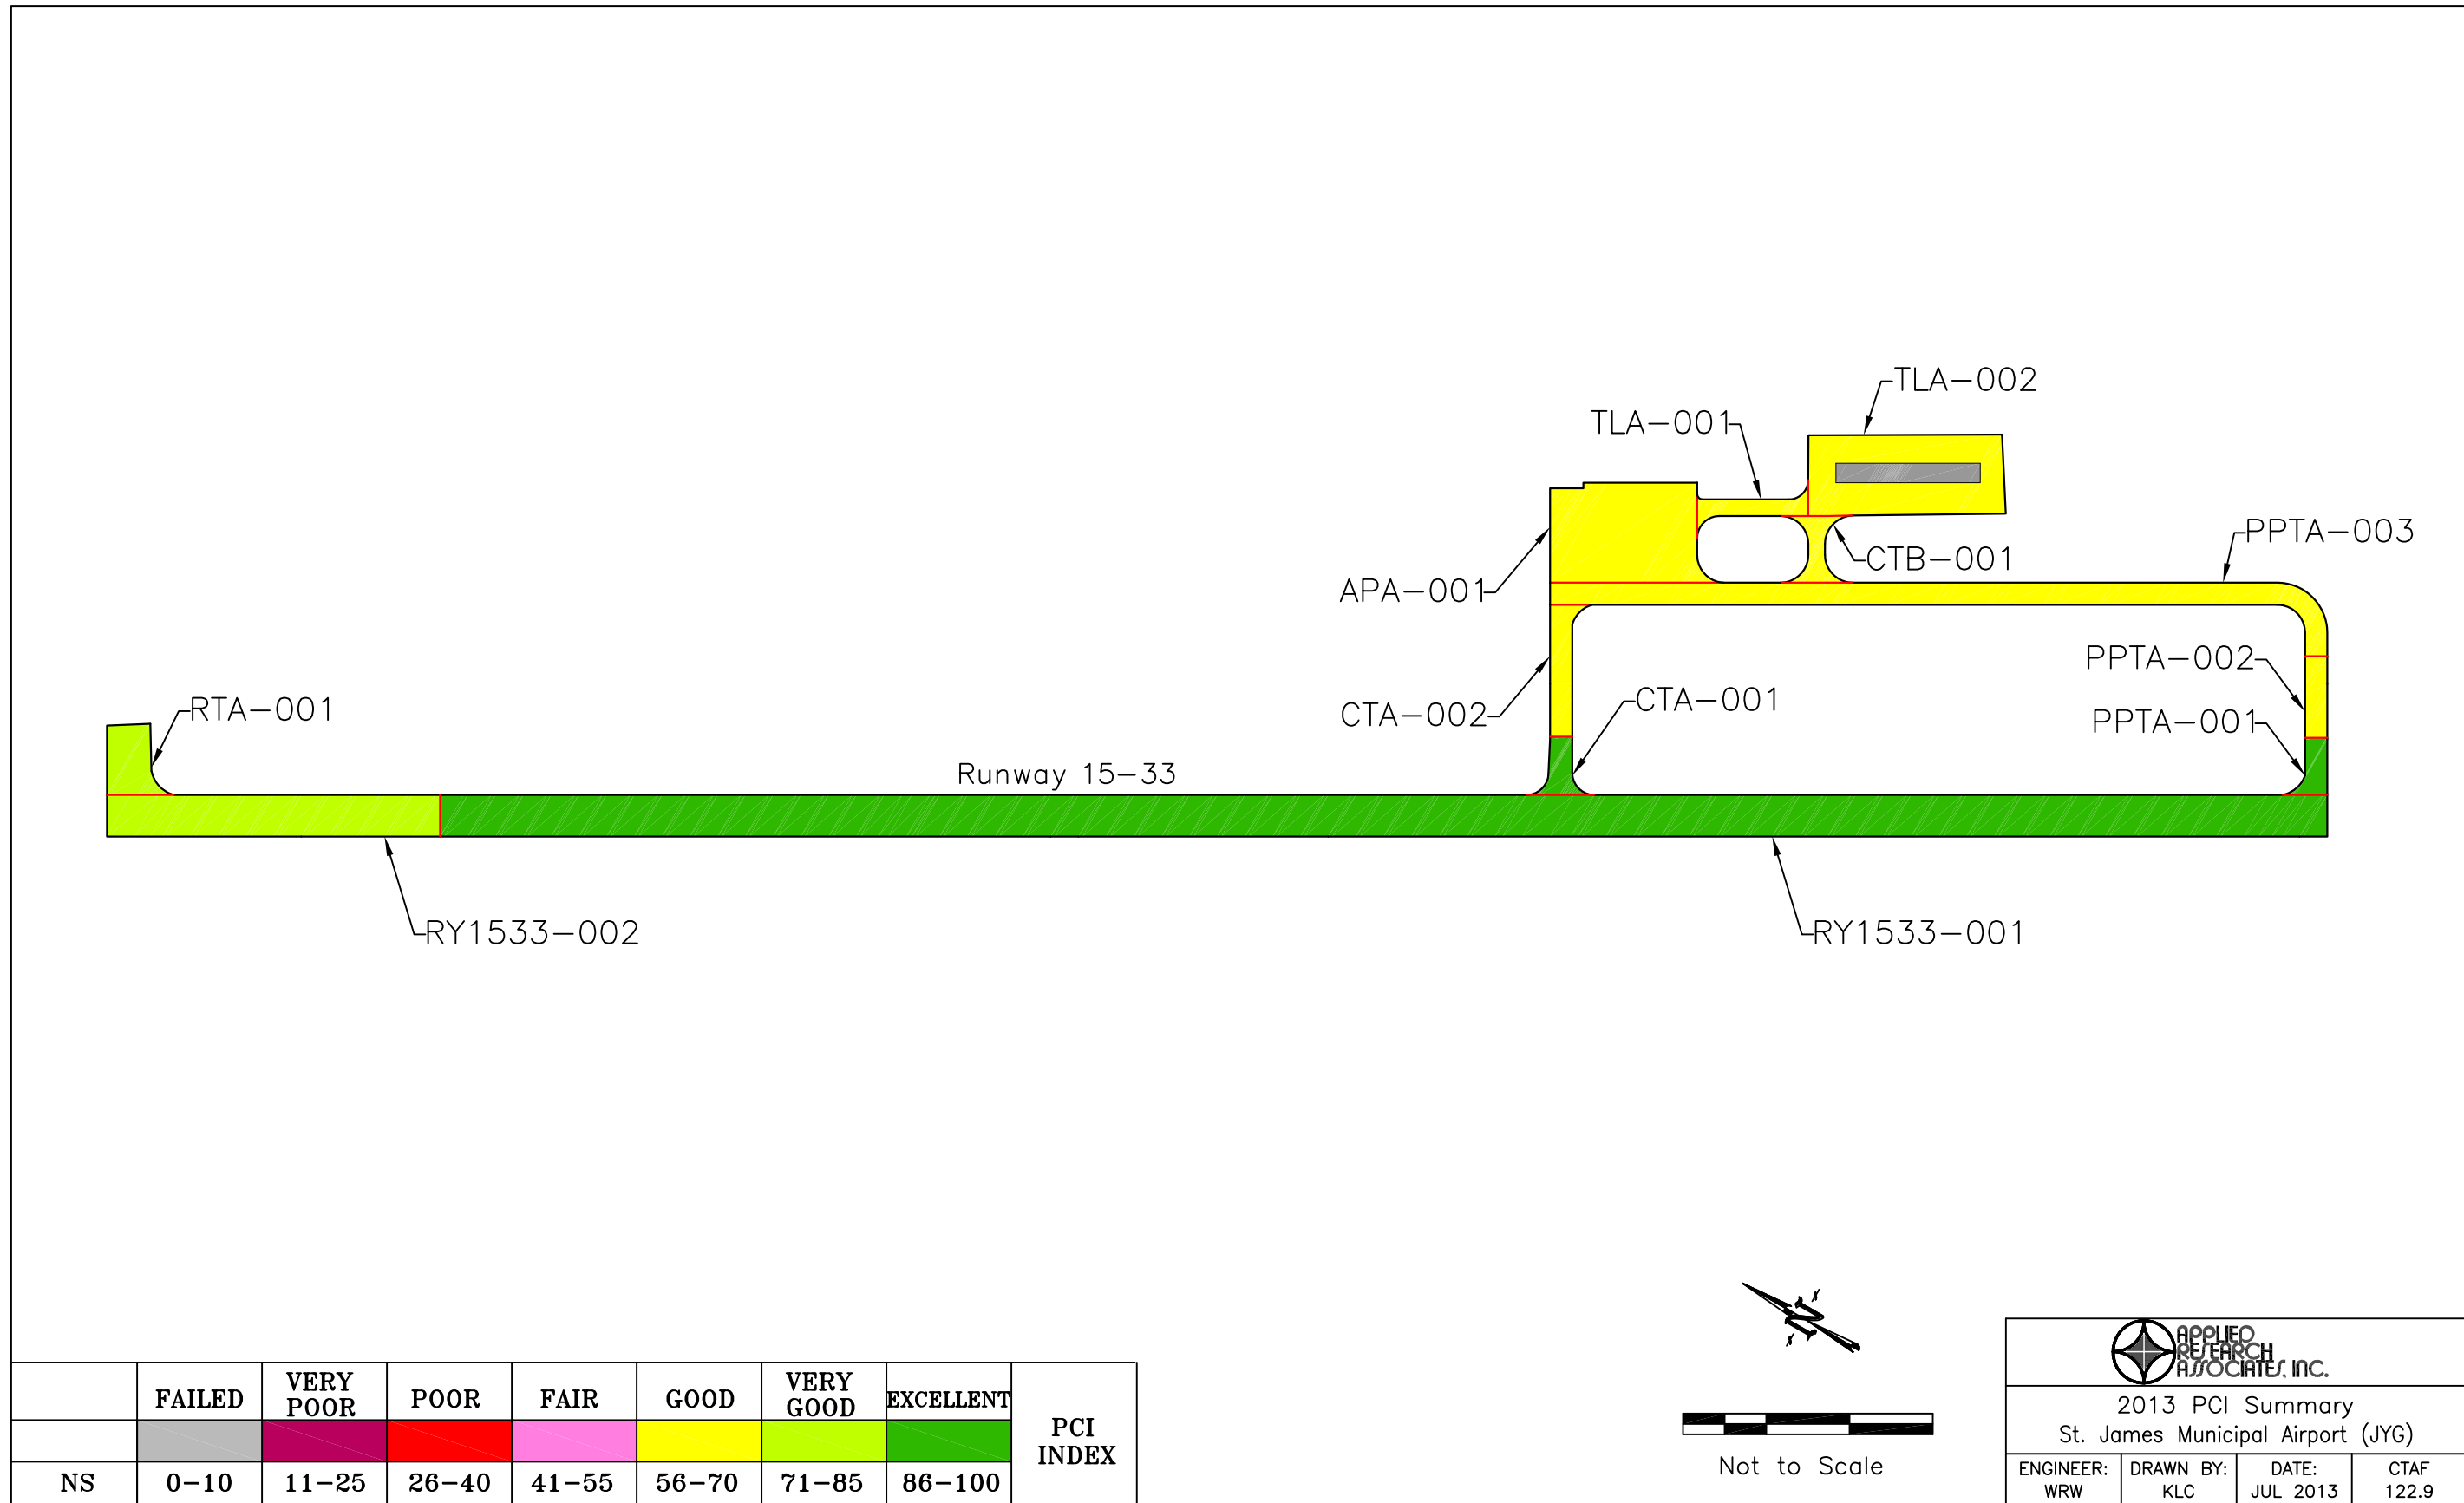
Figure 4. 2013 Pavement Condition Index Rating at St. James Municipal Airport (JYG).

Figures 5 and 6 present the overall PCI for JYG by area distribution and pavement use, respectively. Table 3 presents the PCI summary for each section at JYG, including the drop in PCI per year. Generally, pavement sections will deteriorate between 1 and 3 PCI points per year. Sections deteriorating at higher rates may need maintenance above the normal application rates and should be closely monitored in case major repairs become necessary.

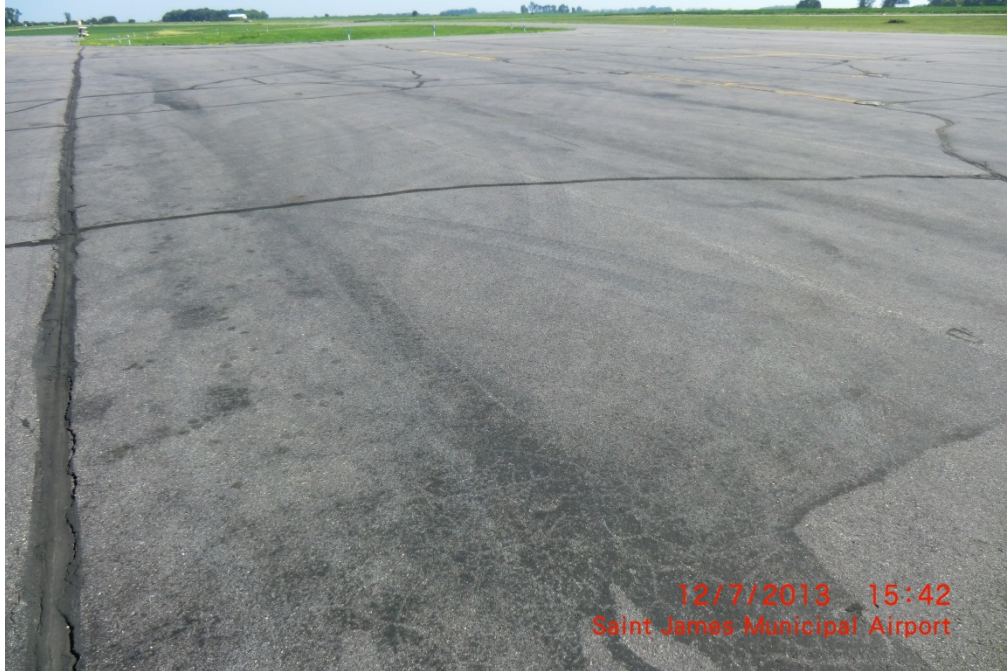
JYG APA 001 (PCI = 61)

Conditions: PCI : 61

48	LONGITUDINAL/TRANSVERSE CRACKING	L	172.00 Ft	Comments:
48	LONGITUDINAL/TRANSVERSE CRACKING	M	74.00 Ft	Comments:
48	LONGITUDINAL/TRANSVERSE CRACKING	H	153.00 Ft	Comments:
52	RAVELING	M	4.00 SqFt	Comments:

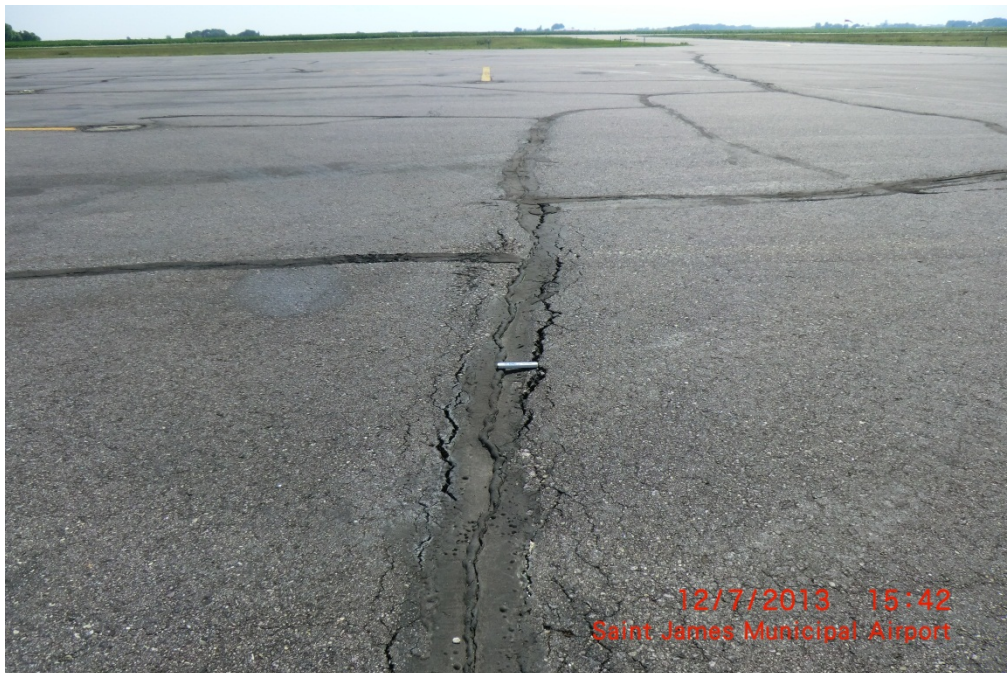
JYG APA 001 (Medium-Severity L&T Cracking)

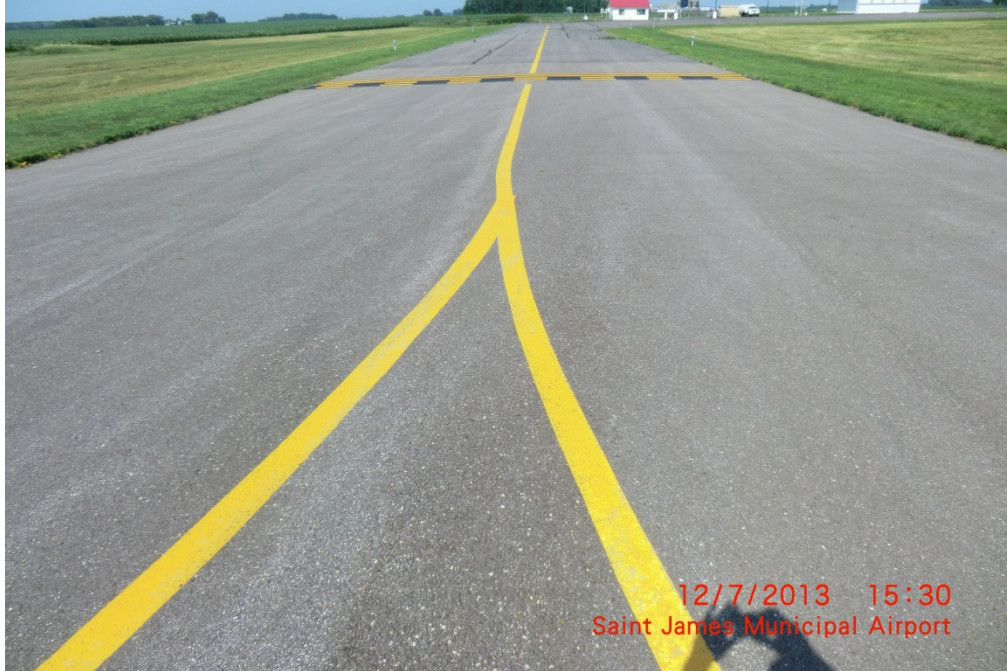
JYG CTA 001 (PCI = 97)

Conditions: PCI: 97

48 LONGITUDINAL/TRANSVERSE CRACKING L 8.00 Ft Comments:

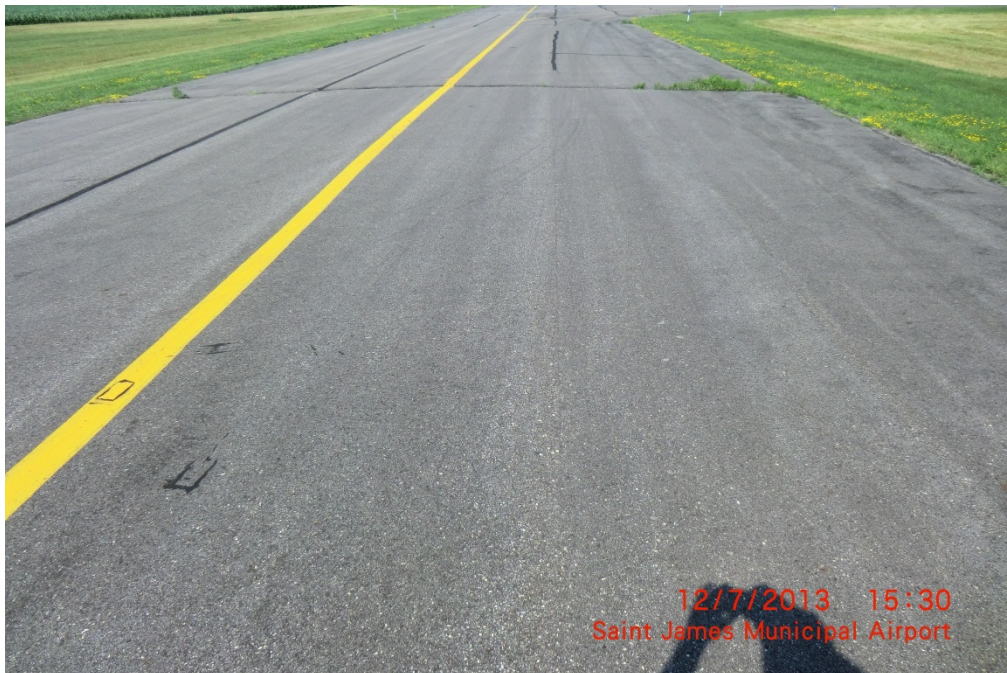
JYG CTA 002 (PCI = 63)

Conditions: PCI : 63

48	LONGITUDINAL/TRANSVERSE CRACKING	L	94.00 Ft	Comments:
48	LONGITUDINAL/TRANSVERSE CRACKING	M	44.00 Ft	Comments:
48	LONGITUDINAL/TRANSVERSE CRACKING	H	48.00 Ft	Comments:
52	RAVELING	M	9.00 SqFt	Comments:

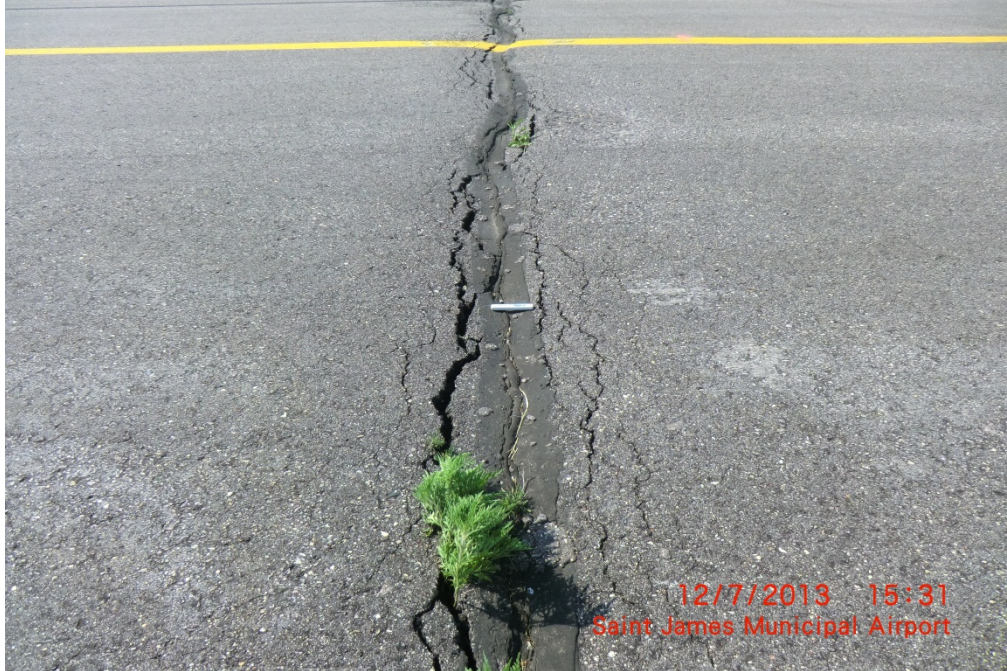
JYG CTA 002 (High-Severity L&T Crack)

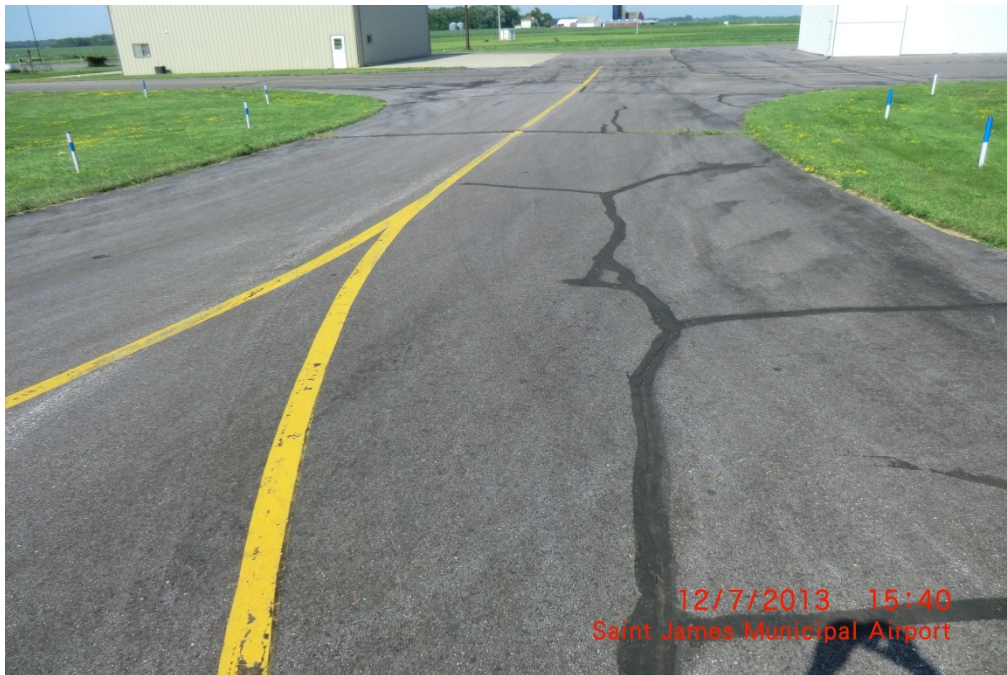
JYG CTB 001 (PCI = 65)

Conditions: PCI: 65

48	LONGITUDINAL/TRANSVERSE CRACKING	L	238.00 Ft	Comments:
48	LONGITUDINAL/TRANSVERSE CRACKING	M	16.00 Ft	Comments:
48	LONGITUDINAL/TRANSVERSE CRACKING	H	25.00 Ft	Comments:
52	RAVELING	M	12.00 SqFt	Comments:

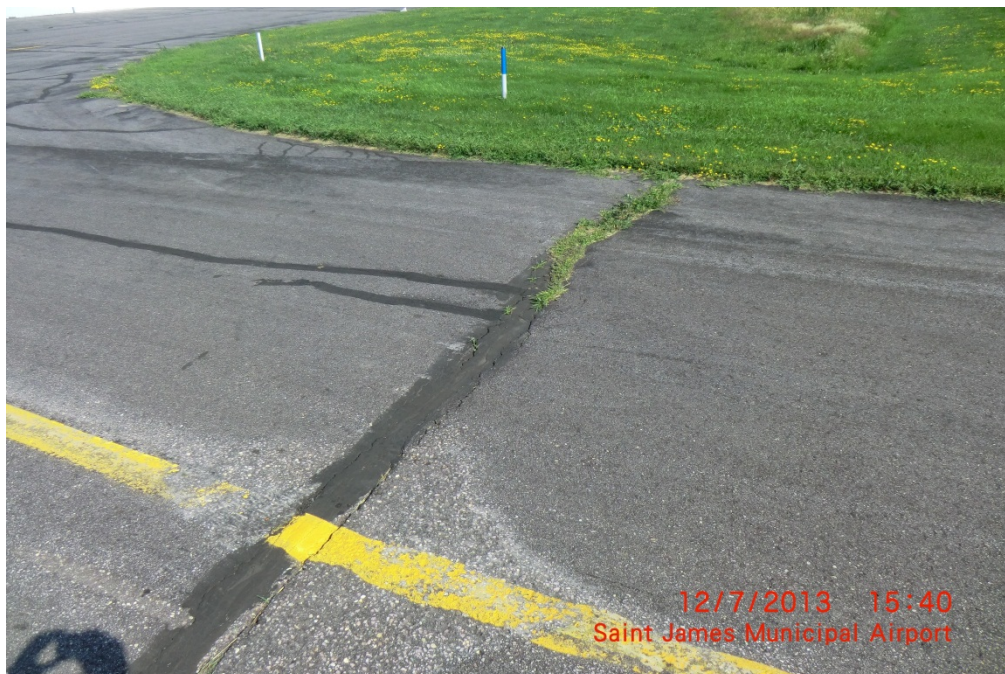
JYG CTB 001 (High-Severity L&T Crack)

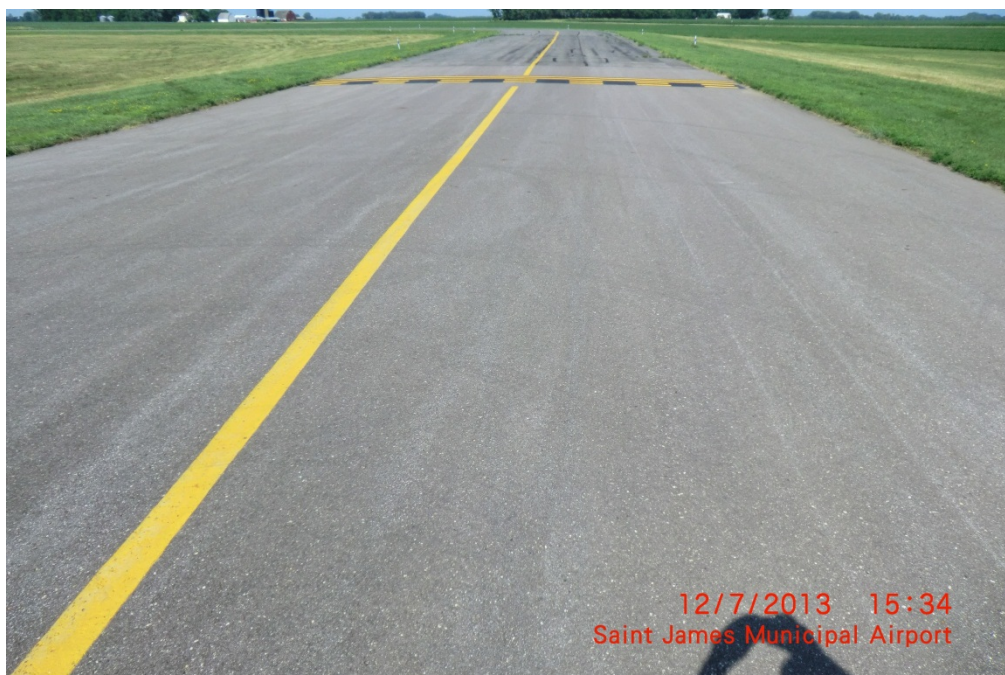
JYG PPTA 001 (PCI = 100)

Conditions: PCI : 100

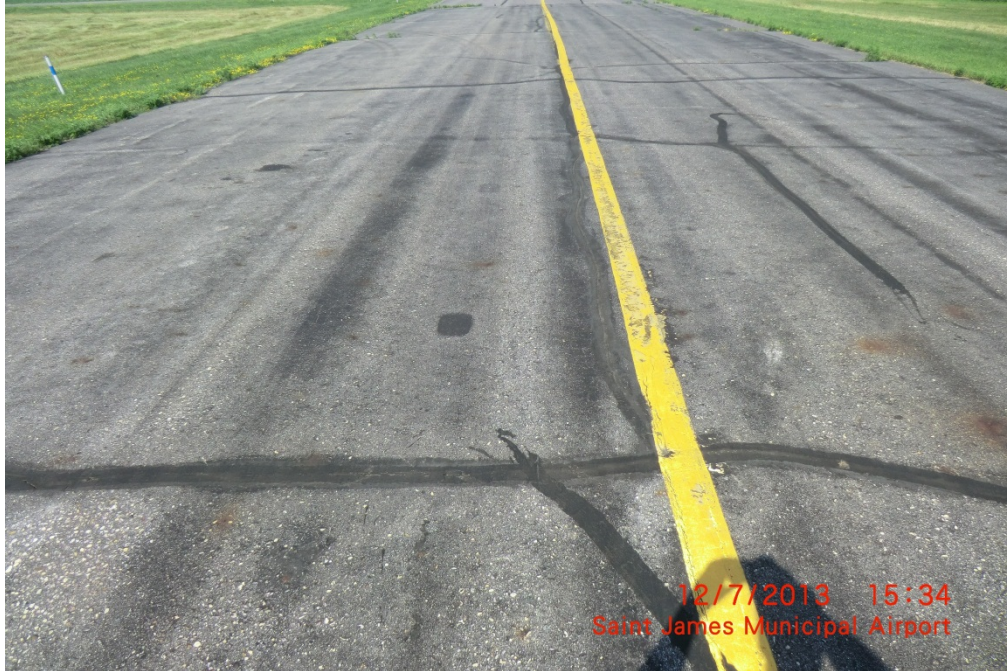
JYG PPTA 002 (PCI = 61)

Conditions: PCI : 61

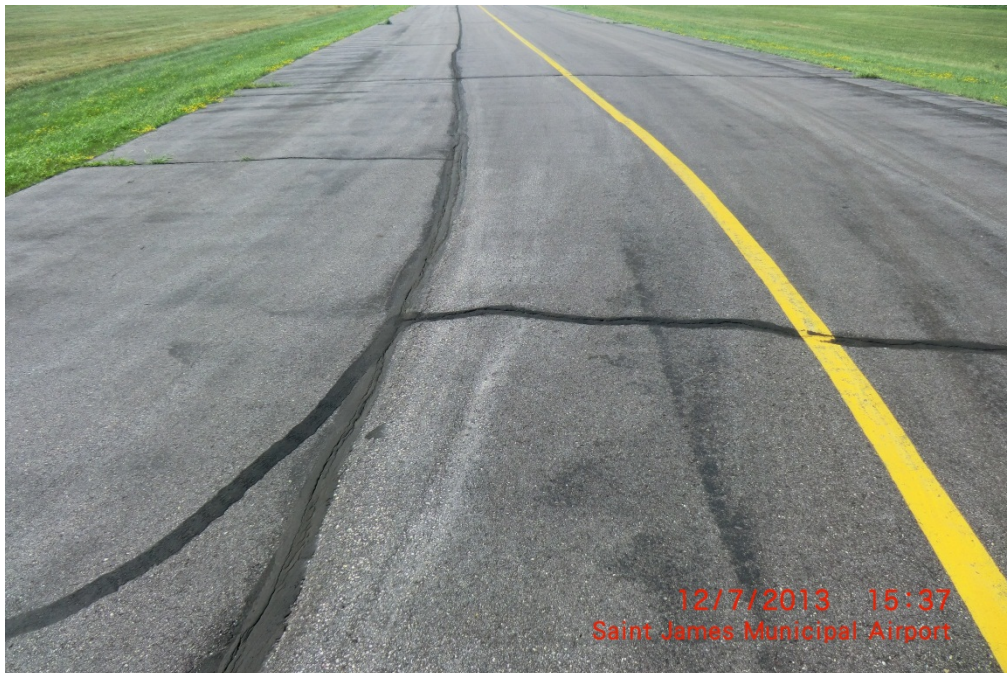
JYG PPTA 003 (PCI = 66)

Conditions: PCI: 66

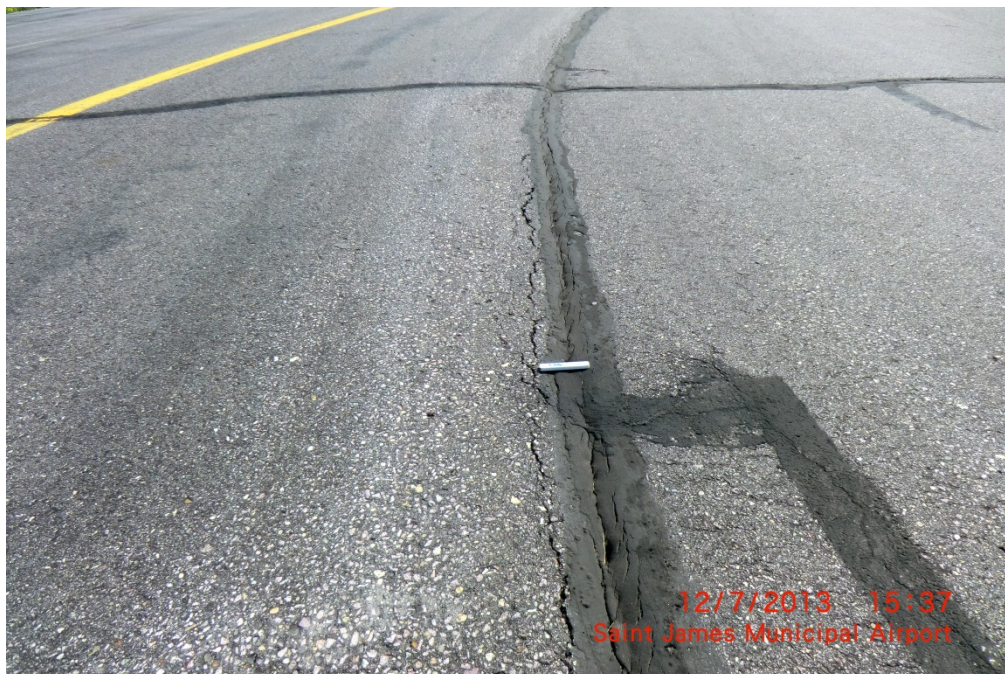
JYG PPTA 003 (Medium-Severity Alligator Cracking)

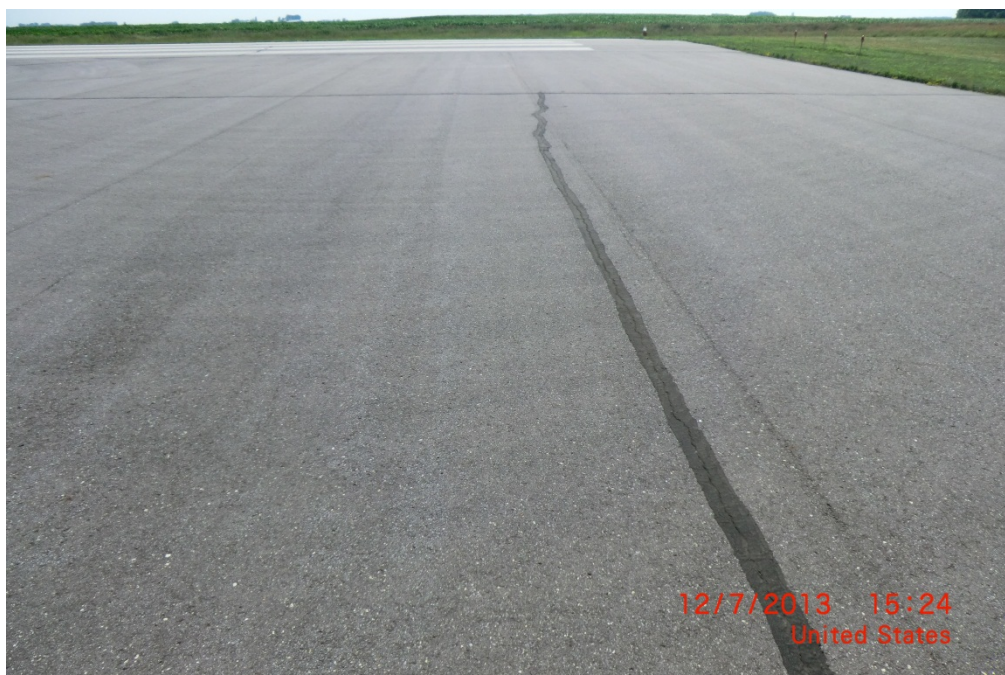
JYG RTA 001 (PCI = 85)

Conditions: PCI : 85

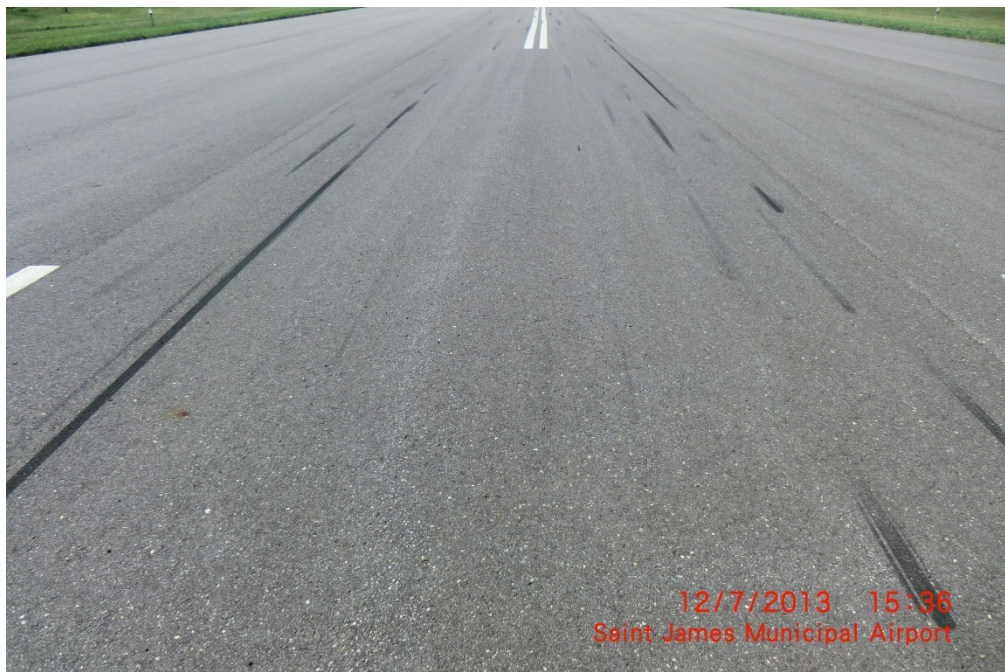
JYG RY1533 001 (PCI = 99)

Conditions: PCI: 99

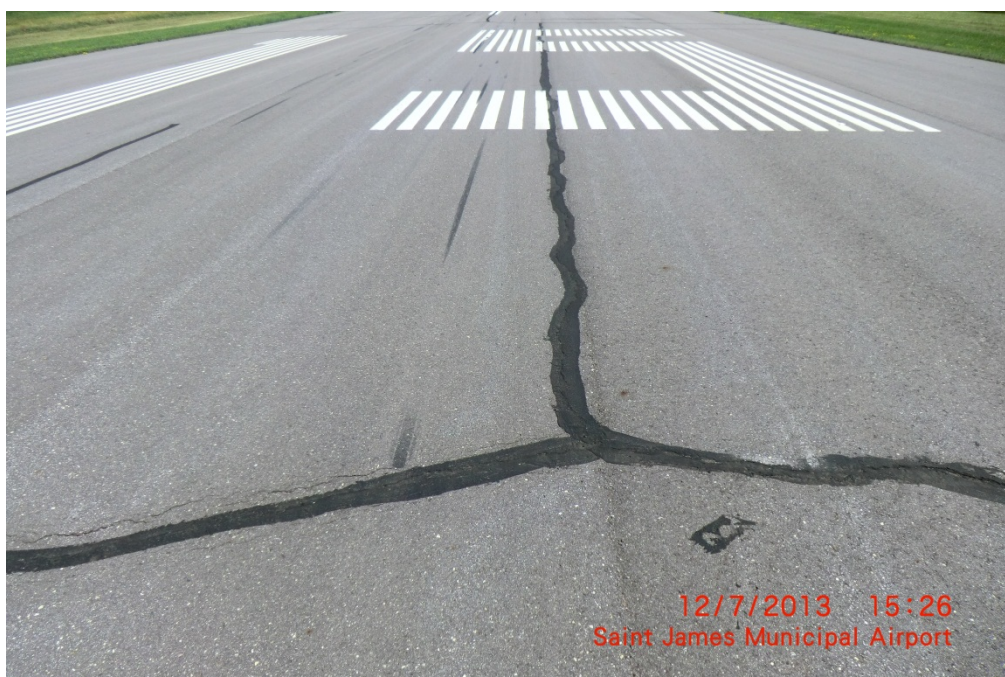
JYG RY1533 002 (PCI = 85)

Conditions: PCI : 85

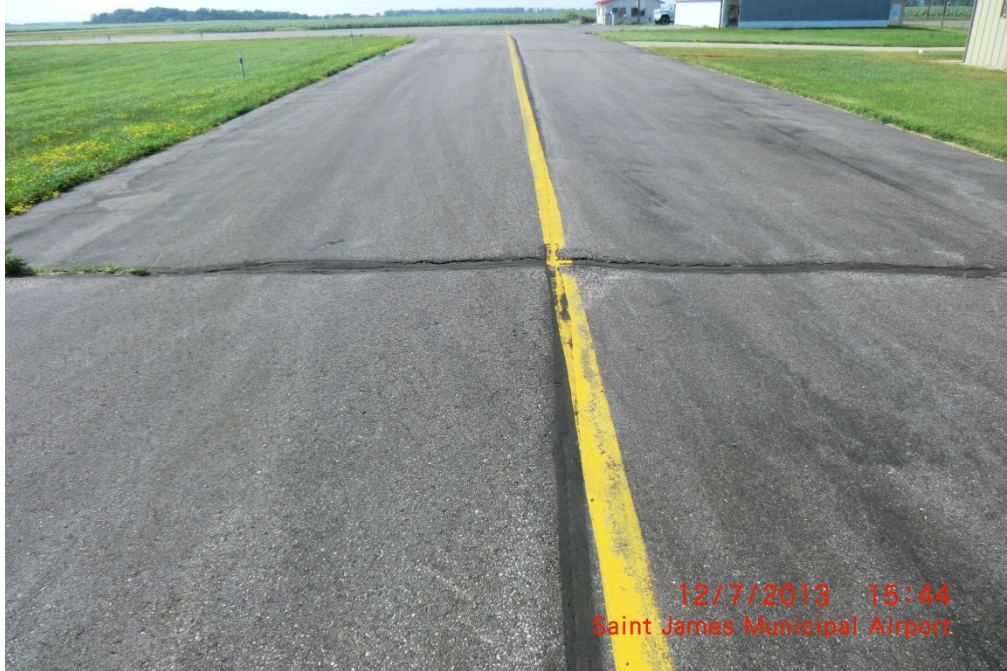
JYG TLA 001 (PCI = 68)

Conditions: PCI : 68

48	LONGITUDINAL/TRANSVERSE CRACKING	L	109.00 Ft	Comments:
48	LONGITUDINAL/TRANSVERSE CRACKING	M	39.00 Ft	Comments:
48	LONGITUDINAL/TRANSVERSE CRACKING	H	24.00 Ft	Comments:
53	RUTTING	M	2.00 SqFt	Comments:
57	WEATHERING	L	9.00 SqFt	Comments:

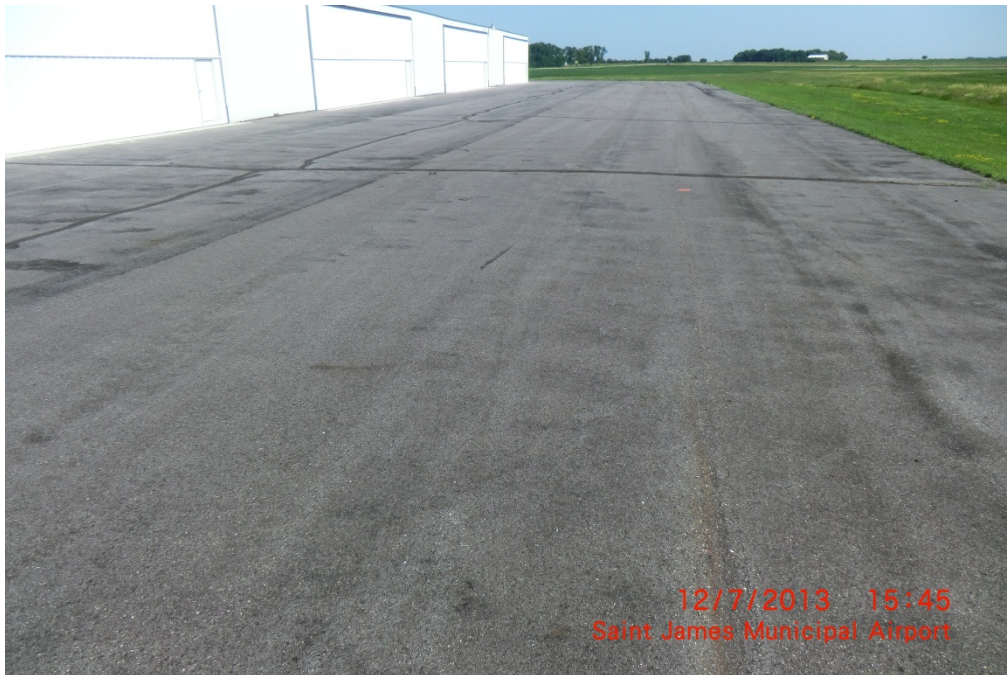
JYG TLA 002 (PCI = 67)

Conditions: PCI : 67

48	LONGITUDINAL/TRANSVERSE CRACKING	L	141.00 Ft	Comments:
48	LONGITUDINAL/TRANSVERSE CRACKING	M	94.00 Ft	Comments:
48	LONGITUDINAL/TRANSVERSE CRACKING	H	64.00 Ft	Comments:
45	DEPRESSION	L	12.00 SqFt	Comments:
52	RAVELING	M	12.00 SqFt	Comments:
