# Minnesota Airport System Pavement Evaluation 2013 Update

Litchfield Municipal Airport (LJF)

Litchfield, Minnesota

October 2013

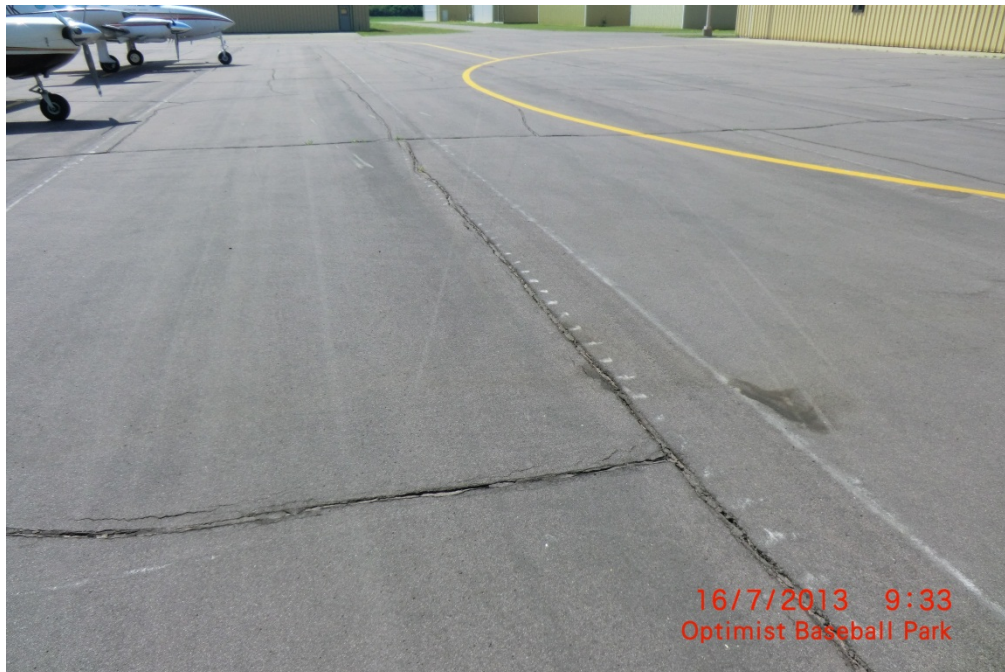
| Branch ID | Section ID | Surface type <sup>1</sup> | Section area (SF) | LCD <sup>2</sup> | 2010 PCI | 2013 PCI | Drop in PCI/Yr <sup>3</sup> | % Deduct due to | | Distress types |
|---|---|---|---|---|---|---|---|---|---|---|
| APA | 1 | AC | 69,000 | 1989 | 67 | 66 | 1.4 | 14 | 86 | Alligator cracking, Longitudinal & transverse (L&T) cracking, raveling, weathering |

LJF APA 001 (PCI = 66)

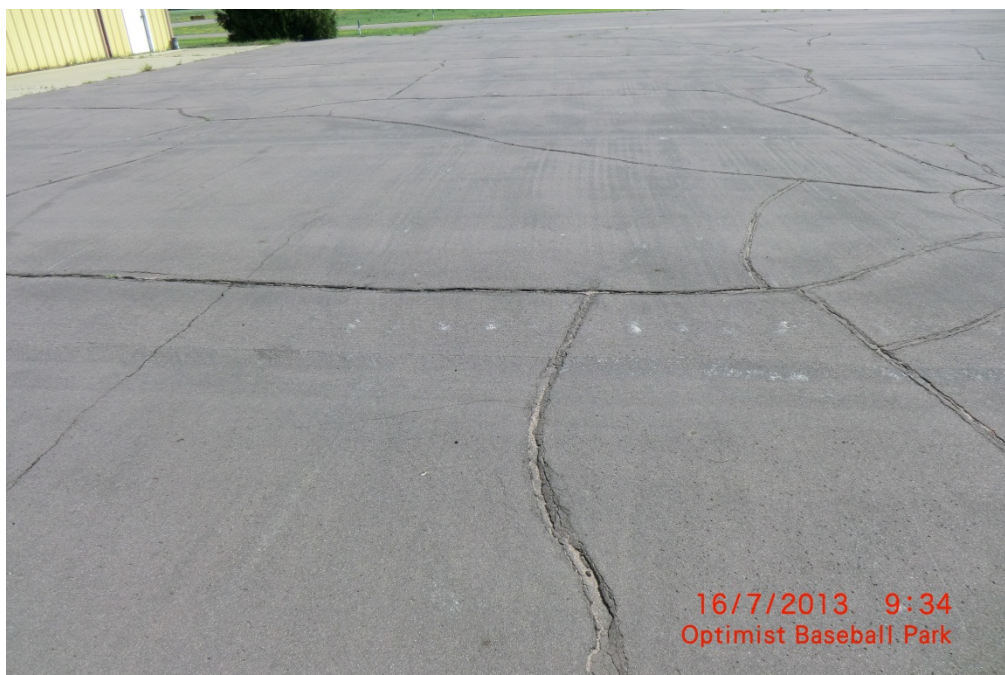
| Branch ID | Section ID | Surface type <sup>1</sup> | Section area (SF) | LCD <sup>2</sup> | 2010 PCI | 2013 PCI | Drop in PCI/Yr <sup>3</sup> | % Deduct due to | | Distress types |
|---|---|---|---|---|---|---|---|---|---|---|
| APA | 2 | AC | 10,300 | 1989 | 70 | 65 | 1.5 | 0 | 97 | L&T cracking, Swelling |

LJF APA 002 (PCI = 65)

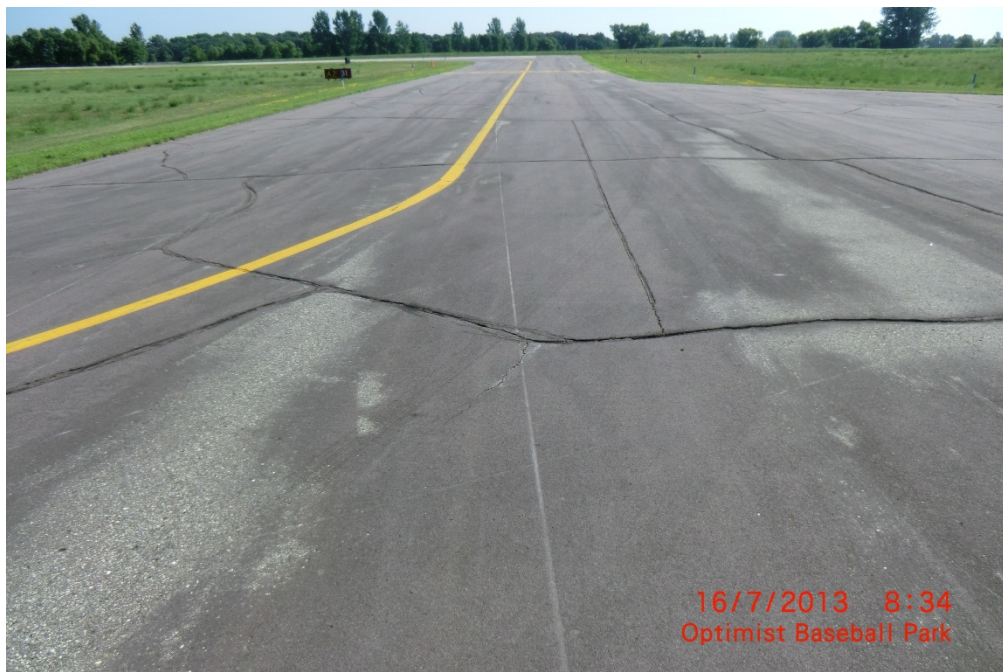
| Branch ID | Section ID | Surface type <sup>1</sup> | Section area (SF) | LCD <sup>2</sup> | 2010 PCI | 2013 PCI | Drop in PCI/Yr <sup>3</sup> | % Deduct due to | | Distress types |
|---|---|---|---|---|---|---|---|---|---|---|
| CTA2 | 1 | AC | 22,800 | 1989 | 69 | 70 | 1.3 | 0 | 100 | L&T cracking, Raveling |

LJF CTA2 001 (PCI = 70)

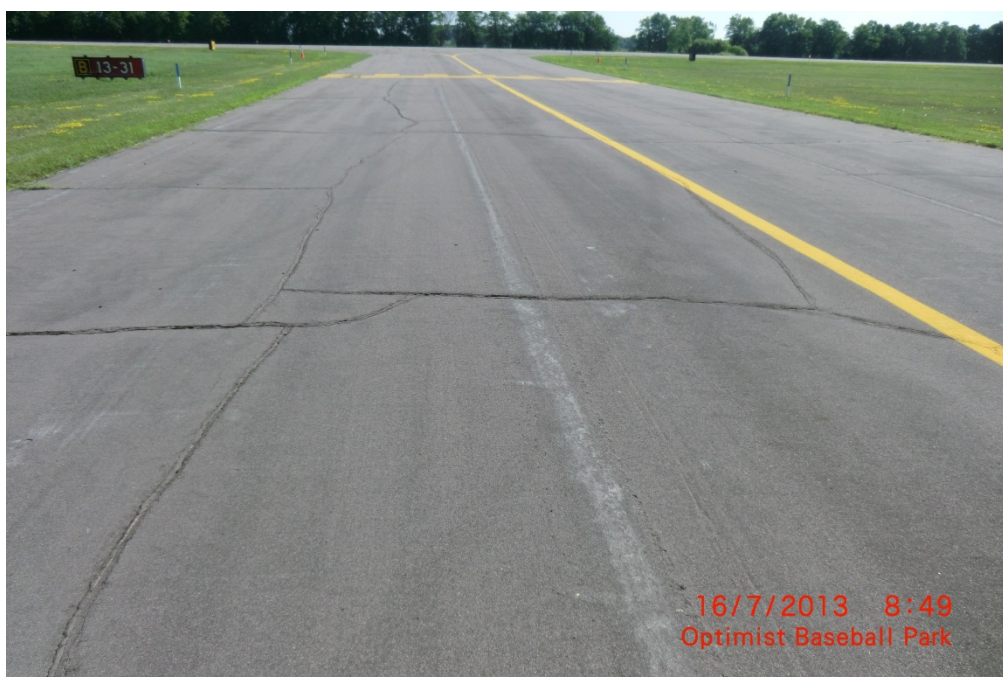
| Branch ID | Section ID | Surface type <sup>1</sup> | Section area (SF) | LCD <sup>2</sup> | 2010 PCI | 2013 PCI | Drop in PCI/Yr <sup>3</sup> | % Deduct due to | | Distress types |
|---|---|---|---|---|---|---|---|---|---|---|
| CTB | 1 | AC | 26,200 | 1989 | 73 | 66 | 1.4 | 0 | 100 | L&T cracking |

LJF CTB 001 (PCI = 66)

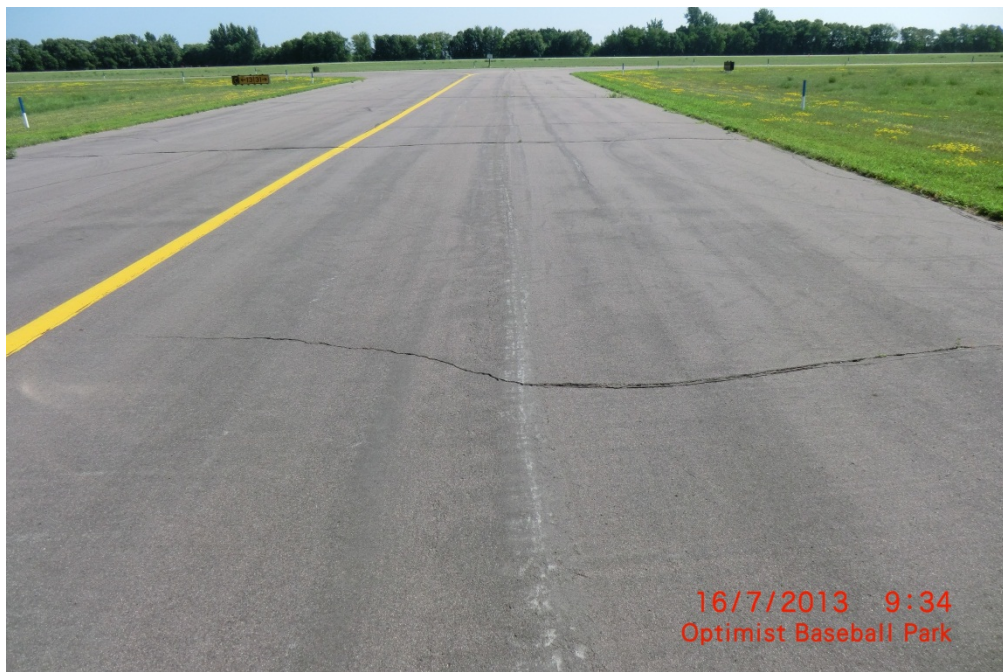
| Branch ID | Section ID | Surface type <sup>1</sup> | Section area (SF) | LCD <sup>2</sup> | 2010 PCI | 2013 PCI | Drop in PCI/Yr <sup>3</sup> | % Deduct due to | | Distress types |
|---|---|---|---|---|---|---|---|---|---|---|
| CTC | 1 | AC | 21,000 | 1989 | 70 | 73 | 1.1 | 0 | 100 | L&T cracking |

LJF CTC 001 (PCI = 73)

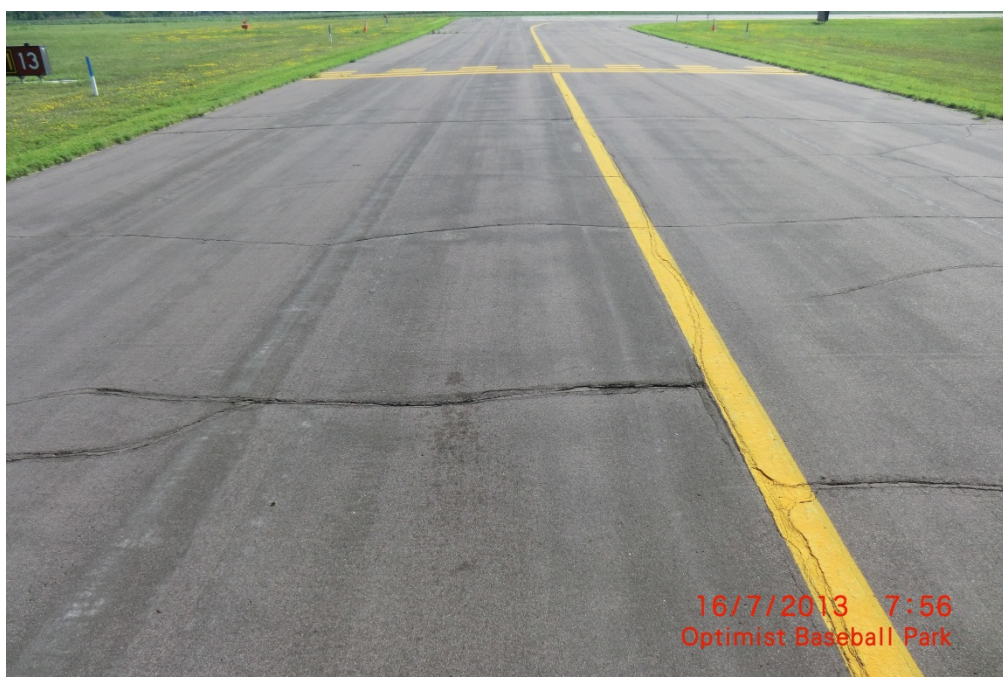
| Branch ID | Section ID | Surface type <sup>1</sup> | Section area (SF) | LCD <sup>2</sup> | 2010 PCI | 2013 PCI | Drop in PCI/Yr <sup>3</sup> | % Deduct due to | | Distress types |
|---|---|---|---|---|---|---|---|---|---|---|
| PTA | 1 | AC | 77,000 | 1989 | 79 | 66 | 1.4 | 0 | 100 | L&T cracking |

LJF PTA 001 (PCI = 66)

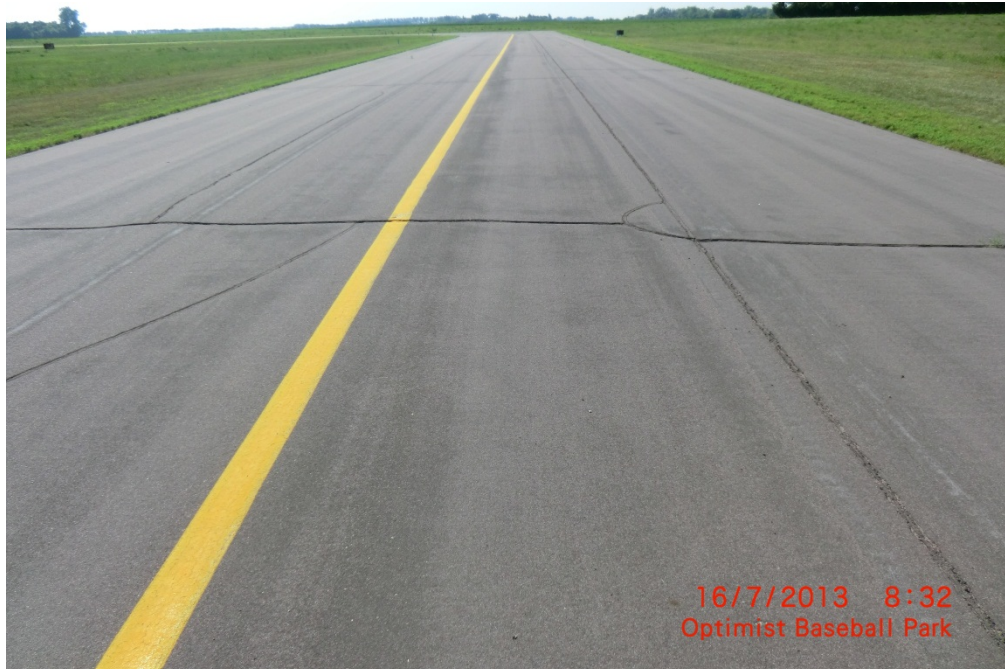
| Branch ID | Section ID | Surface type <sup>1</sup> | Section area (SF) | LCD <sup>2</sup> | 2010 PCI | 2013 PCI | Drop in PCI/Yr <sup>3</sup> | % Deduct due to | | Distress types |
|---|---|---|---|---|---|---|---|---|---|---|
| PTA | 2 | AC | 94,450 | 2005 | 70 | 79 | 2.6 | 0 | 100 | L&T cracking |

LJF PTA 002 (PCI = 79)

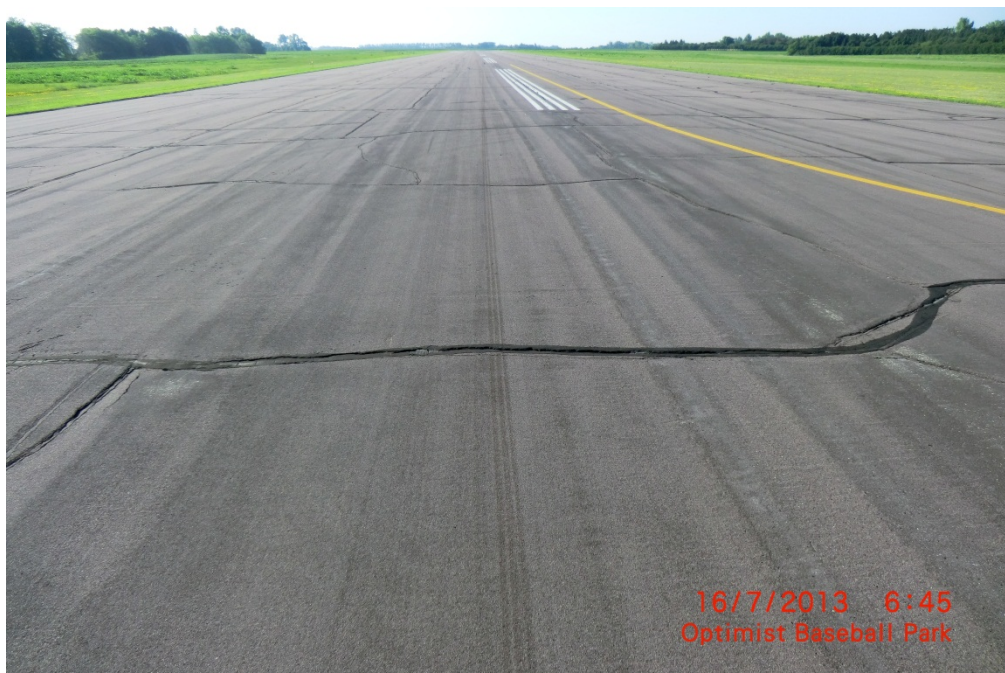
| Branch ID | Section ID | Surface type <sup>1</sup> | Section area (SF) | LCD <sup>2</sup> | 2010 PCI | 2013 PCI | Drop in PCI/Yr <sup>3</sup> | % Deduct due to | | Distress types |
|---|---|---|---|---|---|---|---|---|---|---|
| RY1331 | 1 | AC | 400,000 | 1989 | 69 | 67 | 1.4 | 0 | 100 | L&T cracking |

LJF RY1331 001 (PCI = 67)

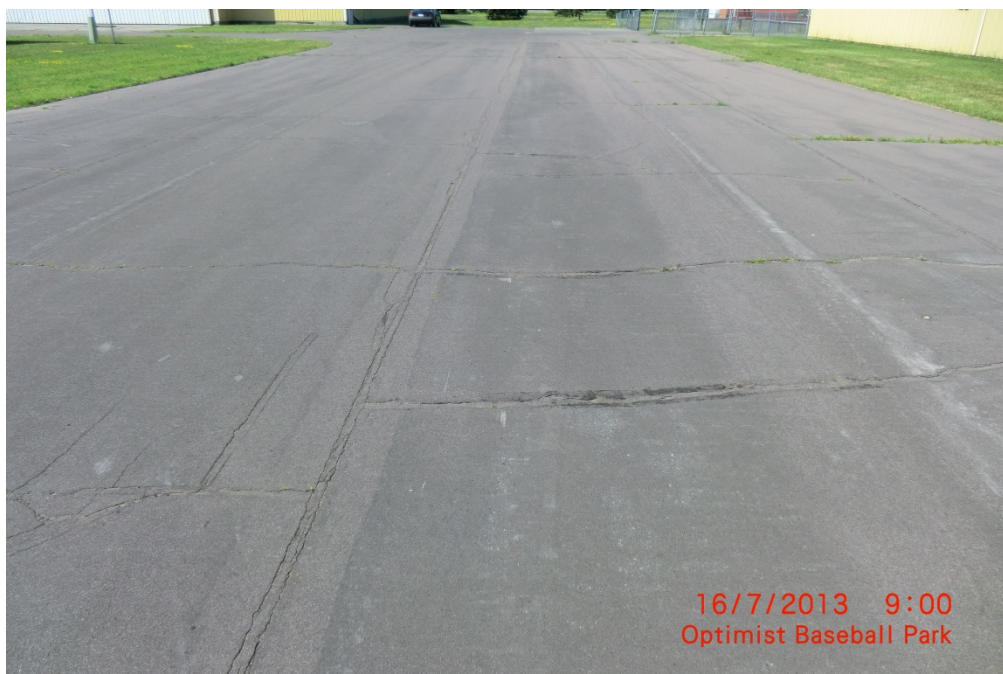
| Branch ID | Section ID | Surface type <sup>1</sup> | Section area (SF) | LCD <sup>2</sup> | 2010 PCI | 2013 PCI | Drop in PCI/Yr <sup>3</sup> | % Deduct due to | | Distress types |
|---|---|---|---|---|---|---|---|---|---|---|
| TLA | 1 | AC | 26,480 | 1989* | 61 | 53 | 2.0 | 41 | 59 | Alligator cracking, Block cracking, L&T cracking, Rutting |

LJF TLA 001 (PCI = 53)

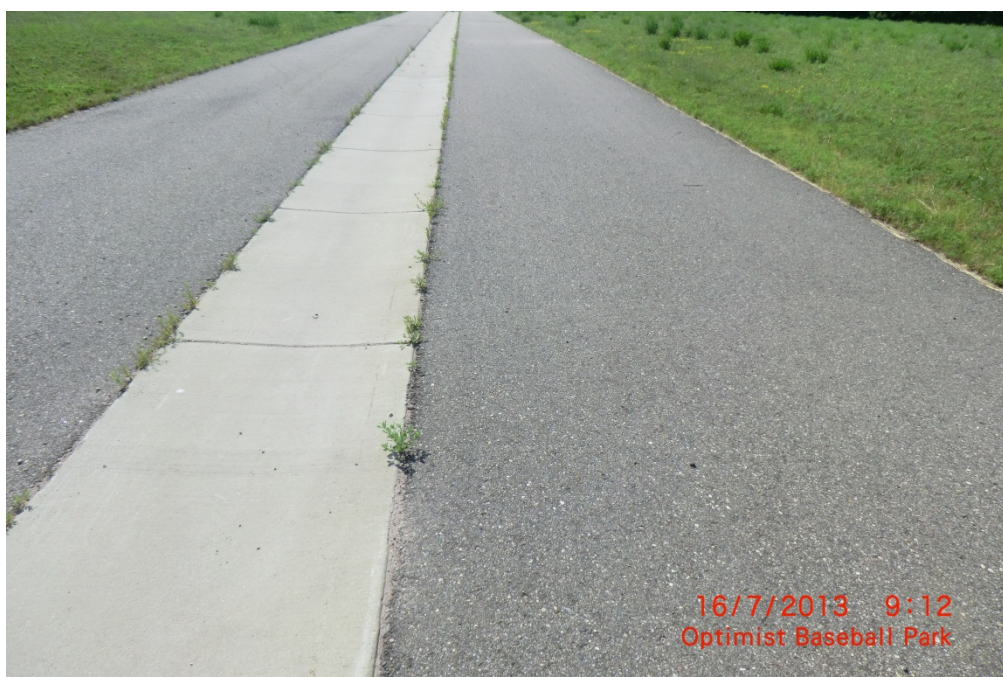
LJF TLA 002 (PCI = 100)

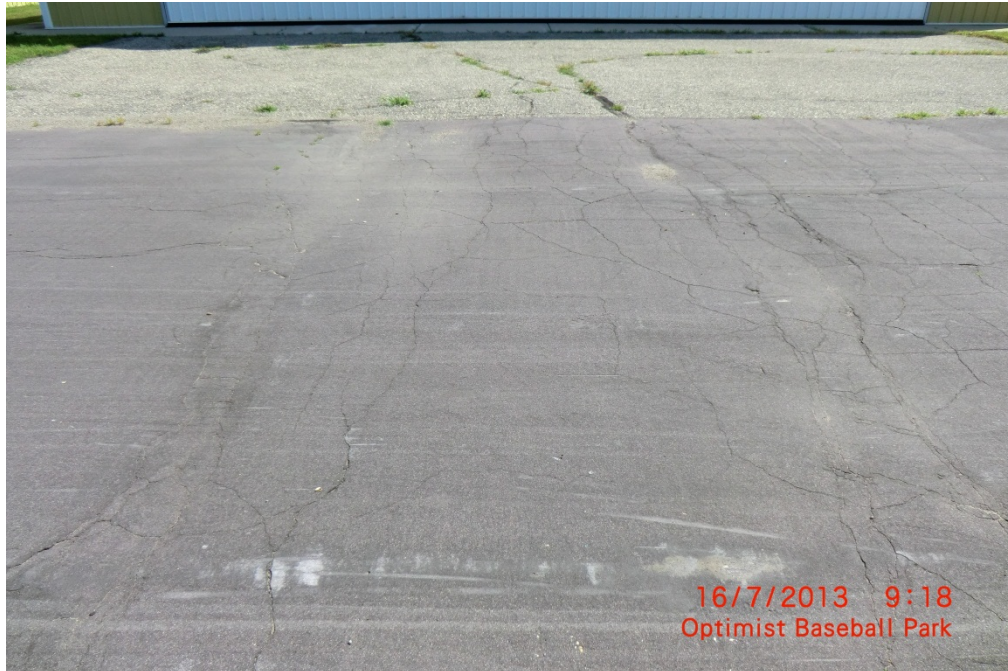
LJF TLA 001 (Medium-Severity Alligator Cracking & Low-Severity Rutting)
