Minnesota Airport System Pavement Evaluation 2013 Update

Jackson Municipal Airport (MJQ)

Final Report

Applied Research Associates, Inc.
100 Trade Centre Dr., Suite 200
Champaign, IL 61820
(217) 356-4500

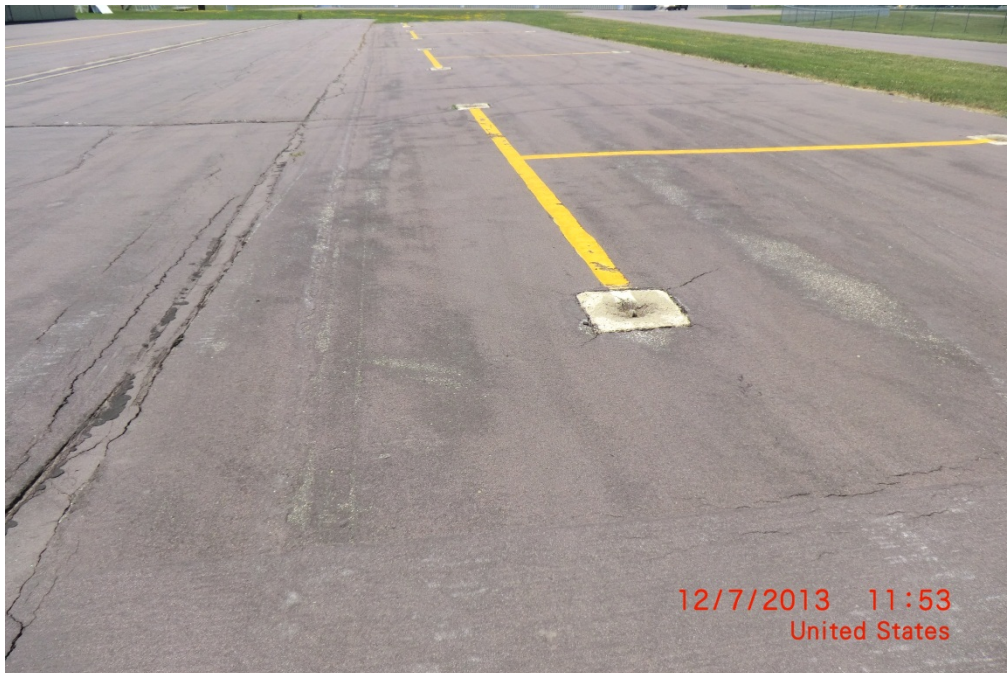
MJQ APA 004 (PCI = 72)

Note: The crack sealing project planned on RY1331, CTA, and CTB was accounted for during the inspection this year. The increase in PCI for APA-004 is due to variable conditions possibly caused by a frost heaved area.

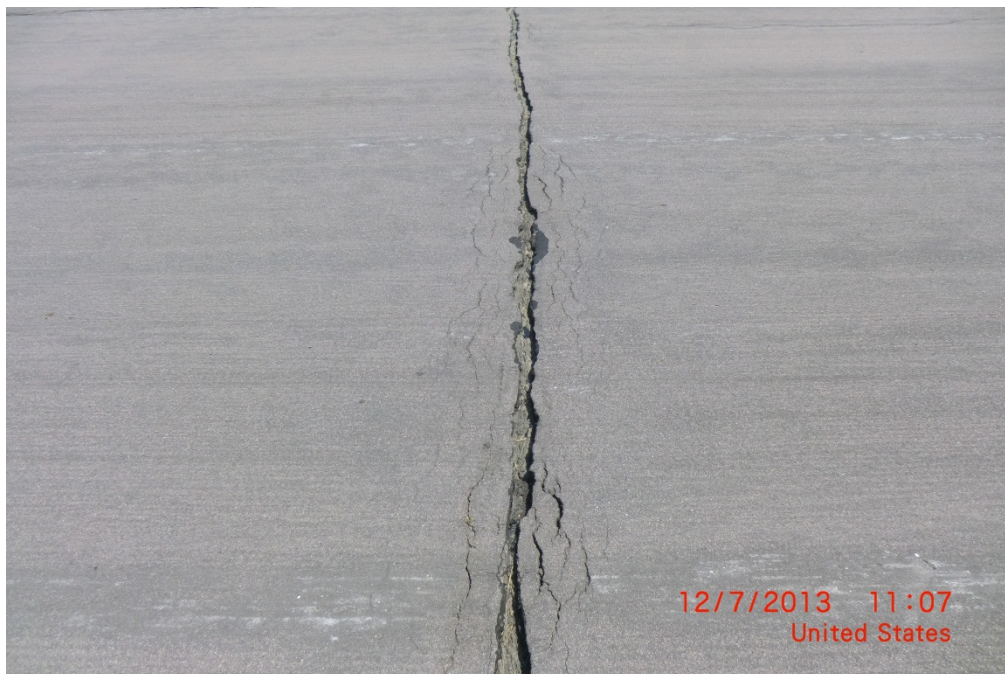
MJQ RY1331 003 (High-Severity L&T Crack)

Low severity longitudinal and transverse cracks are less than $\frac{1}{4}$ inch wide, or if sealed with suitable filler material in satisfactory condition can be any width, less than 3 inches, if they are not spalled. Maintenance usually is not indicated for low-severity cracking. Moderately spalled cracks and cracks wider than $\frac{1}{4}$ inch which are not satisfactorily sealed are at medium severity. Medium-severity cracks should be sealed with a high-quality crack filling material. Severely spalled cracks and cracks wider than 3 inches are at high severity. High-severity L&T cracks normally require patching.

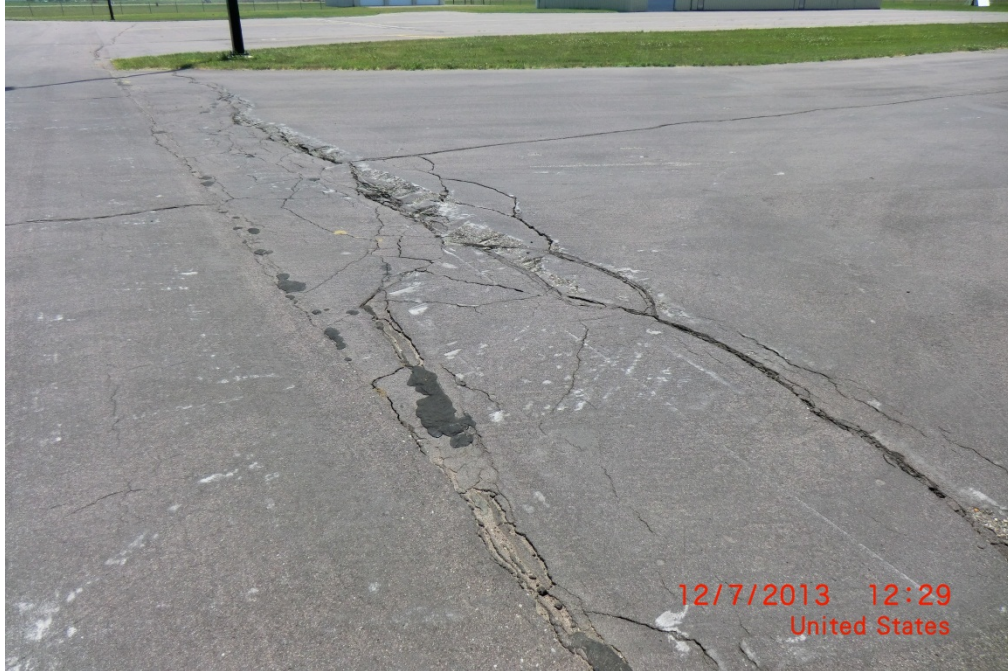
MJQ TLA 001 (Swelling)
