Minnesota Airport System Pavement Evaluation 2013 Update

Morris Municipal Airport (MOX)

Morris, Minnesota

Final Report

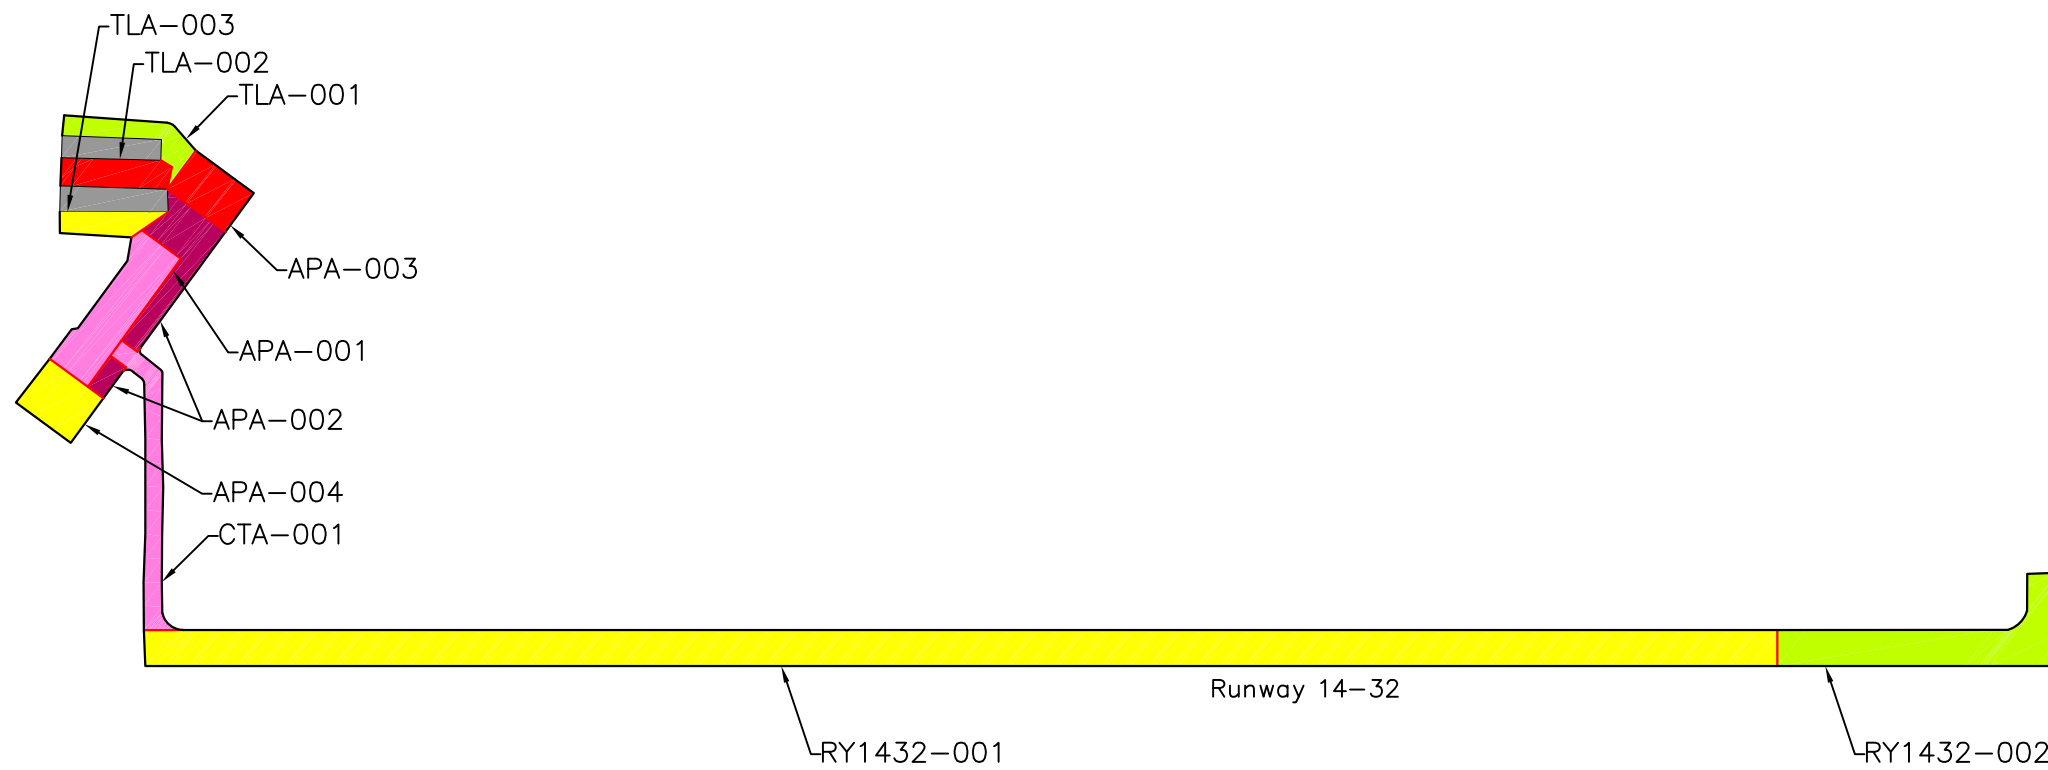
Figure 4. 2013 Pavement Condition Index Rating at Morris Municipal Airport (MOX).

Figures 5 and 6 present the overall PCI for MOX by area distribution and pavement use, respectively. Table 3 presents the PCI summary for each section at MOX, including the drop in PCI per year. Generally, pavement sections will deteriorate between 1 and 3 PCI points per year. Sections deteriorating at higher rates may need maintenance above the normal application rates and should be closely monitored in case major repairs become necessary.

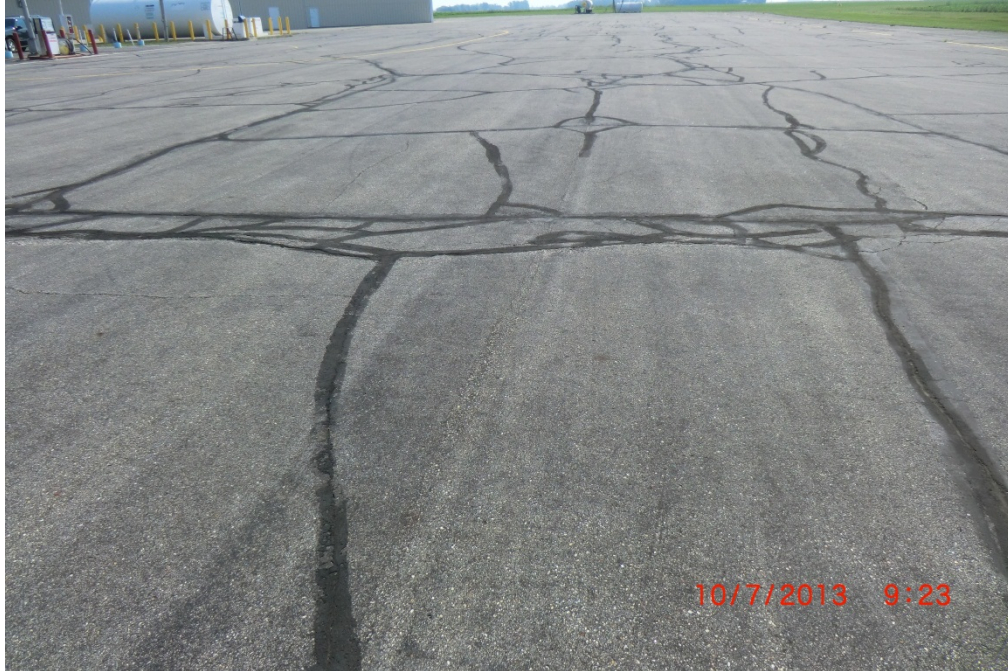
MOX APA 001 (PCI = 46)

Conditions: PCI : 46

41 ALLIGATOR CRACKING	L	28.00 SqFt	Comments:
41 ALLIGATOR CRACKING	M	42.00 SqFt	Comments:
48 LONGITUDINAL/TRANSVERSE CRACKING	L	744.00 Ft	Comments:
48 LONGITUDINAL/TRANSVERSE CRACKING	M	57.00 Ft	Comments:
48 LONGITUDINAL/TRANSVERSE CRACKING	H	4.00 Ft	Comments:

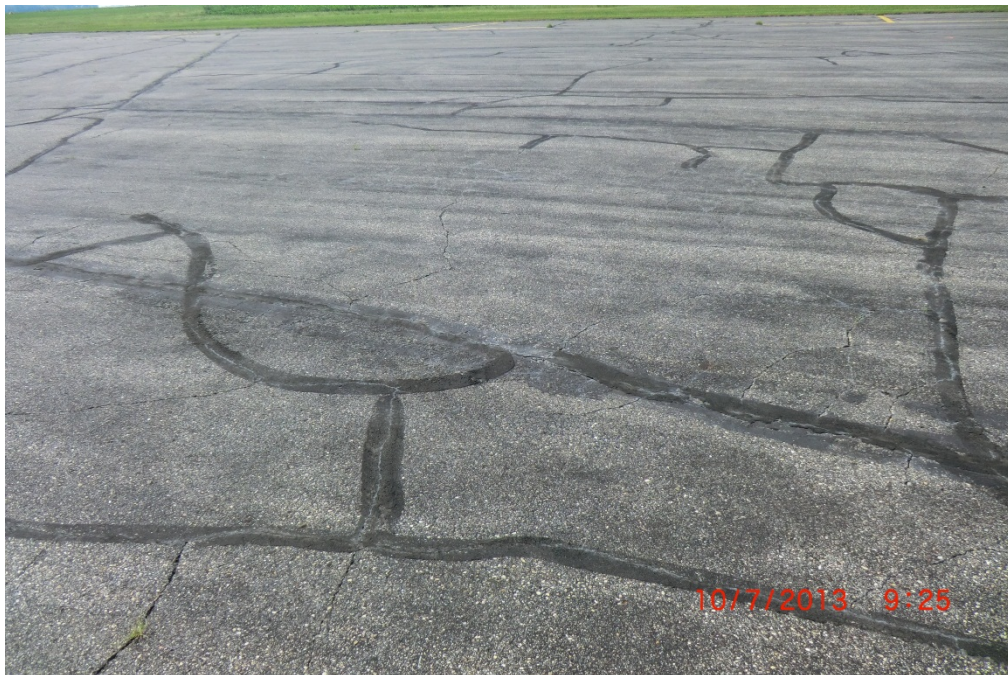
MOX APA 002 (PCI = 25)

Conditions: PCI : 25

48	LONGITUDINAL/TRANSVERSE CRACKING	L	425.00 Ft	Comments:
48	LONGITUDINAL/TRANSVERSE CRACKING	M	37.00 Ft	Comments:
48	LONGITUDINAL/TRANSVERSE CRACKING	H	2.00 Ft	Comments:
41	ALLIGATOR CRACKING	M	178.00 SqFt	Comments:
53	RUTTING	L	42.00 SqFt	Comments:

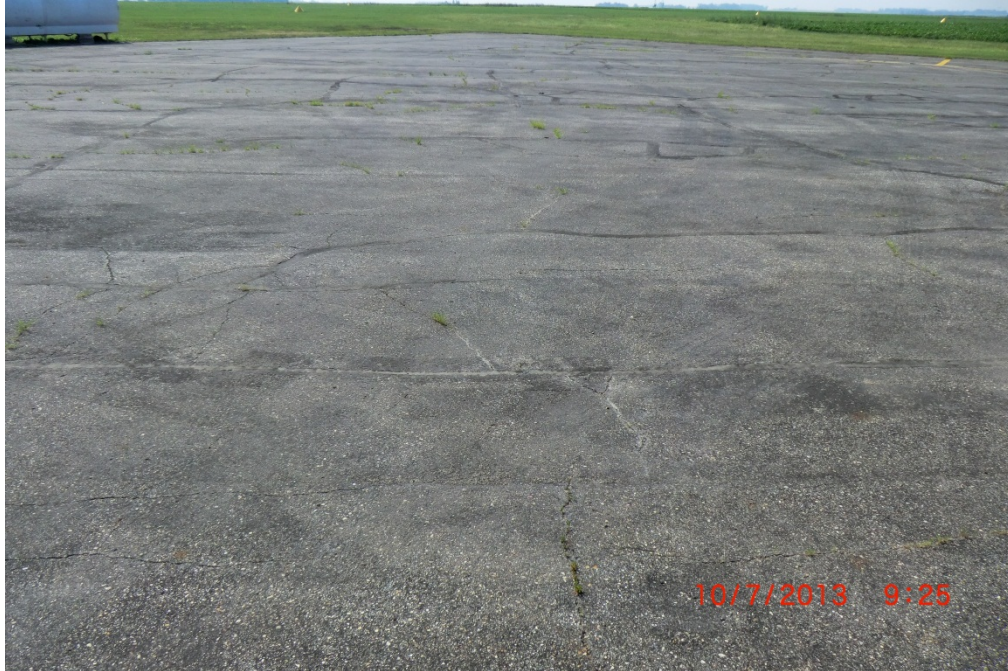
MOX APA 003 (PCI = 30)

Conditions: PCI: 30

41 ALLIGATOR CRACKING	M	105.00 SqFt	Comments:
43 BLOCK CRACKING	L	4,000.00 SqFt	Comments:
45 DEPRESSION	L	240.00 SqFt	Comments:
45 DEPRESSION	M	120.00 SqFt	Comments:
48 LONGITUDINAL/TRANSVERSE CRACKING	L	111.00 Ft	Comments:
48 LONGITUDINAL/TRANSVERSE CRACKING	M	8.00 Ft	Comments:
52 RAVELING	H	1.00 SqFt	Comments:

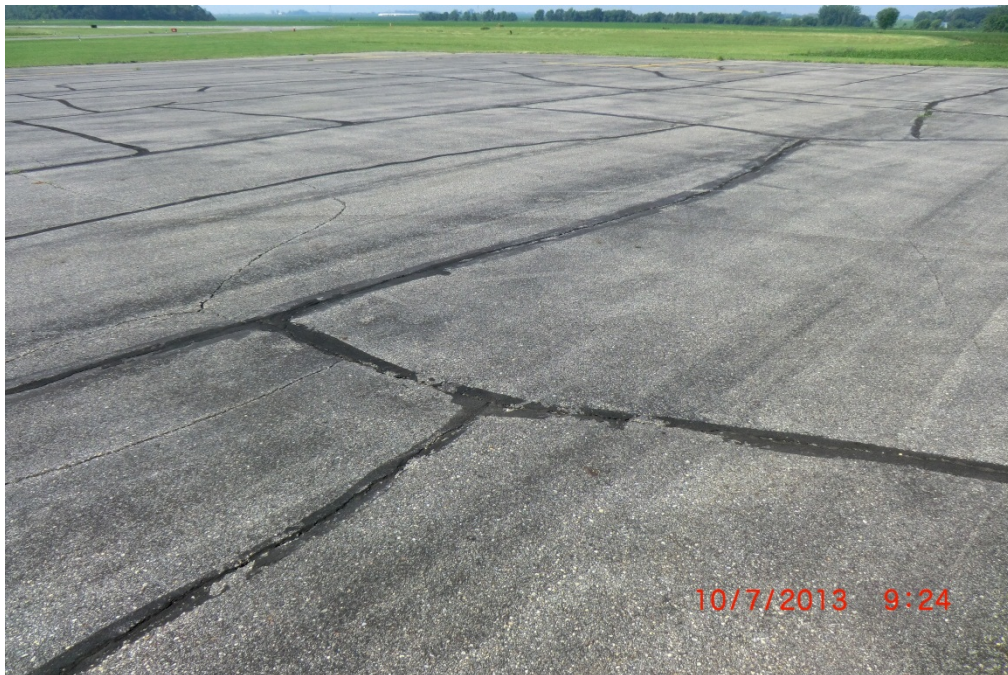
MOX APA 004 (PCI = 59)

Conditions: PCI: 59

48 LONGITUDINAL/TRANSVERSE CRACKING L 950.00 Ft Comments:

48 LONGITUDINAL/TRANSVERSE CRACKING M 10.00 Ft Comments:

41 ALLIGATOR CRACKING L 3.00 SqFt Comments:

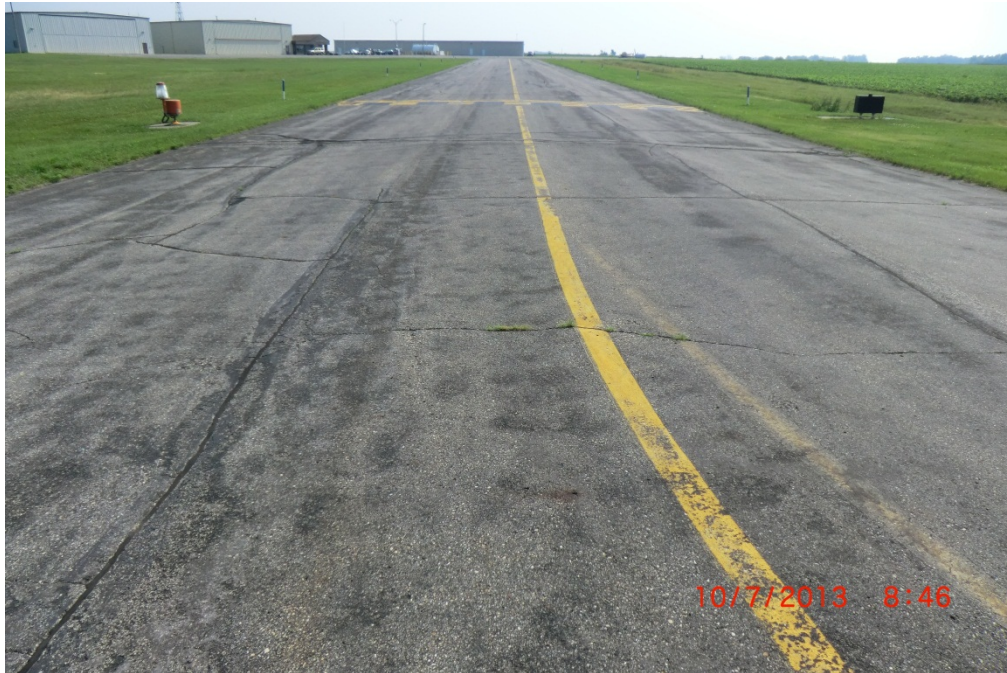
MOX CTA 001 (PCI = 51)

Conditions: PCI : 51

50 PATCHING	L	432.00 SqFt	Comments:
50 PATCHING	M	144.00 SqFt	Comments:
48 LONGITUDINAL/TRANSVERSE CRACKING	L	437.00 Ft	Comments:
48 LONGITUDINAL/TRANSVERSE CRACKING	M	21.00 Ft	Comments:
48 LONGITUDINAL/TRANSVERSE CRACKING	H	4.00 Ft	Comments:
41 ALLIGATOR CRACKING	L	51.00 SqFt	Comments:
41 ALLIGATOR CRACKING	M	38.00 SqFt	Comments:
56 SWELLING	L	15.00 SqFt	Comments:
52 RAVELING	M	45.00 SqFt	Comments:

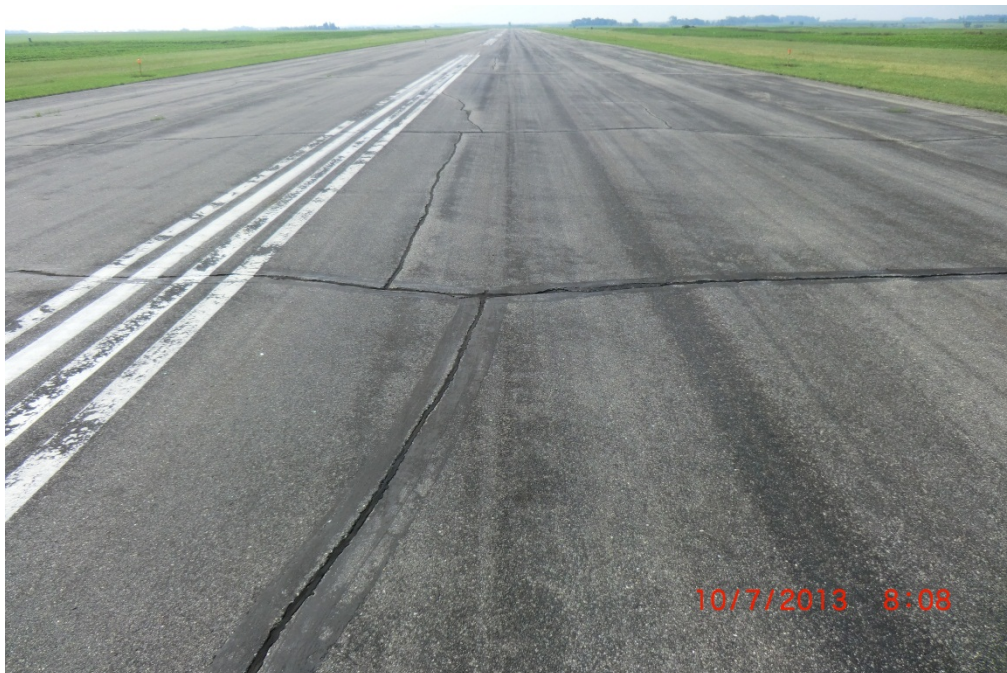
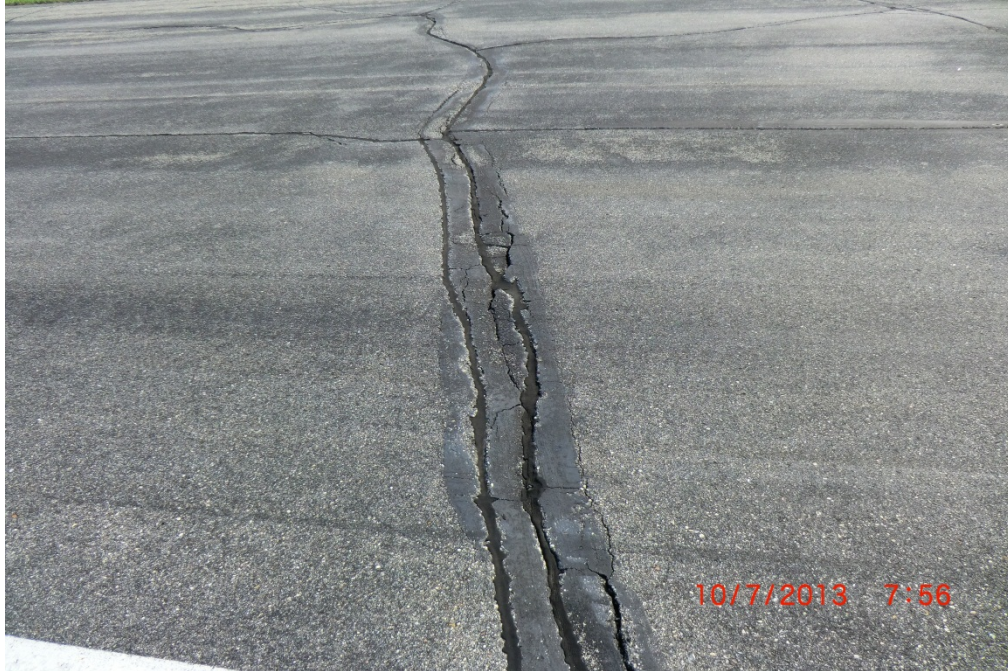
MOX RY1432 001 (PCI = 69)

Conditions: PCI: 69

48 LONGITUDINAL/TRANSVERSE CRACKING L 407.00 Ft Comments:
48 LONGITUDINAL/TRANSVERSE CRACKING M 72.00 Ft Comments:

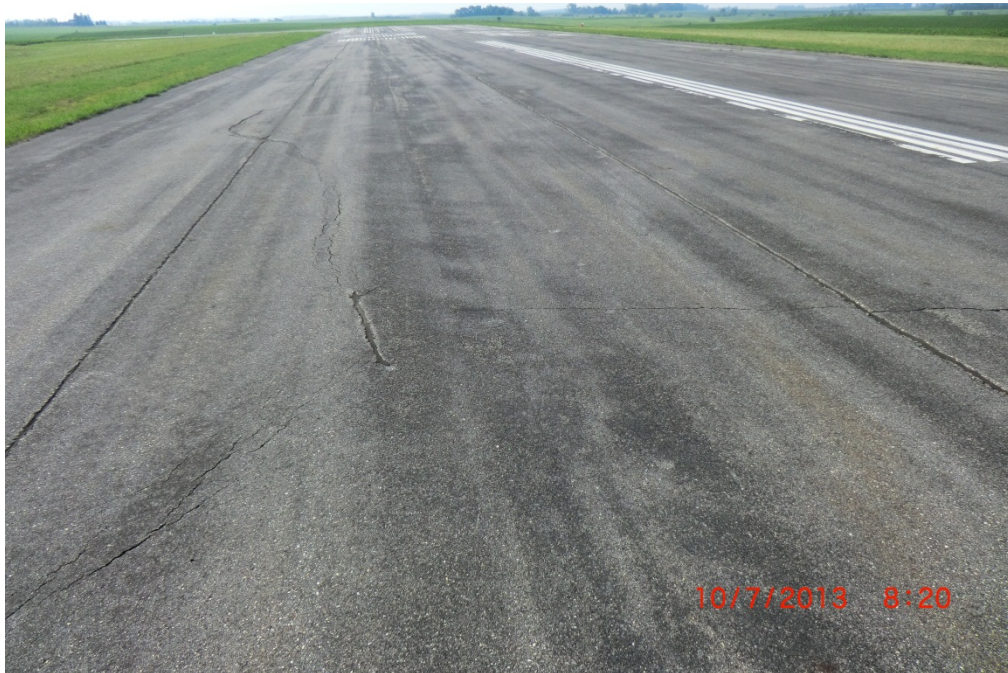
MOX RY1432 002 (PCI = 73)

Conditions: PCI: 73

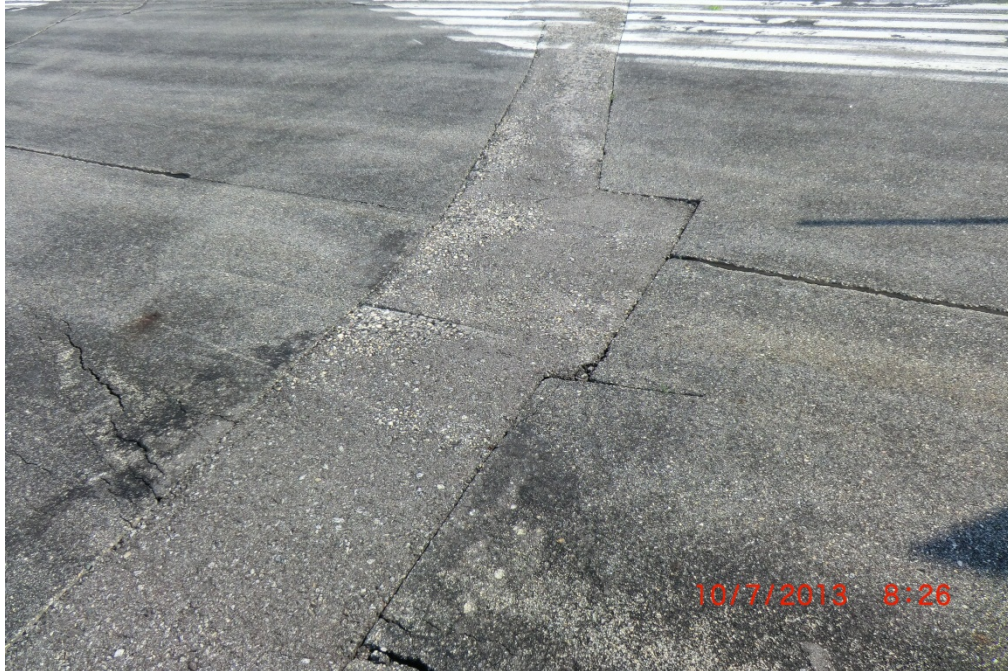
MOX RY1432 002 (Low-Severity Patch)

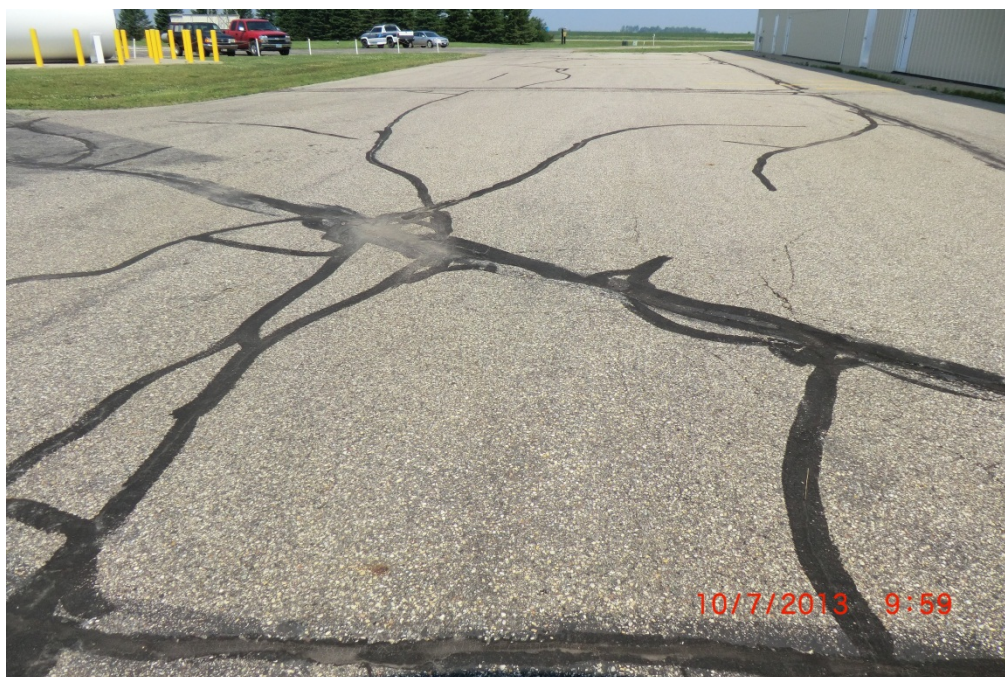
MOX TLA 003 (PCI = 56)

TLA	3	AC	9,500	1976*	69	56	1.2	44	56	Alligator cracking, L&T cracking, Patching
