Minnesota Airport System Pavement Evaluation 2013 Update

Owatonna – Degner Regional Airport
(OWA)

Final Report

Applied Research Associates, Inc.
100 Trade Centre Dr., Suite 200
Champaign, IL 61820
(217) 356-4500

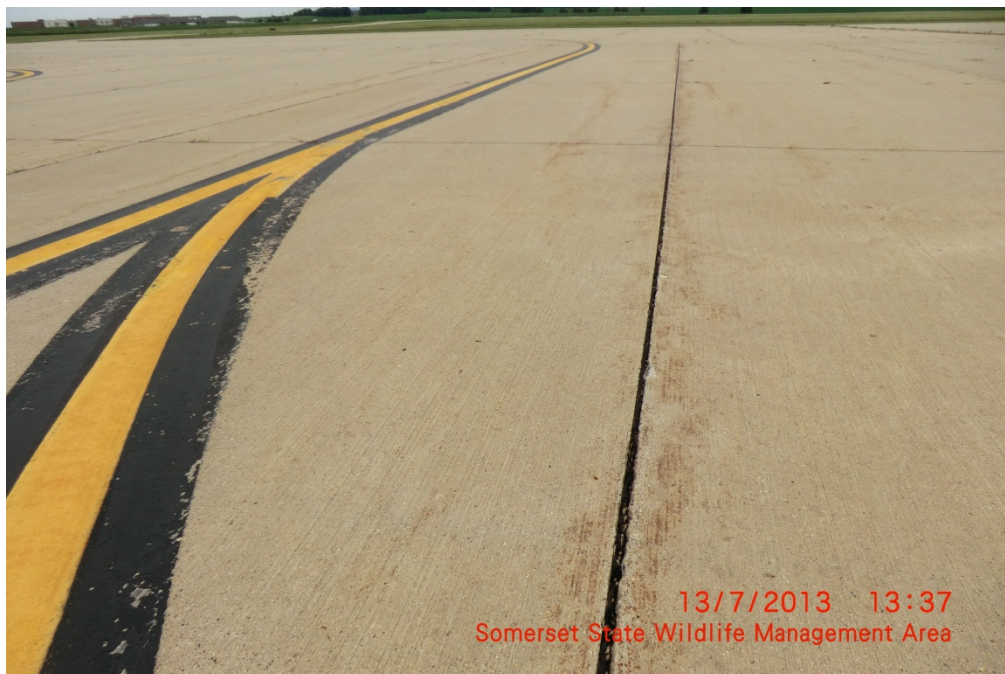
OWA APA 001 (PCI = 87)

Conditions: PCI : 87

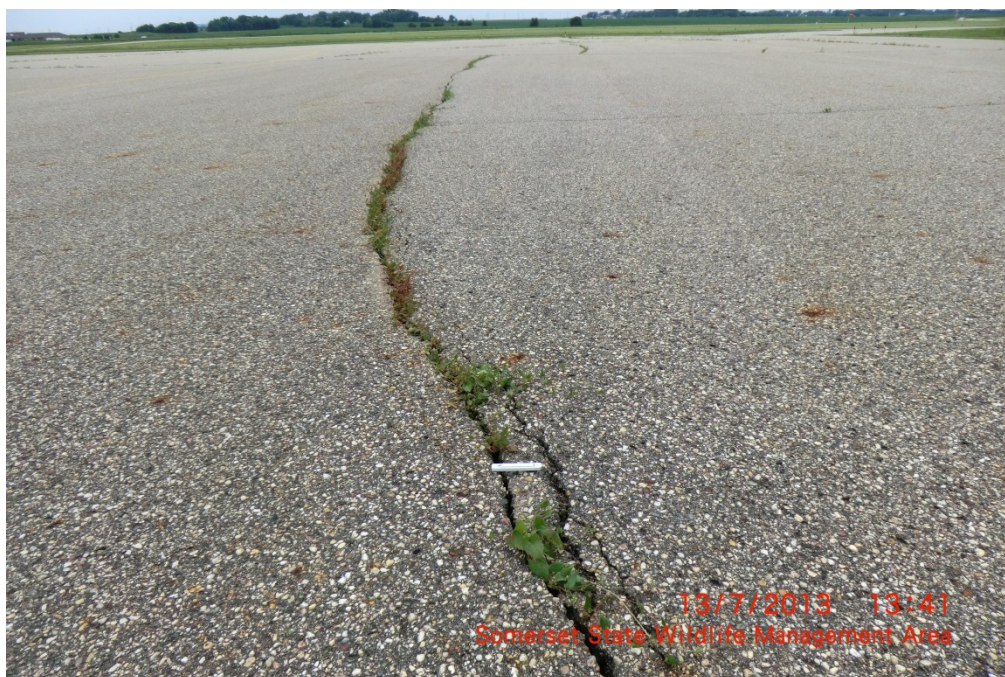
OWA APA 002 (PCI = 52)

Conditions: PCI: 52

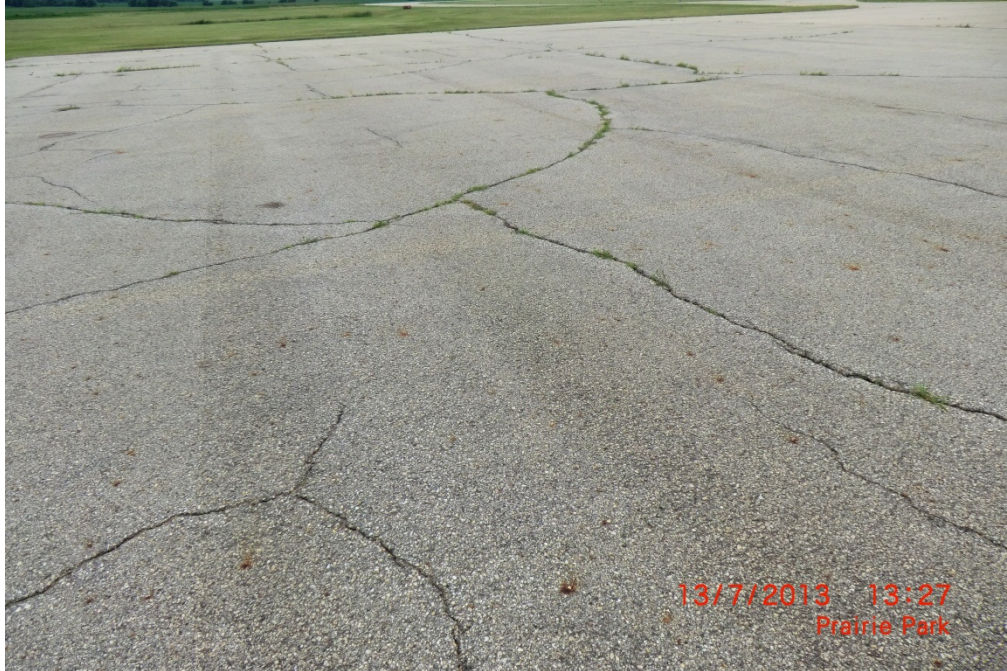
OWA APA 003 (PCI = 47)

Conditions: PCI: 47

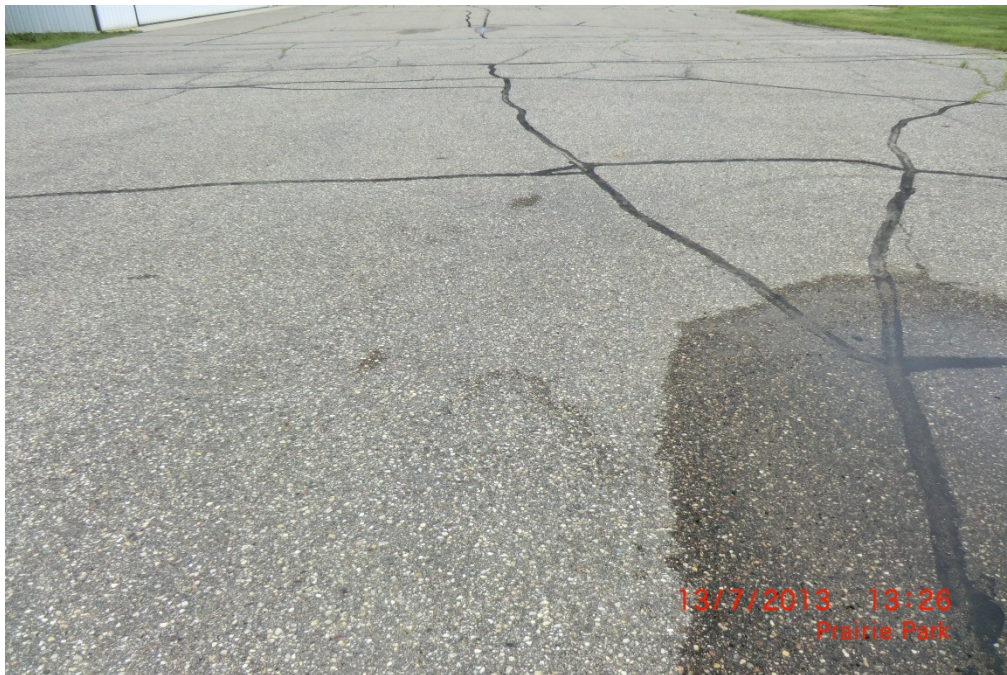
OWA APA 004 (PCI = 14, Medium and High-Severity Raveling Not Visible in Photo)

Conditions: PCI: 14

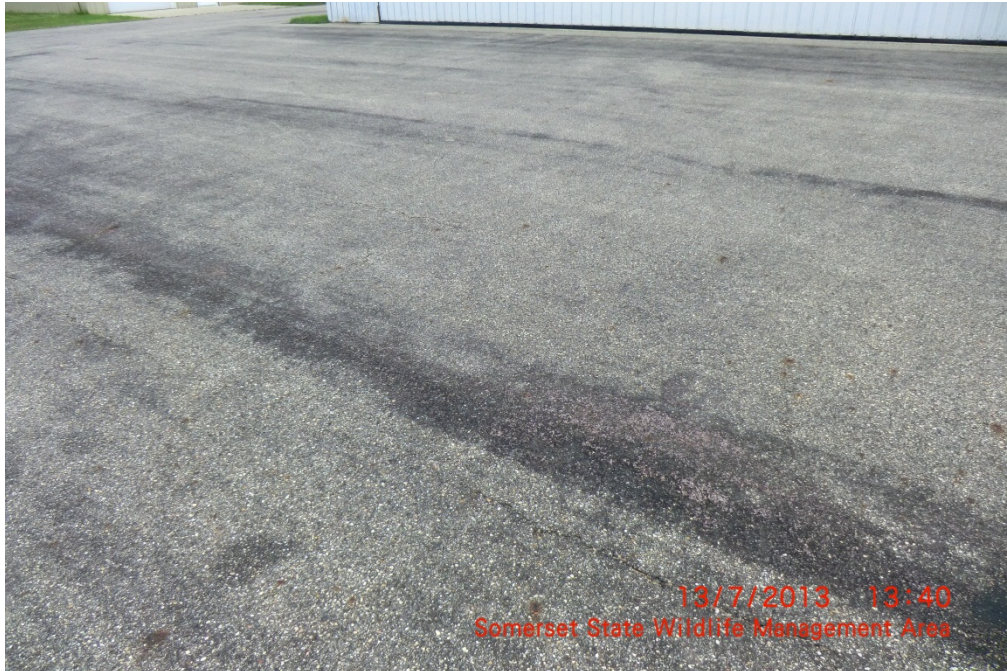
OWA APA 005 (PCI = 90)

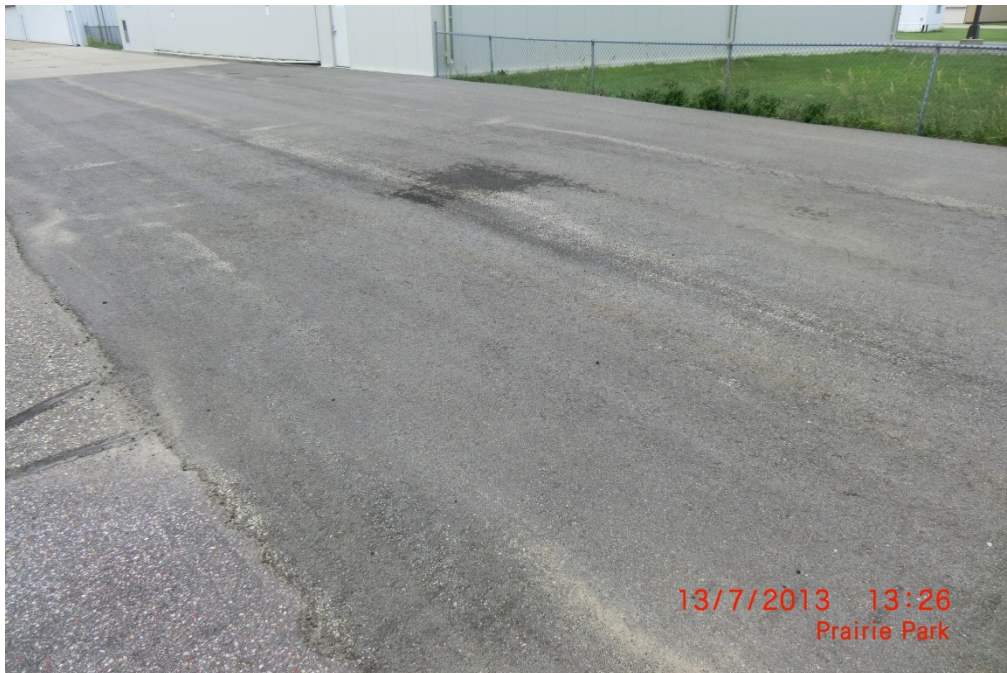
OWA APA 006 (PCI = 100)

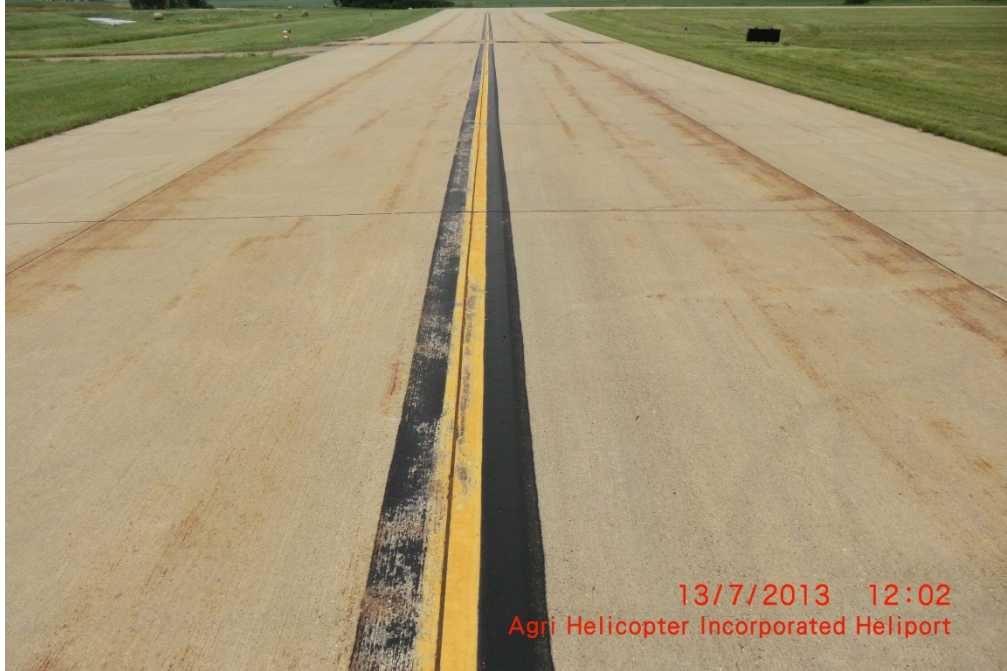
OWA CTA1 001 (PCI = 100)

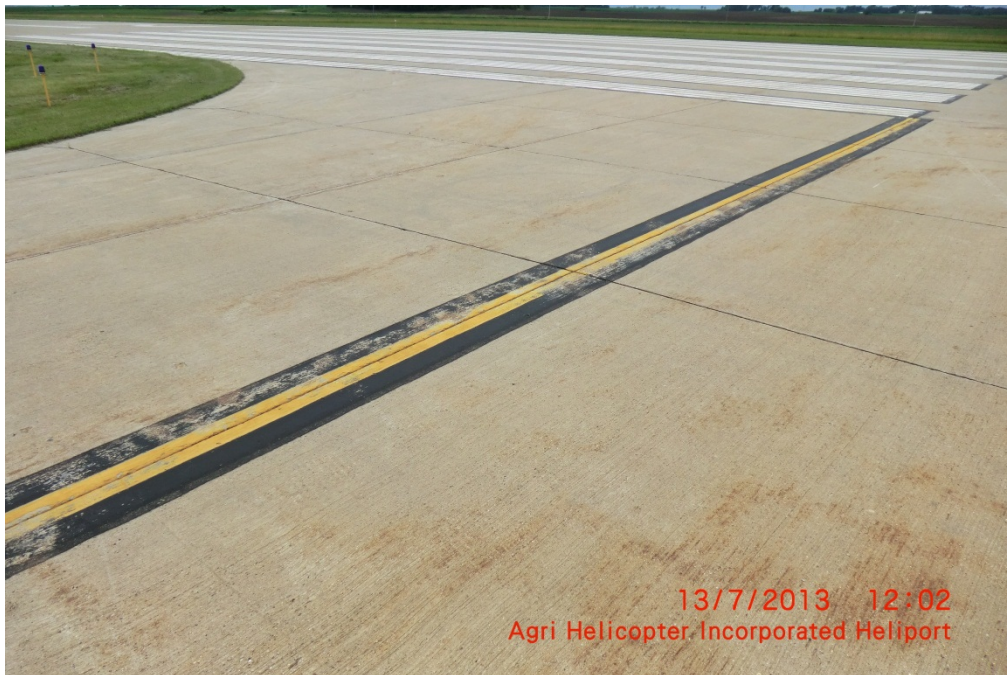
OWA CTA1 002 (PCI = 100)

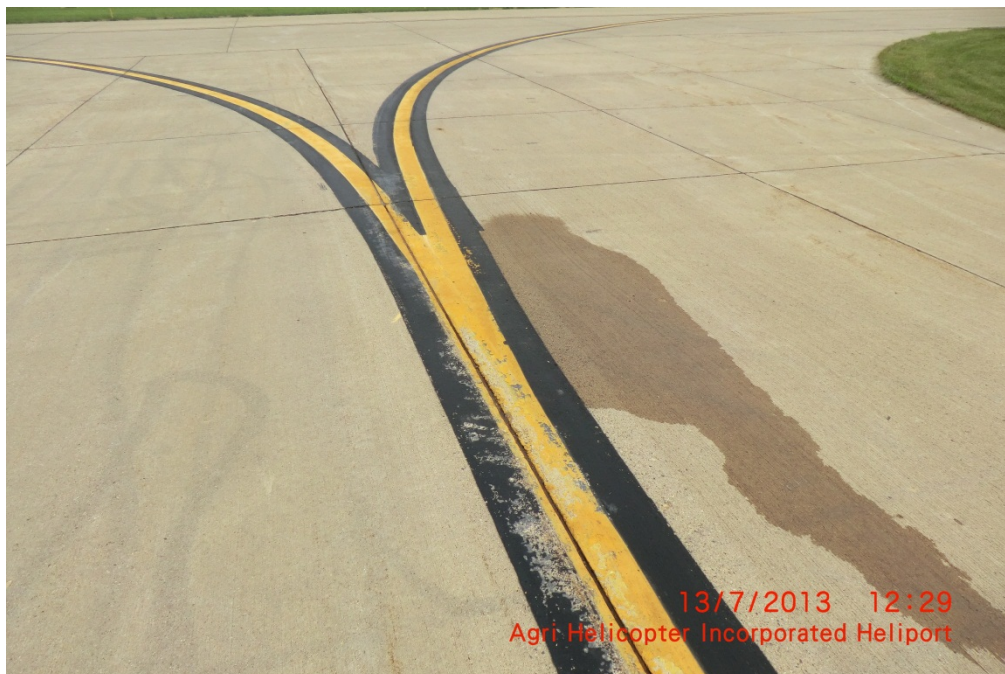
OWA CTA2 001 (PCI = 100)

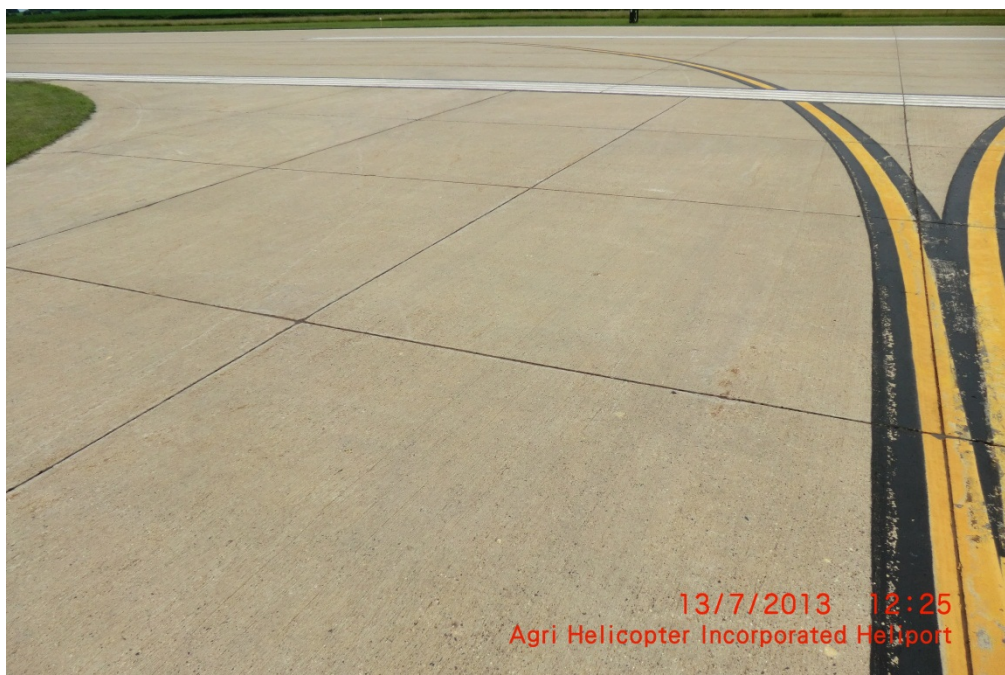
OWA CTA2 002 (PCI = 90)

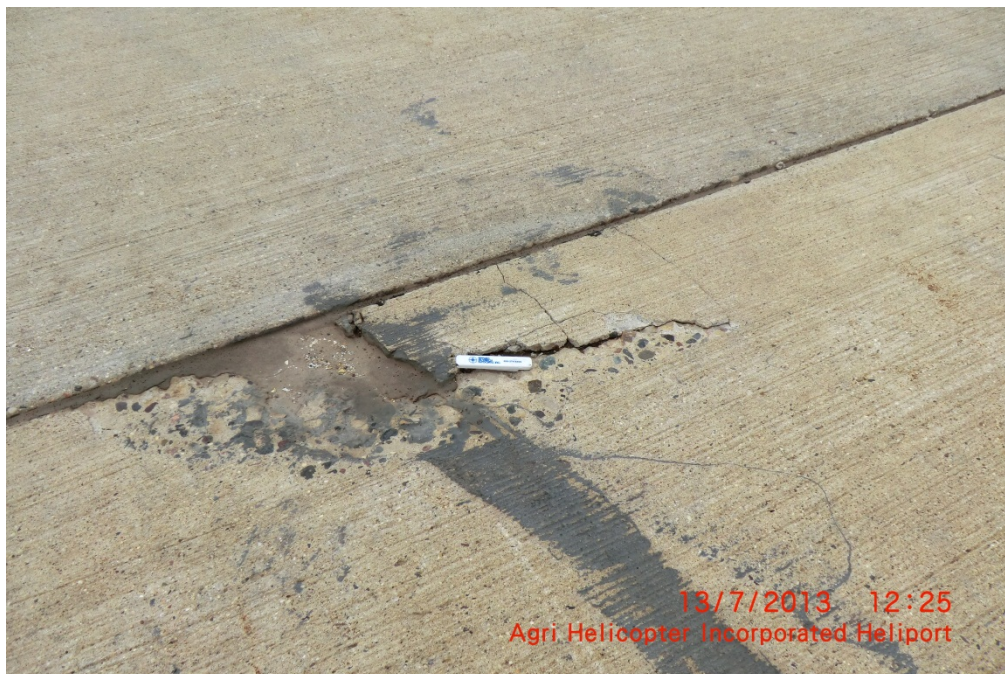
OWA CTA2 002 (High-Severity Joint Spall)

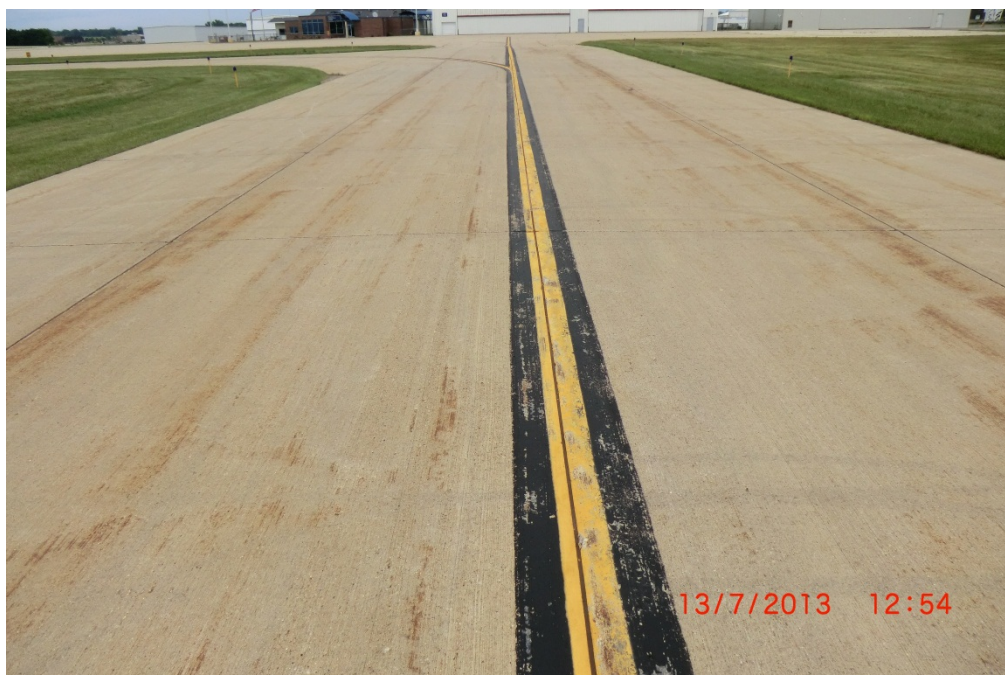
OWA CTA3 001 (PCI = 100)

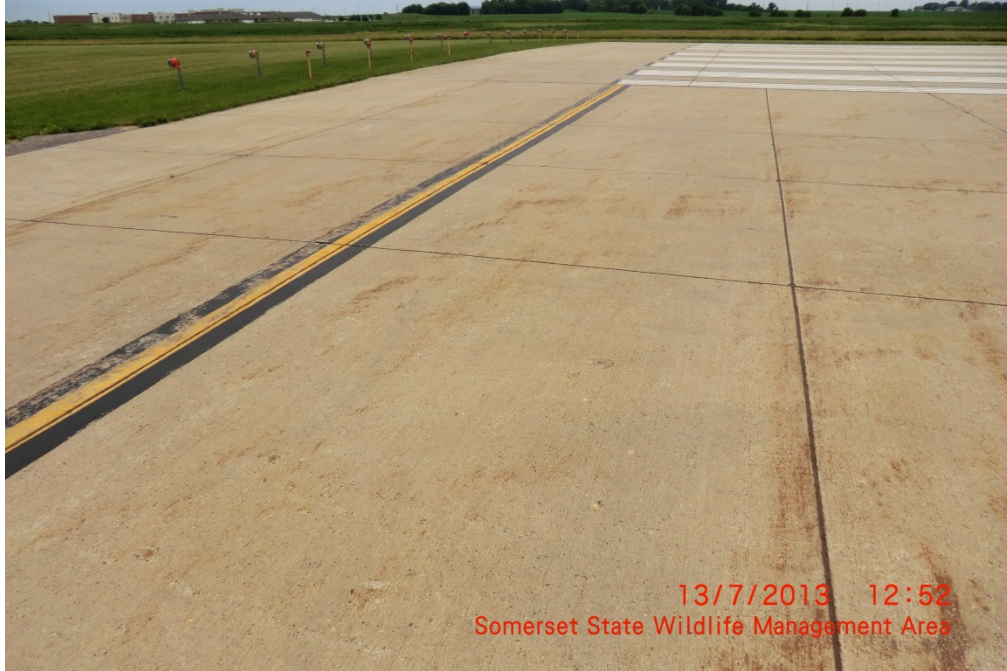
OWA CTA3 002 (PCI = 100)

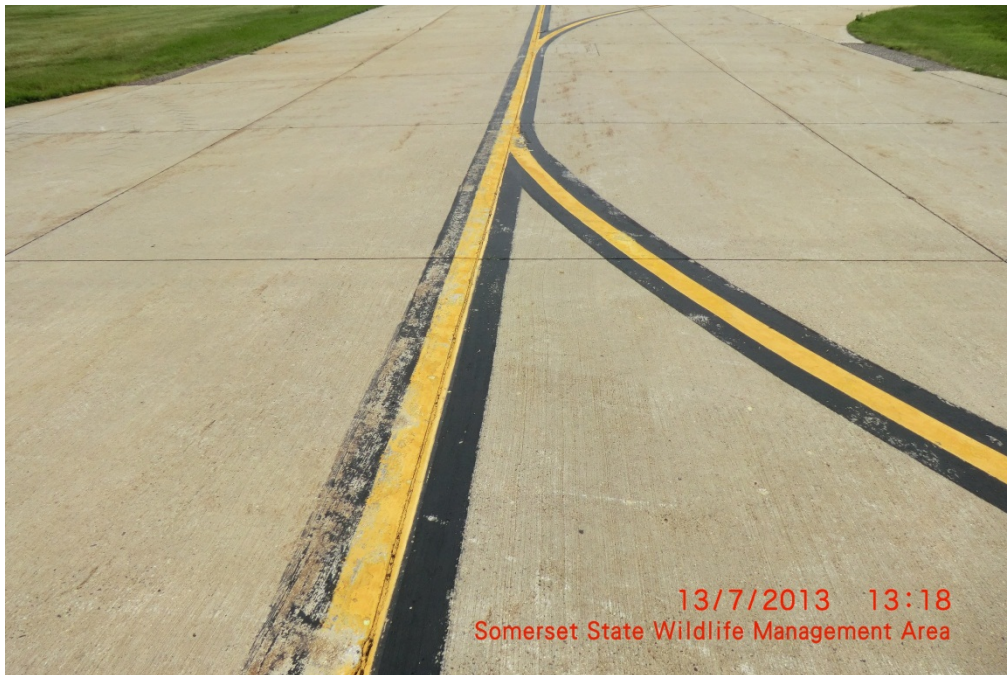
OWA CTA3X 001 (PCI = 70)

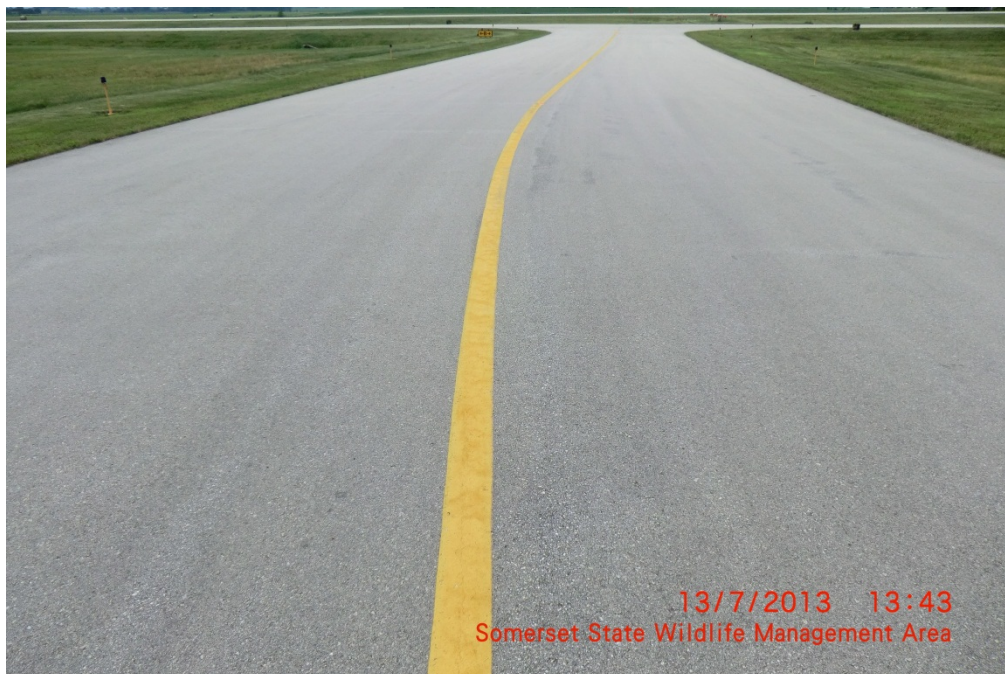
OWA CTB 001 (PCI = 89)

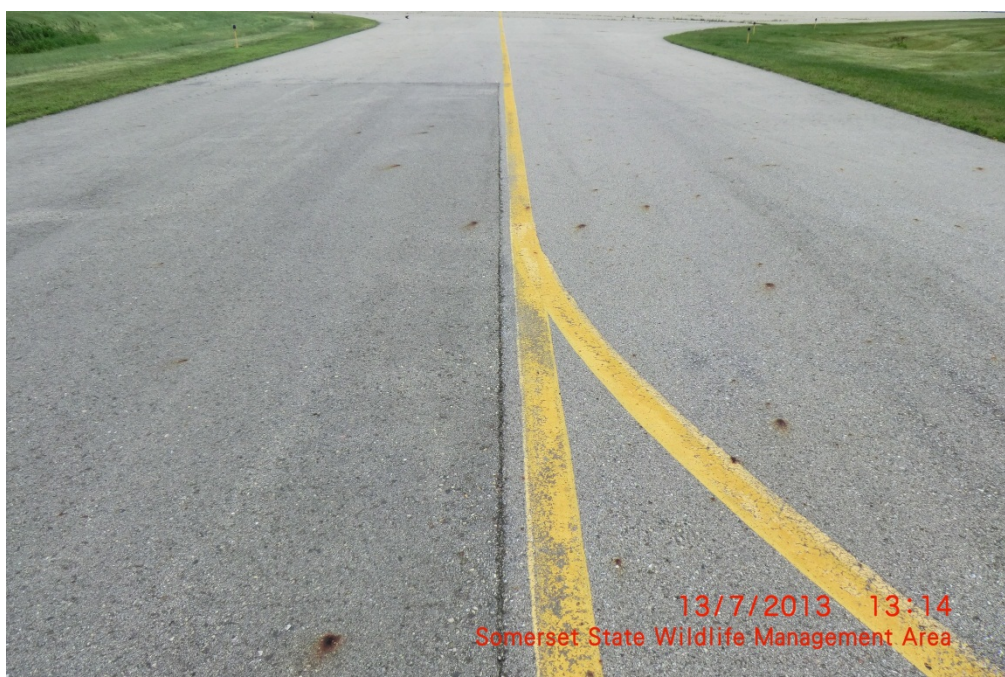
OWA CTRAMP 001 (PCI = 69)

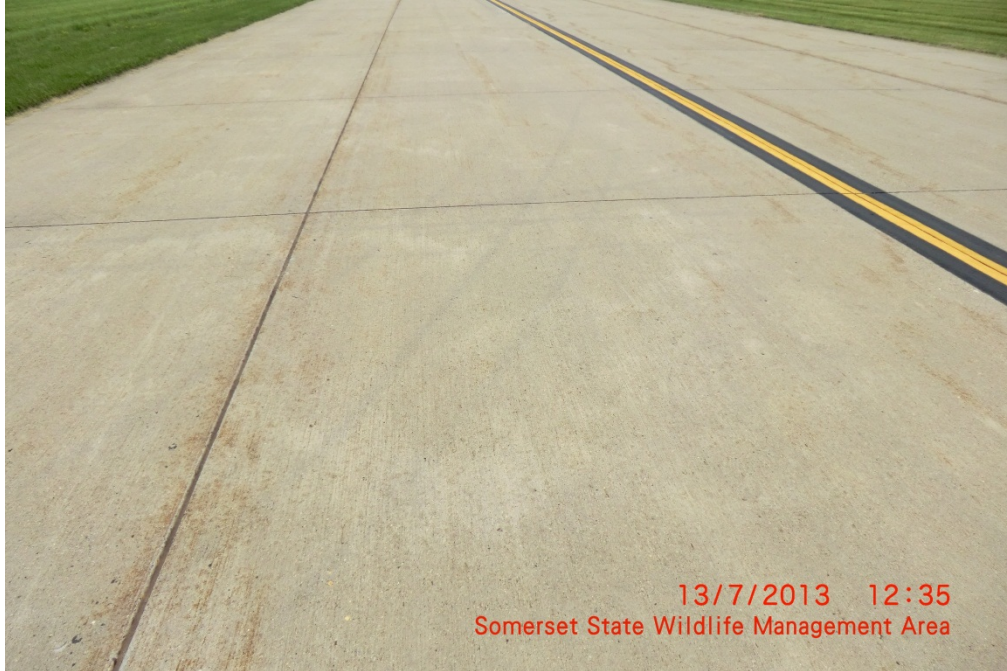
OWA PTA 001 (PCI = 100)

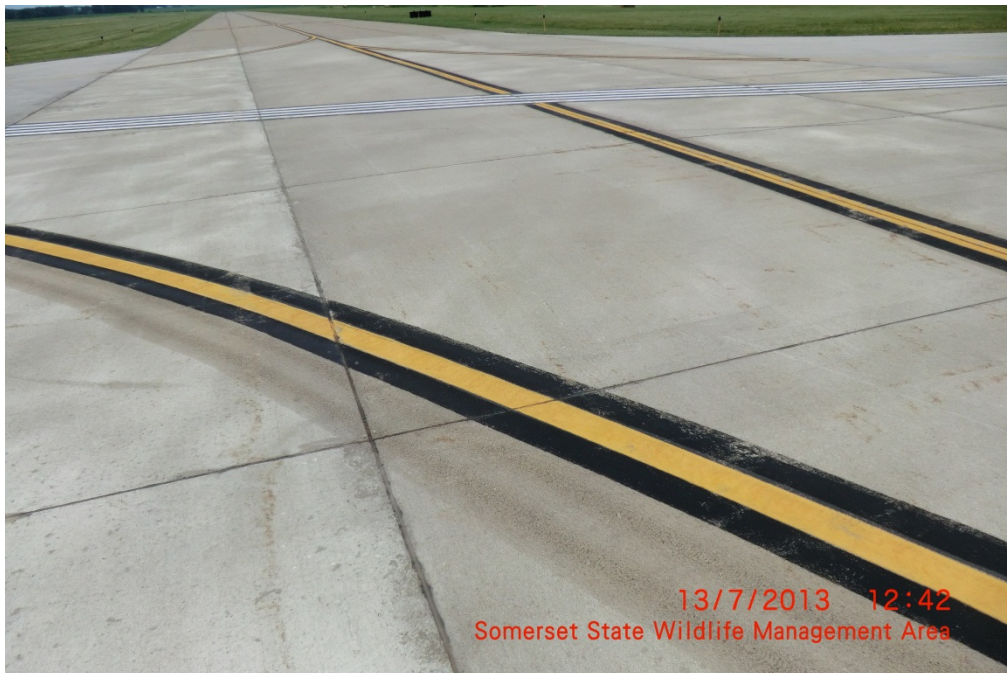
OWA PTA 002 (PCI = 96)

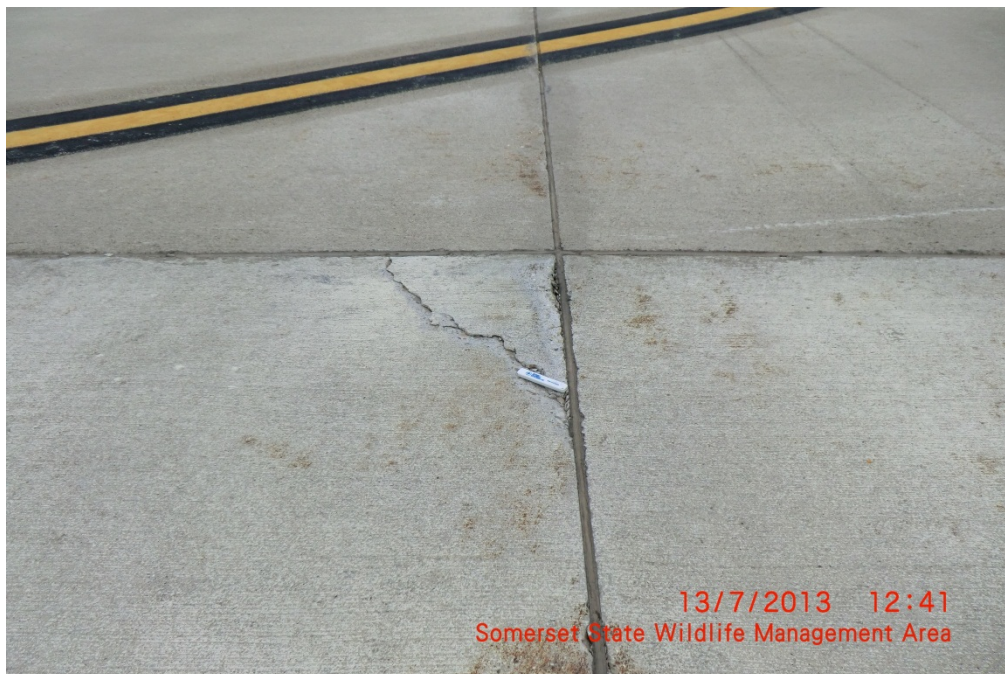
OWA PTA 002 (Medium-Severity Corner Spall)

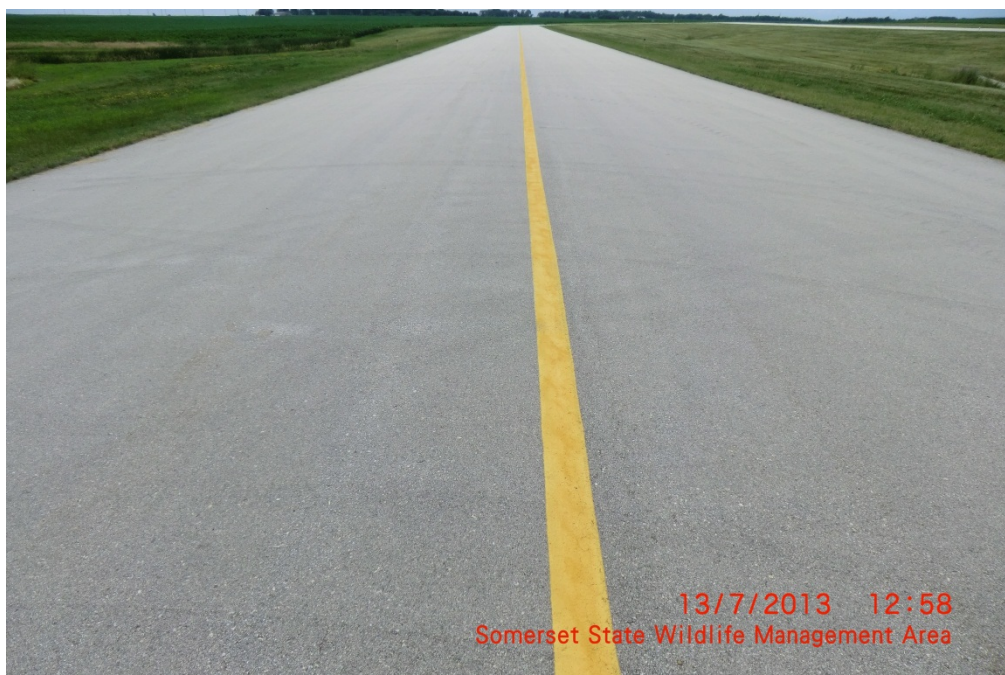
OWA PTB 001 (PCI = 96)

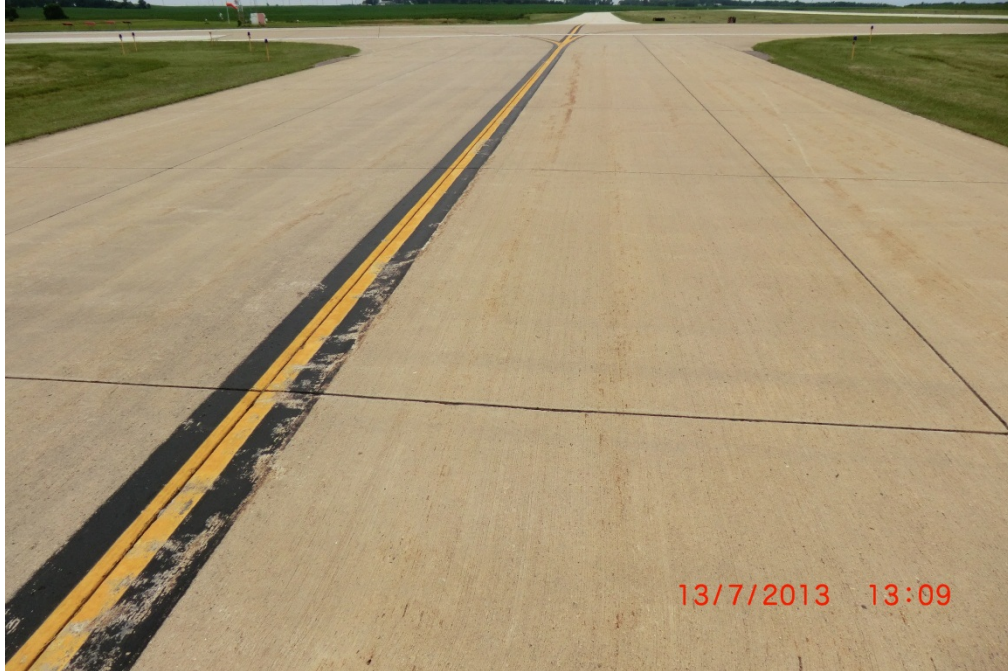
OWA PTB 002 (PCI = 100)

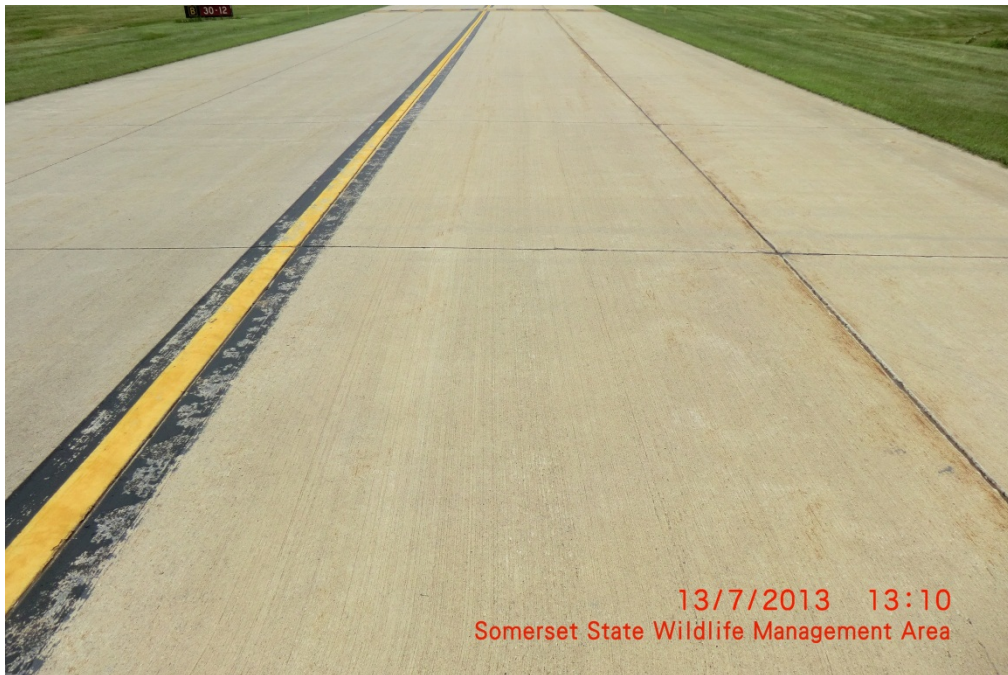
OWA PTB 003 (PCI = 100)

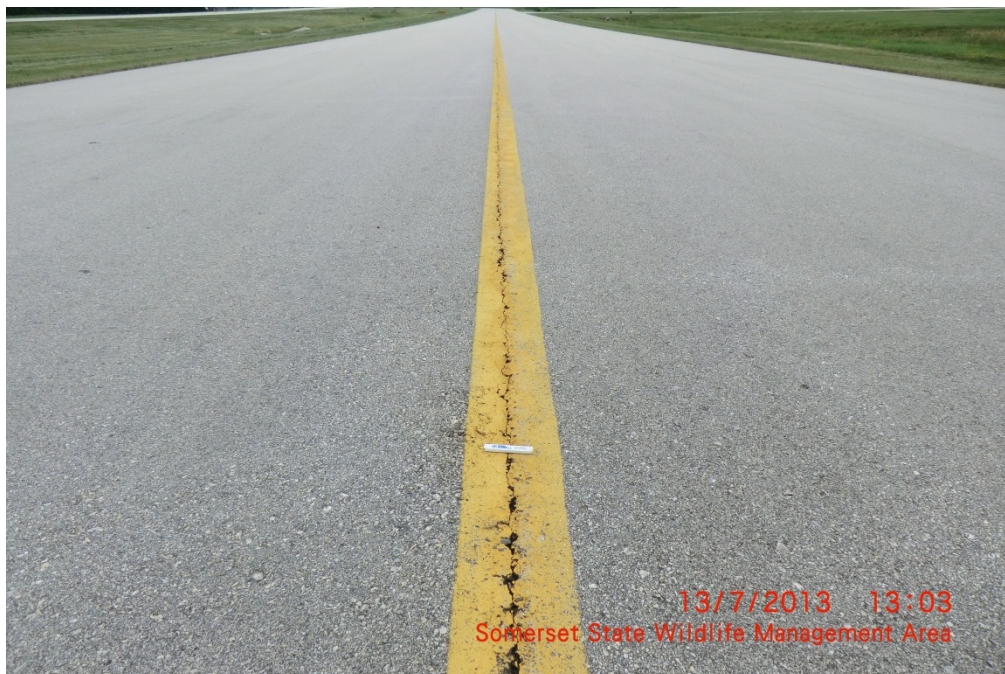
OWA PTB 004 (PCI = 96)

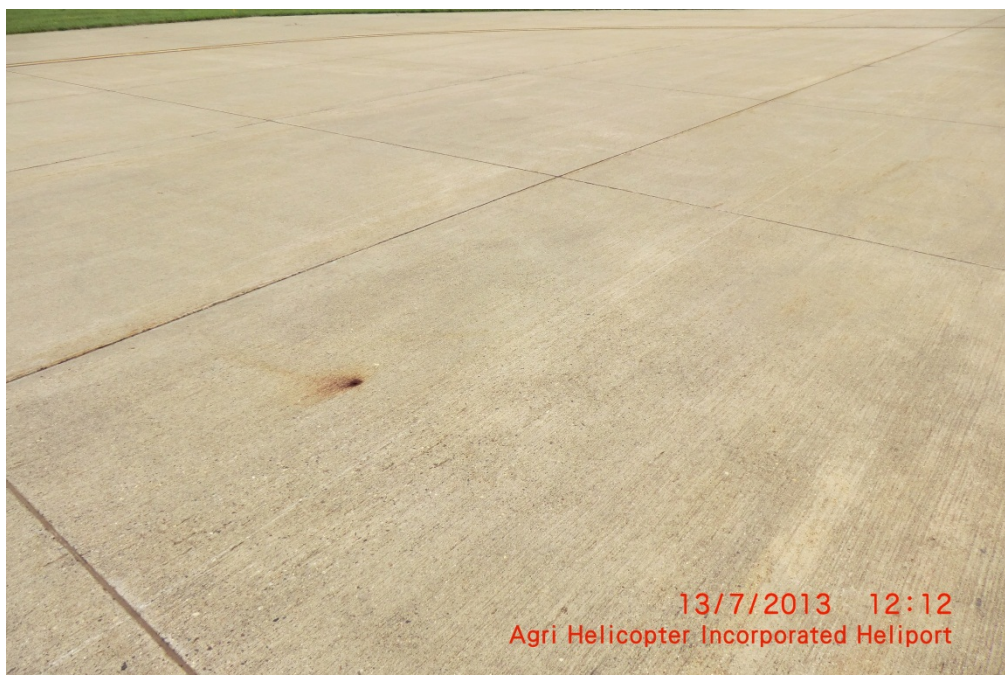
OWA RP12 001 (PCI = 100)

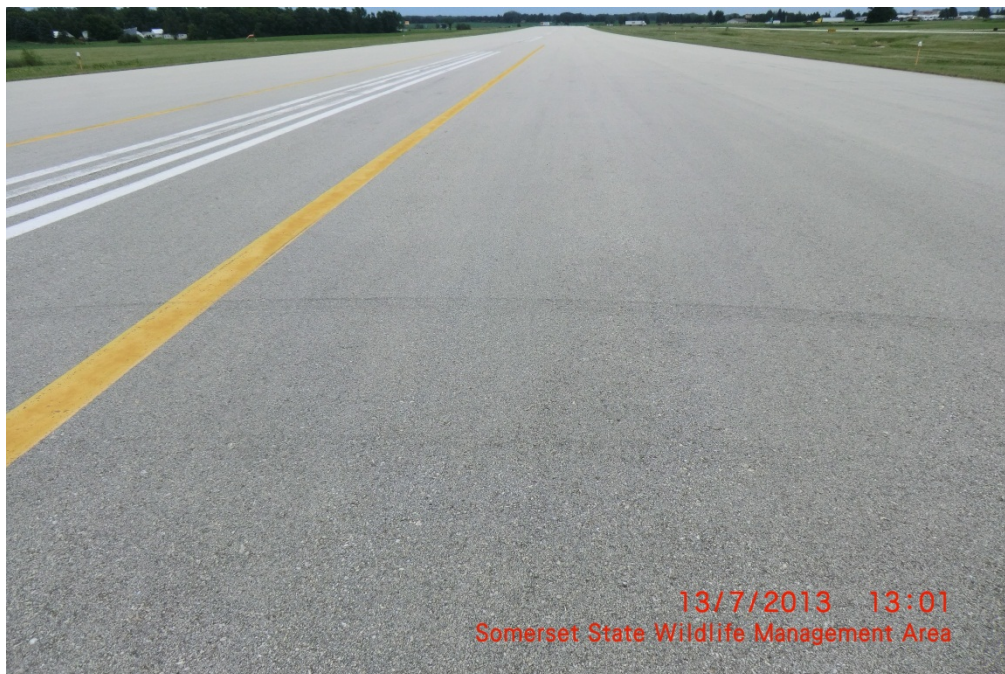
OWA RY523 001 (PCI = 96)

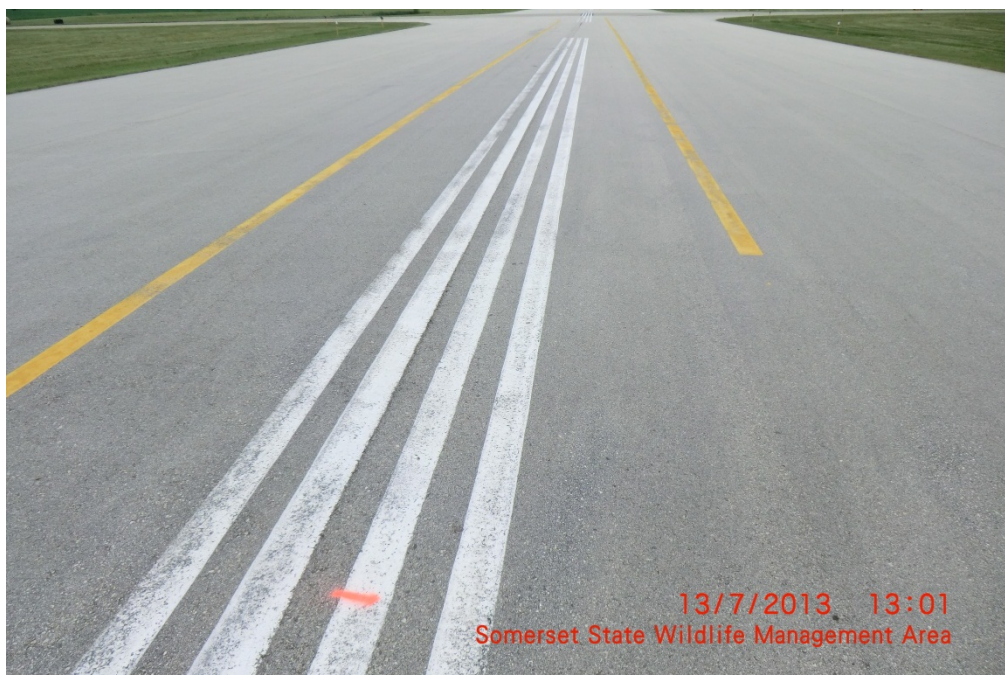
OWA RY523 002 (PCI = 92)

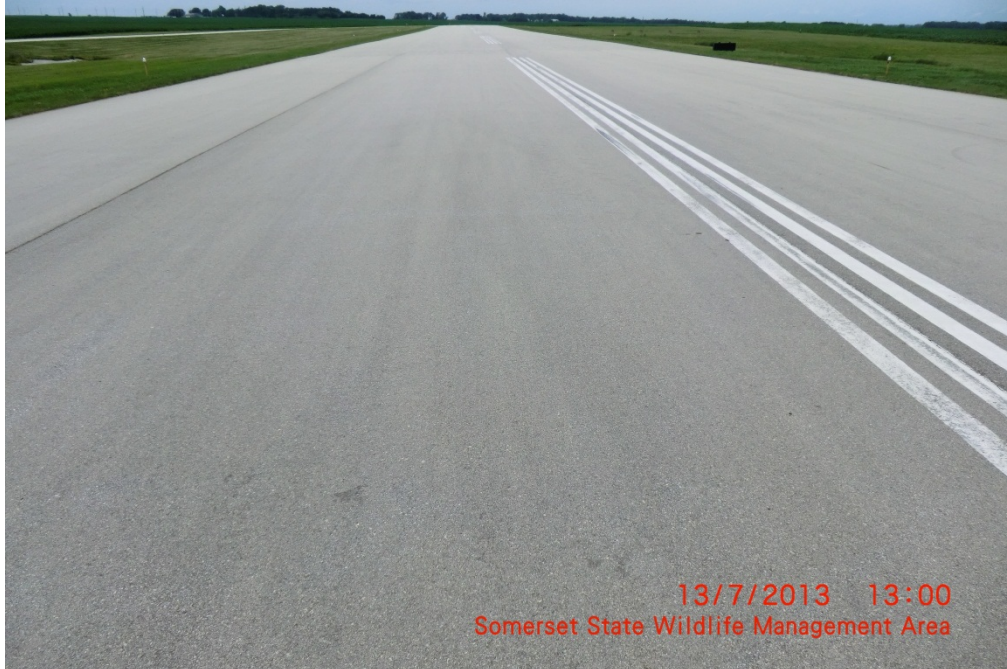
OWA RY523 003 (PCI = 98)

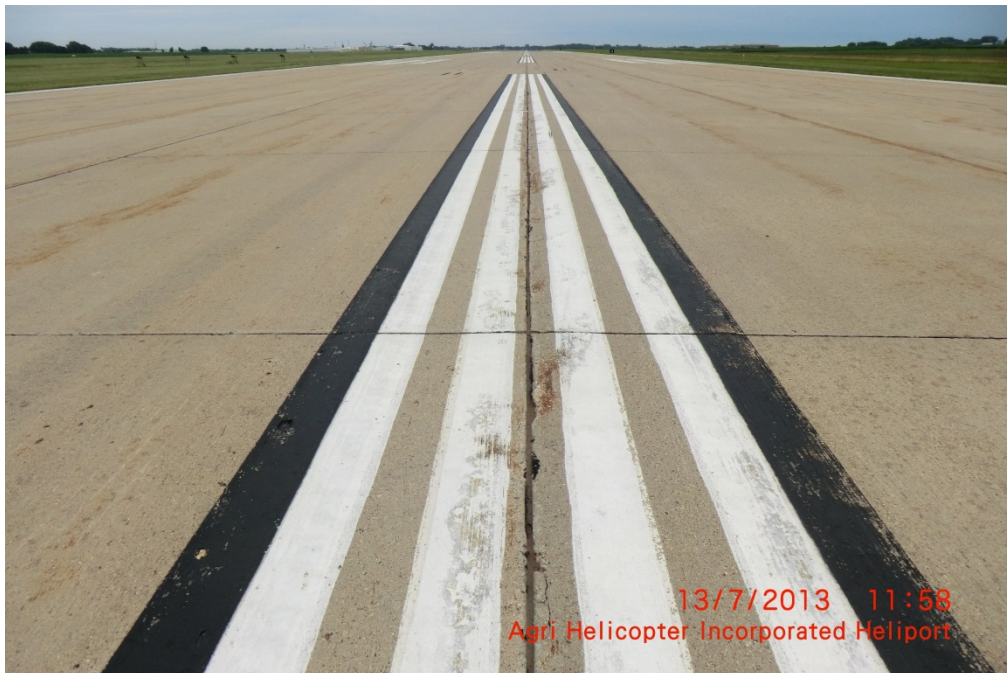
OWA RY1230 001 (PCI = 100)

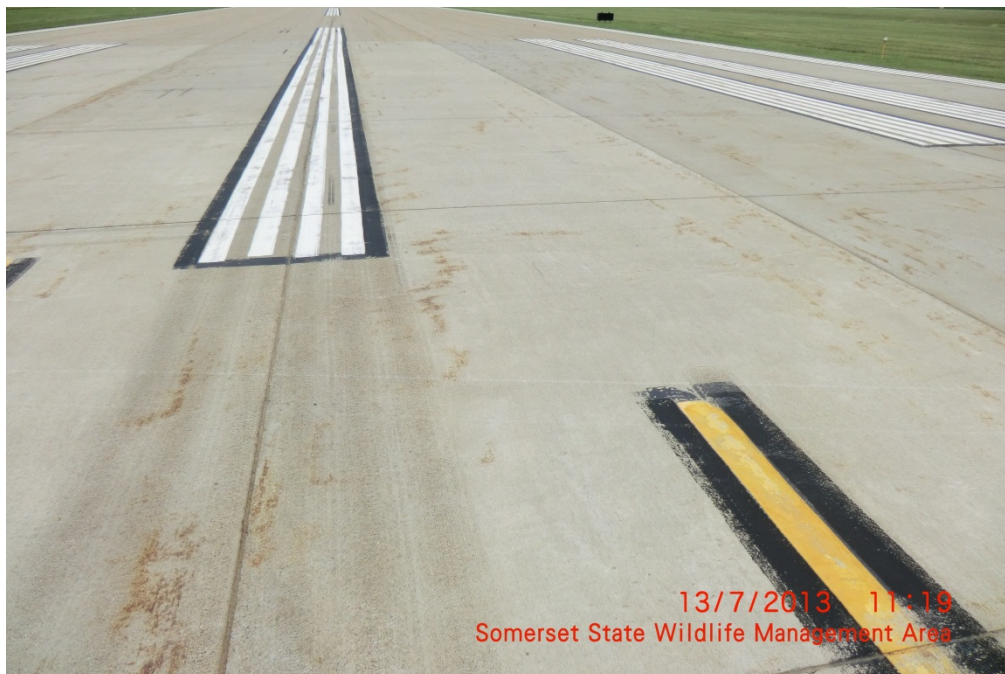
OWA RY1230 002 (PCI = 88)

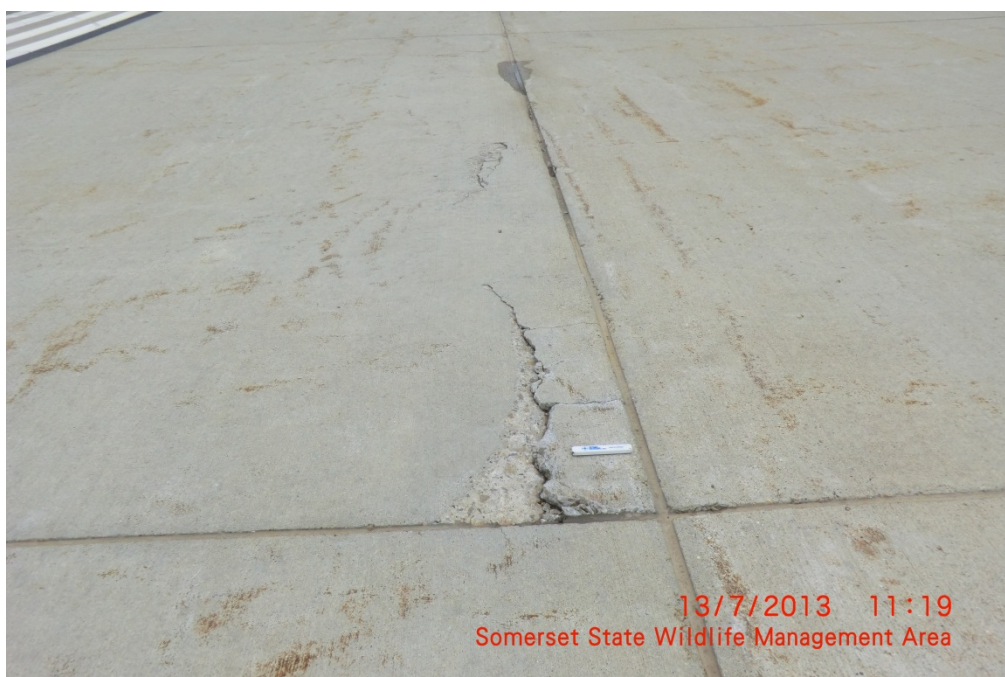
OWA RY1230 002 (High-Severity Joint Spall)

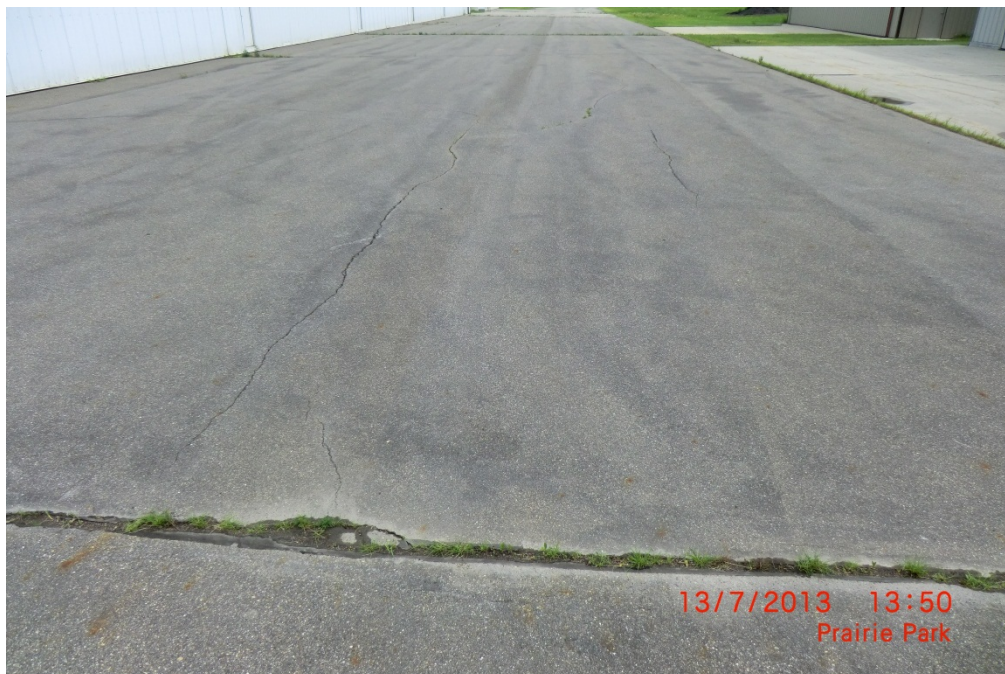
OWA TLA 001 (PCI = 74)

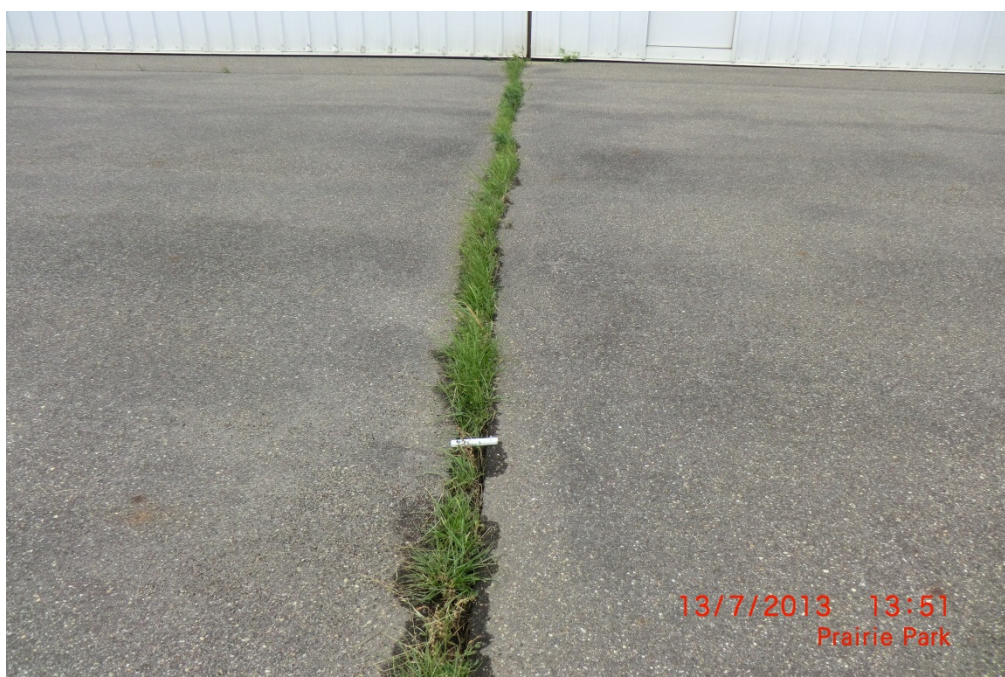
OWA TLA 001 (High-Severity L&T Crack)

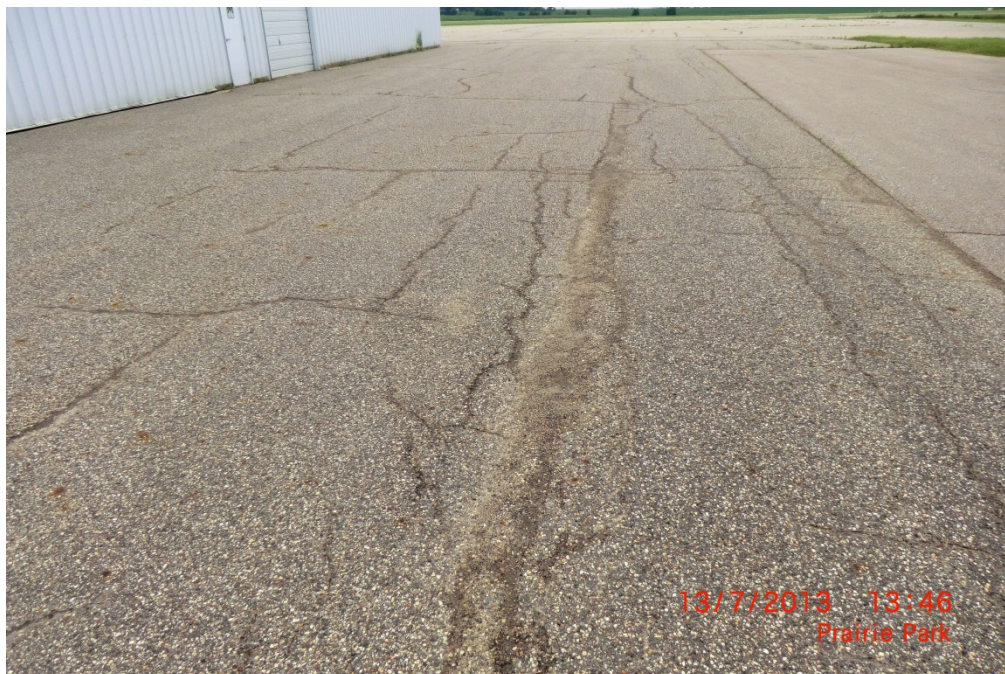
OWA TLA 002 (PCI = 23)

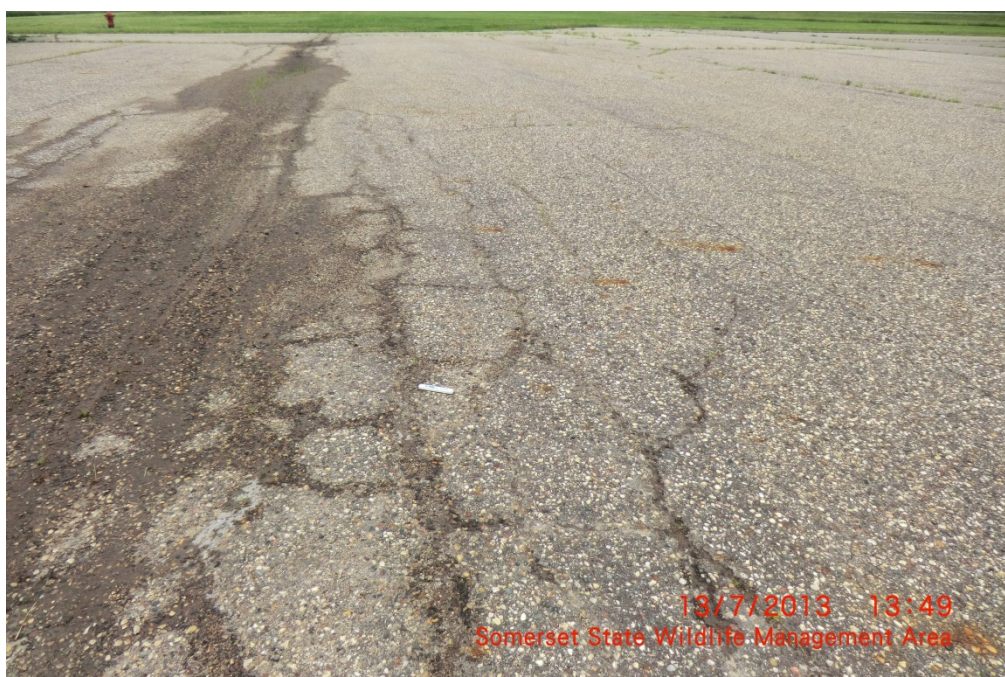
OWA TLA 002 (Medium-Severity Alligator Cracking)
