Minnesota Airport System Pavement Evaluation 2013 Update

Owatonna – Degner Regional Airport
(OWA)

Final Report

Applied Research Associates, Inc.
100 Trade Centre Dr., Suite 200
Champaign, IL 61820
(217) 356-4500

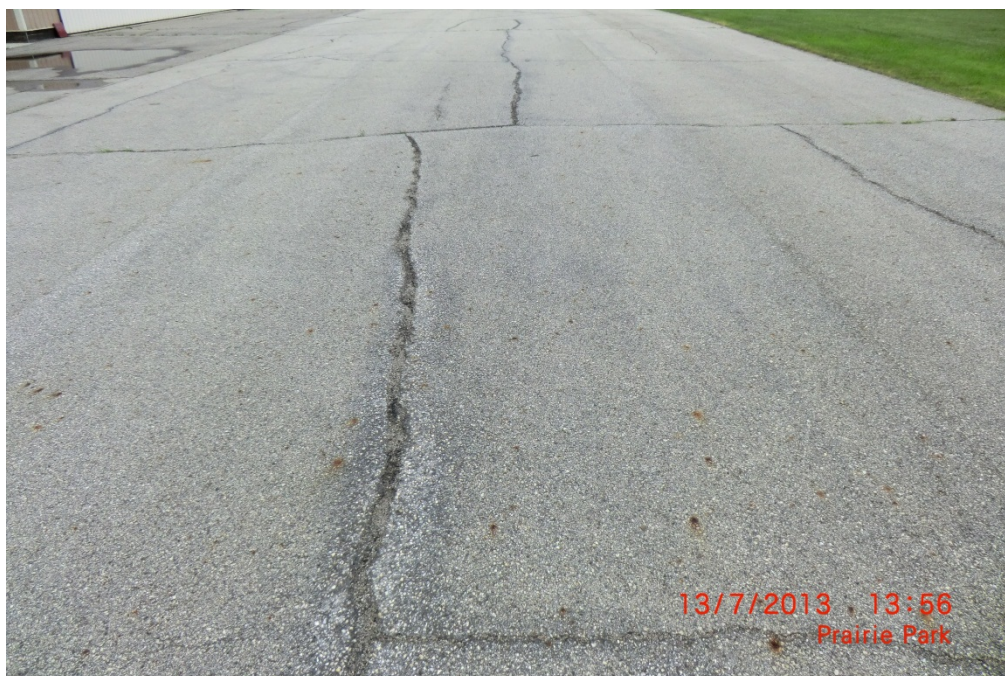
OWA TLA 003 (PCI = 66)

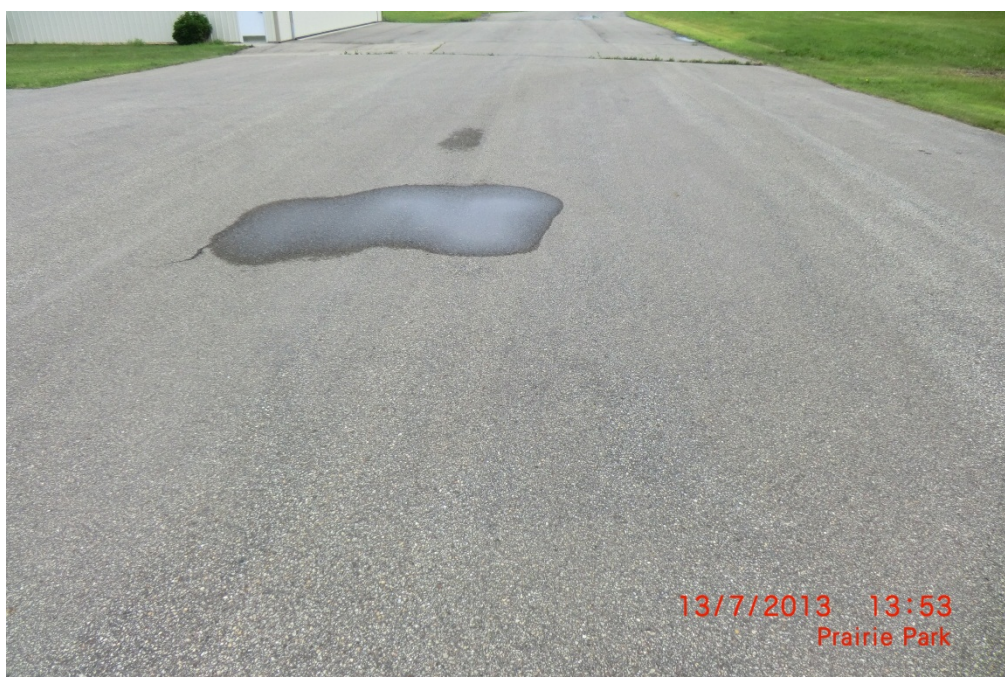
OWA TLA 004 (PCI = 71)

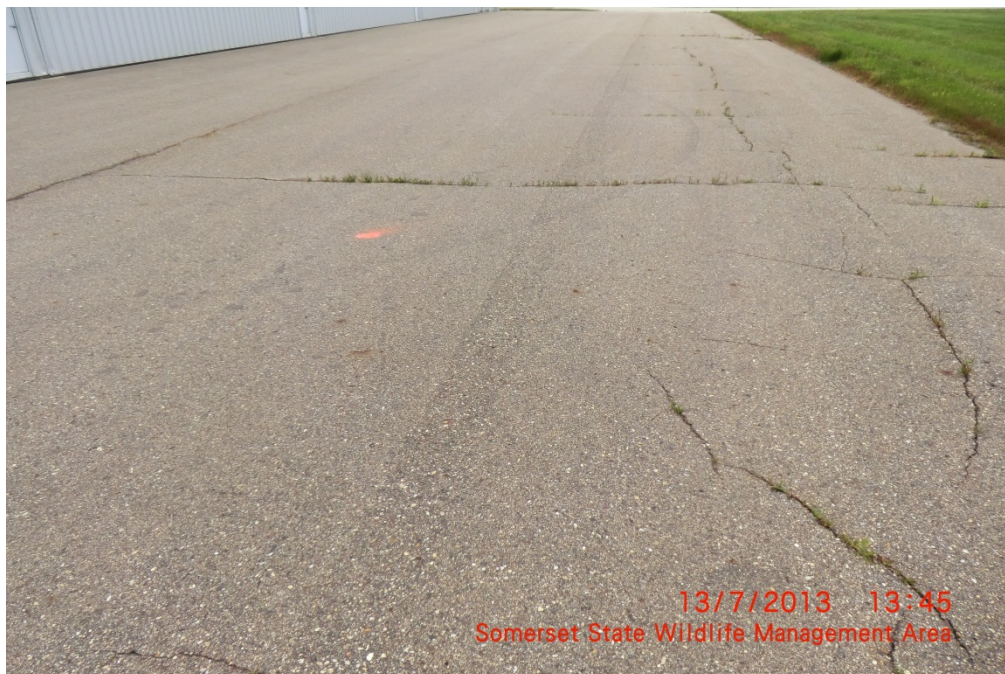
OWA TLA 005 (PCI = 73)
