# Minnesota Airport System Pavement Evaluation 2013 Update

Pine River Regional Airport (PWC)

Pine River, Minnesota

*Final Report*

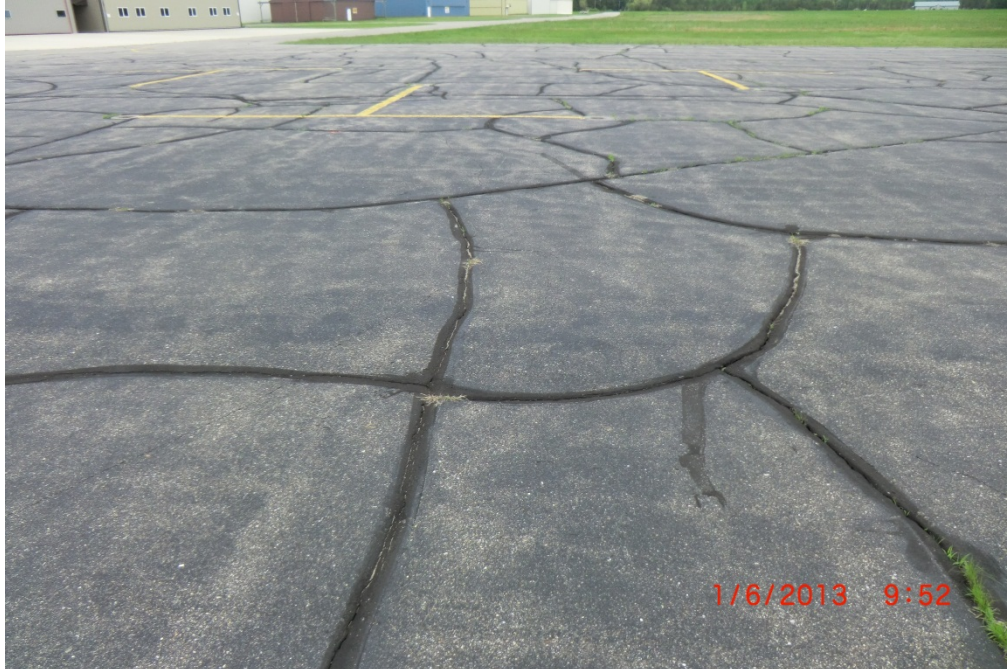
PWC APA 001 (PCI = 47)

| Branch ID | Section ID | Surface type <sup>1</sup> | Section area (SF) | LCD <sup>2</sup> | 2010 PCI | 2013 PCI | Drop in PCI/Yr <sup>3</sup> | % Deduct due to | | Distress types |
|---|---|---|---|---|---|---|---|---|---|---|
| APA | 1 | AC | 67,600 | 1993 | 48 | 47 | 2.7 | 9 | 91 | Alligator cracking, Block cracking, Longitudinal & transverse (L&T) cracking |

Conditions: PCI : 47

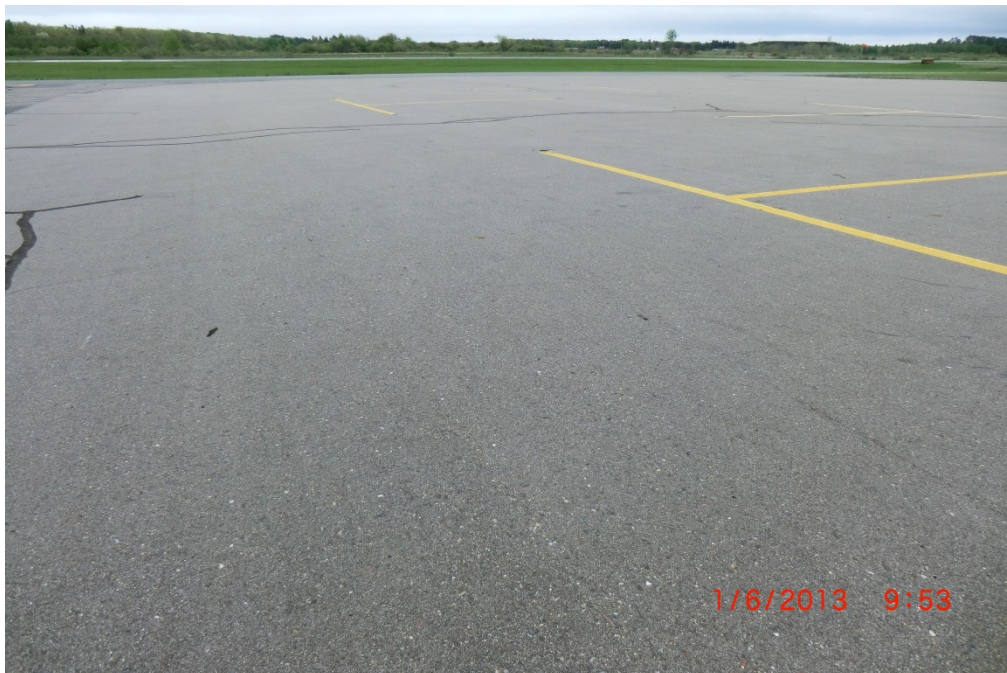
PWC APA 002 (PCI = 92)

| Branch ID | Section ID | Surface type <sup>1</sup> | Section area (SF) | LCD <sup>2</sup> | 2010 PCI | 2013 PCI | Drop in PCI/Yr <sup>3</sup> | % Deduct due to | | Distress types |
|---|---|---|---|---|---|---|---|---|---|---|
| APA | 2 | AC | 40,400 | 2009* | 97 | 92 | 2.0 | 0 | 100 | L&T cracking |

Conditions: PCI : 92

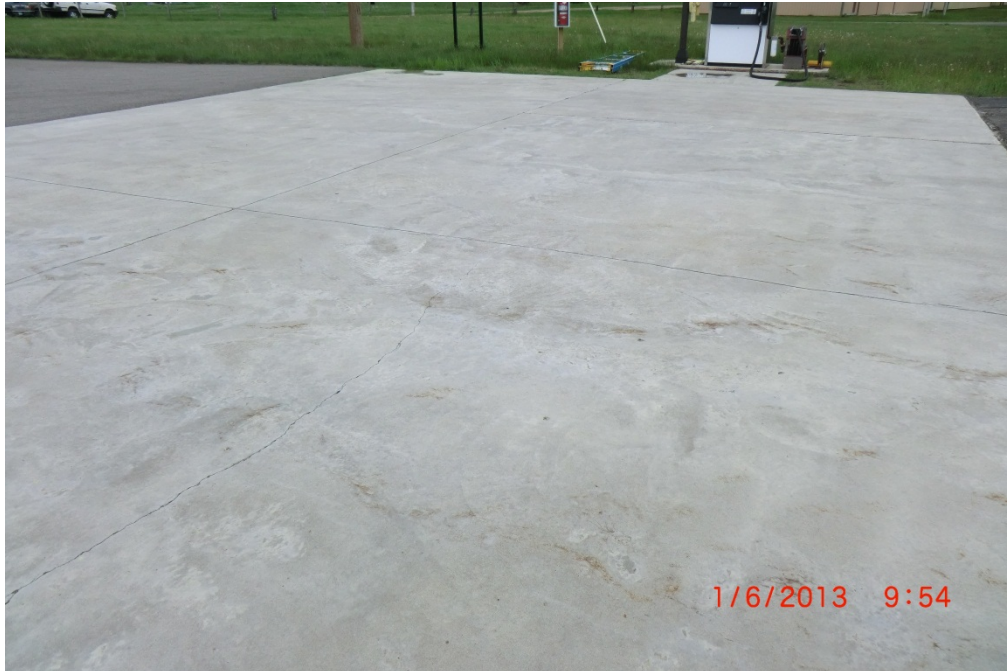
PWC APA 003 (PCI = 80)

| Branch ID | Section ID | Surface type <sup>1</sup> | Section area (SF) | LCD <sup>2</sup> | 2010 PCI | 2013 PCI | Drop in PCI/Yr <sup>3</sup> | % Deduct due to | | Distress types |
|---|---|---|---|---|---|---|---|---|---|---|
| APA | 3 | PCC | 1,200 | 2007* | 80 | 80 | 3.3 | 56 | 32 | Linear cracking, Joint seal damage, Shrinkage cracking |

Conditions: PCI : 80

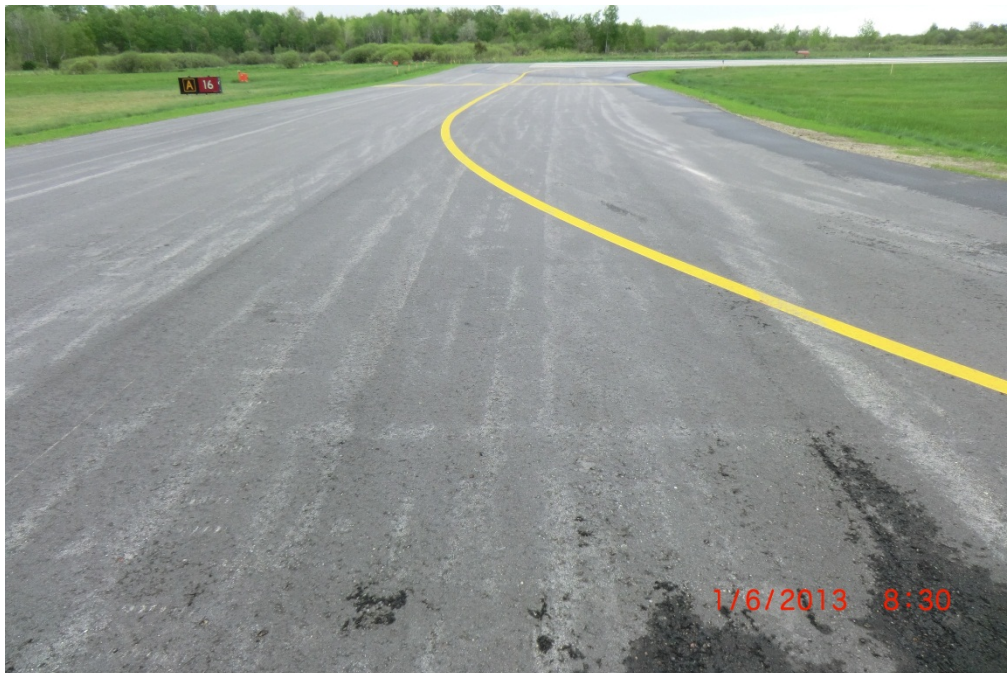
PWC CTA 001 (PCI = 95)

| Branch ID | Section ID | Surface type <sup>1</sup> | Section area (SF) | LCD <sup>2</sup> | 2010 PCI | 2013 PCI | Drop in PCI/Yr <sup>3</sup> | % Deduct due to | | Distress types |
|---|---|---|---|---|---|---|---|---|---|---|
| CTA | 1 | AC | 8,675 | 2012 | 48 | 95 | 5.0 | 0 | 100 | L&T cracking |

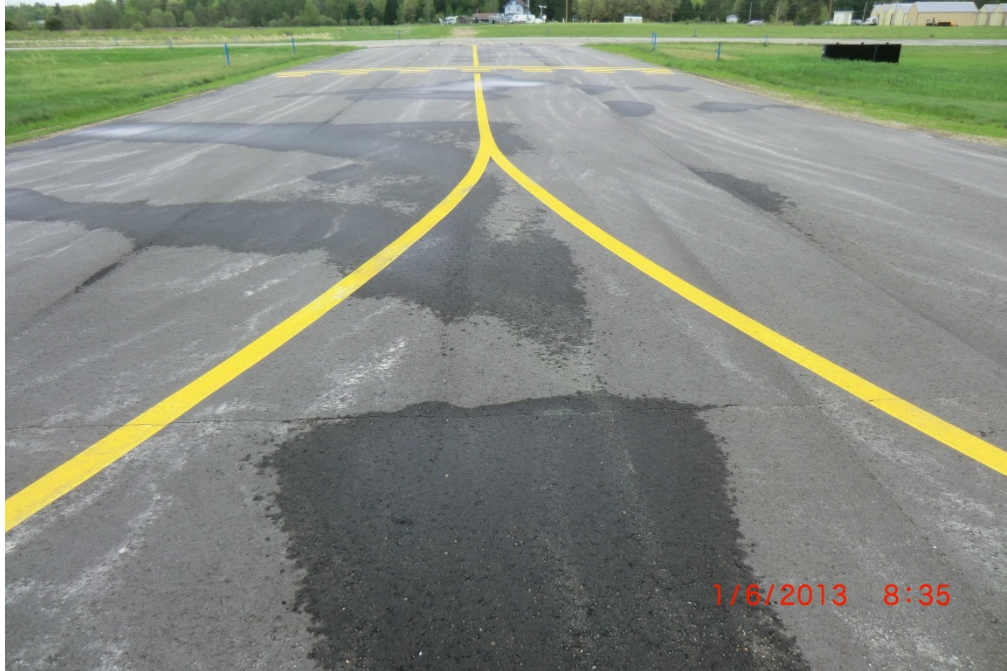
PWC CTB 001 (PCI = 95)

| Branch ID | Section ID | Surface type <sup>1</sup> | Section area (SF) | LCD <sup>2</sup> | 2010 PCI | 2013 PCI | Drop in PCI/Yr <sup>3</sup> | % Deduct due to | | Distress types |
|---|---|---|---|---|---|---|---|---|---|---|
| CTB | 1 | AC | 6,835 | 2012 | 56 | 95 | 5.0 | 0 | 100 | L&T cracking |

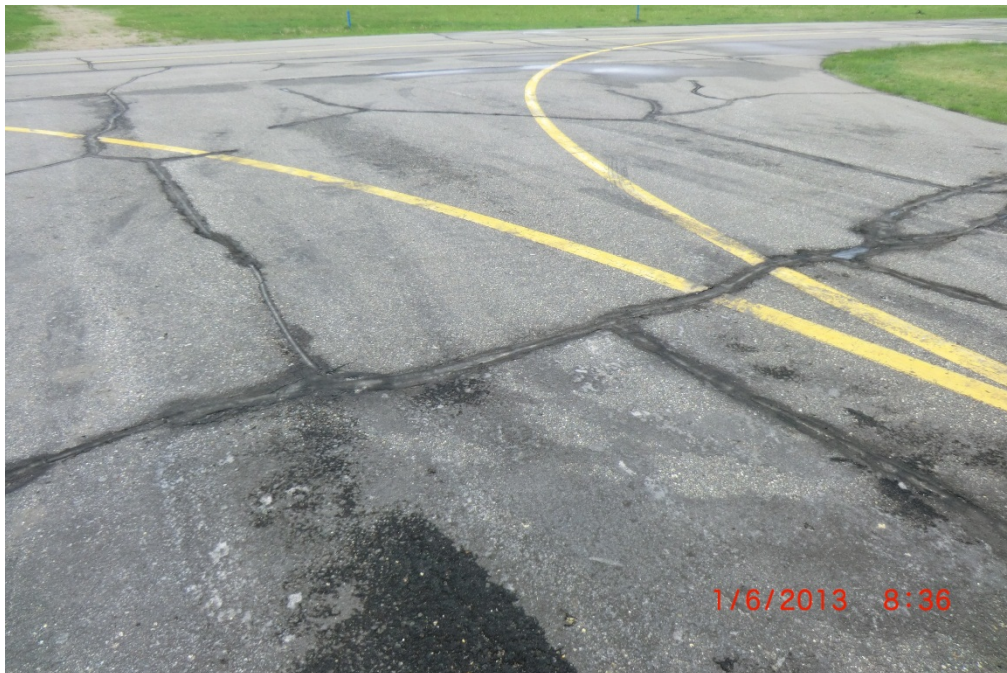
PWC CTB 002 (PCI = 78)

| Branch ID | Section ID | Surface type <sup>1</sup> | Section area (SF) | LCD <sup>2</sup> | 2010 PCI | 2013 PCI | Drop in PCI/Yr <sup>3</sup> | % Deduct due to | | Distress types |
|---|---|---|---|---|---|---|---|---|---|---|
| CTB | 2 | AAC | 2,475 | 2005 | 78 | 78 | 2.8 | 0 | 100 | L&T cracking |

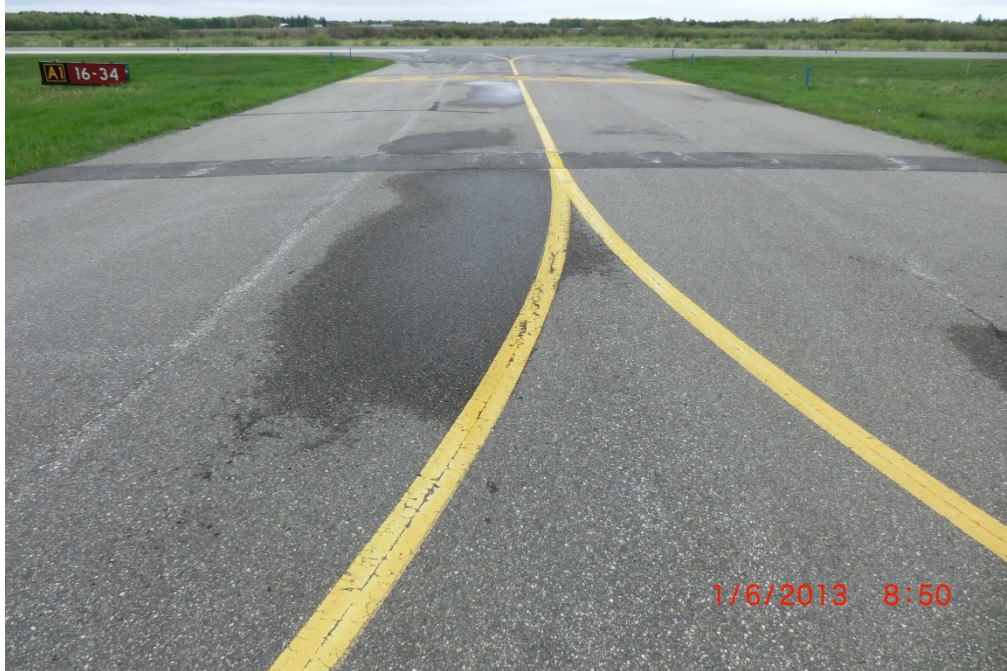
PWC CTC 001 (PCI = 87)

| Branch ID | Section ID | Surface type <sup>1</sup> | Section area (SF) | LCD <sup>2</sup> | 2010 PCI | 2013 PCI | Drop in PCI/Yr <sup>3</sup> | % Deduct due to | | Distress types |
|---|---|---|---|---|---|---|---|---|---|---|
| CTC | 1 | AC | 7,155 | 2005 | 89 | 87 | 1.6 | 0 | 100 | L&T cracking, Patching |

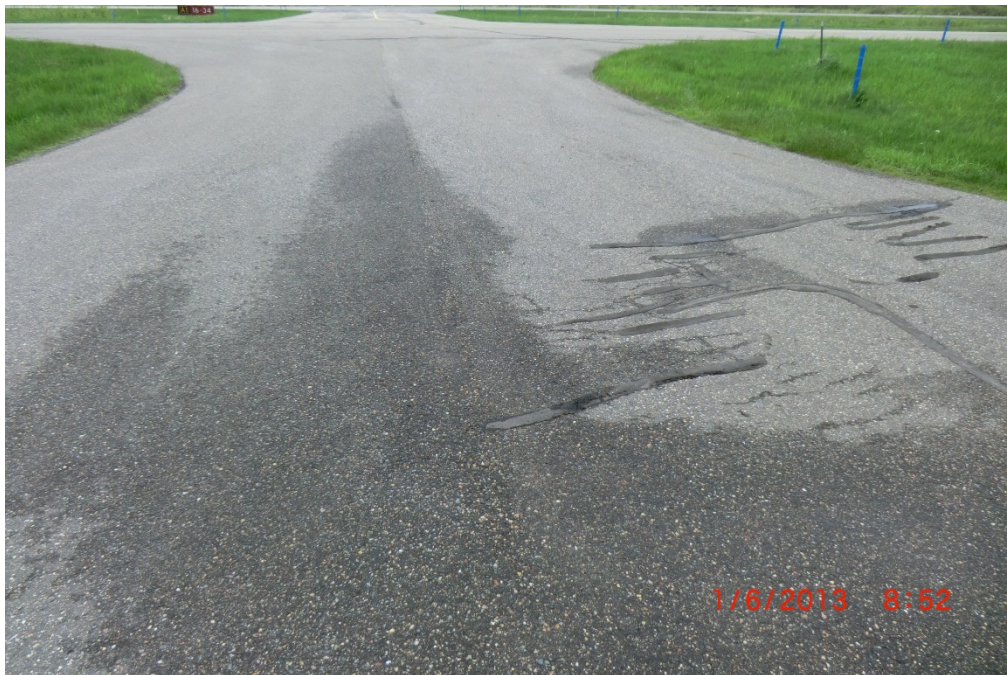
PWC CTCX 001 (PCI = 78)

| Branch ID | Section ID | Surface type <sup>1</sup> | Section area (SF) | LCD <sup>2</sup> | 2010 PCI | 2013 PCI | Drop in PCI/Yr <sup>3</sup> | % Deduct due to | | Distress types |
|---|---|---|---|---|---|---|---|---|---|---|
| CTCX | 1 | AC | 2,260 | 2005 | 86 | 78 | 2.8 | 0 | 100 | L&T cracking |

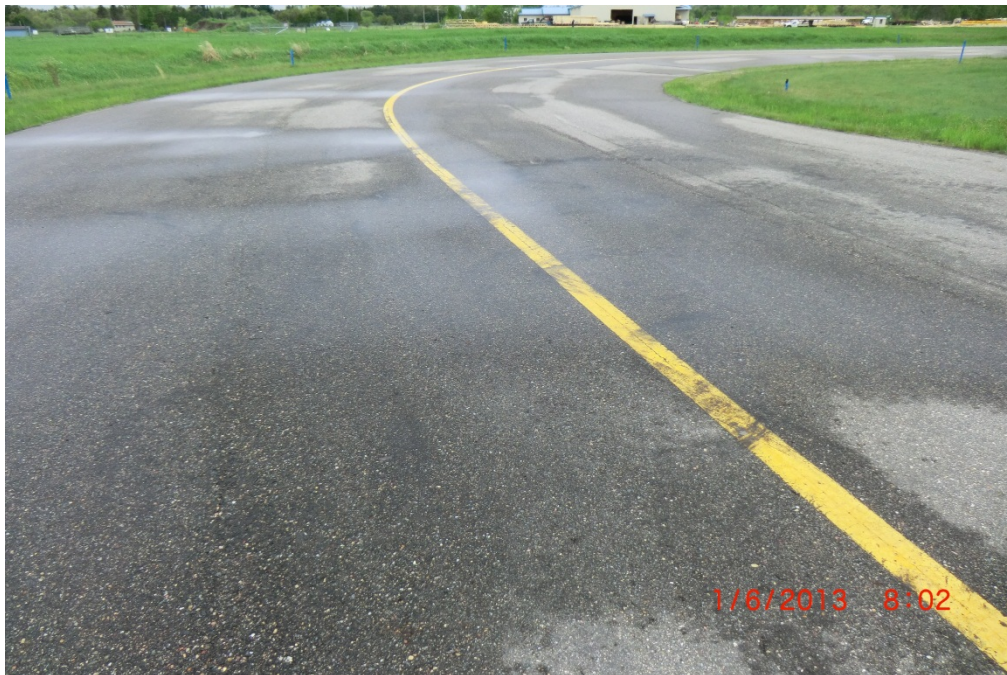
PWC PTA 002 (PCI = 89)

| Branch ID | Section ID | Surface type <sup>1</sup> | Section area (SF) | LCD <sup>2</sup> | 2010 PCI | 2013 PCI | Drop in PCI/Yr <sup>3</sup> | % Deduct due to | | Distress types |
|---|---|---|---|---|---|---|---|---|---|---|
| PTA | 2 | AC | 99,800 | 2005 | 91 | 89 | 1.4 | 0 | 100 | L&T cracking, Weathering |

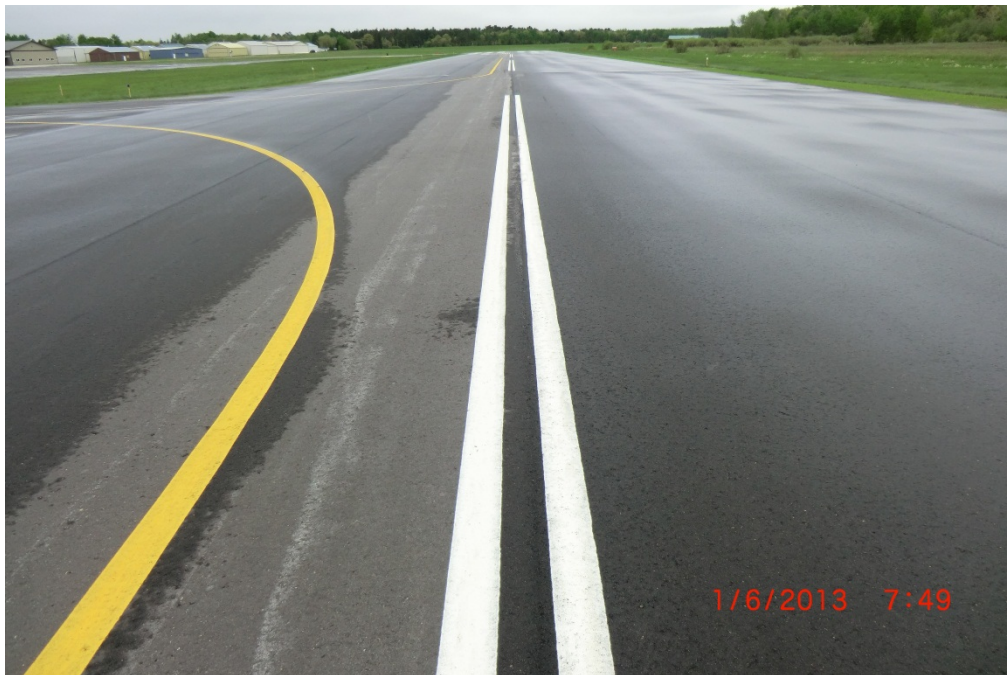
PWC RY1634 001 (PCI = 99)

| Branch ID | Section ID | Surface type <sup>1</sup> | Section area (SF) | LCD <sup>2</sup> | 2010 PCI | 2013 PCI | Drop in PCI/Yr <sup>3</sup> | % Deduct due to | | Distress types |
|---|---|---|---|---|---|---|---|---|---|---|
| RY1634 | 1 | AC | 227,200 | 2012 | 52 | 99 | 1.0 | 0 | 100 | L&T cracking |

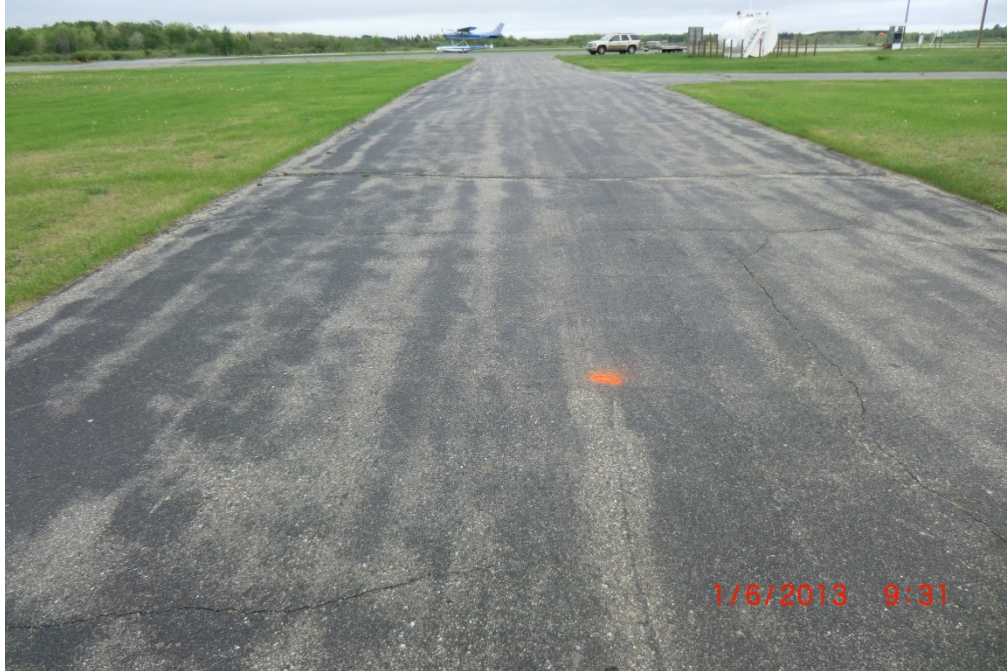
PWC TLA 001 (PCI = 55)

| Branch ID | Section ID | Surface type <sup>1</sup> | Section area (SF) | LCD <sup>2</sup> | 2010 PCI | 2013 PCI | Drop in PCI/Yr <sup>3</sup> | % Deduct due to | | Distress types |
|---|---|---|---|---|---|---|---|---|---|---|
| TLA | 1 | AC | 23,200 | 1993 | 60 | 55 | 2.3 | 38 | 62 | Alligator cracking, Depression, L&T cracking |

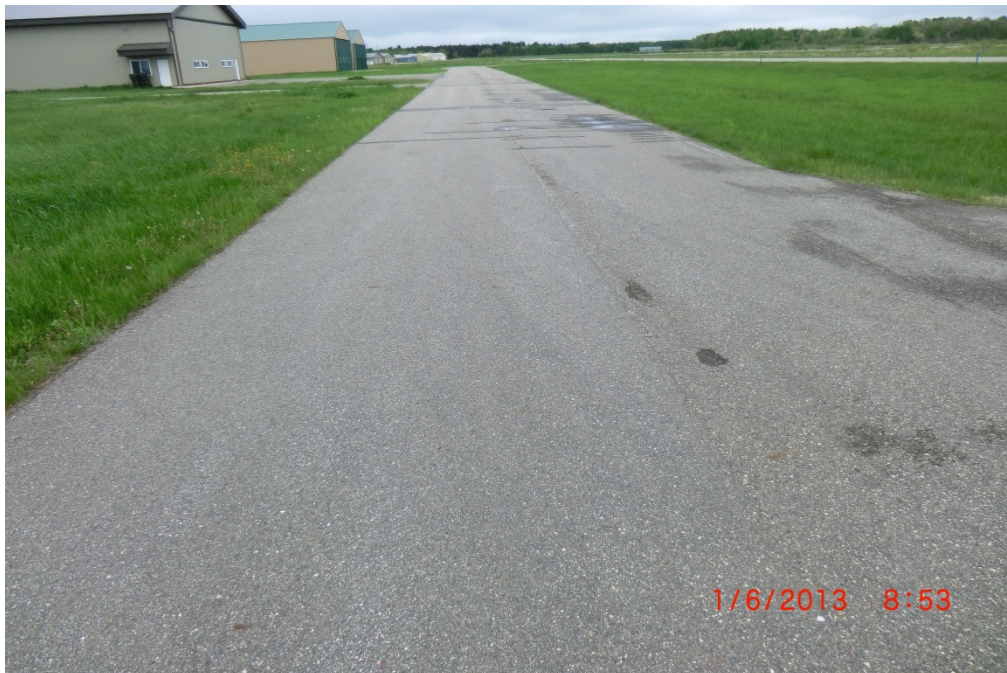
PWC TLB 001 (PCI = 83)

| Branch ID | Section ID | Surface type <sup>1</sup> | Section area (SF) | LCD <sup>2</sup> | 2010 PCI | 2013 PCI | Drop in PCI/Yr <sup>3</sup> | % Deduct due to | | Distress types |
|---|---|---|---|---|---|---|---|---|---|---|
| TLB | 1 | AC | 12,800 | 2005 | 82 | 83 | 2.1 | 0 | 100 | L&T cracking, Patching |

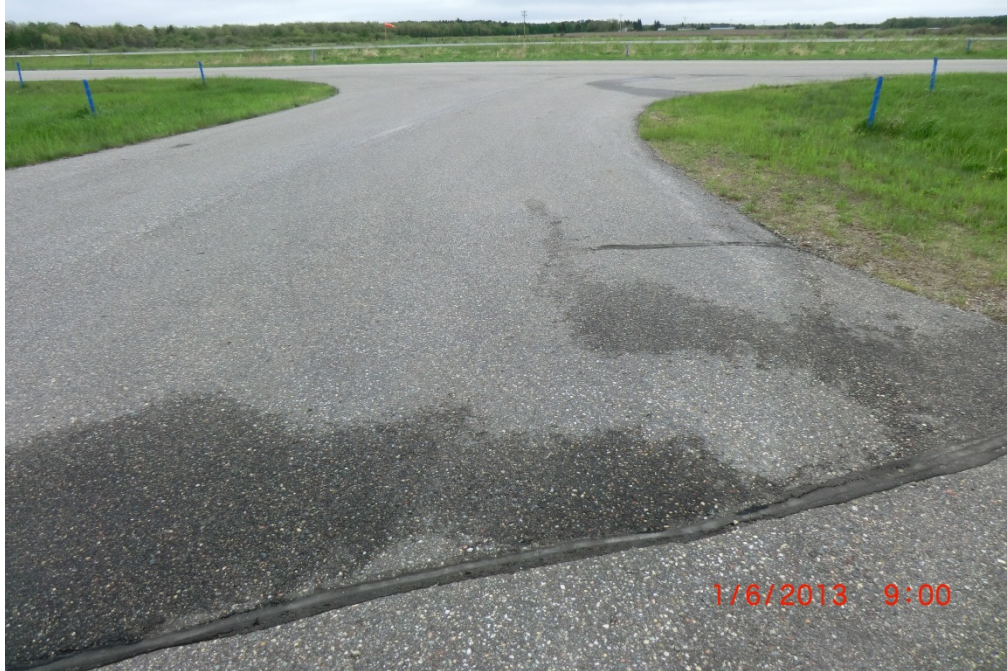
PWC TLB1 001 (PCI = 92)

| Branch ID | Section ID | Surface type <sup>1</sup> | Section area (SF) | LCD <sup>2</sup> | 2010 PCI | 2013 PCI | Drop in PCI/Yr <sup>3</sup> | % Deduct due to | | Distress types |
|---|---|---|---|---|---|---|---|---|---|---|
| TLB1 | 1 | AC | 1,880 | 2005 | 97 | 92 | 1.0 | 0 | 100 | L&T cracking, Raveling |

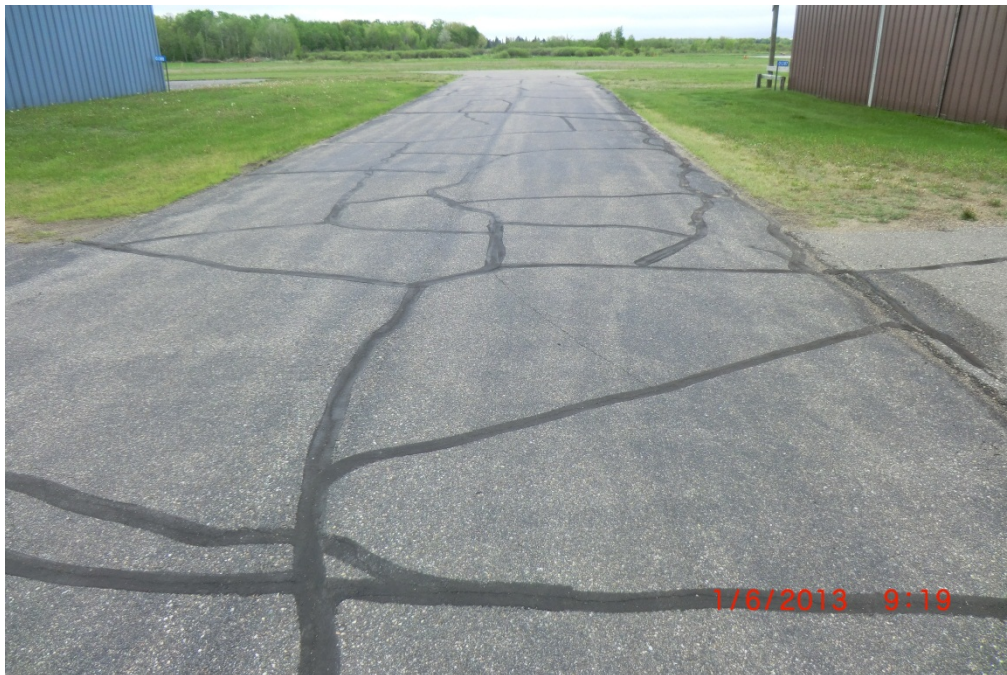
PWC TLC 001 (PCI = 58)

| Branch ID | Section ID | Surface type <sup>1</sup> | Section area (SF) | LCD <sup>2</sup> | 2010 PCI | 2013 PCI | Drop in PCI/Yr <sup>3</sup> | % Deduct due to | | Distress types |
|---|---|---|---|---|---|---|---|---|---|---|
| TLC | 1 | AC | 14,420 | 1993 | 59 | 58 | 2.1 | 0 | 87 | Depression, L&T cracking |

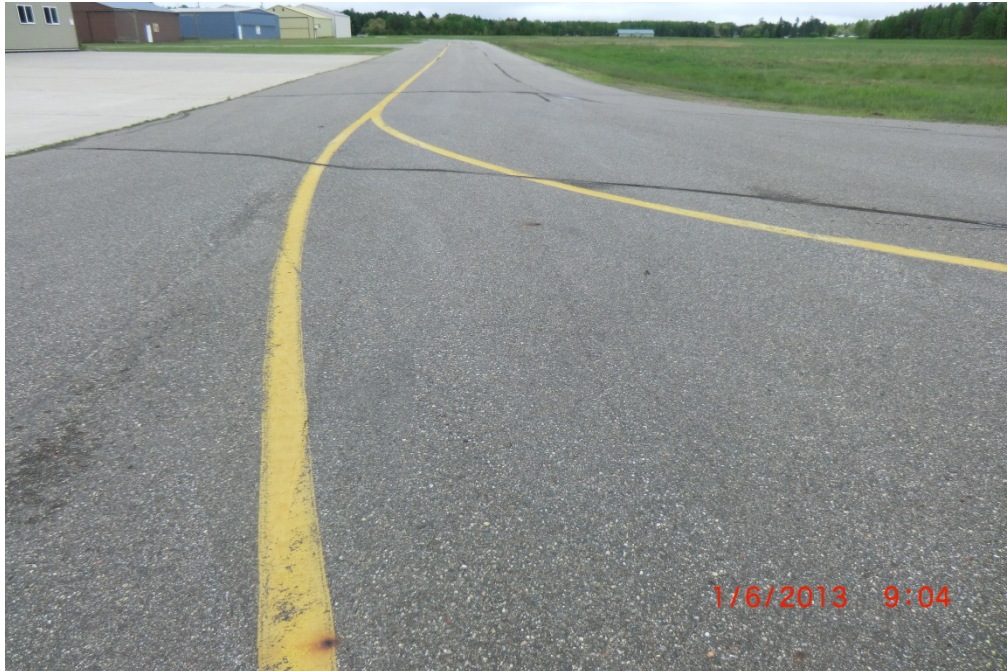
PWC TLD 001 (PCI = 80)

| Branch ID | Section ID | Surface type <sup>1</sup> | Section area (SF) | LCD <sup>2</sup> | 2010 PCI | 2013 PCI | Drop in PCI/Yr <sup>3</sup> | % Deduct due to | | Distress types |
|---|---|---|---|---|---|---|---|---|---|---|
| TLD | 1 | AC | 37,980 | 2005 | 85 | 80 | 2.5 | 0 | 100 | L&T cracking, Patching |

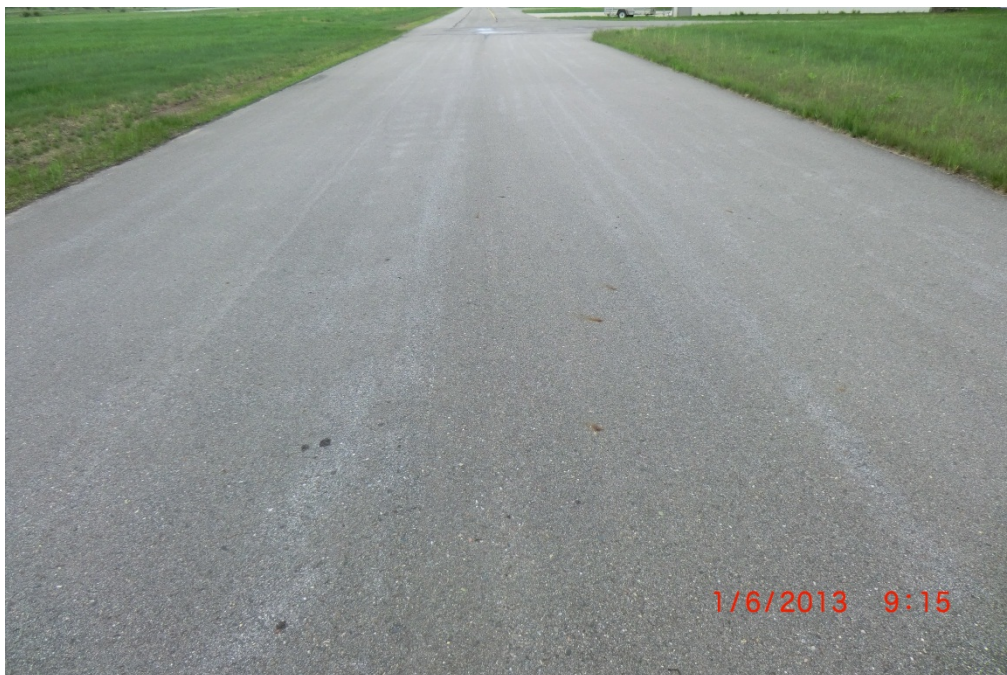
PWC TLD 002 (PCI = 96)

| Branch ID | Section ID | Surface type <sup>1</sup> | Section area (SF) | LCD <sup>2</sup> | 2010 PCI | 2013 PCI | Drop in PCI/Yr <sup>3</sup> | % Deduct due to | | Distress types |
|---|---|---|---|---|---|---|---|---|---|---|
| TLD | 2 | AC | 7,240 | 2008 | 100 | 96 | 0.8 | 0 | 100 | L&T cracking |
