# Minnesota Airport System Pavement Evaluation 2013 Update

Staples Municipal Airport (SAZ)

# Mn/DOT Airport Pavement Management System 2013

Staples Municipal Airport

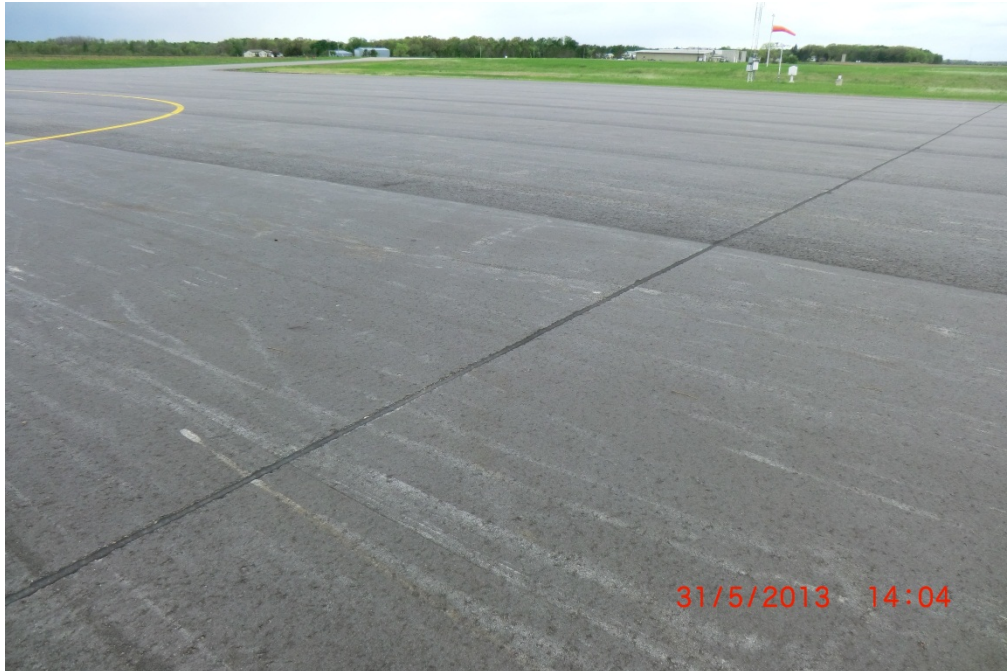
SAZ APA 001 (PCI = 96)

Conditions: PCI: 96

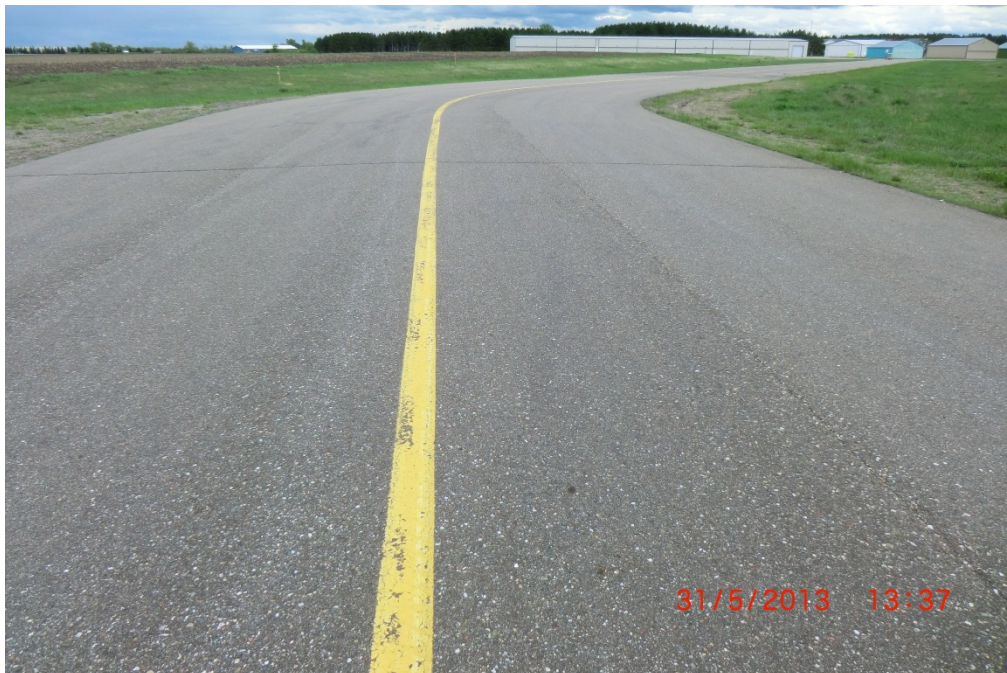
SAZ CTA 001 (PCI = 92)

Conditions: PCI: 92

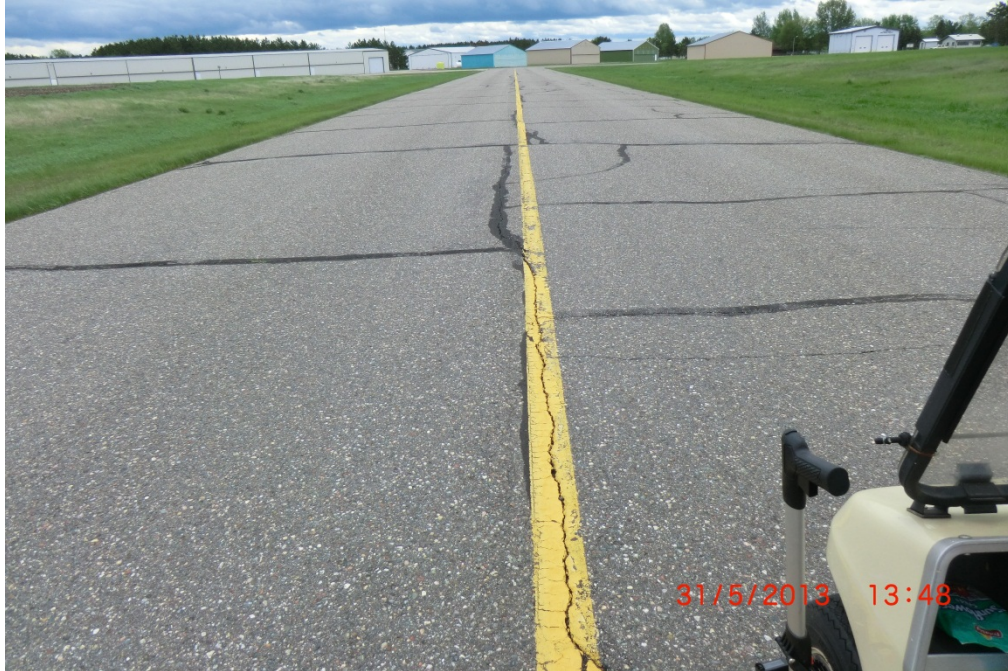
SAZ CTA 002 (PCI = 43)

Conditions: PCI : 43

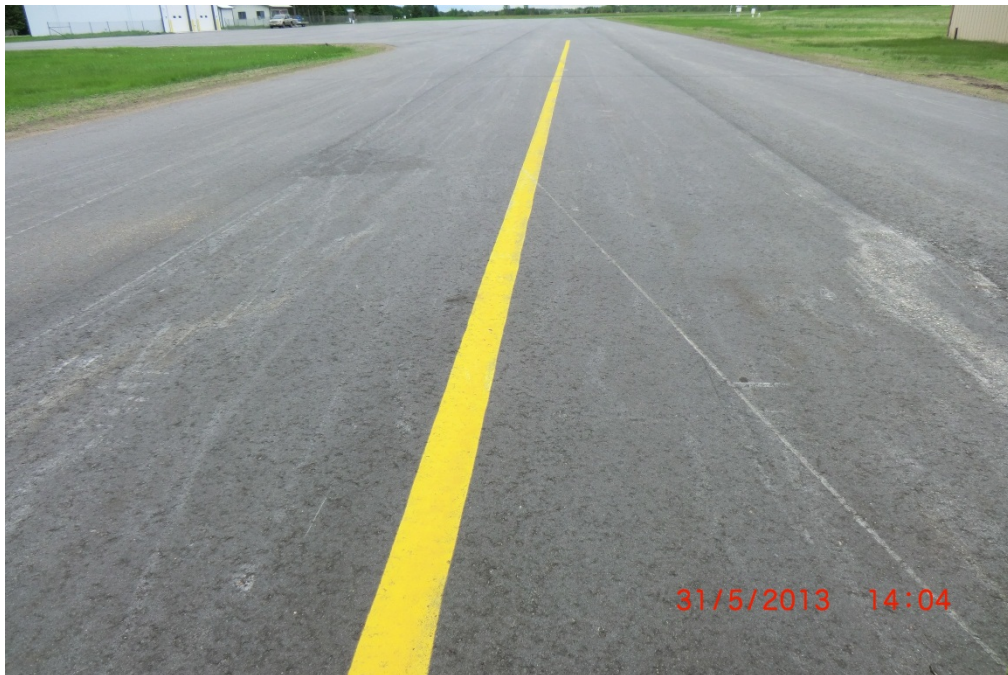
SAZ CTA 003 (PCI = 100)

Conditions: PCI: 100

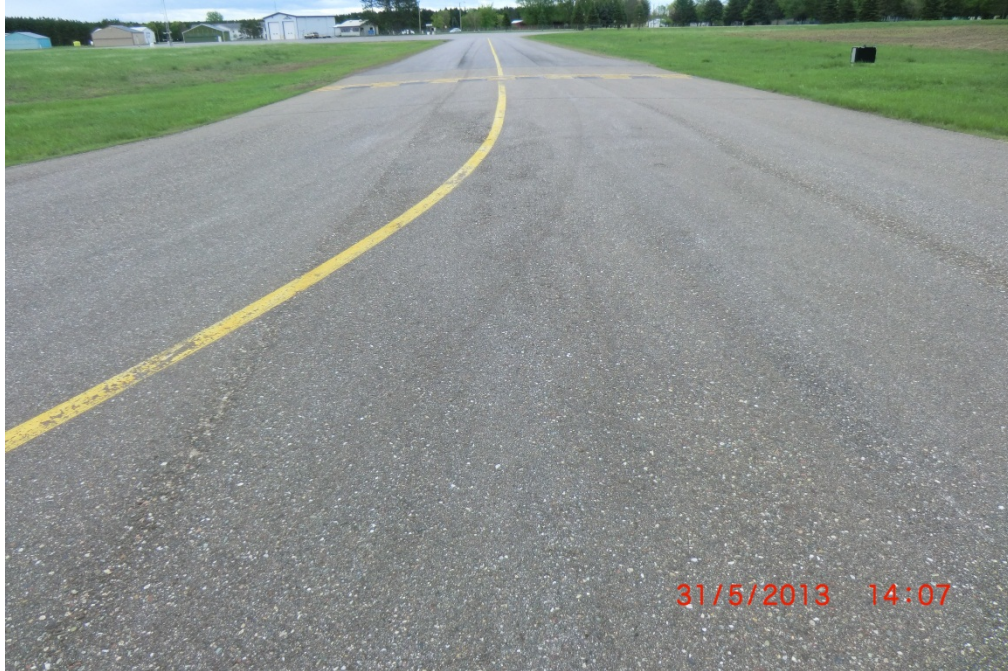
SAZ CTB 001 (PCI = 88)

Conditions: PCI : 88

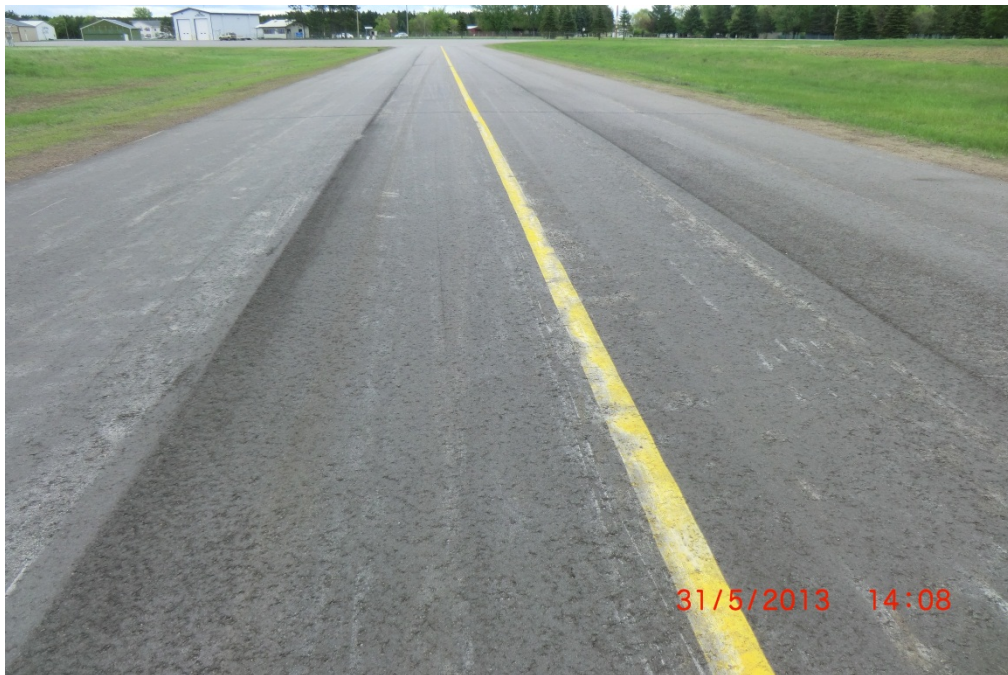
SAZ CTB 002 (PCI = 96)

Conditions: PCI: 96

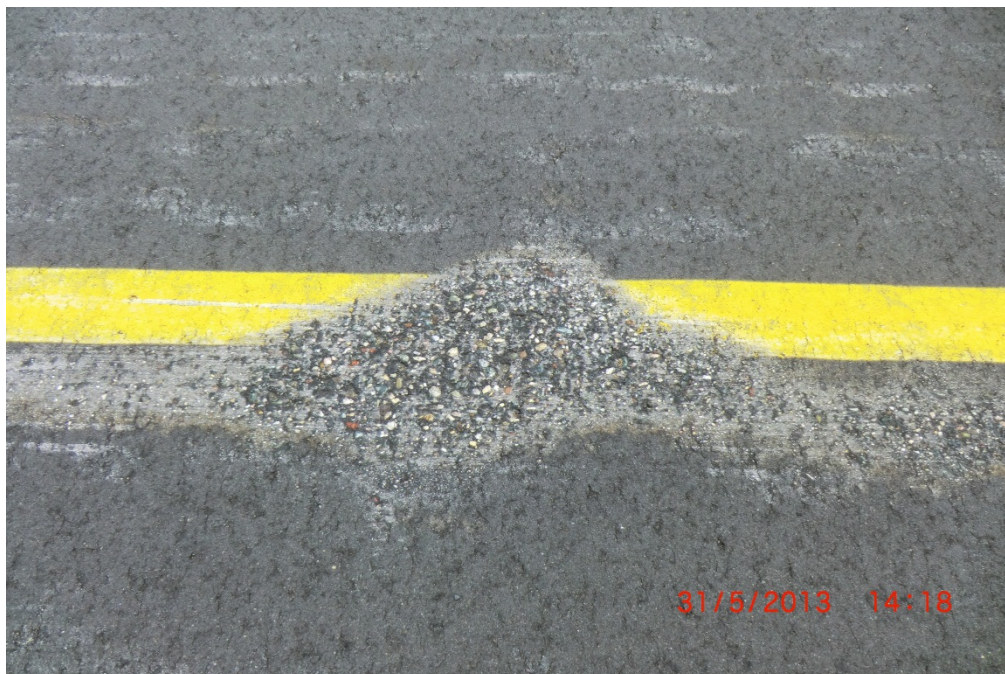
SAZ CTB 002 (Medium-Severity Raveling)

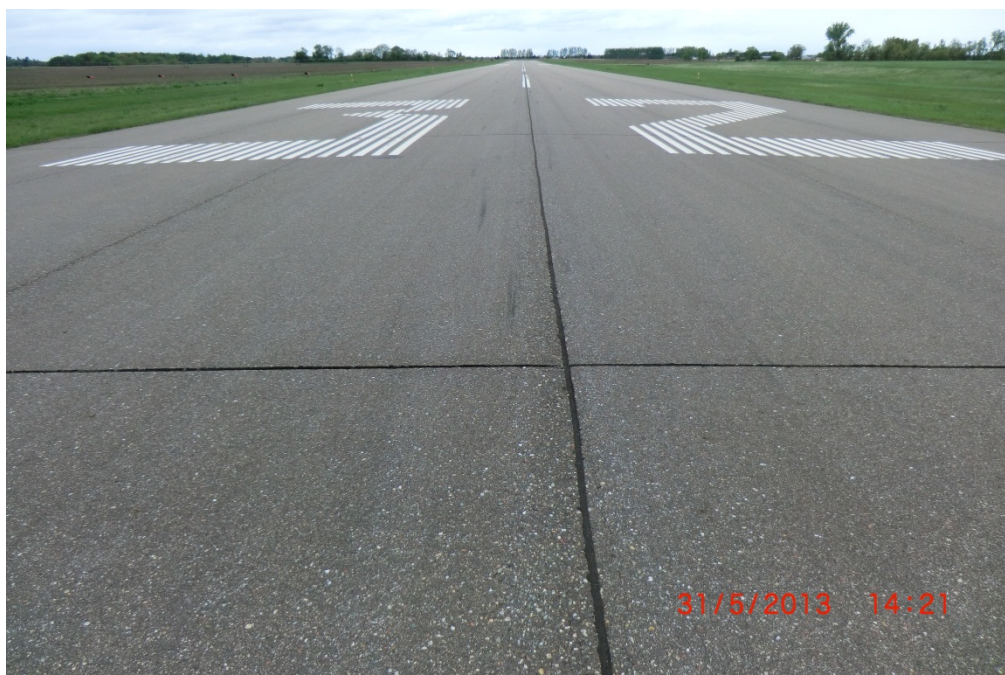
SAZ RY1432 001 (PCI = 86)

Conditions: PCI : 86

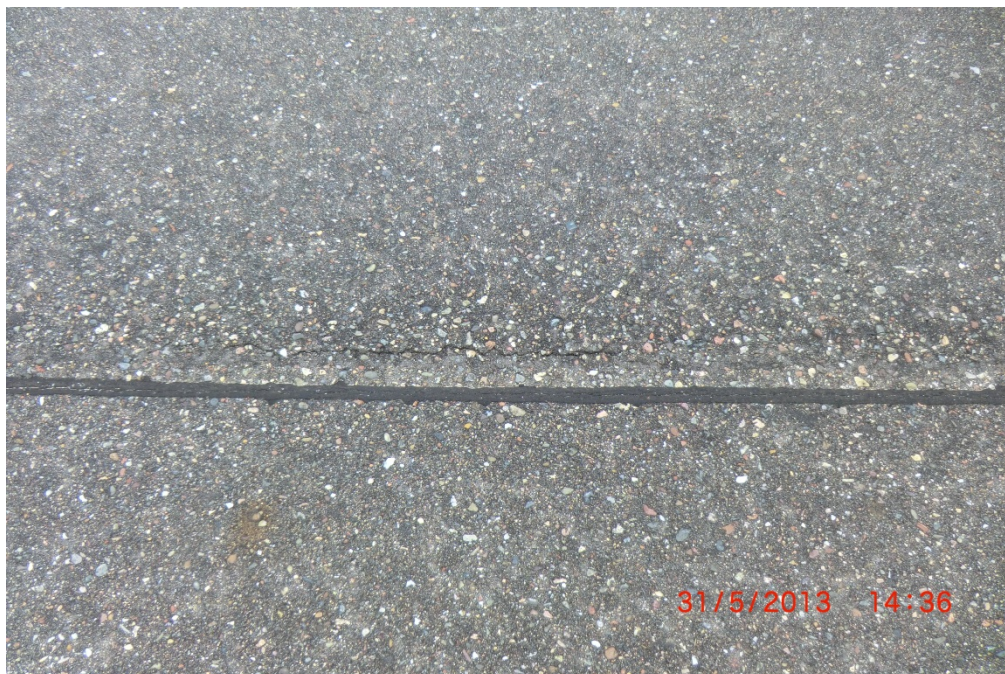
SAZ RY1432 001 (Secondary Crack)

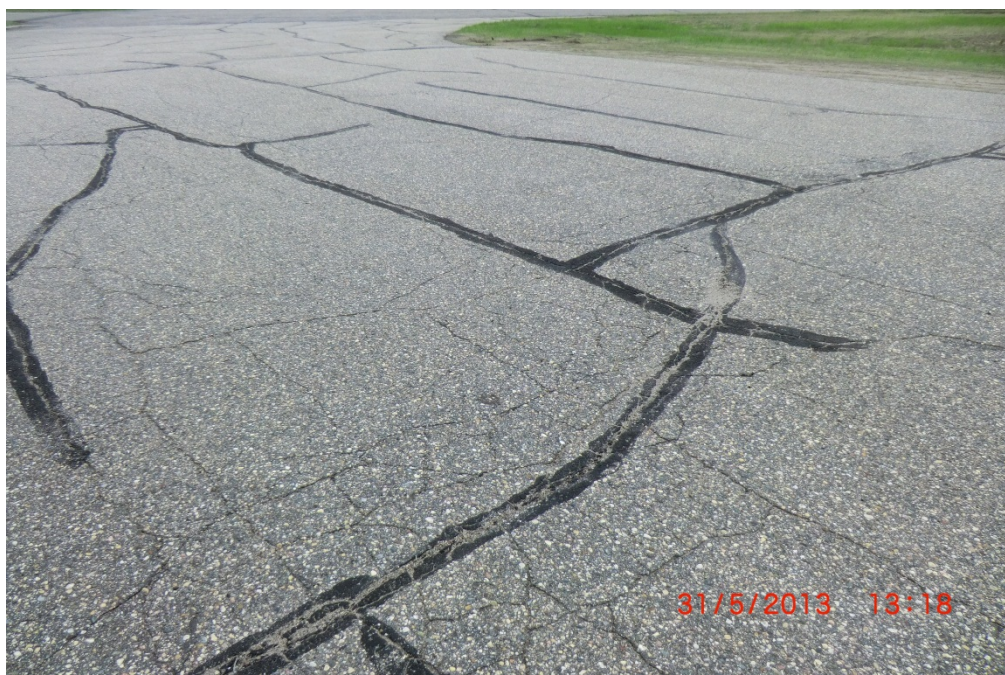
SAZ TLA 001 (PCI = 32)

Conditions: PCI : 32

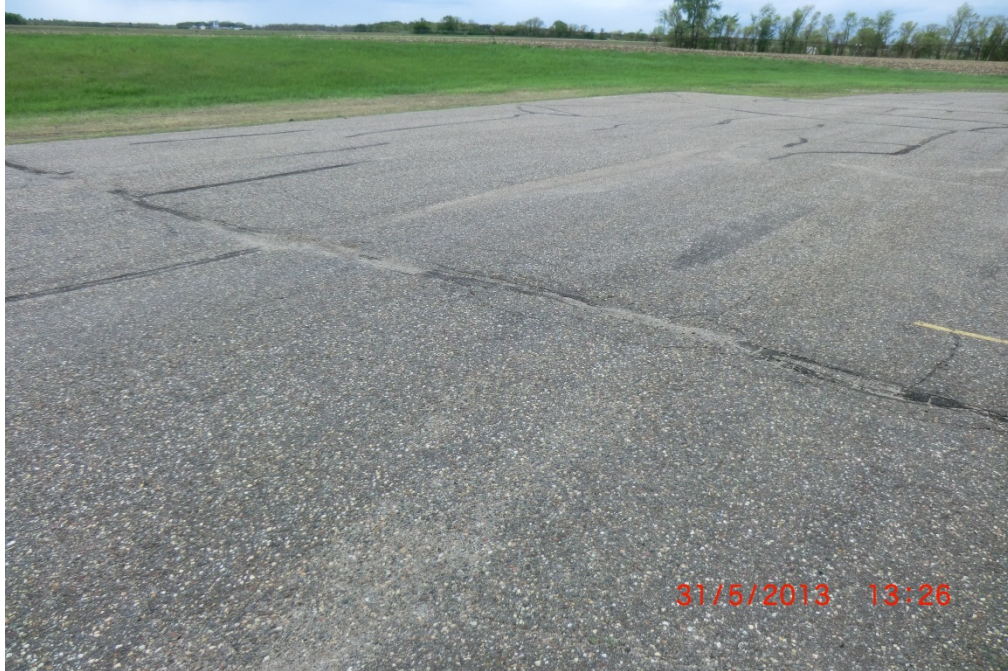
SAZ TLA 002 (PCI = 23)

Conditions: PCI : 23

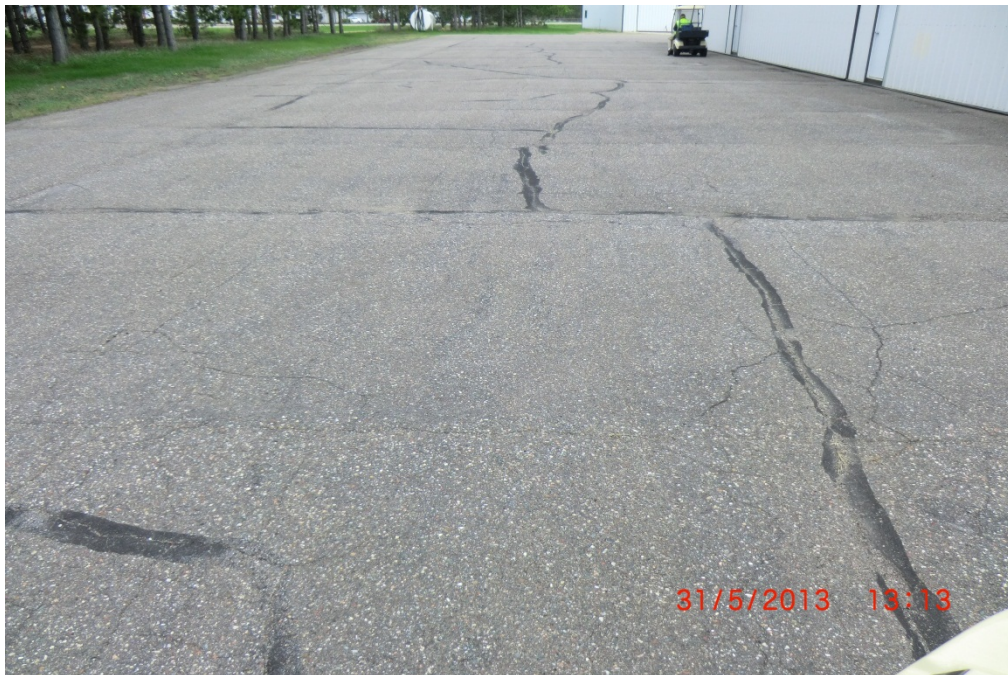
SAZ TLB 001 (PCI = 25)

Conditions: PCI : 25
