Minnesota Airport System Pavement Evaluation 2013 Update

Thief River Falls Regional Airport (TVF)

Thief River Falls, Minnesota

Final Report

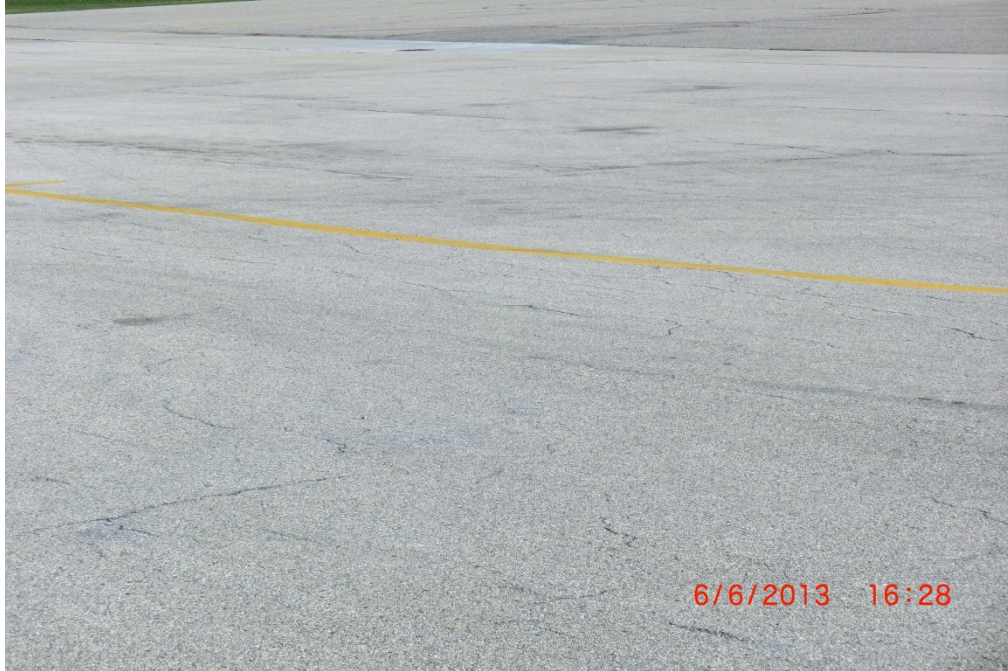
TVF APA 001 (PCI = 51)

Conditions: PCI : 51

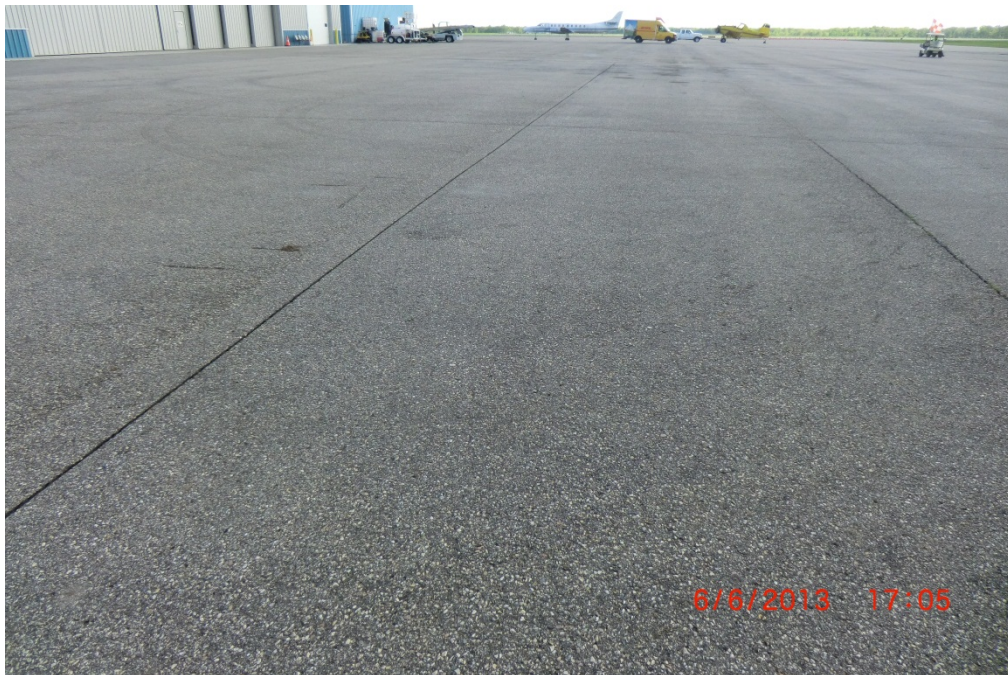
TVF APA 002 (PCI = 68)

Conditions: PCI : 68

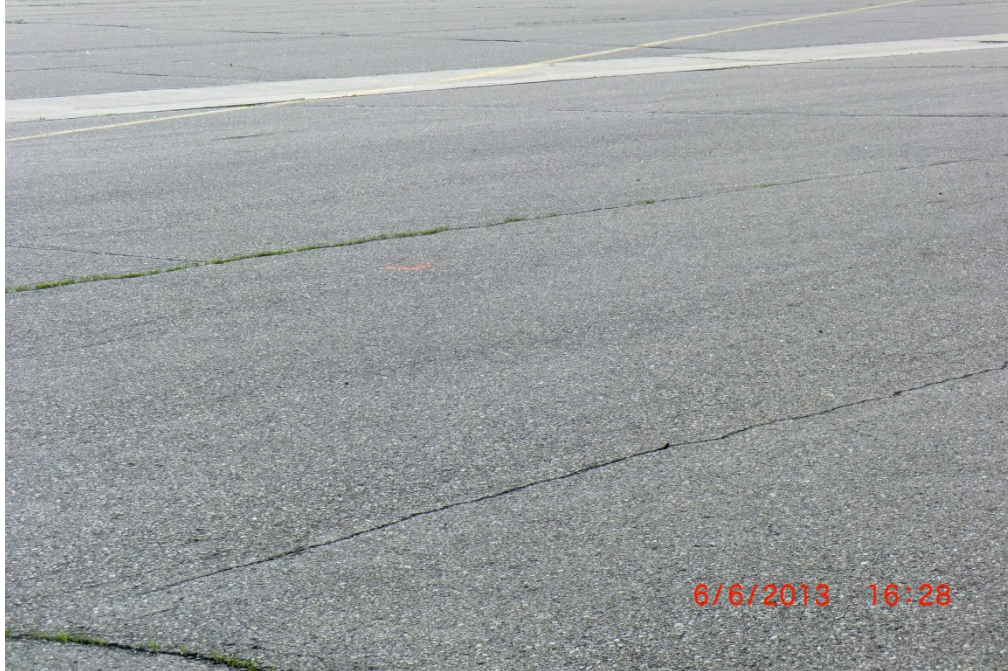
TVF APA 003 (PCI = 45)

Conditions: PCI : 45

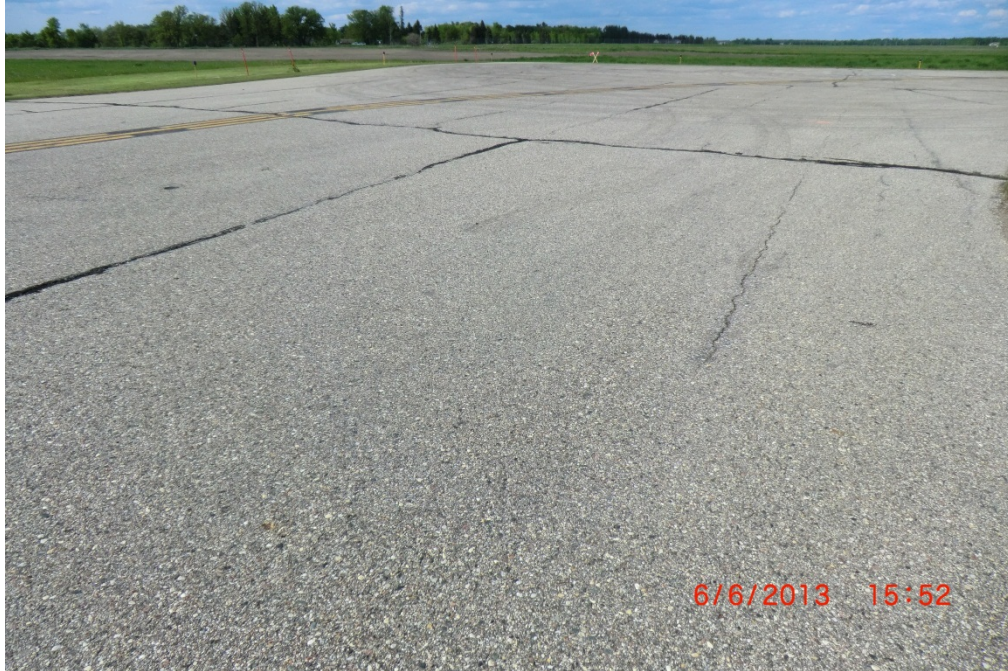
TVF CTA 002 (PCI = 47)

Conditions: PCI : 47

48	LONGITUDINAL/TRANSVERSE CRACKING	L	404.00 Ft	Comments:
48	LONGITUDINAL/TRANSVERSE CRACKING	M	189.00 Ft	Comments:
48	LONGITUDINAL/TRANSVERSE CRACKING	H	16.00 Ft	Comments:
45	DEPRESSION	L	51.00 SqFt	Comments:
41	ALLIGATOR CRACKING	L	68.00 SqFt	Comments:

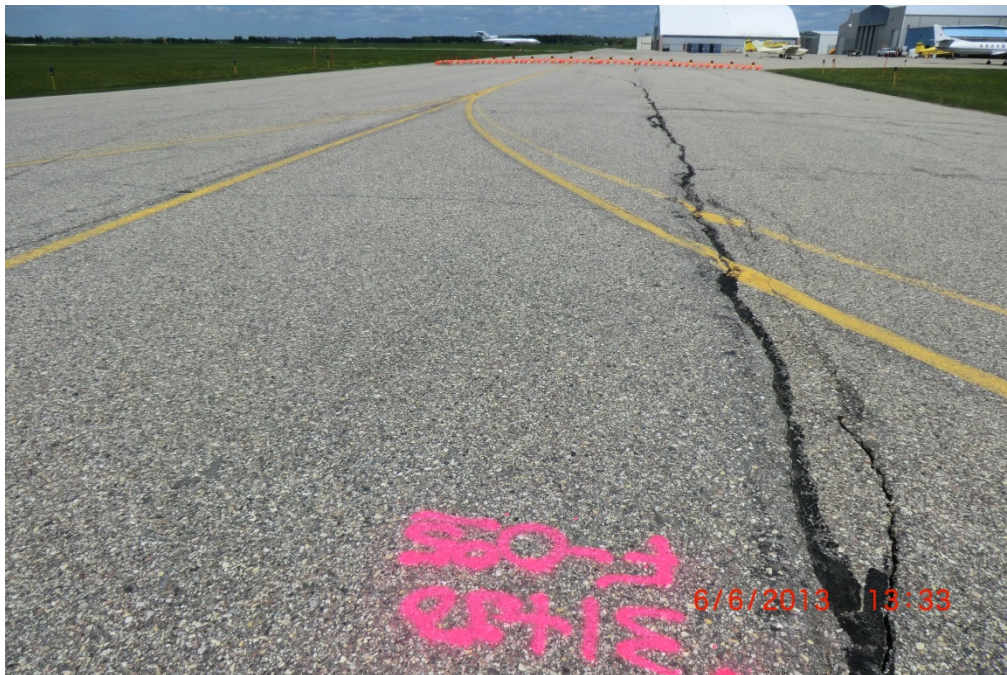
TVF CTA2X 001 (PCI = 62)

Conditions: PCI: 62

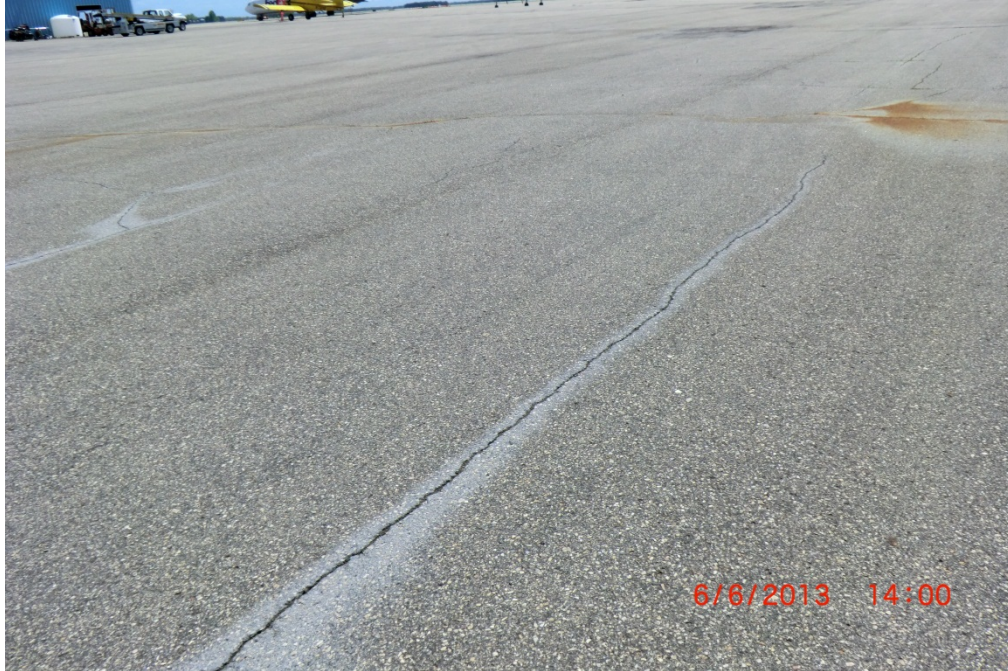
TVF CTA2X 002 (PCI = 48)

Conditions: PCI: 48

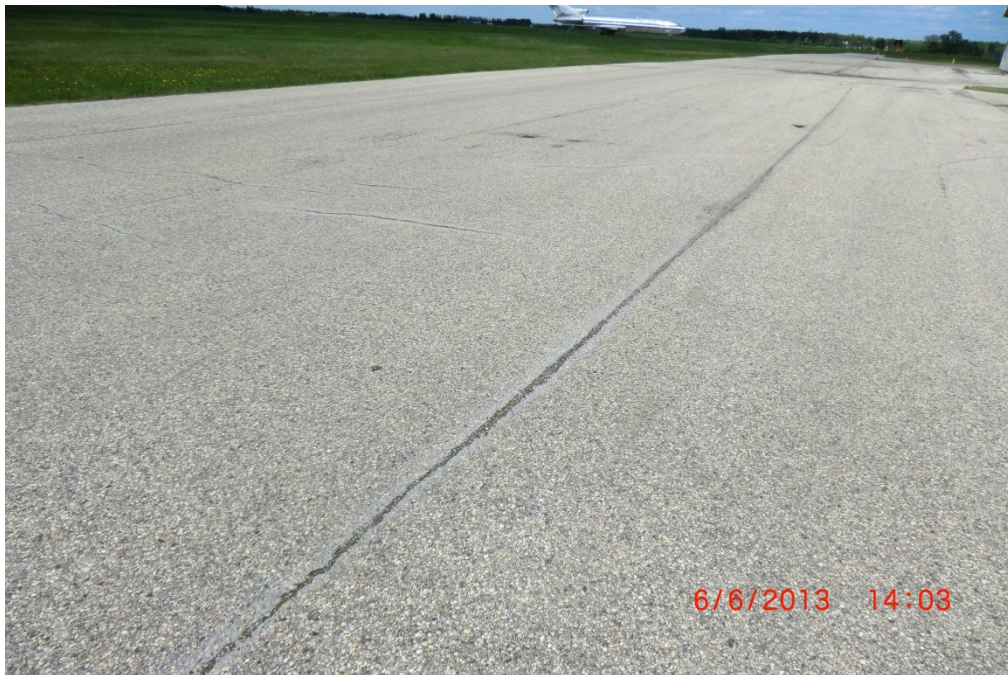
TVF CTA2X 003 (PCI = 52)

Conditions: PCI: 52

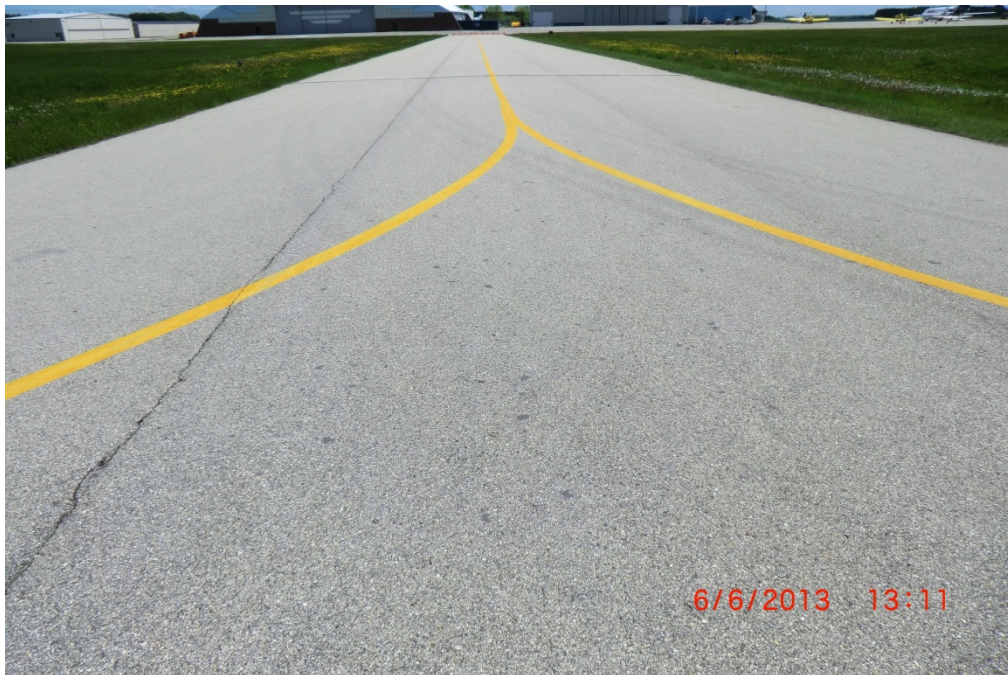
TVF CTC 001 (PCI = 81)

Conditions: PCI : 81

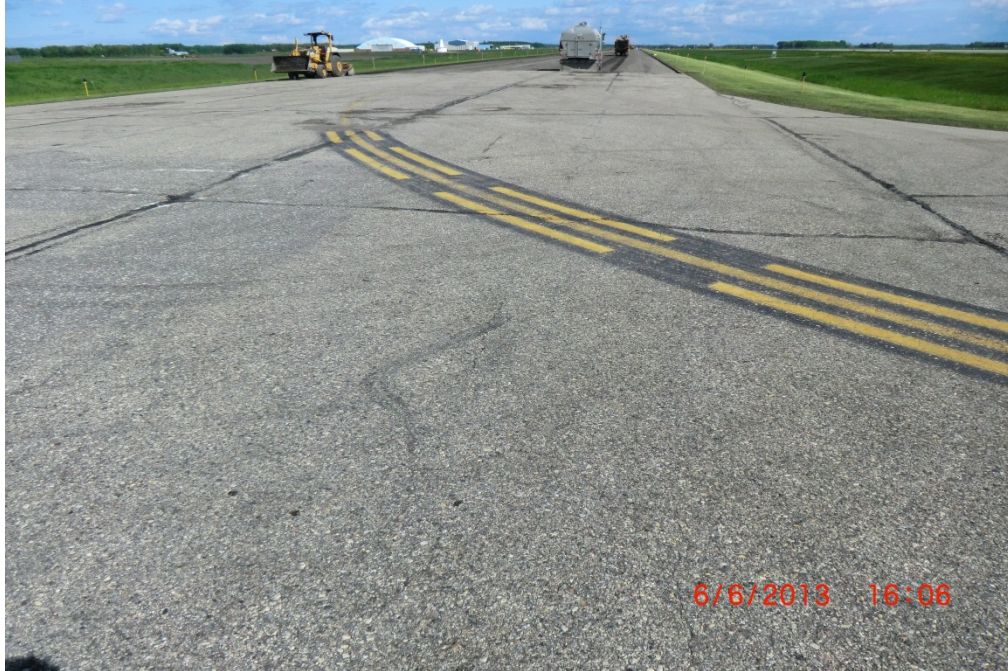
TVF PTA 001 (PCI = 43)

Conditions: PCI : 43

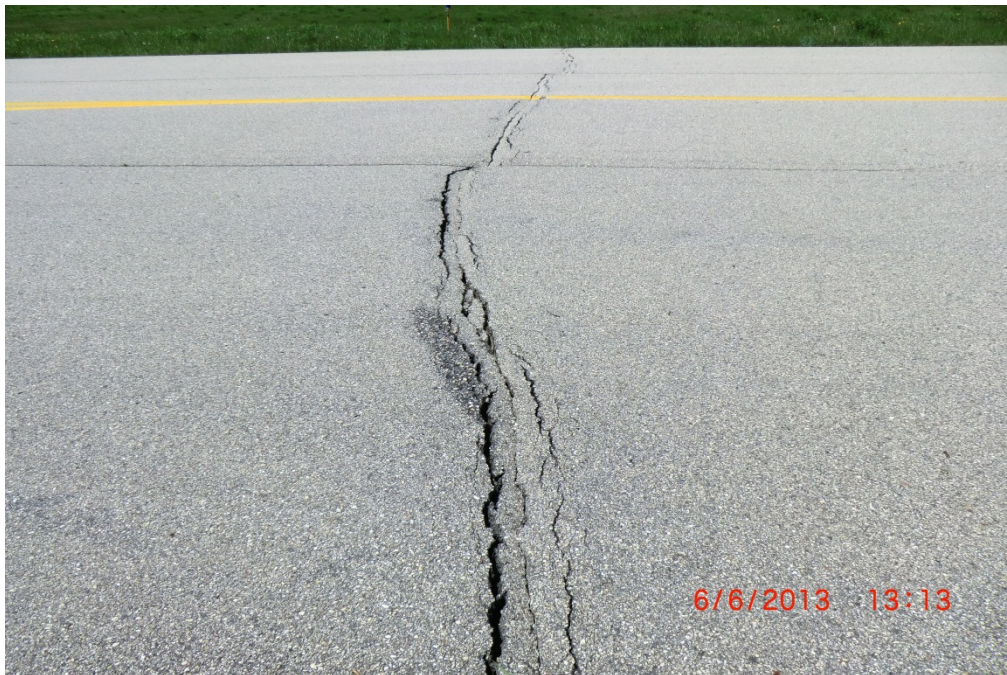
TVF PTB 001 (High-Severity L&T Crack)
