Minnesota Airport System Pavement Evaluation 2013 Update

New Ulm Municipal Airport (ULM)

New Ulm, Minnesota

Final Report

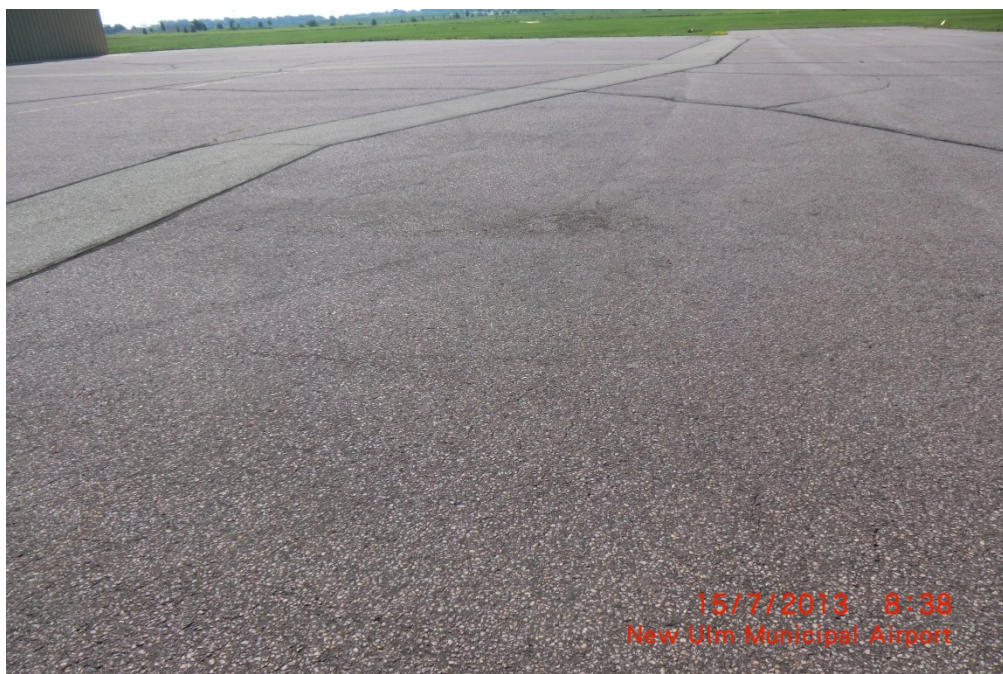
ULM APA 001 (PCI = 63)

Conditions: PCI : 63

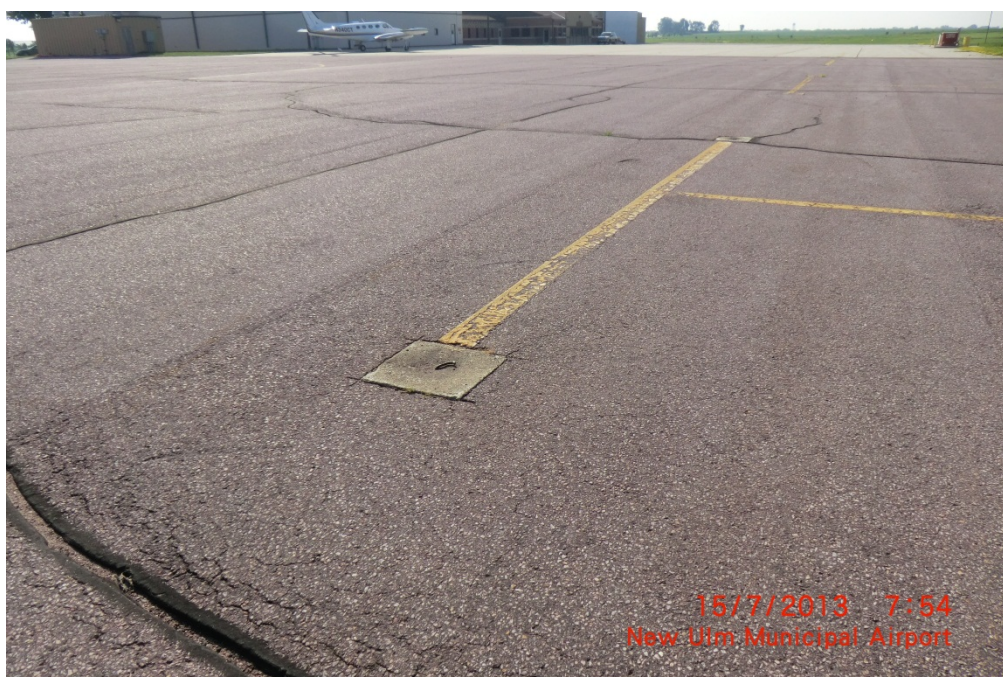
ULM APA 002 (PCI = 59)

Conditions: PCI : 59

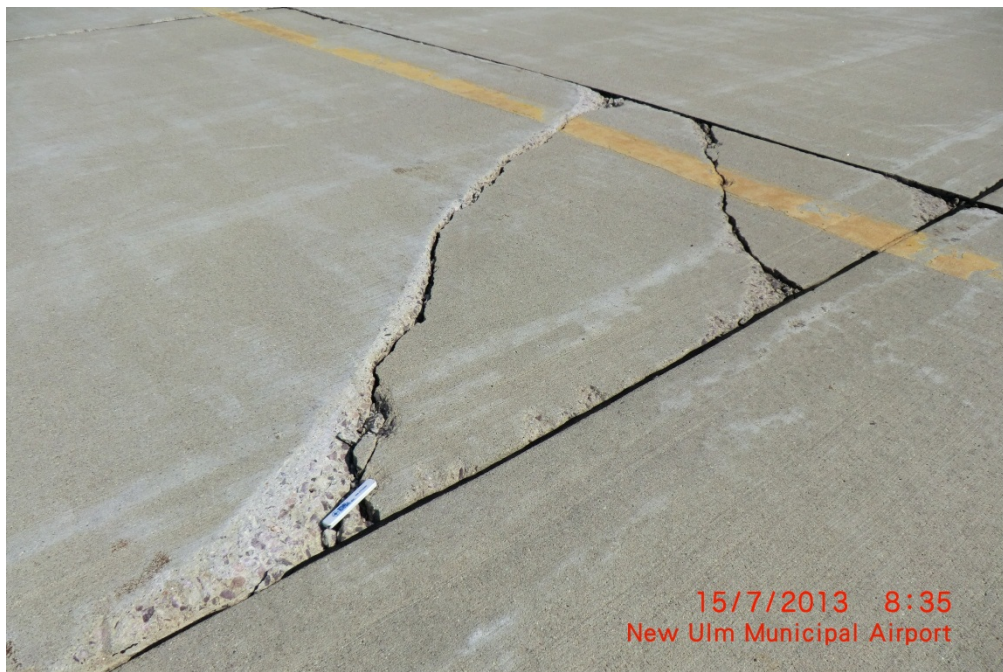
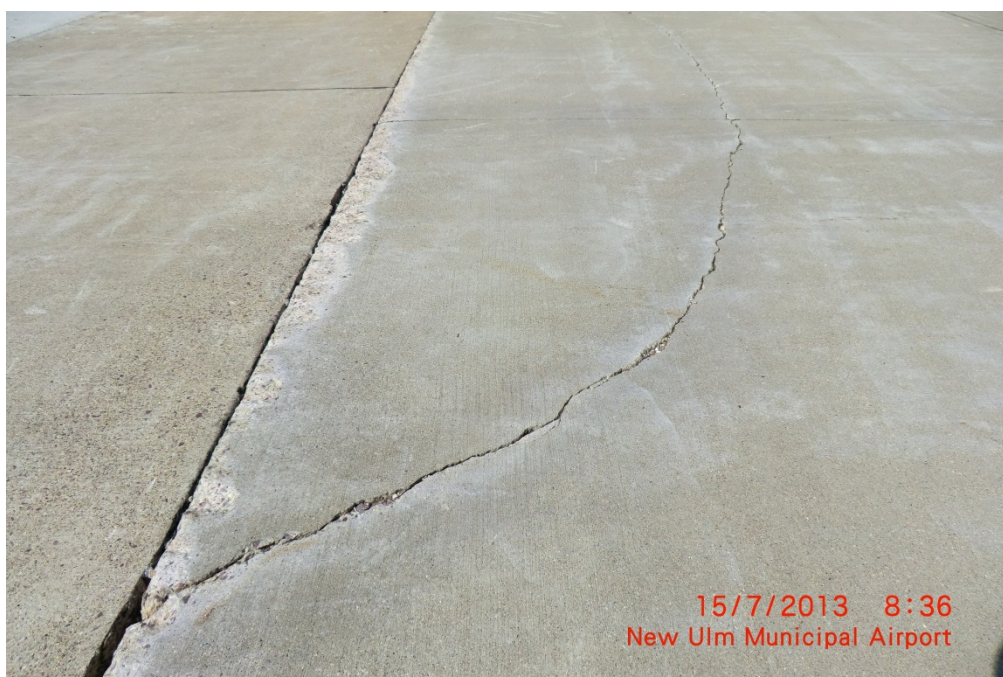
ULM APA 003 (PCI = 74)

Conditions: PCI : 74

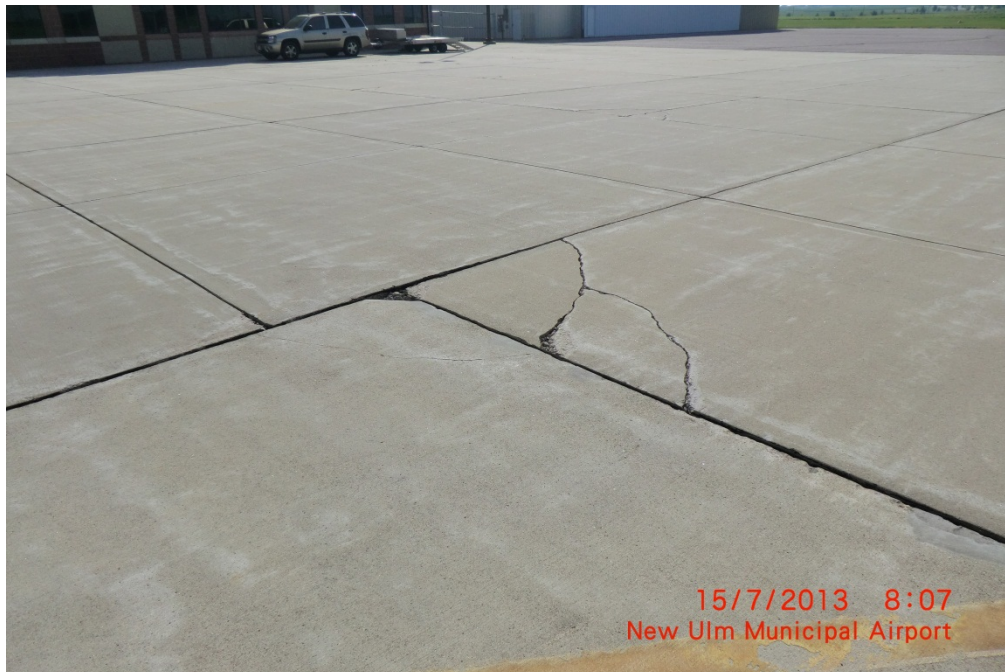
ULM APA 004 (PCI = 32)

Conditions: PCI : 32

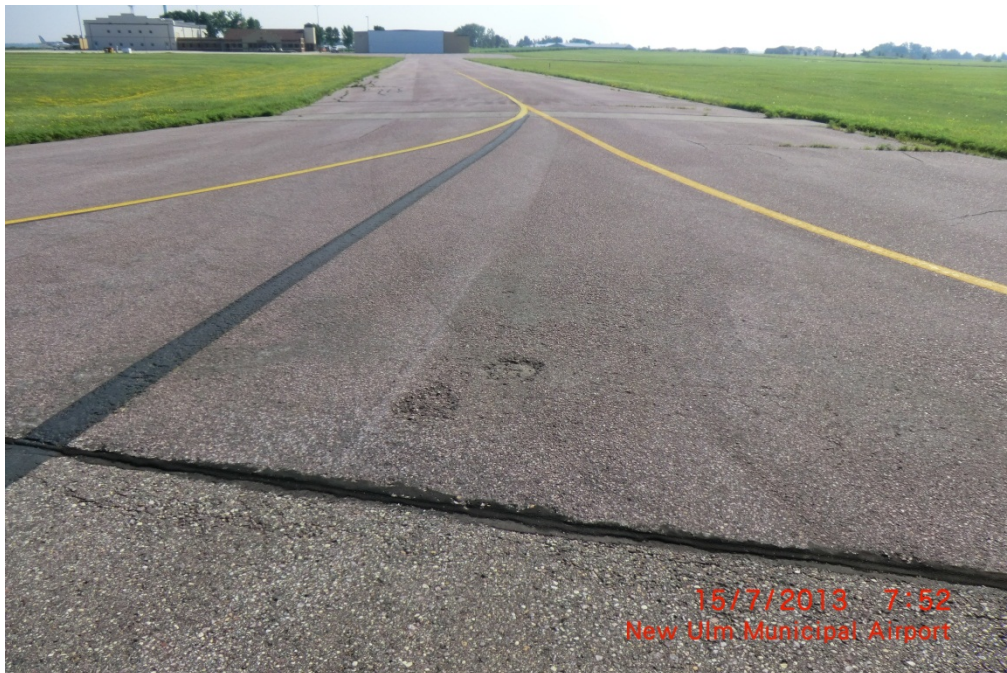
ULM CTB 002 (PCI = 64)

Conditions: PCI : 64

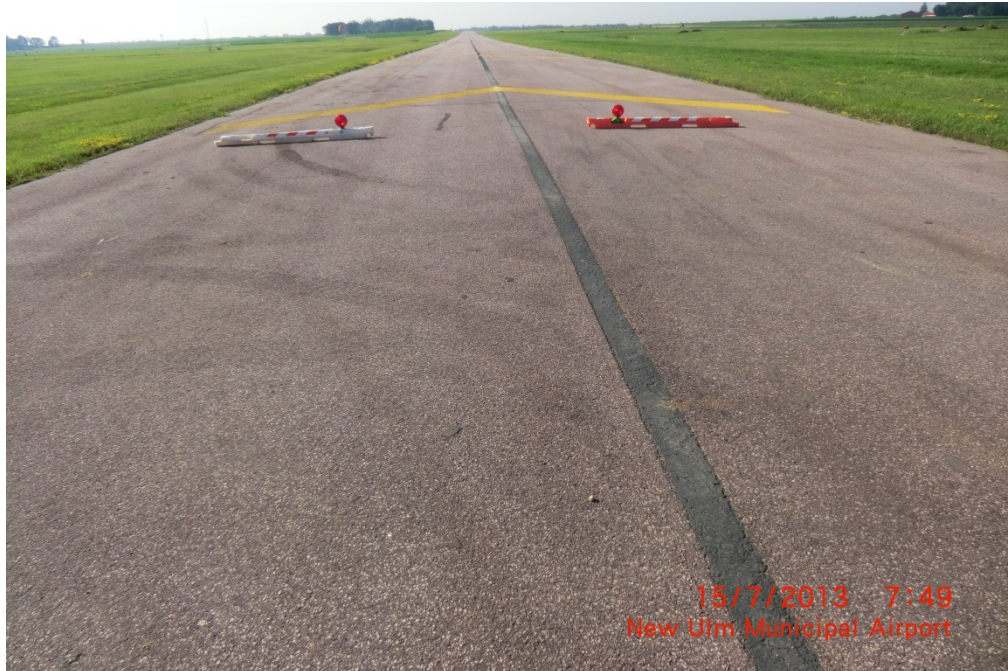
ULM PTA 002 (PCI = 61)

Conditions: PCI : 61
